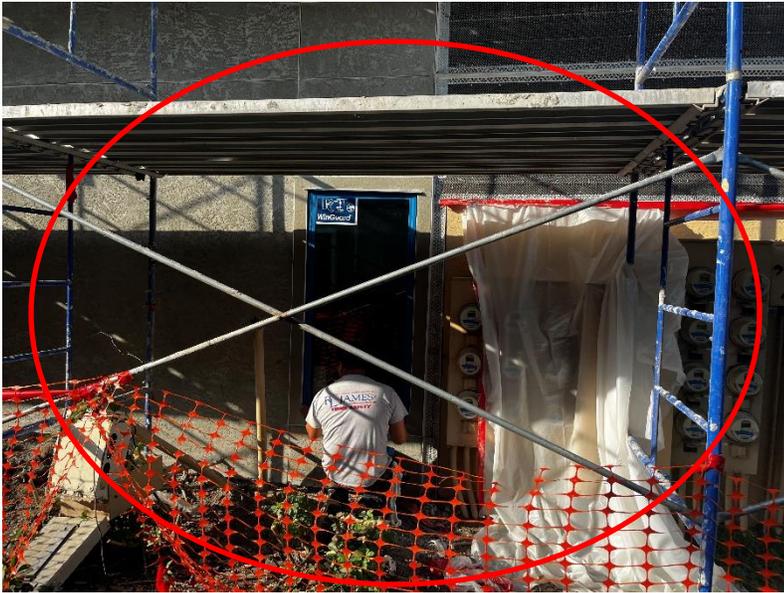
PHOTOGRAPH #1

Contractor masking window framing in preparation for new MasterSeal 150 sealant at window perimeter.

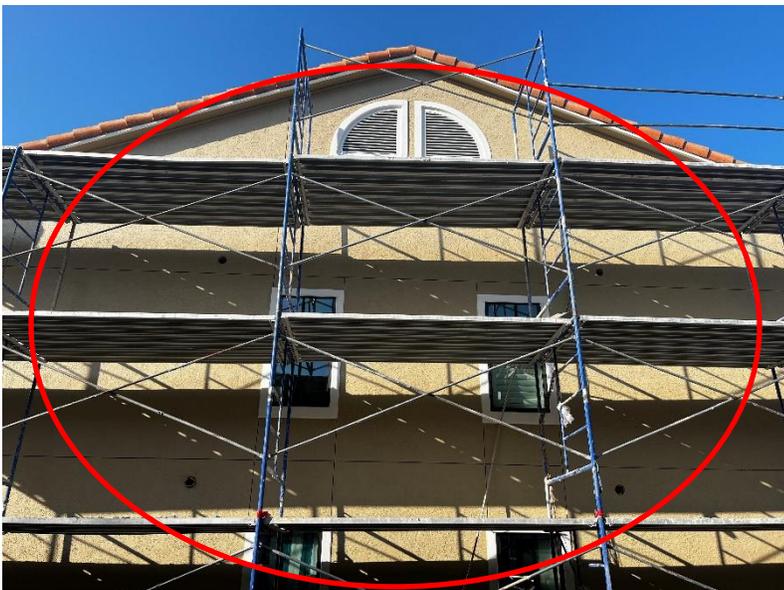
PHOTOGRAPH #2

New Florida Paints primer and finish applied to new stucco at gable end wall.

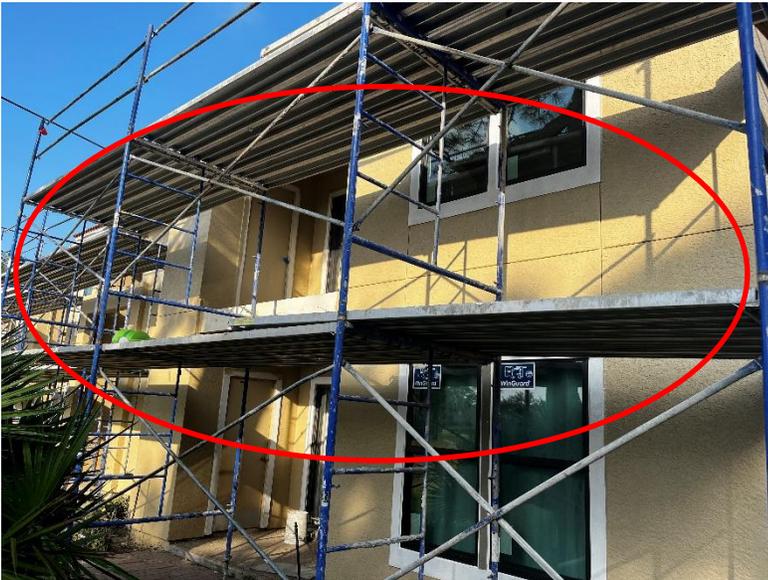
PHOTOGRAPH #3

New Florida Paints primer and finish applied to new stucco.

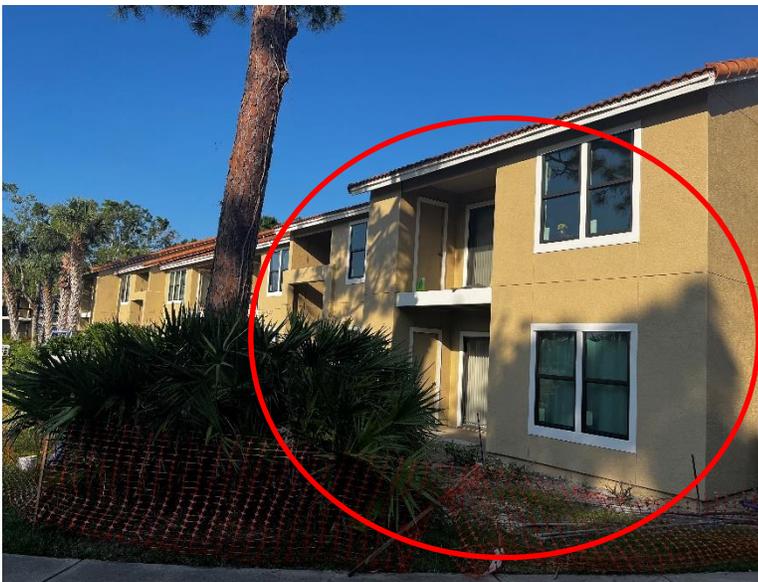
PHOTOGRAPH #4

Contractor has removed framing scaffolding and begun to clean grounds.

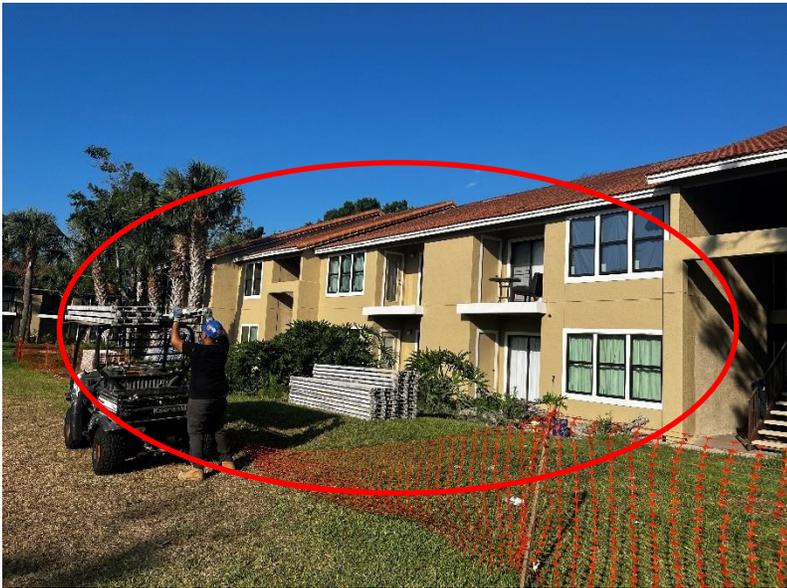
PHOTOGRAPH #5

Contractor has primed and painted new stucco and in process of removing scaffolding.

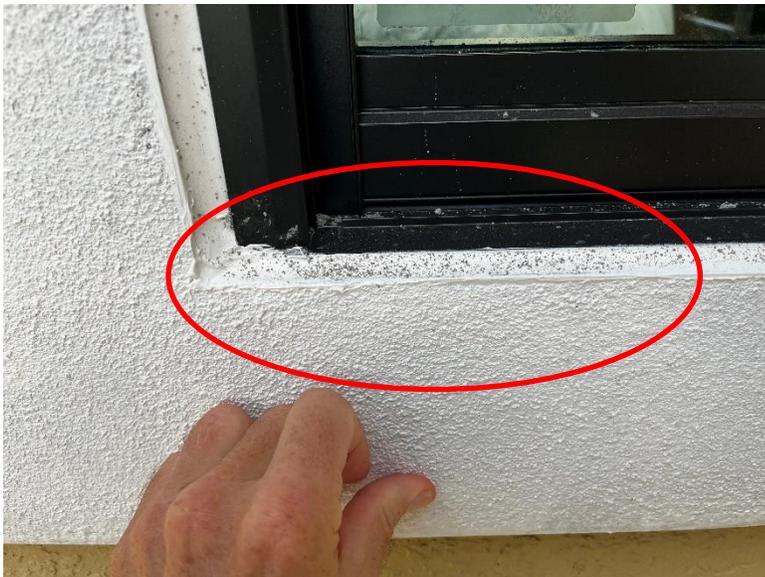
PHOTOGRAPH #6

Sealant at window perimeter has sand stuck to sealant surface and will require painting for proper appearance.

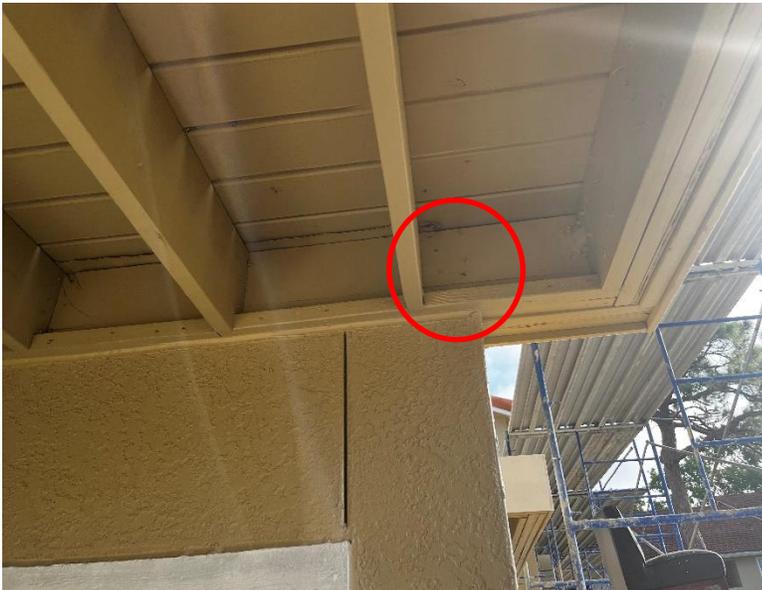
PHOTOGRAPH #7

Simpson Strong- Tie Screws required at balcony deck ledger to blocking have not yet been installed as per drawings.

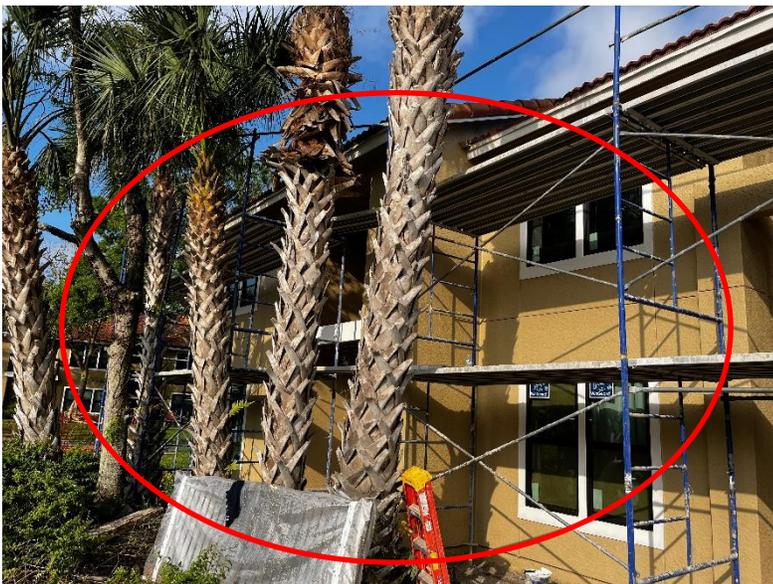
PHOTOGRAPH #8

Contractor has primed and painted new stucco and in process of removing scaffolding.

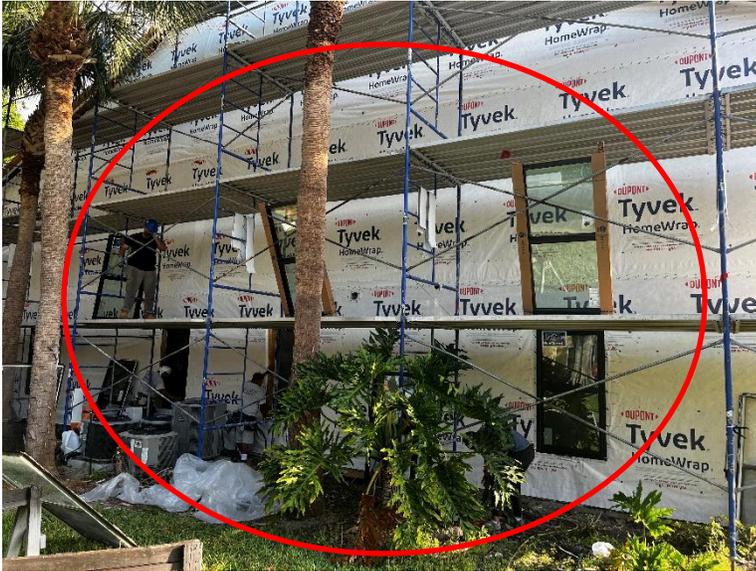
PHOTOGRAPH #9

New PGT SH7700A single hung windows being installed at gale end wall.

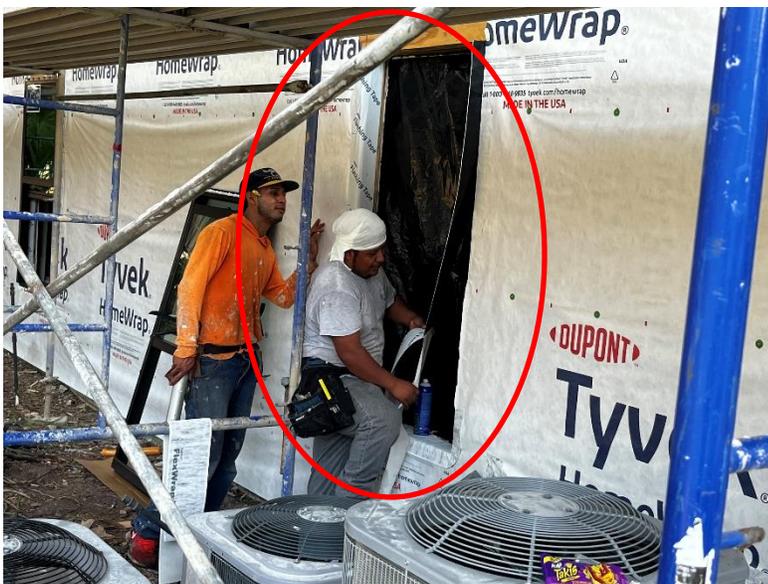
PHOTOGRAPH #10

Dupont FlexWrap applied at windowsill and Straight Flash applied at window jams prior to installation of new window.

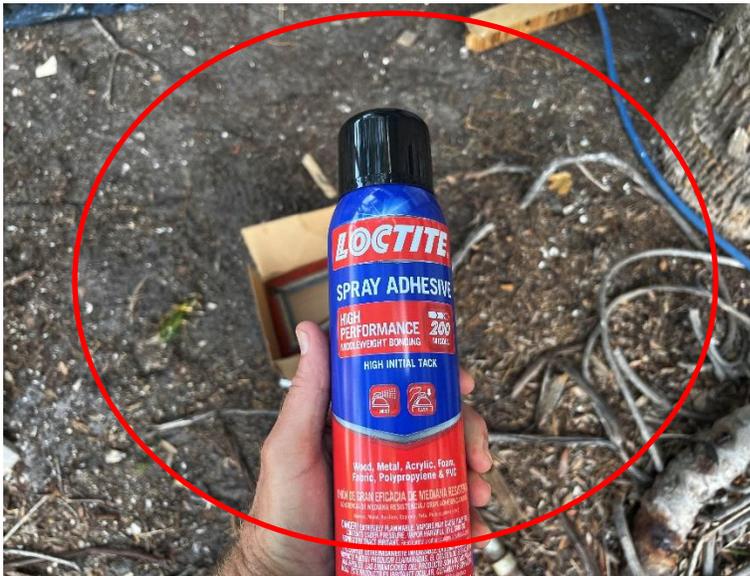
PHOTOGRAPH #11

Loctite spray adhesive used to enhance bond of Dupont flashing to Tyvek HomeWrap as per manufacturers recommendations.

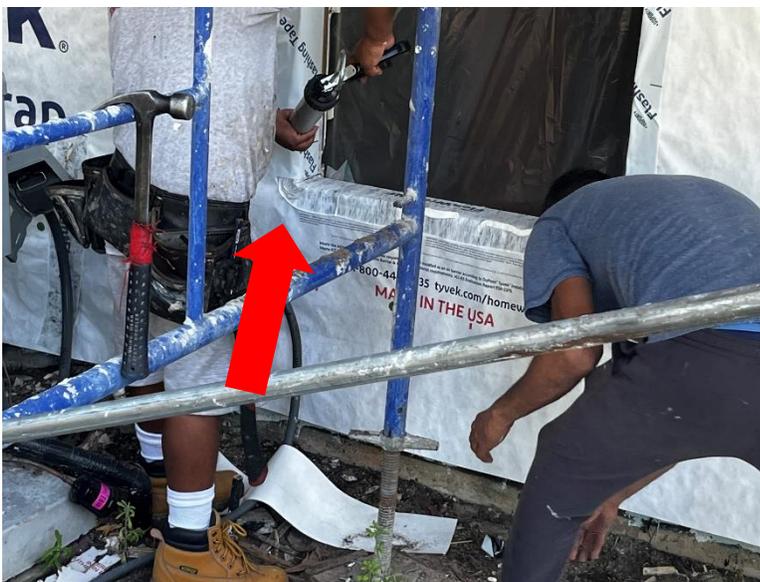
PHOTOGRAPH #12

Urethane Sealant applied between new window flange and Dupont flashings as per manufacturers recommendations.

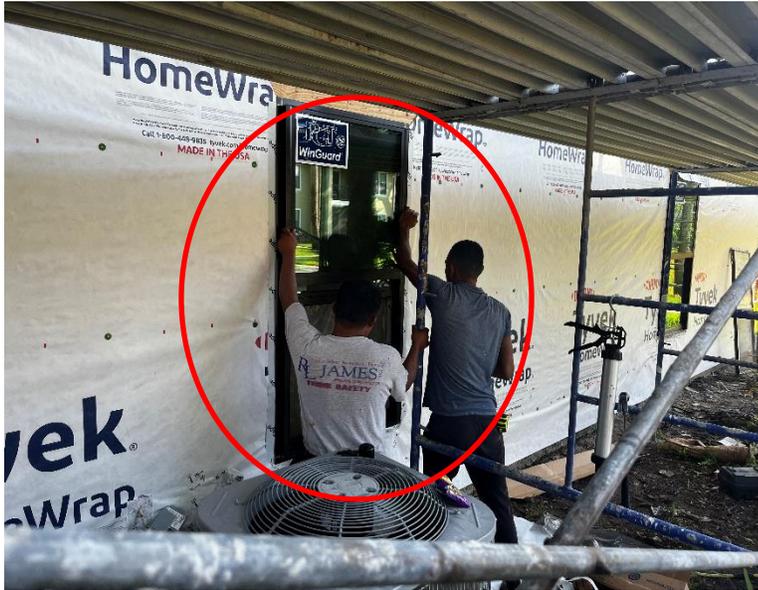
PHOTOGRAPH #13

New window seated into opening and fastened with 2 1/2" 8d common nails spaced along perimeter at 5" O.C.

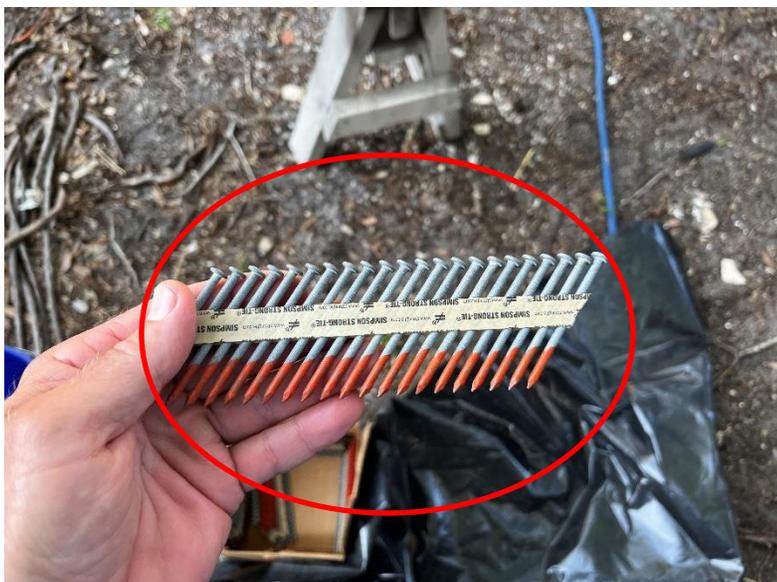
PHOTOGRAPH #14

New window seated into opening and fastened with 2 1/2" 8d common nails spaced along perimeter at 5" O.C.

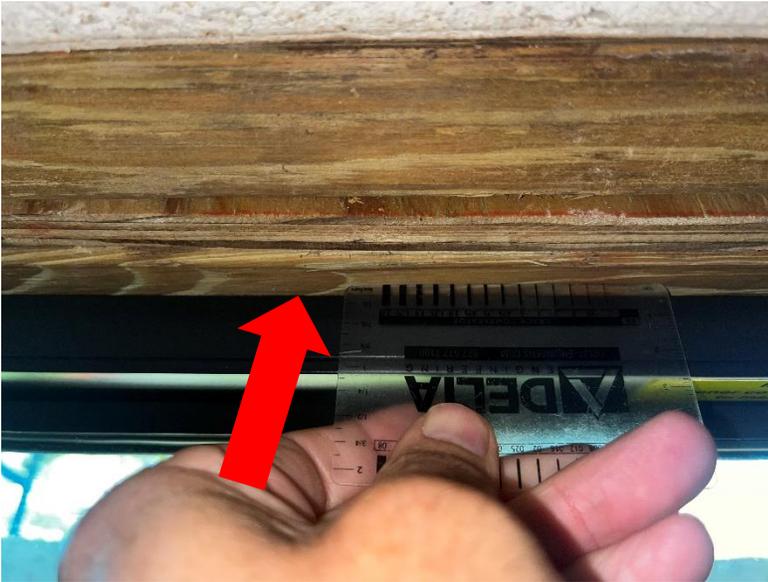
PHOTOGRAPH #15

Interior gap from window frame to head framing meets manufactures Max. 5/16" requirements.

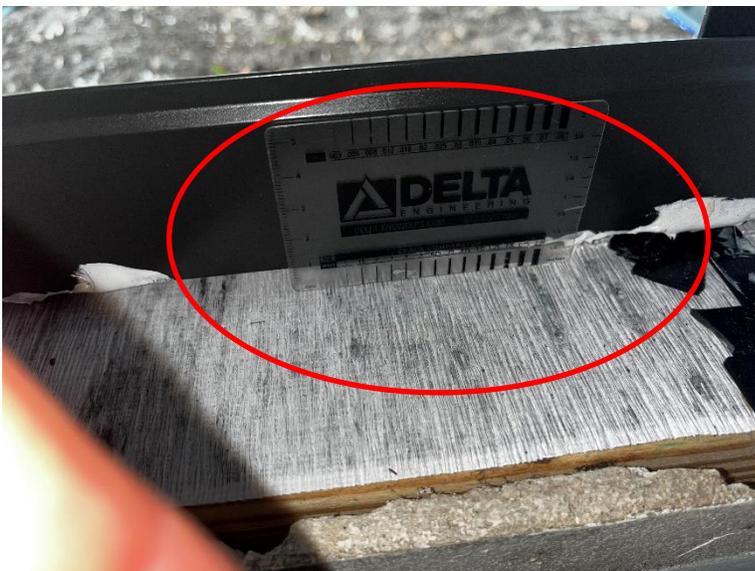
PHOTOGRAPH #16

Interior gap from window frame to sill framing meets manufactures Max. 5/16" requirements.

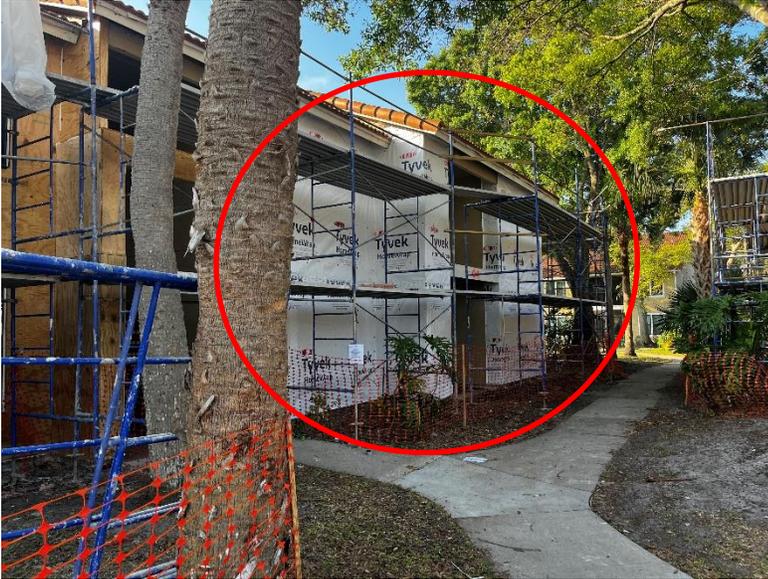
PHOTOGRAPH #17

Contractor has applied new Tyvek HomeWrap WRB over new 15/32" plywood sheathing.

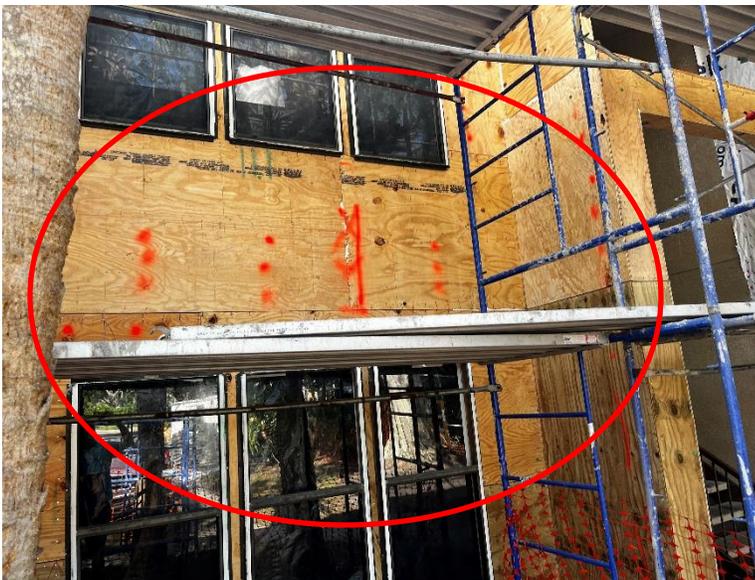
PHOTOGRAPH #18

Missed fasteners and damaged plywood marked for corrections.

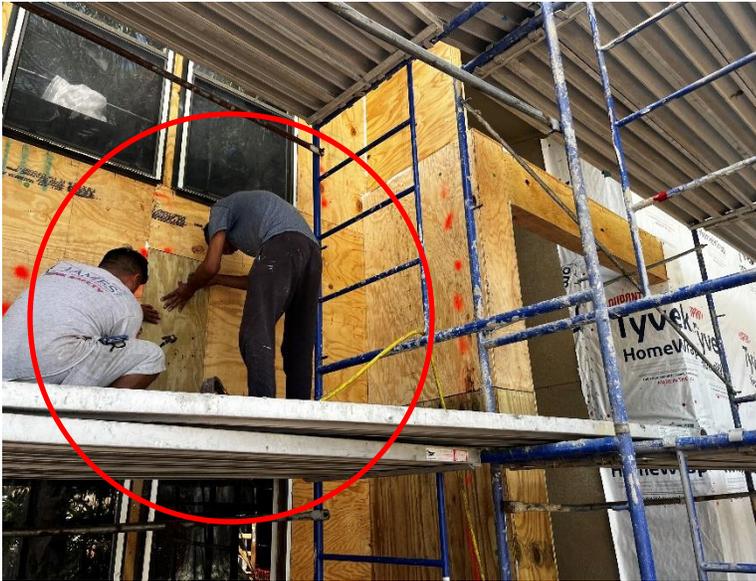
PHOTOGRAPH #19

Contractor making corrections and adding fasteners where required as per drawings and specifications.

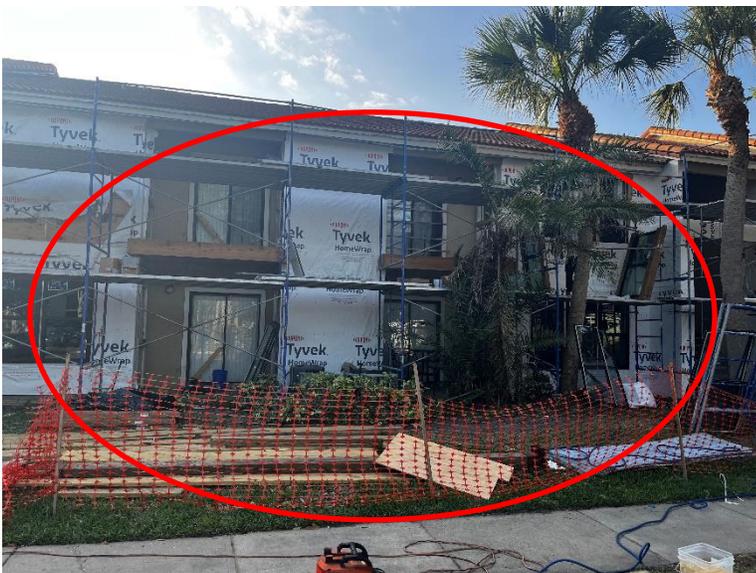
PHOTOGRAPH #20

Contractor has applied new Tyvek HomeWrap WRB over new 15/32" plywood sheathing.

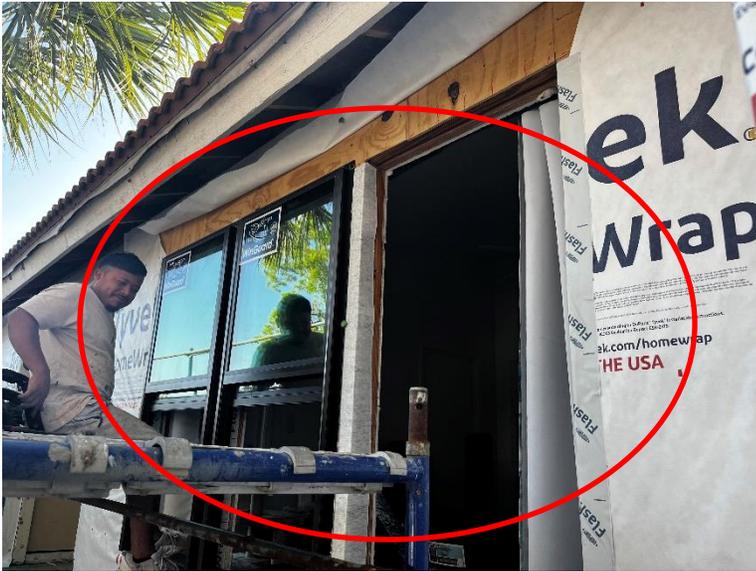
PHOTOGRAPH #21

New PGT windows installed with Dupont flashing as per manufacturers recommendation and drawings.

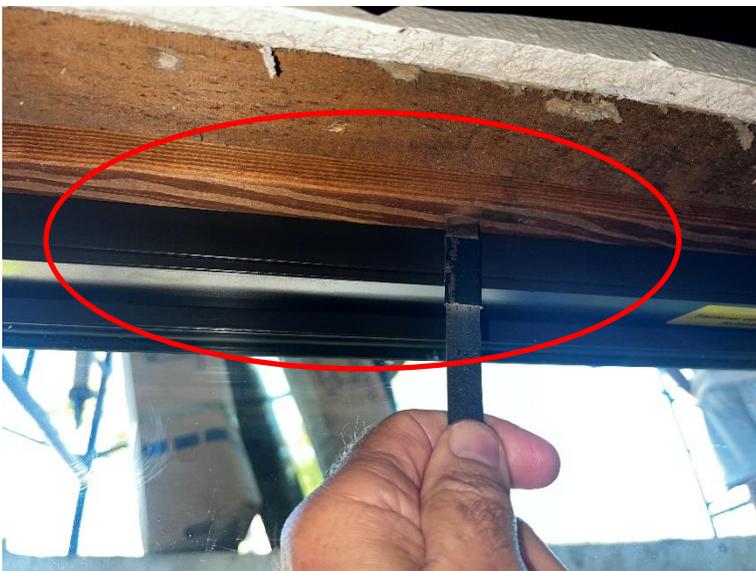
PHOTOGRAPH #22

Interior gap from window frame to head framing meets manufactures Max. 5/16" requirements

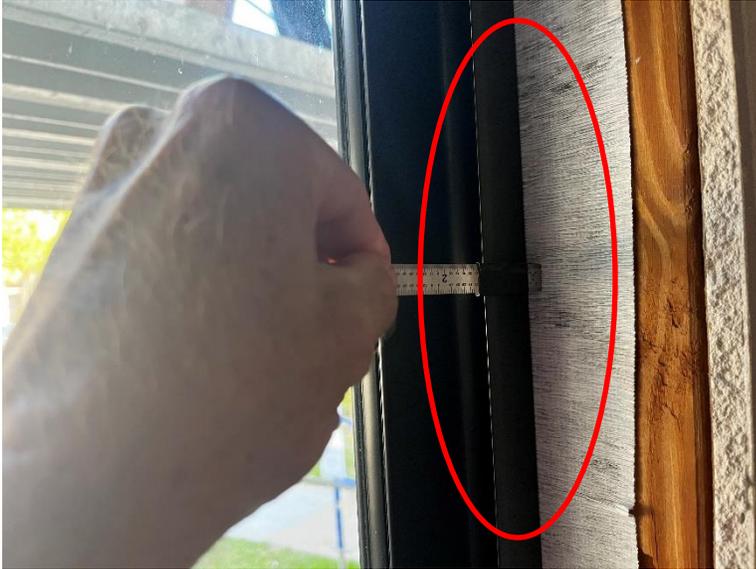
PHOTOGRAPH #23

Interior gap from window frame to jamb framing meets manufactures Max. 5/16" requirements.

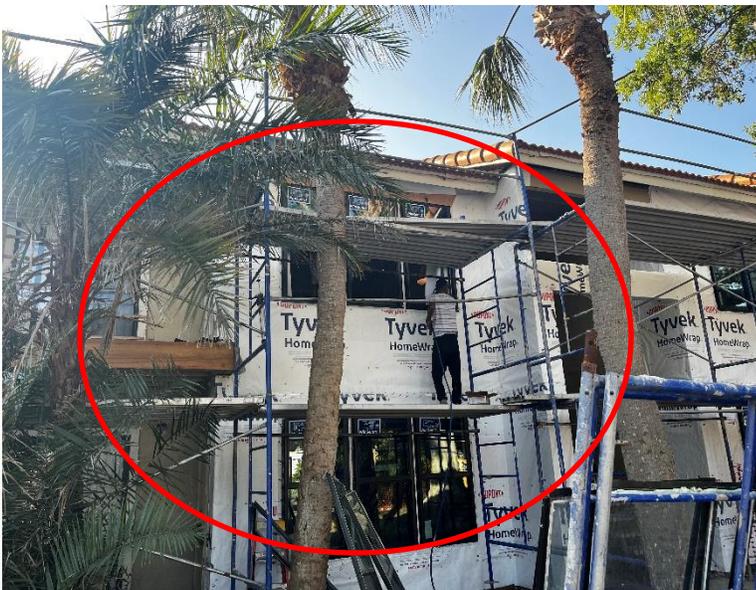
PHOTOGRAPH #24

New PGT windows installed with Dupont flashing as per manufactures recommendation and drawings.

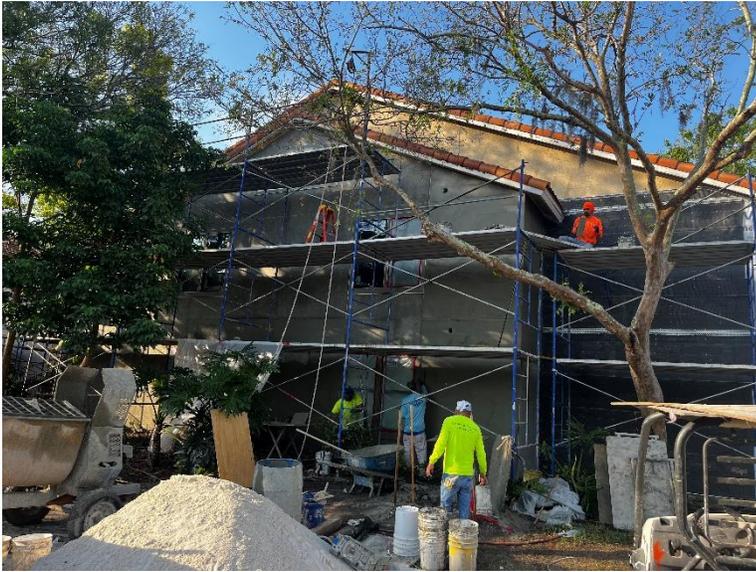
PHOTOGRAPH #25

Stucco sub-contractor applying brown coat of stucco over scratch coat.

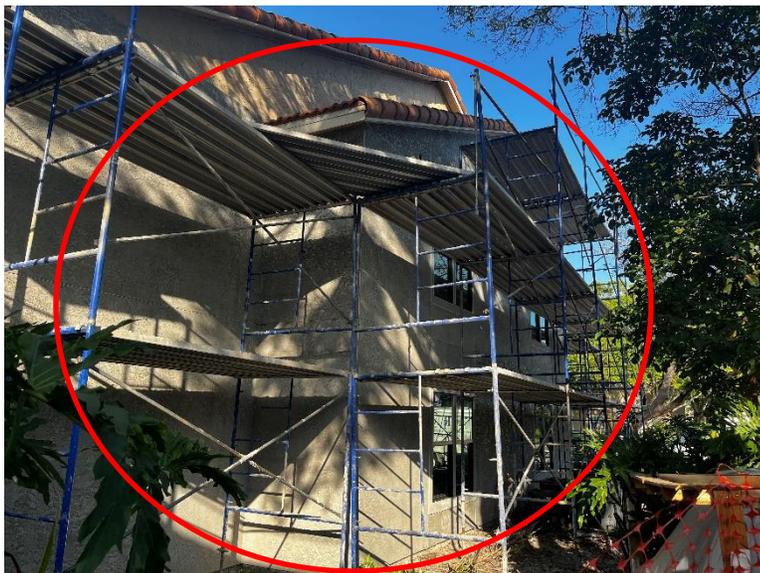
PHOTOGRAPH #26

Stucco sub-contractor has completed application of full three coat 7/8" stucco system.

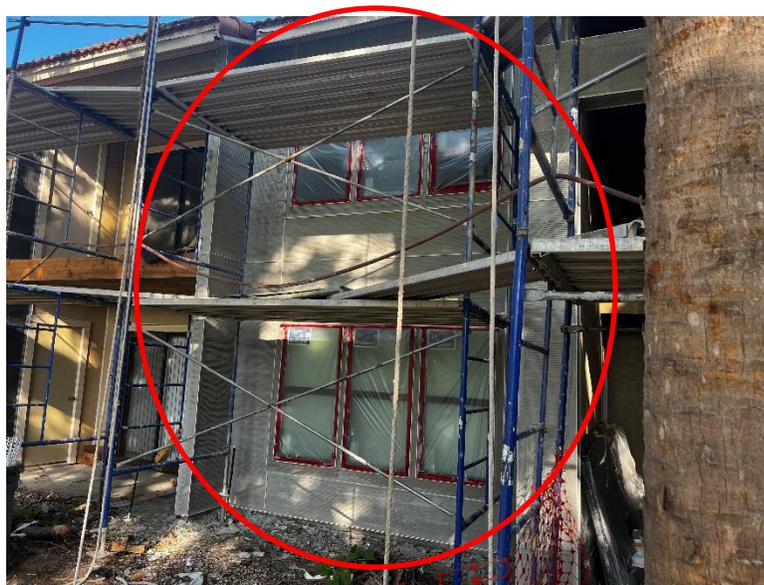
PHOTOGRAPH #27

Stucco sub-contractor has protected windows and applied scratch coat of stucco.

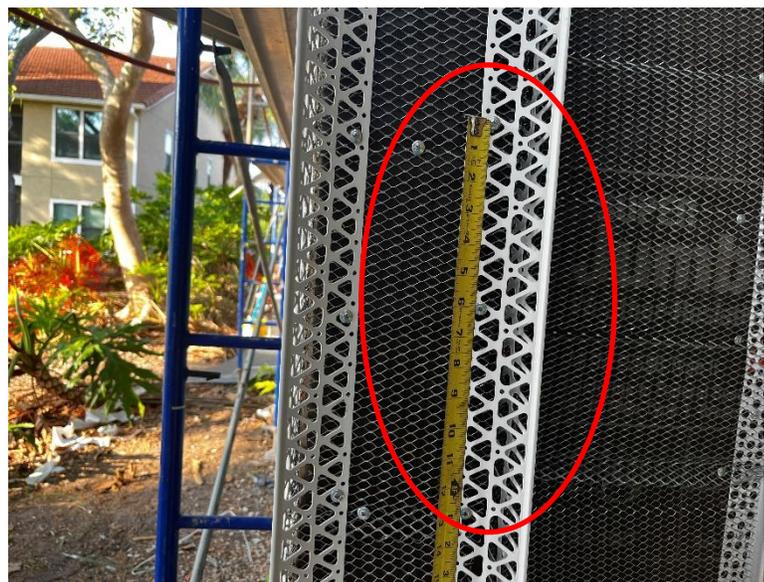
PHOTOGRAPH #28

Vinyl corner bead accessories fastened to framing at no more than 7" intervals.

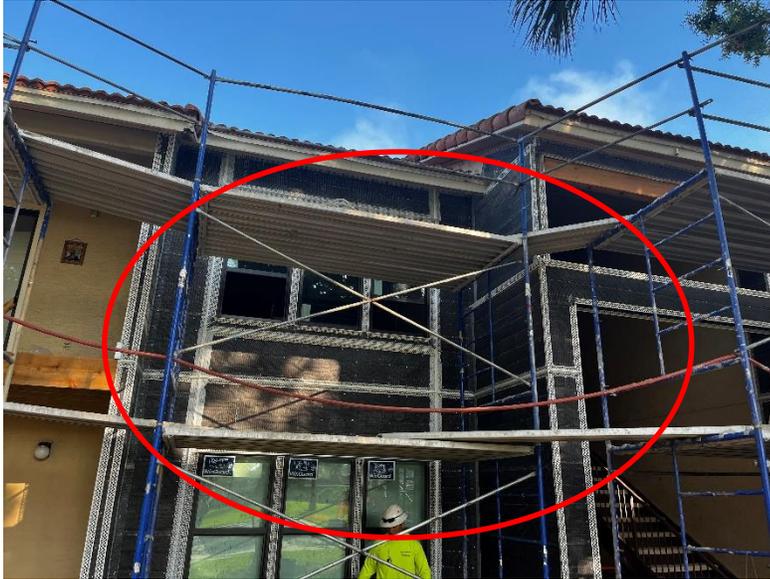
PHOTOGRAPH #29

Stucco sub-contractor applying galvanized self-furring lathing and vinyl stucco accessories in preparation for stucco applications.
