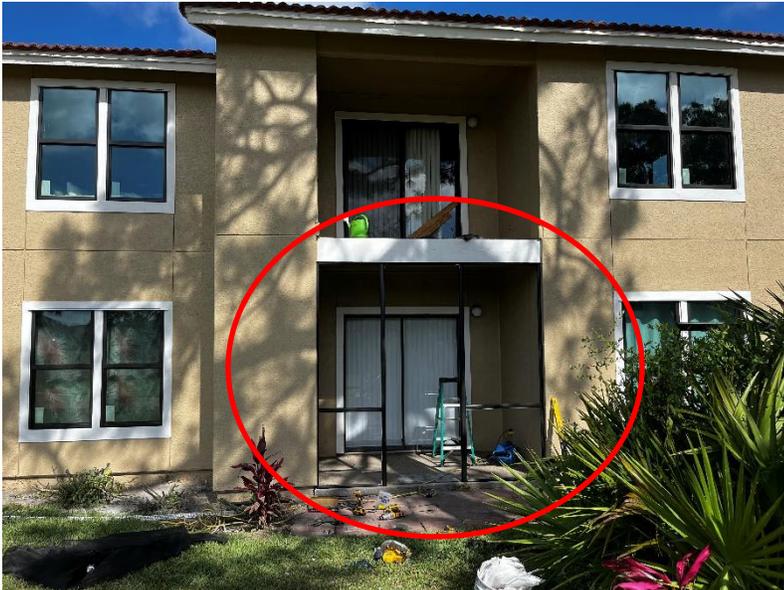
PHOTOGRAPH #1

**BUILDING 11
SECTION G**

Contractor installing screen enclosures at ground floor patios.

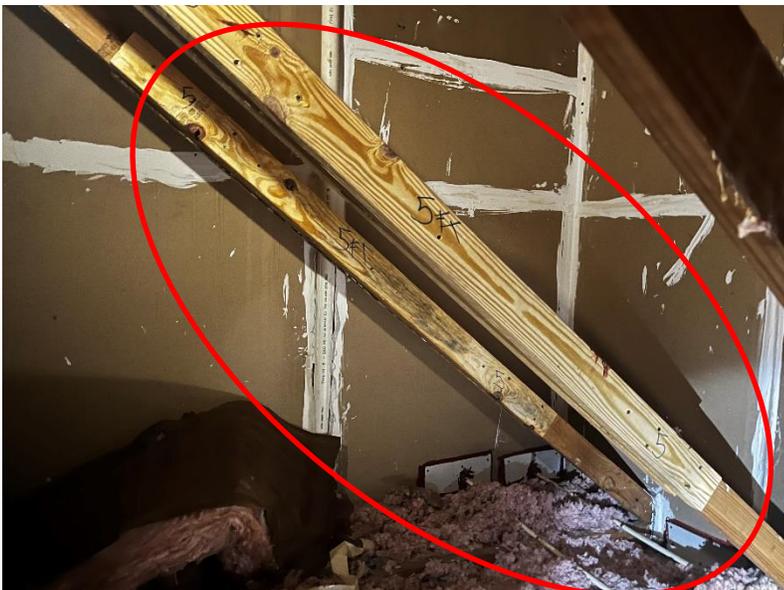
PHOTOGRAPH #2

**BUILDING 11
UNIT #1122 ATTIC- SECTION G**

Contractor has performed scab repairs at damaged trusses.

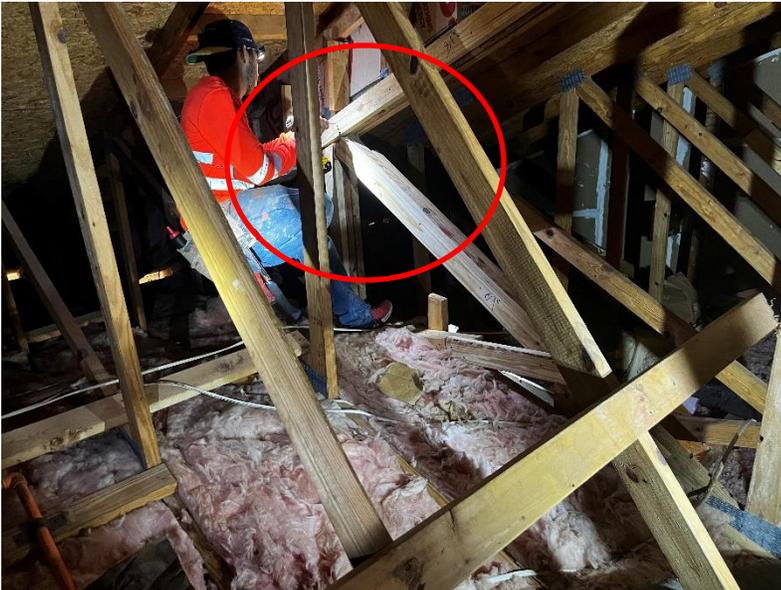
PHOTOGRAPH #3

**BUILDING 11
UNIT #1122 ATTIC - SECTION G**

Contractor adding additional fasteners at truss repairs as required by repair drawings.

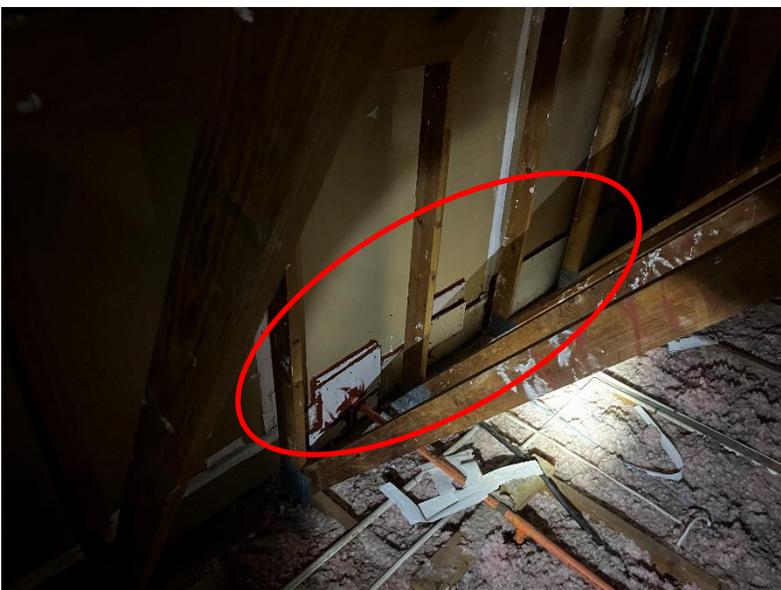
PHOTOGRAPH #4

**BUILDING 11
UNIT #1122 ATTIC - SECTION G**

Contractor has performed fire wall repairs at base of fire wall.

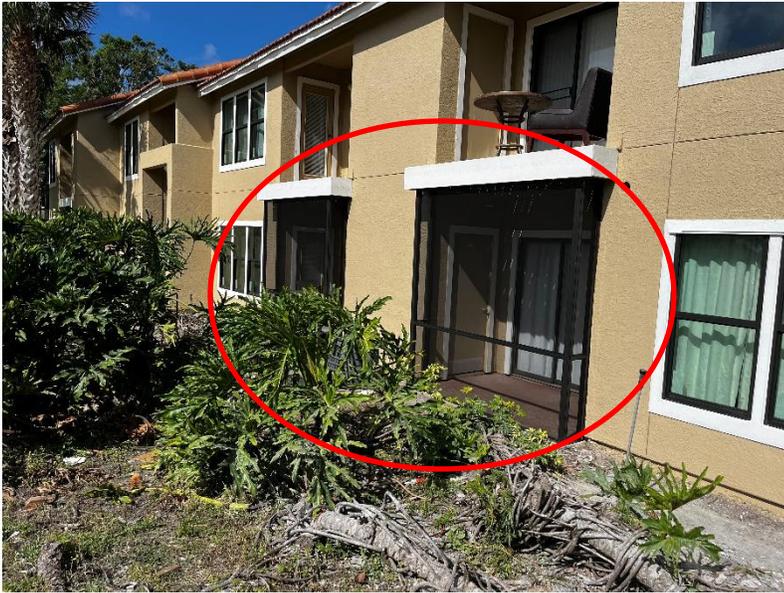
PHOTOGRAPH #5

**BUILDING 11
SECTION F**

Contractor installing screen enclosures at ground floor patios.

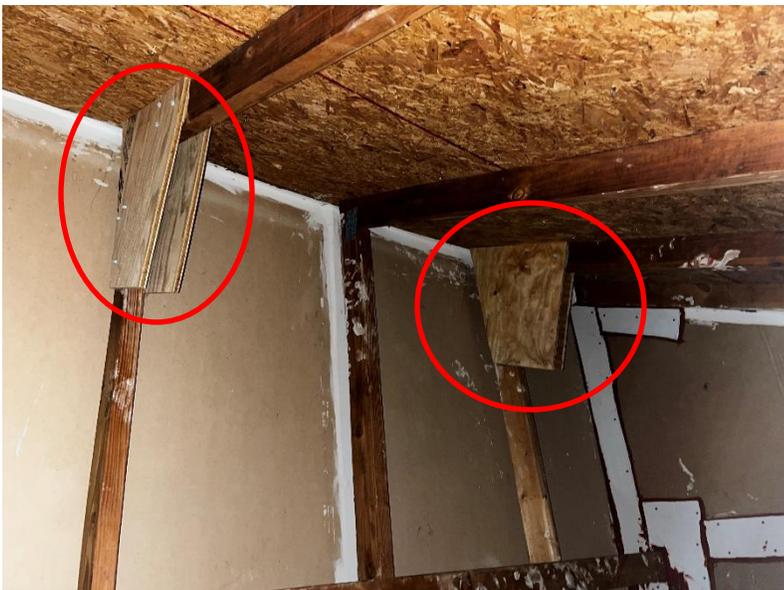
PHOTOGRAPH #6

**BUILDING 11
UNIT #1124 ATTIC- SECTION F**

Contractor has performed gusset repairs where required at trusses as per repair drawings.

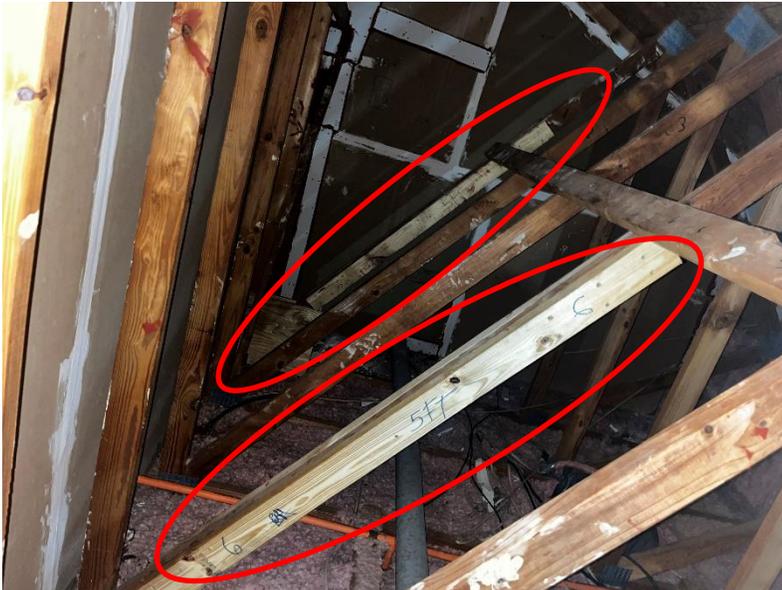
PHOTOGRAPH #7

**BUILDING 11
UNIT #1124 ATTIC- SECTION F**

Contractor has performed scab repairs at damaged trusses.

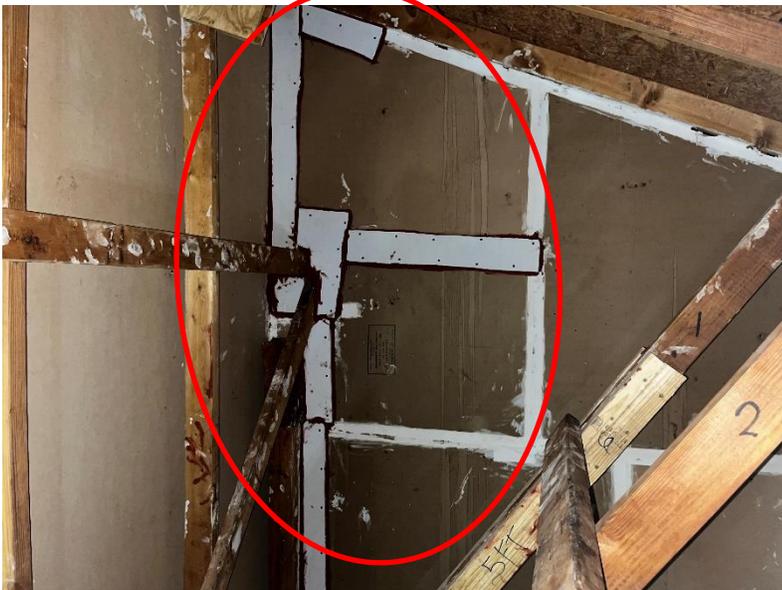
PHOTOGRAPH #8

**BUILDING 11
UNIT #1124 ATTIC- SECTION F**

Contractor has performed firewall and fire sealants repairs at attic space firewalls.

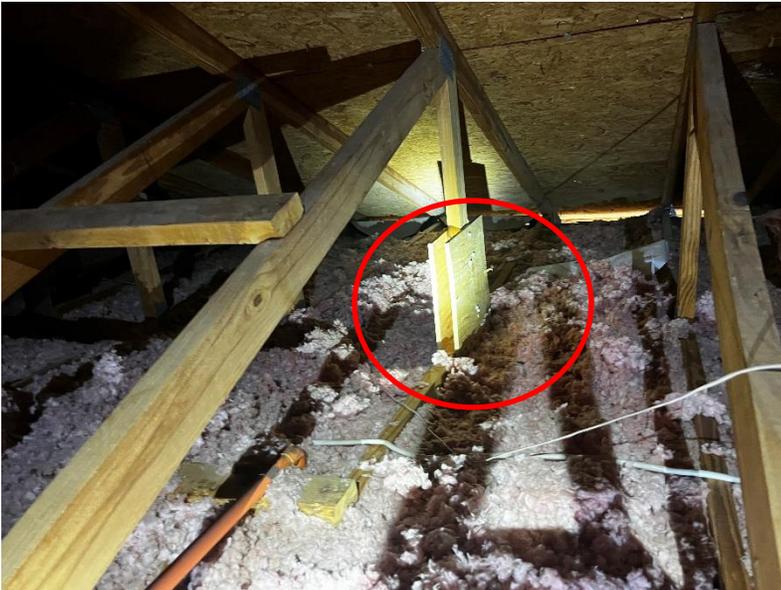
PHOTOGRAPH #9

**BUILDING 11
UNIT #1128 ATTIC- SECTION E**

Contractor has performed gusset repairs where required at trusses as per repair drawings.

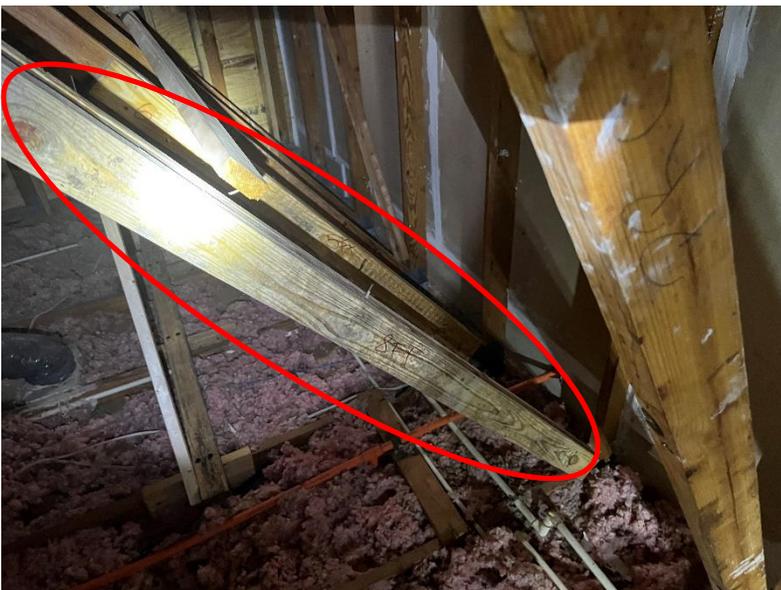
PHOTOGRAPH #10

**BUILDING 11
UNIT #1128 ATTIC - SECTION E**

Contractor has performed scab repairs at damaged trusses.

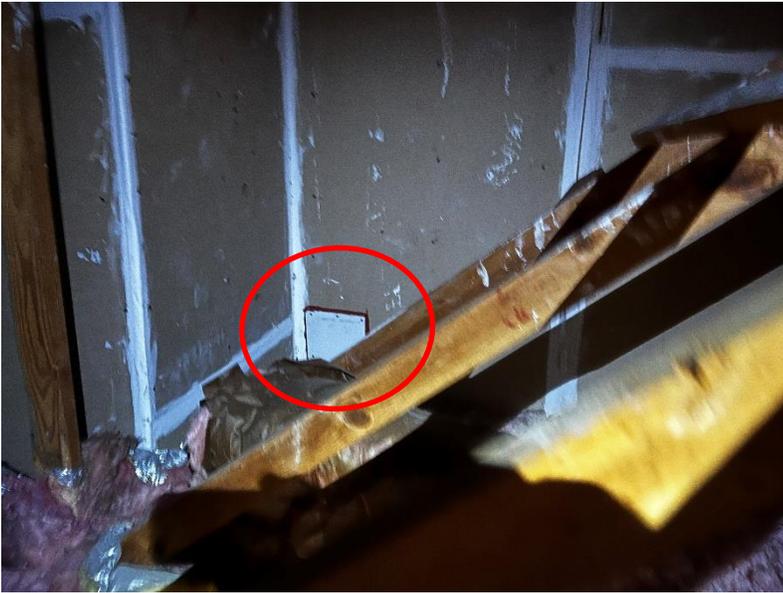
PHOTOGRAPH #11

**BUILDING 11
UNIT #1128 ATTIC- SECTION E**

Contractor has performed firewall and fire sealants repairs at attic space firewalls.

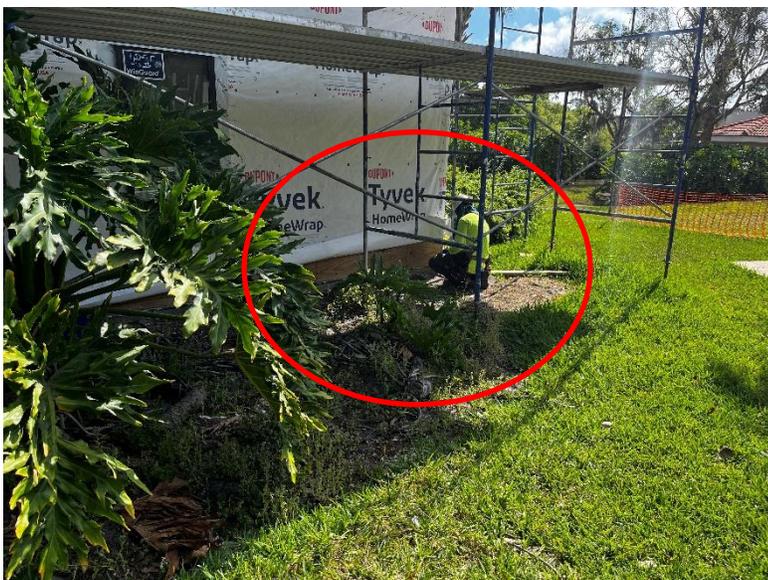
PHOTOGRAPH #12

**BUILDING 11
SECTION D**

Stucco subcontractor installing new vinyl stucco stop weep accessory at base of wall.

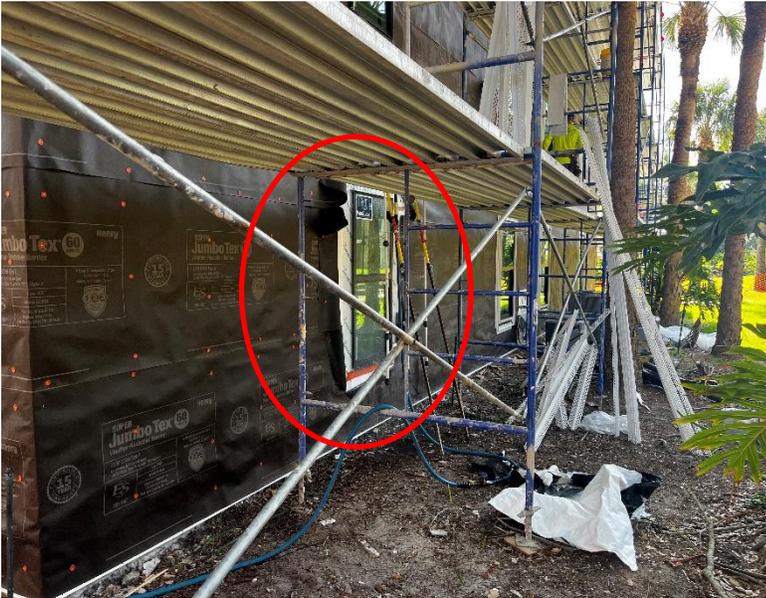
PHOTOGRAPH #13

**BUILDING 11
UNIT #1117- SECTION D**

Independent Testing Agency performed water infiltration testing of window as per AAMA 502 specifications. Testing passed with no water observed.

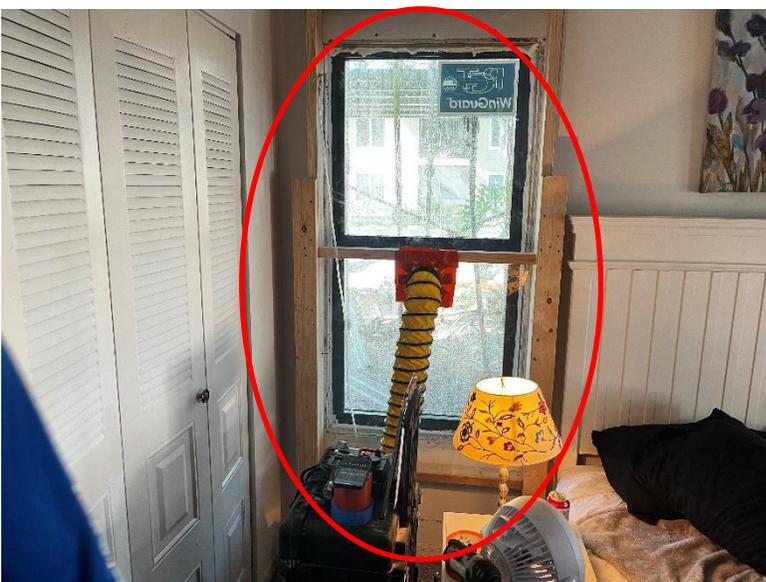
PHOTOGRAPH #14

**BUILDING 11
UNIT #1117- SECTION D**

Independent Testing Agency performed water infiltration testing of window as per AAMA 502 specifications. Testing passed with no water observed.

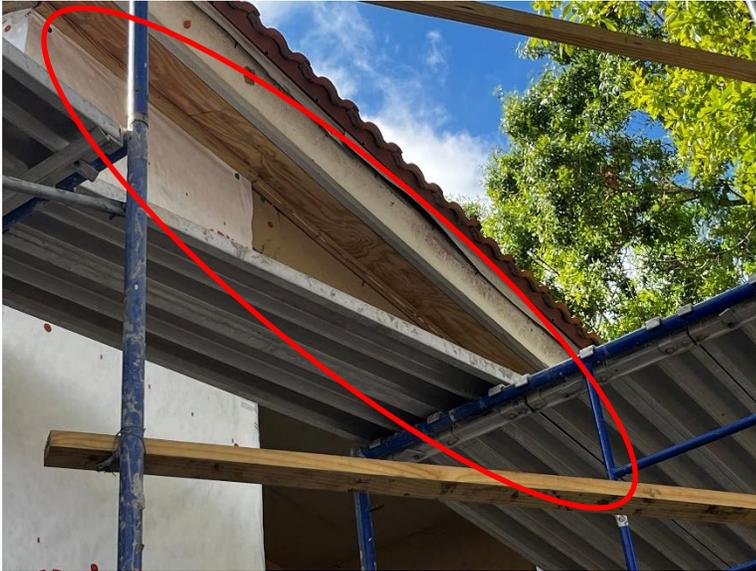
PHOTOGRAPH #15

**BUILDING 11
SECTION C**

Contractor has installed new plywood soffit and vinyl vent at soffit area as per drawings.

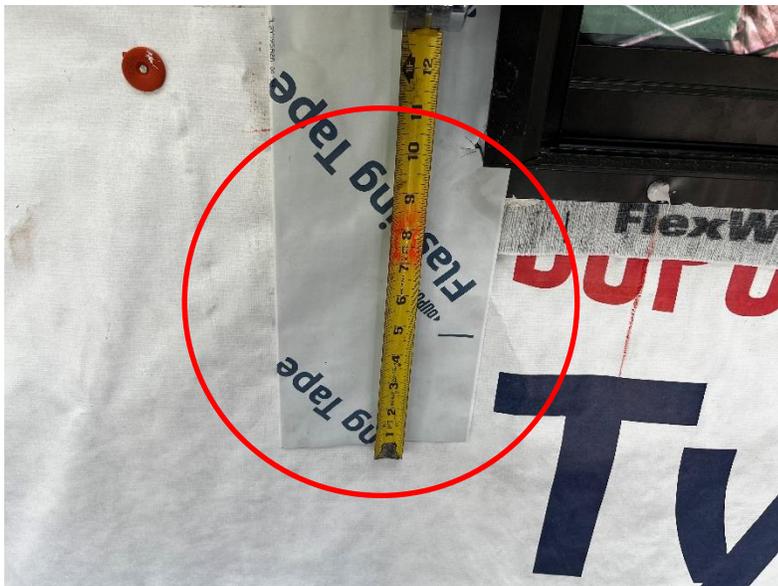
PHOTOGRAPH #16

**BUILDING 11
SECTION C**

Dupont Flashing Tape applied at window fin extends past window a minimum of 6" as per manufacturer's requirements.

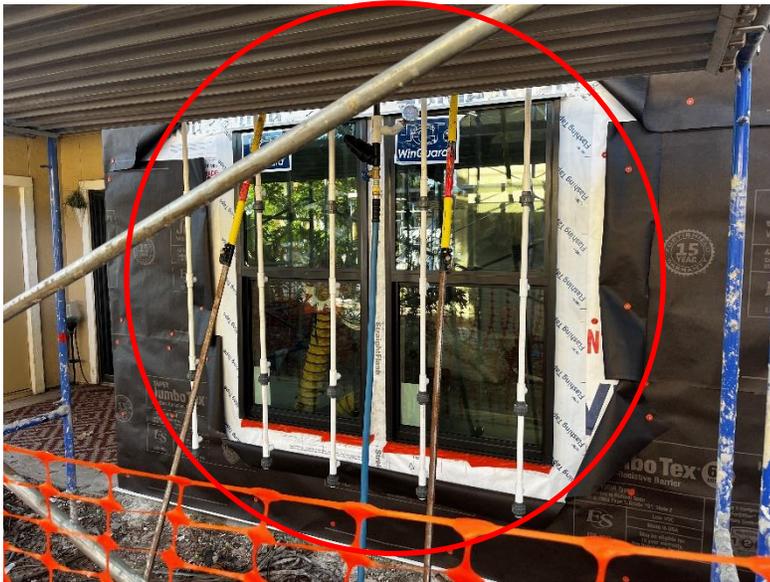
PHOTOGRAPH #17

**BUILDING 11
UNIT #1117- SECTION C**

Independent Testing Agency performed water infiltration testing of window opening as per AAMA 502 specifications. Testing failed with water observed between bottom corner of window and Tyvek flashing.

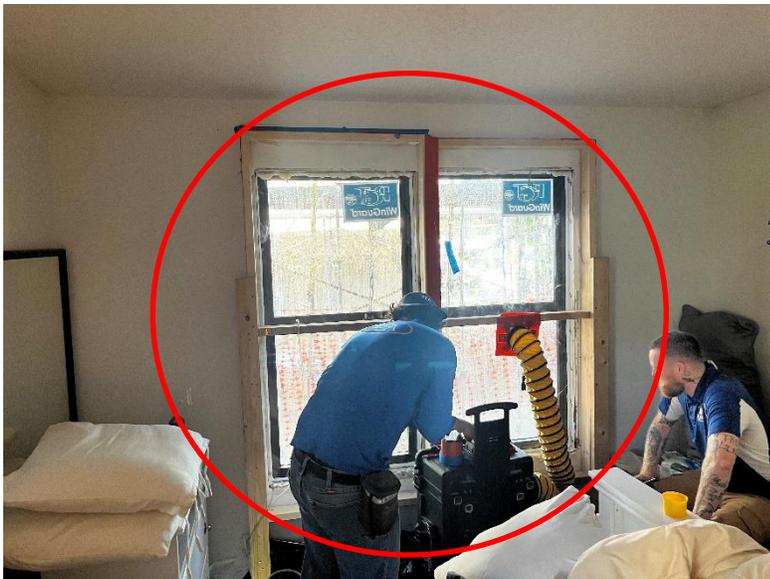
PHOTOGRAPH #18

**BUILDING 11
UNIT #1117- SECTION C**

Independent Testing Agency performed water infiltration testing of window opening as per AAMA 502 specifications. Testing failed with water observed between bottom corner of window and Tyvek flashing.

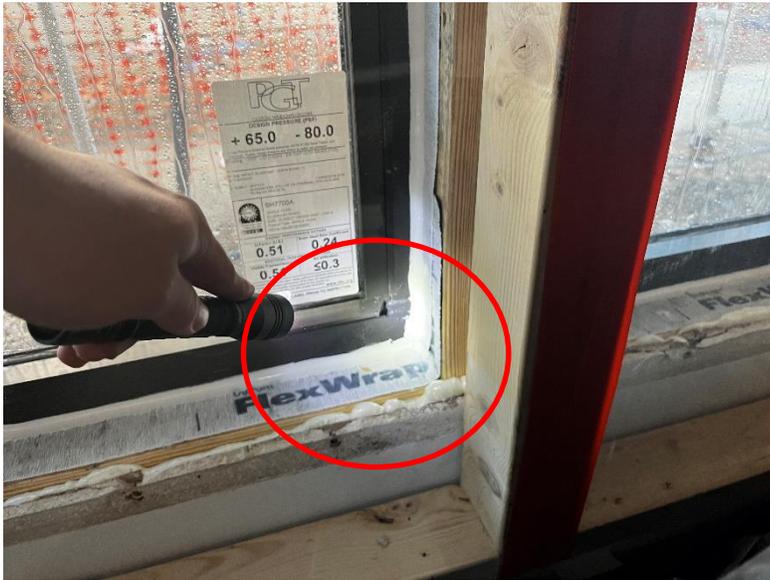
PHOTOGRAPH #19

**BUILDING 11
UNIT #1117- SECTION C**

Independent Testing Agency performed water infiltration testing of window opening as per AAMA 502 specifications. Testing failed with water observed between bottom corner of window and Tyvek flashing.

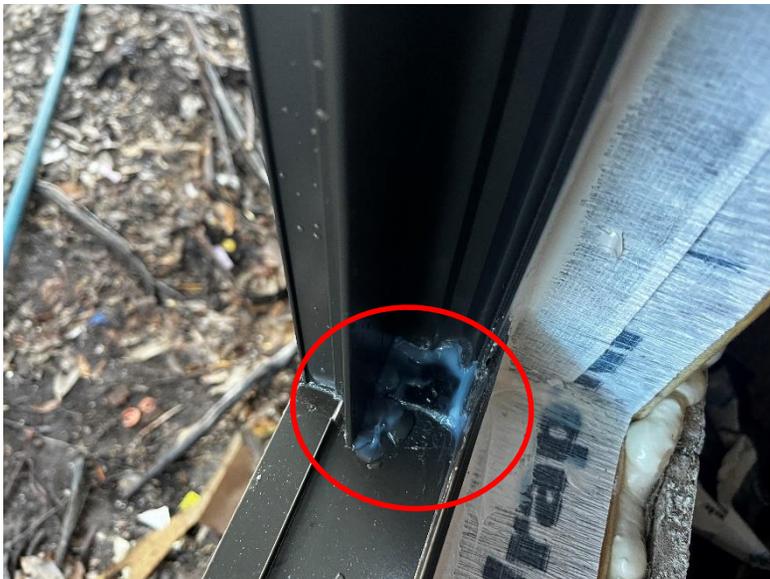
PHOTOGRAPH #20

**BUILDING 11
UNIT #1117- SECTION C**

PGT representative applied silicone sealant at base of window joinery as a retro fit repair.

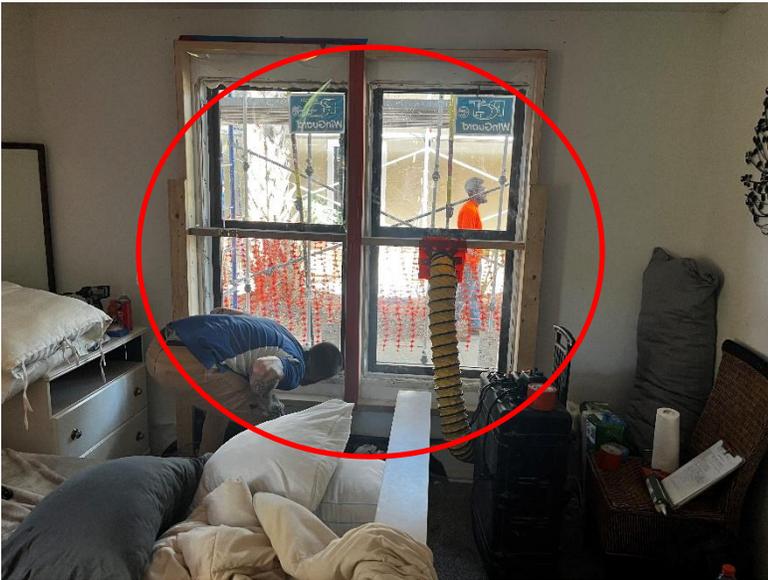
PHOTOGRAPH #21

**BUILDING 11
UNIT #1117- SECTION C**

ITA retested window opening after retrofit repairs and again failed the test showing water infiltration at same location.

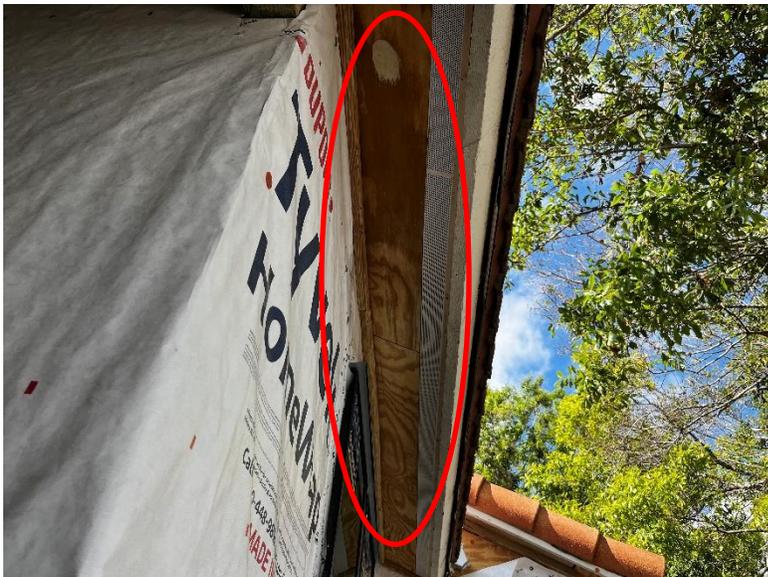
PHOTOGRAPH #22

**BUILDING 11
SECTION B**

Contractor has installed new plywood soffit and vinyl vent at soffit area as per drawings.

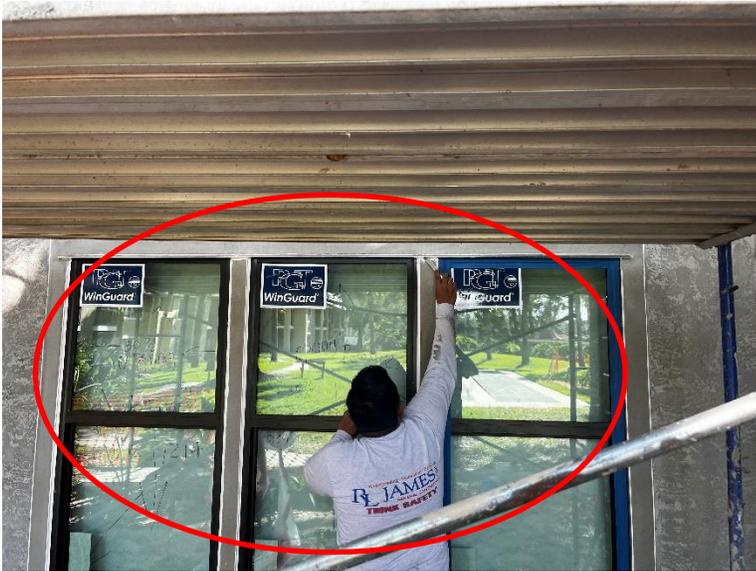
PHOTOGRAPH #23

**BUILDING 12
SECTION H**

Contractor applying new sealants at window perimeters.

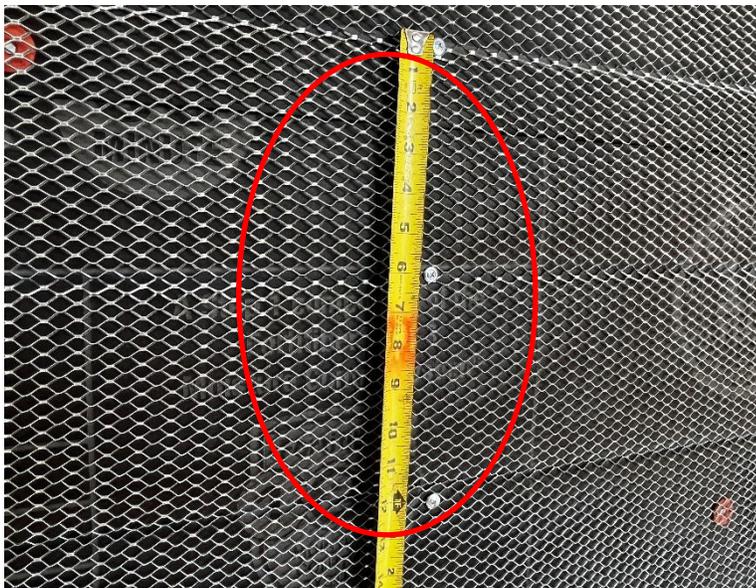
PHOTOGRAPH #24

**BUILDING 12
SECTION F**

New self-furring galvanized lathing attached to framing at 6" O.C. spacing.

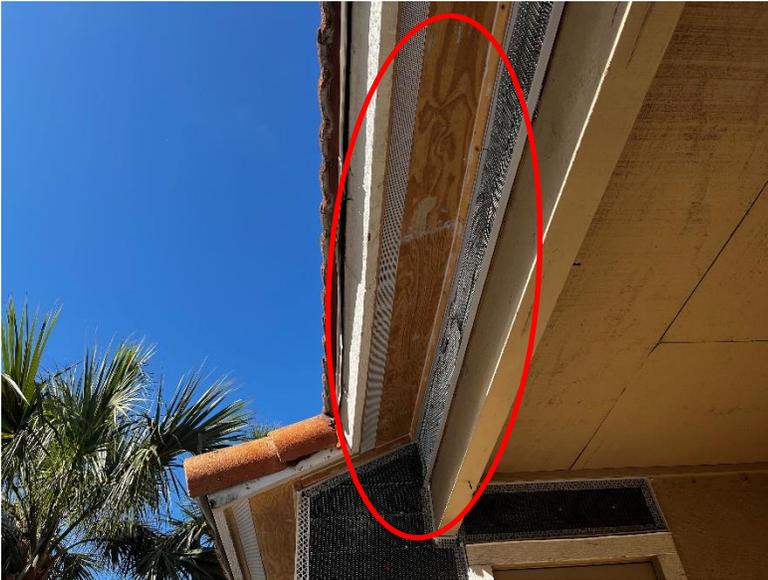
PHOTOGRAPH #25

**BUILDING 12
SECTION F**

Contractor has installed new plywood soffit and vinyl vent at soffit area as per drawings.

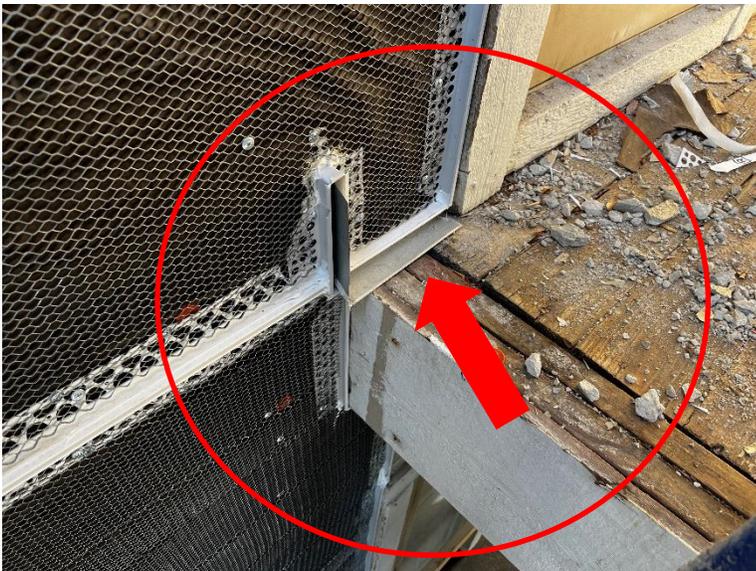
PHOTOGRAPH #26

**BUILDING 12
SECTION E**

Kick out flashing installed at edge of balcony. Additional sealant required to fully seal to decking and built-up beam.

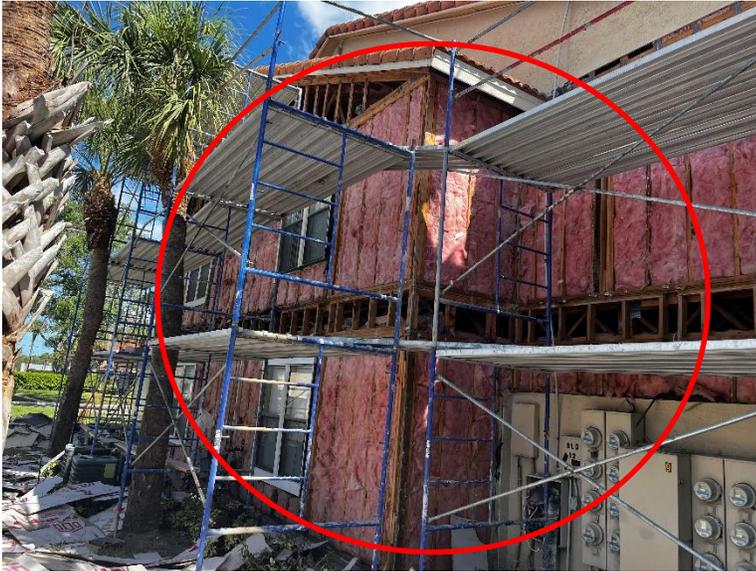
PHOTOGRAPH #27

**BUILDING 12
SECTION D**

Contractor has removed old stucco and sheathing board, exposing framing conditions.

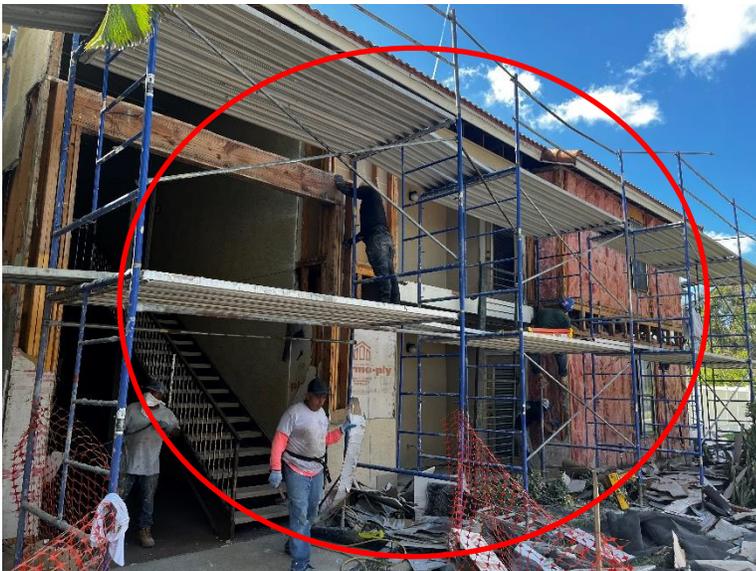
PHOTOGRAPH #28

**BUILDING 12
SECTION C**

Contractor removing old stucco and sheathing board, exposing framing conditions.

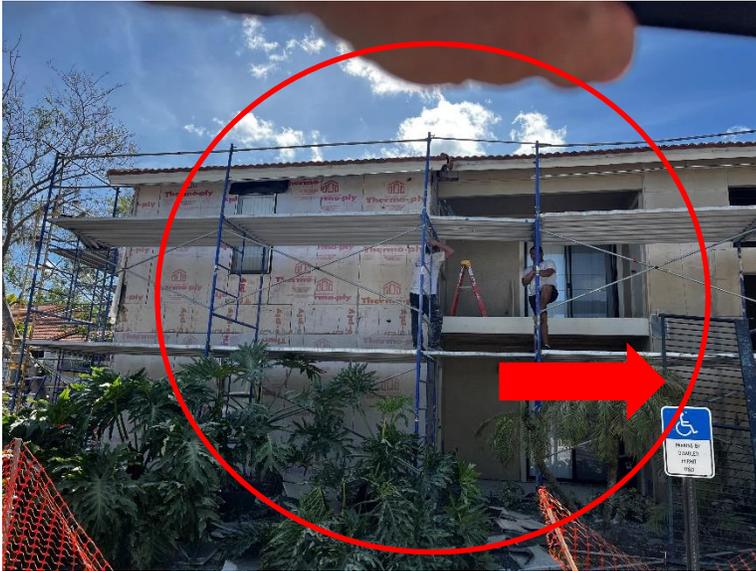
PHOTOGRAPH #29

**BUILDING 12
SECTION A**

Contractor cutting and removing old stucco and removing balcony railings.
