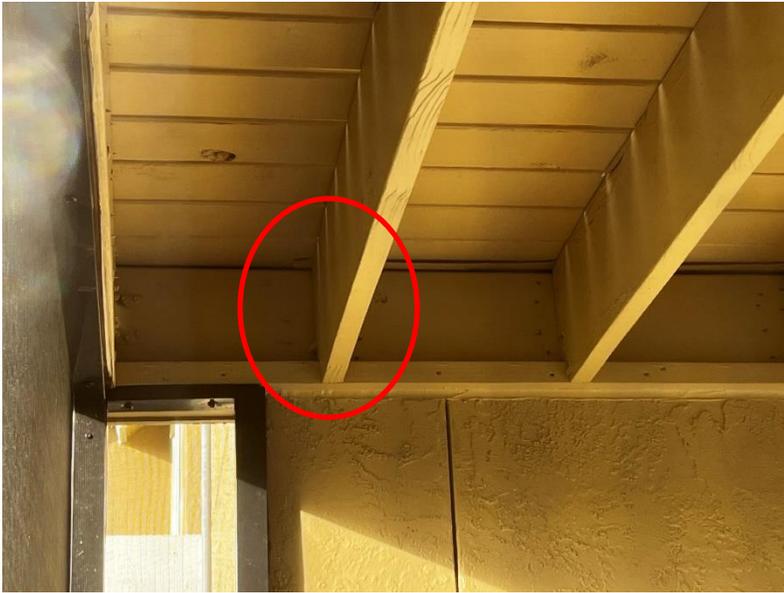
PHOTOGRAPH #1

**BUILDING 11
SECTION G**

Contractor has not yet installed Simpson #SDW22458 screws @ ledger and corner blocking as per drawings.

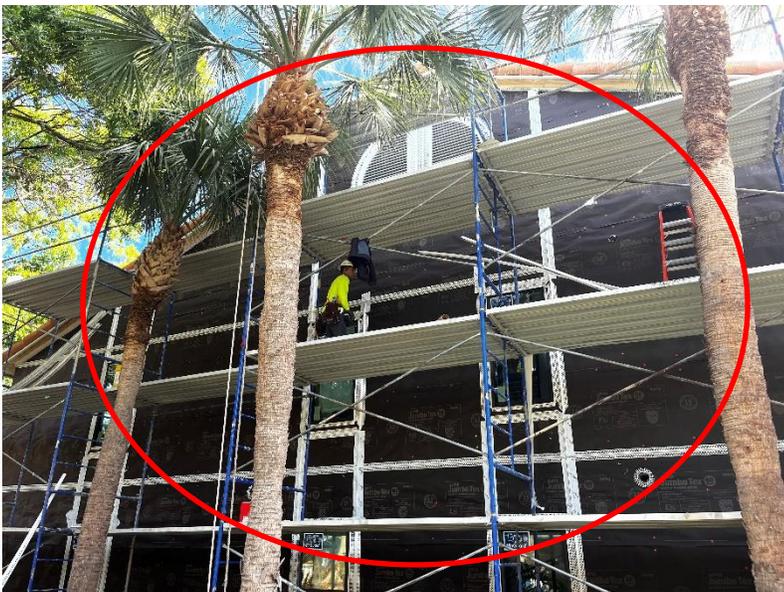
PHOTOGRAPH #2

**BUILDING 11
SECTION D**

Stucco Sub-contractor installing vinyl stucco accessories over Jumbo Tex 60 water resistant barrier at gable end wall.

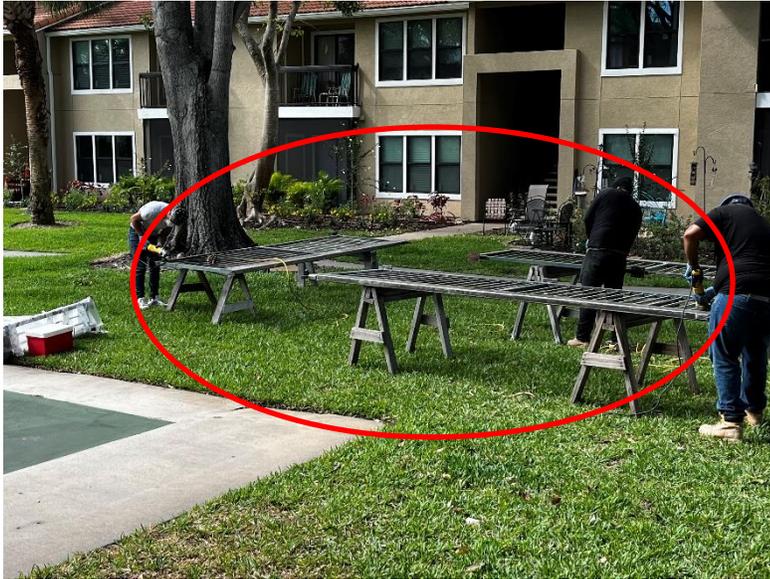
PHOTOGRAPH #3

**BUILDING 11
SECTION D**

Contractor grinding loose paint and corrosion from balcony railings in preparation for new paint system.

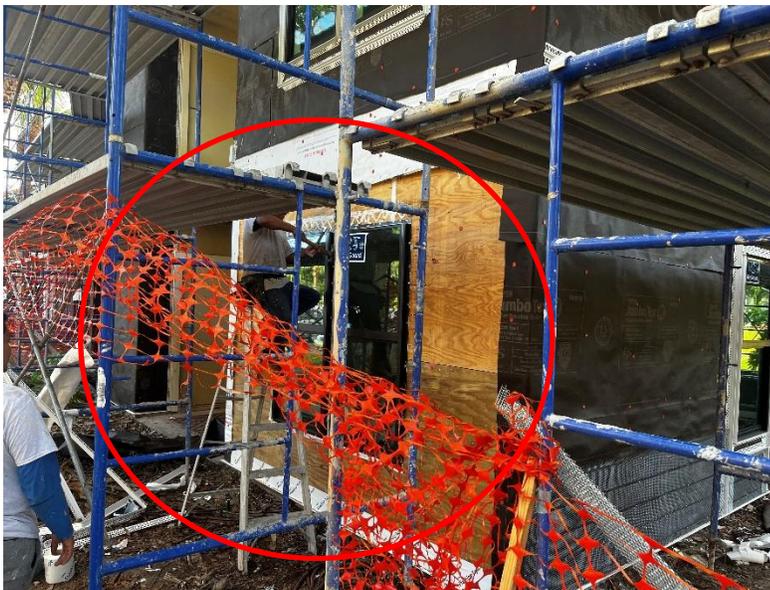
PHOTOGRAPH #4

**BUILDING 11
UNIT #1117- SECTION C**

Contractor removing bedroom windows that failed independent testing agency water infiltration testing.

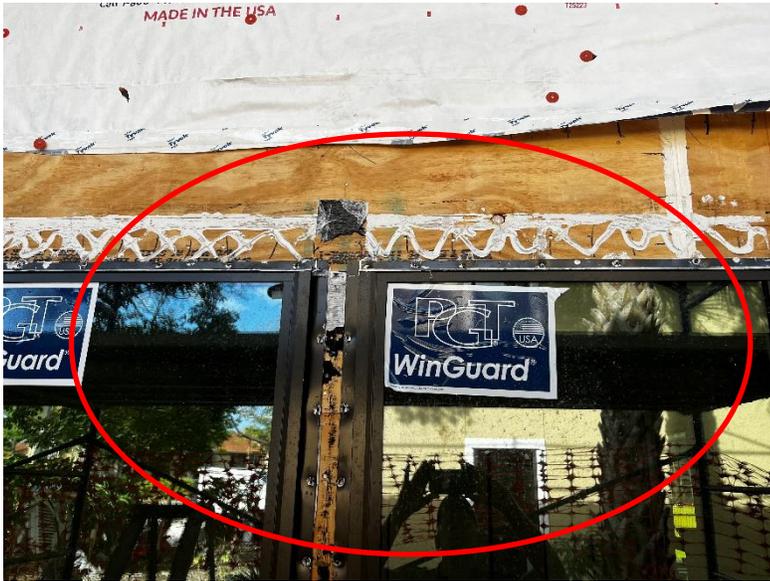
PHOTOGRAPH #5

**BUILDING 11
UNIT #1117- SECTION C**

Contractor removing bedroom windows that failed independent testing agency water infiltration testing.

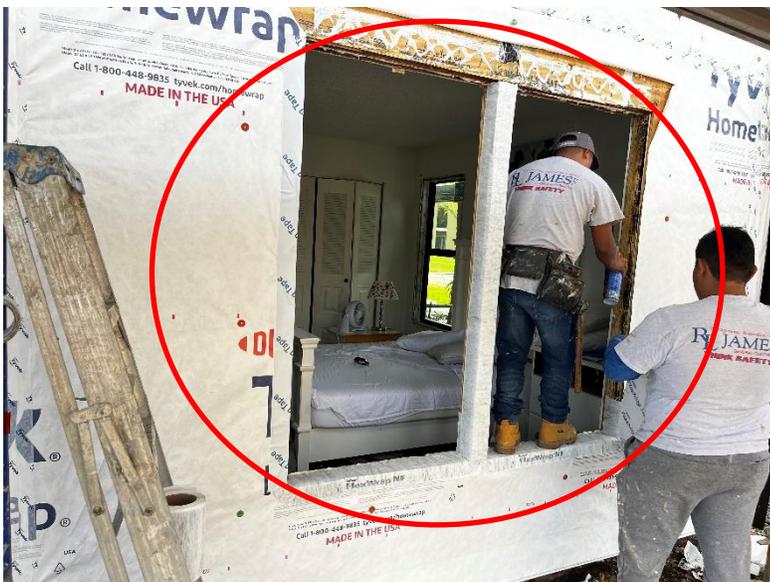
PHOTOGRAPH #6

**BUILDING 11
UNIT #1117- SECTION C**

Contractor installing new Dupont flashings at window opening as per drawings and window manufacturers requirements.

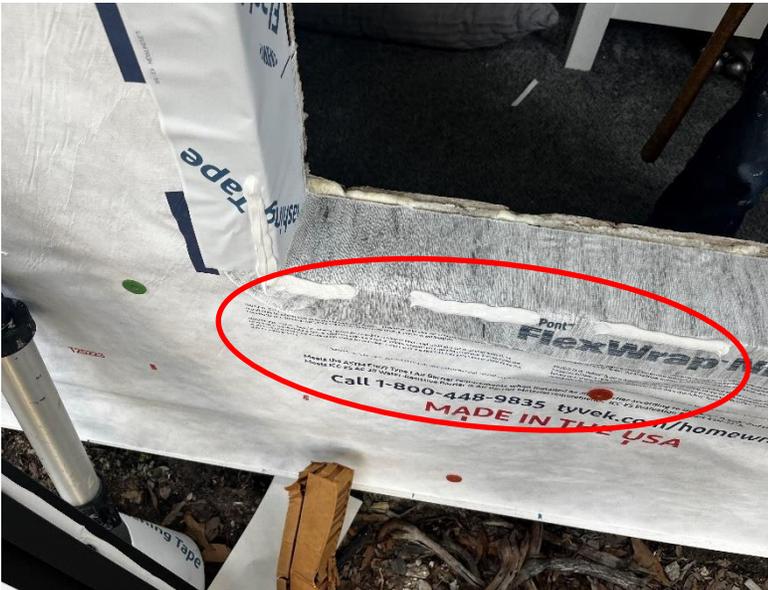
PHOTOGRAPH #7

**BUILDING 11
UNIT #1117- SECTION C**

New sealant installed at sill allowing space for weeping as per installation drawings.

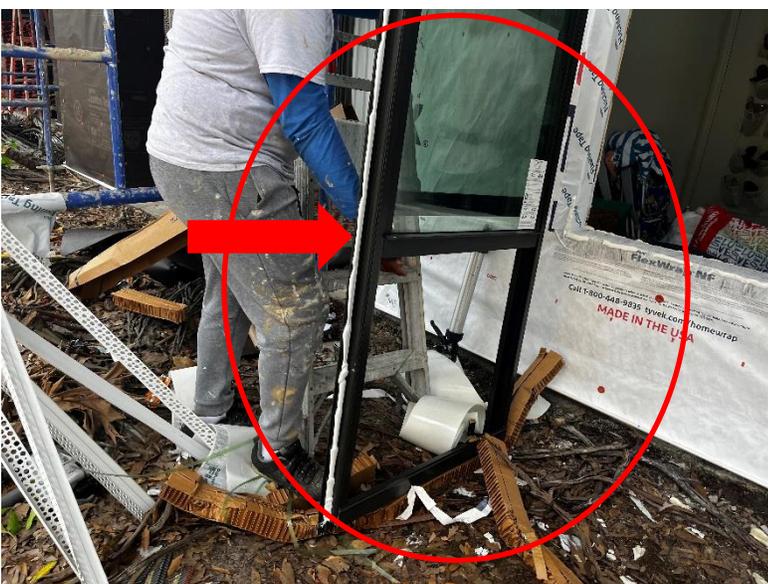
PHOTOGRAPH #8

**BUILDING 11
UNIT #1117- SECTION C**

New sealant installed at back side of window mounting flange as per installation drawings.

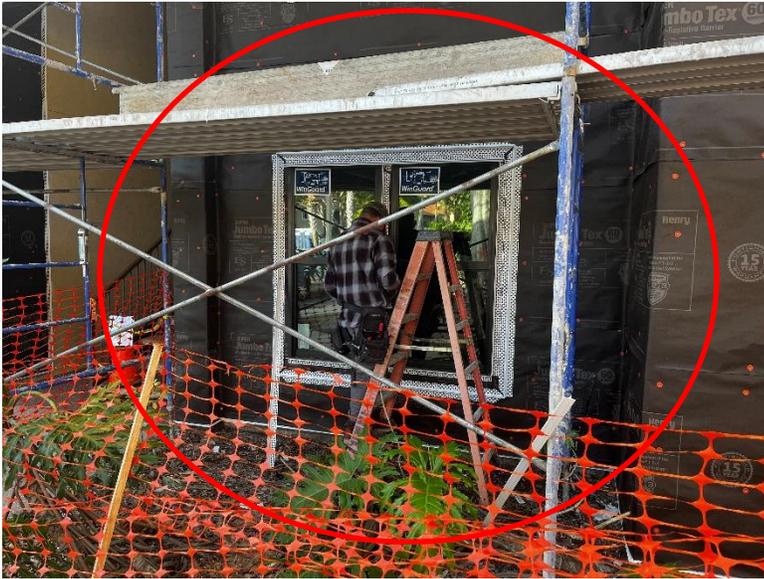
PHOTOGRAPH #9

**BUILDING 11
SECTION C**

Stucco Sub-contractor installing vinyl stucco accessories around new window, over Jumbo Tex 60 water resistant barrier.

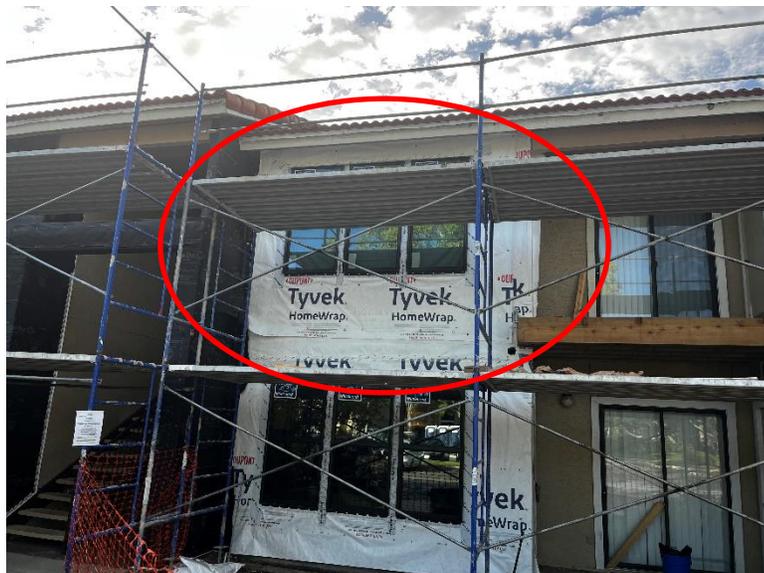
PHOTOGRAPH #10

**BUILDING 11
UNIT #1123 - SECTION B**

New PGT window installed with Dupont flashing details as per drawings and specifications.

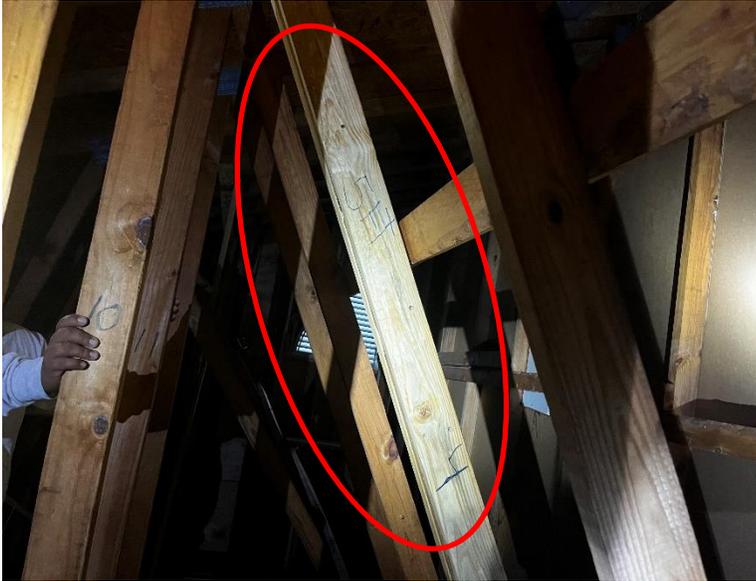
PHOTOGRAPH #11

**BUILDING 11
UNIT #1121 - ATTIC**

Contractor has performed scab repairs at damaged trusses.

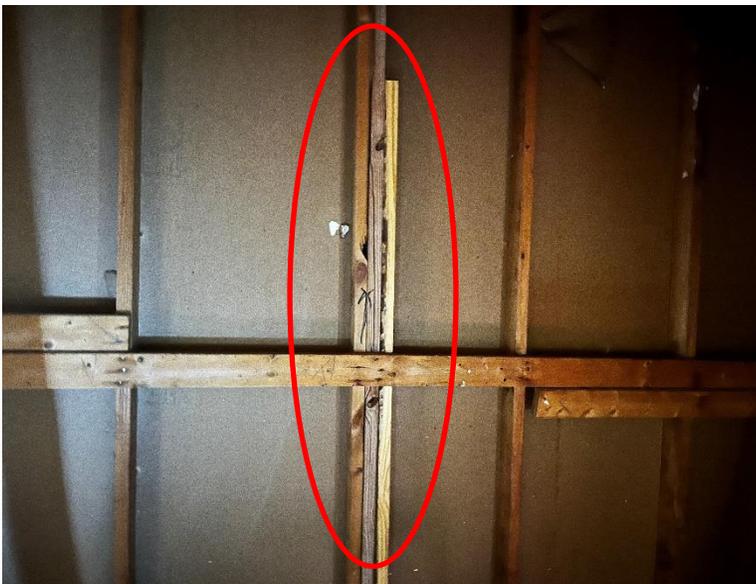
PHOTOGRAPH #12

**BUILDING 11
UNIT #1121 - ATTIC**

Contractor has performed scab repairs at damaged trusses.

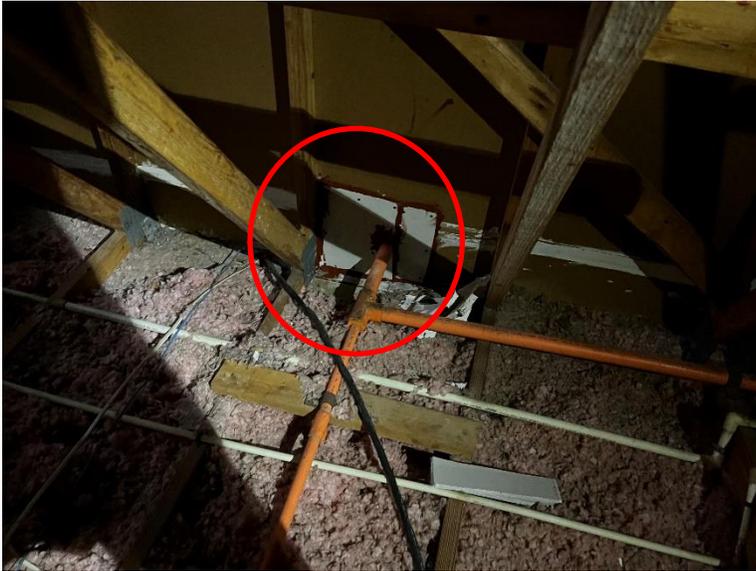
PHOTOGRAPH #13

**BUILDING 11
UNIT #1121 - ATTIC**

Contractor has performed fire wall repairs
at base of fire wall.

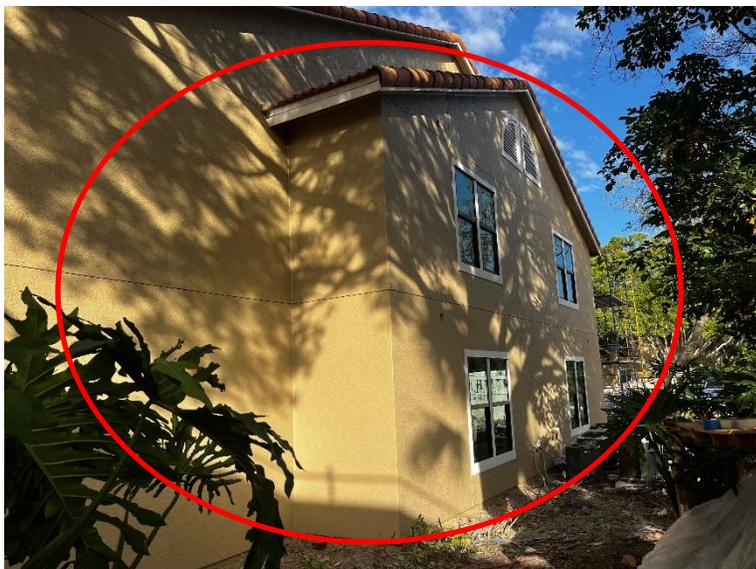
PHOTOGRAPH #14

**BUILDING 12
SECTION H**

New Florida Paints primer and finish
applied to new stucco at gable end wall.

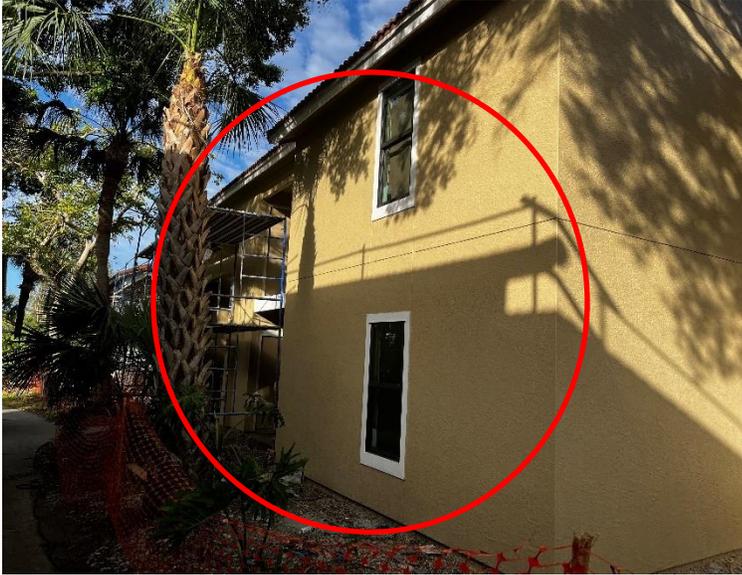
PHOTOGRAPH #15

**BUILDING 12
SECTION G**

New Florida Paints primer and finish applied to new stucco.

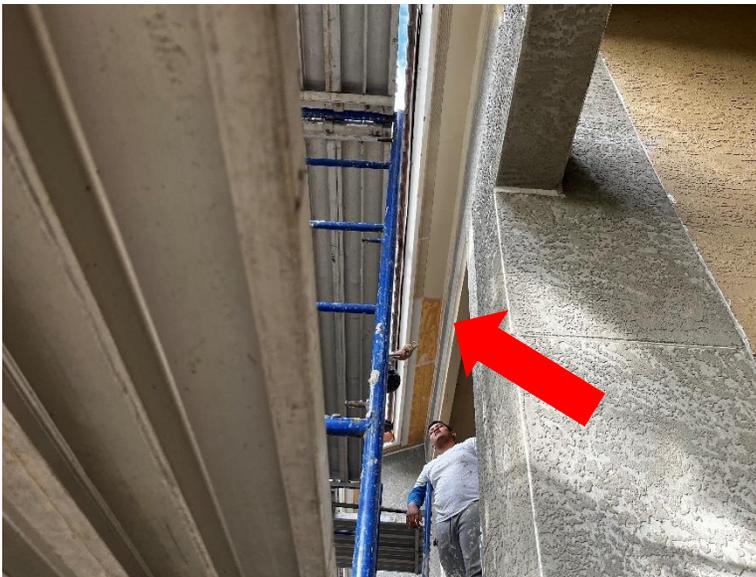
PHOTOGRAPH #16

**BUILDING 12
SECTION E**

Contractor priming new wood soffit with Florida Paint Legacy UltraPrime all-purpose primer.

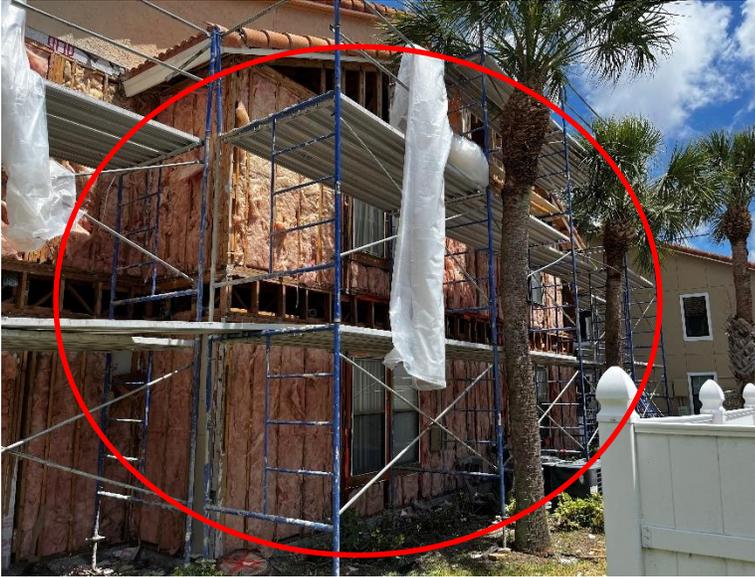
PHOTOGRAPH #17

**BUILDING 12
SECTION D**

Framing inspected and marked for repairs by Delta.

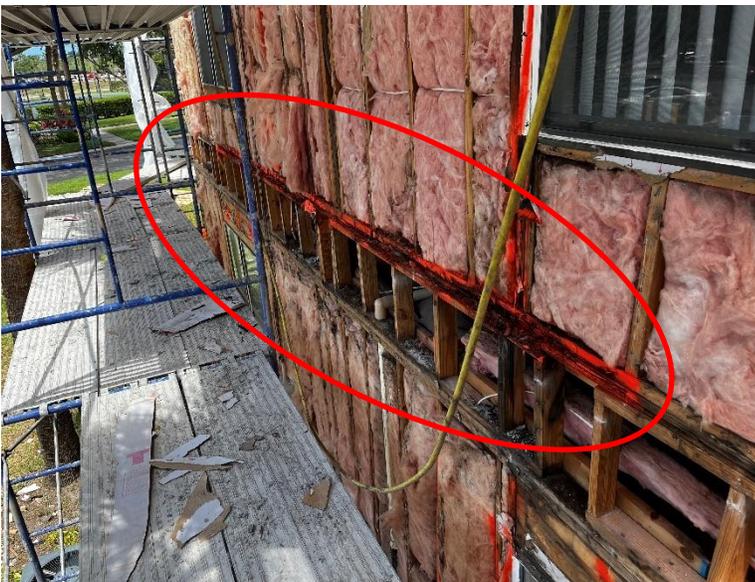
PHOTOGRAPH #18

**BUILDING 12
SECTION D**

Second floor bottom plates and intermediate floor framing marked for repairs.

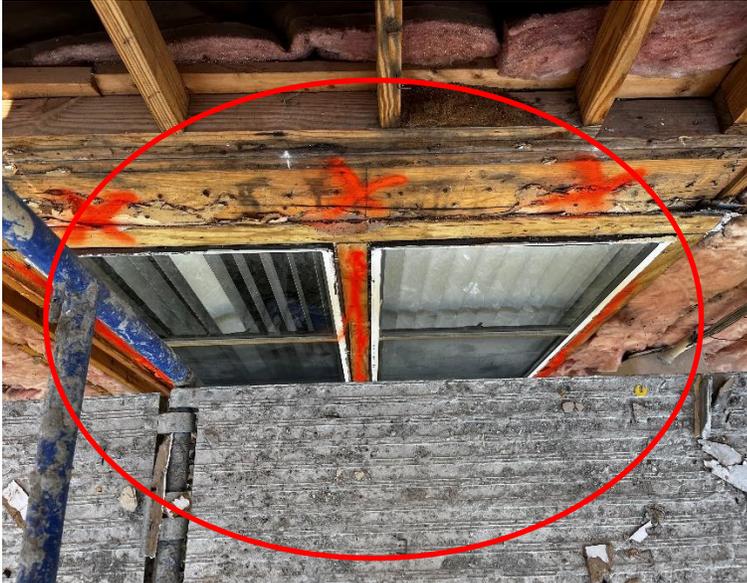
PHOTOGRAPH #19

**BUILDING 12
SECTION D**

Window framing and headers marked for repairs.

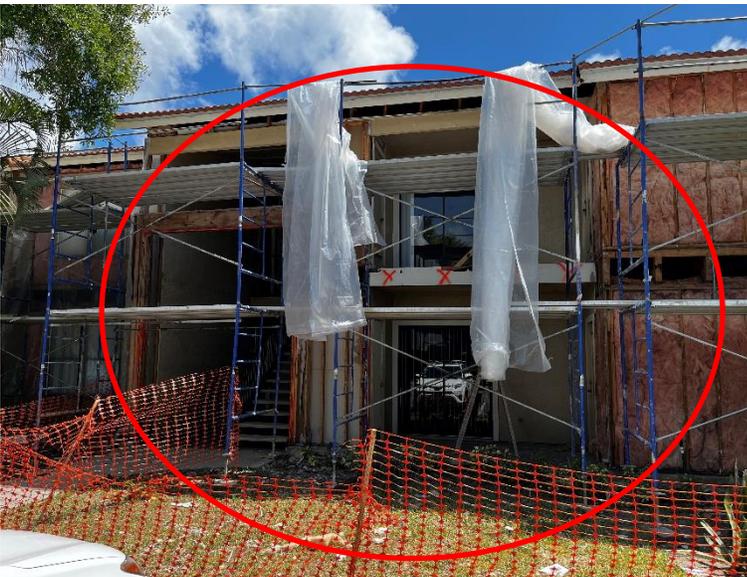
PHOTOGRAPH #20

**BUILDING 12
SECTION C**

Framing inspected and marked for repairs by Delta.

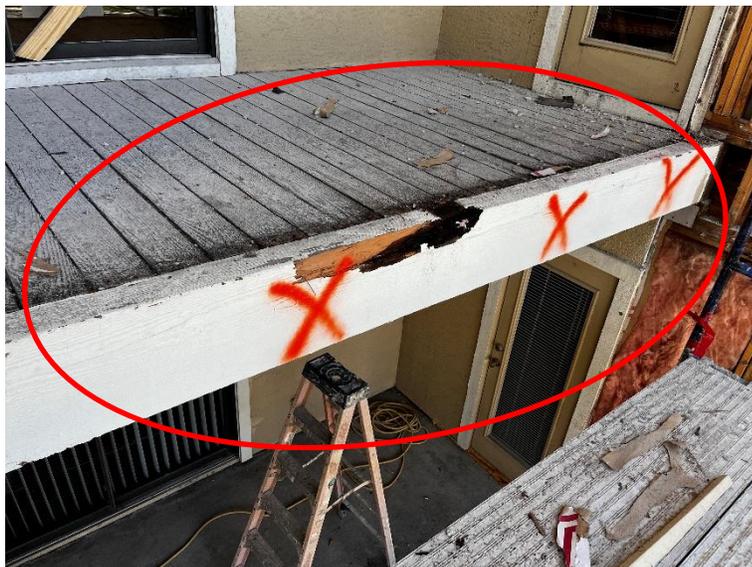
PHOTOGRAPH #21

**BUILDING 12
UNIT #1227- SECTION C**

Damaged balcony built up beam marked for repairs.

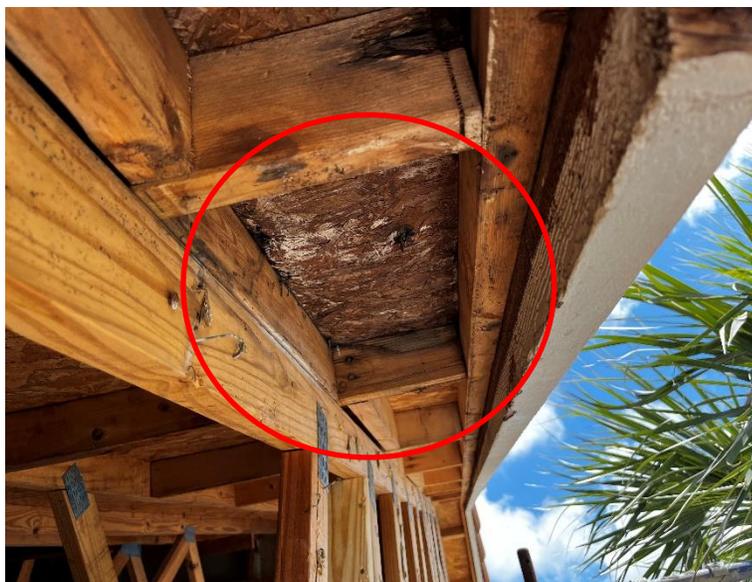
PHOTOGRAPH #22

**BUILDING 12
SECTION C**

Roof sheathing damaged by roof leaks not part of wall repair work and will be repaired by owners roofing contractors.

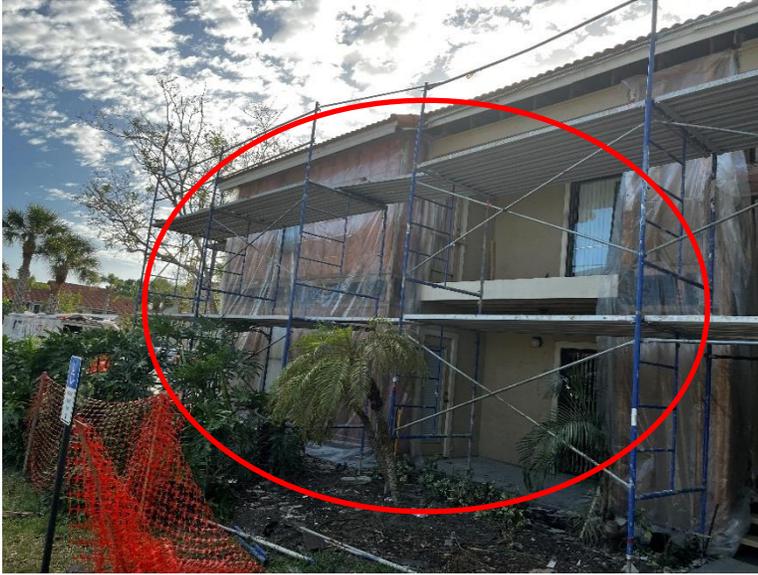
PHOTOGRAPH #23

**BUILDING 12
SECTION A**

Contractor has covered open walls with plastic tarps for weather protection during repairs.
