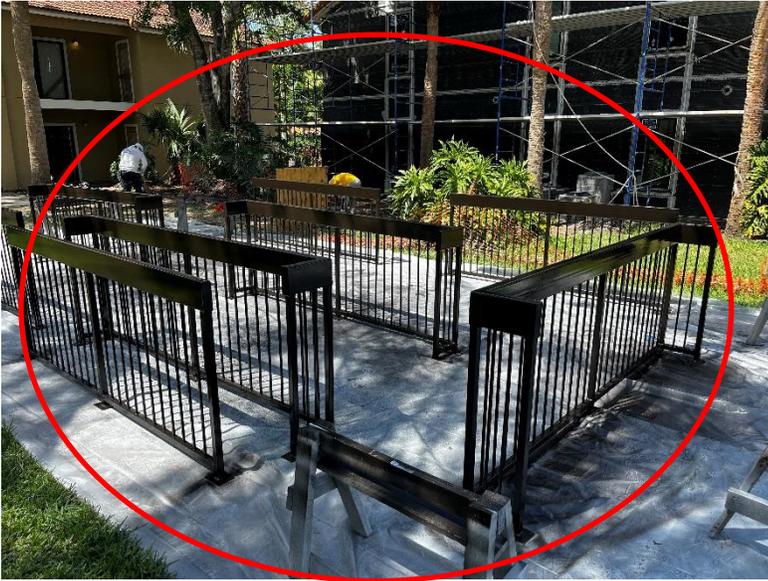
**PHOTOGRAPH #1**

Contractor has applied primer and finish coat of Florida Paint products on balcony handrailing.

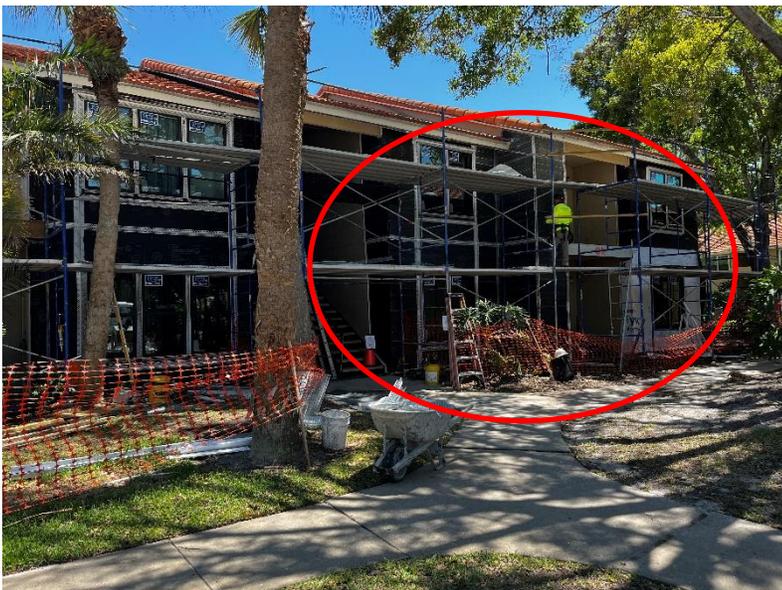
**PHOTOGRAPH #2**

Stucco sub-contractor installing stucco accessories and self-furring galvanized lathing.

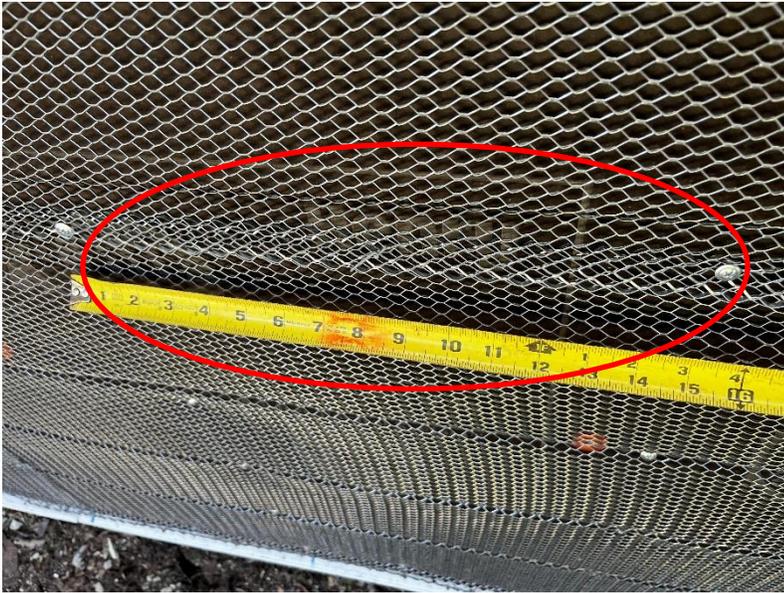
**PHOTOGRAPH #3**

Self-furring galvanized lathing fastened at framing members and tied between framing attachments at overlap with stainless tie wire at intervals no more than 9" O.C.

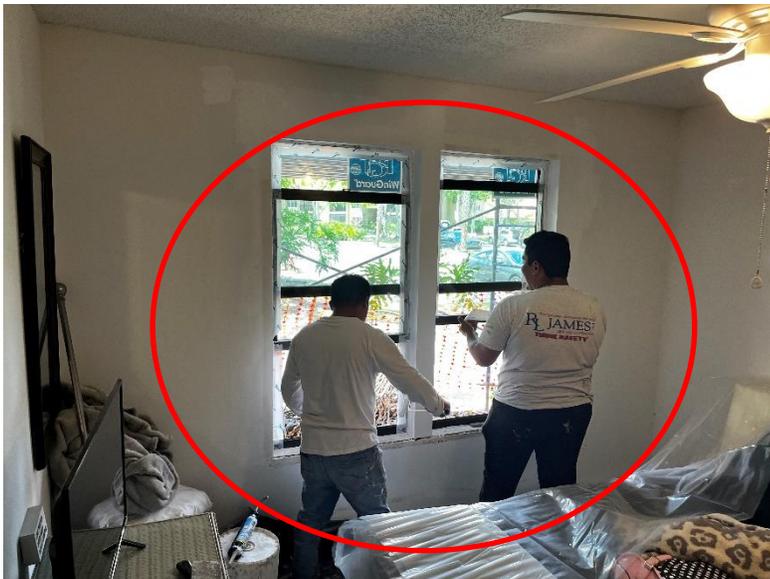
**PHOTOGRAPH #4**

Contractor repairing interior drywall and sills at new window installation.

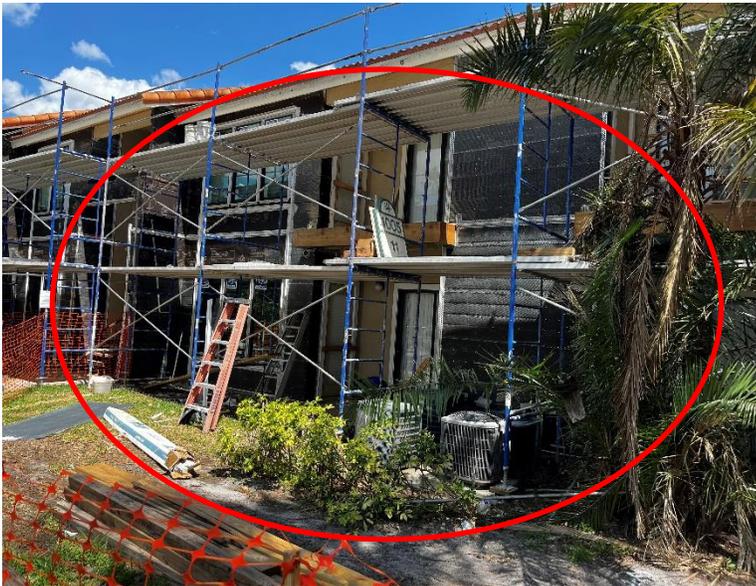
**PHOTOGRAPH #5**

Stucco sub-contractor installing stucco accessories and self-furring galvanized lathing.

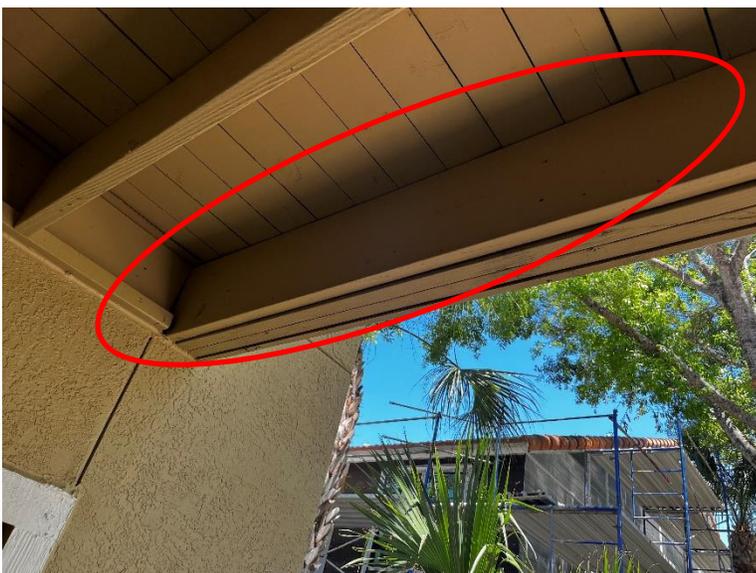
**PHOTOGRAPH #6**

Contractor has not installed Simpson Strong screws or clips at built up beam as per drawings.

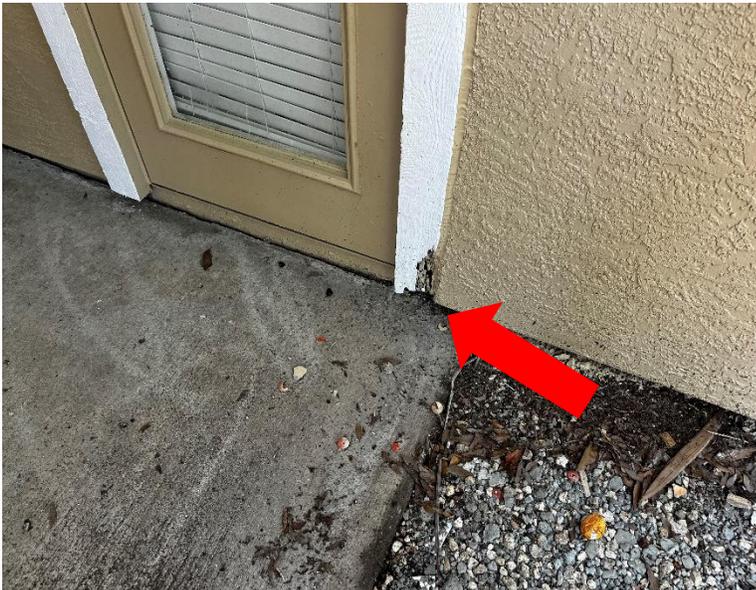
**PHOTOGRAPH #7**

Damaged cedar trim at patio doorway will require replacement.

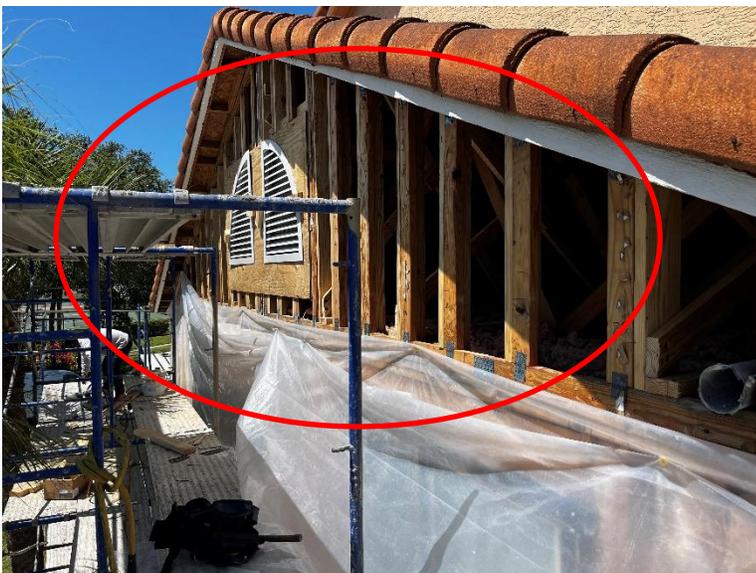
**PHOTOGRAPH #8**

Gable end wall bracing and Green Heck louver installation repairs in progress.

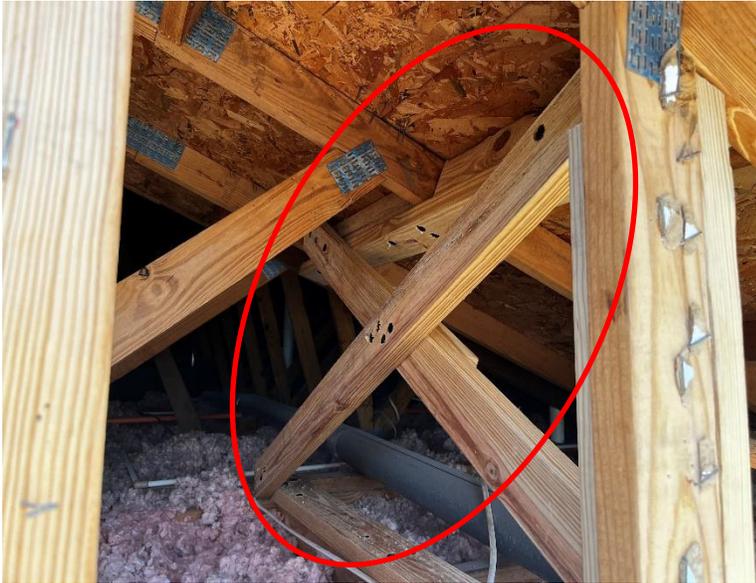
**PHOTOGRAPH #9**

Gable end wall bracing cross braces are installed at 48" O.C.

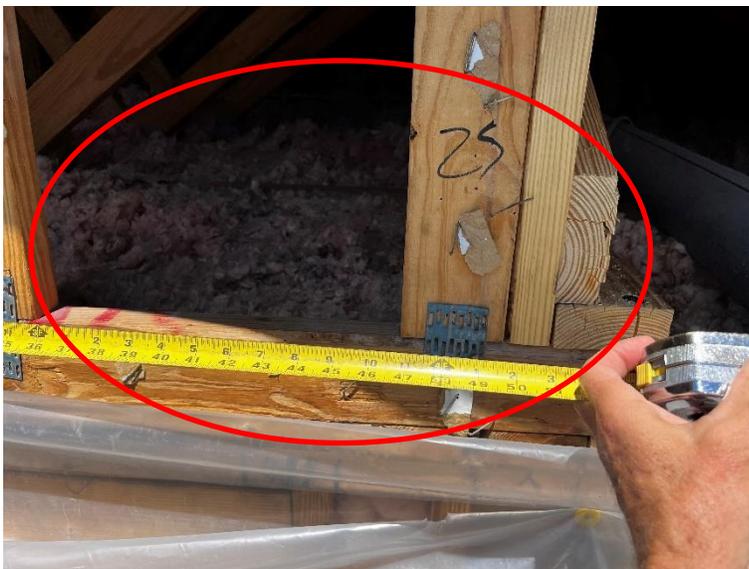
**PHOTOGRAPH #10**

Gable end wall bracing cross braces are installed at 48" O.C.

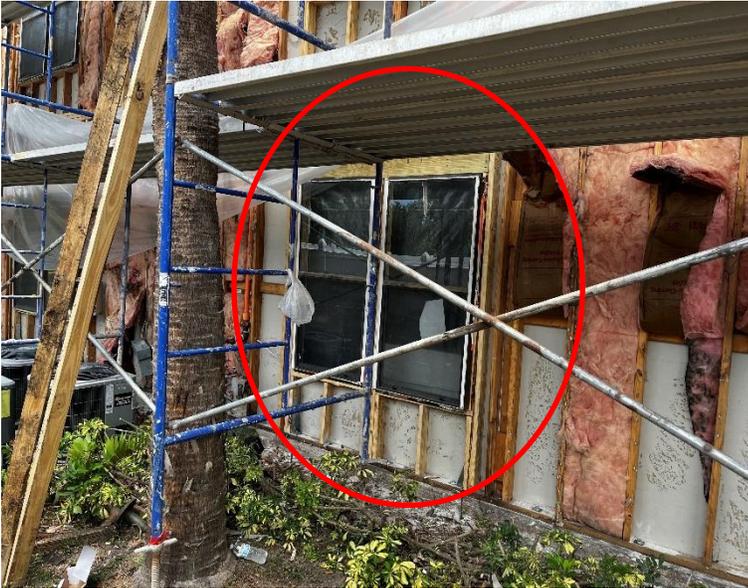
**PHOTOGRAPH #11**

Framing and header repairs performed at window opening where marked for replacement.

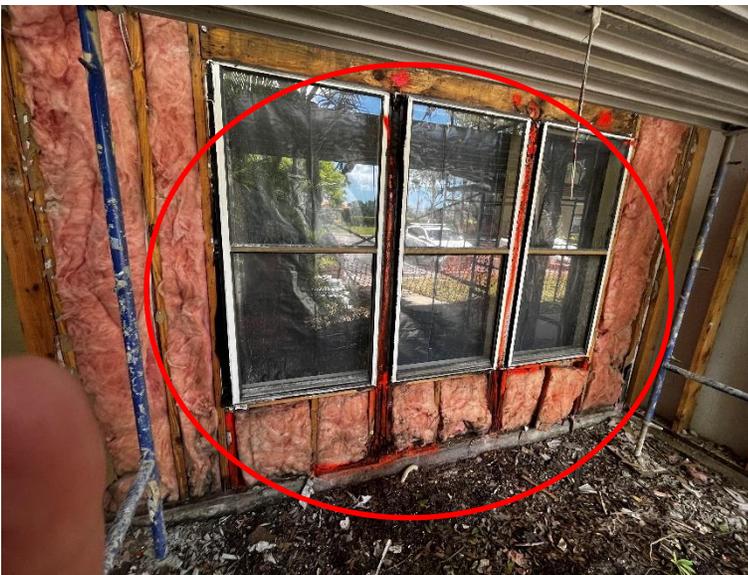
**PHOTOGRAPH #12**

Damaged window framing and headers marked for repairs.

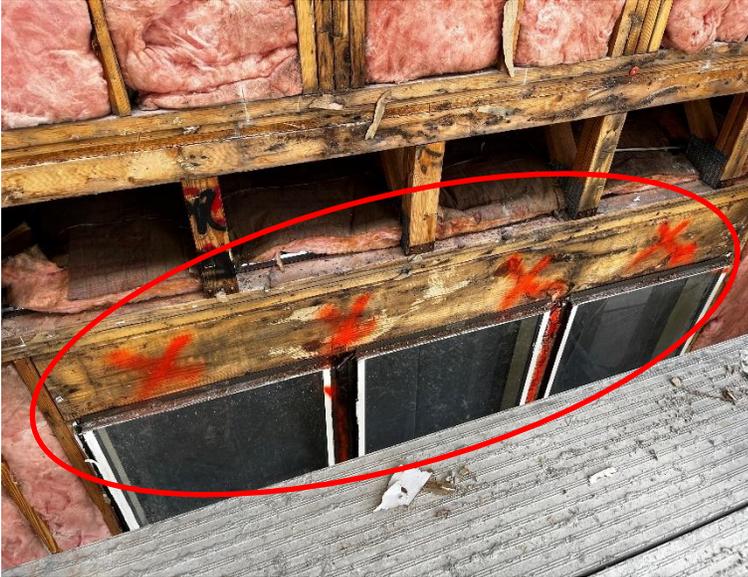
**PHOTOGRAPH #13**

Damaged window framing and headers marked for repairs.

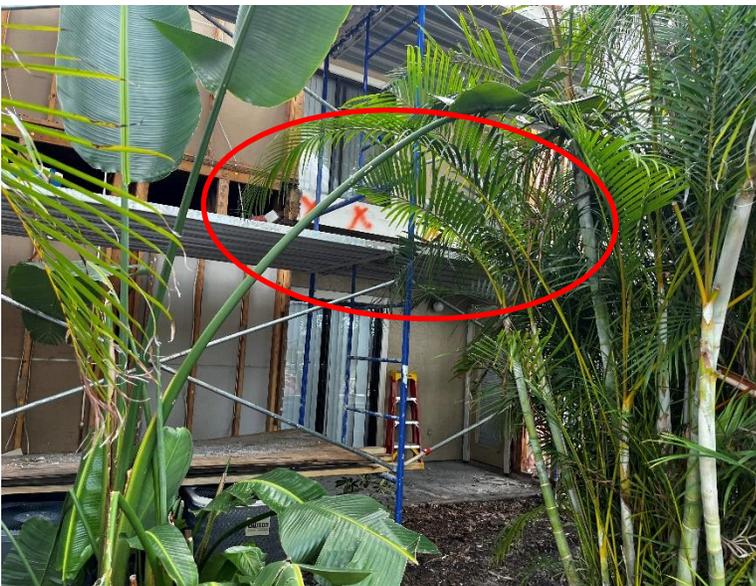
**PHOTOGRAPH #14**

Damaged balcony built up beam marked for full repairs.

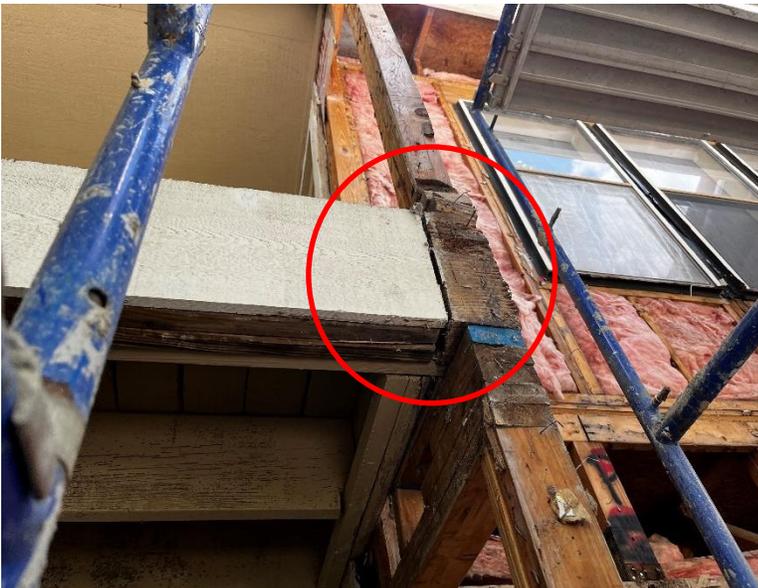
**PHOTOGRAPH #15**

Previous repairs at balcony built up rail beam was cut short of wall and is not bearing on wall framing or post.
