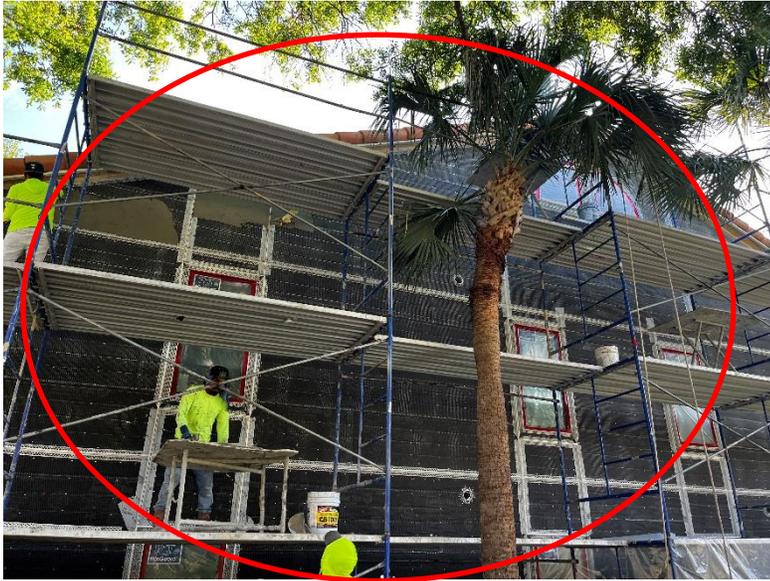
PHOTOGRAPH #1

**BUILDING 11
SECTION D**

Stucco sub-contractor has protected new windows and adjacent surfaces with plastic and begun application of scratch coat of stucco.

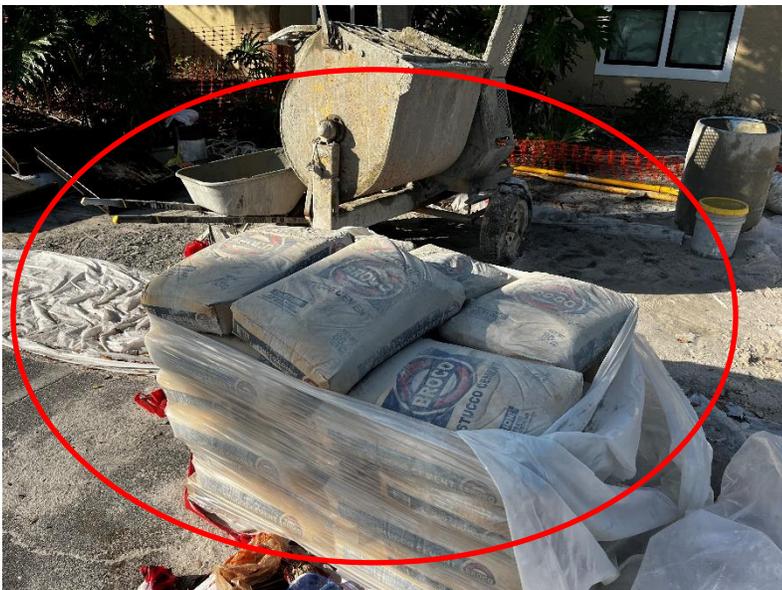
PHOTOGRAPH #2

**BUILDING 11
SECTION D**

BROCO bag mix stucco mixed with sand on site.

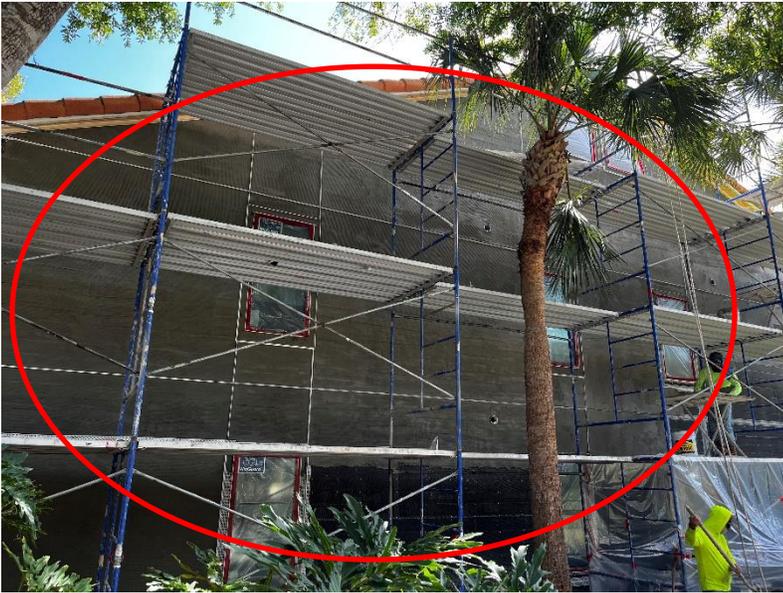
PHOTOGRAPH #3

**BUILDING 11
SECTION D**

Stucco sub-contractor has applied scratch coat of stucco at gable end walls.

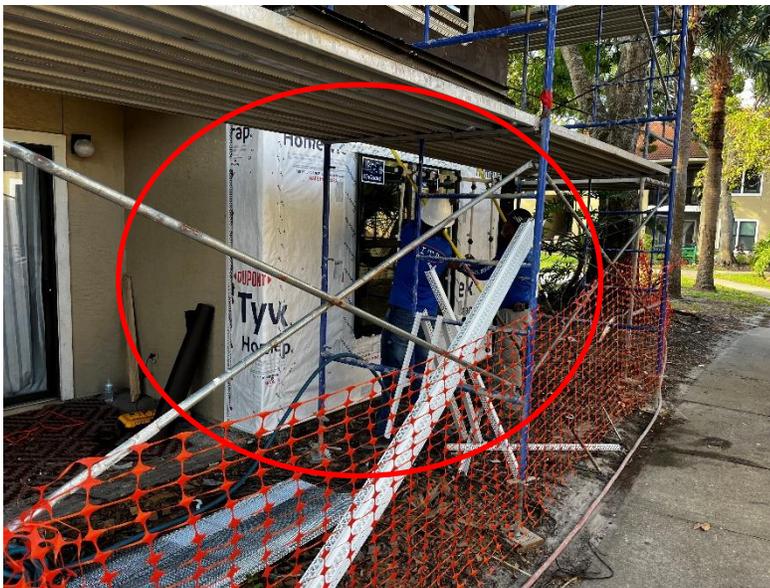
PHOTOGRAPH #4

**BUILDING 11
UNIT #1117- WATER TESTING**

Independent Testing Agency setting up for retesting double window that had previously failed testing.

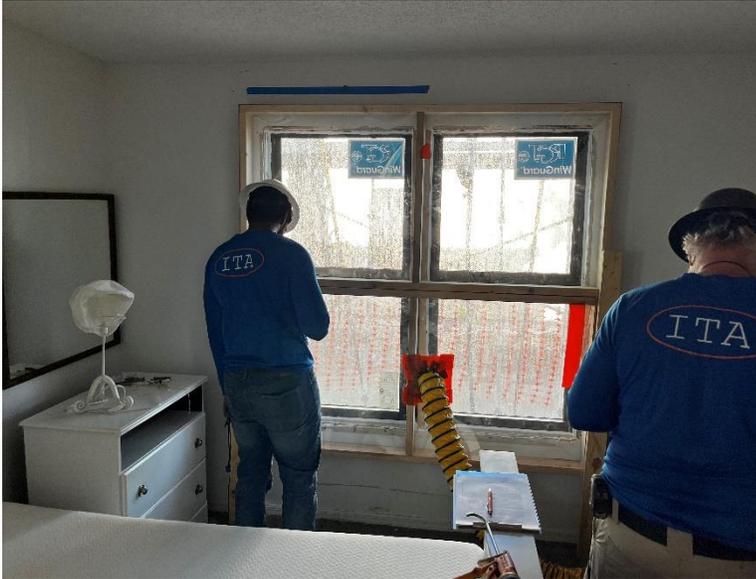
PHOTOGRAPH #5

**BUILDING 11
UNIT #1117- WATER TESTING**

Independent Testing Agency performed water infiltration testing of window as per AAMA 502 specifications. Testing passed with no water observed.

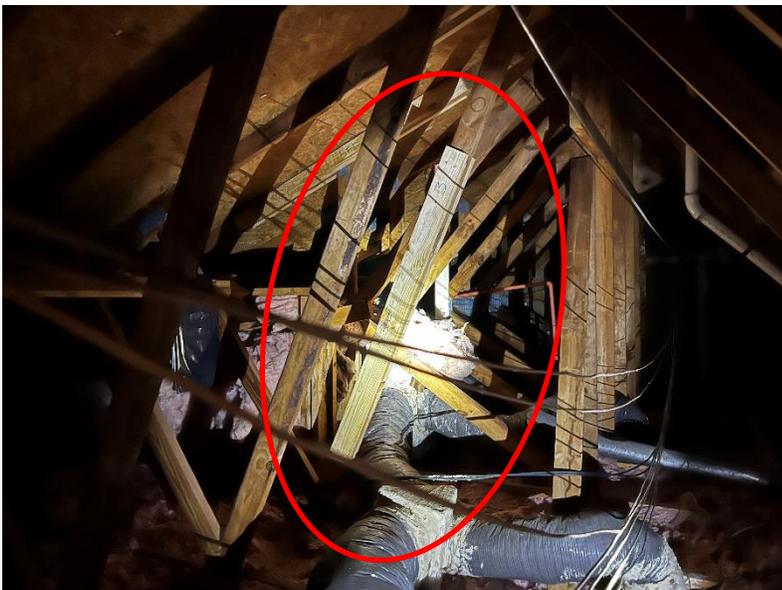
PHOTOGRAPH #6

**BUILDING 11
UNIT #1127- ATTIC REPAIRS**

Contractor has performed scab repairs at damaged trusses.

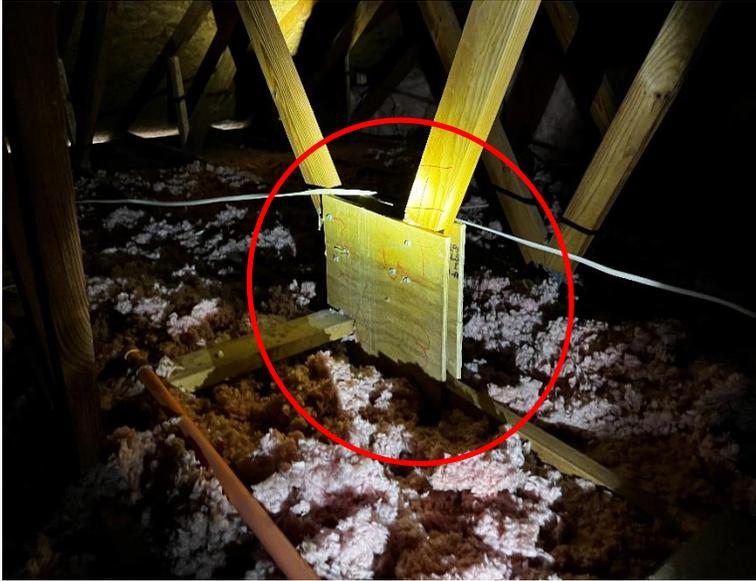
PHOTOGRAPH #7

**BUILDING 11
UNIT #1127- ATTIC REPAIRS**

Contractor has performed gusset repairs where required at trusses as per repair drawings.

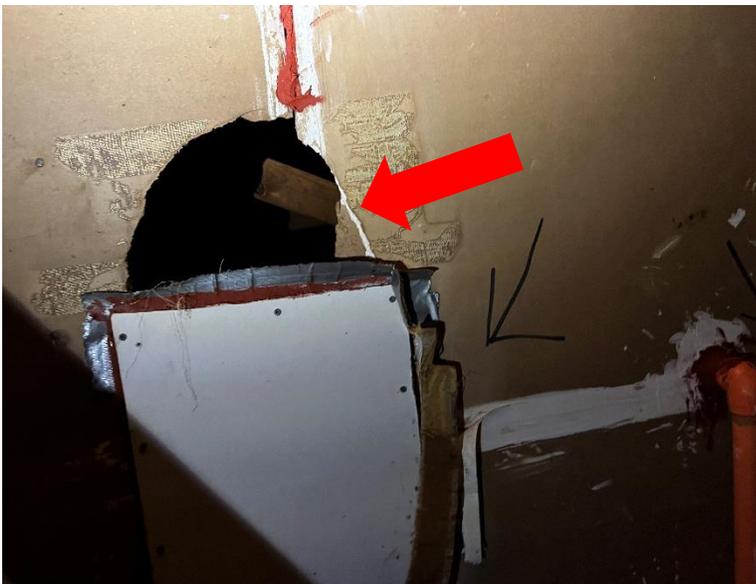
PHOTOGRAPH #8

**BUILDING 11
UNIT #1127- ATTIC REPAIRS**

Fire wall repairs had not been completed upon inspection.

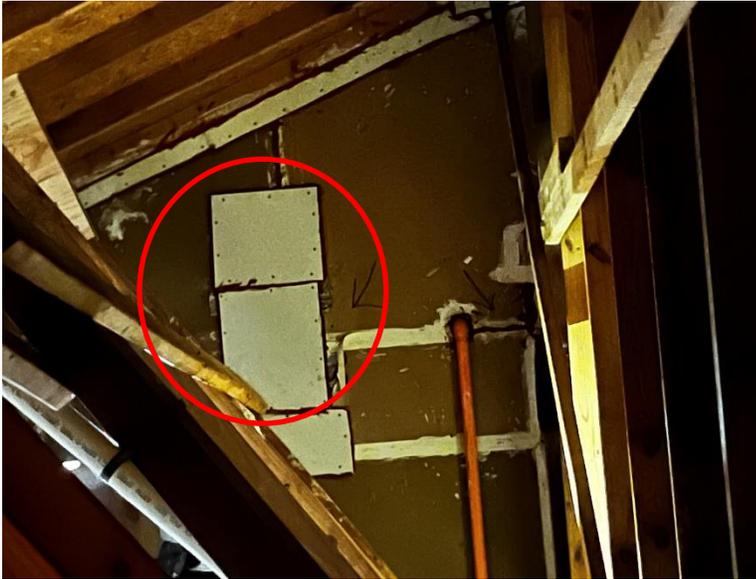
PHOTOGRAPH #9

**BUILDING 11
UNIT #1127- ATTIC REPAIRS**

Contractor completed fire wall repairs upon notification of incomplete repairs.

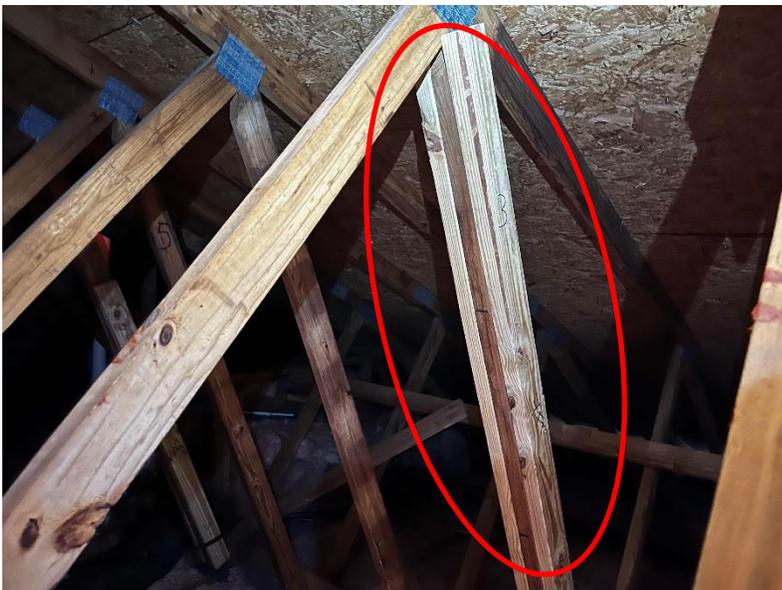
PHOTOGRAPH #10

**BUILDING 11
UNIT #1125- ATTIC REPAIRS**

Contractor has performed scab repairs at damaged trusses.

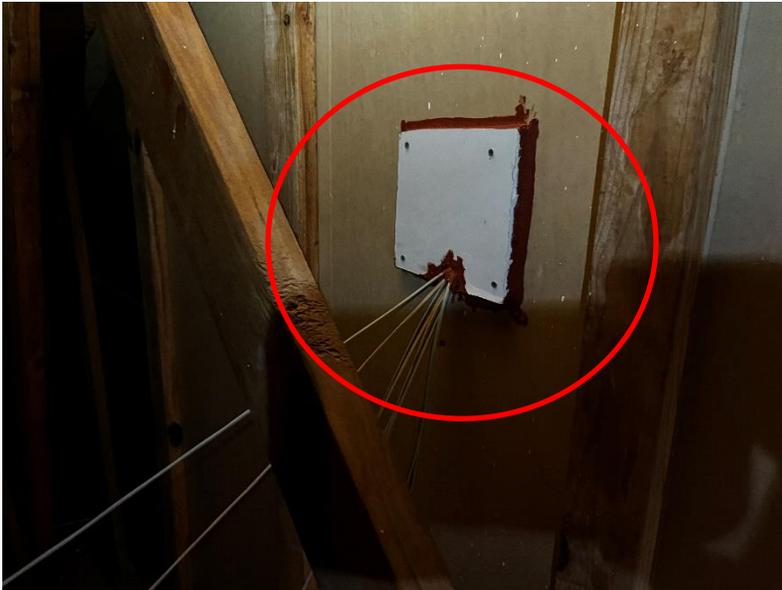
PHOTOGRAPH #11

**BUILDING 11
UNIT #1125- ATTIC REPAIRS**

Contractor has performed firewall and fire sealants repairs at attic space firewalls.

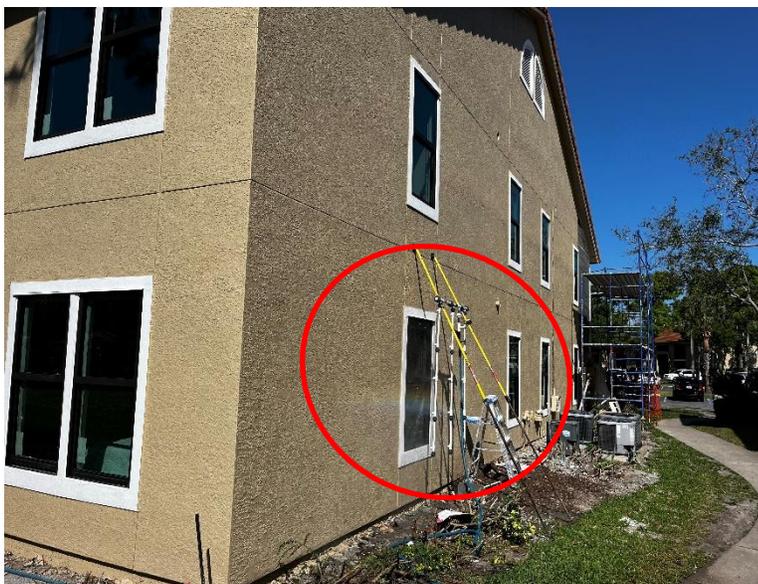
PHOTOGRAPH #12

**BUILDING 11
UNIT #1112- WATER TESTING**

Independent Testing Agency performed water infiltration testing of window as per AAMA 502 specifications. Testing passed with no water observed.

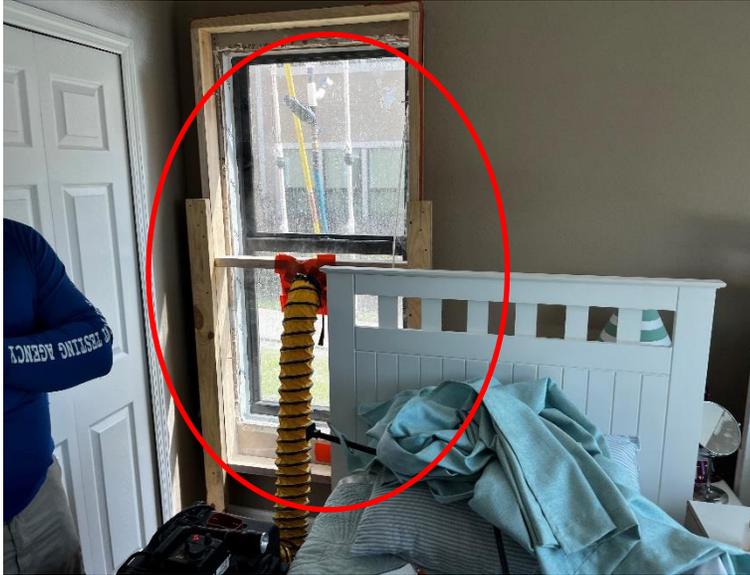
PHOTOGRAPH #13

**BUILDING 11
UNIT #1112- WATER TESTING**

Independent Testing Agency performed water infiltration testing of window as per AAMA 502 specifications. Testing passed with no water observed

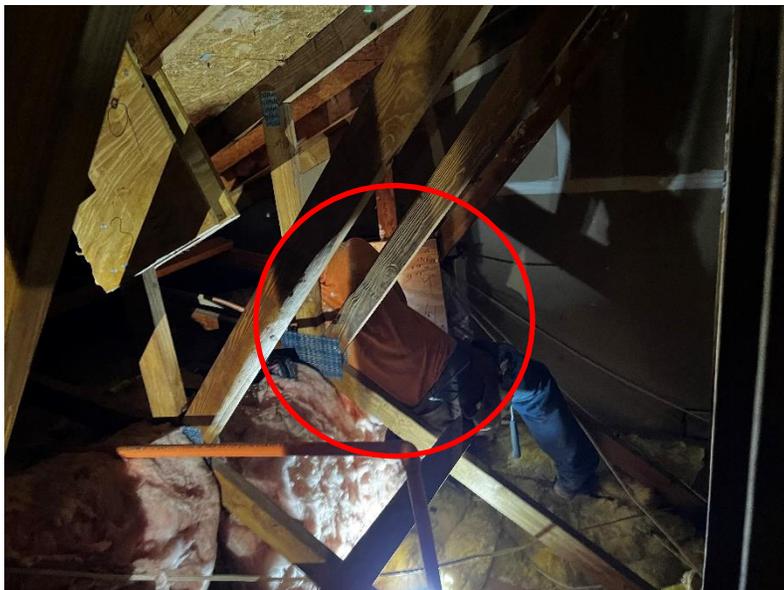
PHOTOGRAPH #14

**BUILDING 11
UNIT #1126- ATTIC REPAIRS**

Contractor performing gusset repairs where required at trusses as per repair drawings.

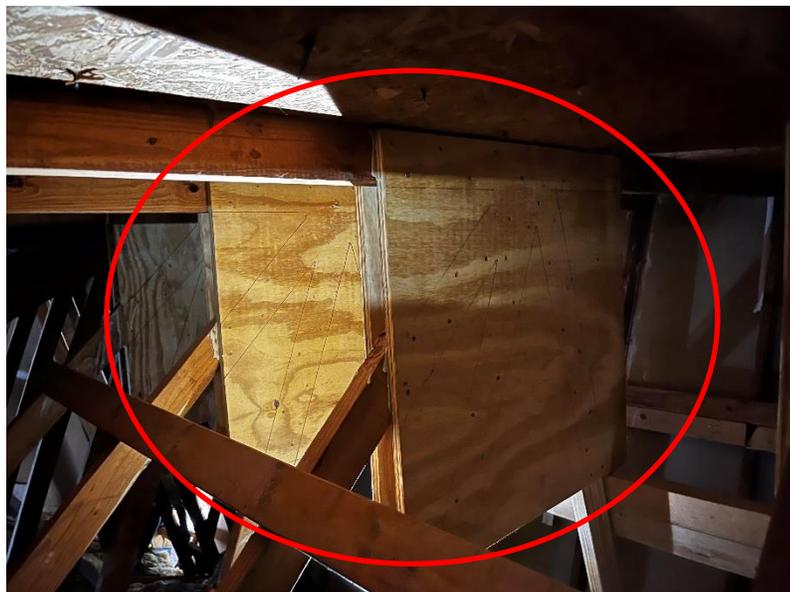
PHOTOGRAPH #15

**BUILDING 11
UNIT #1126- ATTIC REPAIRS**

Previous gusset and framing repairs done by other contractors observed in one section of attic.

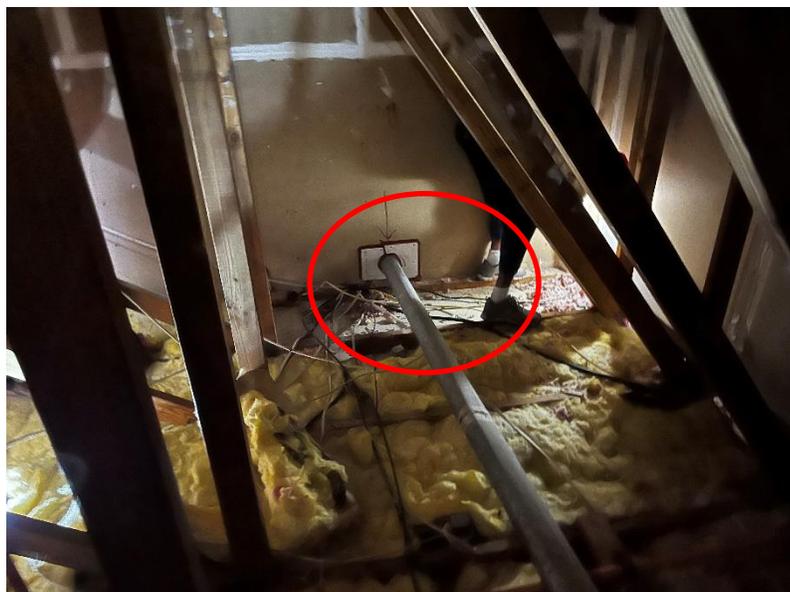
PHOTOGRAPH #16

**BUILDING 11
UNIT #1126- ATTIC REPAIRS**

Contractor has performed firewall and fire sealants repairs at attic space firewalls.

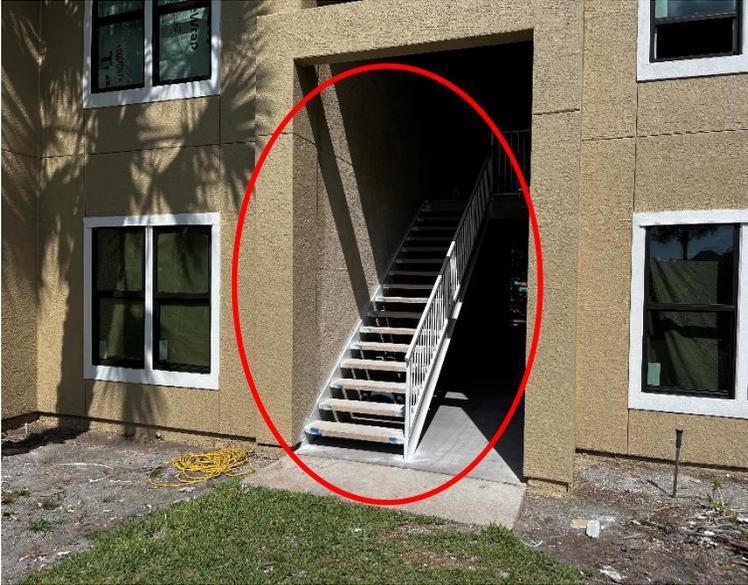
PHOTOGRAPH #17

**BUILDING 11
SECTION E**

Breezeway stairways primed with Florida Paint Epoxy primer.

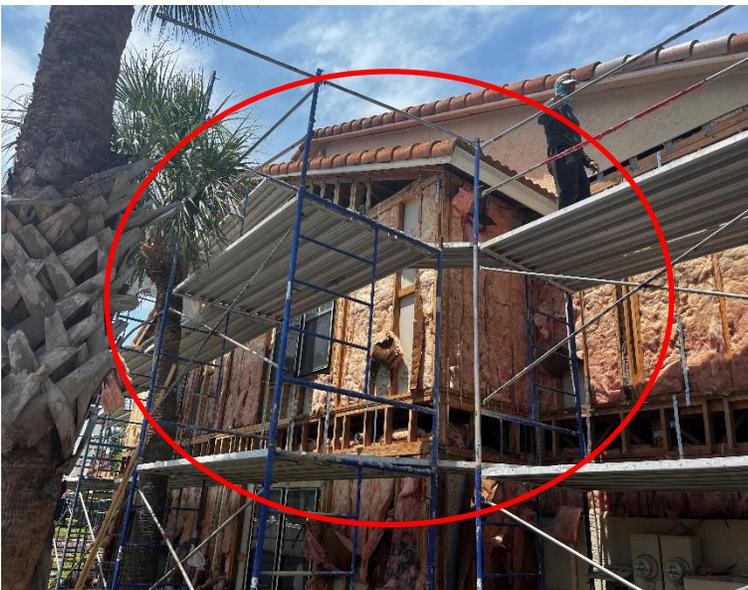
PHOTOGRAPH #18

**BUILDING 12
SECTION D**

Contractor performing framing repairs and framing connectors as per drawings and specifications.

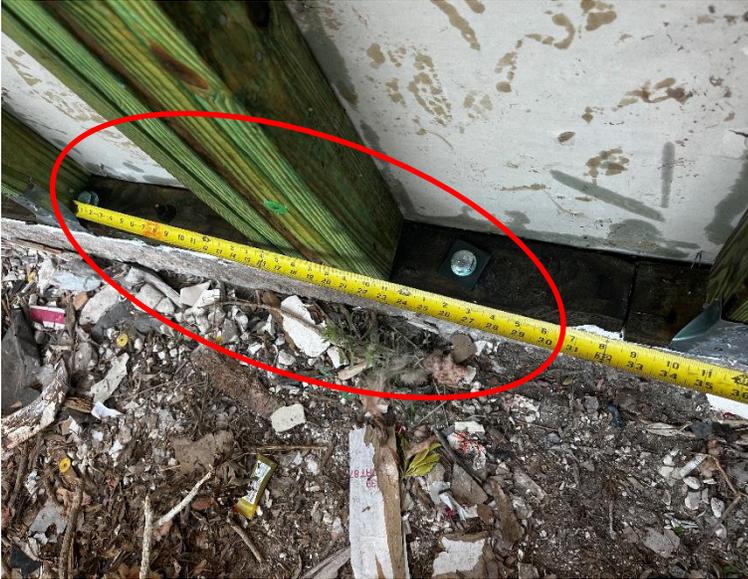
PHOTOGRAPH #19

**BUILDING 12
SECTION D**

5/8" Simpson Titen HD anchors installed at sill plate @ 24" O.C.

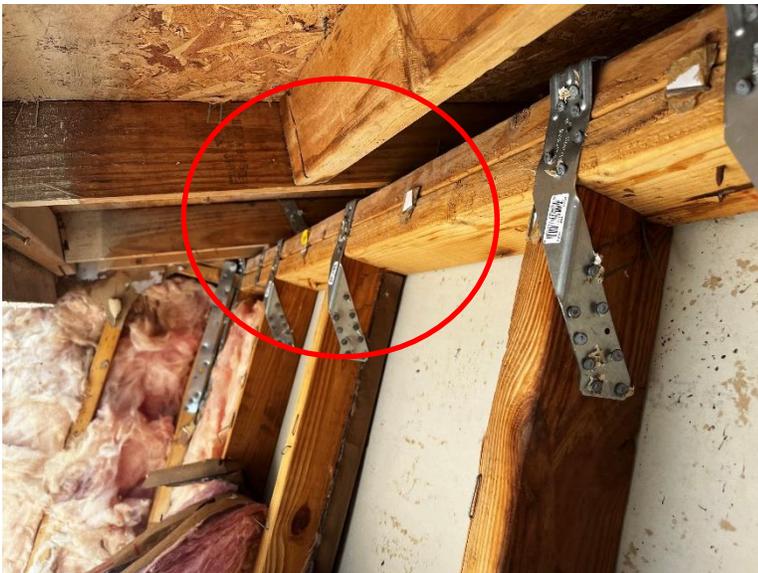
PHOTOGRAPH #20

**BUILDING 12
SECTION D**

Simpson MTS 18 connector strap has not been installed from Truss to Double Top plate and SDWC 15600 screws have not been installed with connectors at double top plate as per drawings and specifications.

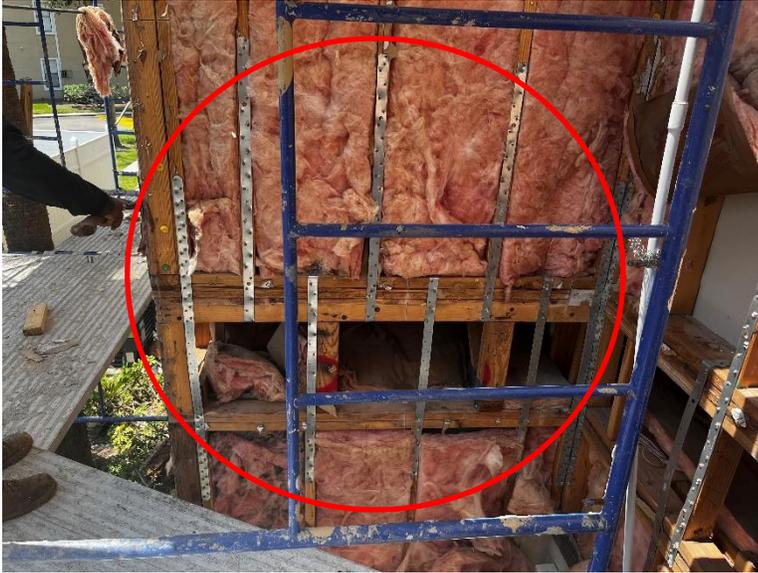
PHOTOGRAPH #21

**BUILDING 12
SECTION D**

Simpson MST A49 and MST A36 framing connector straps have been installed as per drawings and specifications.

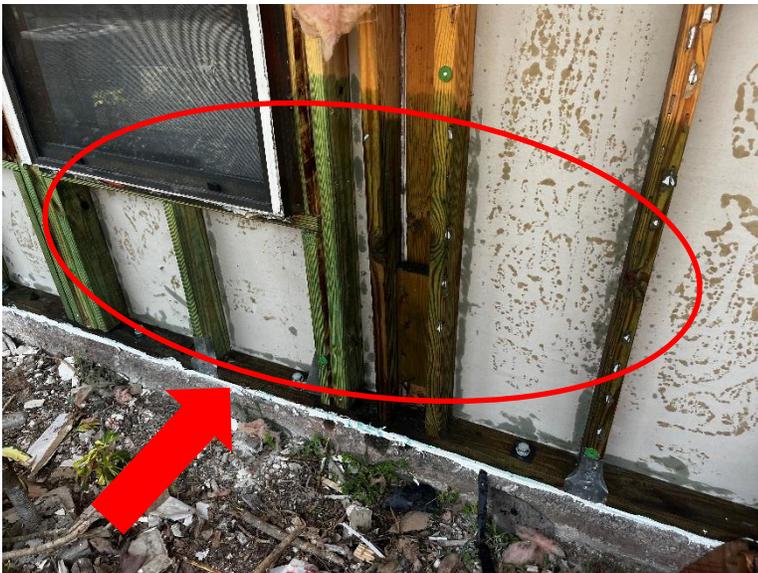
PHOTOGRAPH #22

**BUILDING 12
SECTION D**

Sealant installed at existing footing to sill plate and Copper Green wood preservative applied at framing as per drawings and specifications.
