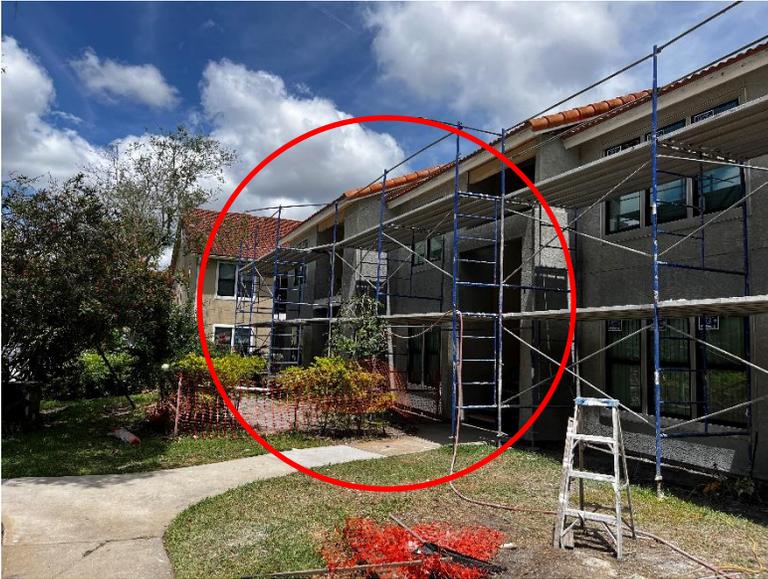
PHOTOGRAPH #1

**BUILDING 11
SECTION A**

Stucco sub-contractor has completed full three coat 7/8" stucco system as per drawings and specifications.

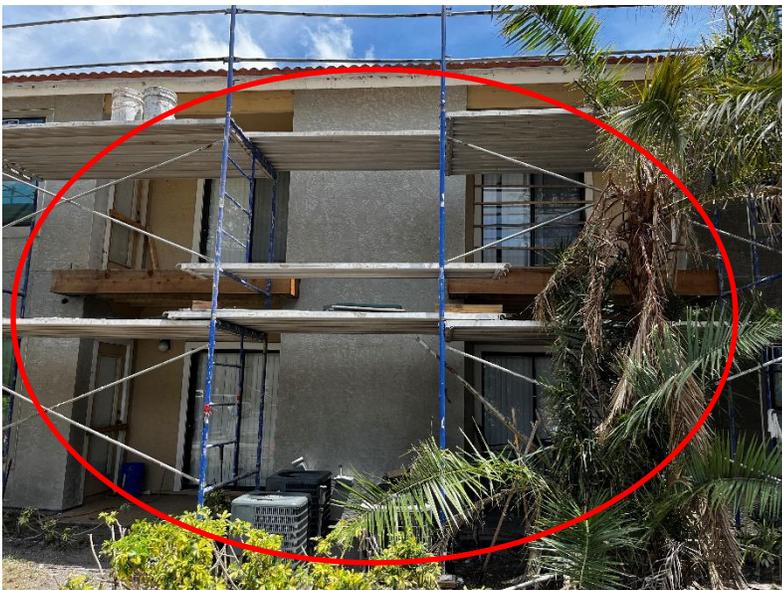
PHOTOGRAPH #2

**BUILDING 11
SECTION B**

Stucco sub-contractor has completed full three coat 7/8" stucco system as per drawings and specifications.

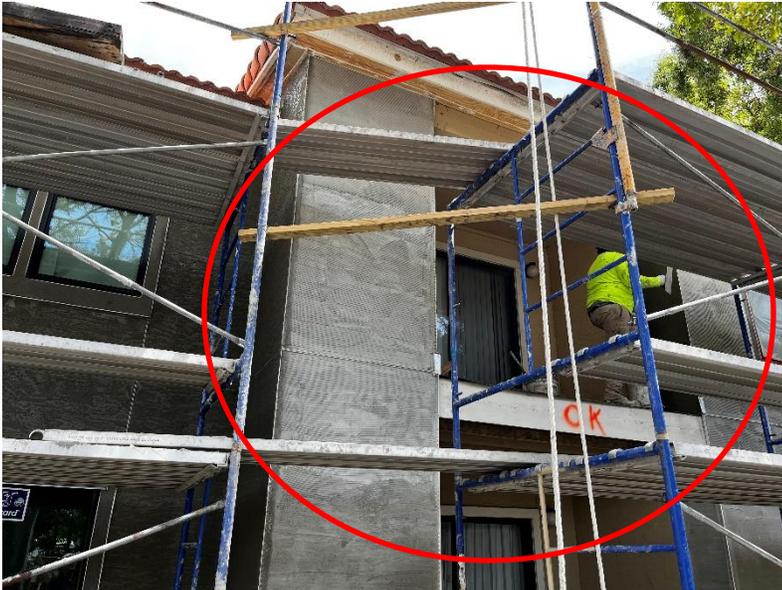
PHOTOGRAPH #3

**BUILDING 11
SECTION C**

Stucco sub-contractor has applied scratch coat and in process of applying brown coat as per drawings and specifications.

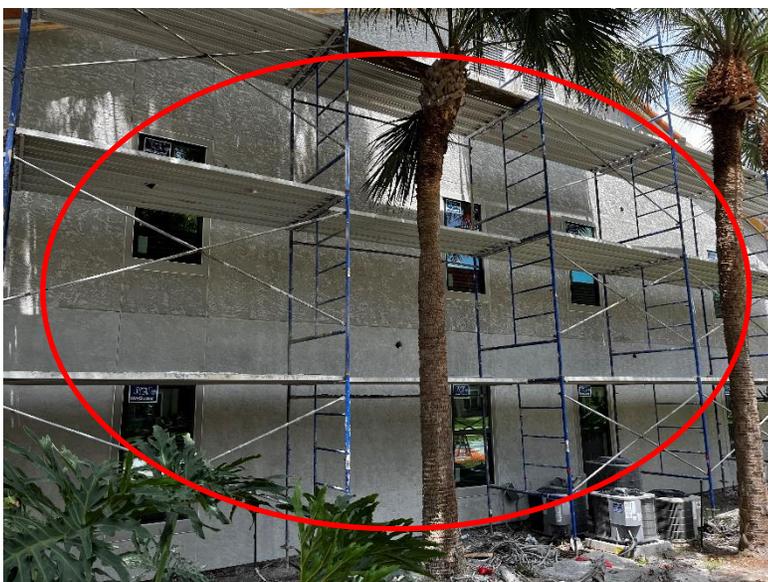
PHOTOGRAPH #4

**BUILDING 11
SECTION D**

Stucco sub-contractor has completed full three coat 7/8" stucco system as per drawings and specifications.

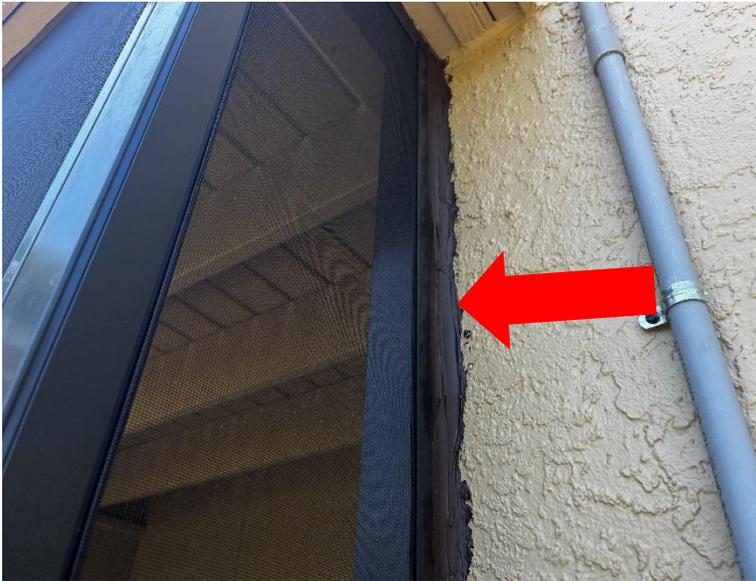
PHOTOGRAPH #5

**BUILDING 11
SECTION E**

Sealant applied at new screen enclosure to stucco is poorly applied and required to be removed and replaced.

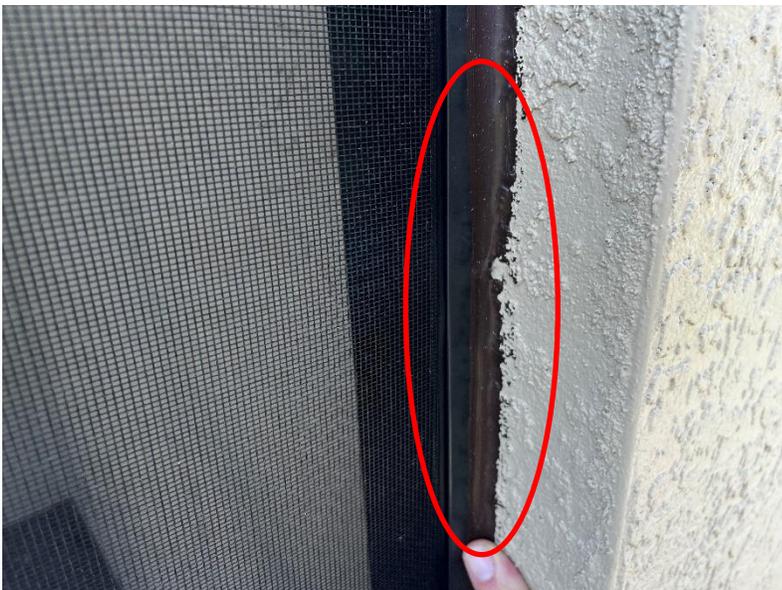
PHOTOGRAPH #6

**BUILDING 11
SECTION F**

Sealant applied at new screen enclosure to stucco is poorly applied and required to be removed and replaced.

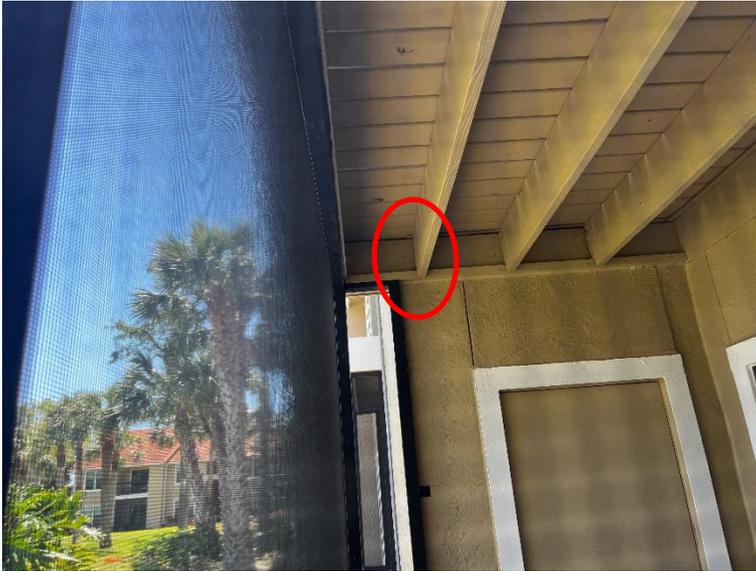
PHOTOGRAPH #7

**BUILDING 11
SECTION F**

Contractor has not yet installed Simpson #SDW22458 screws @ ledger and corner blocking as per drawings.

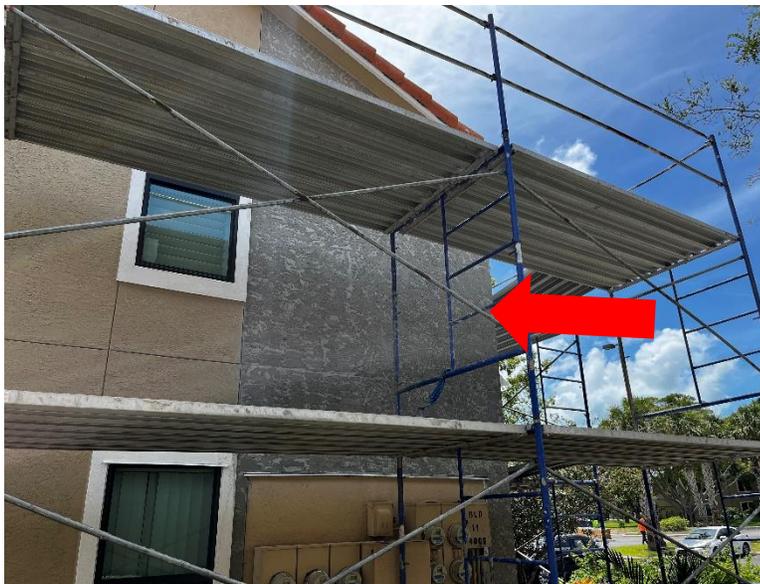
PHOTOGRAPH #8

**BUILDING 11
SECTION H**

Stucco sub-contractor has completed full three coat 7/8" stucco system as per drawings and specifications.

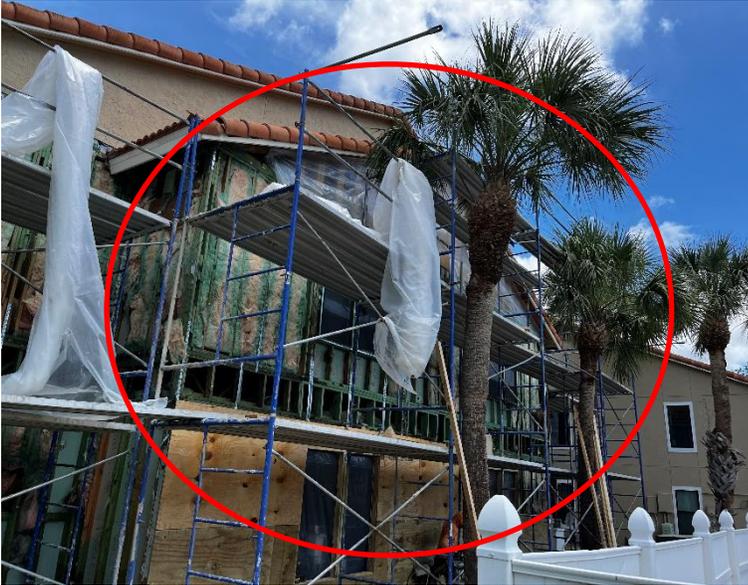
PHOTOGRAPH #9

**BUILDING 12
SECTION D**

Bora Care termite treatment applied by pest contractor and new plywood sheathing in progress.

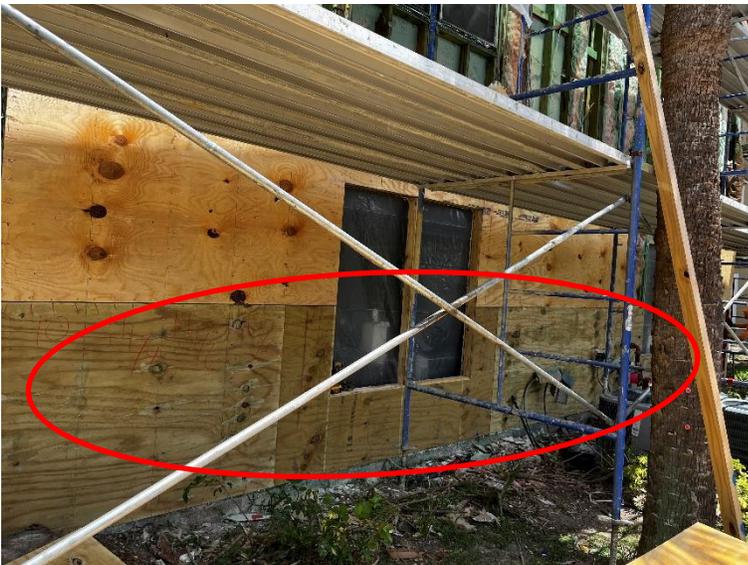
PHOTOGRAPH #10

**BUILDING 12
SECTION D**

Contractor installing new pressure treated 15/32" plywood sheathing at bottom 4'X8' sheet as per specifications.

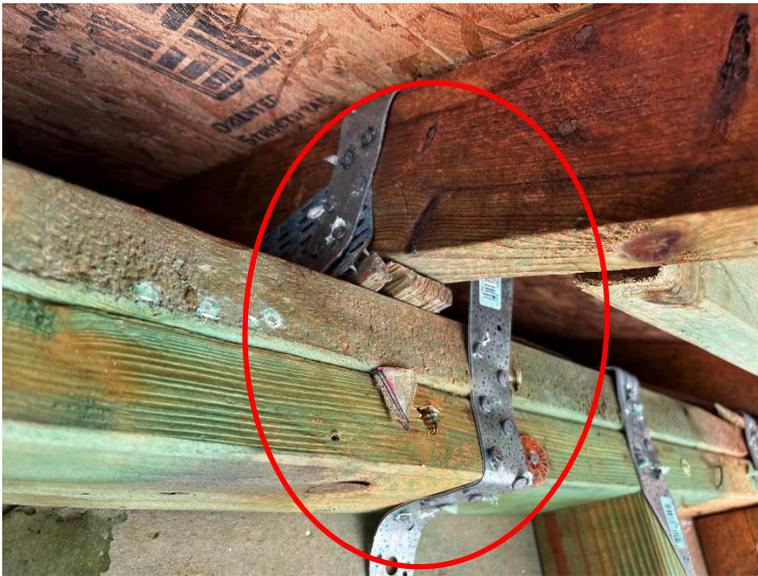
PHOTOGRAPH #11

**BUILDING 12
SECTION D**

Simpson MTS connector strap installed from Truss to Double Top plate and SDWC 15600 screws installed with connectors at double top plate as per drawings and specifications.

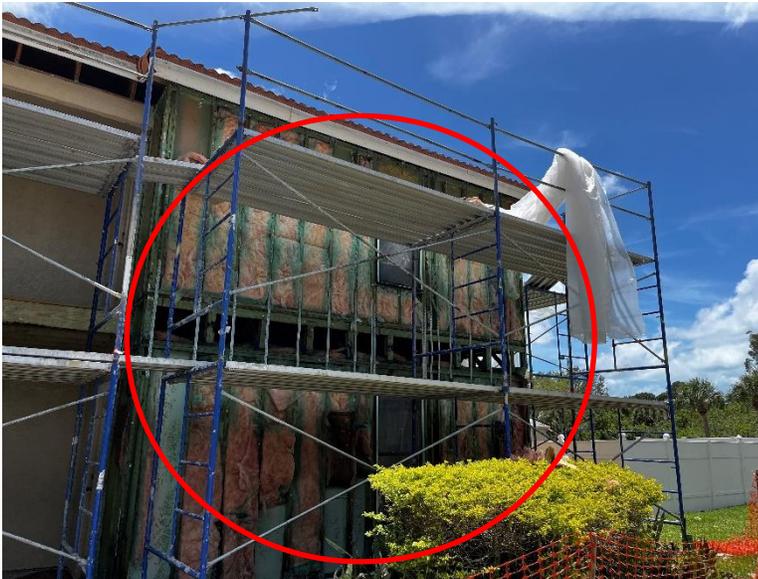
PHOTOGRAPH #12

**BUILDING 12
SECTION C**

Bora Care termite treatment applied by pest contractor and new insulation installed where missing or damaged.

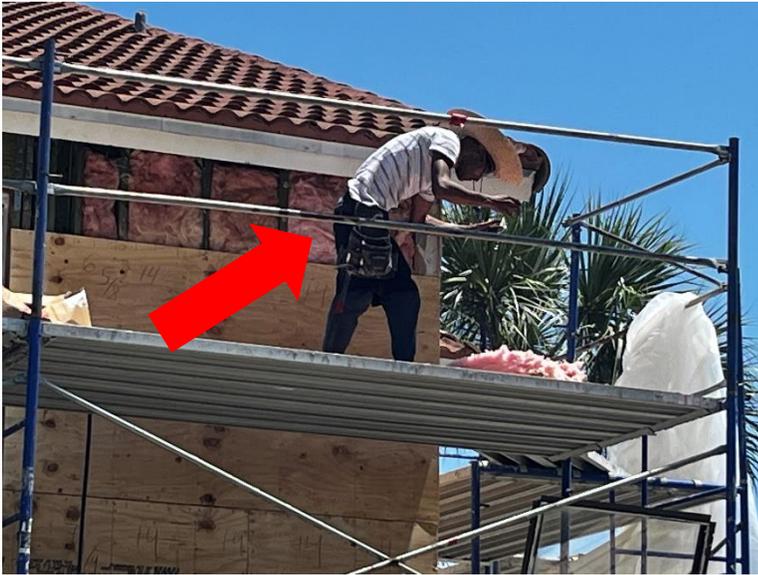
PHOTOGRAPH #13

**BUILDING 12
SECTION C**

Contractor installing new Owens Corning insulation were missing or damaged as per contract and specifications.

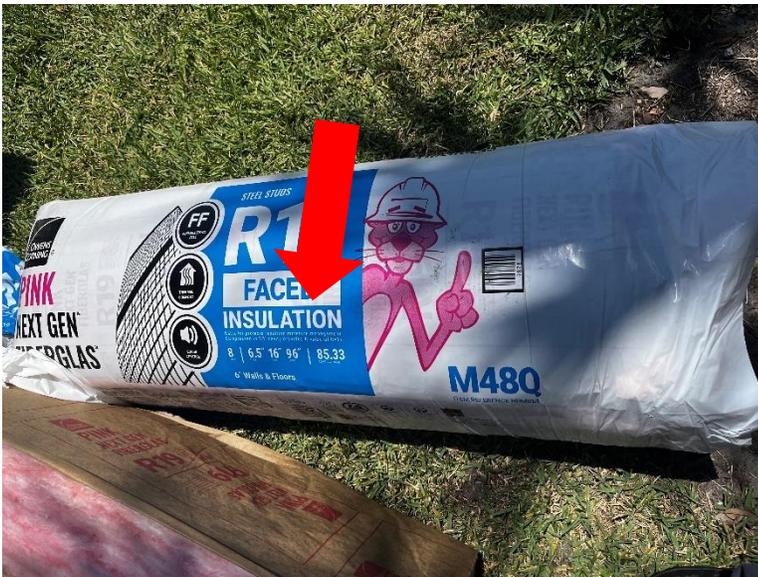
PHOTOGRAPH #14

**BUILDING 12
SECTION C**

Contractor installing new Owens Corning insulation were missing or damaged as per contract and specifications.

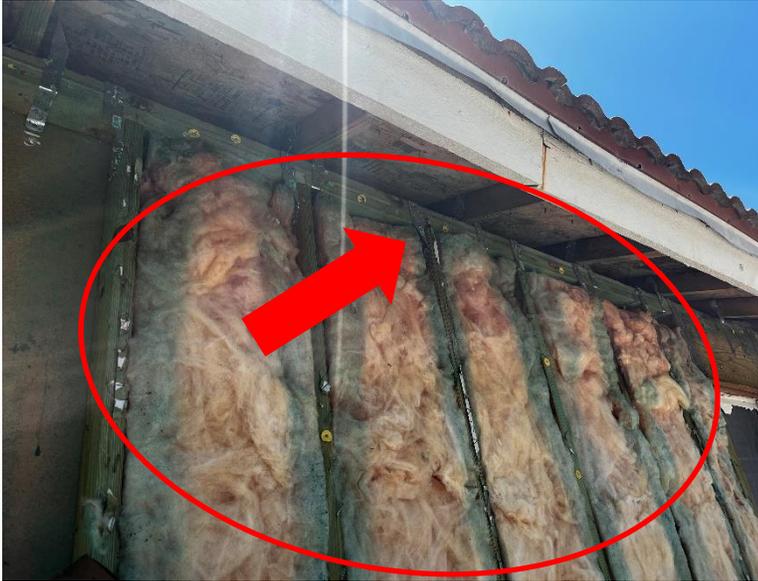
PHOTOGRAPH #15

**BUILDING 12
SECTION B**

Bora Care termite treatment applied by pest contractor and Simpson MTS connector straps installed from Truss to Double Top plate and SDWC 15600 screws installed with connectors at double top plate as per drawings and specifications.

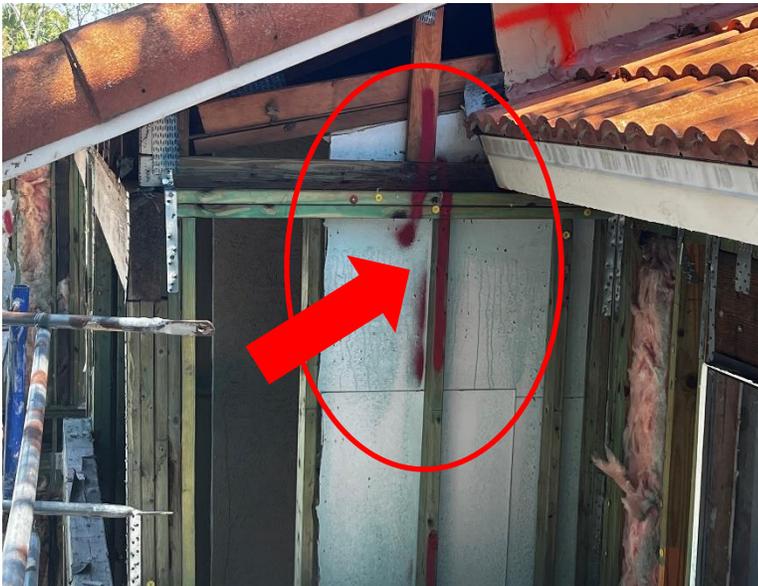
PHOTOGRAPH #16

**BUILDING 12
SECTION B**

Connector straps missed at return walls from studs to top plate and top plate to truss marked for correction.

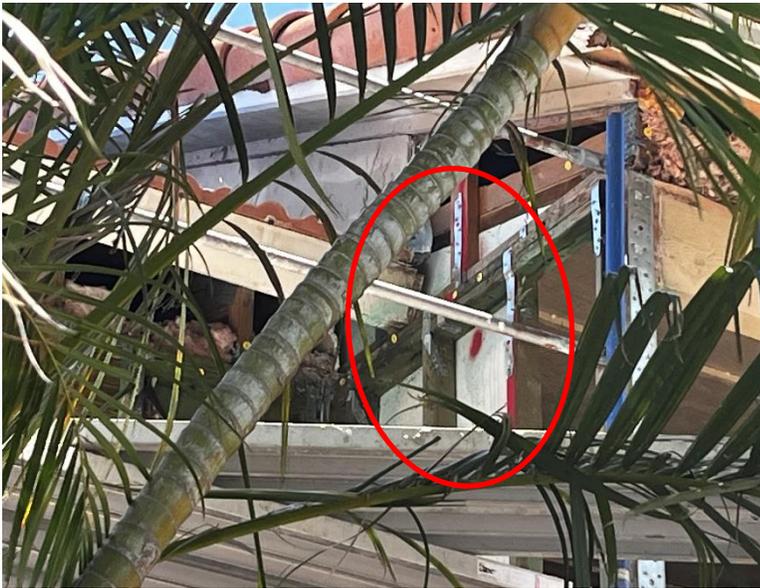
PHOTOGRAPH #17

**BUILDING 12
SECTION B**

Contractor has installed connector straps missed at return walls from studs to top plate and top plate to truss.

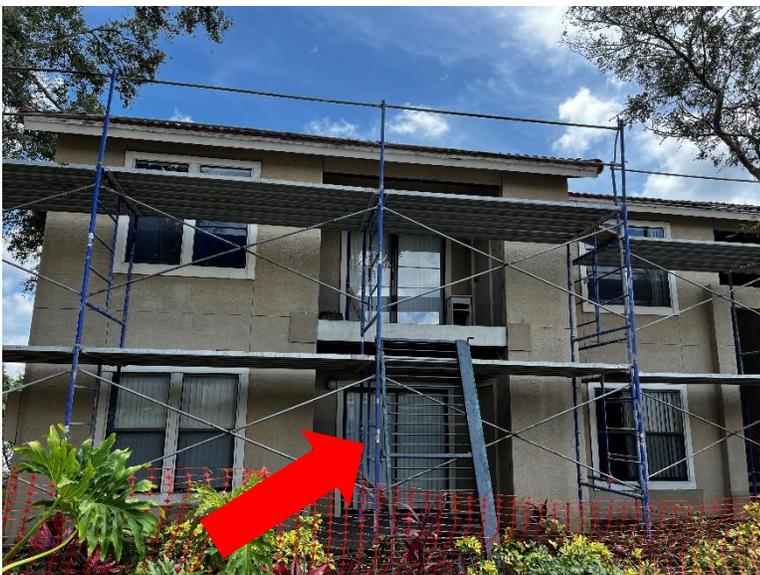
PHOTOGRAPH #18

**BUILDING 9
SECTION E**

Contractor has mobilized repairs, provided access scaffolding, and removed balcony railings.

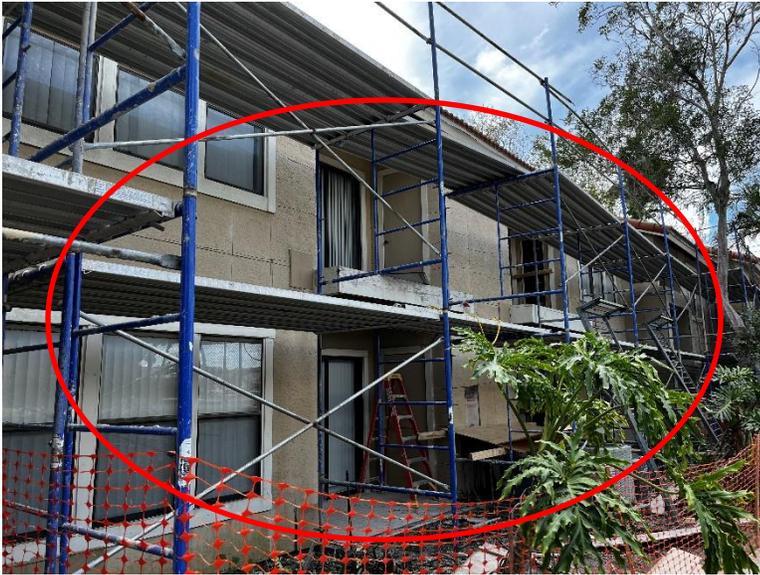
PHOTOGRAPH #19

**BUILDING 9
SECTION F**

Contractor has mobilized repairs, provided access scaffolding, and removed balcony railings.

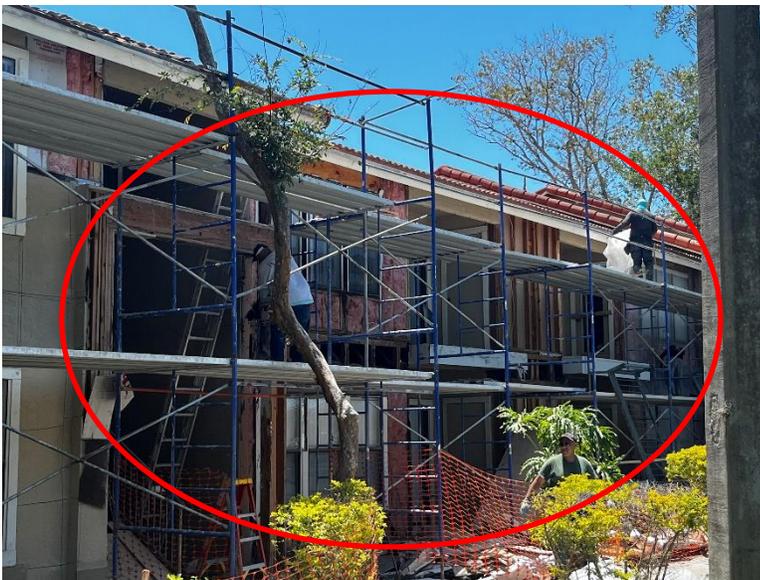
PHOTOGRAPH #20

**BUILDING 9
SECTION F**

Contractor has removed stucco and sheathing exposing wall framing for repairs.

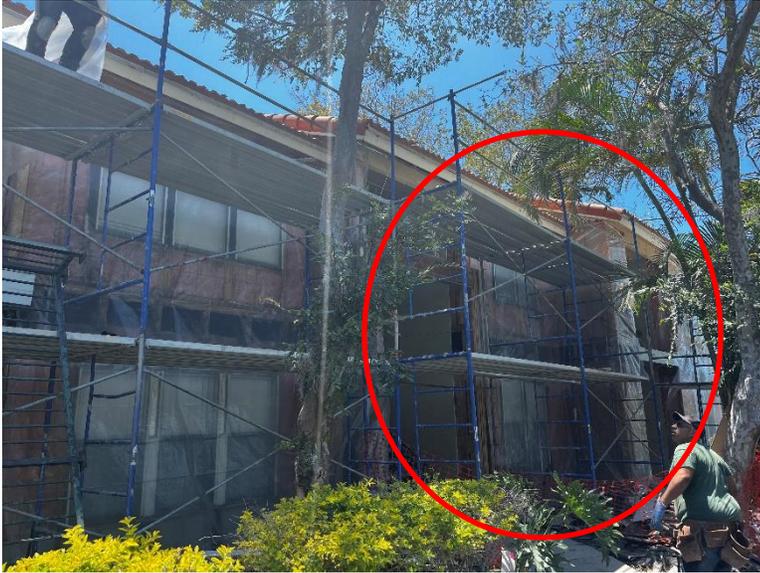
PHOTOGRAPH #21

**BUILDING 9
SECTION G**

Contractor has removed stucco and sheathing exposing wall framing for repairs.

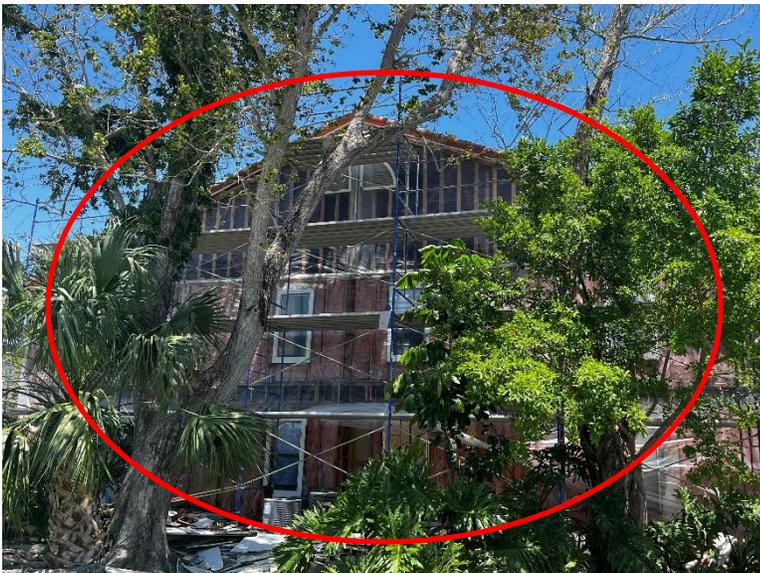
PHOTOGRAPH #22

**BUILDING 9
SECTION H**

Contractor has removed stucco and sheathing exposing wall framing for repairs.
