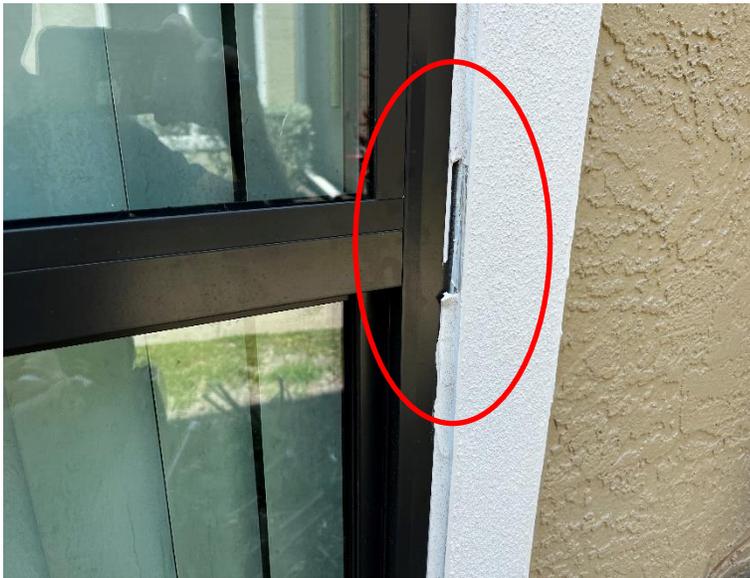
PHOTOGRAPH #1

**BUILDING 11
SECTION H**

Delta performed successful sealant
adhesion pull testing at new window
perimeter.

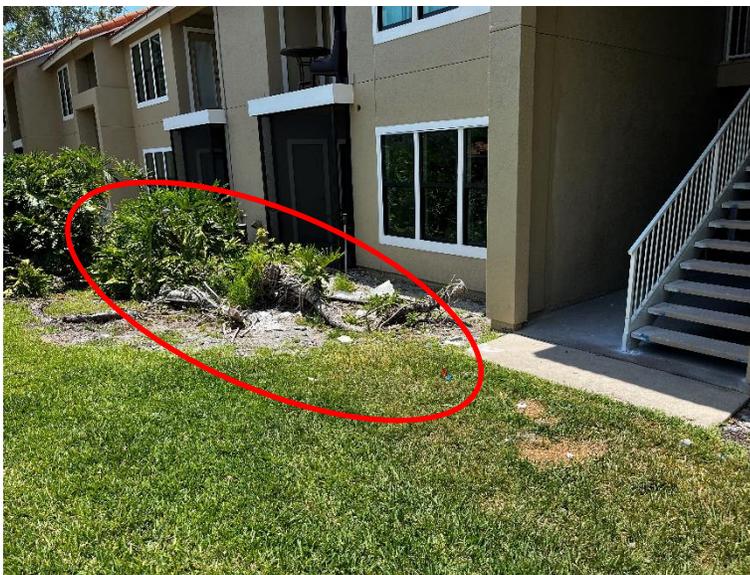
PHOTOGRAPH #2

**BUILDING 11
SECTION F**

Contractor has not cleaned up grounds
from construction debris.

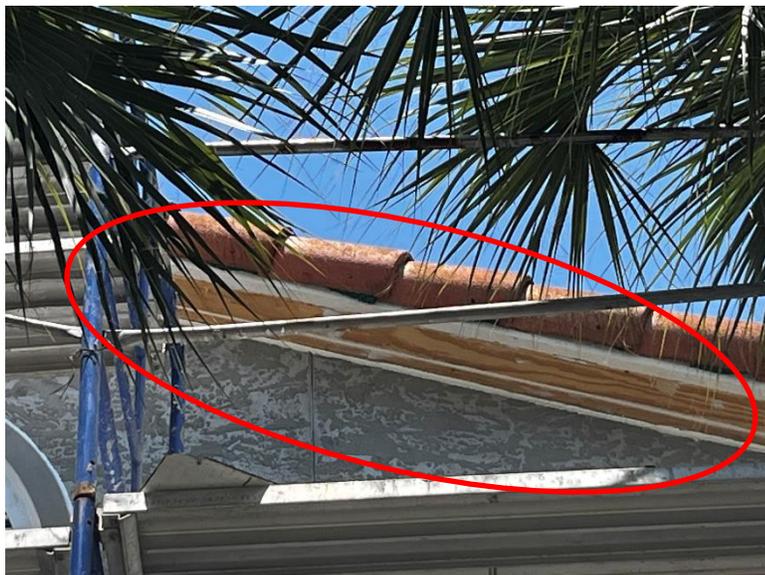
PHOTOGRAPH #3

**BUILDING 11
SECTION D**

New plywood soffit installed at gable end wall as per specifications.

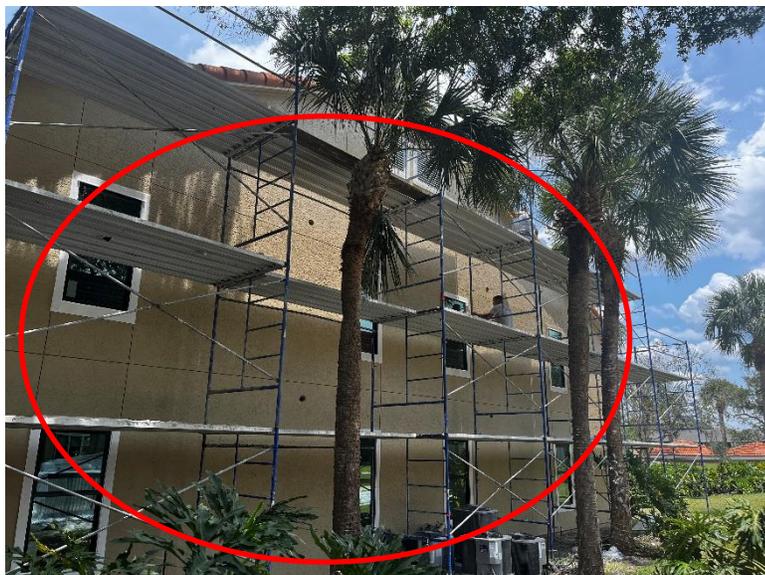
PHOTOGRAPH #4

**BUILDING 11
SECTION D**

Florida Paints Glades Exterior 100% acrylic coating applied to new stucco.

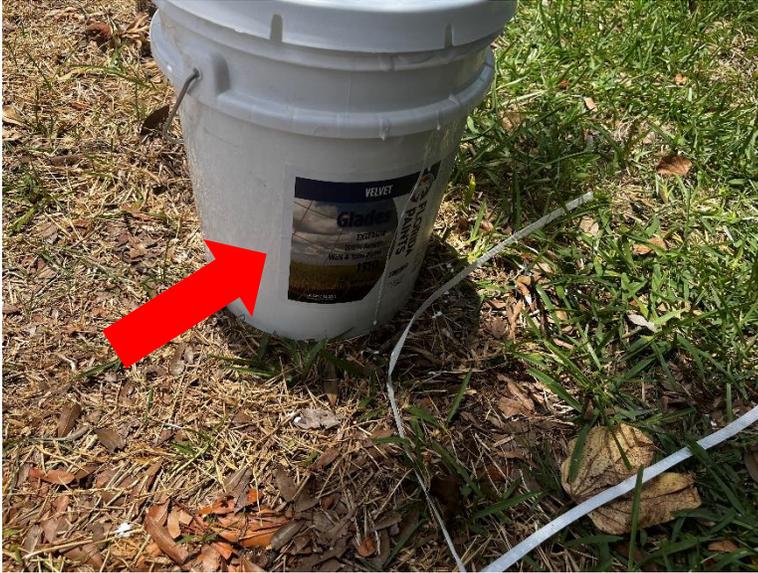
PHOTOGRAPH #5

**BUILDING 11
SECTION D**

Florida Paints Glades Exterior 100% acrylic coating applied to new stucco.

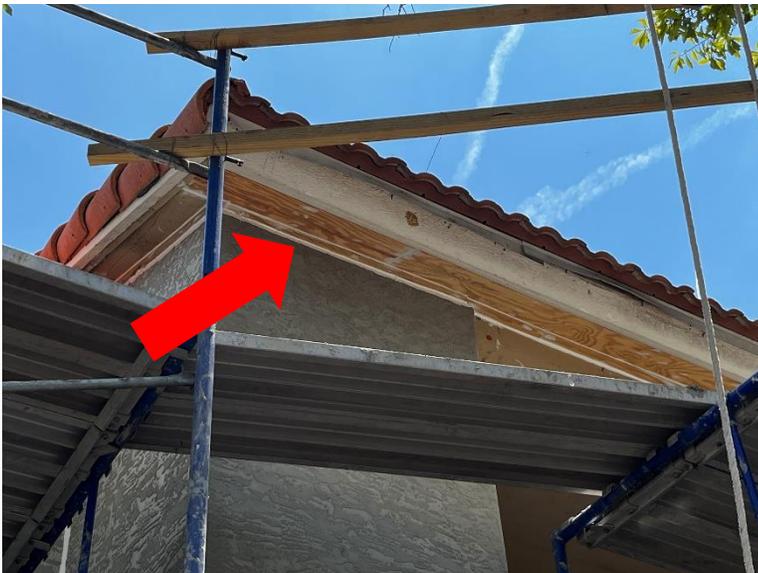
PHOTOGRAPH #6

**BUILDING 11
SECTION C**

New plywood soffit with vinyl venting installed as per specifications.

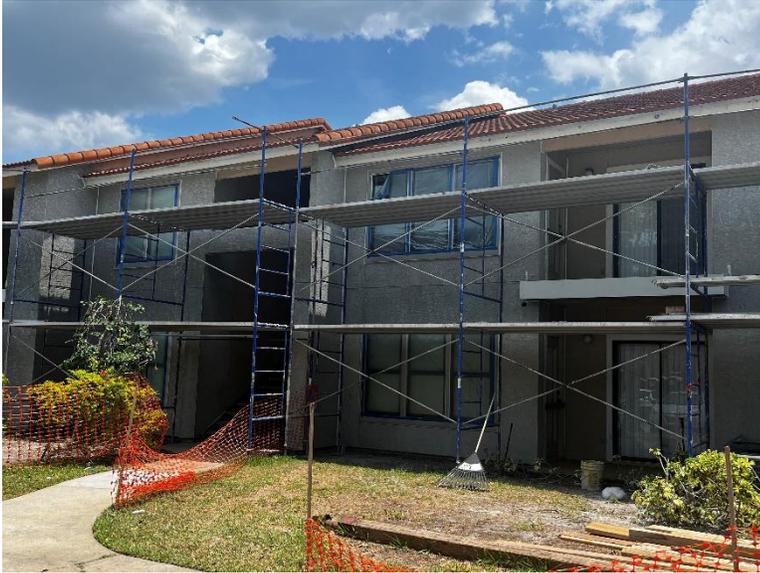
PHOTOGRAPH #7

**BUILDING 11
SECTION B**

Contractor installing new BASF MasterSeal sealants at window perimeter and corner joints.

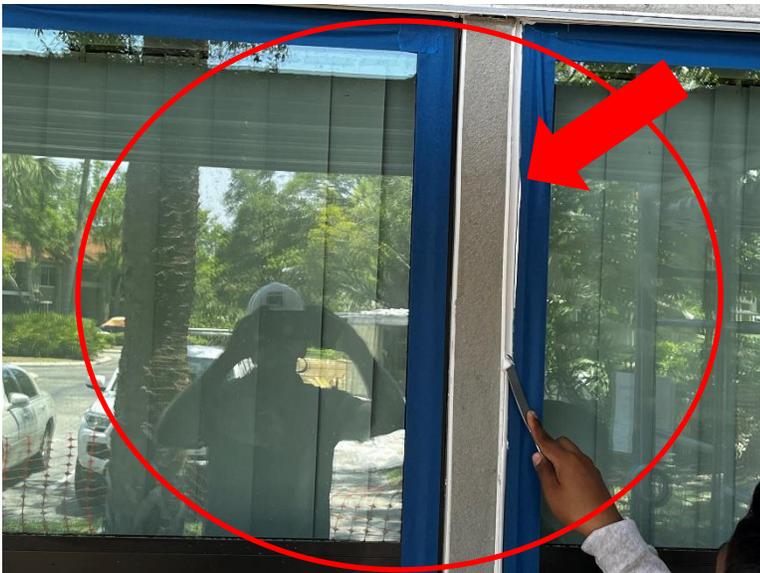
PHOTOGRAPH #8

**BUILDING 11
SECTION B**

Contractor applying and dry tooling new MasterSeal sealant at window perimeter.

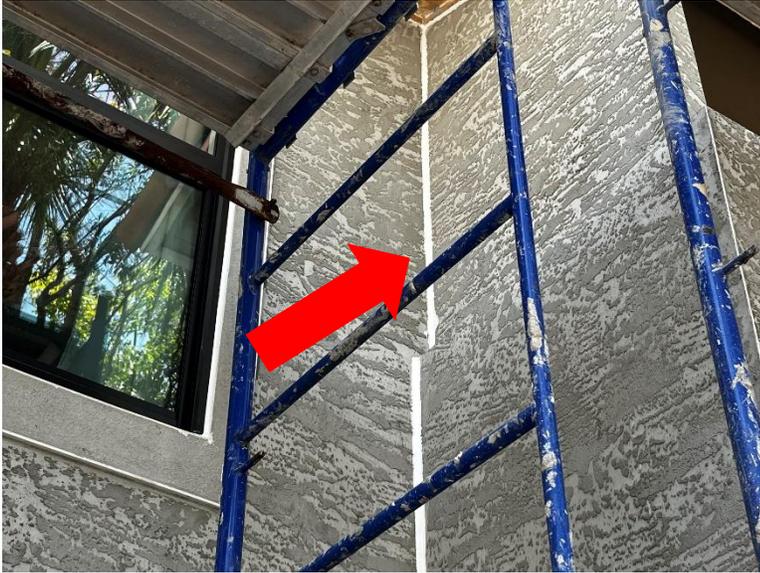
PHOTOGRAPH #9

**BUILDING 11
SECTION B**

Contractor has applied new sealant at corners and stucco to stucco transitions.

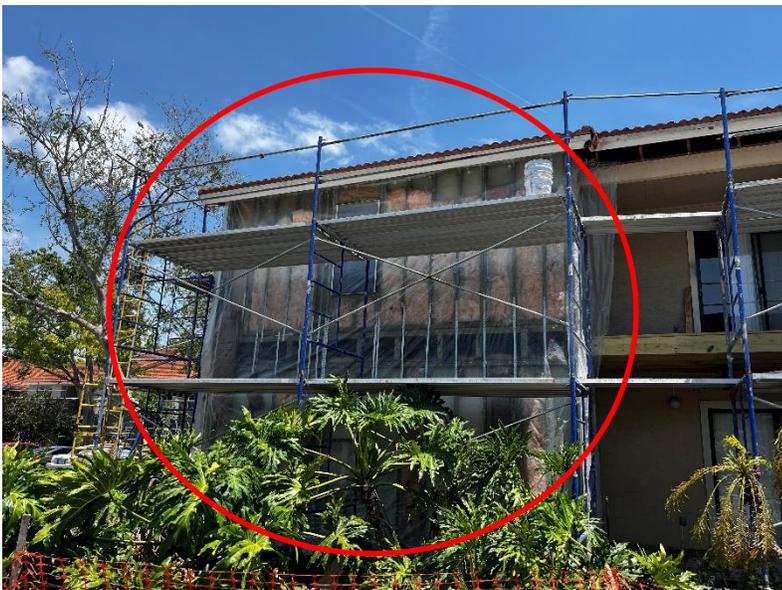
PHOTOGRAPH #10

**BUILDING 12
SECTION A**

Bora Care termite treatment applied, and Simpson Strong-Tie connectors installed as per drawings and specifications.

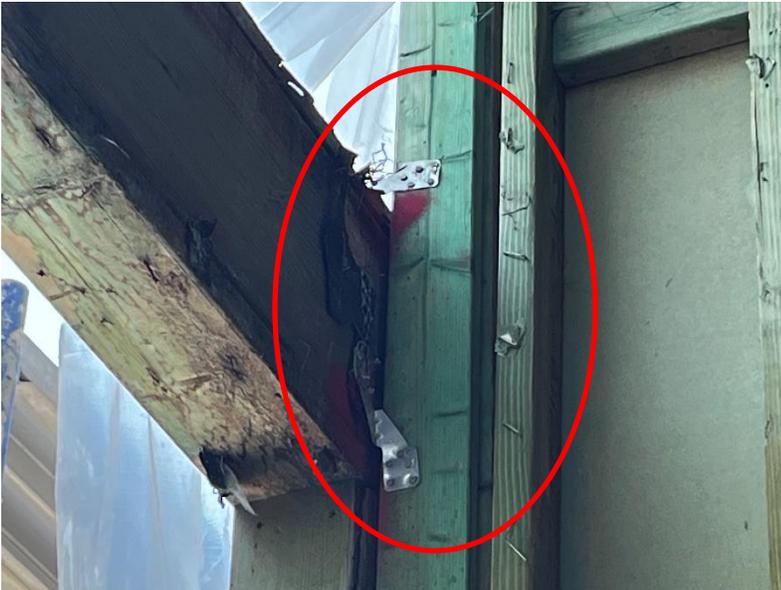
PHOTOGRAPH #11

**BUILDING 12
SECTION A- BREEZEWAY**

Breezeway box beam to stud connected as per drawings and details with Simpson Strong Tie H3 connector.

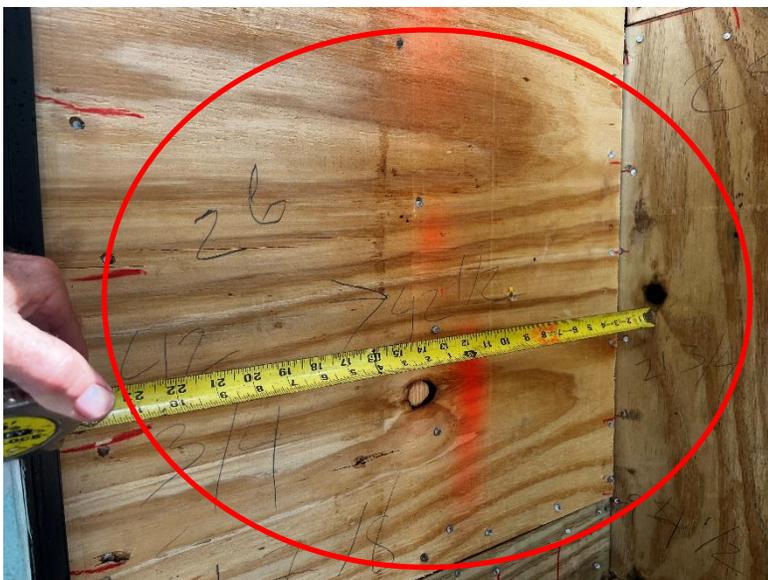
PHOTOGRAPH #12

**BUILDING 12
SECTION A**

Plywood sheathing attached to 16" O.C. wall framing studs, 4" O.C. along end studs and 6" O.C. in field.

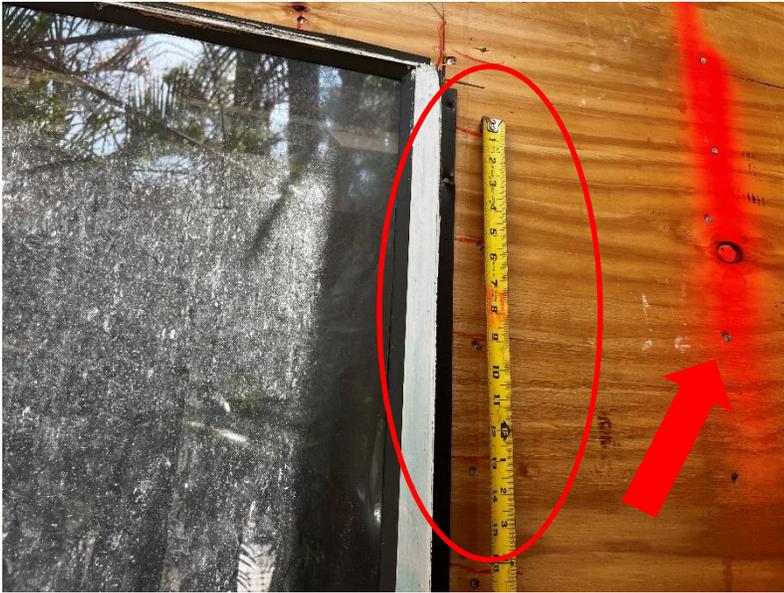
PHOTOGRAPH #13

**BUILDING 12
SECTION B**

Plywood sheathing attached to 16" O.C. wall framing studs, 4" O.C. along end studs and 6" O.C. in field.

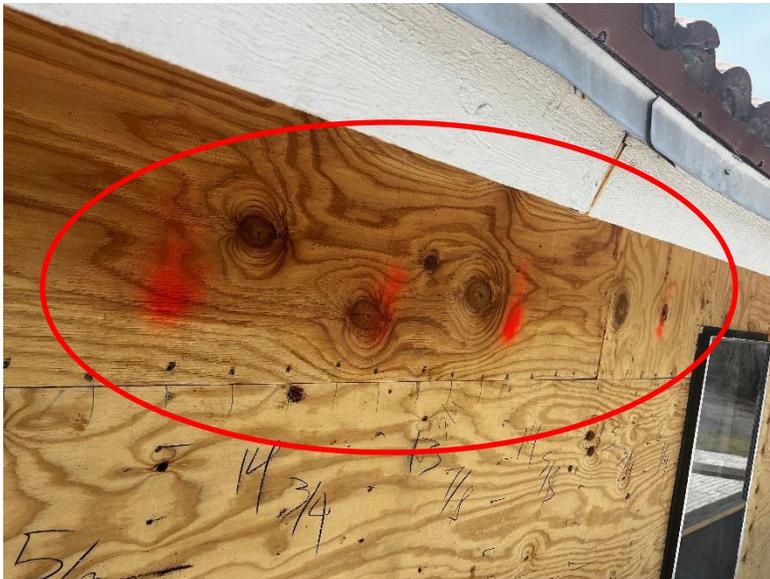
PHOTOGRAPH #14

**BUILDING 12
SECTION C**

Delta marked attachments to framing studs missed at top sheet of plywood.

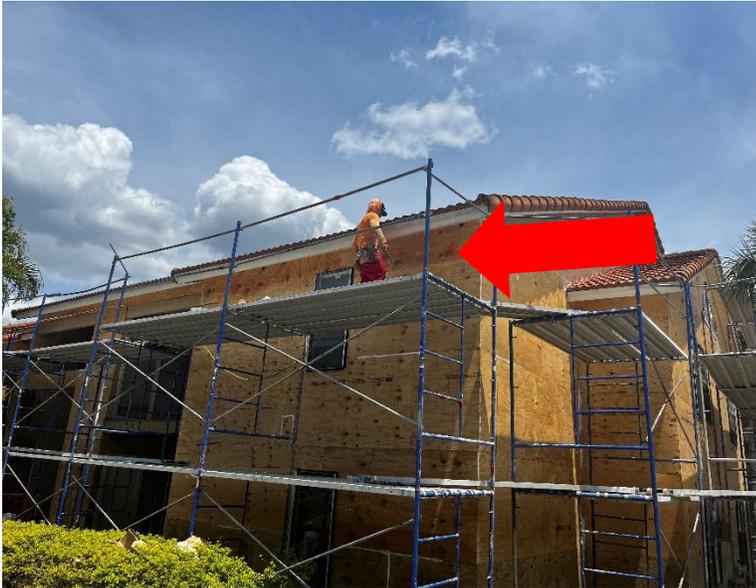
PHOTOGRAPH #15

**BUILDING 12
SECTION C**

Contractor making corrections by adding fasteners at marked areas of plywood sheathing.

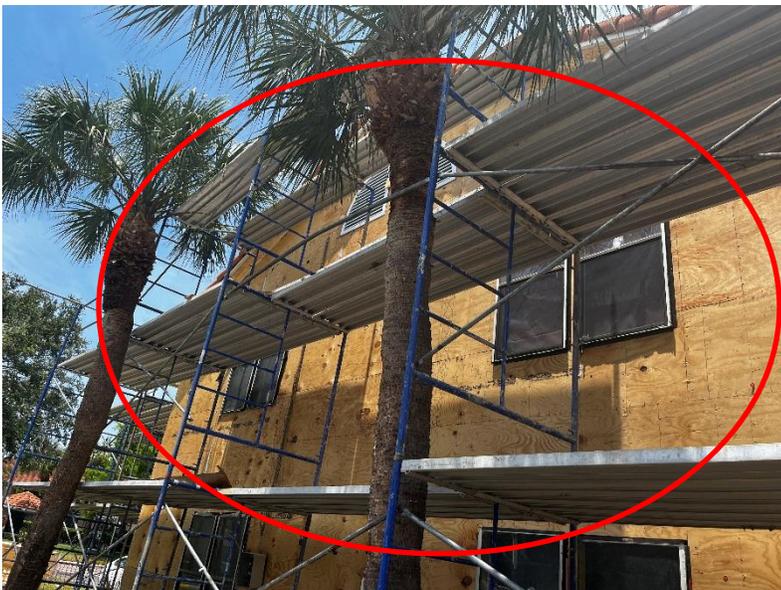
PHOTOGRAPH #16

**BUILDING 12
SECTION D**

15/32" plywood sheathing attached to framing studs at gable end as per drawings and specifications.

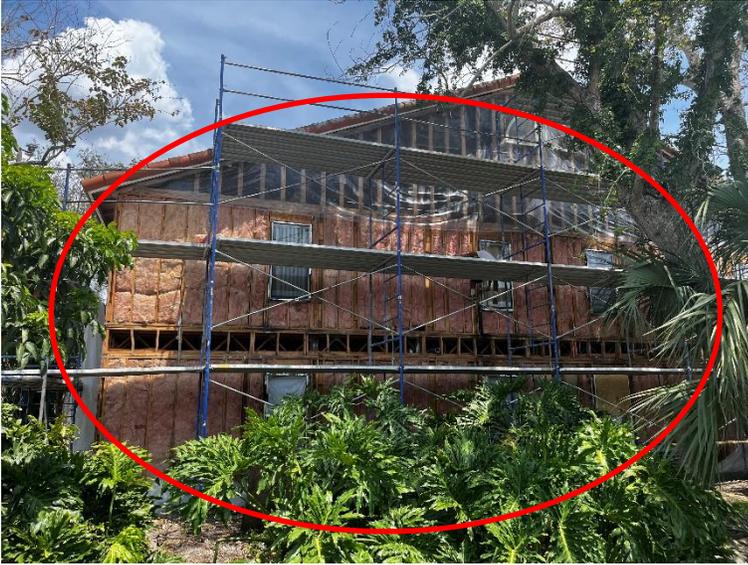
PHOTOGRAPH #17

**BUILDING 9
SECTION H**

Delta inspected and marked damaged framing for repairs.

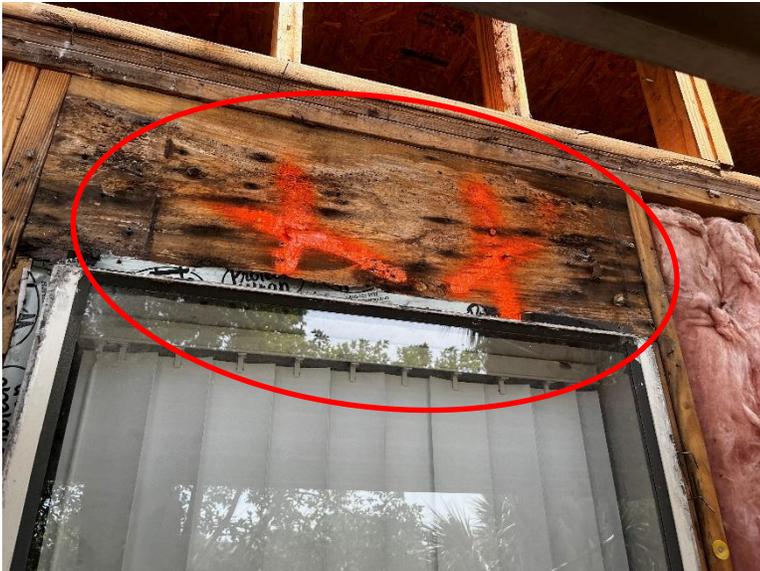
PHOTOGRAPH #18

**BUILDING 9
SECTION H**

Damaged single window header marked for repairs.

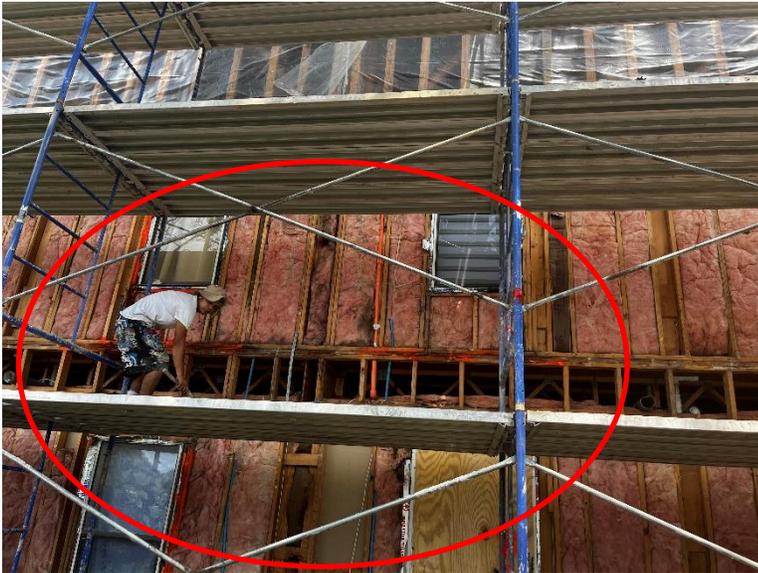
PHOTOGRAPH #19

**BUILDING 9
SECTION H**

Damaged window framing, wall studs and bottom plates marked for repairs.

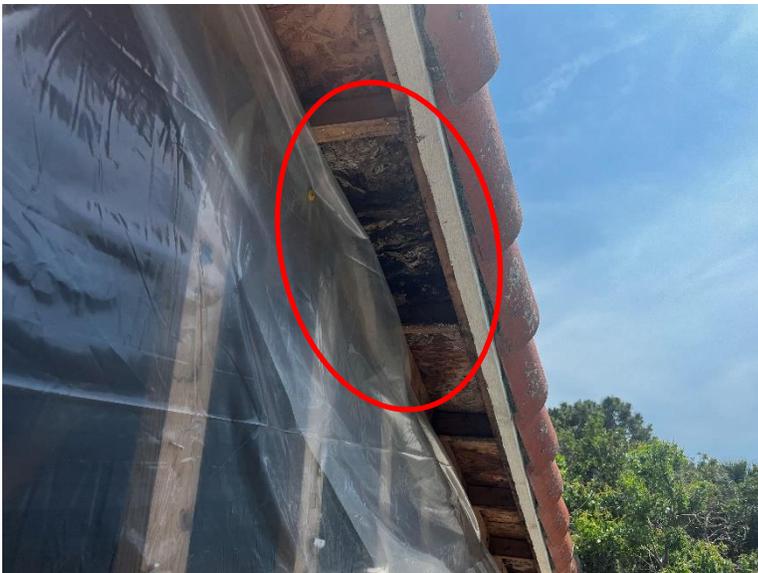
PHOTOGRAPH #20

**BUILDING 9
SECTION H**

Damaged roof sheathing exposed by removal of soffit. Not part of wall repair scope of work and to be repaired by owners' roofers.

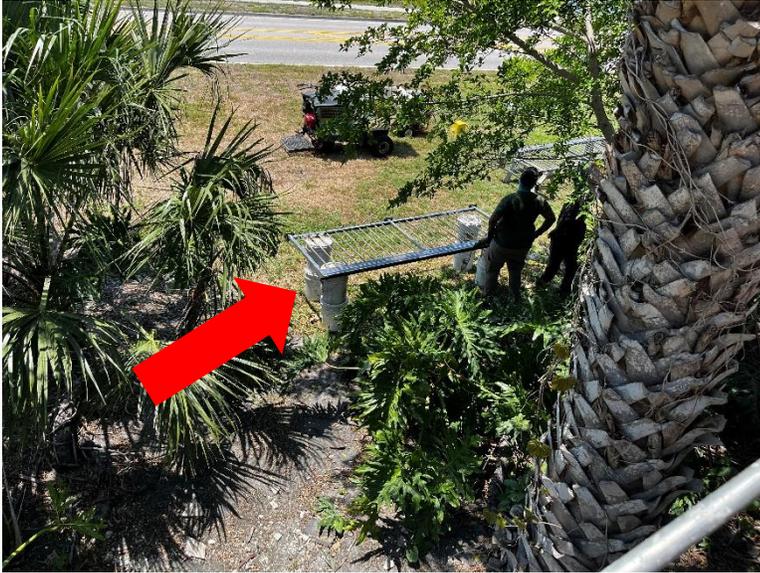
PHOTOGRAPH #21

**BUILDING 9
SECTION H**

Contractor grinding loose paint and rust from balcony railings in preparation for primer and paint applications.

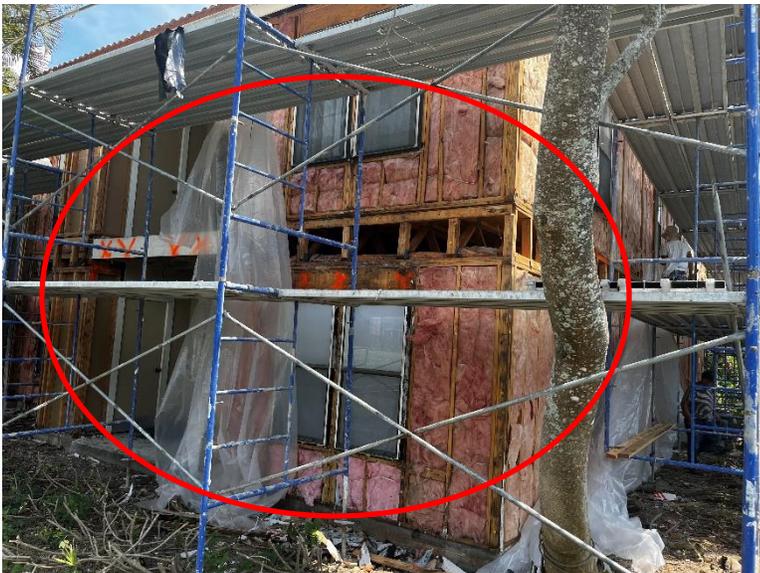
PHOTOGRAPH #22

**BUILDING 9
SECTION G**

Delta inspected and marked damaged framing for repairs.

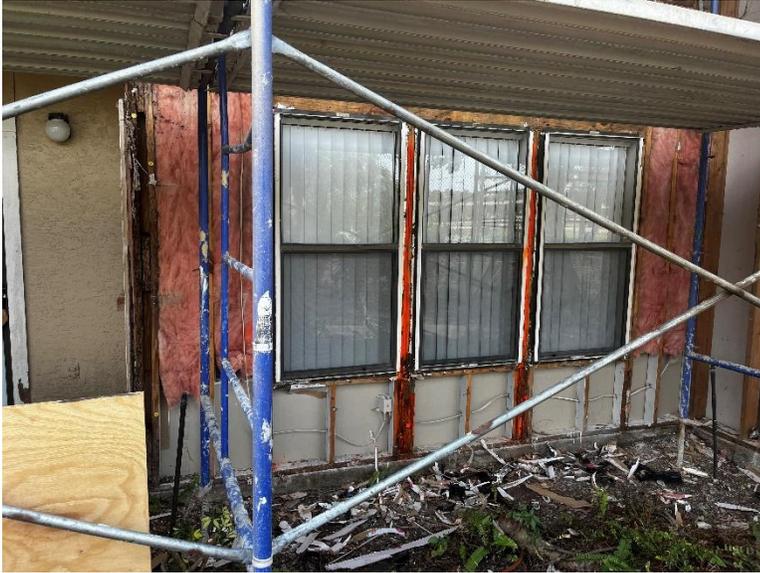
PHOTOGRAPH #23

**BUILDING 9
SECTION F**

Damaged window framing and jacks
marked for repairs.
