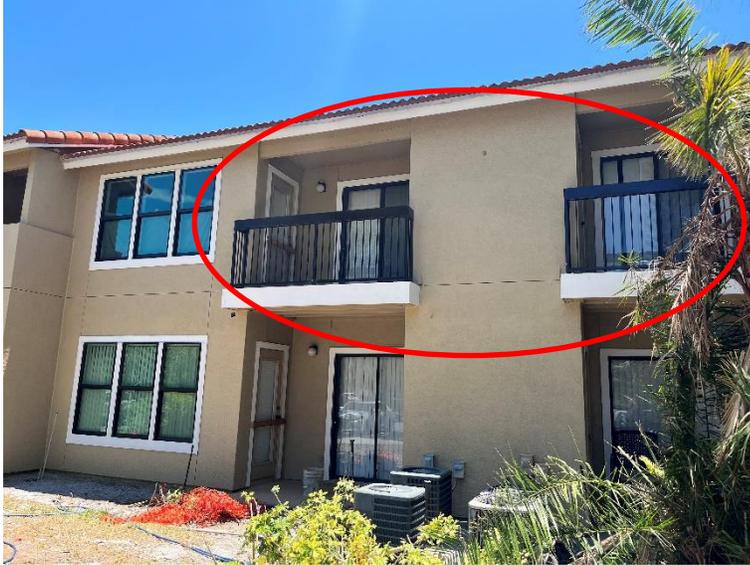
**PHOTOGRAPH #1**

**BUILDING 11  
SECTION B**

Contractor has reinstalled newly painted balcony railings.

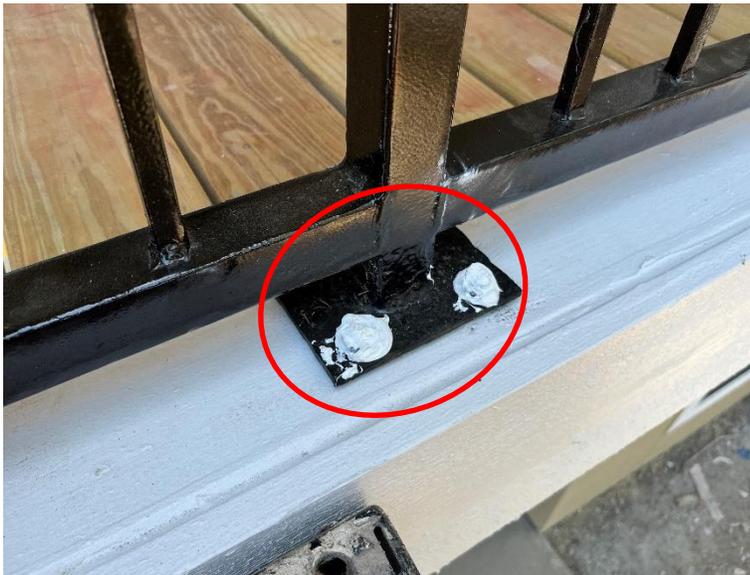
**PHOTOGRAPH #2**

**BUILDING 11  
SECTION B**

Railing post fastened to built-up beam framing with 4"x 3/8" galvanized lag screws as per drawings and specifications.

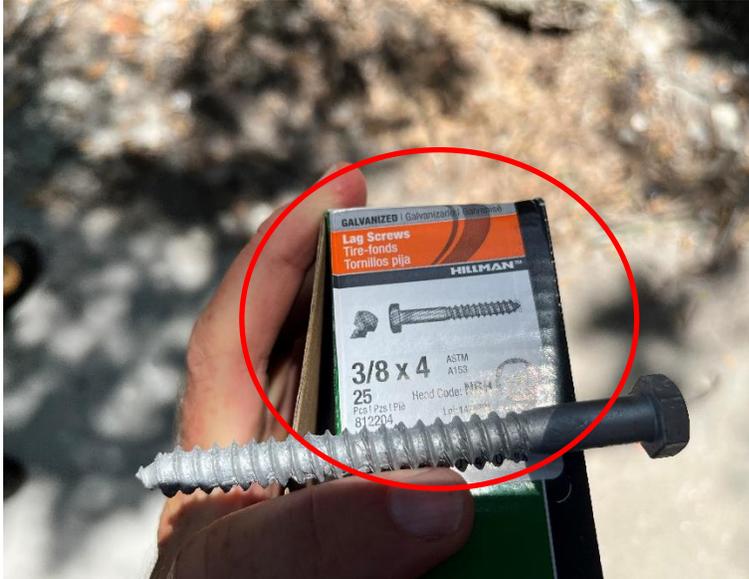
**PHOTOGRAPH #3**

**BUILDING 11  
SECTION B**

Railing post fastened to built-up beam framing with 4"x 3/8" galvanized lag screws as per drawings and specifications.

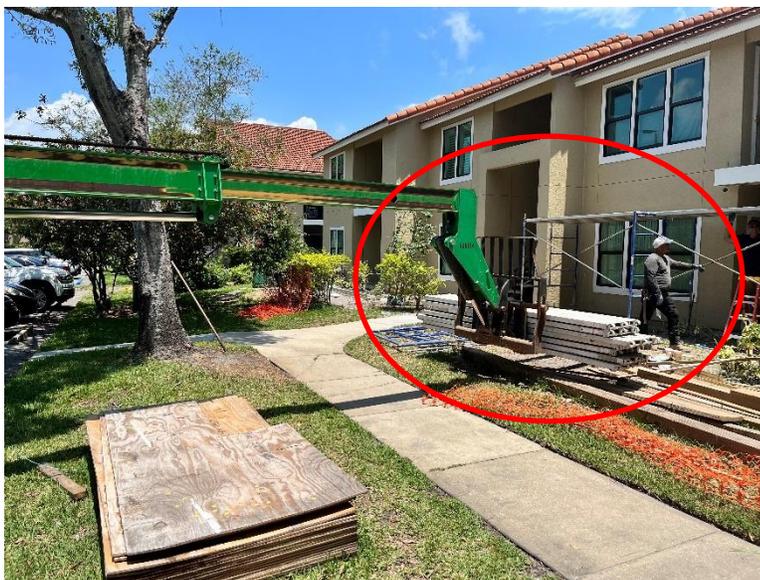
**PHOTOGRAPH #4**

**BUILDING 11  
SECTION B**

Contractor removing pipe scaffold access equipment.

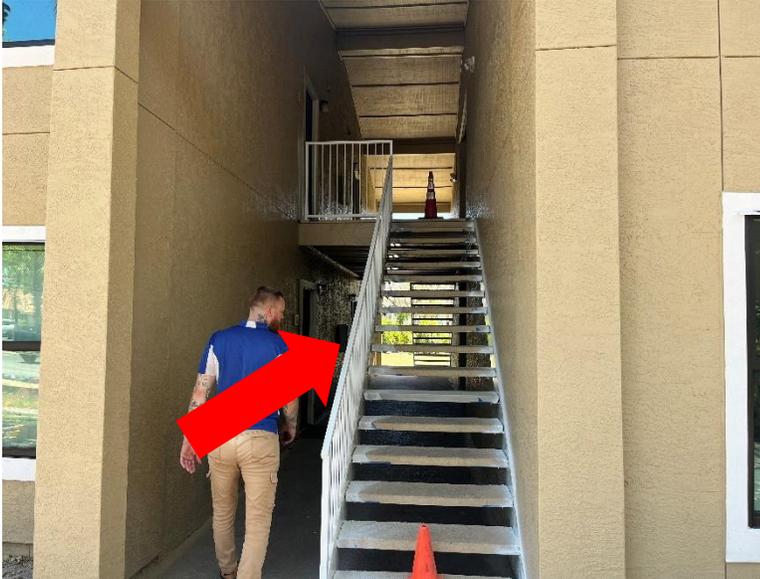
**PHOTOGRAPH #5**

**BUILDING 11  
SECTION C**

Florida Paints Encapsulon epoxy mastic primer applied to stairway railing as per specifications.

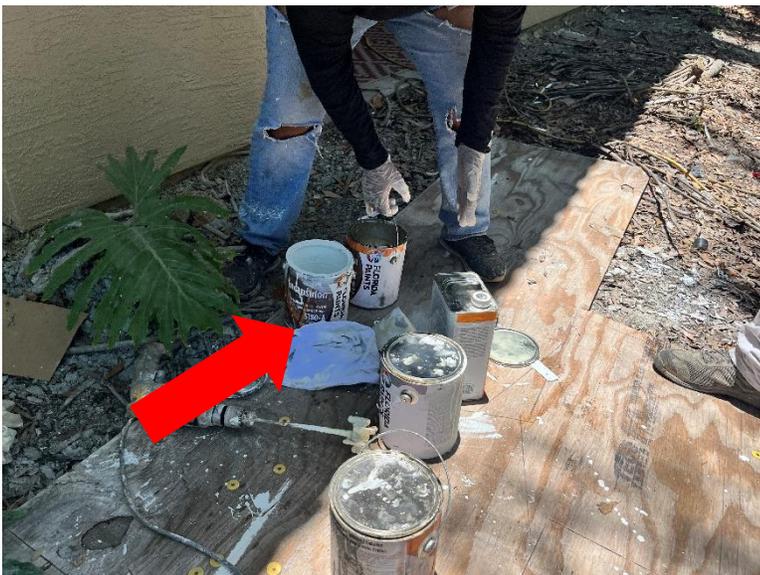
**PHOTOGRAPH #6**

**BUILDING 11  
SECTION C**

Florida Paints Encapsulon epoxy mastic primer applied to stairway railing as per specifications.

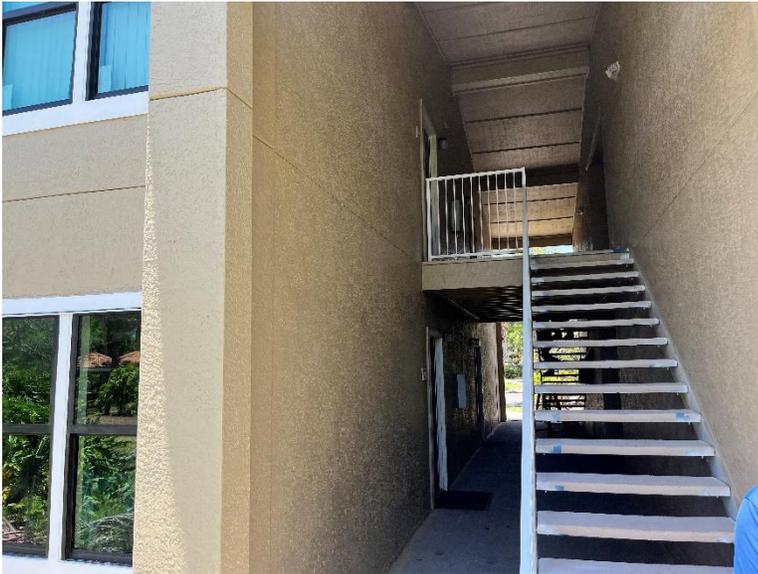
**PHOTOGRAPH #7**

**BUILDING 11  
SECTION G**

Florida Paints Encapsulon epoxy mastic primer applied to stairway railing as per specifications.

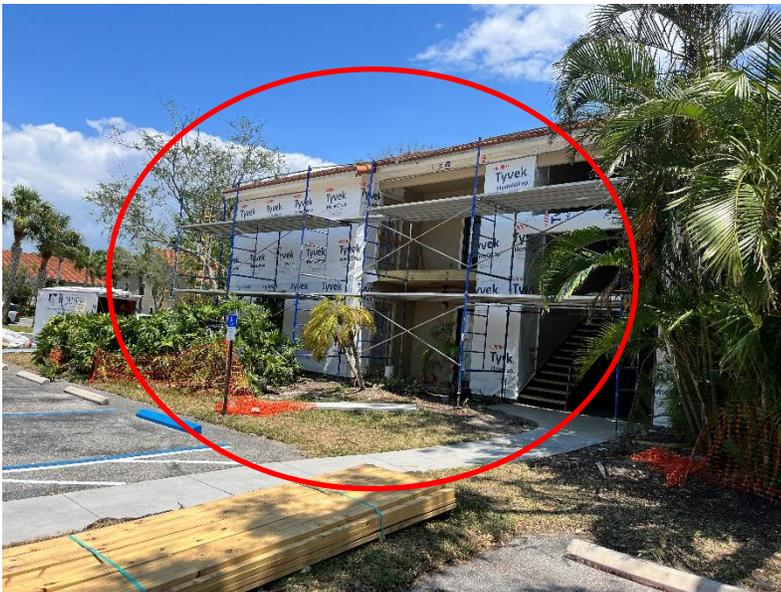
**PHOTOGRAPH #8**

**BUILDING 12  
SECTION A**

Tyvek HomeWrap WRB applied over new plywood sheathing and new PGT windows installed.

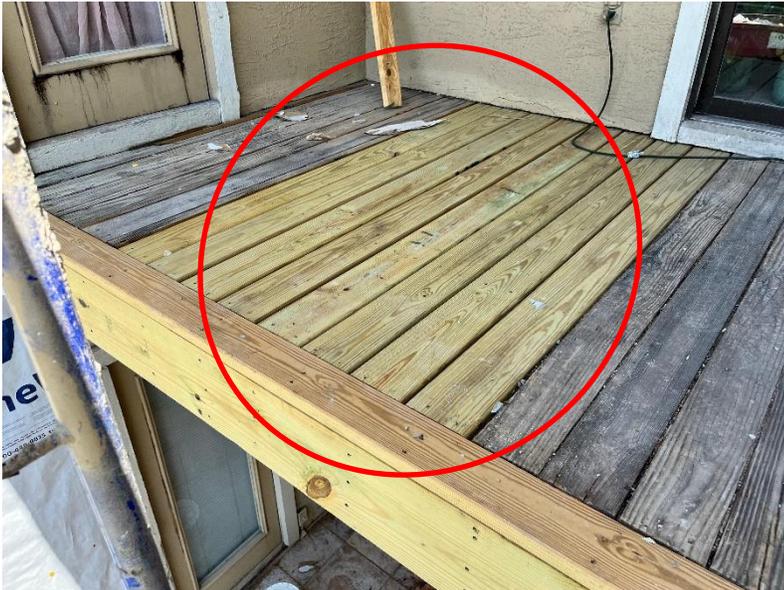
**PHOTOGRAPH #9**

**BUILDING 12  
UNIT # 1221- SECTION A**

New pressure treated 2"x6" deck boards installed where marked for replacement.

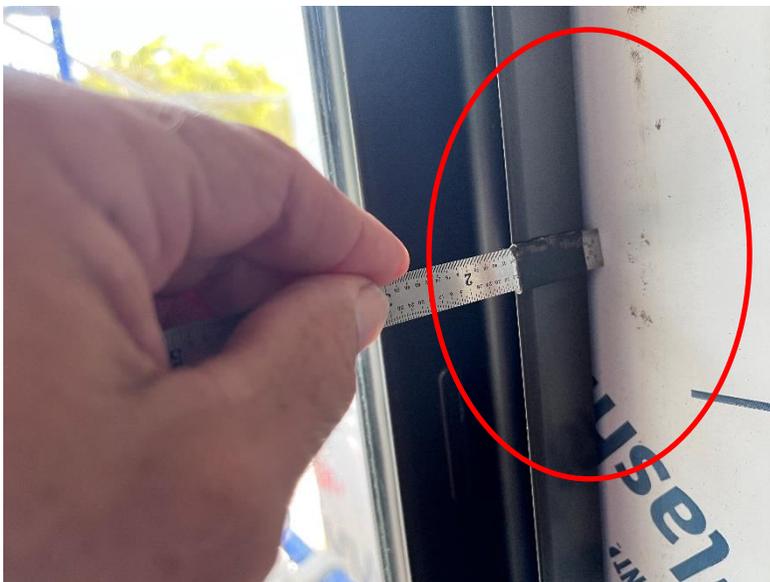
**PHOTOGRAPH #10**

**BUILDING 12  
UNIT #1223-SECTION B**

Gap between wood studs and new window frame in compliance with drawings and window manufacturers attachment requirements at jambs.

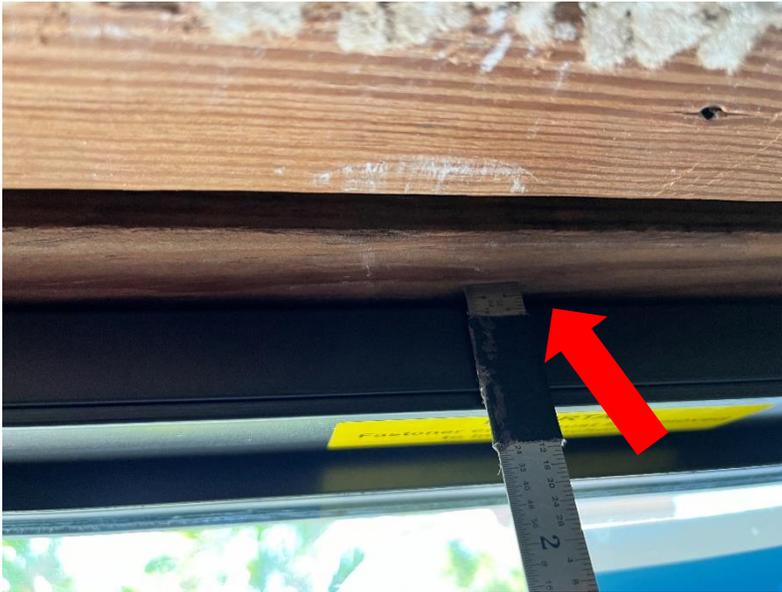
**PHOTOGRAPH #11**

**BUILDING 12  
UNIT #1223-SECTION B**

Gap between wood studs and new window frame in compliance with drawings and window manufacturers attachment requirements at head.

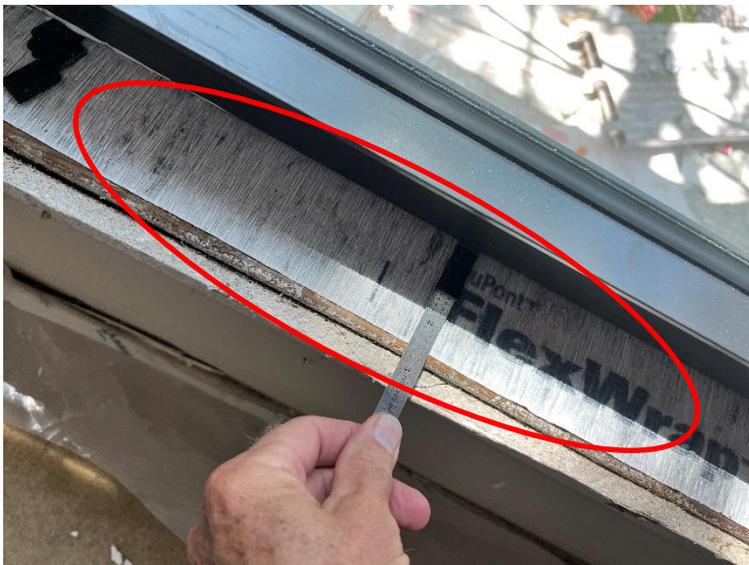
**PHOTOGRAPH #12**

**BUILDING 12  
UNIT #1223-SECTION B**

Dupont FlexWrap flashing extends over sill framing as per manufacturers drawings and requirements.

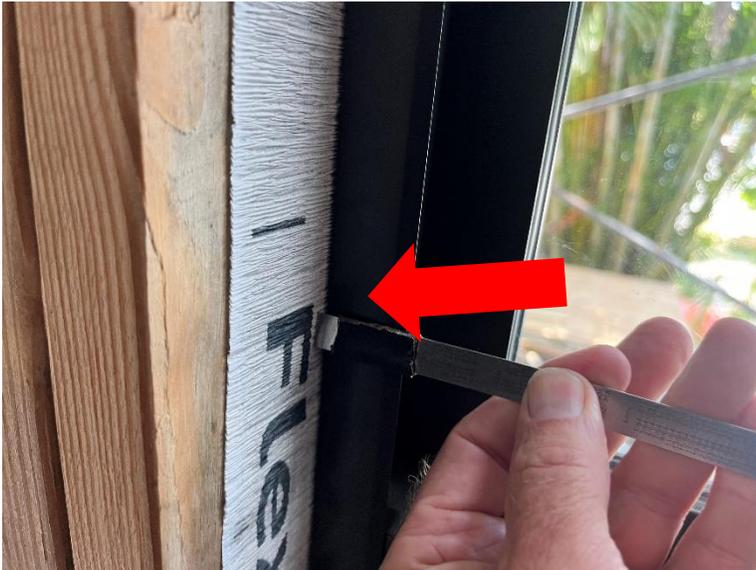
**PHOTOGRAPH #13**

**BUILDING 12  
UNIT #1213-SECTION B**

Gap between wood studs and new window frame in compliance with drawings and window manufacturers attachment requirements at jambs.

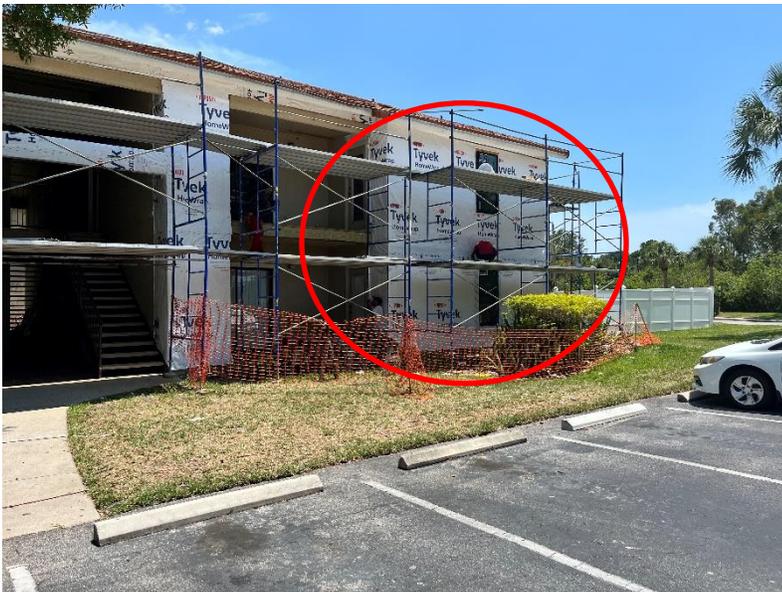
**PHOTOGRAPH #14**

**BUILDING 12  
SECTION C**

Tyvek HomeWrap WRB applied over new plywood sheathing and new PGT windows installed.

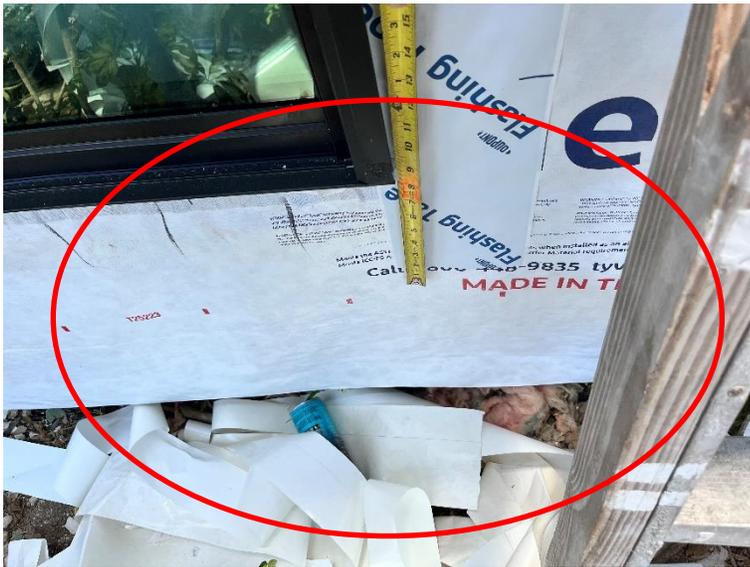
**PHOTOGRAPH #15**

**BUILDING 12  
SECTION D**

Dupont flashing tape extends down 4" to 6" below bottom edge of sill flashing as per drawings and manufacturers requirements.

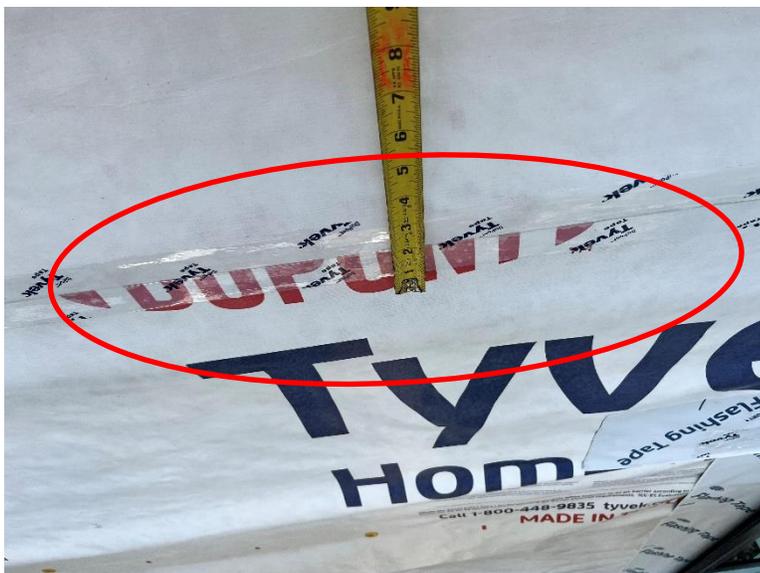
**PHOTOGRAPH #16**

**BUILDING 12  
SECTION D**

Tyvek 3" seam tape applied at Home Wrap overlaps as per manufacturers requirements.

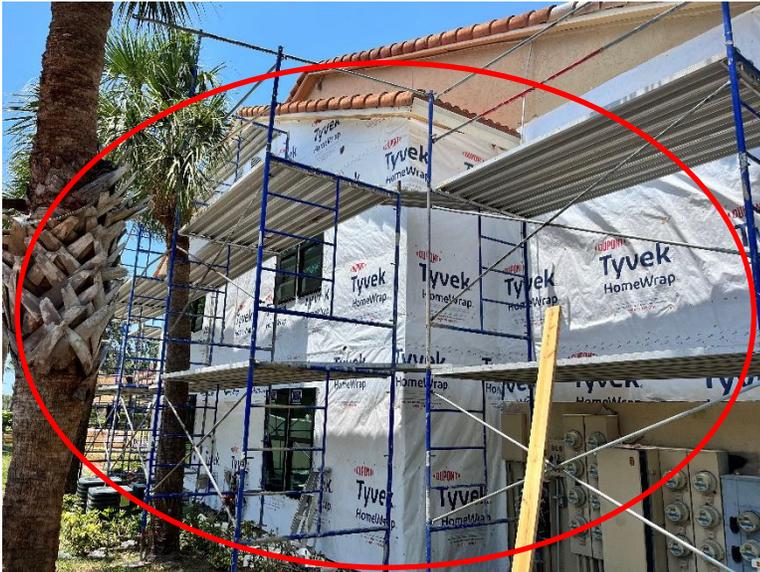
**PHOTOGRAPH #17**

**BUILDING 12  
SECTION D**

Tyvek HomeWrap WRB applied over new plywood sheathing and new PGT windows installed.

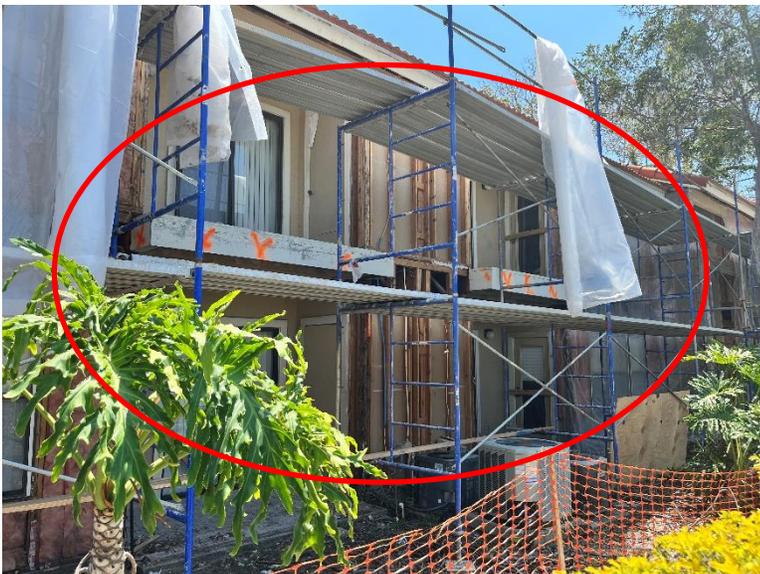
**PHOTOGRAPH #18**

**BUILDING 9  
SECTION F**

Delta inspected and marked damaged framing for repairs.

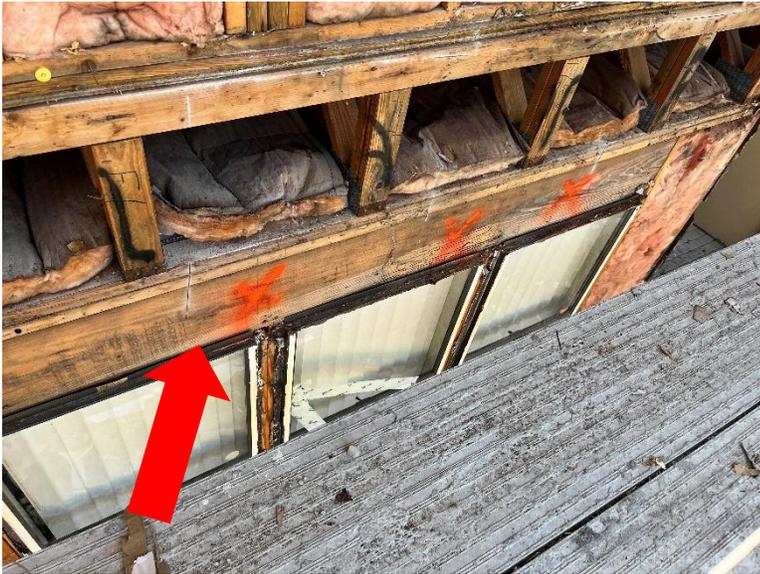
**PHOTOGRAPH #19**

**BUILDING 9  
SECTION F**

Damaged triple header marked for removal and replacement.

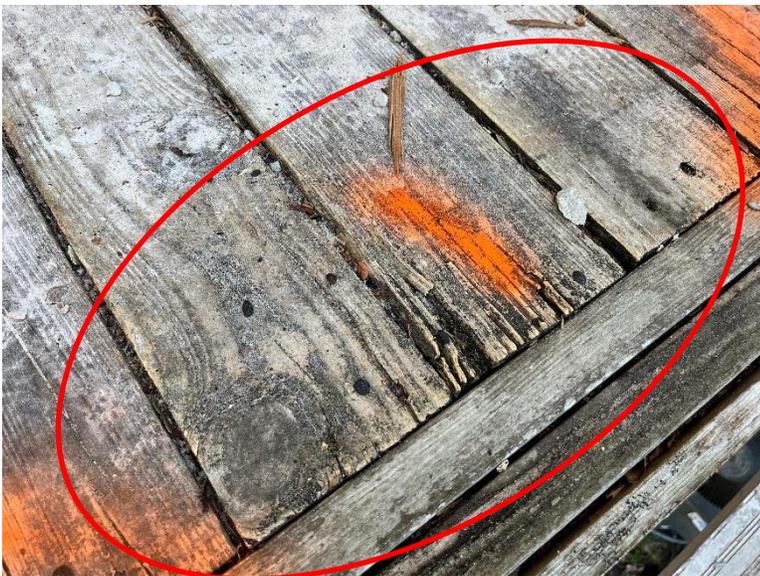
**PHOTOGRAPH #20**

**BUILDING 9  
SECTION F**

Damaged balcony deck boards marked for removal and replacement.

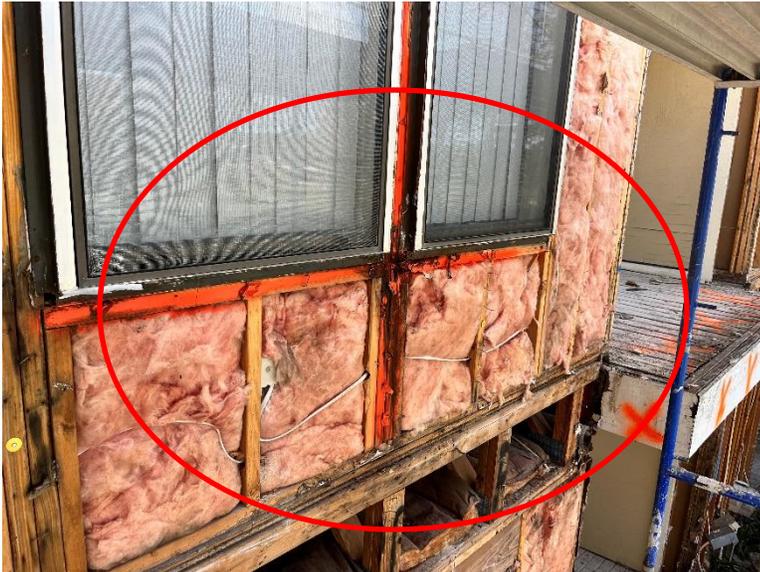
**PHOTOGRAPH #21**

**BUILDING 9  
SECTION F**

Delta marked damaged window jacks and framing for repairs.

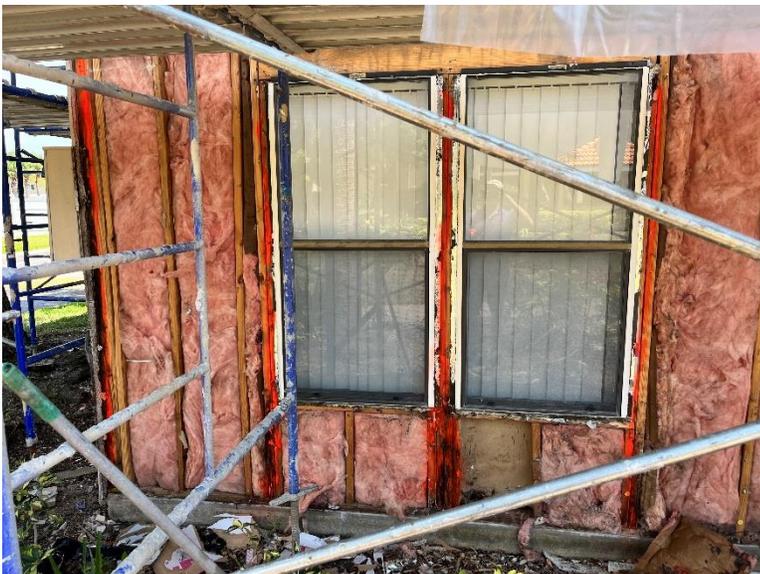
**PHOTOGRAPH #22**

**BUILDING 9  
SECTION E**

Delta marked damaged window jacks and framing for repairs.
