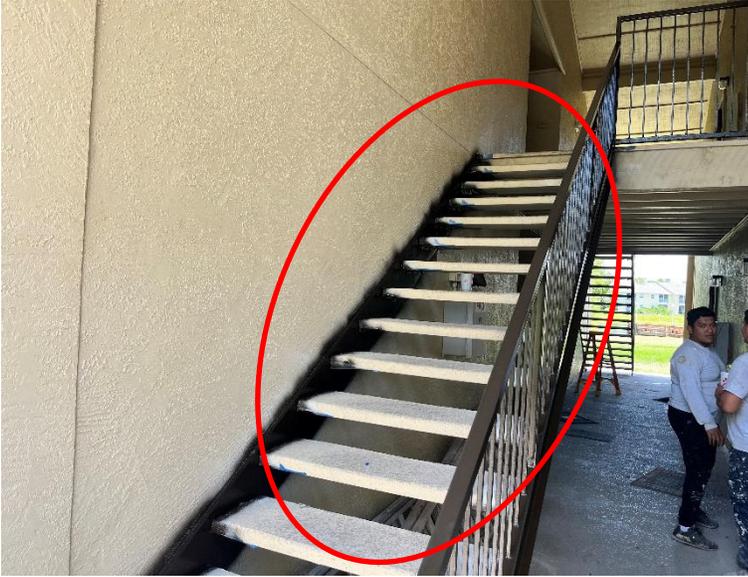
PHOTOGRAPH #1

**BUILDING 11
SECTION A-BREEZEWAY**

Breezeway stair railings finish painted with Florida Paints urethane acrylic enamel.

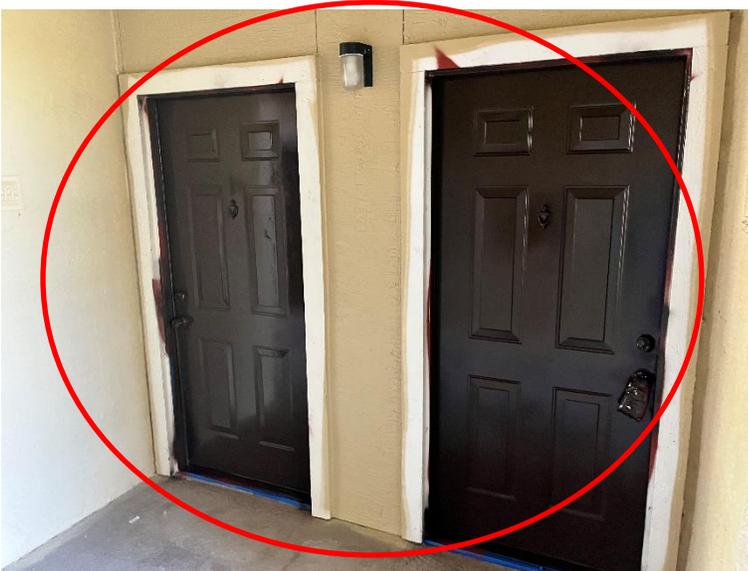
PHOTOGRAPH #2

**BUILDING 11
SECTION A-BREEZEWAY**

Entrance doors spray painted with Florida Paints All Grip Semi-Gloss Exterior paint.

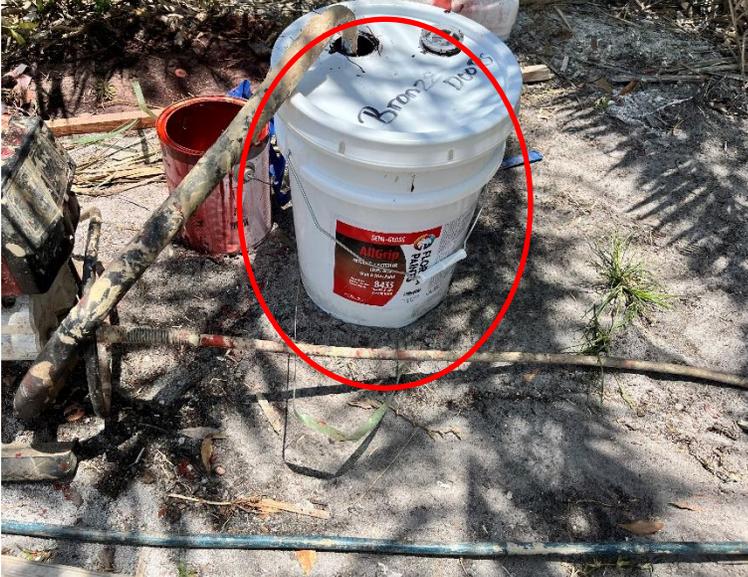
PHOTOGRAPH #3

**BUILDING 11
SECTION A-BREEZEWAY**

Entrance doors spray painted with Florida Paints All Grip Semi-Gloss Exterior paint.

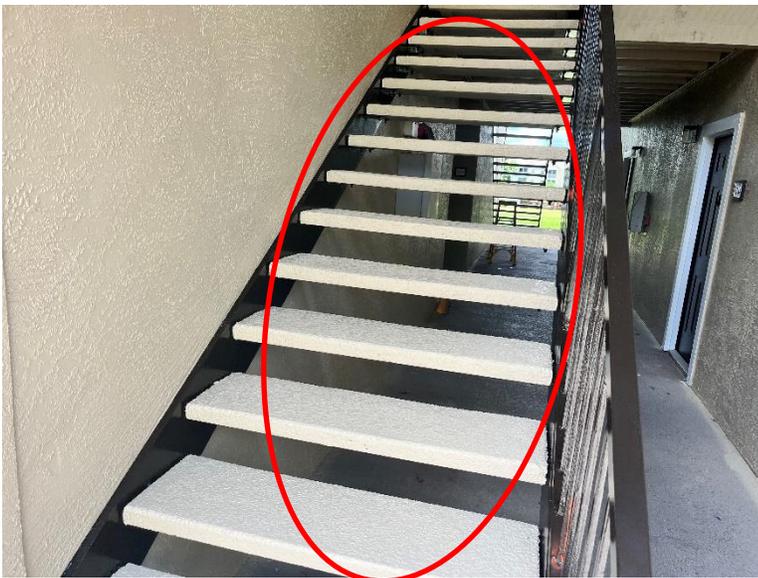
PHOTOGRAPH #4

**BUILDING 11
SECTION A-BREEZEWAY**

Breezeway stairs painted with Florida Paints TropiCrete concrete sealer.

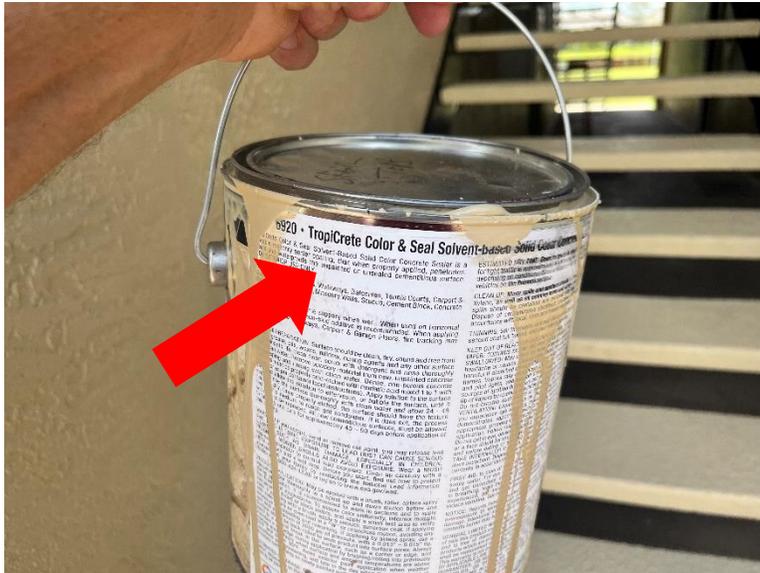
PHOTOGRAPH #5

**BUILDING 11
SECTION A-BREEZEWAY**

Breezeway stairs painted with Florida Paints TropiCrete concrete sealer.

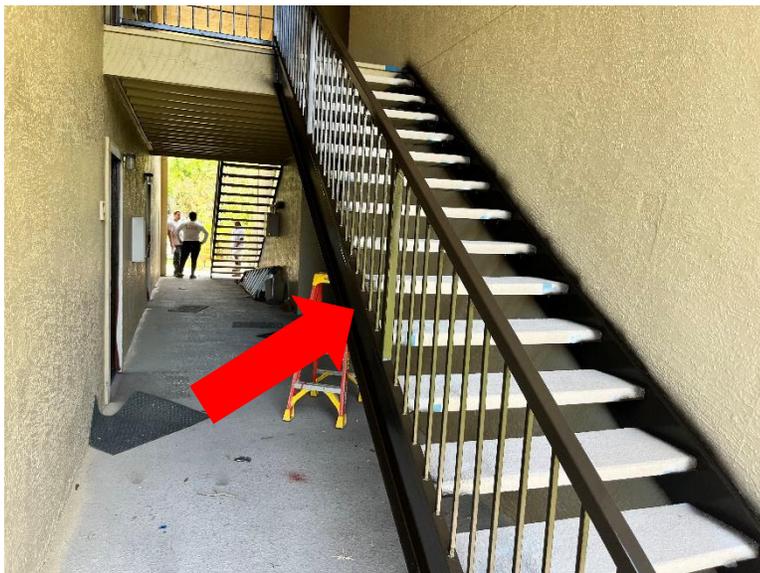
PHOTOGRAPH #6

**BUILDING 11
SECTION C- BREEZEWAY**

Breezeway stair railings finish painted with Florida Paints urethane acrylic enamel.

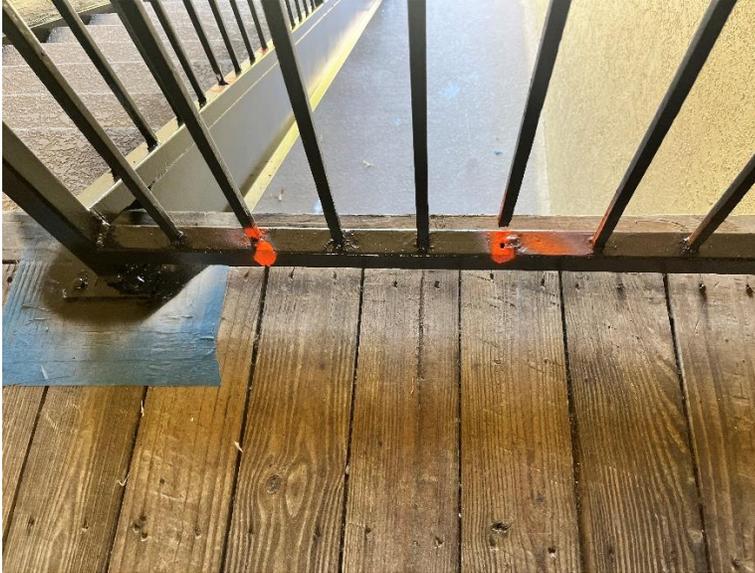
PHOTOGRAPH #7

**BUILDING 11
SECTION C- BREEZEWAY**

Deteriorated steel railings and pickets marked for welding repairs being performed by owner's contractor.

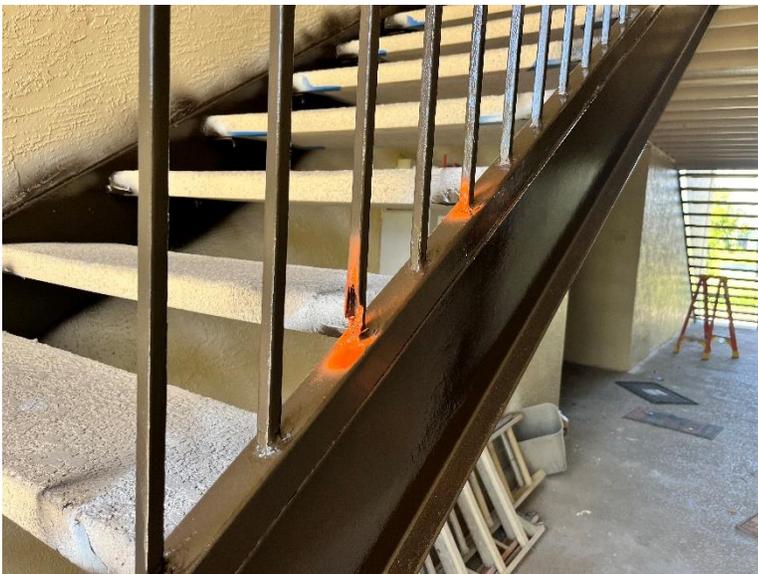
PHOTOGRAPH #8

**BUILDING 11
SECTION C- BREEZEWAY**

Deteriorated steel railings and pickets marked for welding repairs being performed by owner's contractor.

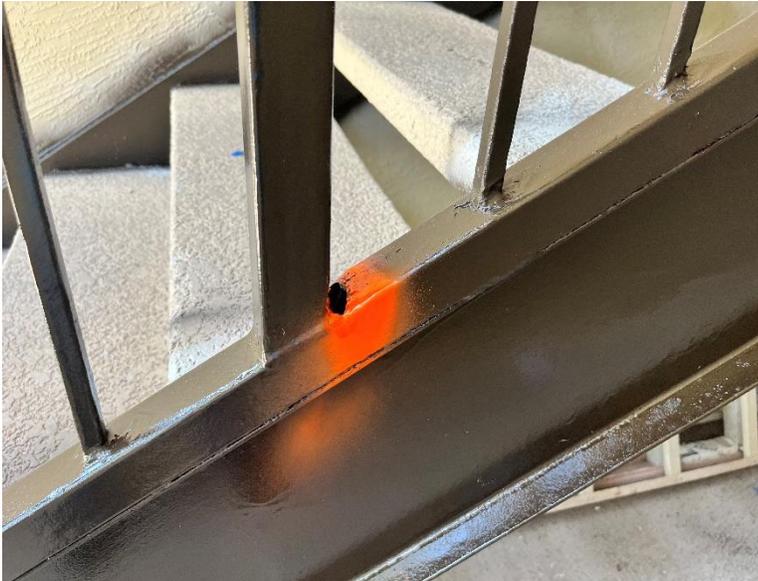
PHOTOGRAPH #9

**BUILDING 11
SECTION C- BREEZEWAY**

Deteriorated steel railings and pickets marked for welding repairs being performed by owner's contractor.

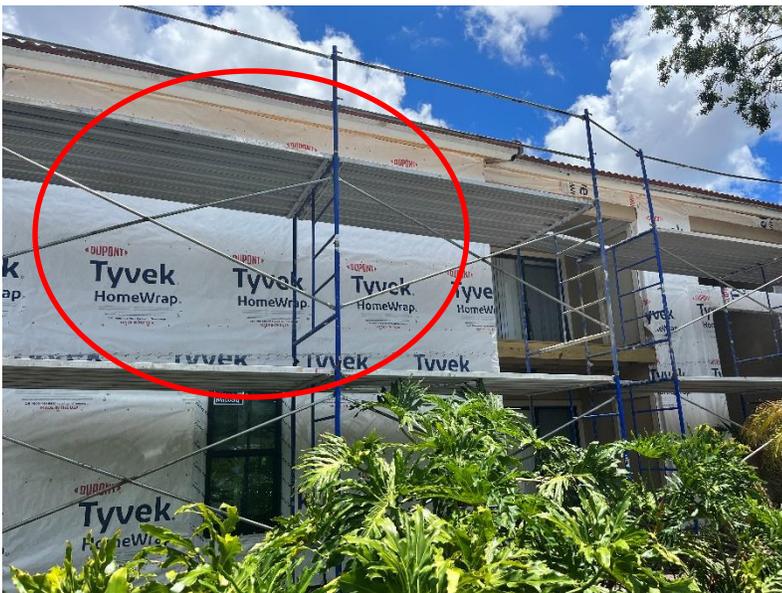
PHOTOGRAPH #10

**BUILDING 12
SECTION A-UNIT 1221**

New PGT window still not installed due to homeowner availability.

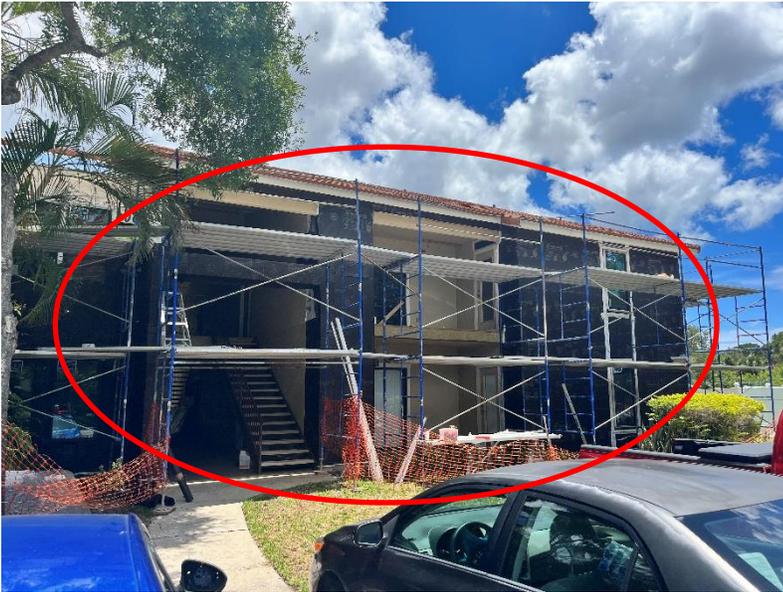
PHOTOGRAPH #11

**BUILDING 12
SECTION C**

Stucco sub-contractor installing JumboTex-60 water resistant barrier and new vinyl stucco accessories at windows and control joints.

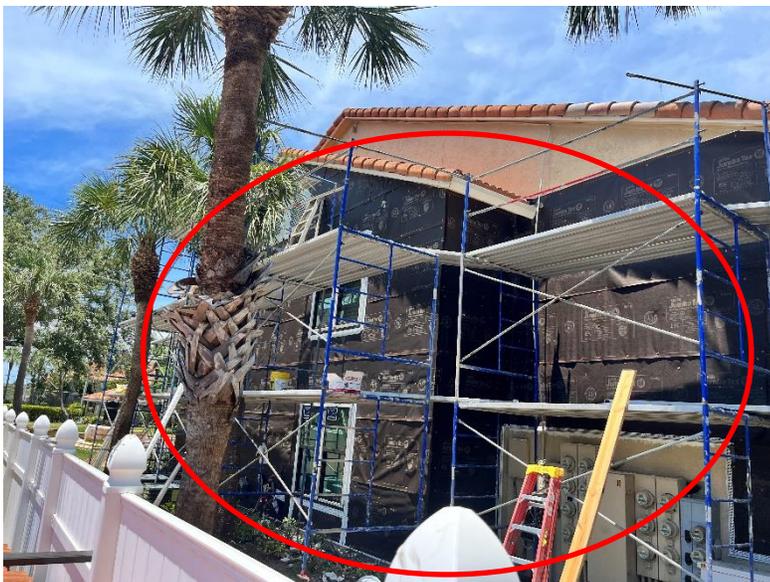
PHOTOGRAPH #12

**BUILDING 12
SECTION D**

Stucco sub-contractor installing JumboTex-60 water resistant barrier and new vinyl stucco accessories at windows and control joints.

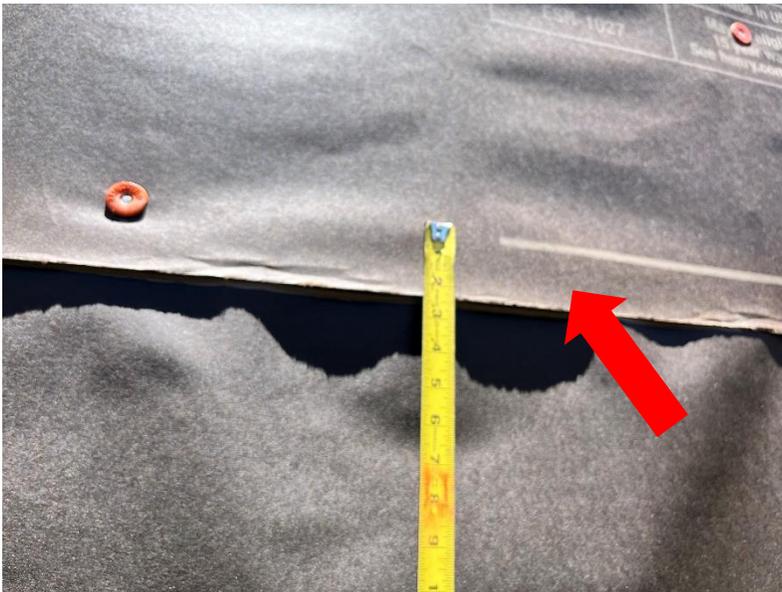
PHOTOGRAPH #13

**BUILDING 12
SECTION D**

Minimum overlapping of 2" provided at Jumbo Tex water resistant barrier installed over new plywood sheathing.

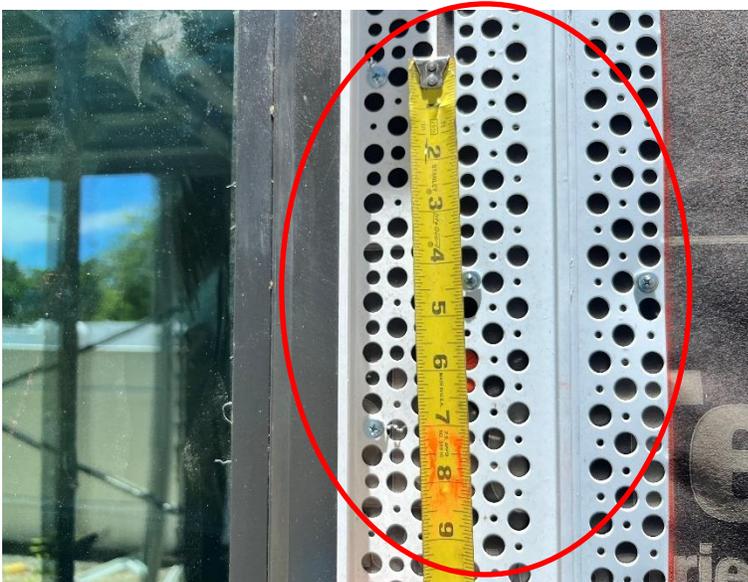
PHOTOGRAPH #14

**BUILDING 12
SECTION D**

New vinyl stucco accessories attached to framing at no more than 7" intervals around window opening.

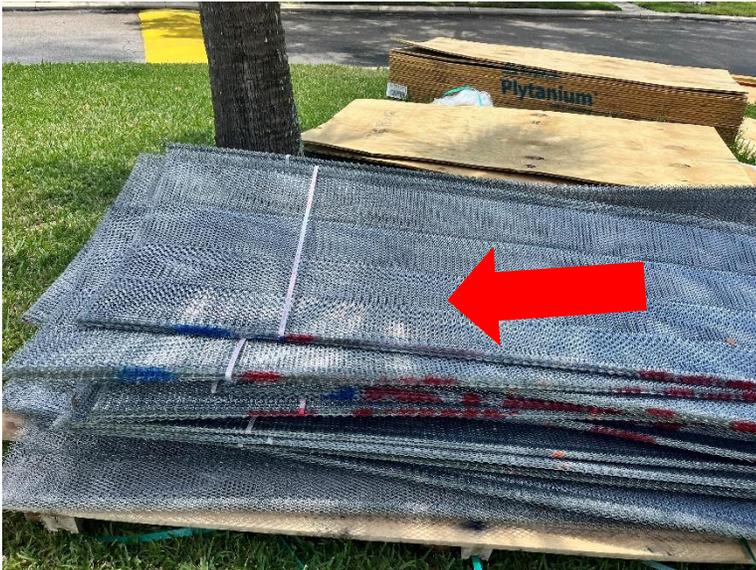
PHOTOGRAPH #15

**BUILDING 12
SECTION D**

AMICO V-grooved self-furred 2.5 lbs. galvanized metal lath delivered for installation.

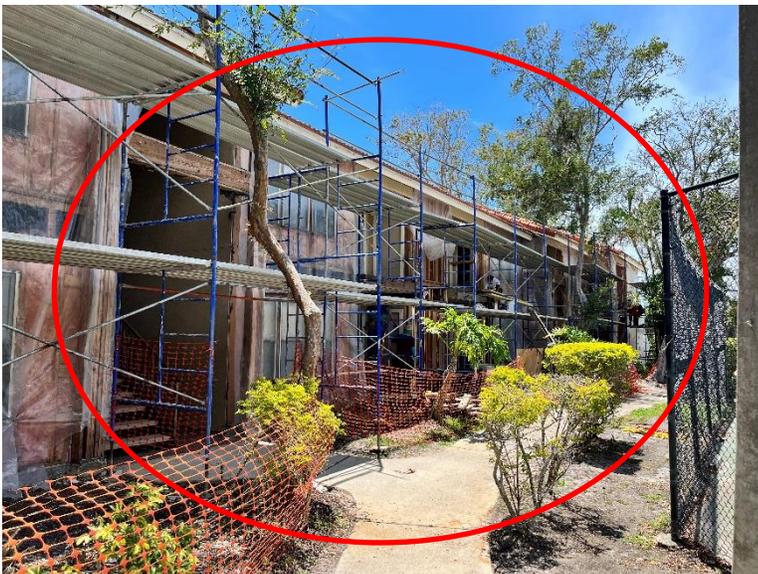
PHOTOGRAPH #16

**BUILDING 9
SECTION F**

Contractor performing framing and balcony repairs.

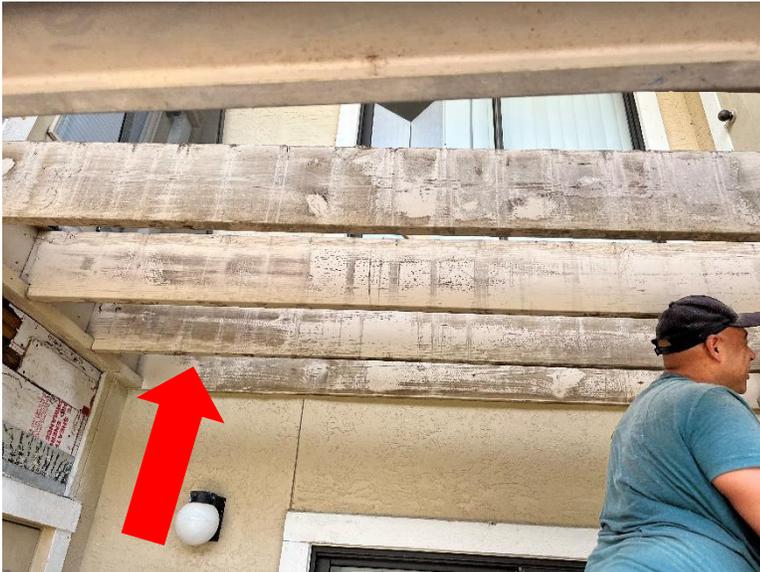
PHOTOGRAPH #17

**BUILDING 9
SECTION F- UNIT 926**

Damaged wood decking and built-up beam at front face removed for replacement. Existing floor joists will remain.

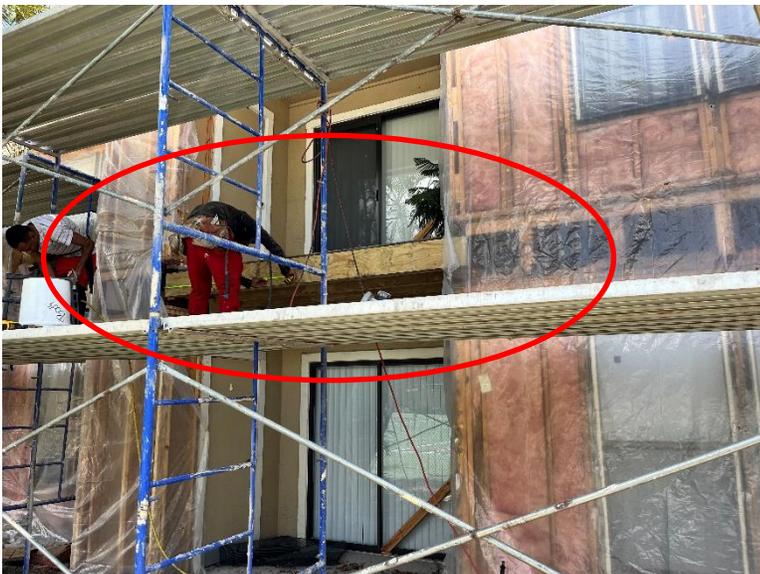
PHOTOGRAPH #18

**BUILDING 9
SECTION F- UNIT 924**

Contractor replacing damaged built-up beam and balcony decking with pressure treated lumber as per drawings and specifications.

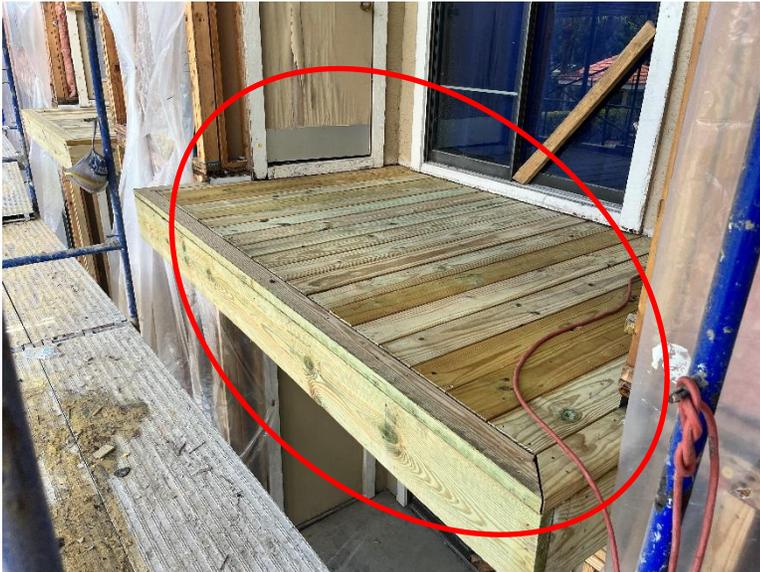
PHOTOGRAPH #19

**BUILDING 9
SECTION F-UNIT 924**

Contractor replacing damaged built-up beam and balcony decking with pressure treated lumber as per drawings and specifications.

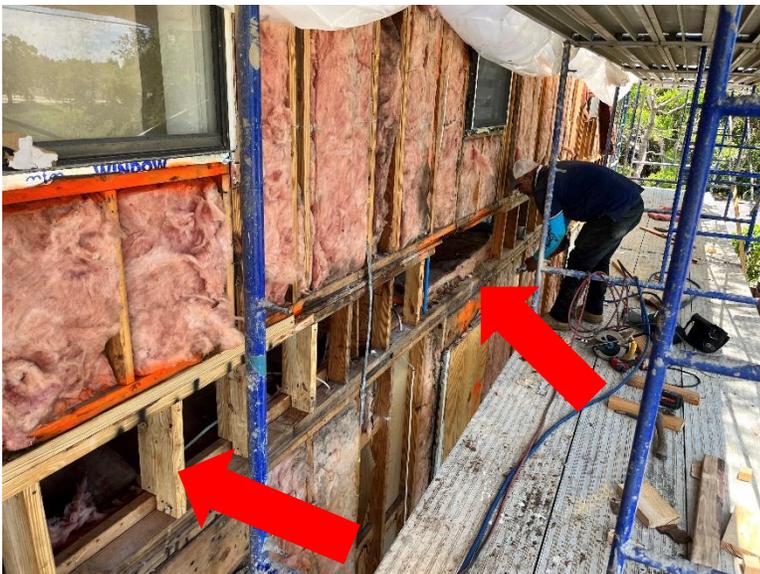
PHOTOGRAPH #20

**BUILDING 9
SECTION H**

Contractor has begun framing repairs at plates and cripple studs between floors.
