FIELD OBSERVATION REPORT - Bldg. #11

Permit No. 2023 100329 000 00 BR
 Owner: Vintage Grand Condo Assn. Inc.
 Project Address: 4005 Crockers Lake Blvd., Sarasota, FL
 Contractor: RL James Inc
 Inspector (s): Mark Boss CDT
 Type of Assessment: Progress

FIELD OBSERVATION REPORT - Bldg. #12

FIELD OBSERVATION REPORT - Bldg. #9

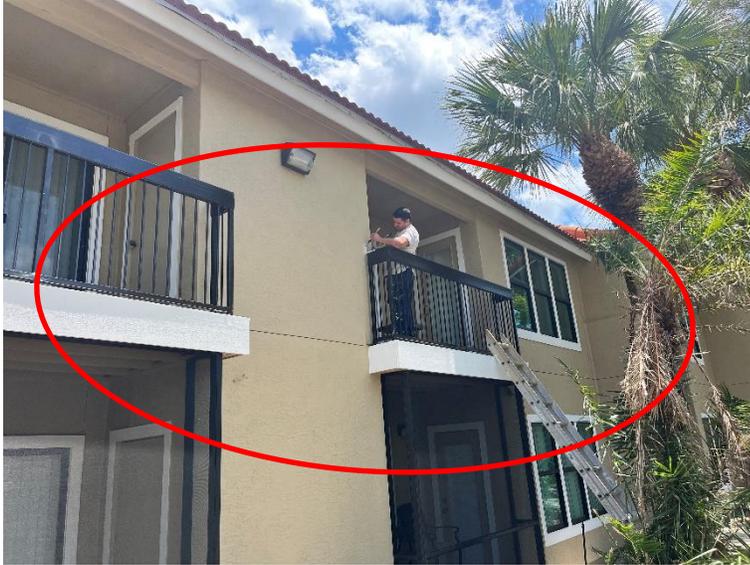
PHOTOGRAPH #1

**BUILDING 11
SECTION B**

Contractor painting railing attachment steel angles with finish coat of Florida Paint Hi-Performance Urethane Enamel.

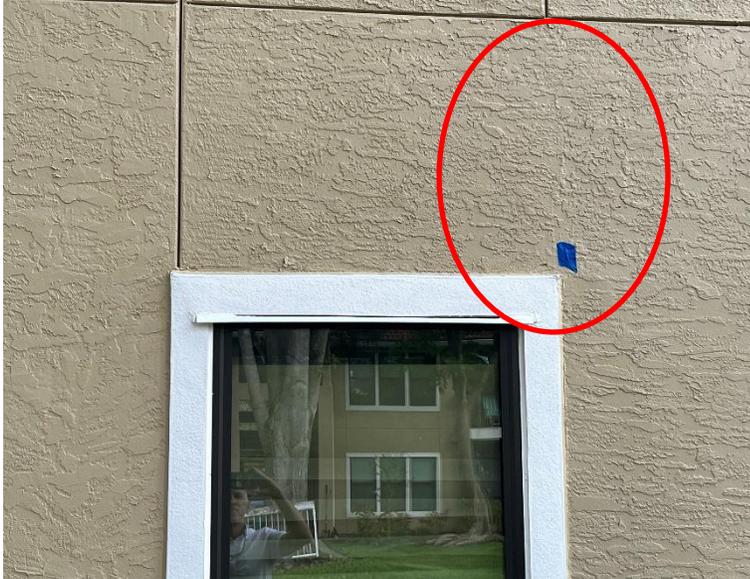
PHOTOGRAPH #3

**BUILDING 11
SECTION D**

Stucco applied over control joint added to the exterior punch list being developed by Delta with contractor and owner's representative.

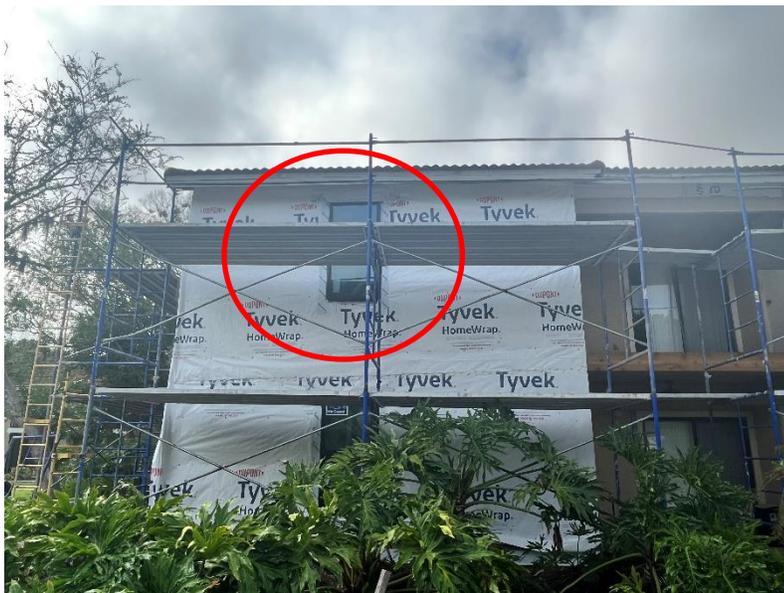
PHOTOGRAPH #4

**BUILDING 12
UNIT 1221- SECTION A**

Final new PGT window in building 12 installed as per drawings and specifications.

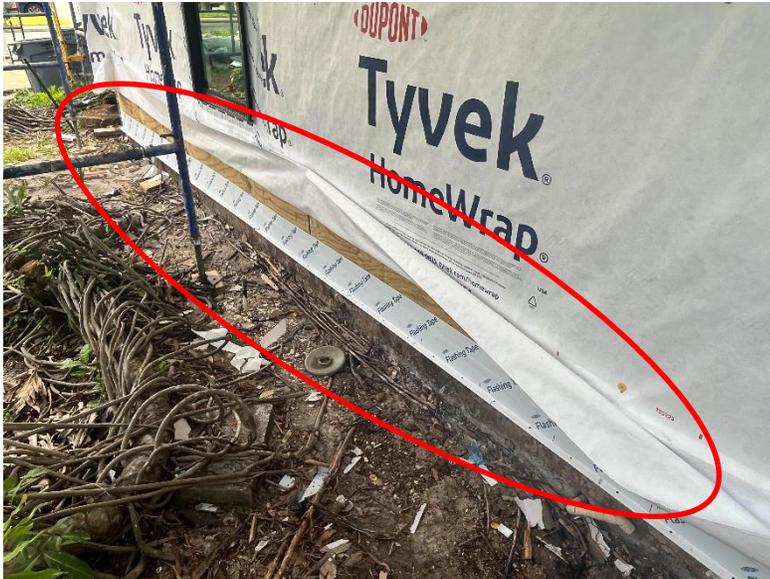
PHOTOGRAPH #5

**BUILDING 12
SECTION A**

Stucco sub-contractor installing vinyl weep accessory at base of wall and flashing onto new plywood sheathing with Dupont flashing tape.

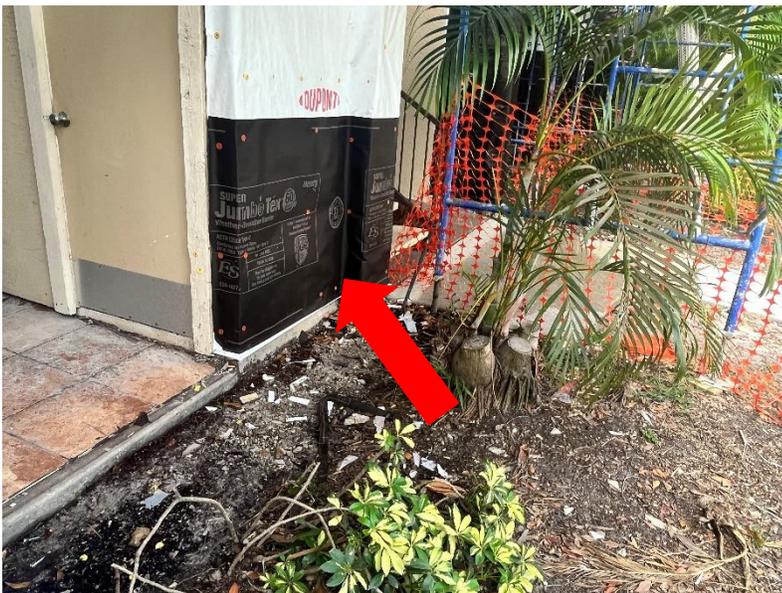
PHOTOGRAPH #6

**BUILDING 12
SECTION A**

Stucco sub-contractor has begun to install JumboTex WRB over Dupont HomeWrap WRB.

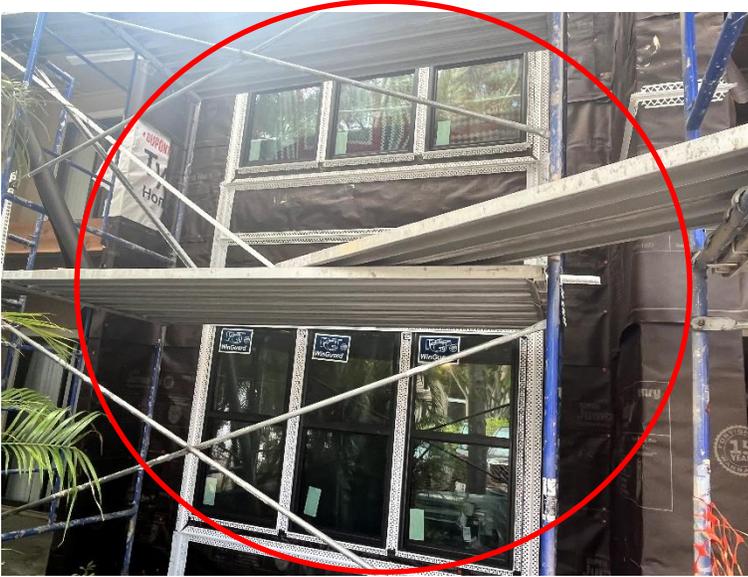
PHOTOGRAPH #7

**BUILDING 12
SECTION B**

New vinyl stucco accessories installed over JumboTex WBR at windows and control joints as per drawings.

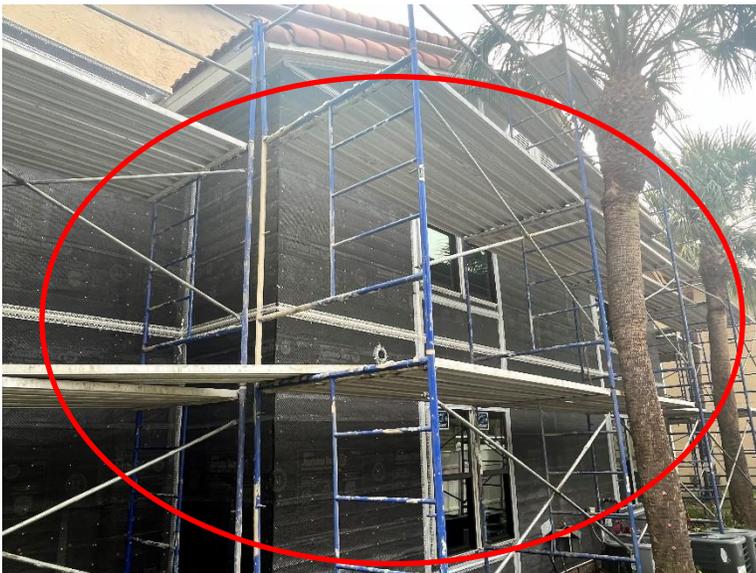
PHOTOGRAPH #8

**BUILDING 12
SECTION D**

AMICO V-grooved self-furred 2.5 lbs. galvanized metal lath applied over water resistant barriers as per drawings.

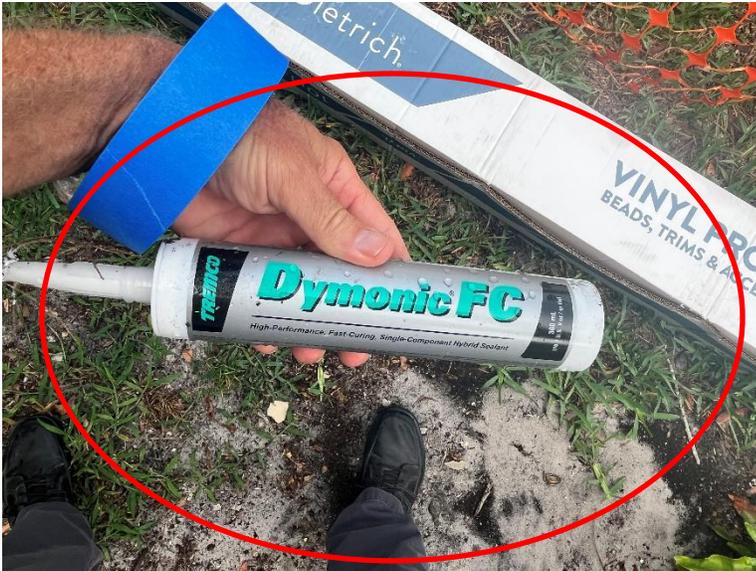
PHOTOGRAPH #9

**BUILDING 12
SECTION D**

Fast Cure Urethane sealant applied at vinyl trim intersections and joints as per drawing.

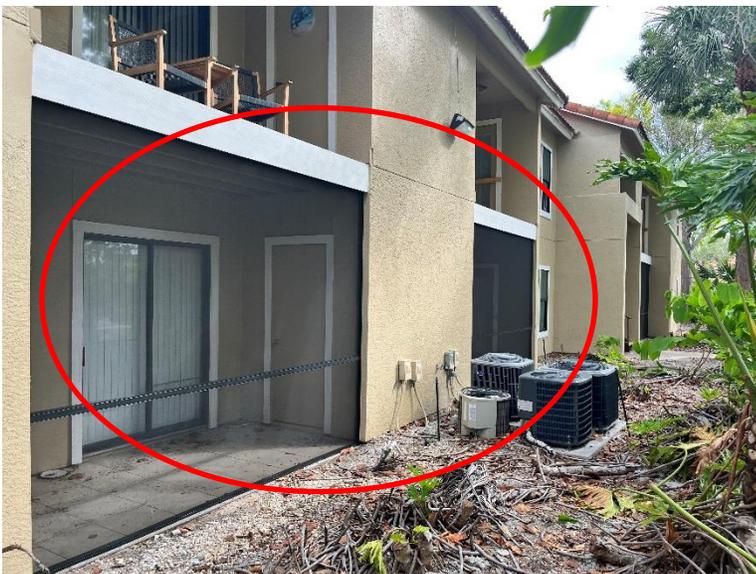
PHOTOGRAPH #10

**BUILDING 12
SECTION F**

New screen enclosures installed at ground level patios replacing preexisting screen enclosures.

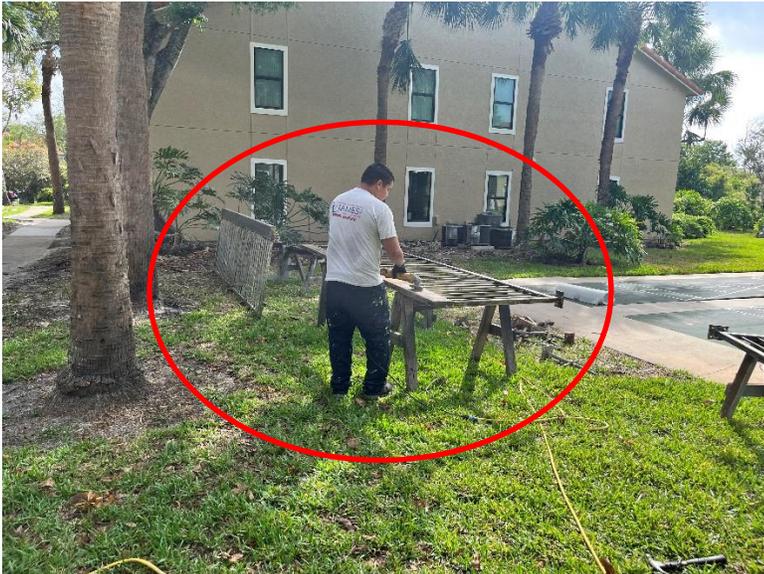
PHOTOGRAPH #11

**BUILDING 12
SECTION F**

Contractor preparing balcony railings for new paint system by grinding and removing previous loose paint, rust, and corrosion.

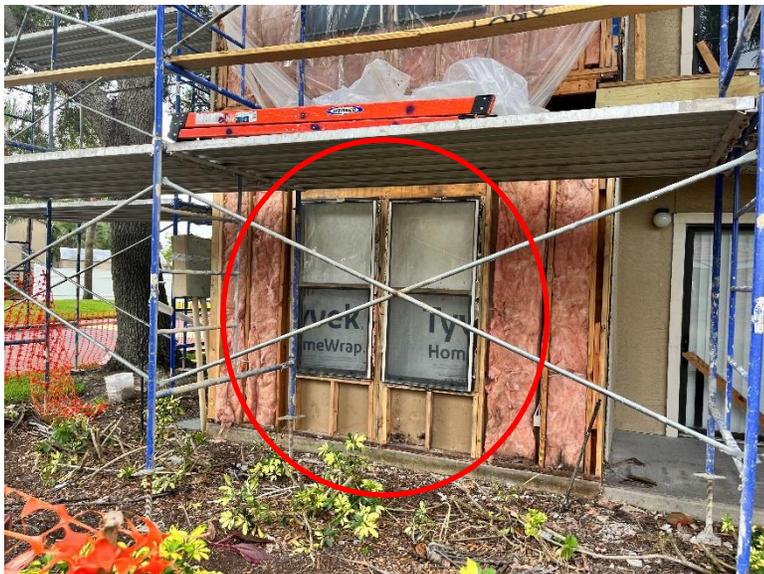
PHOTOGRAPH #12

**BUILDING 9
SECTION E**

Contractor performing wood framing repairs at window framing studs.

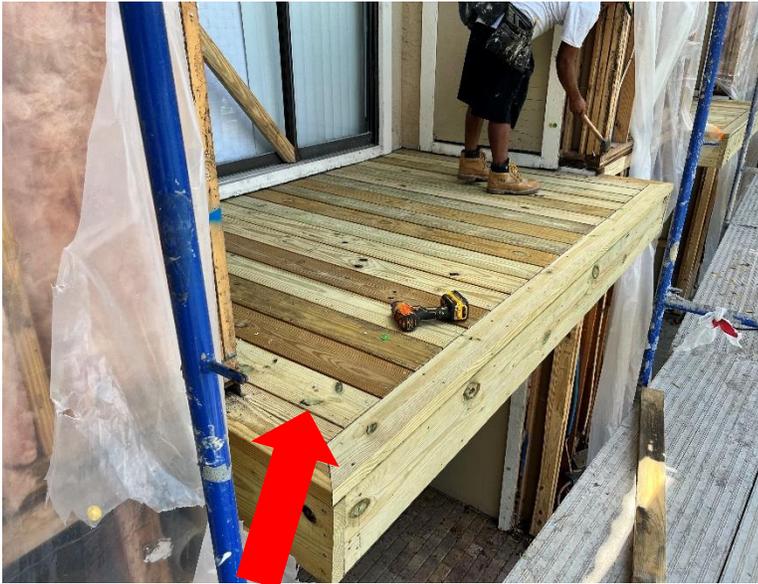
PHOTOGRAPH #13

**BUILDING 9
SECTION F- UNIT 926**

Contractor has replaced damaged built-up beam and balcony decking with pressure treated lumber as per drawings and specifications.

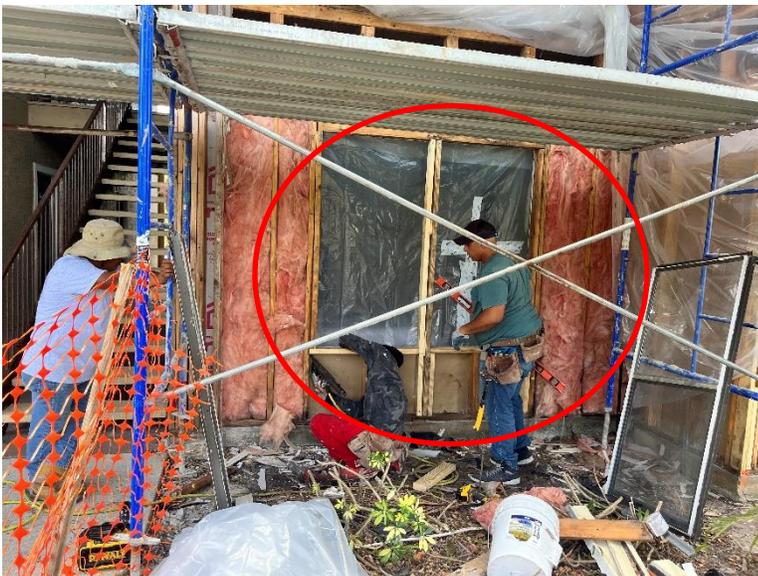
PHOTOGRAPH #14

**BUILDING 9
SECTION F**

Contractor performing wood framing repairs at window framing studs.

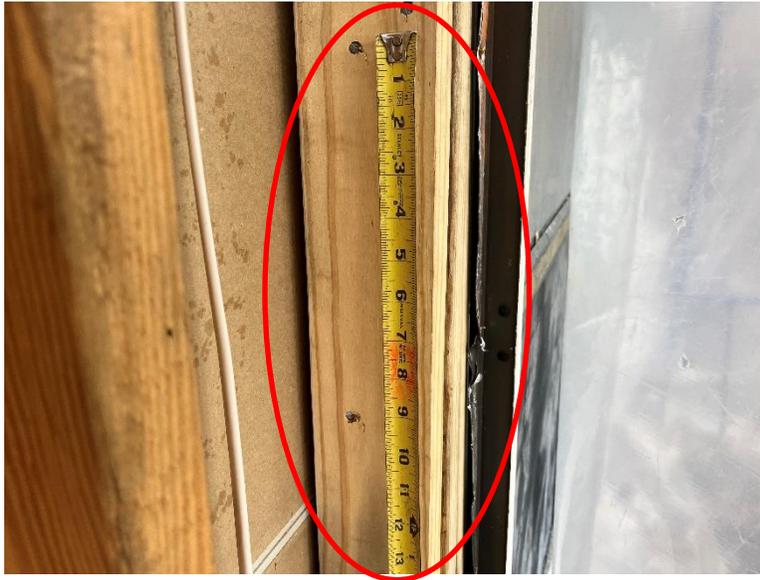
PHOTOGRAPH #15

**BUILDING 9
SECTION F**

Wood framing king studs nailed with 16d common nails at no more than 12"O.C.

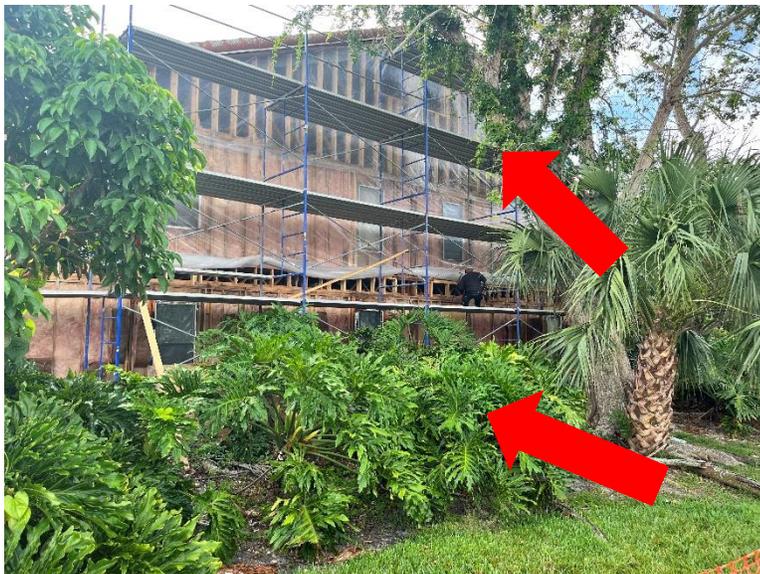
PHOTOGRAPH #16

**BUILDING 9
SECTION H**

Contractor has begun gable end reinforcement and is repairing damaged wall and window framing where marked for repairs.

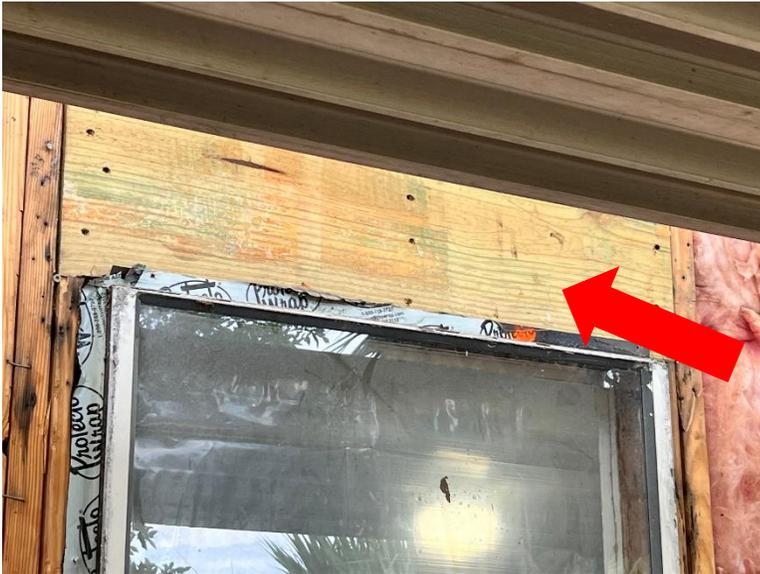
PHOTOGRAPH #17

**BUILDING 9
SECTION H**

Contractor has replaced damaged header above single window opening.

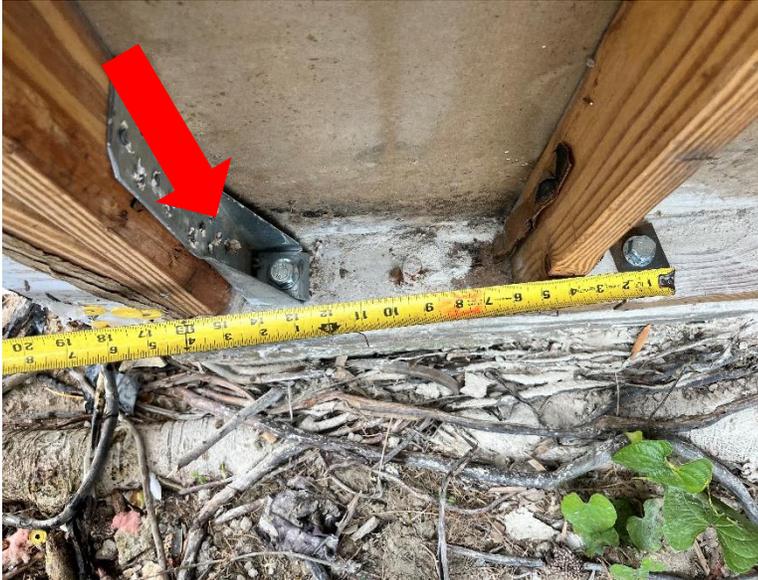
PHOTOGRAPH #19

**BUILDING 9
SECTION H**

Contractor installing Simpson HTT4 with TITEN HD fastener at window frame king studs to bottom plate as per drawings.
