FIELD OBSERVATION REPORT - Bldg. #11

Permit No. 2023 100329 000 00 BR
 Owner: Vintage Grand Condo Assn, Inc.
 Project Address: 4005 Crockers Lake Blvd., Sarasota, FL
 Contractor: RL James Inc
 Inspector (s): Mark Boss CDT
 Type of Assessment: Progress

FIELD OBSERVATION REPORT - Bldg. #12

FIELD OBSERVATION REPORT - Bldg. #9

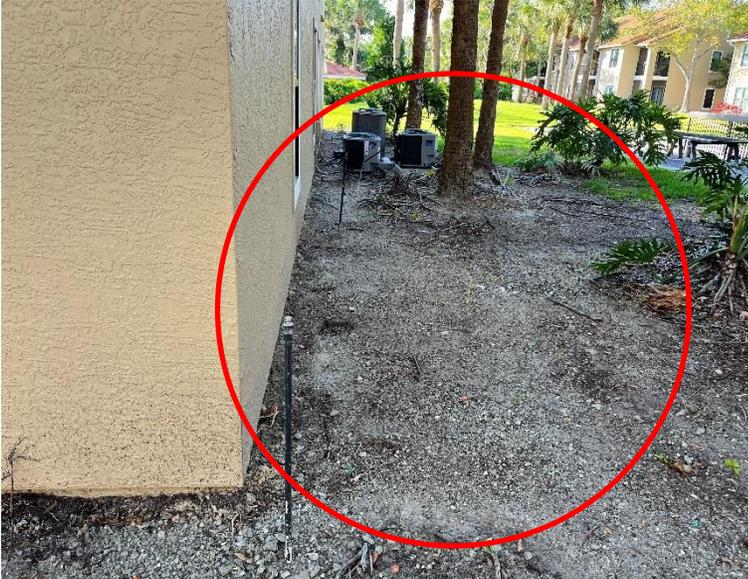
PHOTOGRAPH #1

**BUILDING 11
SECTION D**

Contractor has rake cleaned all around building.

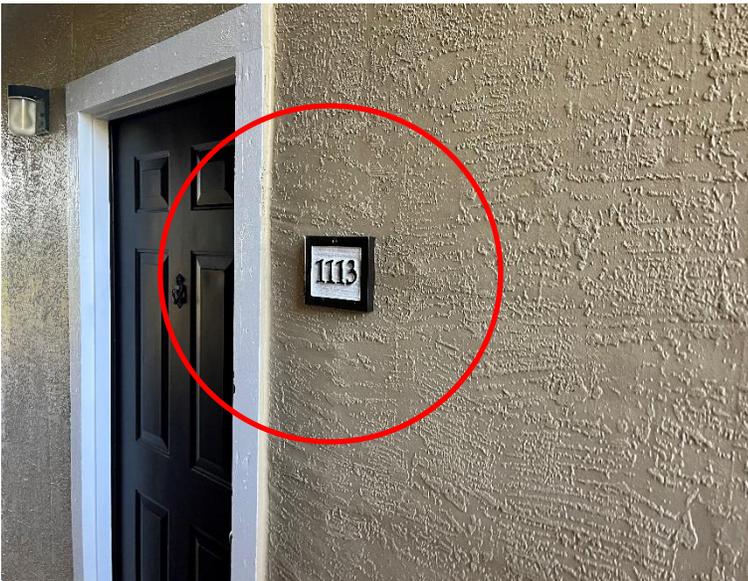
PHOTOGRAPH #2

**BUILDING 11
SECTION D- UNIT #1113**

Contractor and management walked through each unit with Delta for development of final punch list.

1. Complete Punch list provided 6.7.23

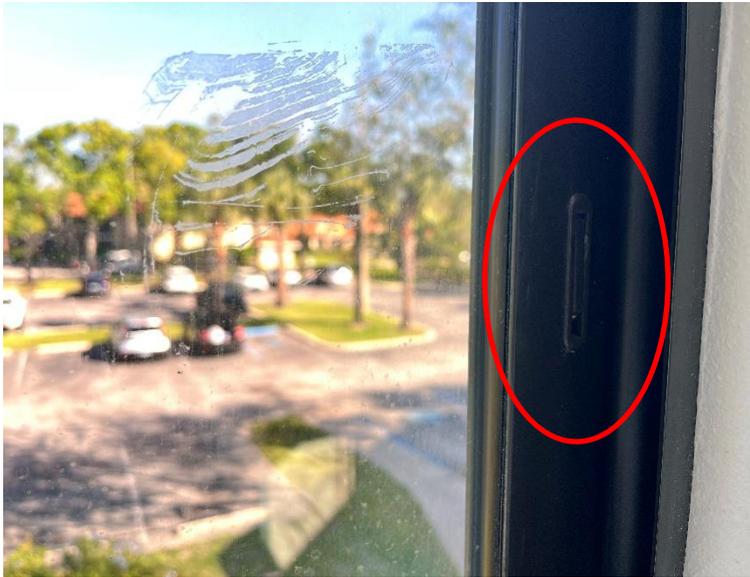
PHOTOGRAPH #3

**BUILDING 11
SECTION D- UNIT #1113**

Child Safety lock buttons on right side of windows does not function. This is a typical problem noted on punch list for all 2nd floor windows.

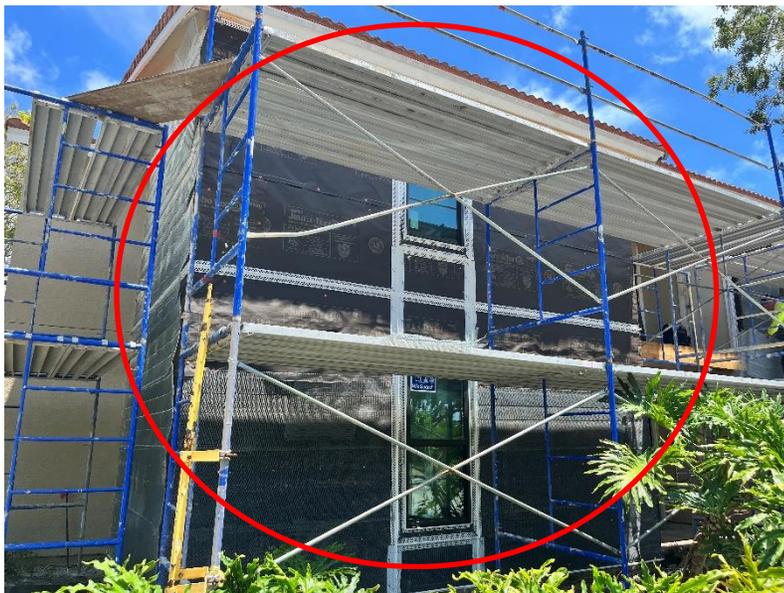
PHOTOGRAPH #4

**BUILDING 12
SECTION A**

Subcontractor in process of installing new vinyl accessories and galvanized self-furring lath in preparation for new stucco finish.

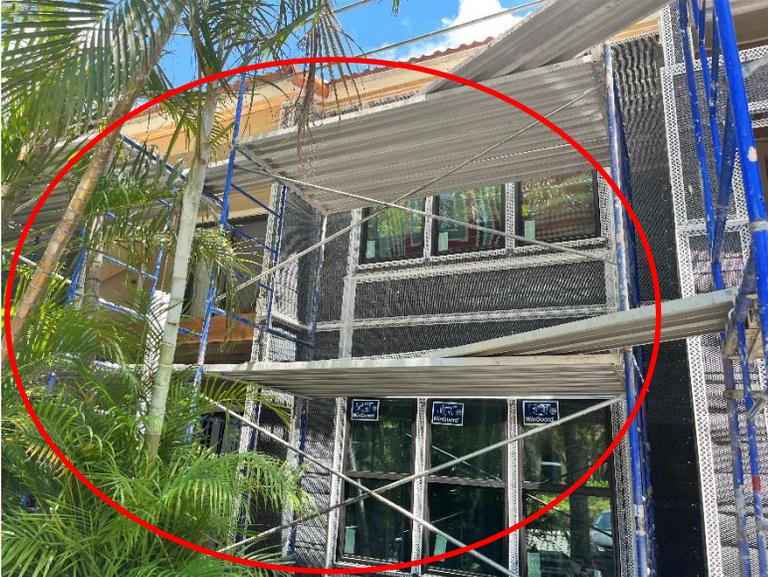
PHOTOGRAPH #5

**BUILDING 12
SECTION B**

Subcontractor in process of installing new vinyl accessories and galvanized self-furring lath in preparation for new stucco finish.

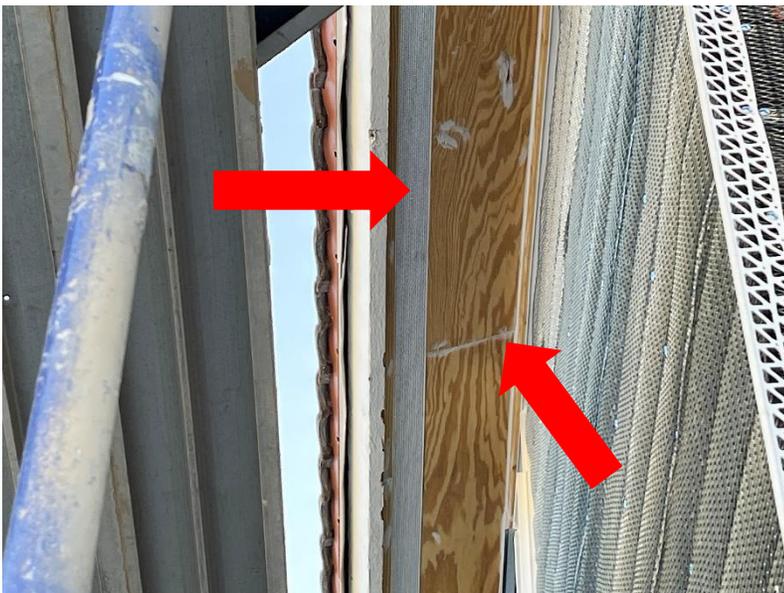
PHOTOGRAPH #6

**BUILDING 12
SECTION C**

New plywood soffit and vinyl soffit vent installed as per drawings and specifications.

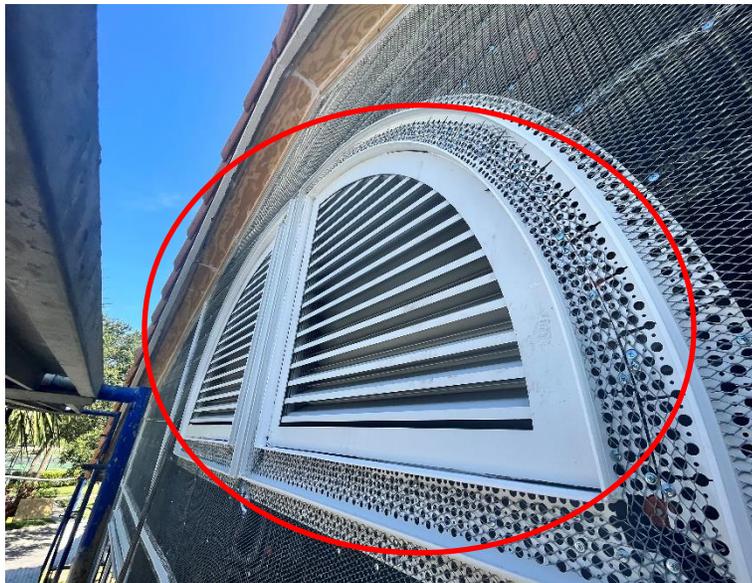
PHOTOGRAPH #7

**BUILDING 12
SECTION D**

New GreenHeck EHH-601D louver Vents installed at gable end attic space.

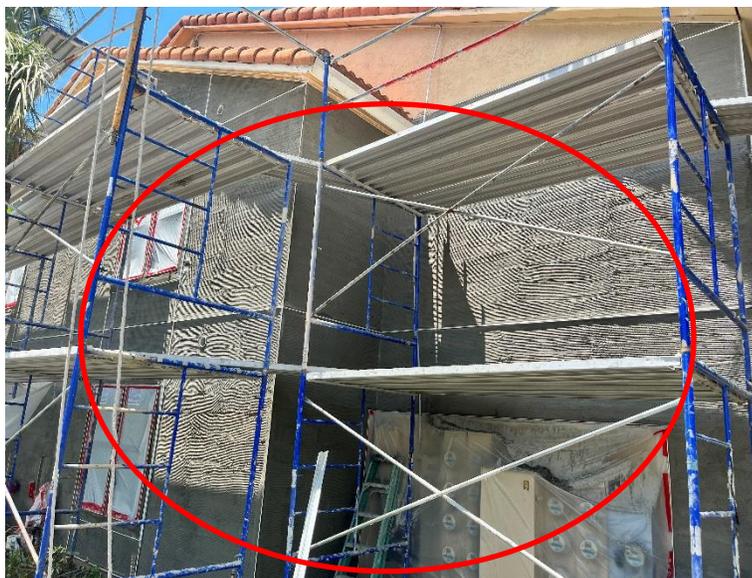
PHOTOGRAPH #8

**BUILDING 12
SECTION D**

Stucco sub-contractor has protected new windows and applied scratch coat of stucco at gable end walls.

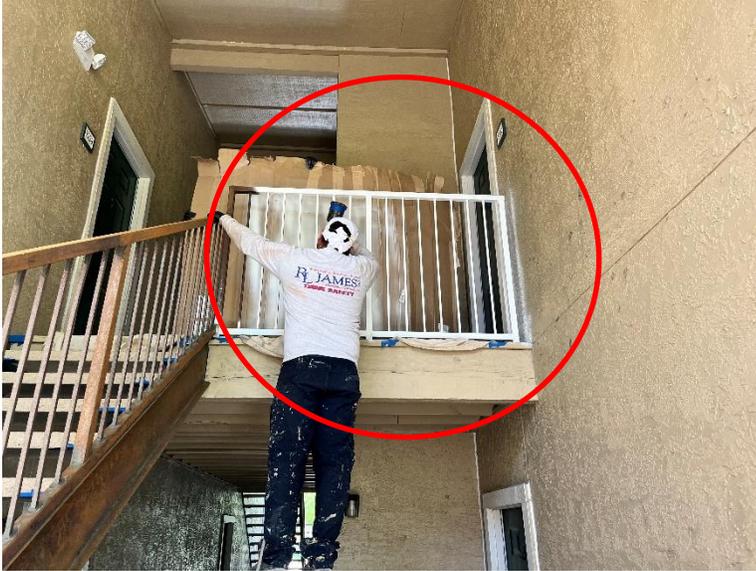
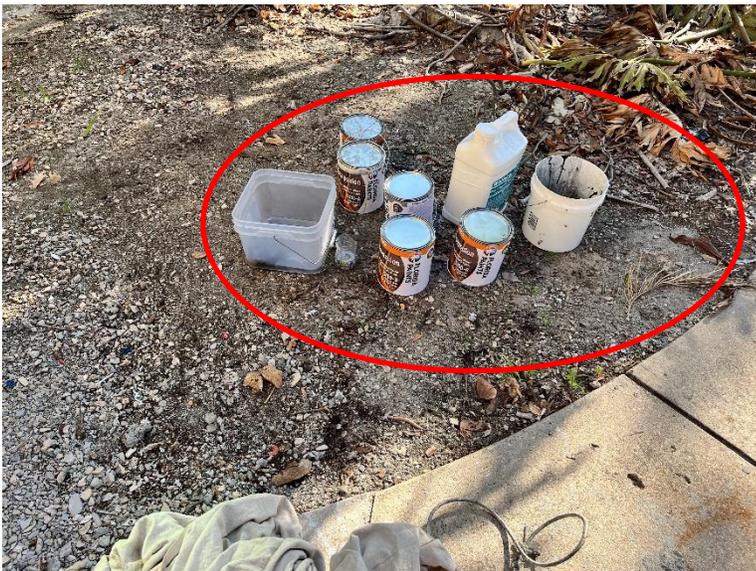
**BUILDING 12
SECTION E**

Contractor applying Florida Paints Encapsulon Epoxy Mastic primer to steel railings at breezeway.

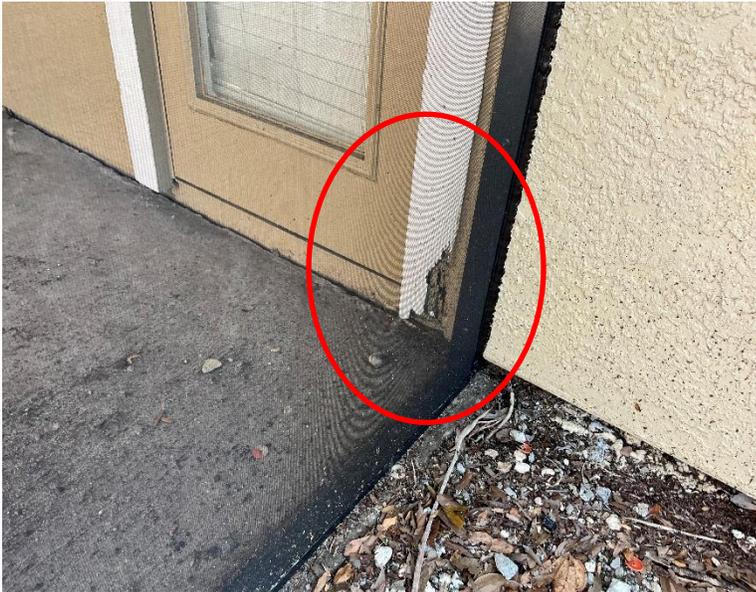
PHOTOGRAPH #11

**BUILDING 12
SECTION G -UNIT #1212**

Damaged cedar wood trim at patio door requires replacement.

1. Damaged cedar wood trim at patio door requires replacement (Photograph #11).

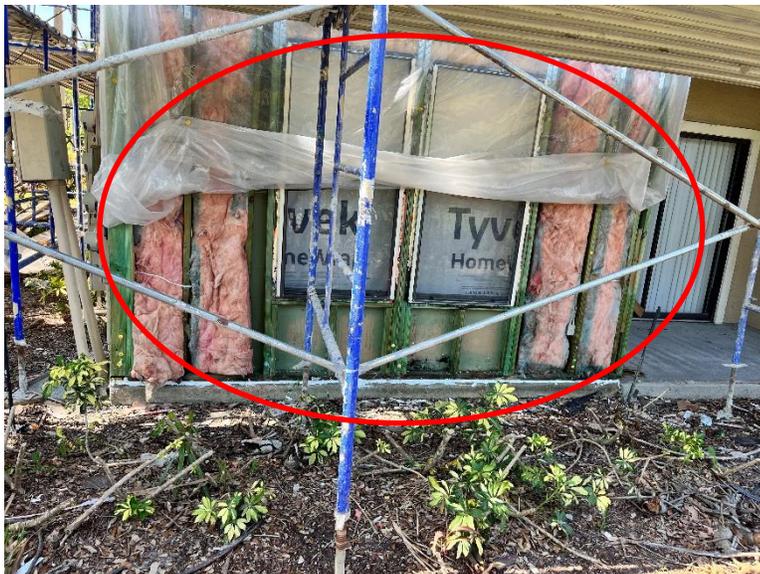
PHOTOGRAPH #12

**BUILDING 9
SECTION E**

Pest control contractor has applied BoraCare termite treatment to exterior wall framing as per specifications.

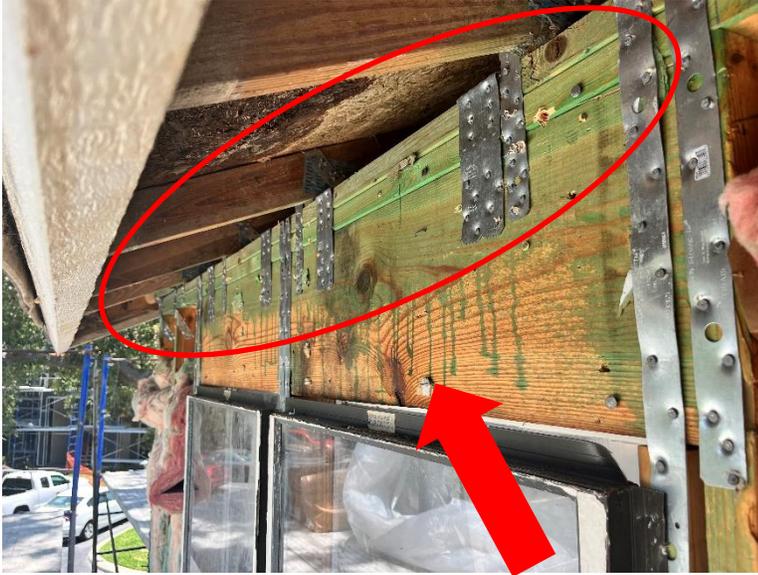
PHOTOGRAPH #13

**BUILDING 9
SECTION E**

Simpson Strong-Tie connectors and screws installed at headers to top plates and top plates to trusses as per drawings. BoraCare termite treatment will require hand application at missed areas of wood header.

1. BoraCare termite treatment will require hand application at missed areas of wood header (Photograph #13).

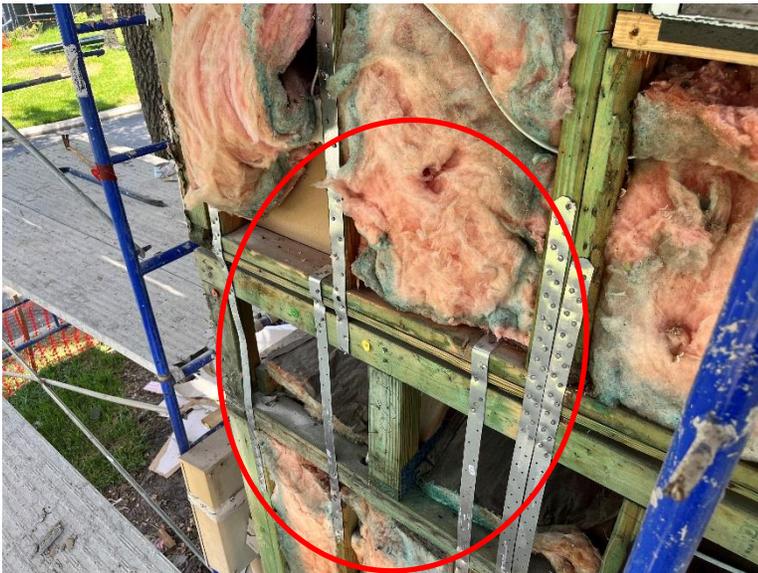
PHOTOGRAPH #14

**BUILDING 9
SECTION E**

Simpson Strong connector straps MTS A49. Installed as per drawing where studs do not align between floors.

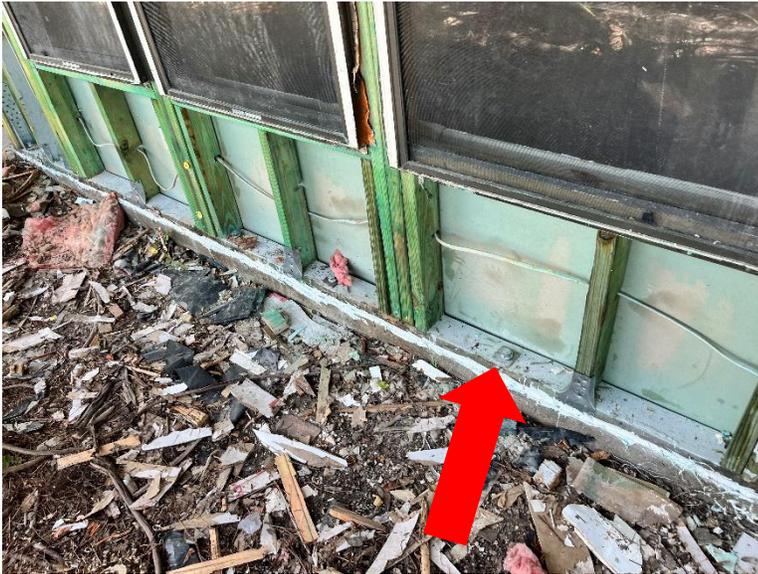
PHOTOGRAPH #15

**BUILDING 9
SECTION F**

Simpson Titen HD fastener with base plate installed as per drawings and specifications.

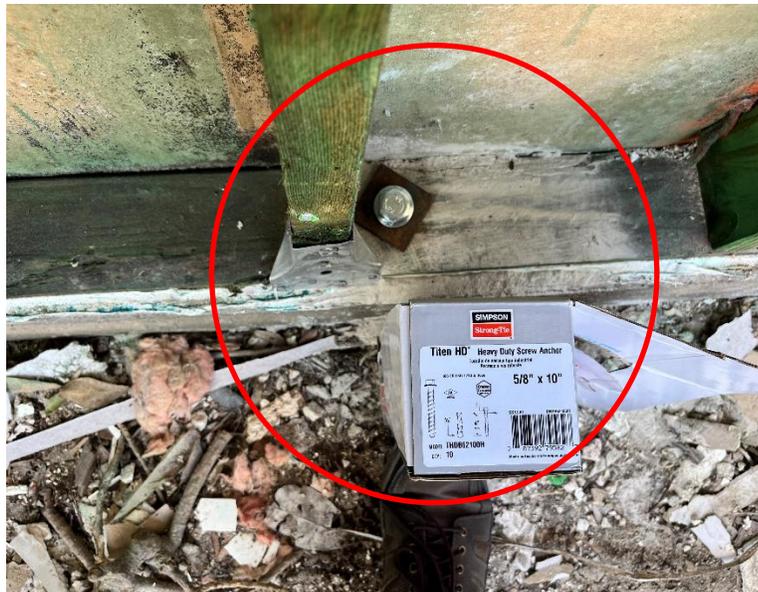
PHOTOGRAPH #16

**BUILDING 9
SECTION F**

Simpson Titen HD fastener with base plate installed as per drawings and specifications.

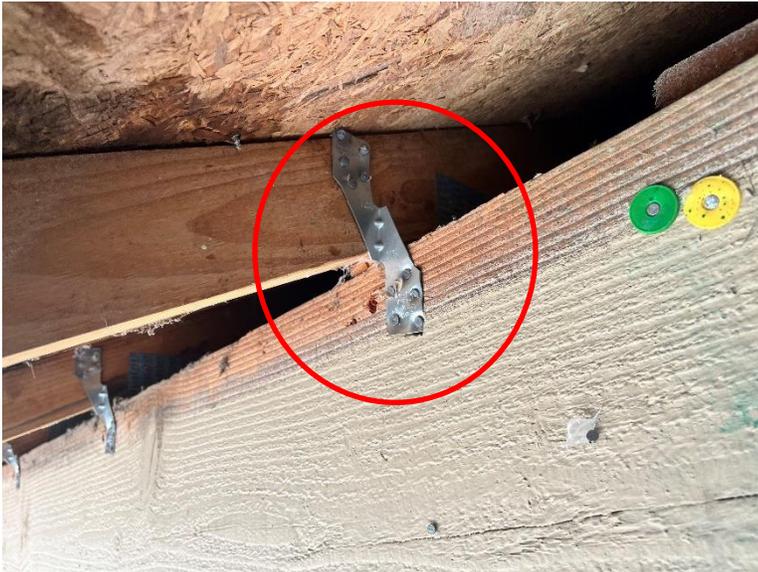
PHOTOGRAPH #17

**BUILDING 9
SECTION F**

Simpson #H2.5A hurricane tie installed at truss to roof beam as per drawings.

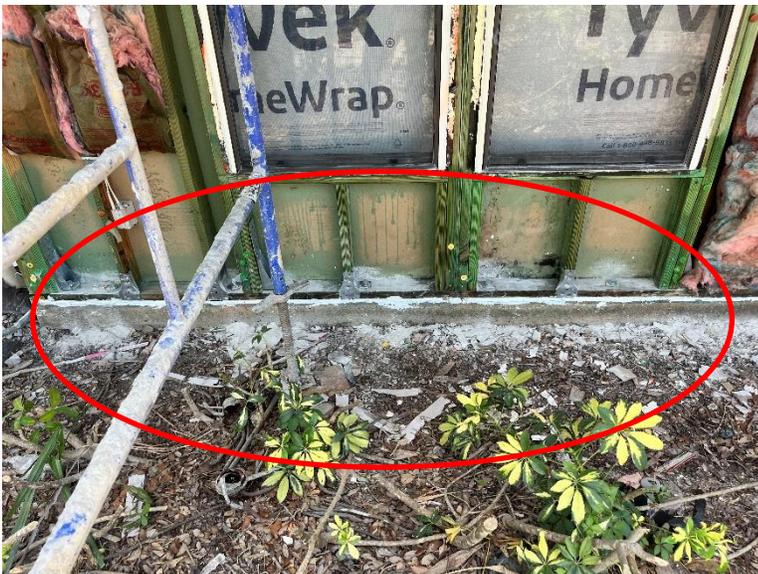
PHOTOGRAPH #18

**BUILDING 9
SECTION F**

Simpson Titen HD fastener with base plate installed as per drawings and specifications. New sealant applied at base plate to concrete slab as per drawings.

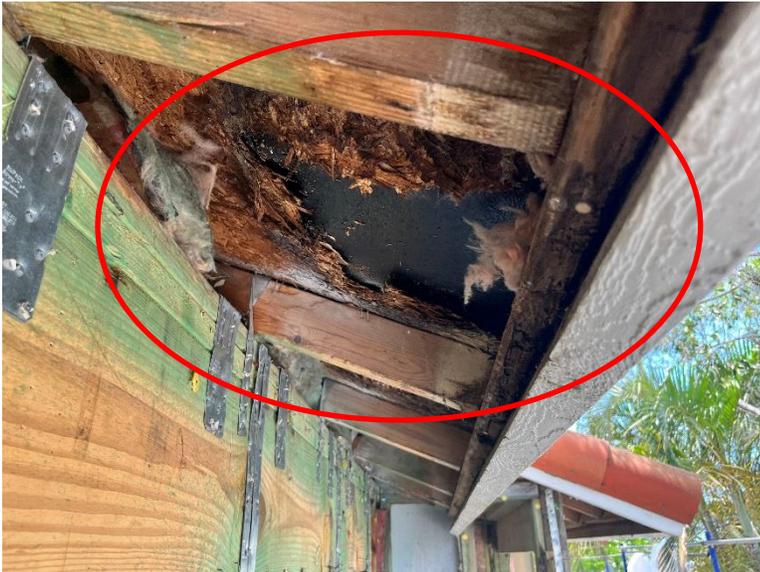
PHOTOGRAPH #19

**BUILDING 9
SECTION F**

Existing roof sheathing damage.

1. Previous and current leaks have damaged roof sheathing. Owners to have repairs done by others (Photograph #19).

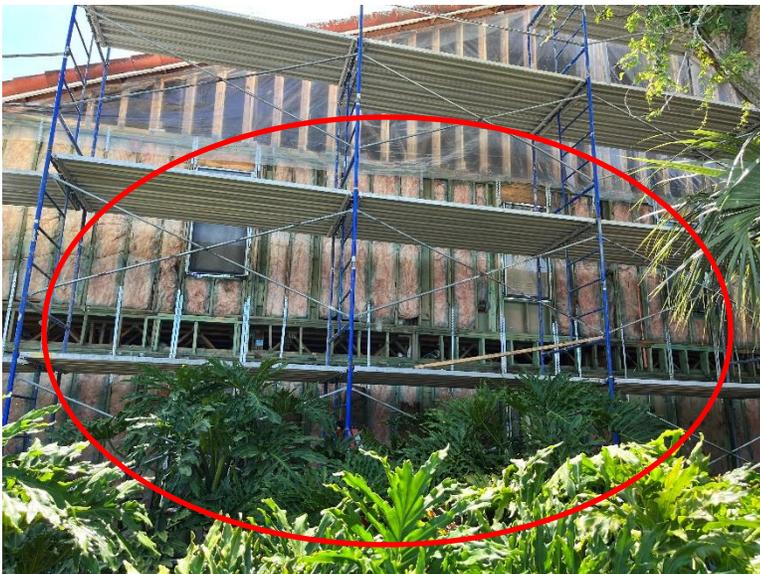
PHOTOGRAPH #20

**BUILDING 9
SECTION H**

Gable end reinforcements repairs, BoraCare Termite treatment and Simpson Strong connector applications performed in preparation for new sheathing.

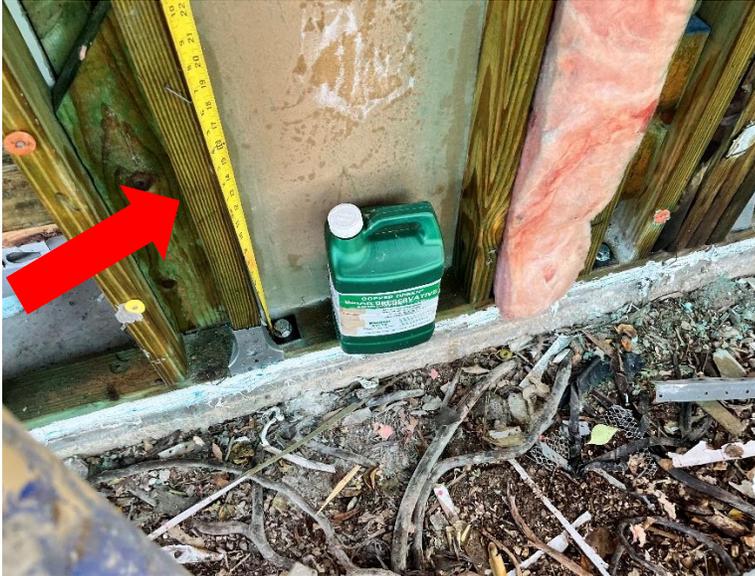
PHOTOGRAPH #21

**BUILDING 9
SECTION H**

Contractor has applied Copper Green wood preservative at lower two feet of wood framing as per specifications.

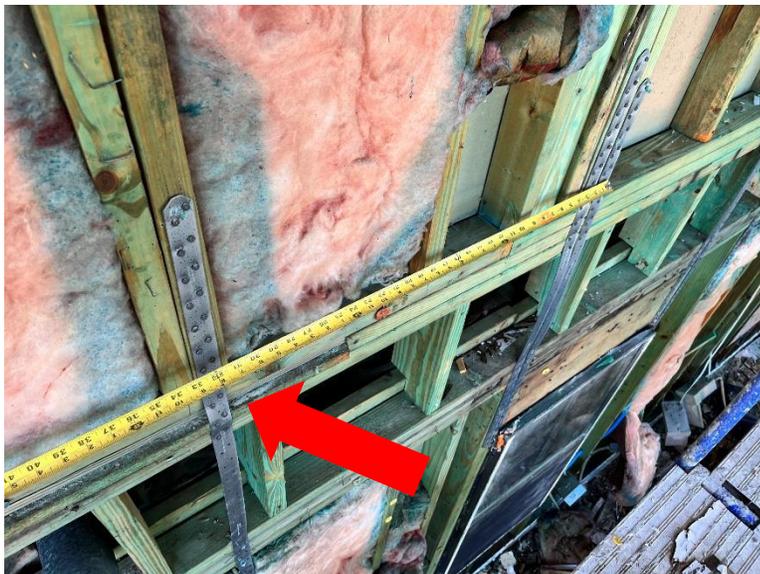
PHOTOGRAPH #22

**BUILDING 9
SECTION H**

Contractor has replaced damaged header above single window opening.

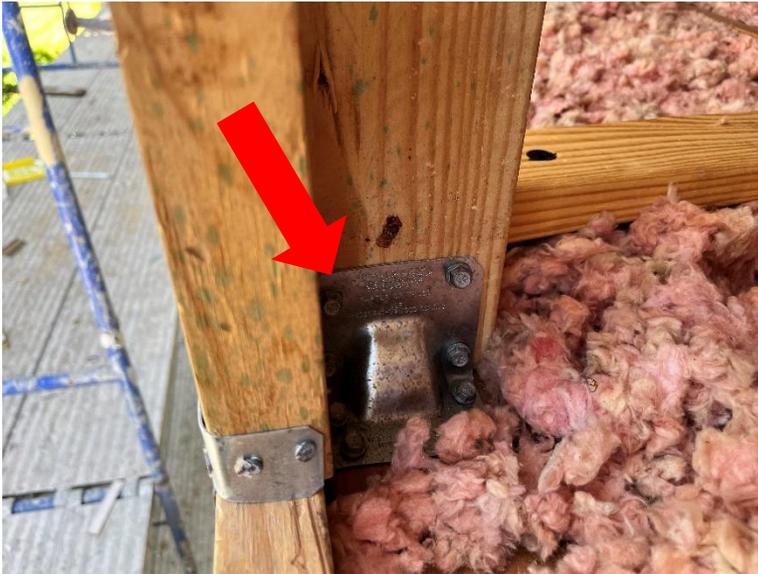
PHOTOGRAPH #23

**BUILDING 9
SECTION H**

Simpson LSTA-21 straps and #HGA10 clips installed at new wall bracing as per drawings.

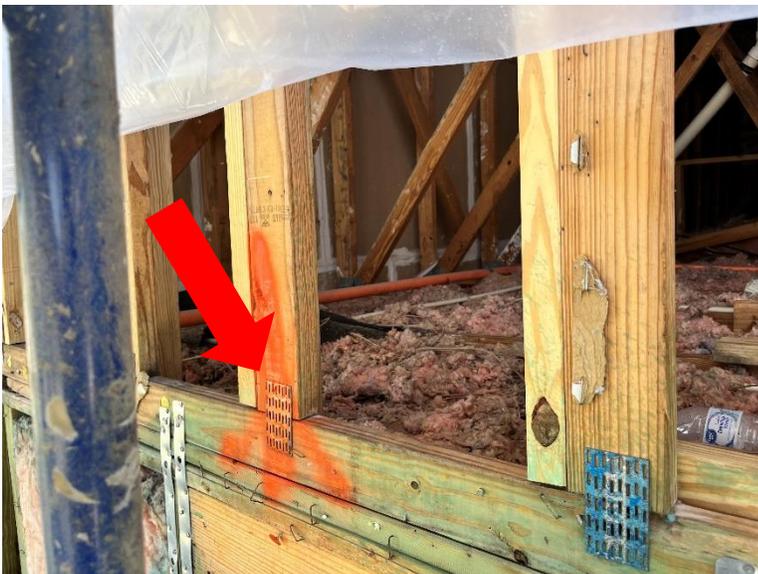
PHOTOGRAPH #24

**BUILDING 9
SECTION H**

Contractor has missed placing new 2"X4" cross bracing at 48" O.C. required spacing.

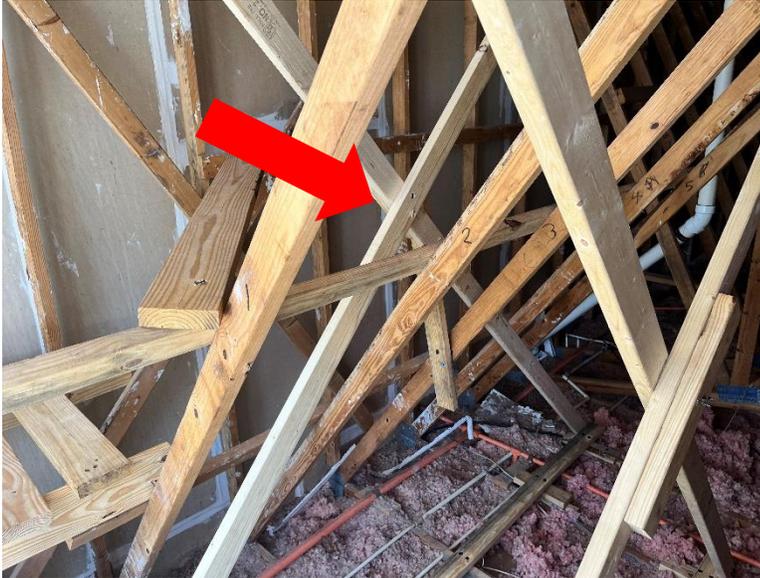
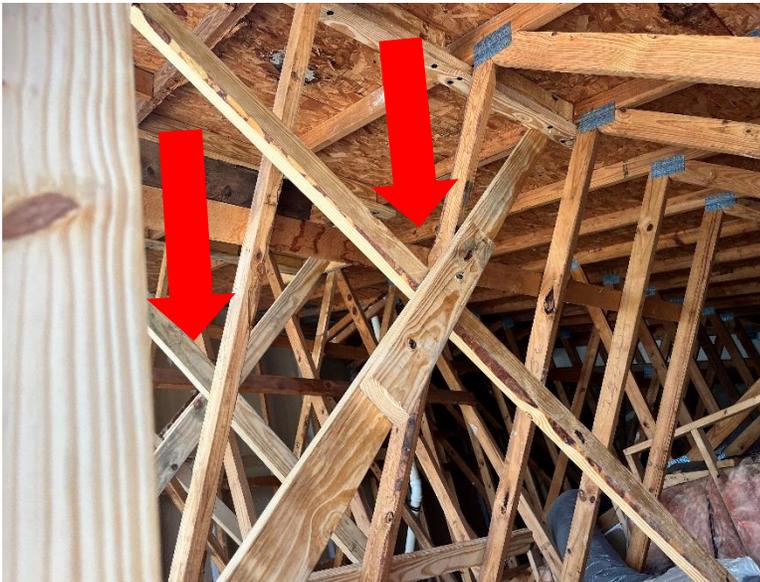
**BUILDING 9
SECTION H**

Contractor installed missing cross bracing as per drawings at 48" max spacing.

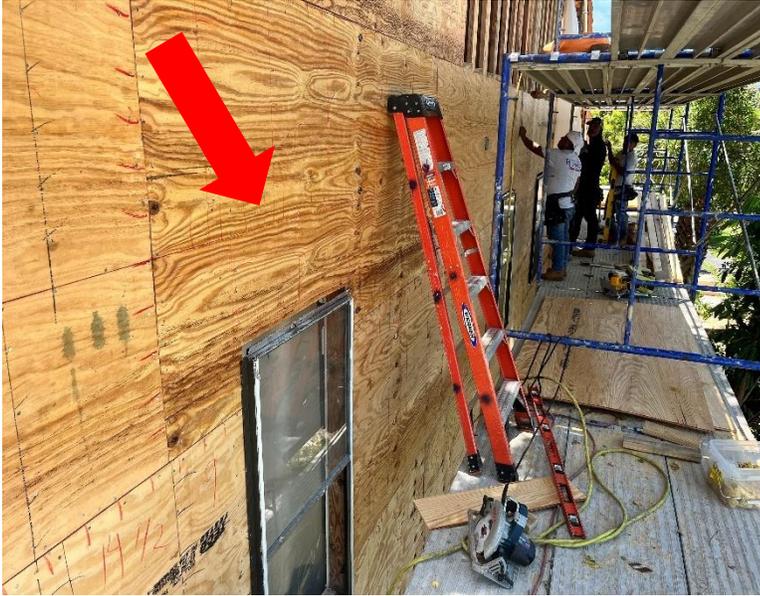
PHOTOGRAPH #27

**BUILDING 9
SECTION H**

Contractor installing new 15/32" plywood sheathing at gable end wall.
