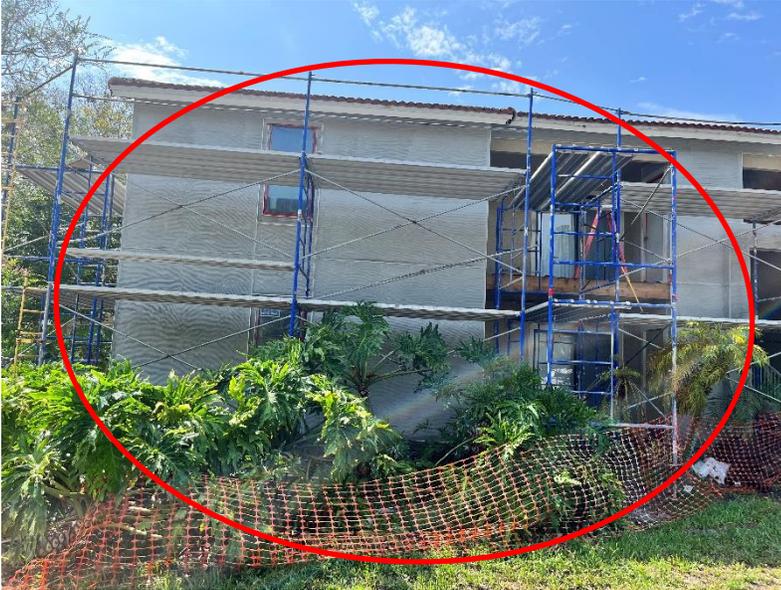
PHOTOGRAPH #1

**BUILDING 12
SECTION A**

Subcontractor has applied scratch coat of three coat 7/8" stucco finish system as per specifications.

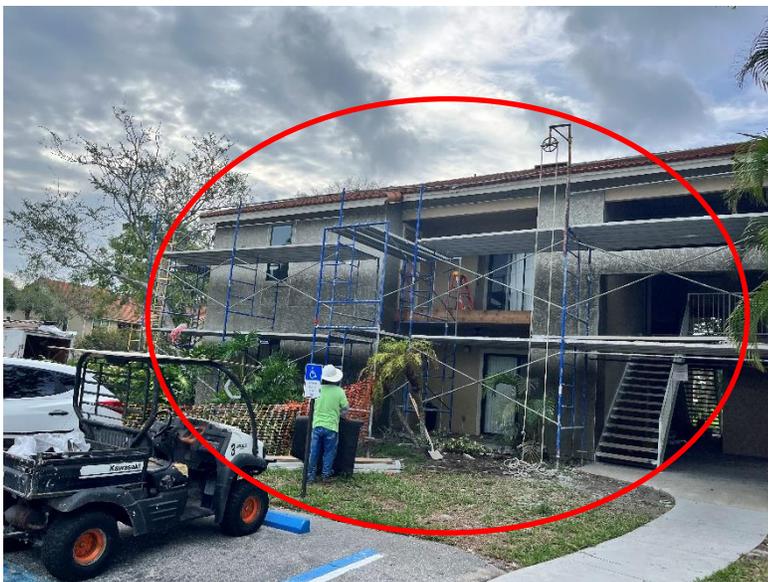
PHOTOGRAPH #2

**BUILDING 12
SECTION A**

Subcontractor applying brown and finish coats of three coat 7/8" stucco finish system as per specifications.

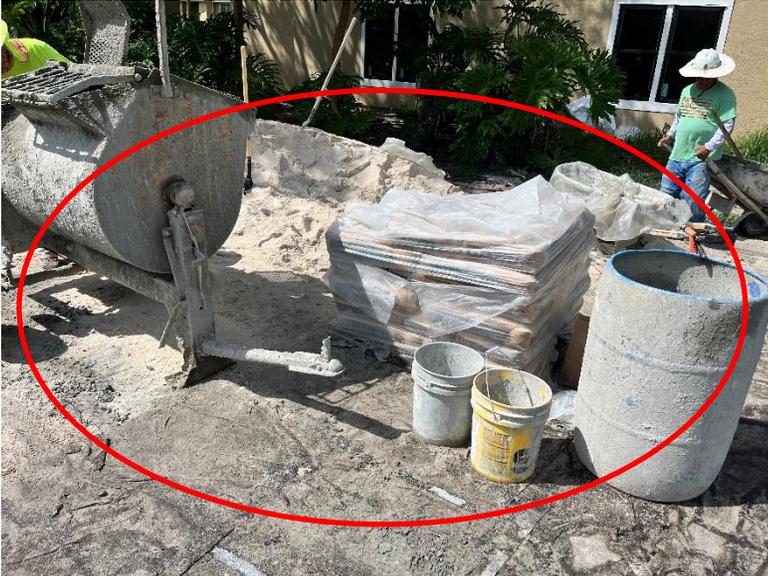
PHOTOGRAPH #3

**BUILDING 12
SECTION A**

Stucco Sub-Contractor mixing Broco bag stucco cement mix with sand and water.

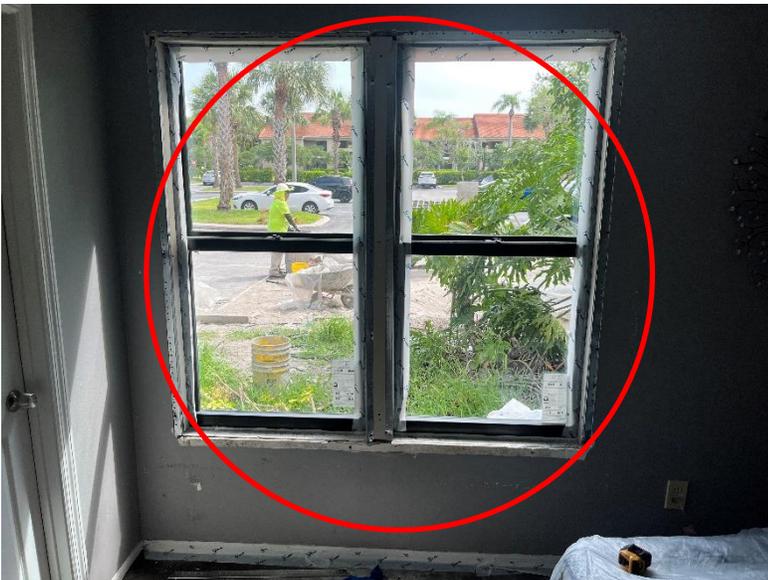
PHOTOGRAPH #4

**BUILDING 12
SECTION A- UNIT 1211**

Contractor performing dry wall and finish repairs at interior units around new PGT window openings.

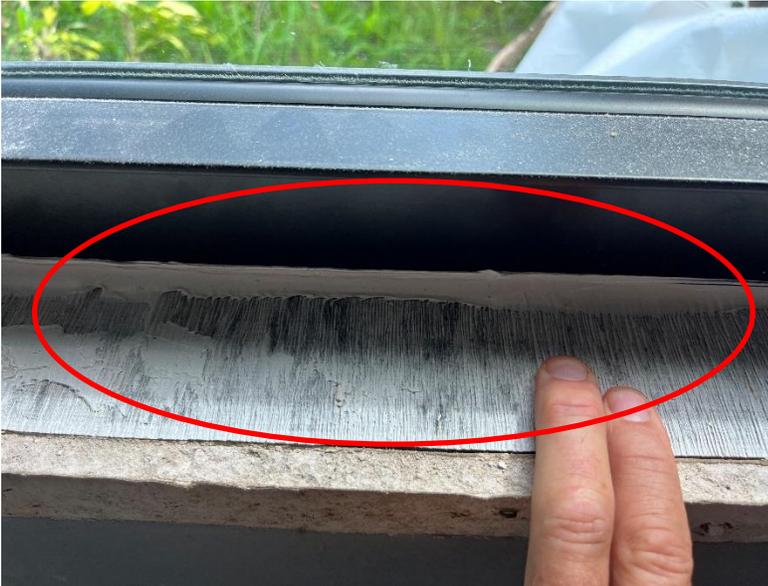
PHOTOGRAPH #5

**BUILDING 12
SECTION A- UNIT 1211**

New urethane sealant applied at window frame to Dupont flashing at windowsill as per manufacturer's installation instructions and drawings.

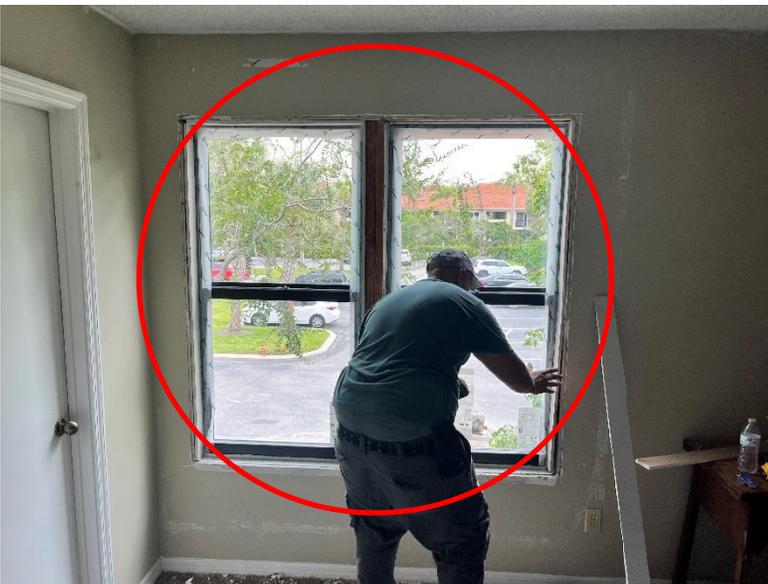
PHOTOGRAPH #6

**BUILDING 12
SECTION A- UNIT 1221**

Contractor performing dry wall and finish repairs at interior units around new PGT window openings.

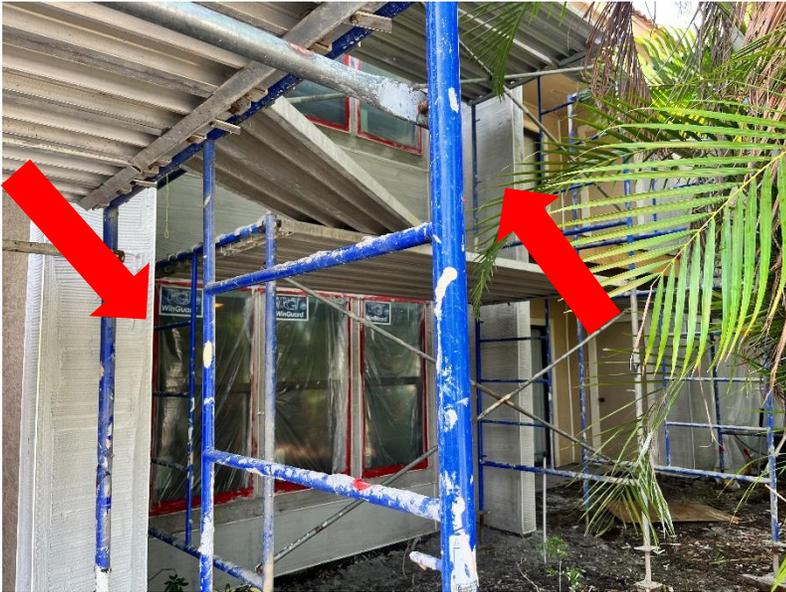
PHOTOGRAPH #7

**BUILDING 12
SECTION B**

Subcontractor has applied scratch coat of three coat 7/8" stucco finish system as per specifications.

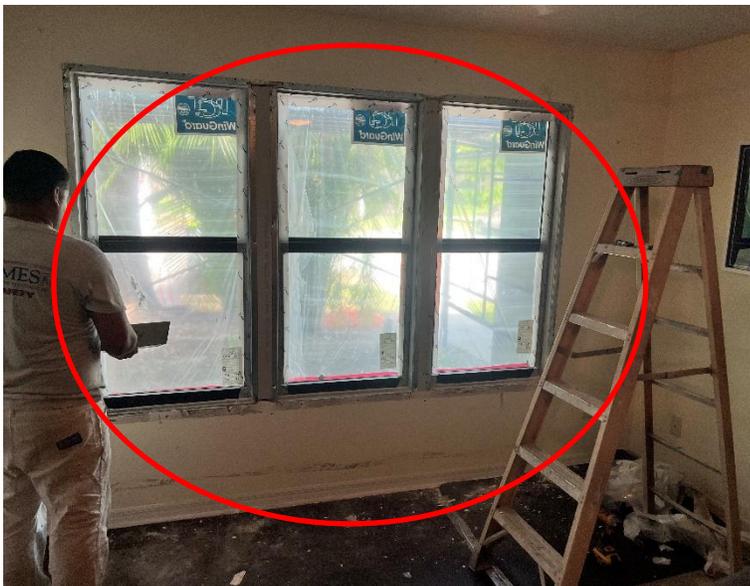
PHOTOGRAPH #8

**BUILDING 12
SECTION B UNIT 1213**

Contractor performing dry wall and finish repairs at interior units around new PGT window openings.

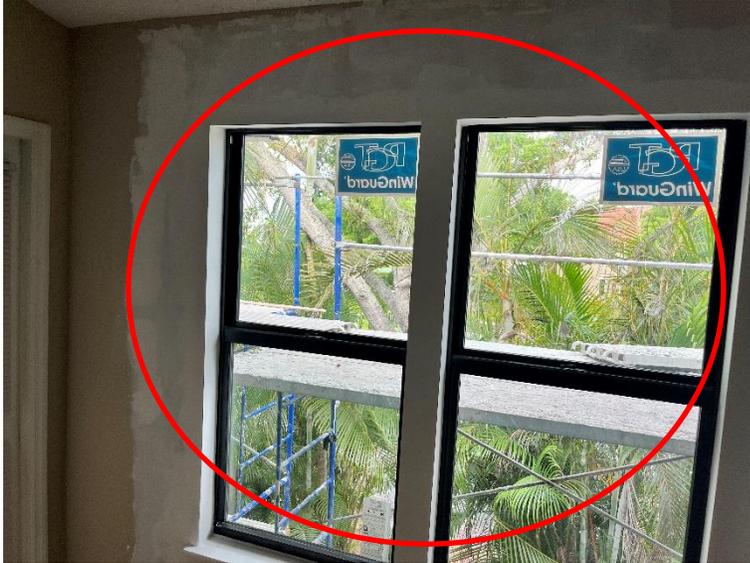
PHOTOGRAPH #9

**BUILDING 12
SECTION B UNIT 1223**

Contractor has completed dry wall and finish repairs at interior units around new PGT window openings

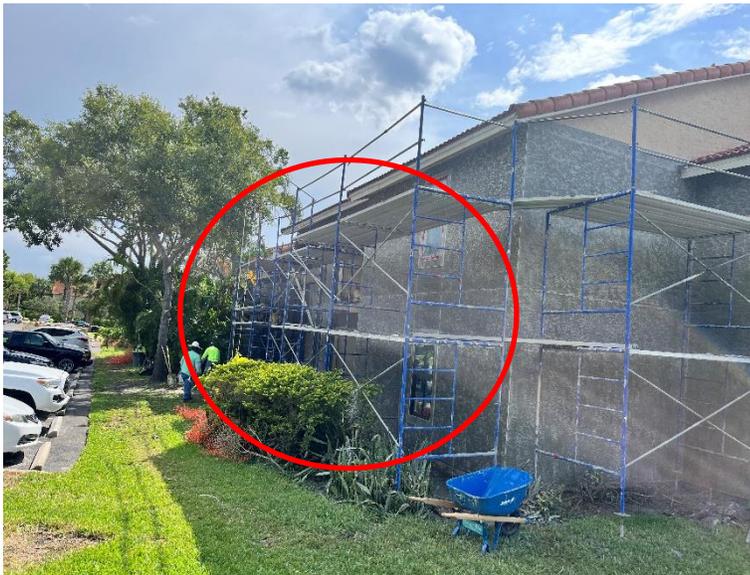
PHOTOGRAPH #10

**BUILDING 12
SECTION C**

Subcontractor has applied finish texture coat of three coat 7/8" stucco finish system as per specifications.

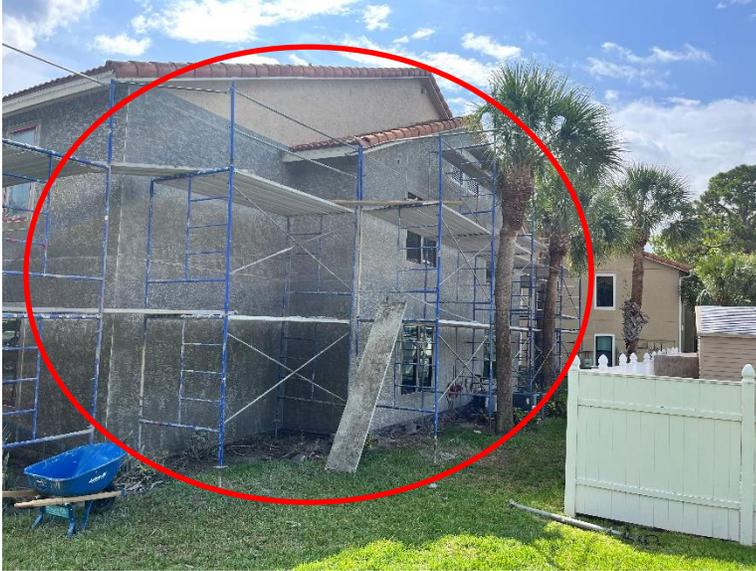
PHOTOGRAPH #11

**BUILDING 12
SECTION D**

Subcontractor has applied finish texture coat of three coat 7/8" stucco finish system as per specifications.

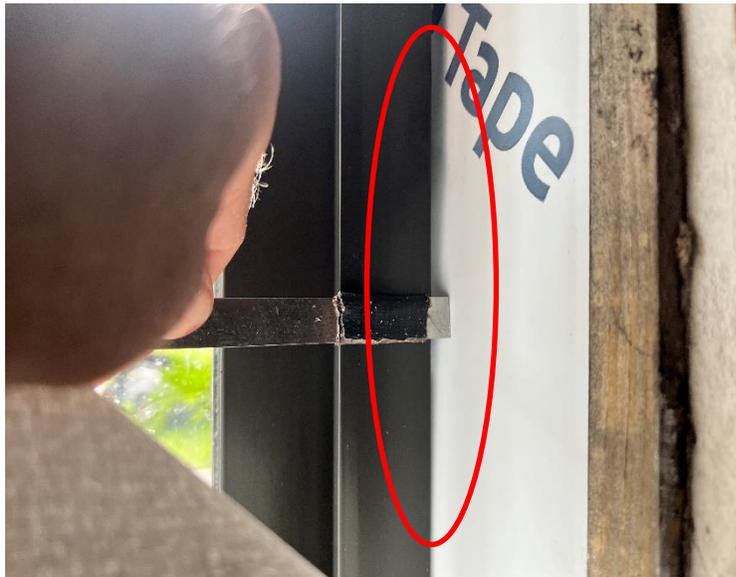
PHOTOGRAPH #12

**BUILDING 12
SECTION F- UNIT 1214**

Delta checking window gap at interior jambs for compliance with PGT product approval requirements and drawings.

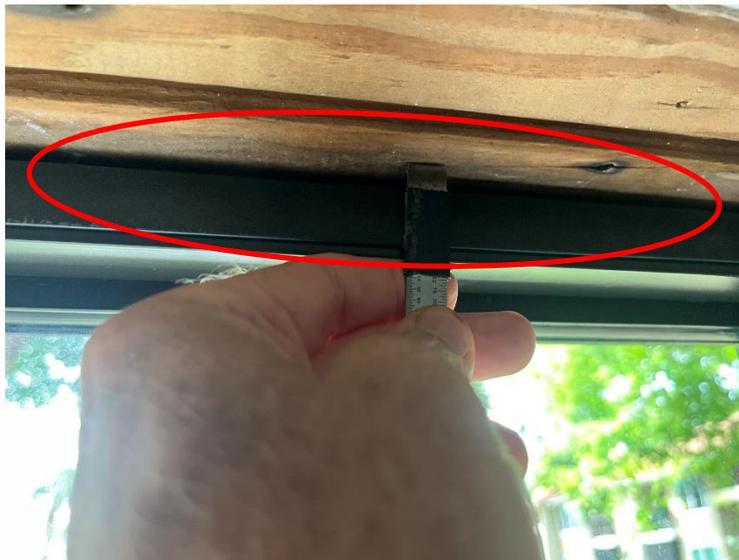
PHOTOGRAPH #13

**BUILDING 12
SECTION F- UNIT 1214**

Delta checking window gap at interior head for compliance with PGT product approval requirements and drawings.

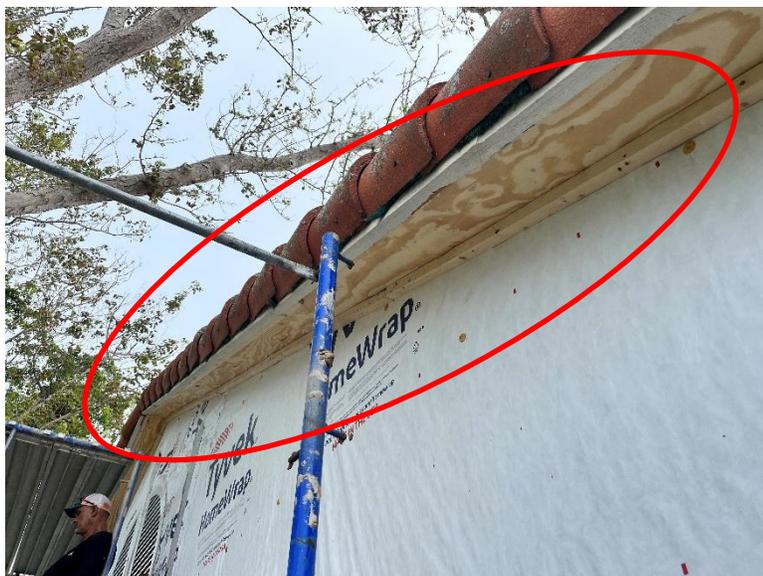
PHOTOGRAPH #14

**BUILDING 9
SECTION H**

Contractor has installed new plywood soffit at gable end wall.

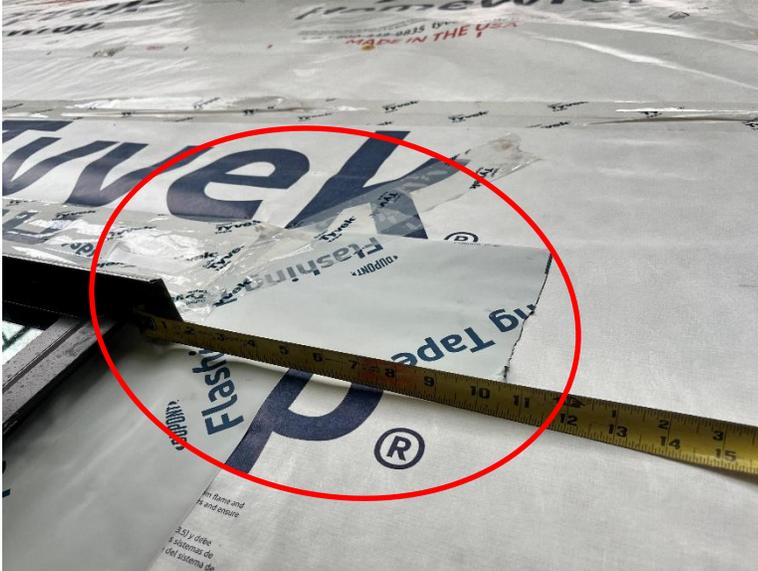
PHOTOGRAPH #15

**BUILDING 9
SECTION H**

DuPont flashing installed at head of window extends out beyond outer edges of Jamb flashing as per drawings.

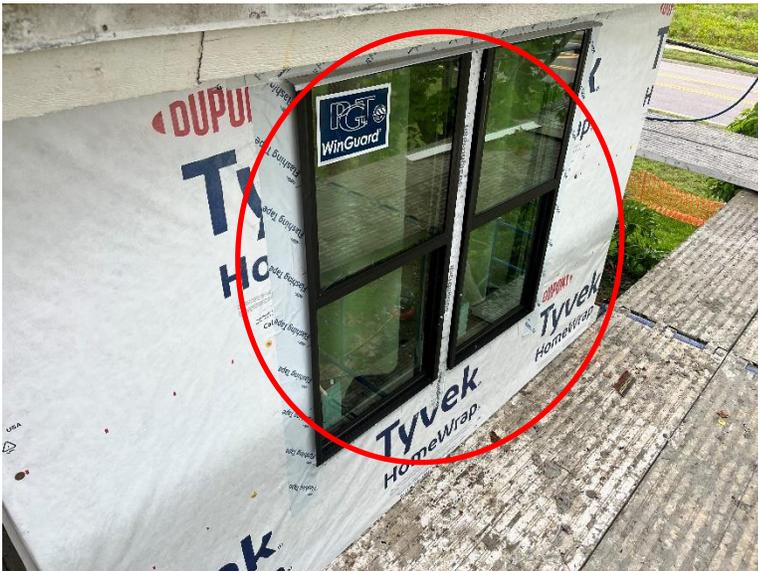
PHOTOGRAPH #16

**BUILDING 9
SECTION G**

New PGT SH7700A single hung windows installed with Dupont Flashings as per drawing and specifications.

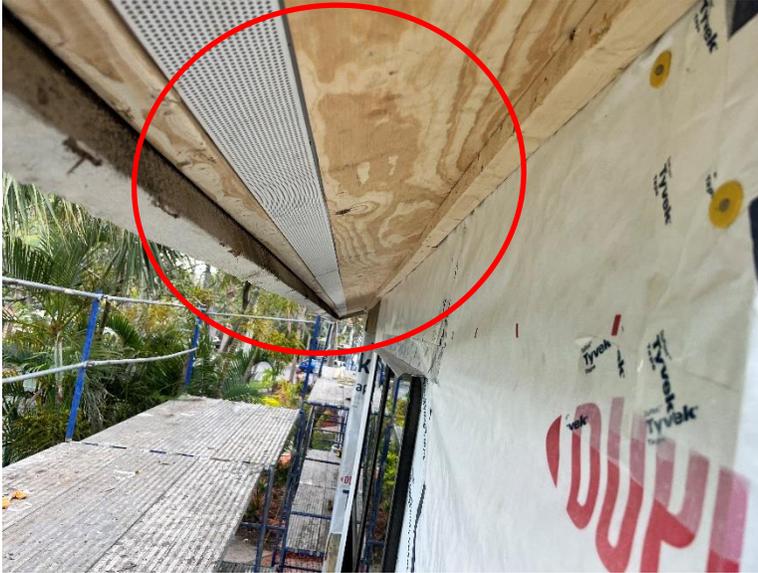
PHOTOGRAPH #17

**BUILDING 9
SECTION G**

New plywood soffit and vinyl vent installed as per drawings.

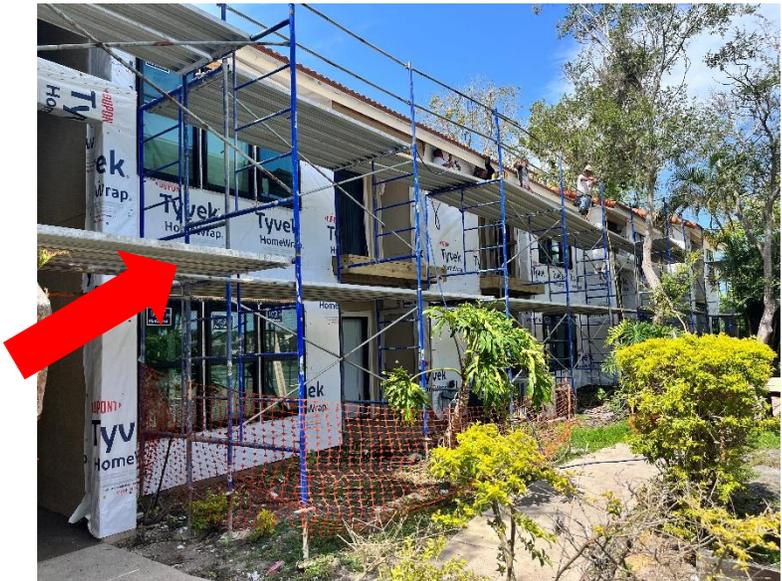
PHOTOGRAPH #18

**BUILDING 9
SECTION F**

New PGT SH7700A single hung windows installed with Dupont Flashings as per drawing and specifications.

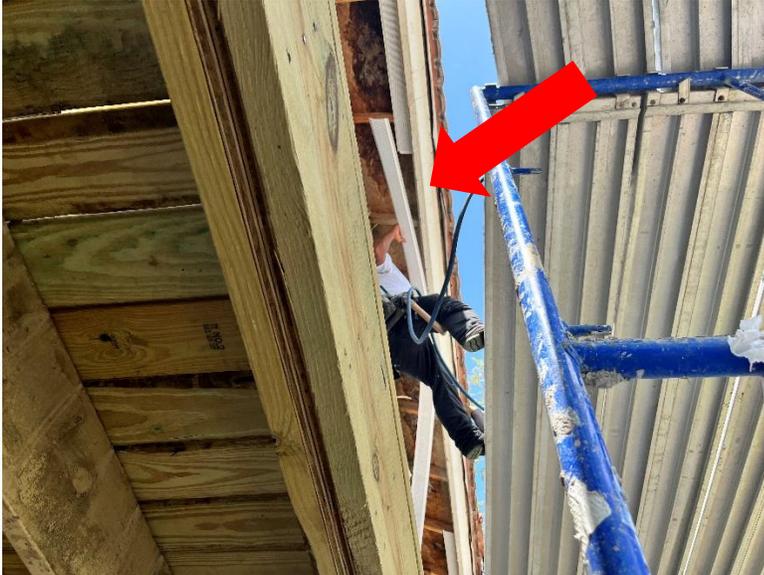
PHOTOGRAPH #19

**BUILDING 9
SECTION F**

New plywood soffit and vinyl vent installation in progress.

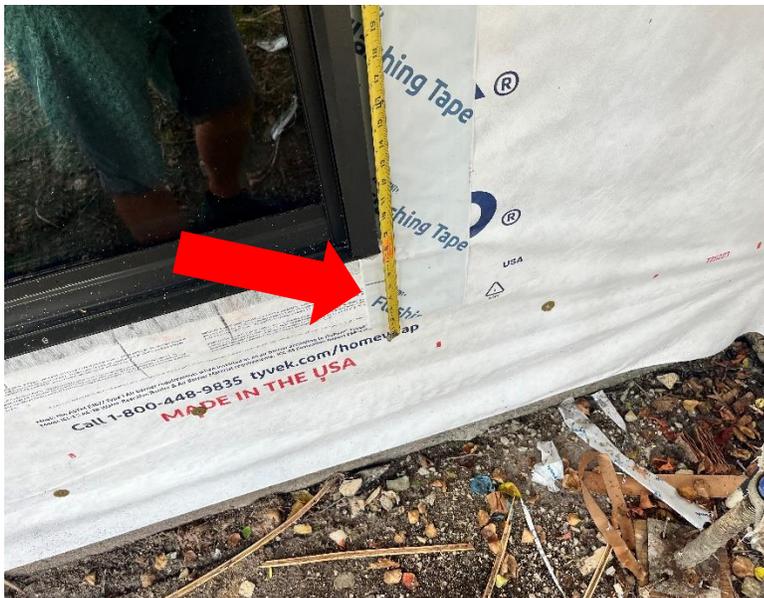
PHOTOGRAPH #20

**BUILDING 9
SECTION E**

Dupont Flashing Tape applied over window flange onto Tyvek HomeWrap extends down past window frame as per drawings and manufacturer's recommendations.

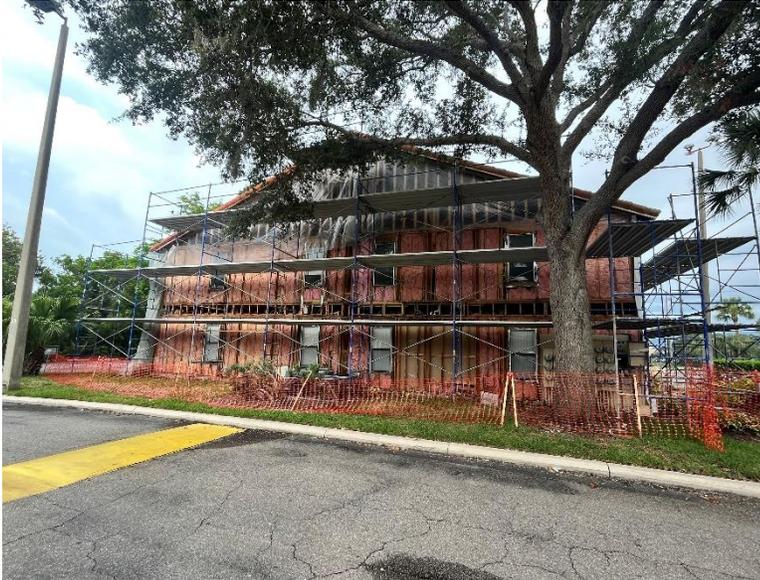
PHOTOGRAPH #21

**BUILDING 9
SECTION D**

Contractor has removed stucco and previous sheathing for inspection and marking of damaged framing by Delta.

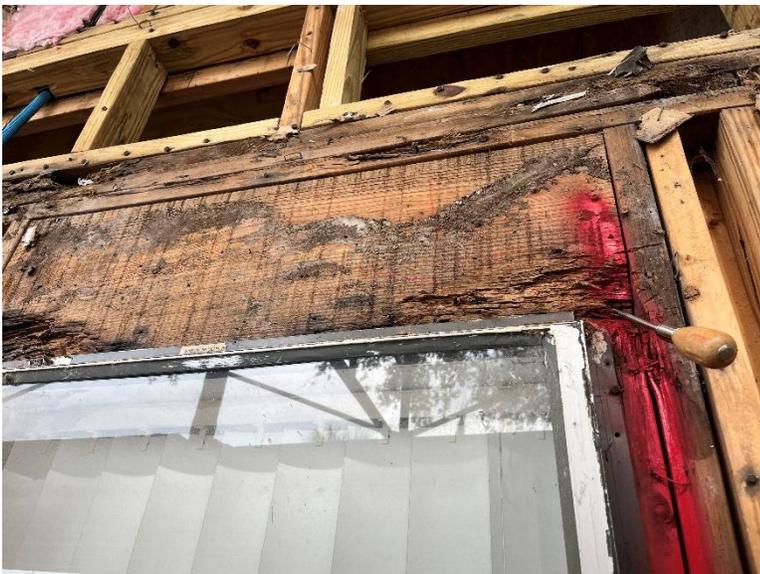
PHOTOGRAPH #22

**BUILDING 9
SECTION D**

Single window header damaged and marked for removal and replacement.

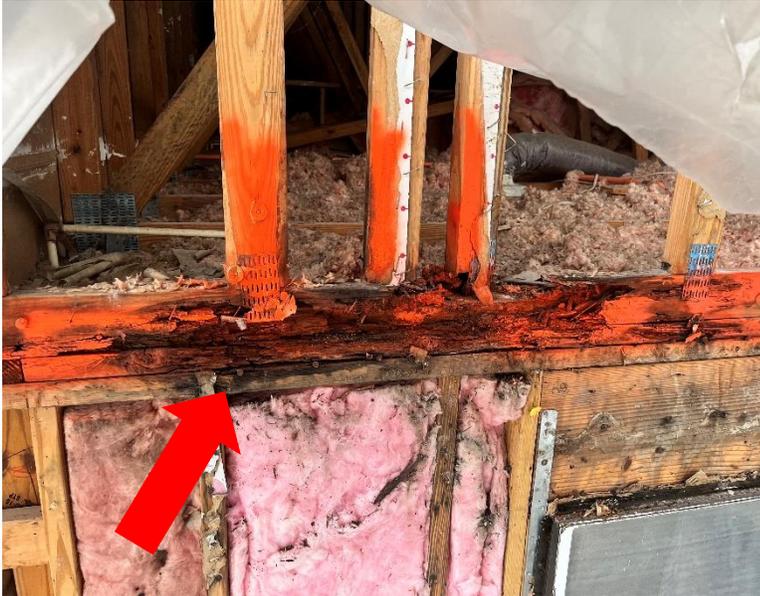
PHOTOGRAPH #23

**BUILDING 9
SECTION D**

Damaged 2nd floor top plate and gable end truss marked for repairs.

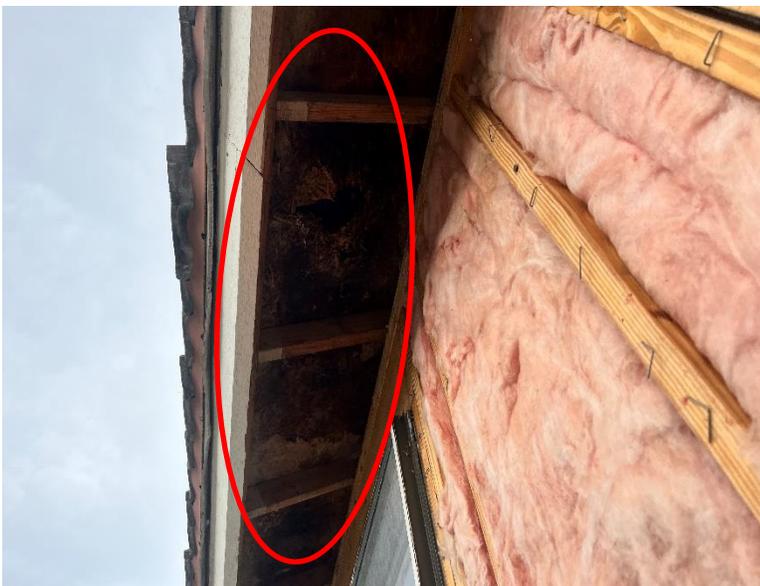
PHOTOGRAPH #24

**BUILDING 9
SECTION C**

Previous roof leaks have damaged roof sheathing above the soffit.

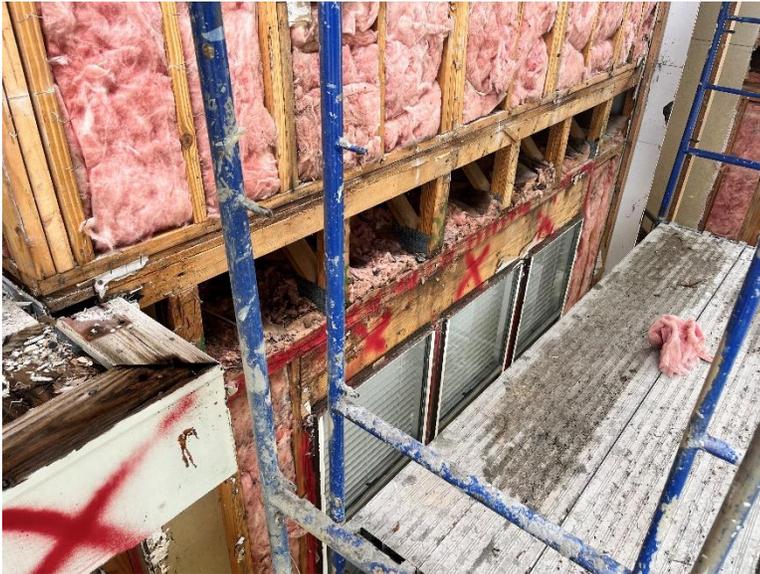
PHOTOGRAPH #25

**BUILDING 9
SECTION B**

Triple window headers and top plate damaged and marked for repairs.

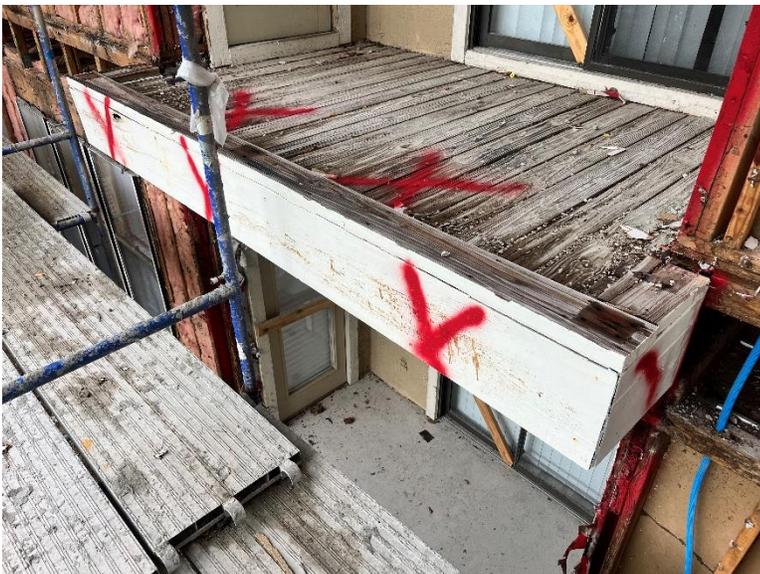
PHOTOGRAPH #26

**BUILDING 9
SECTION B – UNIT #923**

Damaged balcony built up rail beam and deck boards marked for full repairs.

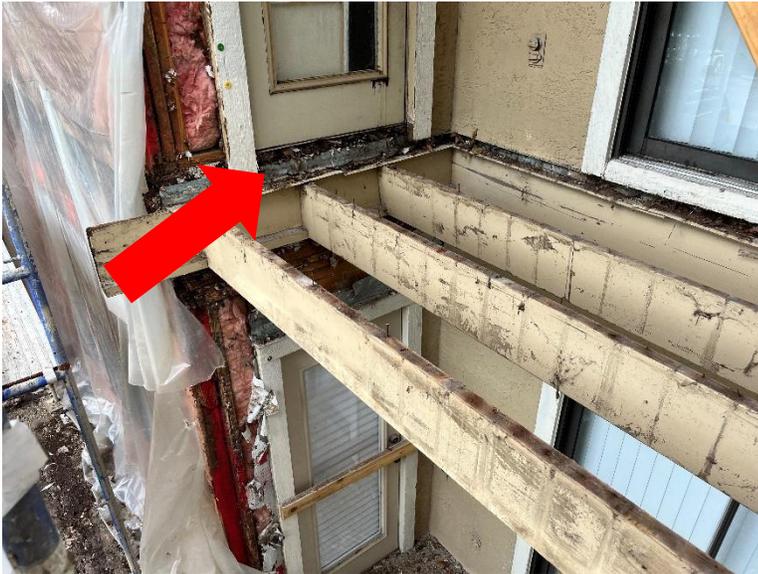
PHOTOGRAPH #27

**BUILDING 9
SECTION B-UNIT 923**

Contractor has removed deck boards and built-up beam, exposing additional damage at framing below doorway.

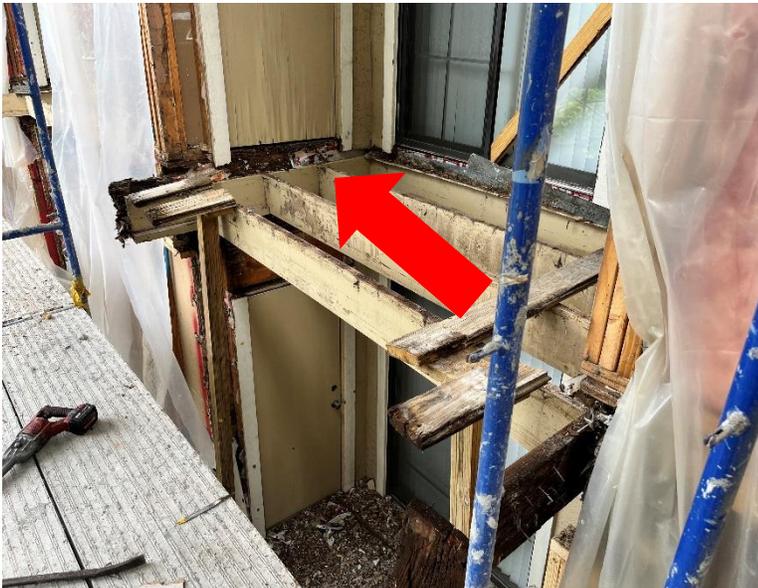
PHOTOGRAPH #28

**BUILDING 9
SECTION B - UNIT 925**

Contractor has removed deck boards and built-up beam, exposing additional damage at framing below doorway.

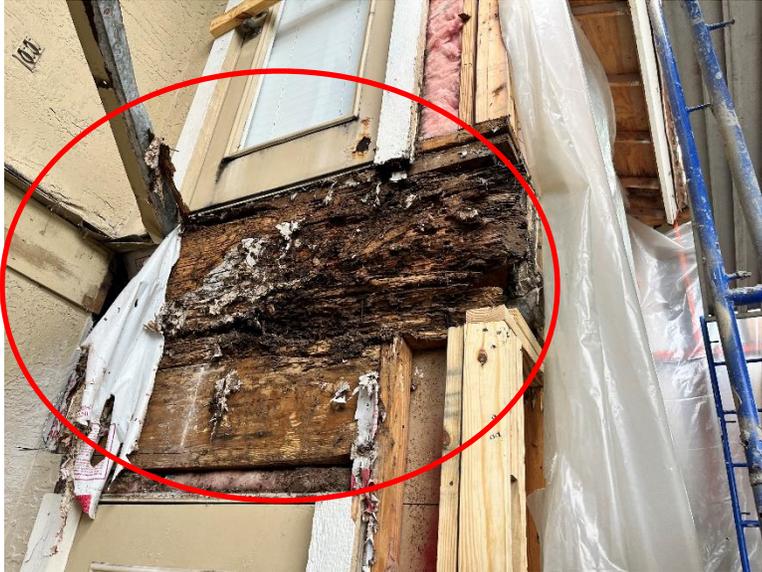
PHOTOGRAPH #29

**BUILDING 9
SECTION B – UNIT 925**

Original cedar beam, door header and all framing damaged will require removal and new framing members.
