**BUILDING 11
UNIT 1227 - WATER TEST**

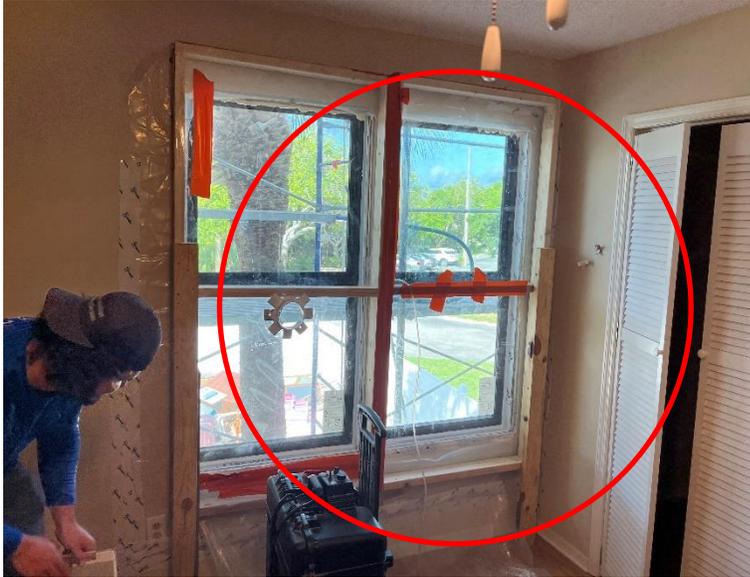
PHOTOGRAPH #1 A

Independent Testing Agency performed water infiltration testing at double windows in accordance with AAAMA 502. Testing failed with leak occurring at left windowsill.

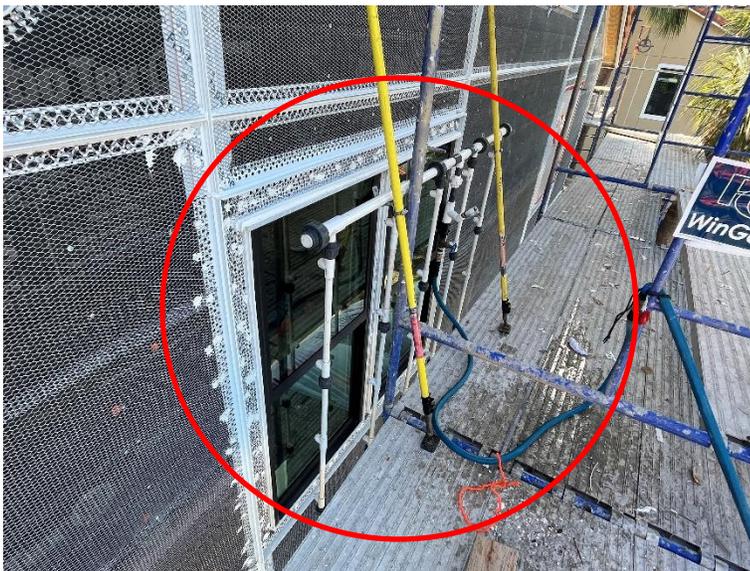
PHOTOGRAPH #2 A

**BUILDING 11
UNIT 1227 - WATER TEST**

Independent Testing Agency performed water infiltration testing at double windows in accordance with AAAMA 502. Testing failed with leak occurring at left windowsill.

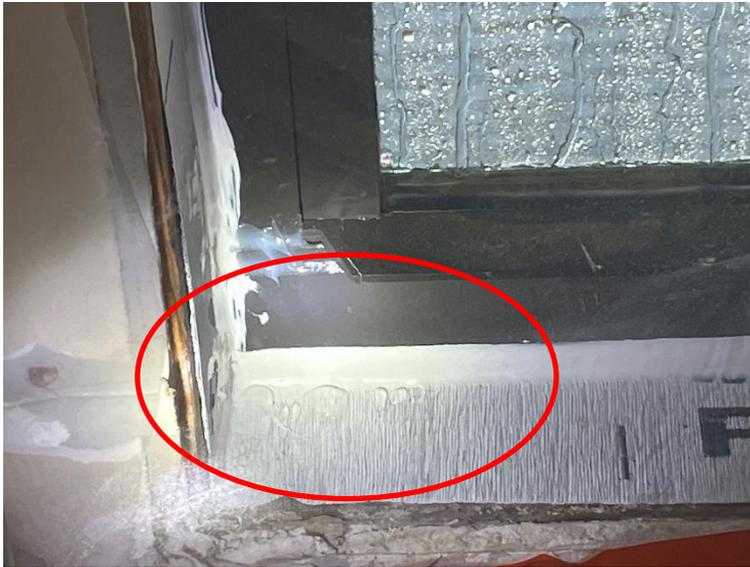
PHOTOGRAPH #3 A

**BUILDING 11
UNIT 1227 - WATER TEST**

Independent Testing Agency performed water infiltration testing at double windows in accordance with AAAMA 502. Testing failed with leak occurring at left windowsill.

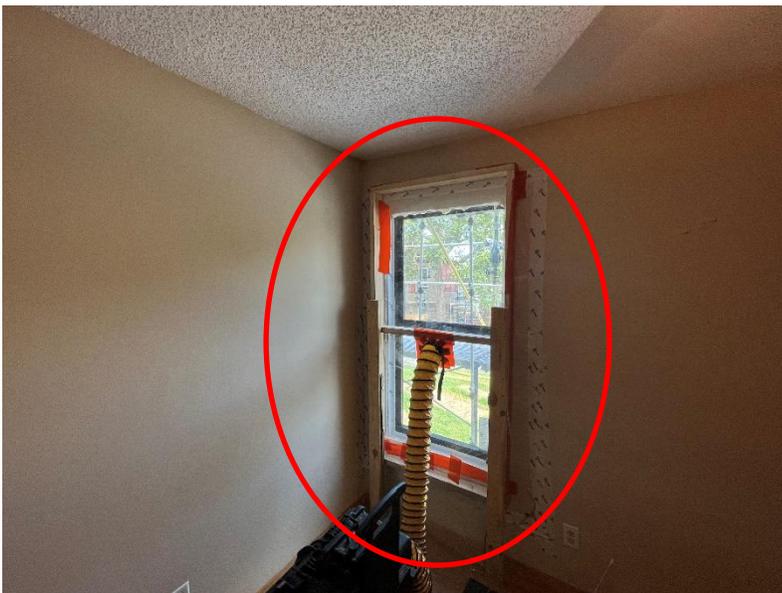
PHOTOGRAPH #4 A

**BUILDING 11
UNIT 1227 - WATER TEST**

Independent Testing Agency performed water infiltration testing at single window in accordance with AAAMA 502. Testing passed with no leaks occurring.

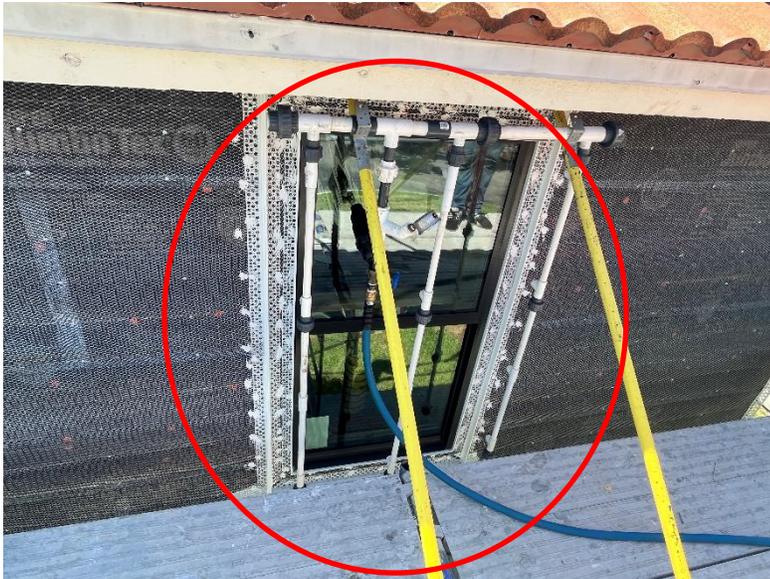
PHOTOGRAPH #5 A

**BUILDING 11
UNIT 1227 - WATER TEST**

Independent Testing Agency performed water infiltration testing at single window in accordance with AAAMA 502. Testing passed with no leaks occurring.
