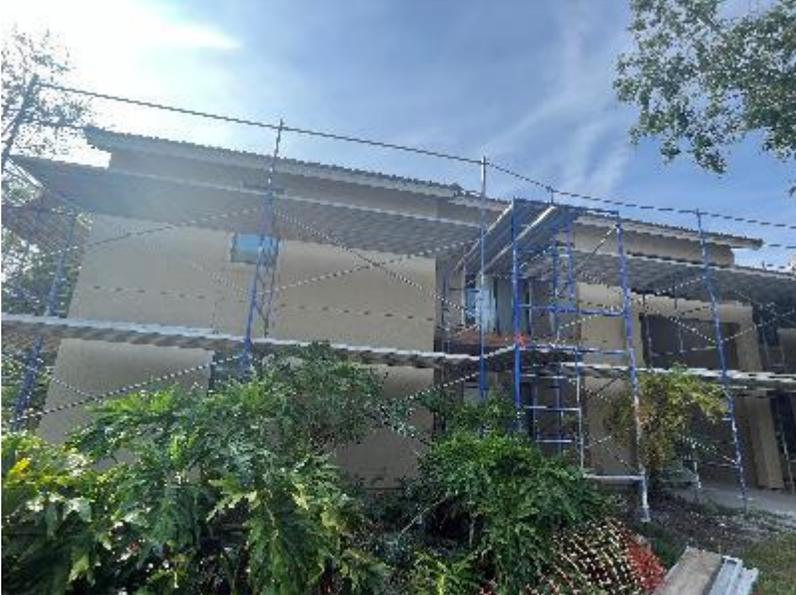
PHOTOGRAPH #1

**BUILDING 12
SECTION A**

Painting in progress.

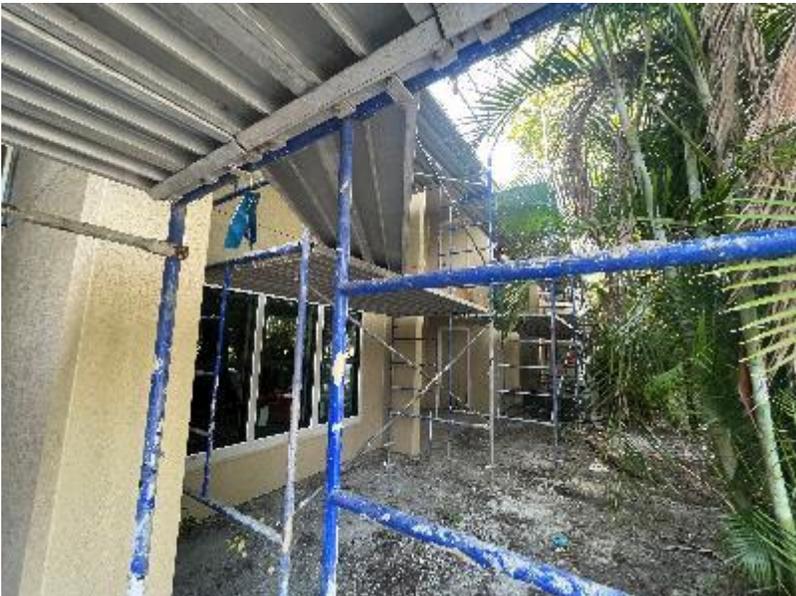
PHOTOGRAPH #2

**BUILDING 12
SECTION B**

Painting in progress.

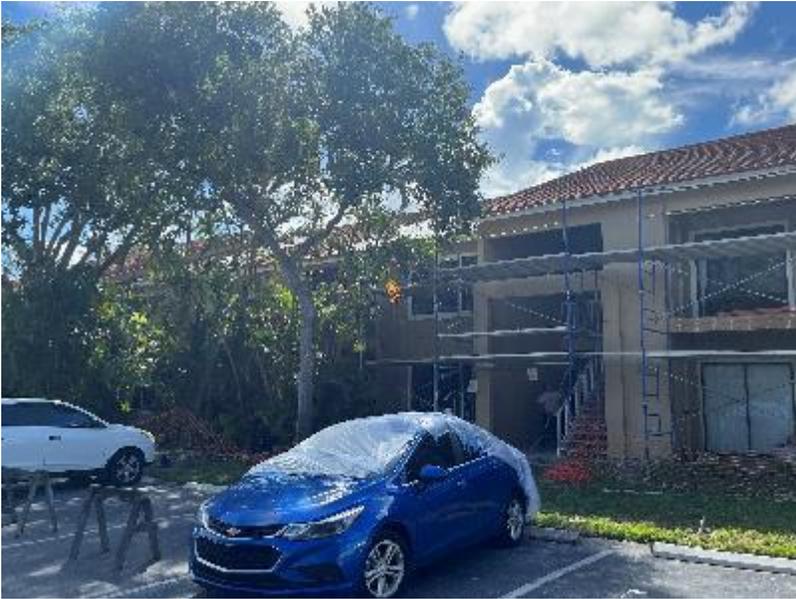
PHOTOGRAPH #3

**BUILDING 12
SECTION C**

Painting in progress.

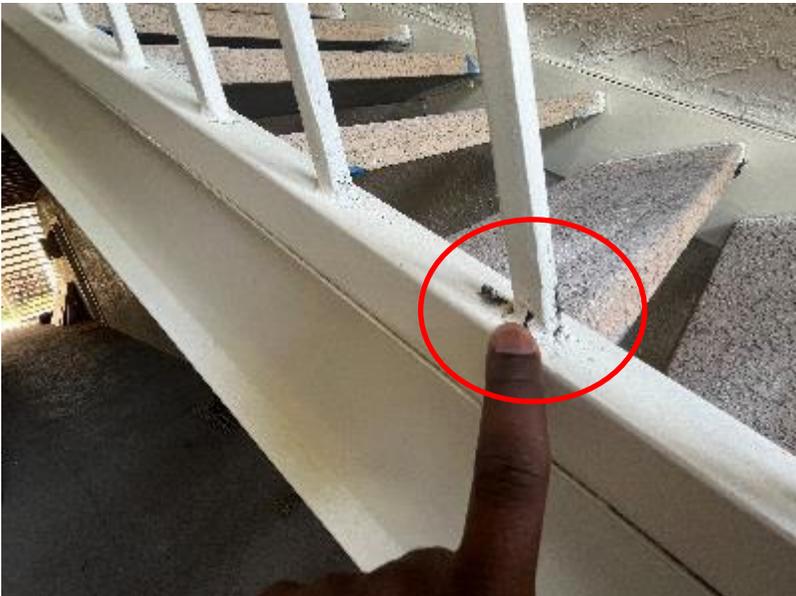
PHOTOGRAPH #4

**BUILDING 12
SECTION C**

Rust observed at bottom of stair railing picket.

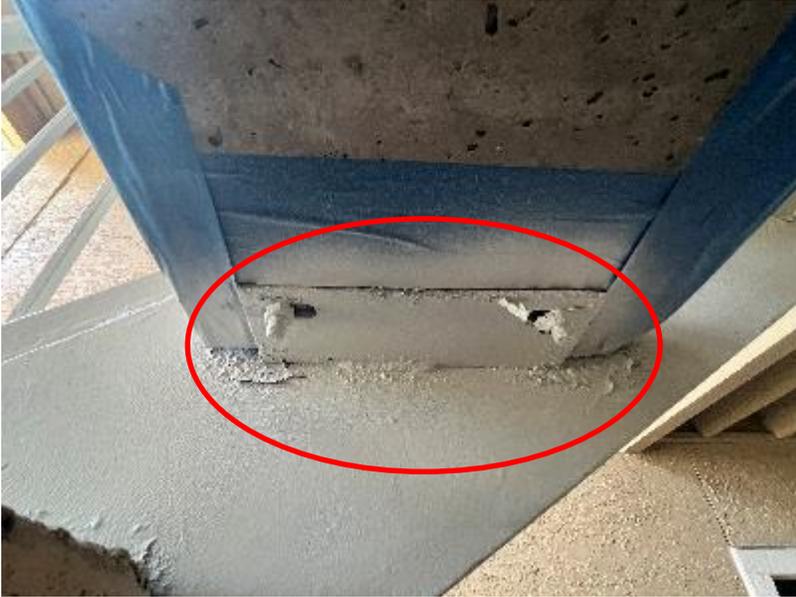
PHOTOGRAPH #5

**BUILDING 12
SECTION C**

Rust and peeling paint observed at steel support for stairs.

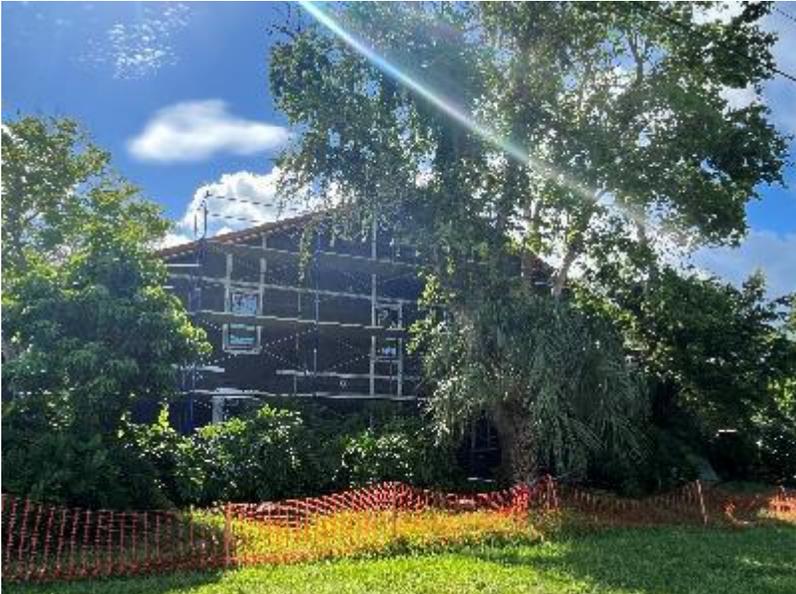
PHOTOGRAPH #6

**BUILDING 9
SECTION H**

Installation of stucco lath and accessories in progress.

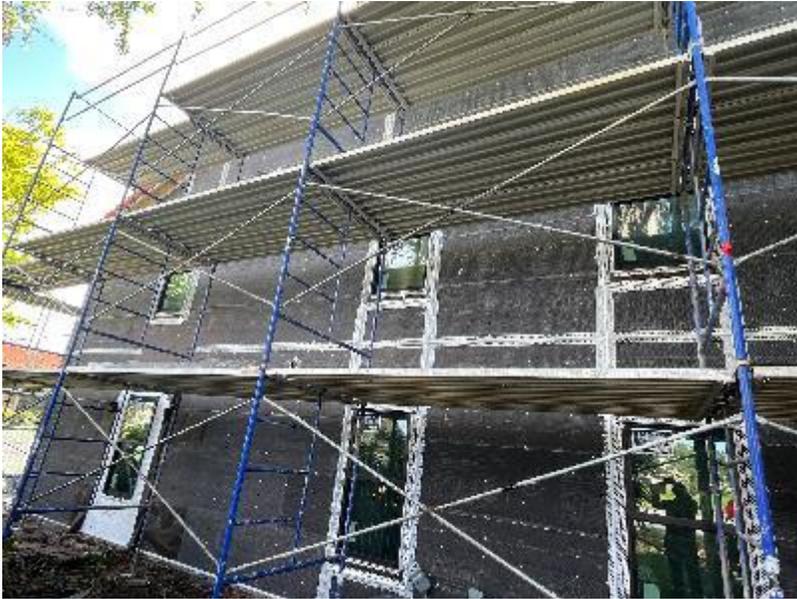
PHOTOGRAPH #7

**BUILDING 9
SECTION H**

Installation of stucco lath and accessories in progress.

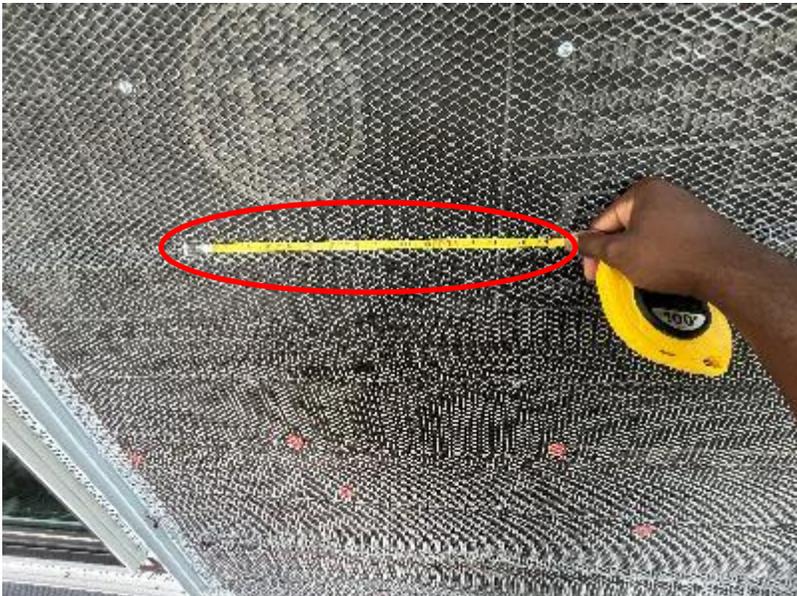
PHOTOGRAPH #8

**BUILDING 9
SECTION H**

Contractor attaching stucco lath with 8x1-1/2" metal screws spaced at 16" O.C. in the horizontal directions and 7" O.C. in the vertical directions.

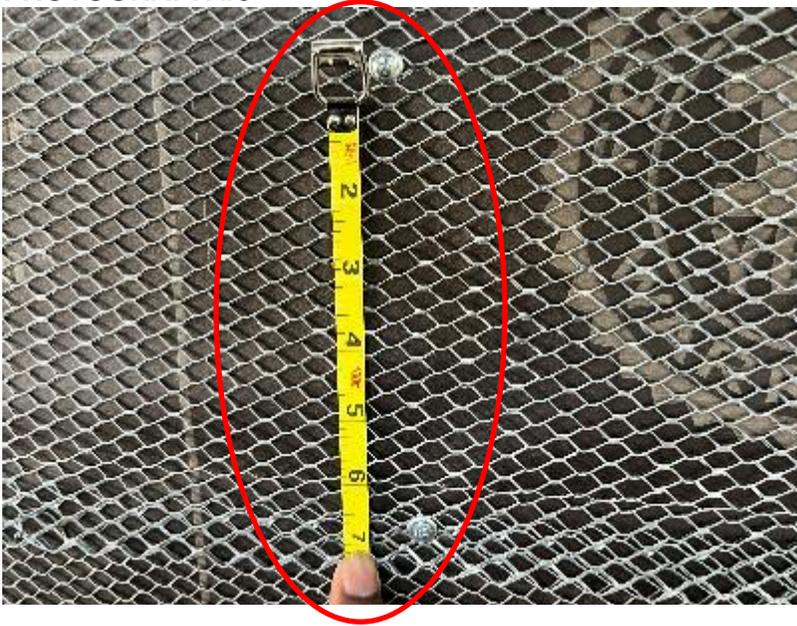
PHOTOGRAPH #9

**BUILDING 9
SECTION H**

Contactor attaching stucco lath with 8x1-1/2" metal screws spaced at 16" O.C. in the horizontal directions and 7" O.C. in the vertical directions.

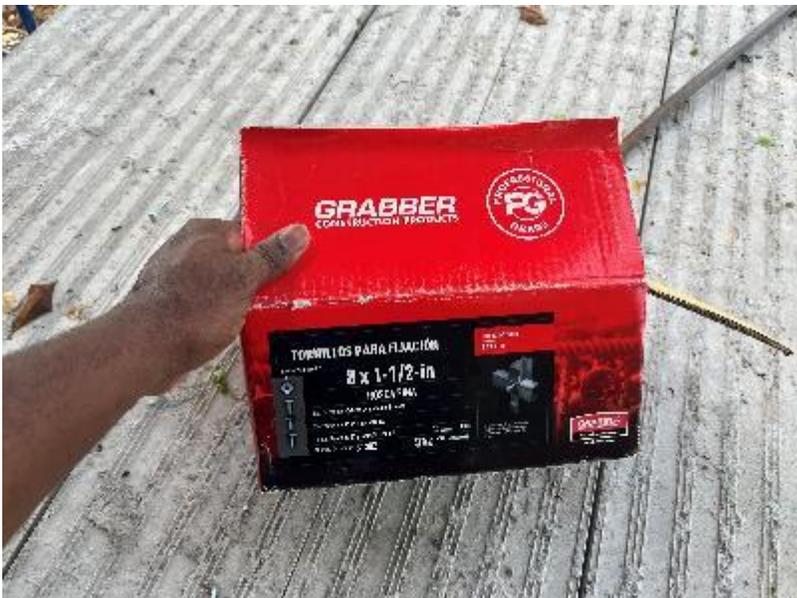
PHOTOGRAPH #10

**BUILDING 9
SECTION H**

Contactor attaching stucco lath with 8x1-1/2" metal screws spaced at 16" O.C. in the horizontal directions and 7" O.C. in the vertical directions.

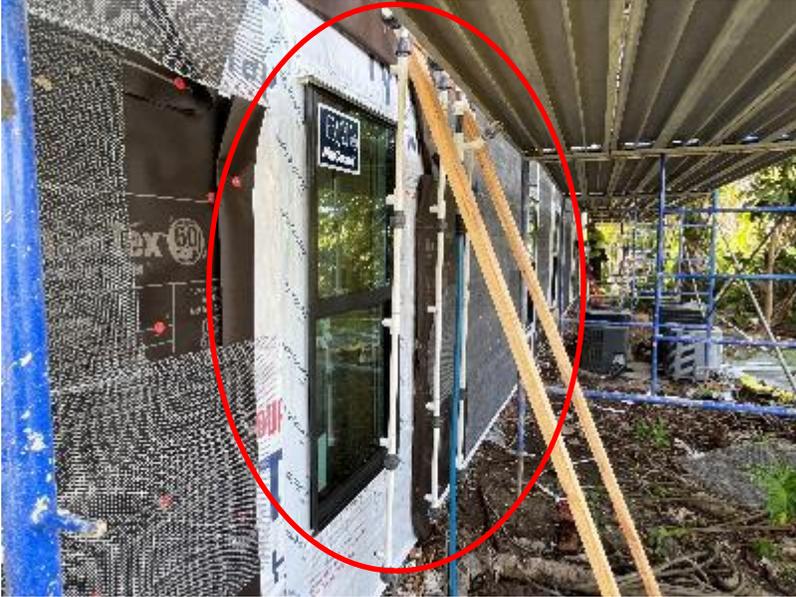
PHOTOGRAPH #11

**BUILDING 9
SECTION H**

Water testing of single panel window conducted at unit #912. The window passed the water test.

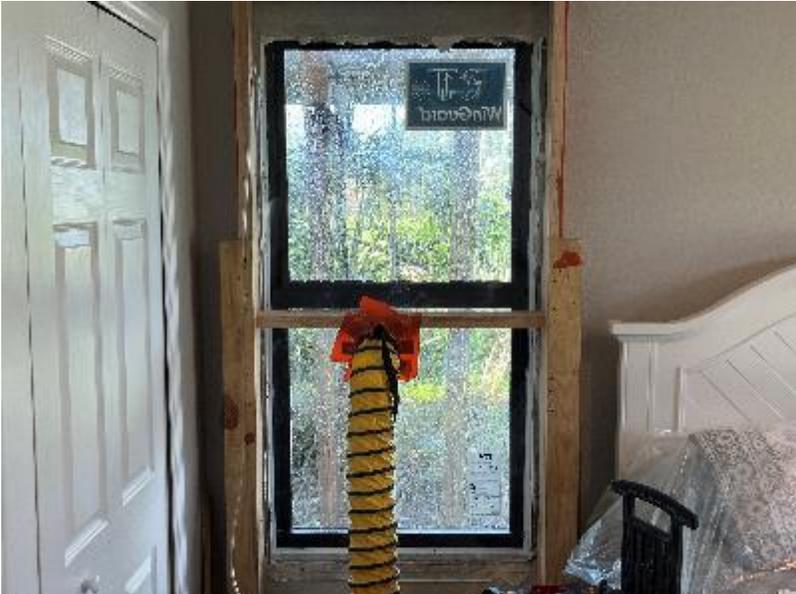
PHOTOGRAPH #12

**BUILDING 9
SECTION H**

Water testing of single panel window conducted at unit #912. The window passed the water test.

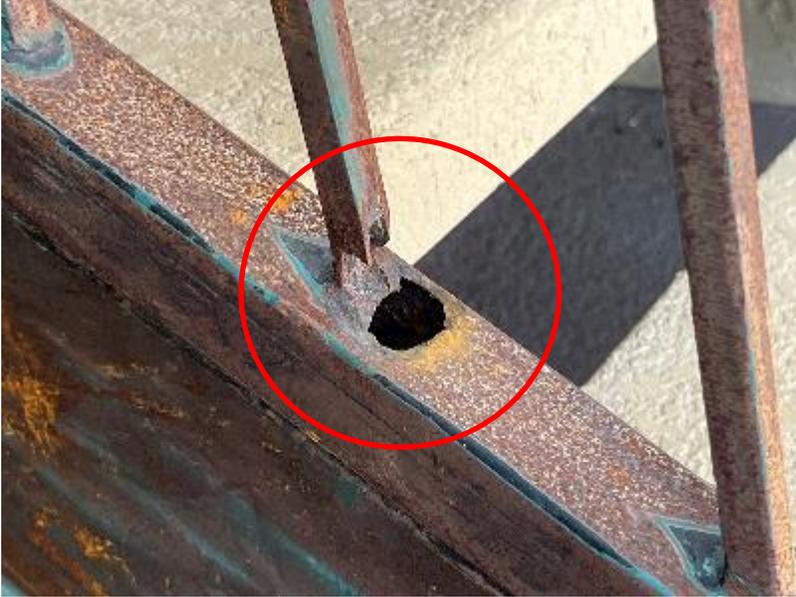
PHOTOGRAPH #13

**BUILDING 9
SECTION G**

Section loss and hole at stair picket railing.

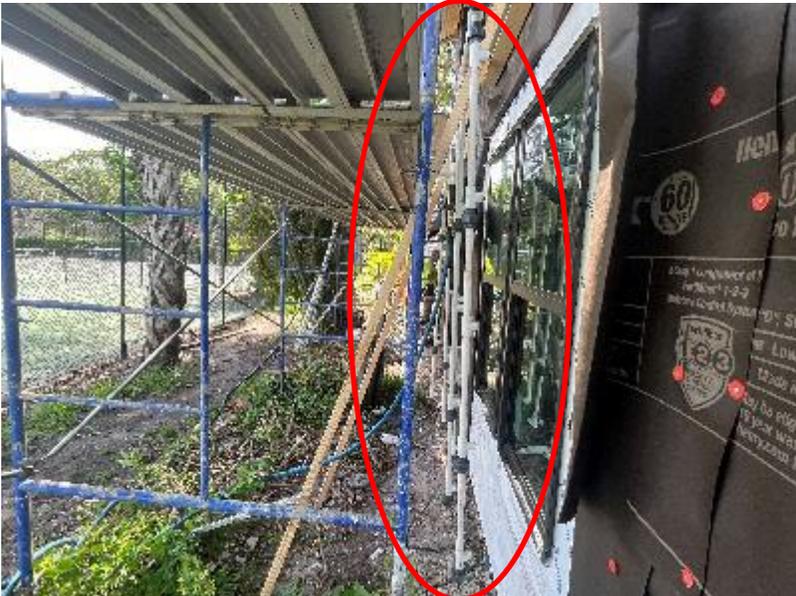
PHOTOGRAPH #14

**BUILDING 9
SECTION G**

Water testing of double panel window
conducted at unit #912.

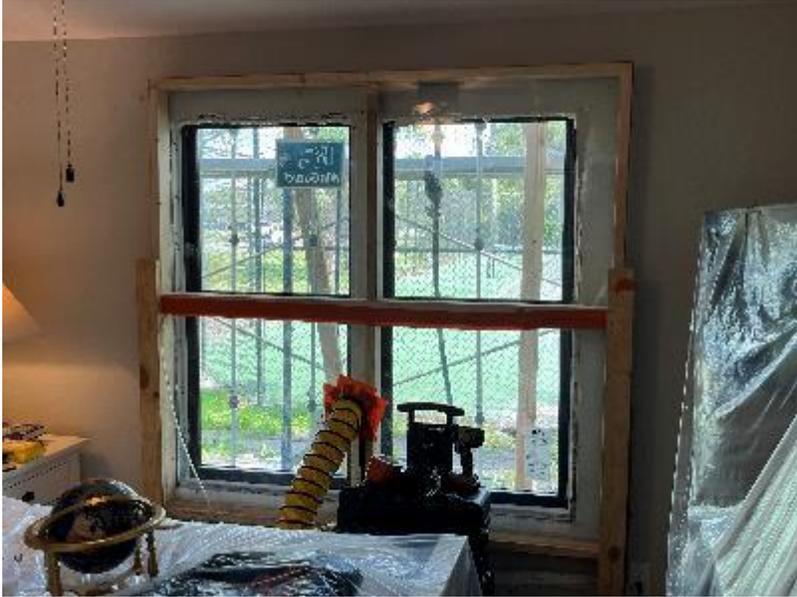
PHOTOGRAPH #15

**BUILDING 9
SECTION G**

Water testing of double panel window conducted at unit #912.

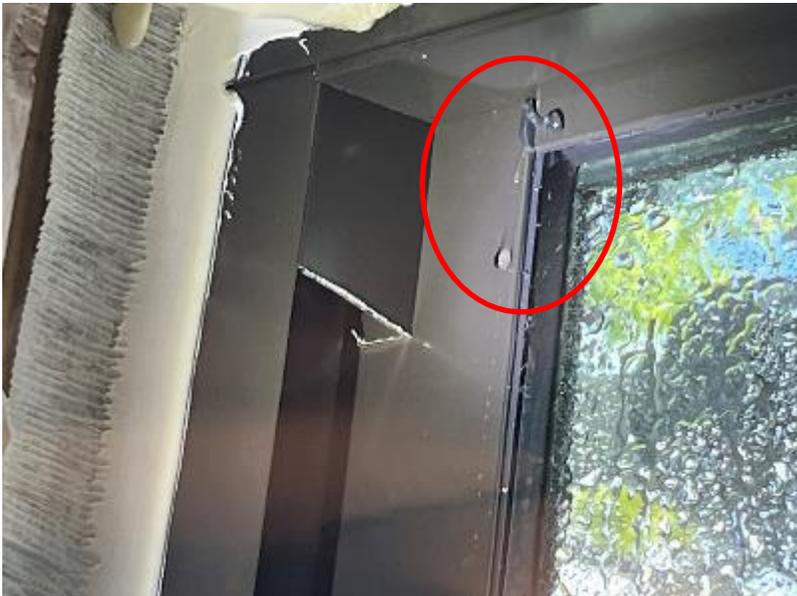
PHOTOGRAPH #16

**BUILDING 9
SECTION G**

Water testing of double panel window conducted at unit #912:

During the water testing, water droplets were observed at the upper left seam of window frame. Water test failed.

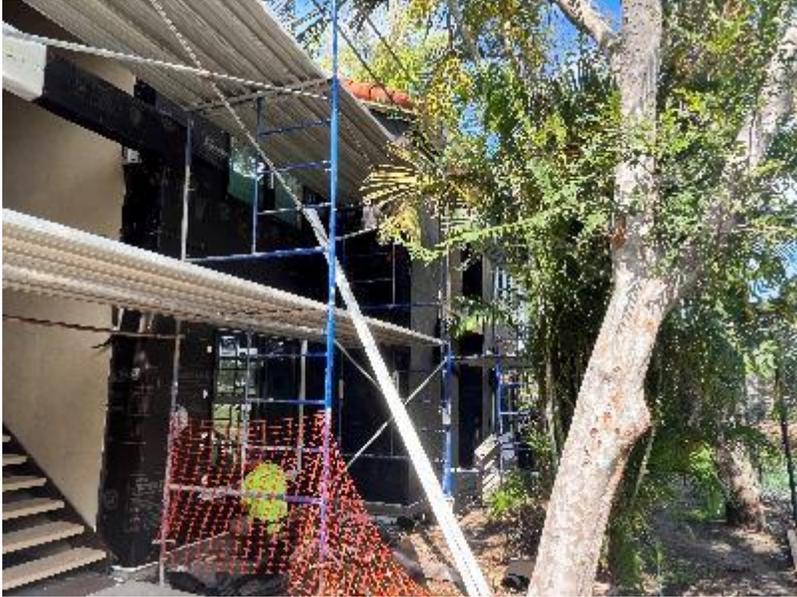
PHOTOGRAPH #17

**BUILDING 9
SECTION G**

Installation of Super Jumbo Tex Weather-Resistive Barrier and stucco accessories in progress.

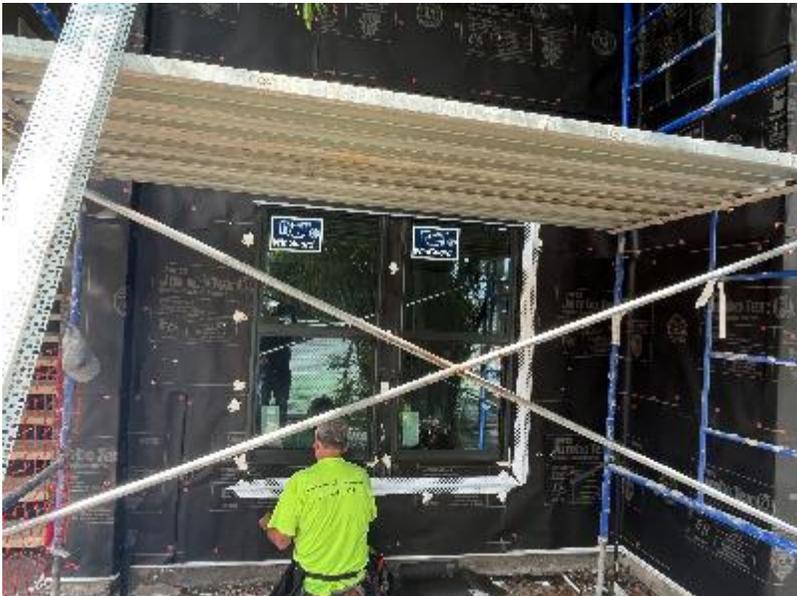
PHOTOGRAPH #18

**BUILDING 9
SECTION G**

Installation of Super Jumbo Tex Weather-Resistive Barrier and stucco accessories in progress.

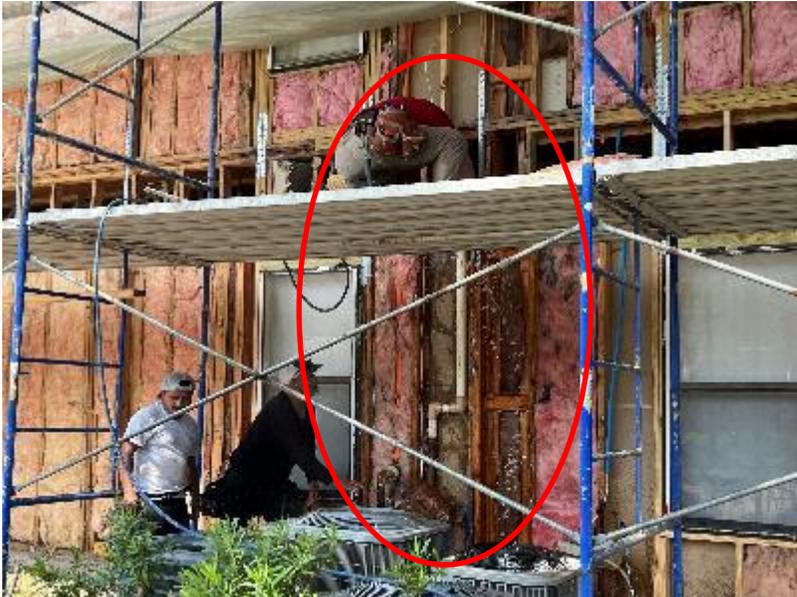
PHOTOGRAPH #19

**BUILDING 9
SECTION D**

While nailing the strapping the contractor accidentally hit the main water line.

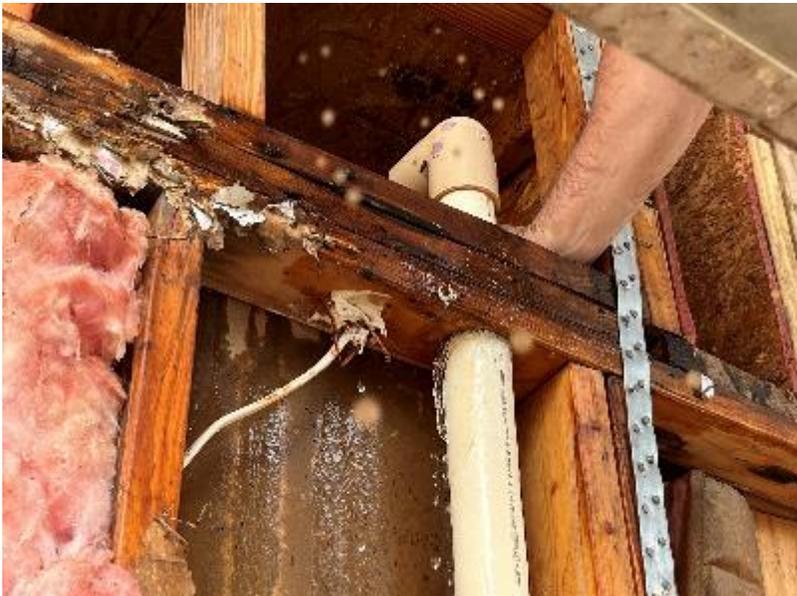
PHOTOGRAPH #20

**BUILDING 9
SECTION D**

While nailing the strapping the contractor accidentally hit water line.

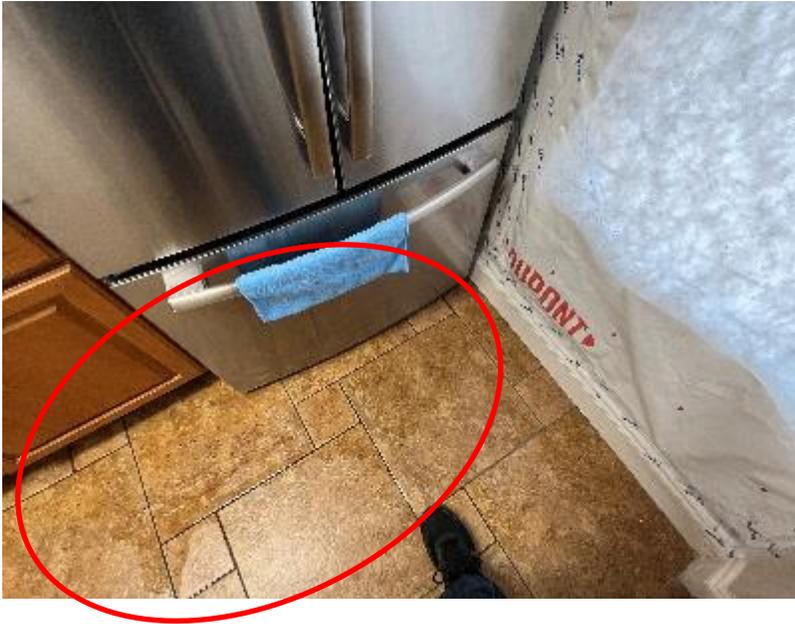
PHOTOGRAPH #21

**BUILDING 9
SECTION D – UNIT #917**

Water intrusion observed at unit #917.

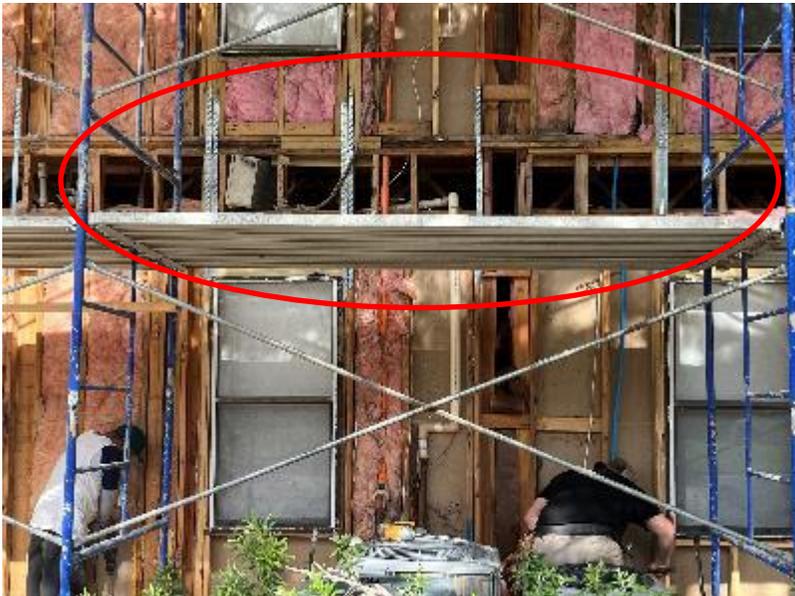
PHOTOGRAPH #22

**BUILDING 9
SECTION D**

Strapping, Simpson Strong connector applications and BoraCare Termite treatment performed in preparation for new sheathing:

Strapping nailing in progress.

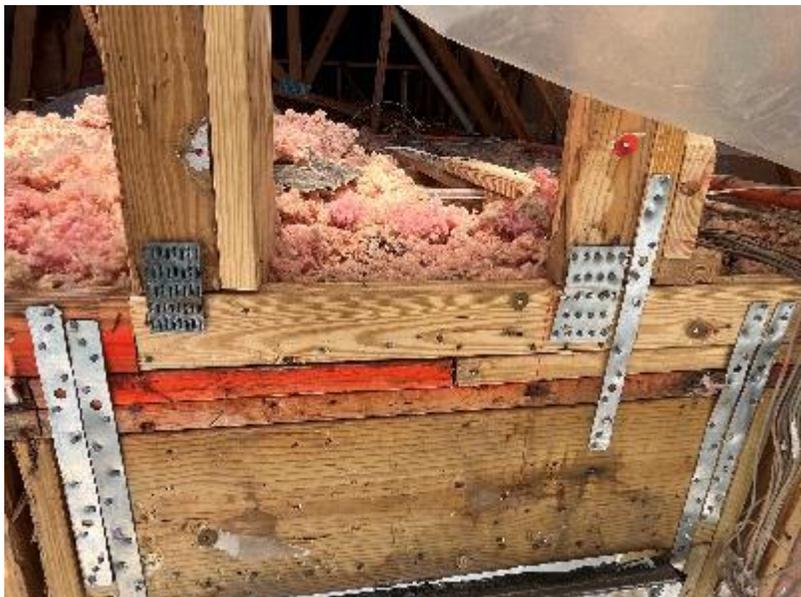
PHOTOGRAPH #23

**BUILDING 9
SECTION D**

Strapping, Simpson Strong connector applications and BoraCare Termite treatment performed in preparation for new sheathing:

Strapping nailing in progress.

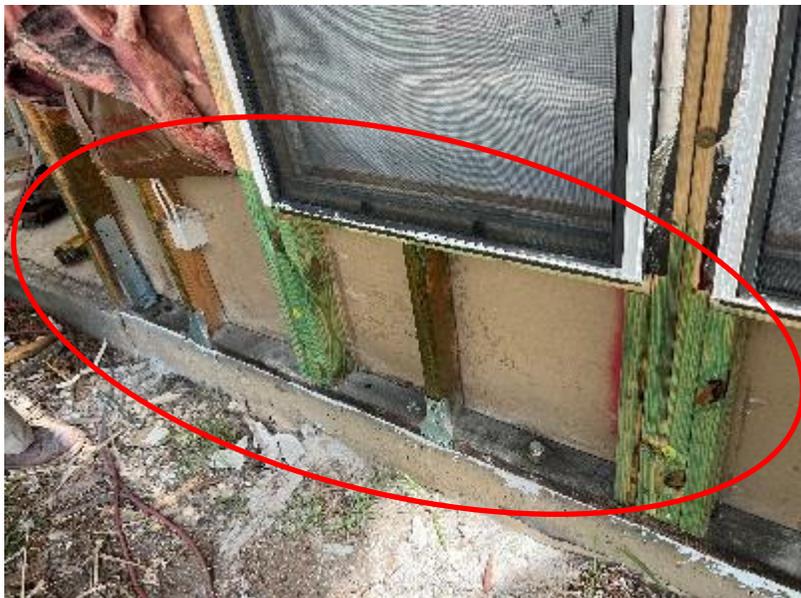
PHOTOGRAPH #24

**BUILDING 9
SECTION D**

Contractor has applied Copper Green wood preservative at lower two feet of wood framing as per specifications.

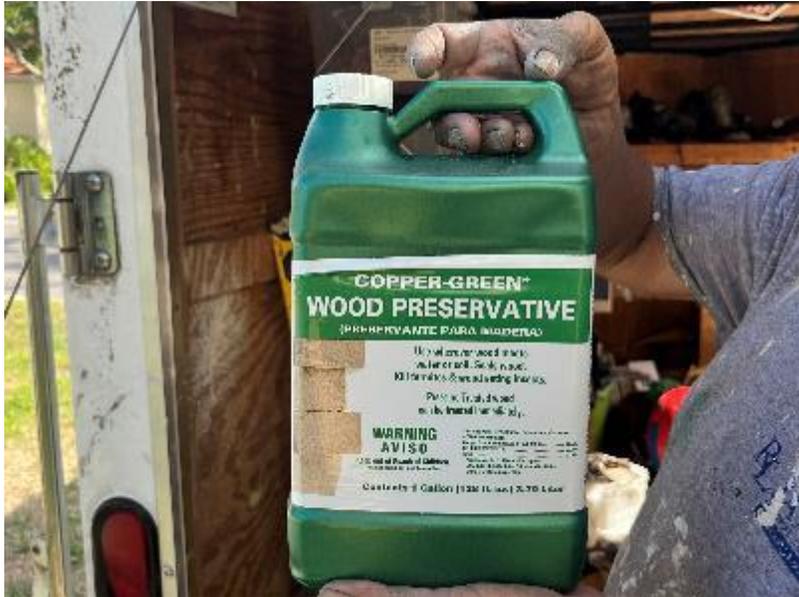
PHOTOGRAPH #25

**BUILDING 9
SECTION D**

Contractor has applied Copper Green wood preservative at lower two feet of wood framing as per specifications.

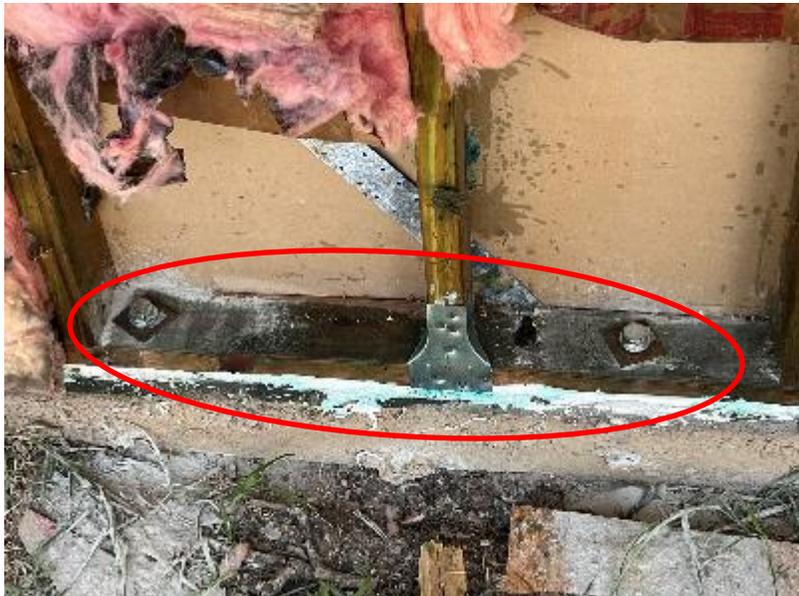
PHOTOGRAPH #26

**BUILDING 9
SECTION D**

Installation Simpson Strong connectors in progress.

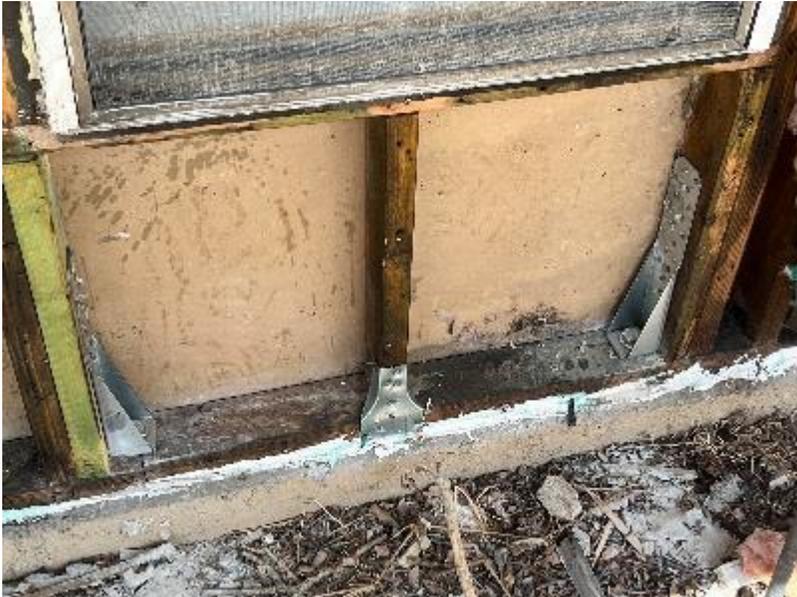
PHOTOGRAPH #27

**BUILDING 9
SECTION D**

Installation Simpson Strong connectors in progress.

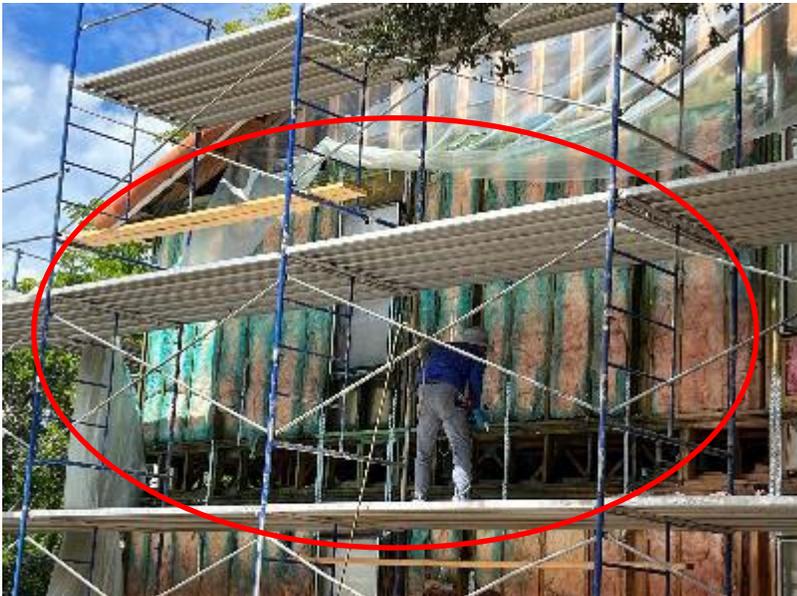
PHOTOGRAPH #28

**BUILDING 9
SECTION D**

Subcontractor applying BoraCare Termite treatment to framing.

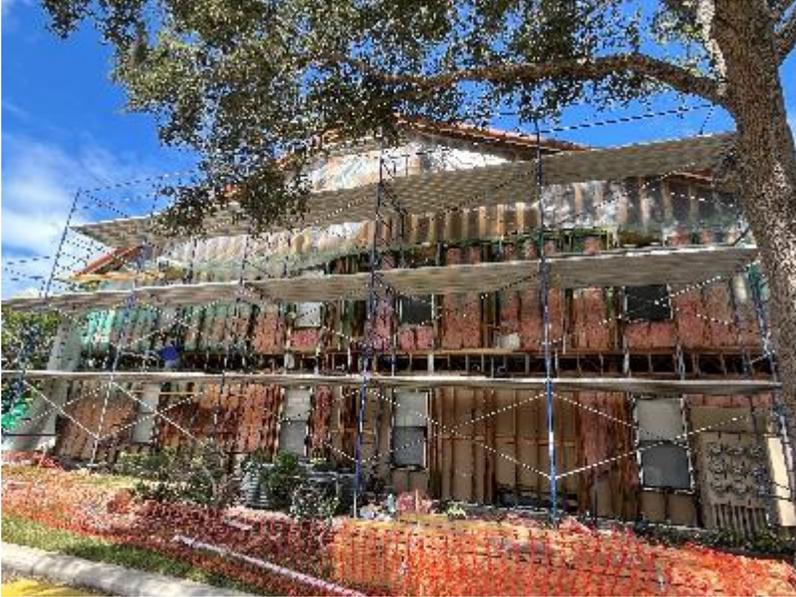
PHOTOGRAPH #29

**BUILDING 9
SECTION D**

Subcontractor applying BoraCare Termite treatment to framing.

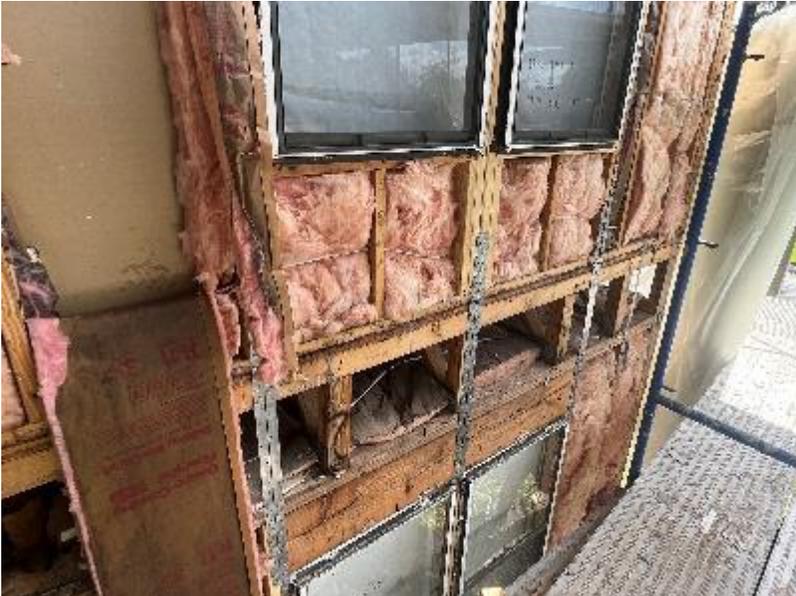
PHOTOGRAPH #30

**BUILDING 9
SECTION C**

Strapping, Simpson Strong connector applications and BoraCare Termite treatment performed in preparation for new sheathing:

Strapping nailing in progress.

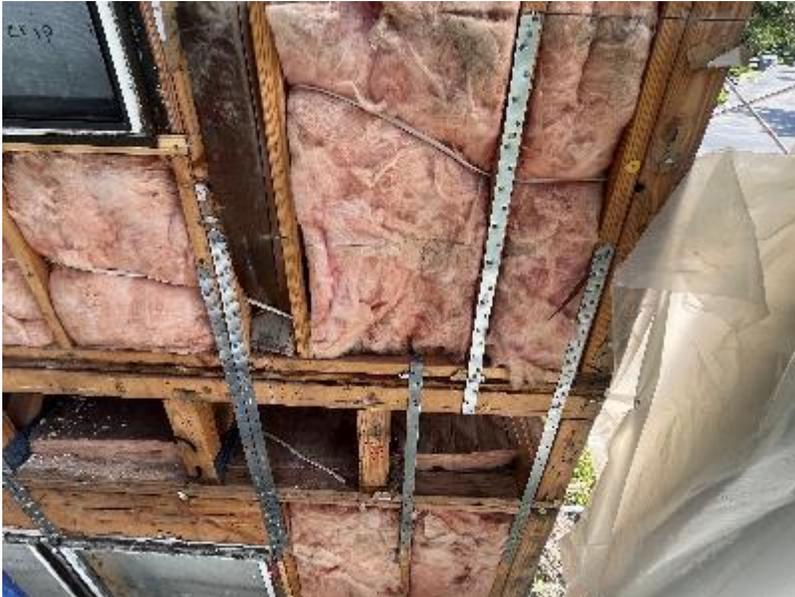
PHOTOGRAPH #31

**BUILDING 9
SECTION C**

Strapping, Simpson Strong connector applications and BoraCare Termite treatment performed in preparation for new sheathing:

Strapping nailing in progress.

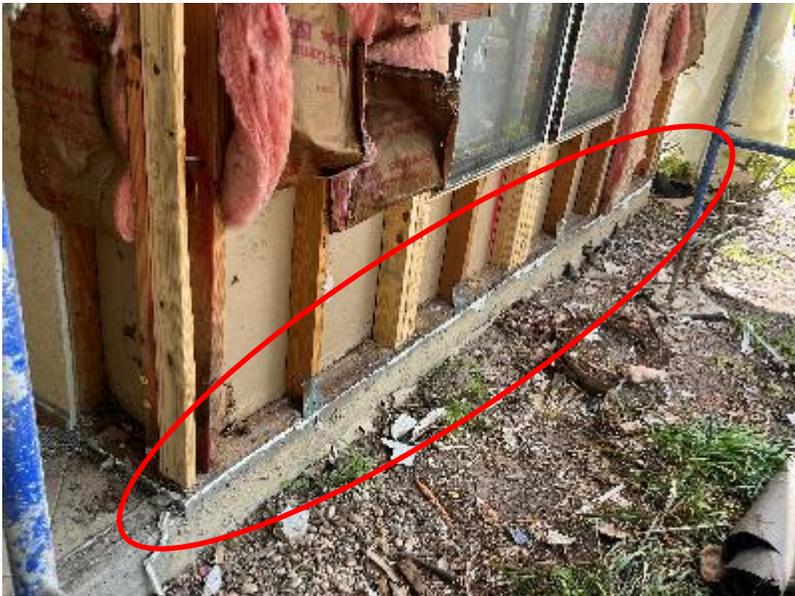
PHOTOGRAPH #32

**BUILDING 9
SECTION C**

Installation Simpson Strong connectors in progress.

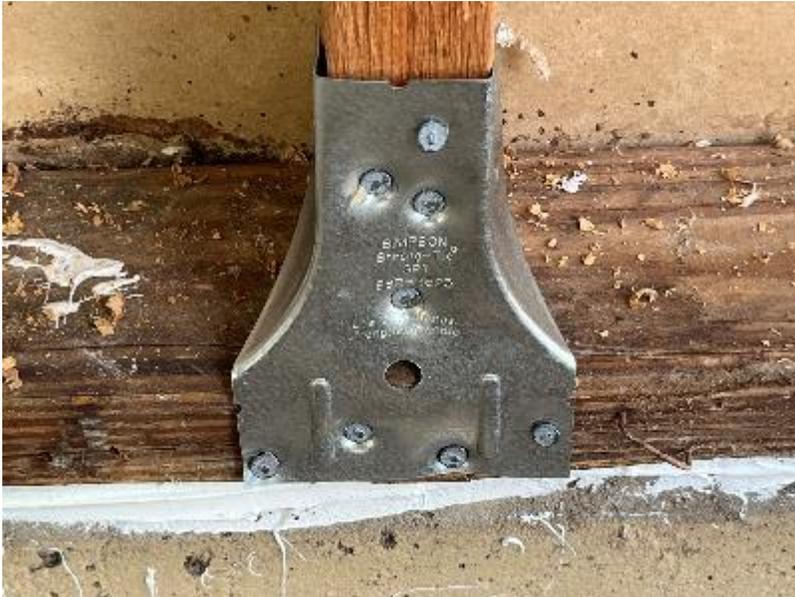
PHOTOGRAPH #33

**BUILDING 9
SECTION C**

Installation Simpson Strong connectors in progress.
Contractor installing Simpson Strong-Tie SP1 at stud frames.

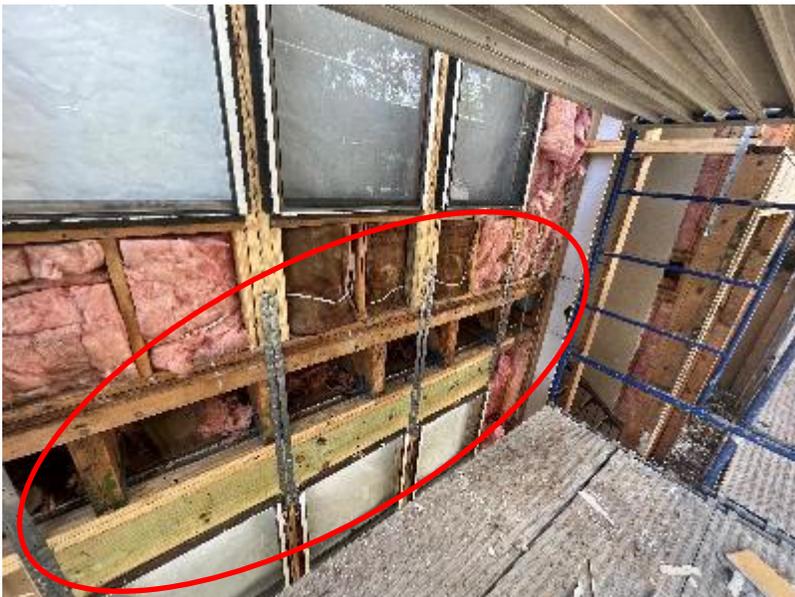
PHOTOGRAPH #34

**BUILDING 9
SECTION B**

Nailing of strapping in progress.

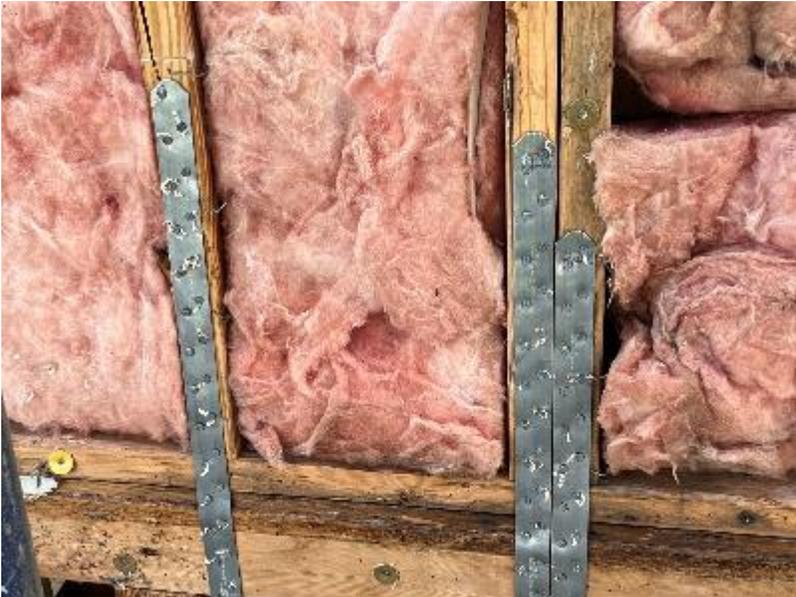
PHOTOGRAPH #35

**BUILDING 9
SECTION B**

Nailing of strapping in progress.

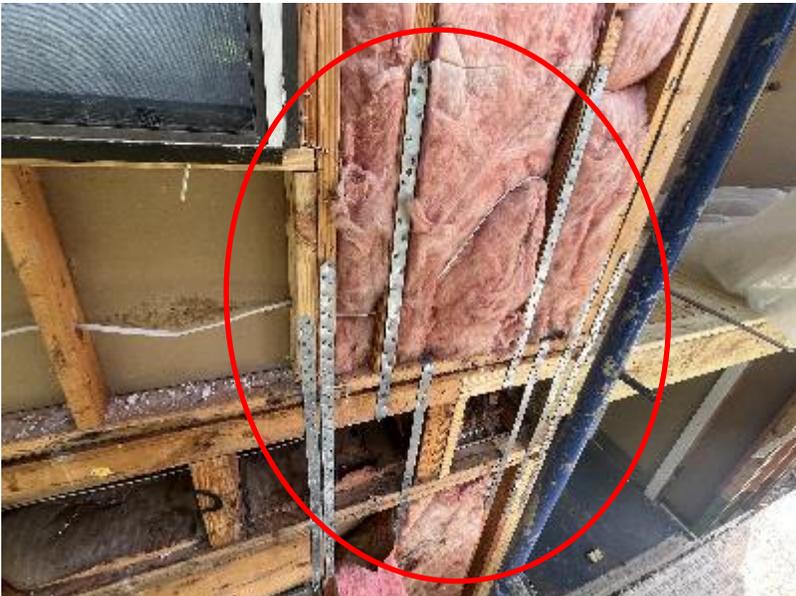
PHOTOGRAPH #36

**BUILDING 9
SECTION A**

Nailing of strapping in progress.

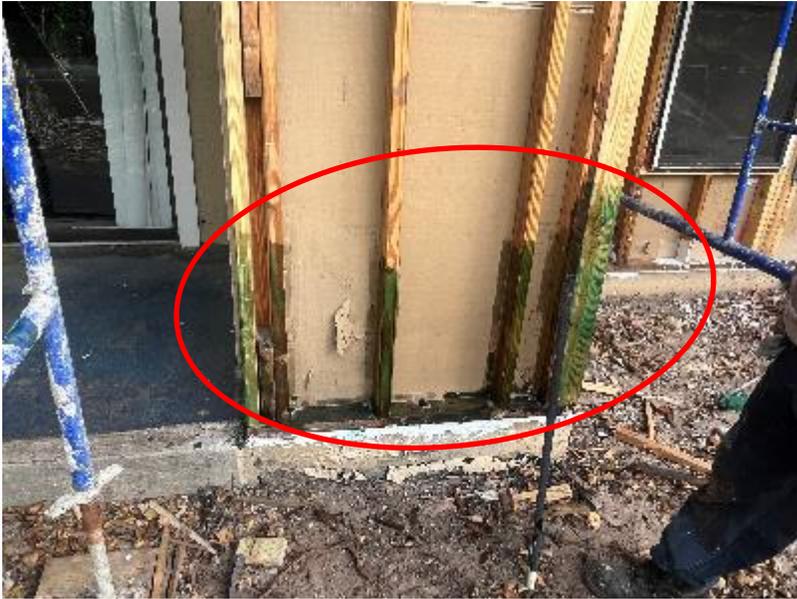
PHOTOGRAPH #37

**BUILDING 9
SECTION A**

Contractor has applied Copper Green wood preservative at lower two feet wood framing per specifications.
