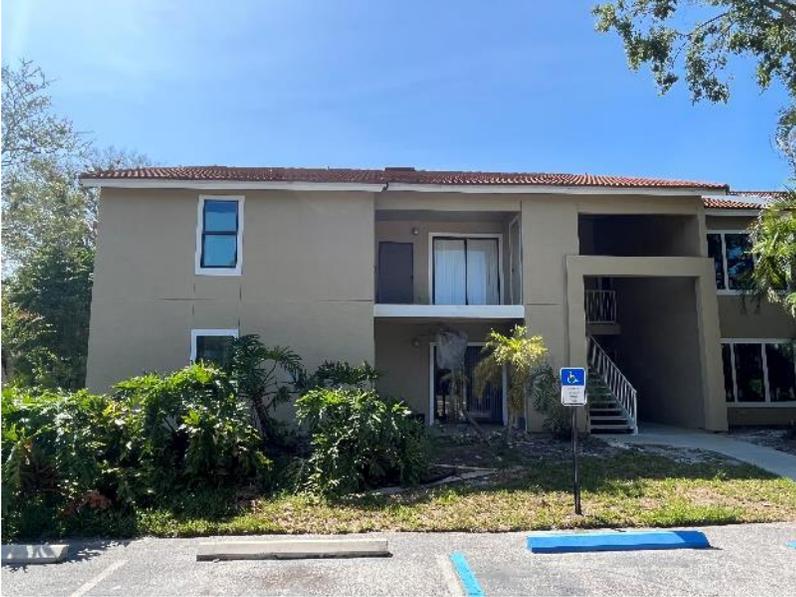
PHOTOGRAPH #1

Painting completed.

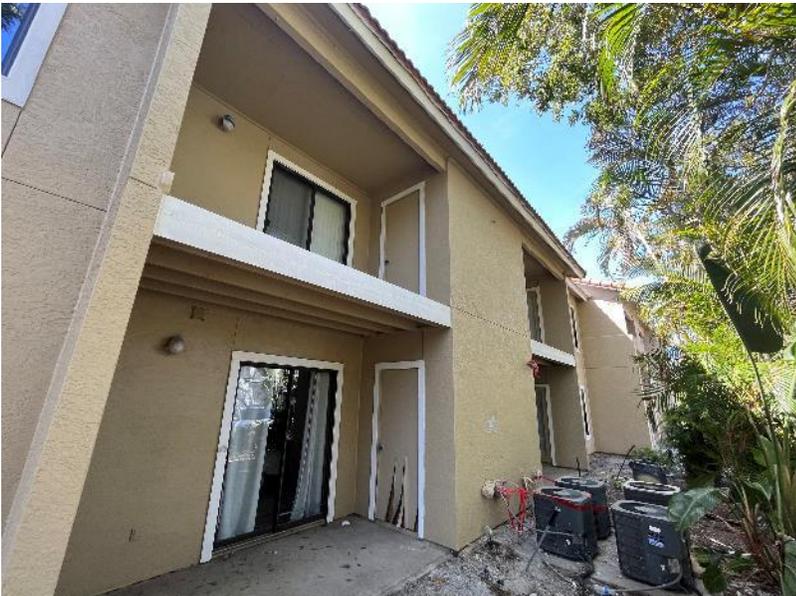
PHOTOGRAPH #2

Painting completed.

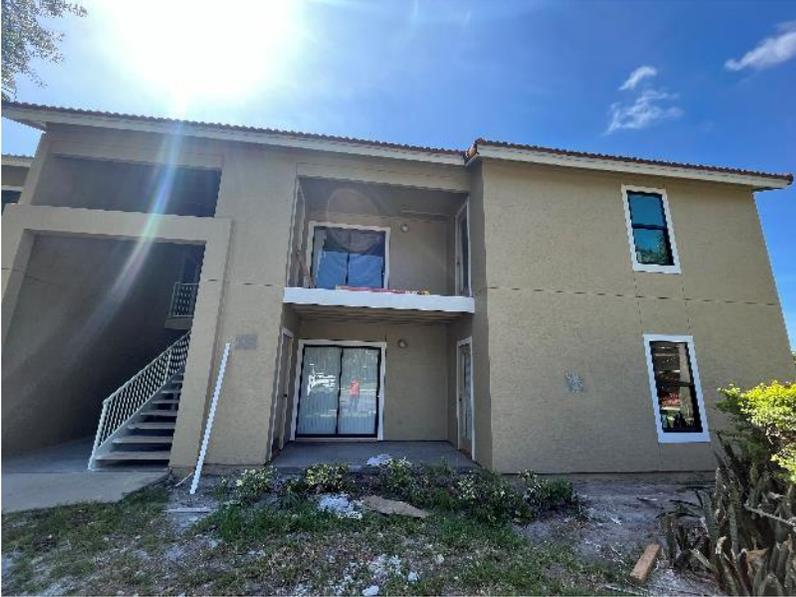
PHOTOGRAPH #3

Painting completed.

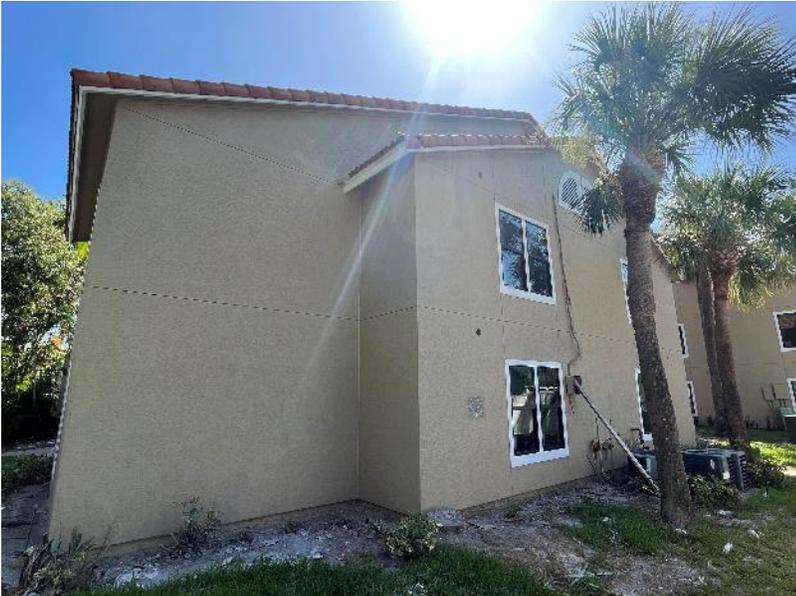
PHOTOGRAPH #4

Painting completed.

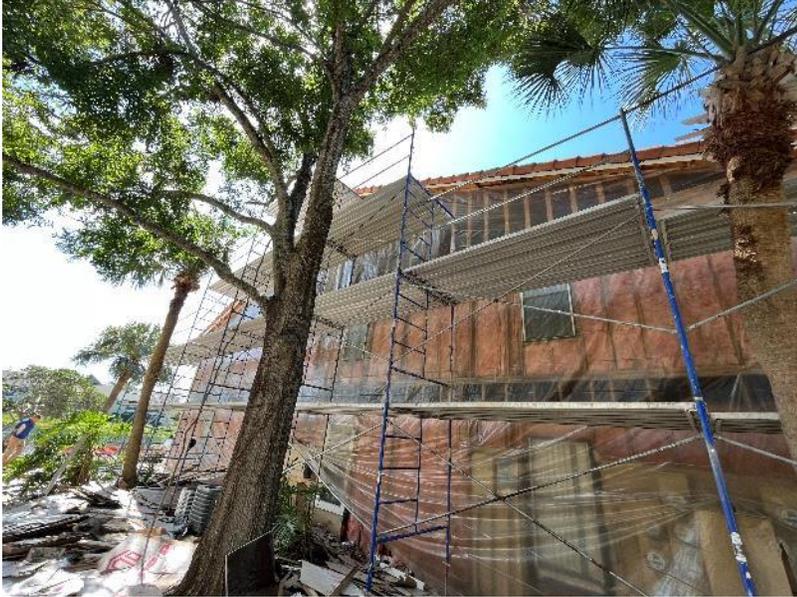
PHOTOGRAPH #5

Demolition of existing stucco and sheathing in progress.

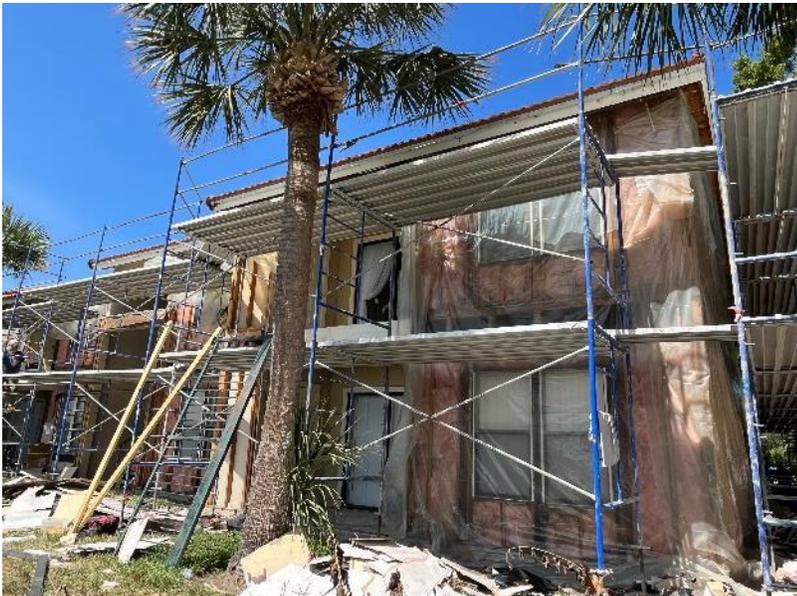
PHOTOGRAPH #6

Demolition of existing stucco and sheathing in progress.

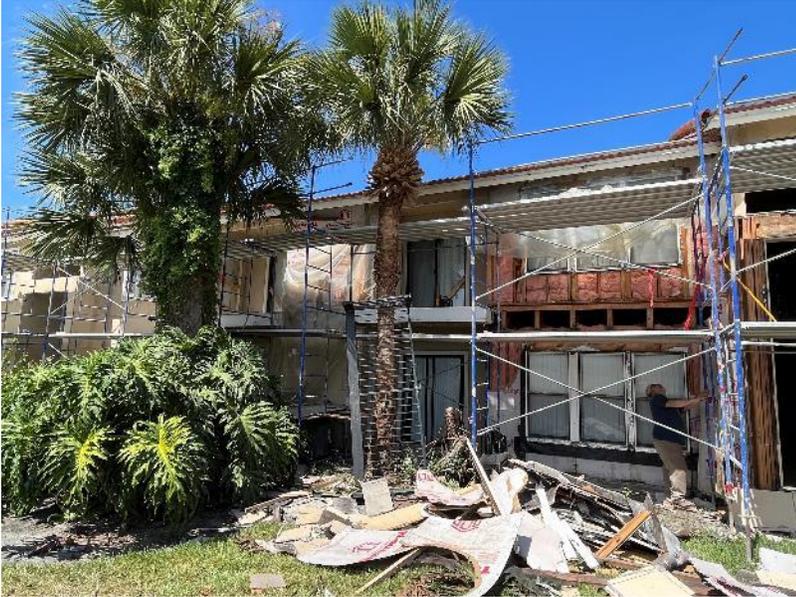
PHOTOGRAPH #7

Demolition of existing stucco and sheathing in progress.

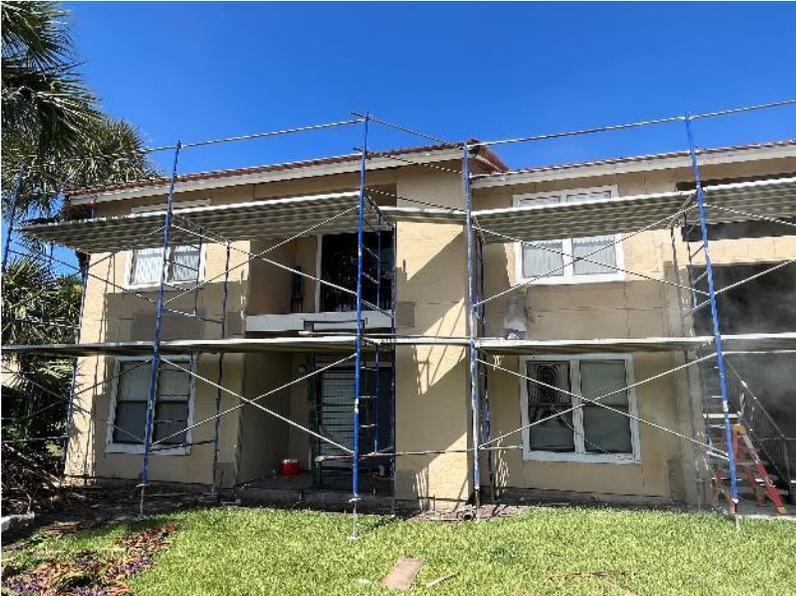
PHOTOGRAPH #8

Demolition of existing stucco and sheathing in progress.

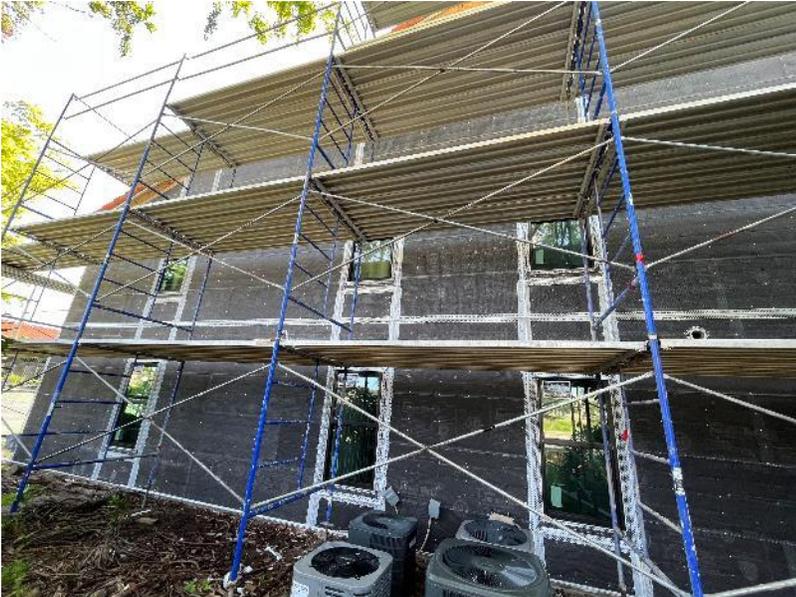
PHOTOGRAPH #9

Installation of stucco lath and accessories completed.

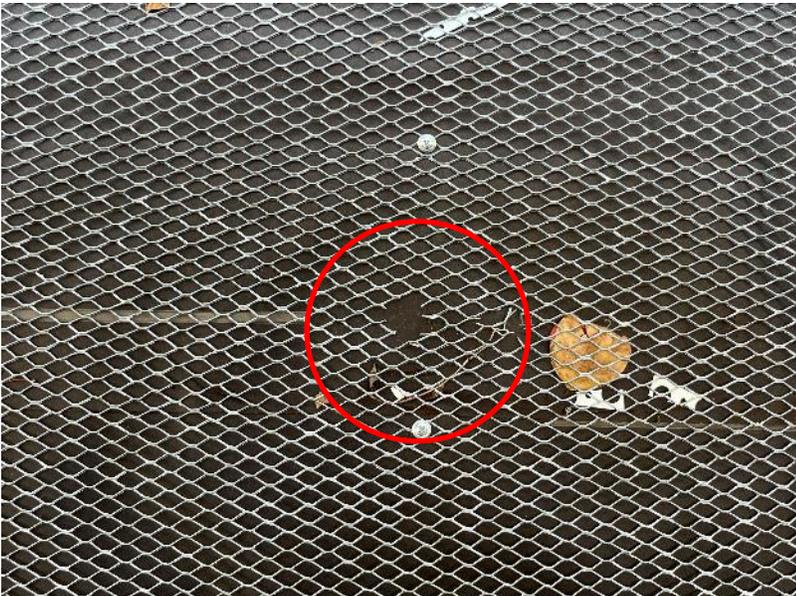
PHOTOGRAPH #10

Hole found in stucco lath and vapor barrier.

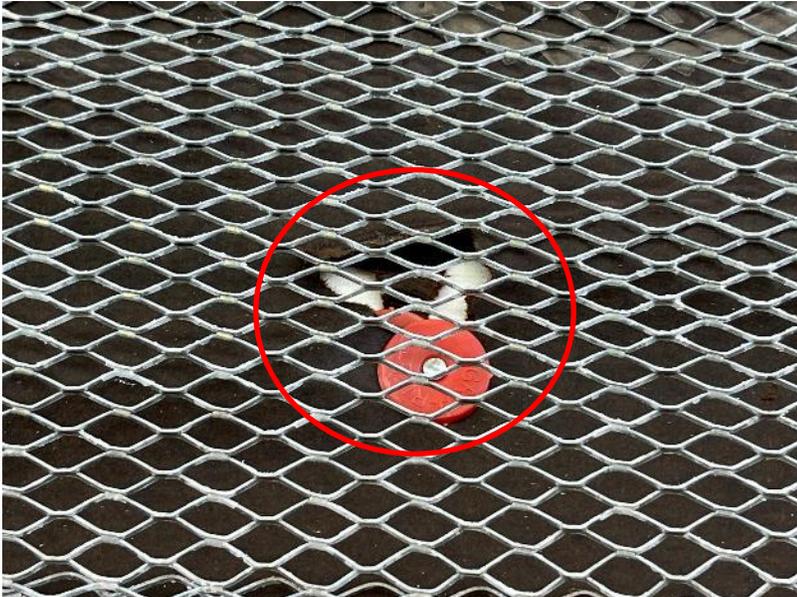
PHOTOGRAPH #11

Hole found in stucco lath and vapor barrier.

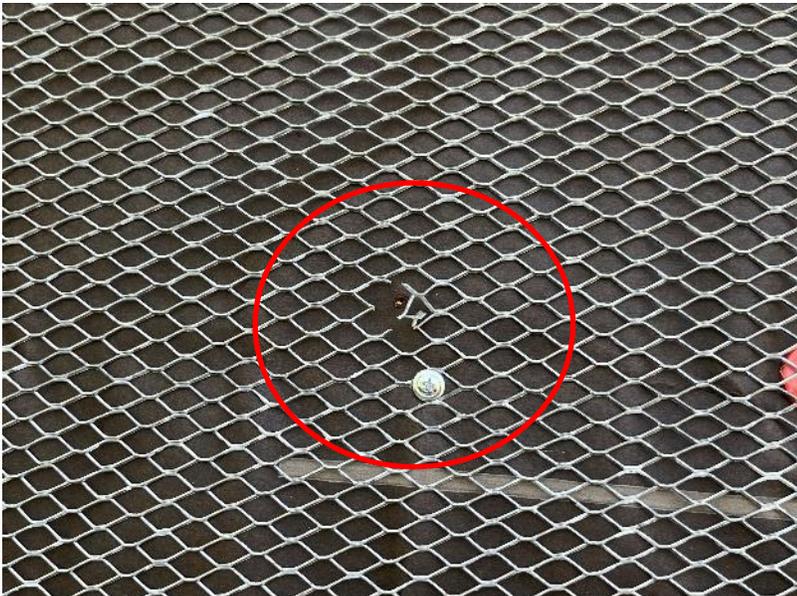
PHOTOGRAPH #12

Hole found in stucco lath and vapor barrier.

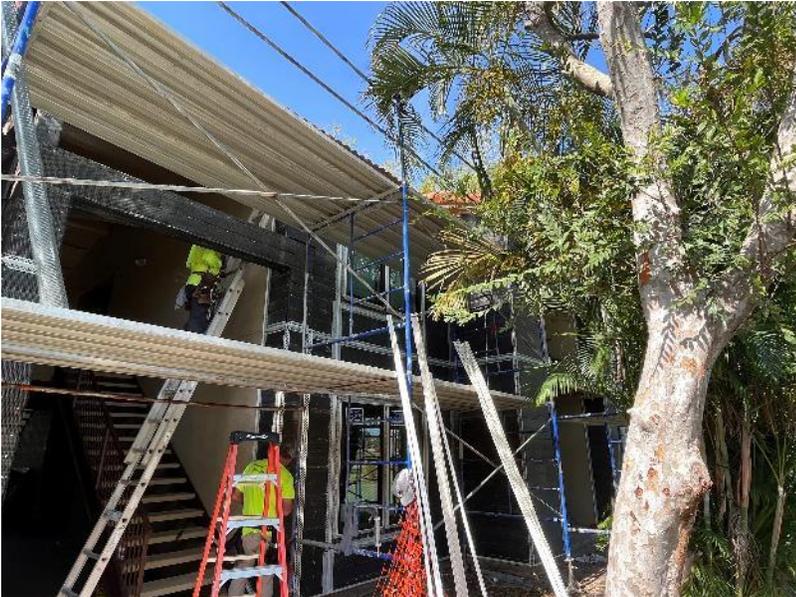
PHOTOGRAPH #13

Installation of stucco lath and accessories in progress.

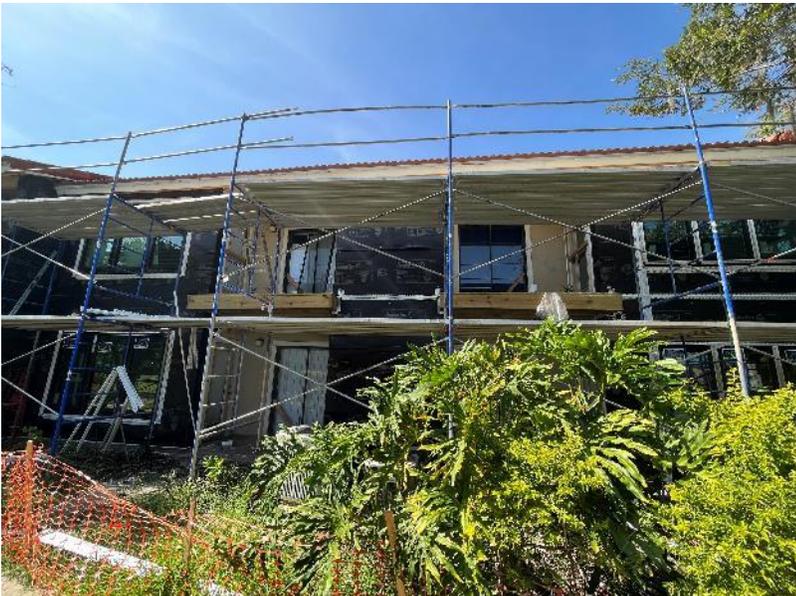
PHOTOGRAPH #14

Installation of Super Jumbo Tex Weather-Resistive Barrier and stucco accessories completed.

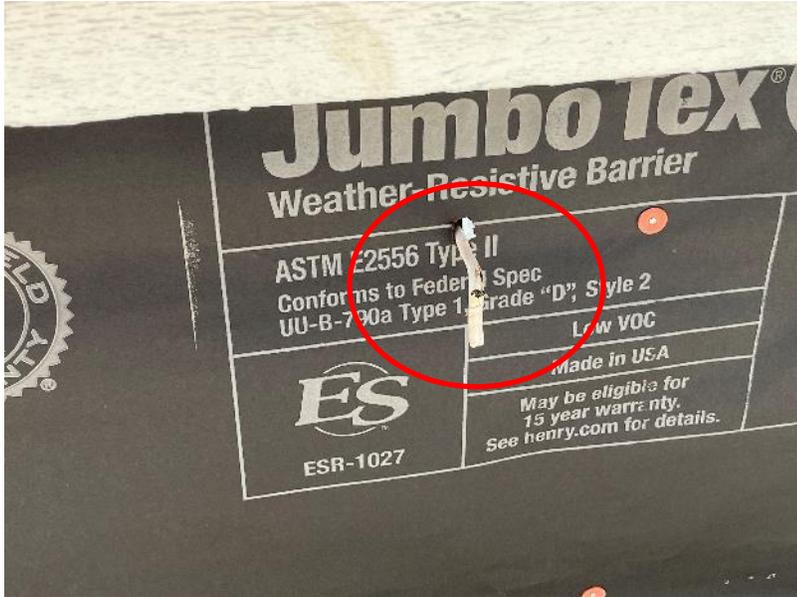
PHOTOGRAPH #15

Penetration found in weather barrier.

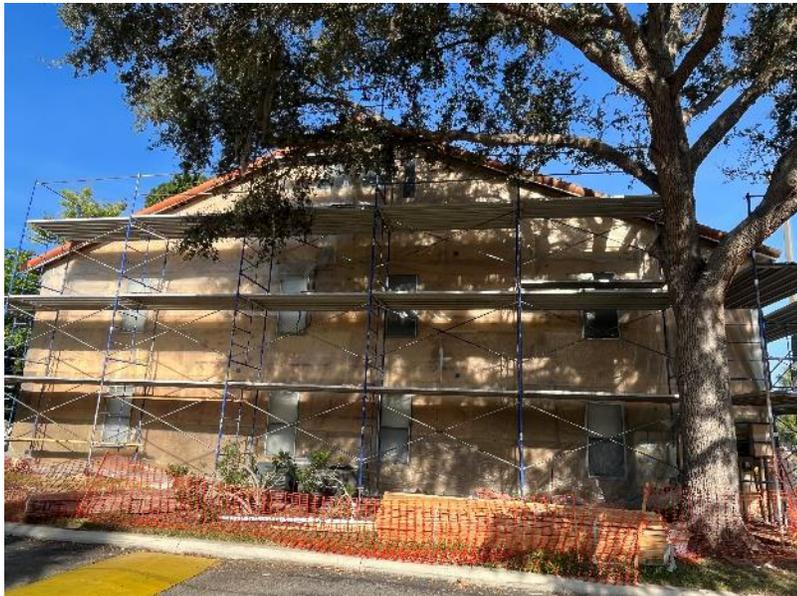
PHOTOGRAPH #16

Contractor installing 15/32 exterior rated plywood sheathing fastened with 0.113" x 2-3/8" electro galvanized ring shank nails at 4" O.C. along panel edges 6" O.C. in field.

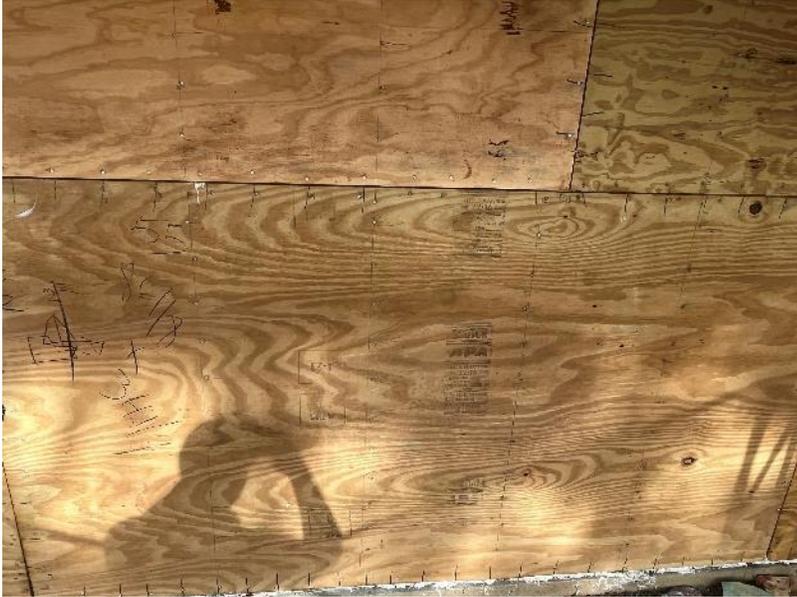
PHOTOGRAPH #17

Contractor installing 15/32 exterior rated plywood sheathing fastened with 0.113" x 2-3/8" electro galvanized ring shank nails at 4" O.C. along panel edges 6" O.C. in field.

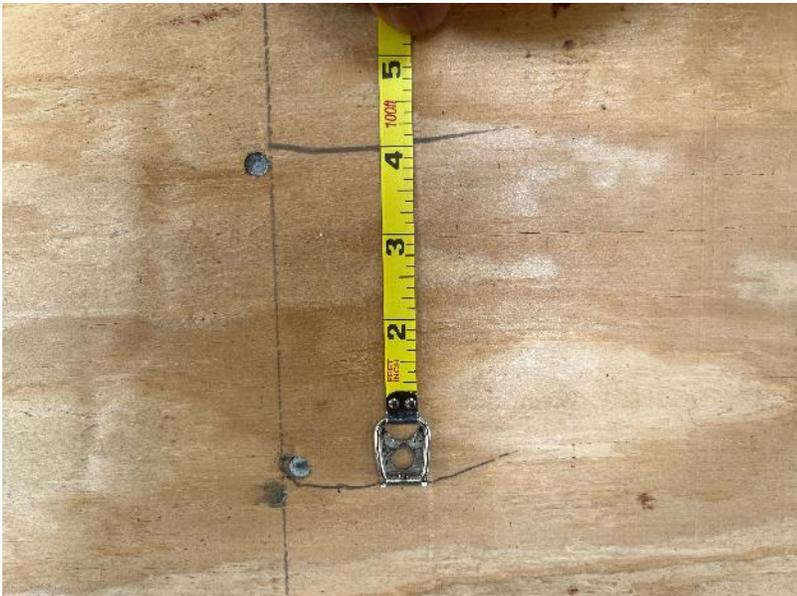
PHOTOGRAPH #18

Contractor installing 15/32 exterior rated plywood sheathing fastened with 0.113" x 2-3/8" electro galvanized ring shank nails at 4" O.C. along panel edges 6" O.C. in field.

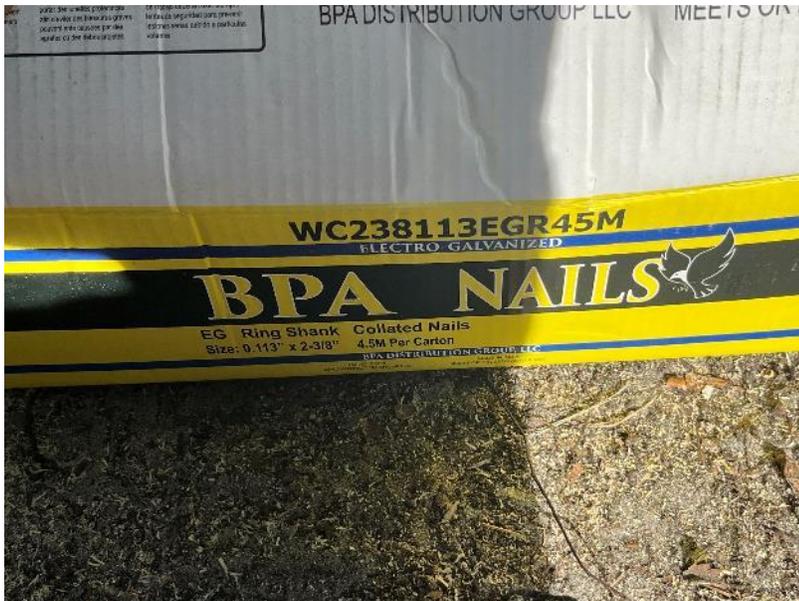
PHOTOGRAPH #19

Plywood sheathing fastened with 0.113" x 2-3/8" electro galvanized ring shank nails.

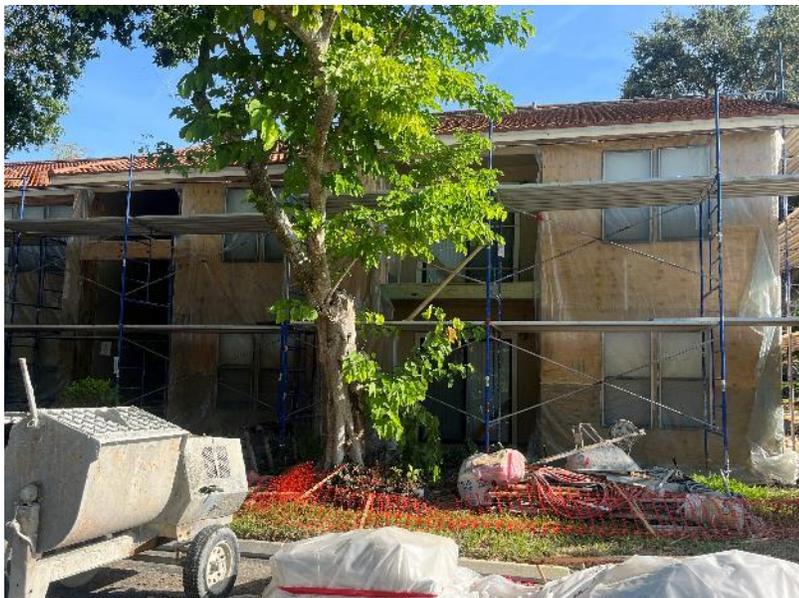
PHOTOGRAPH #20

Contractor installing 15/32 exterior rated plywood sheathing fastened with 0.113" x 2-3/8" electro galvanized ring shank nails at 4" O.C. along panel edges 6" O.C. in field.

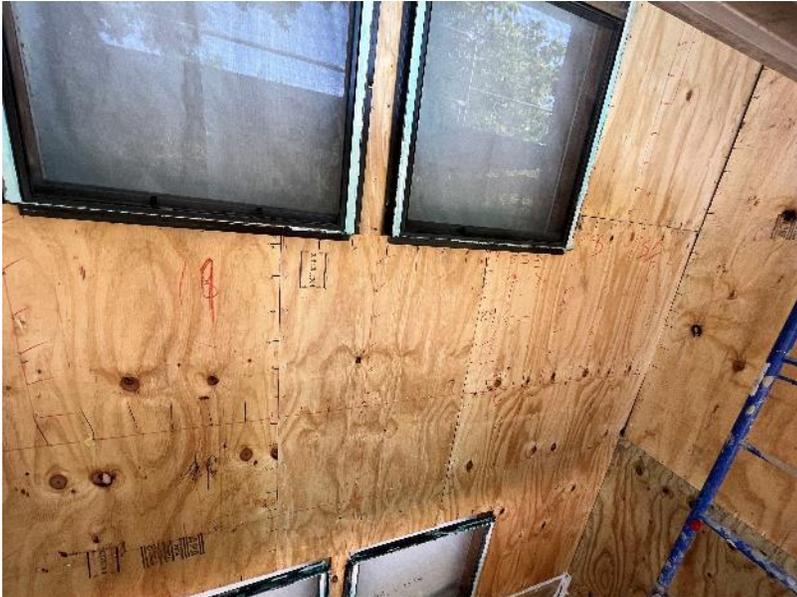
PHOTOGRAPH #21

Contractor installing 15/32 exterior rated plywood sheathing fastened with 0.113" x 2-3/8" electro galvanized ring shank nails at 4" O.C. along panel edges 6" O.C. in field.

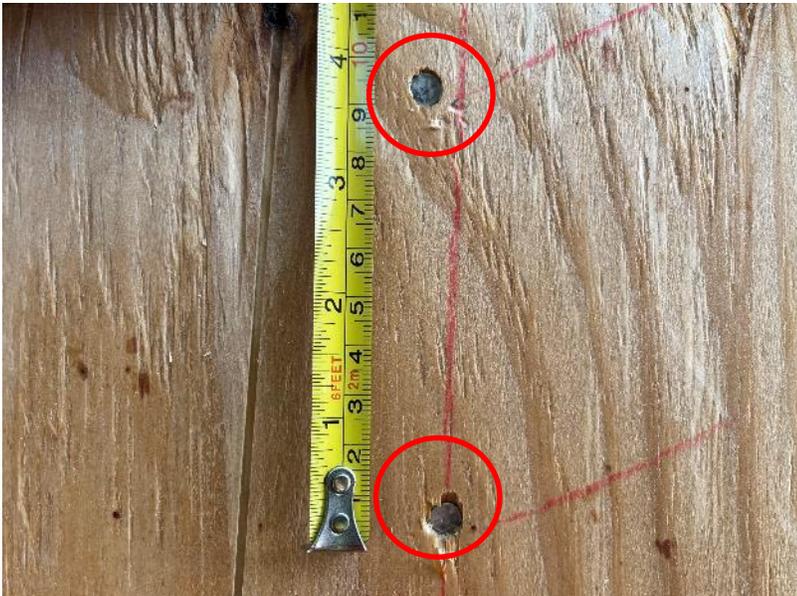
PHOTOGRAPH #22

Overdriven nails were observed. Contractor to ensure nails are flushed with sheathing.

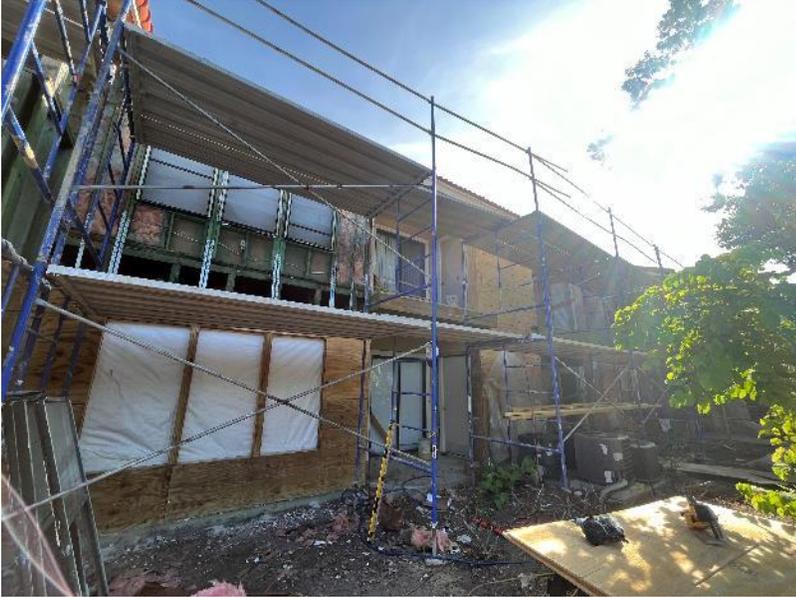
PHOTOGRAPH #23

Nailing of strapping completed and installation of plywood sheathing in progress.

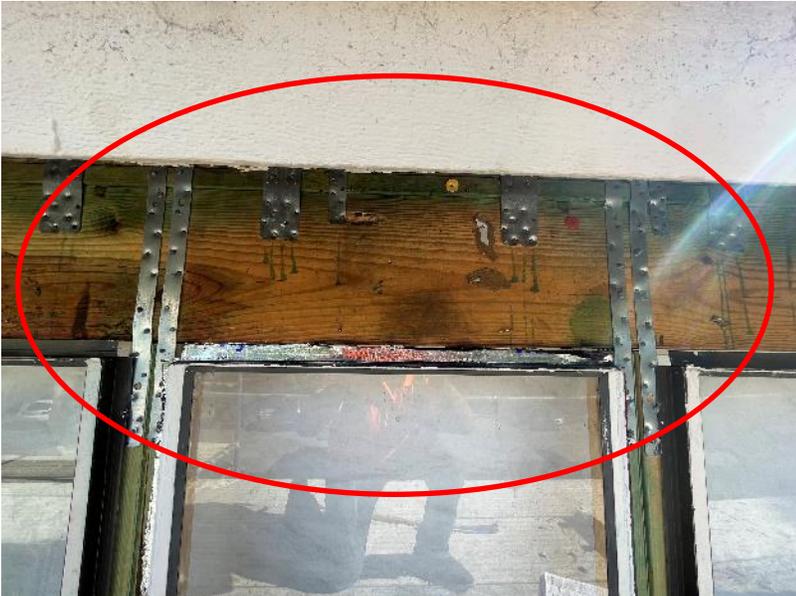
PHOTOGRAPH #24

Nailing of strapping completed.

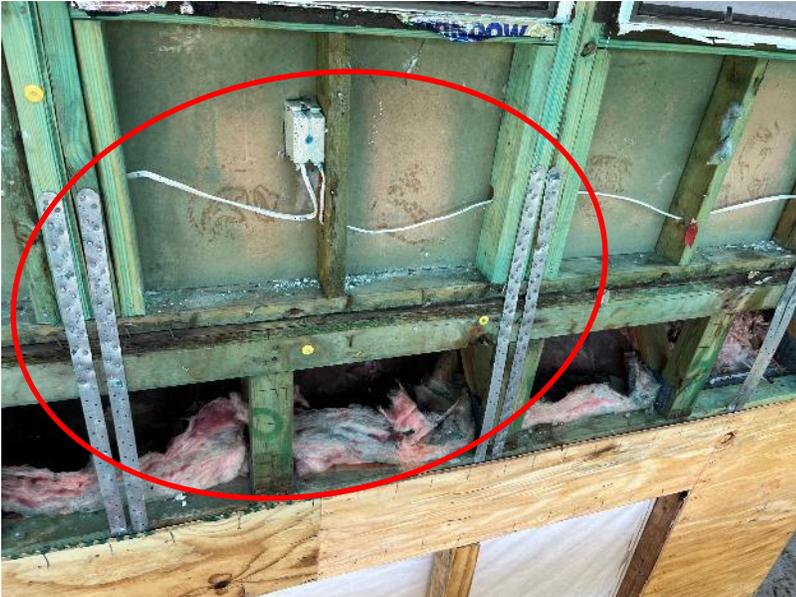
PHOTOGRAPH #25

Nailing of strapping completed.

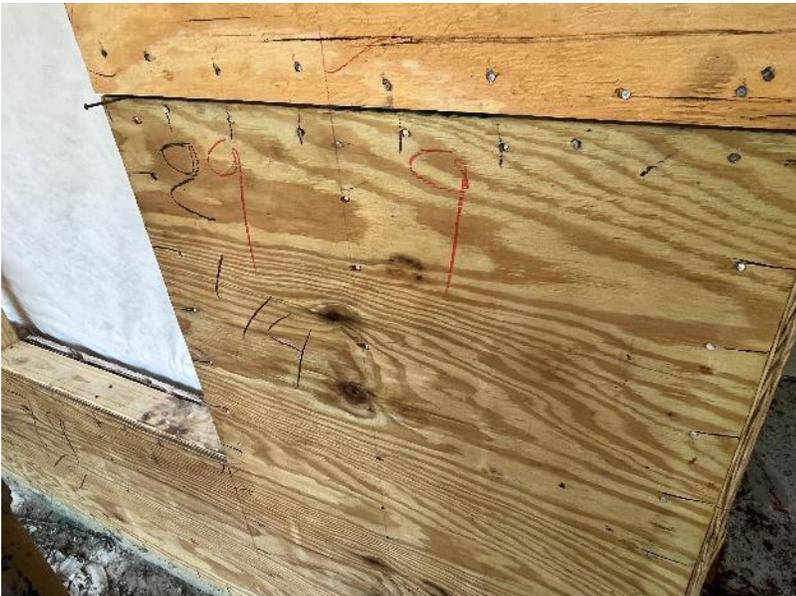
PHOTOGRAPH #26

Contractor installing 15/32 exterior rated plywood sheathing fastened with 0.113" x 2-3/8" electro galvanized ring shank nails at 4" O.C. along panel edges 6" O.C. in field.
