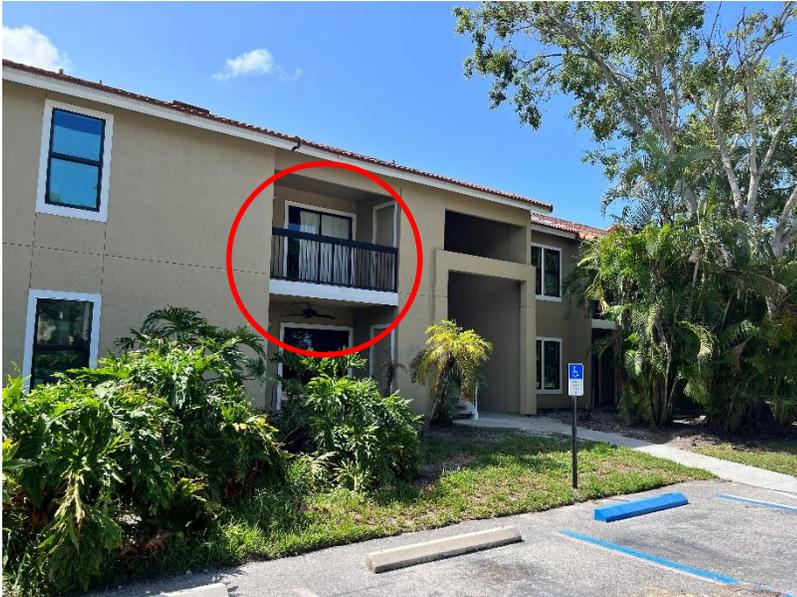
PHOTOGRAPH #1

**BUILDING 12
SECTION A**

Balcony railings installed.

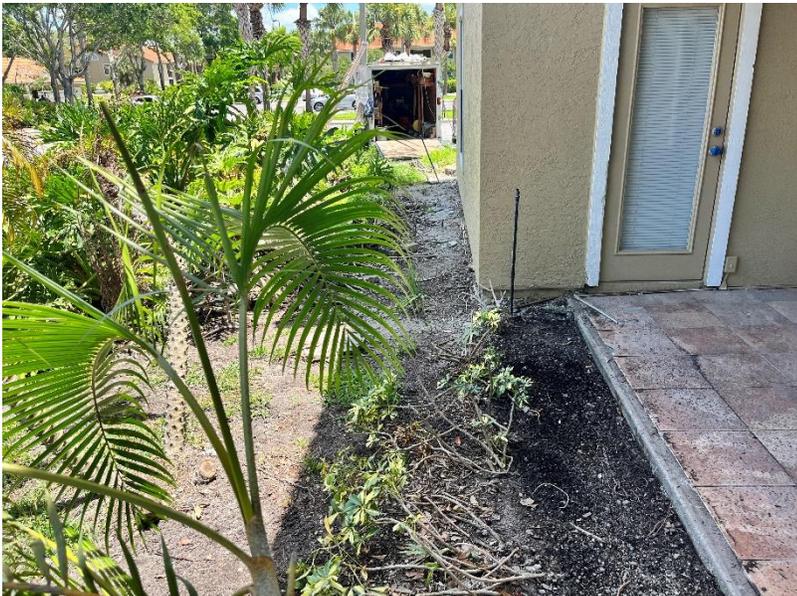
PHOTOGRAPH #2

**BUILDING 12
SECTION A**

Clean up of grounds has been performed.

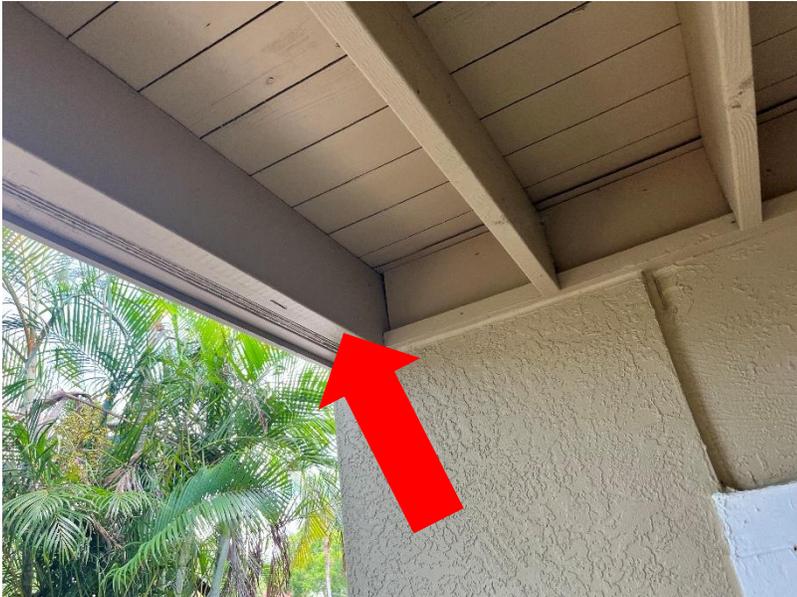
PHOTOGRAPH #3

**BUILDING 12
SECTION A**

Simpson Strong Tie Screws and connector hardware has not yet been installed at the built-up beam.

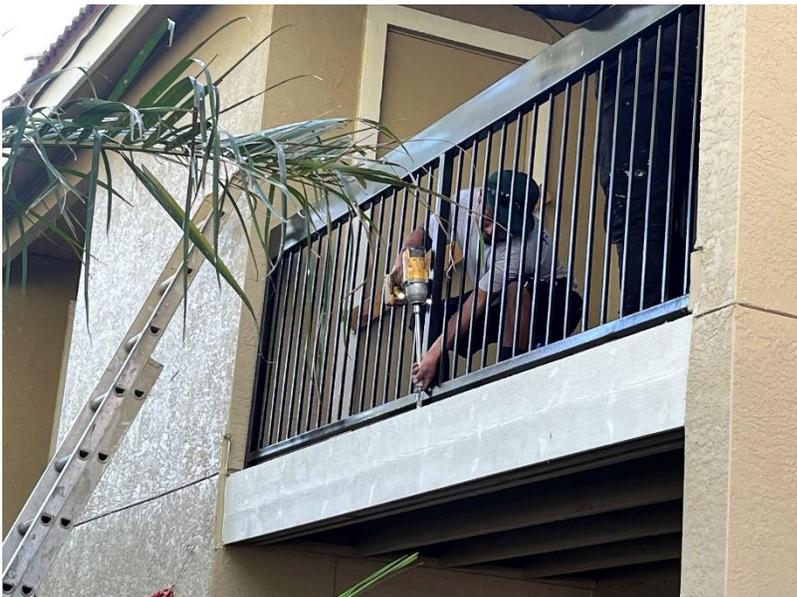
PHOTOGRAPH #4

**BUILDING 12
SECTION B**

Balcony railing being installed with 4" galvanized fasteners as per drawings.

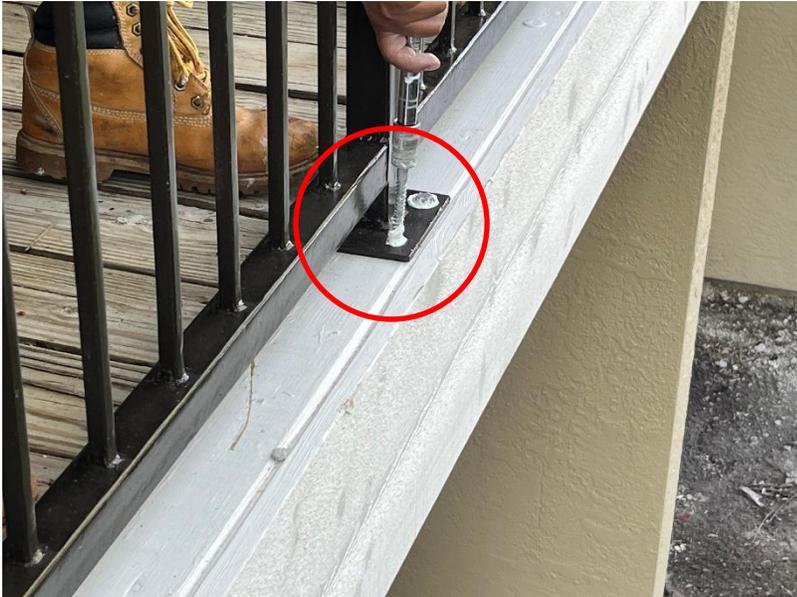
PHOTOGRAPH #5

**BUILDING 12
SECTION B**

Balcony railing being installed with 4" galvanized fasteners as per drawings

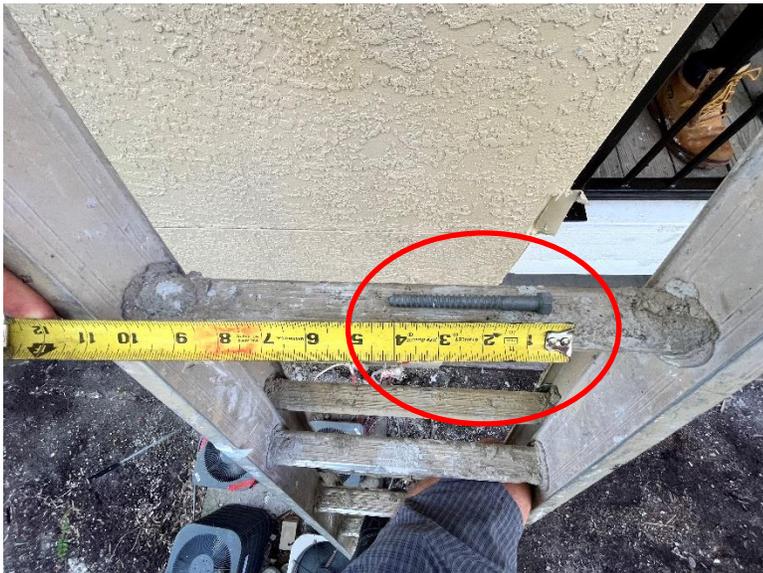
PHOTOGRAPH #6

**BUILDING 12
SECTION B**

Balcony railing being installed with 4" galvanized fasteners as per drawings.

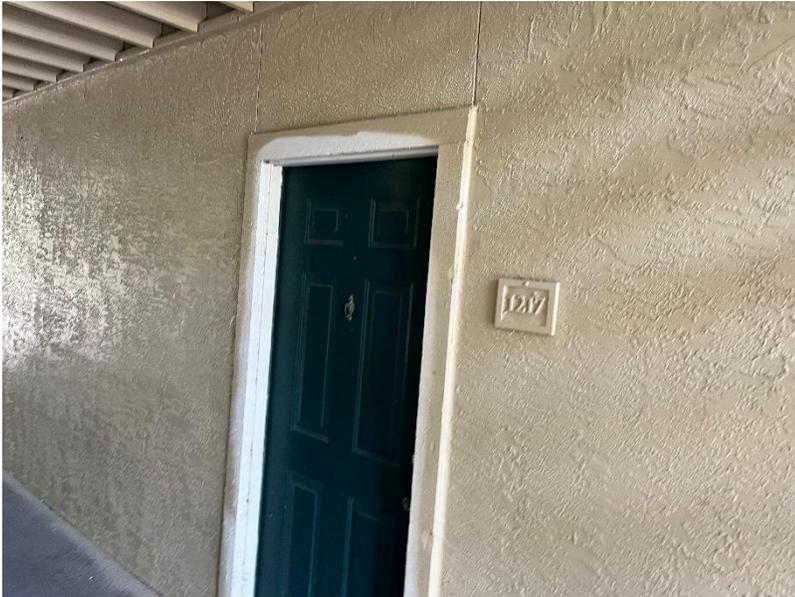
PHOTOGRAPH #7

**BUILDING 12
SECTION C**

Walkway stucco walls have been painted.
Front doors have not been painted.

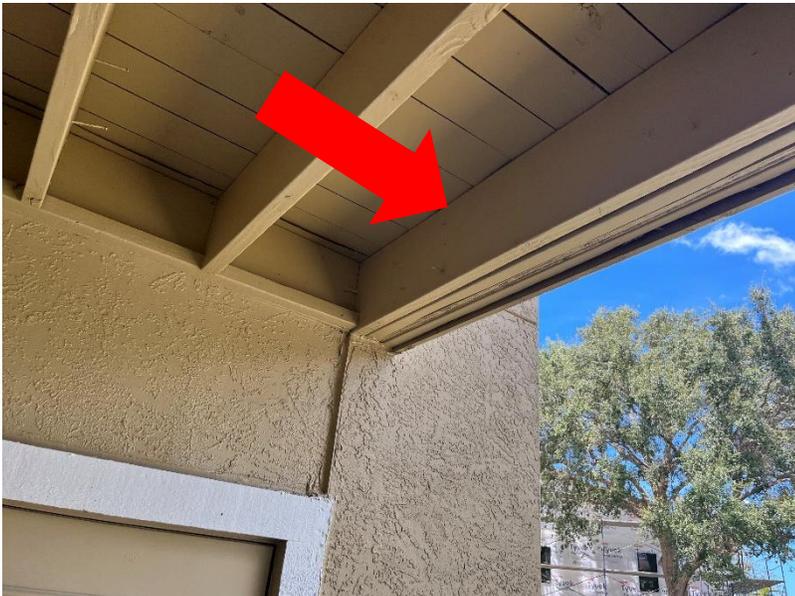
PHOTOGRAPH #8

**BUILDING 12
SECTION C**

Simpson Strong Tie Screws and
connector hardware has not yet been
installed at the built-up beam

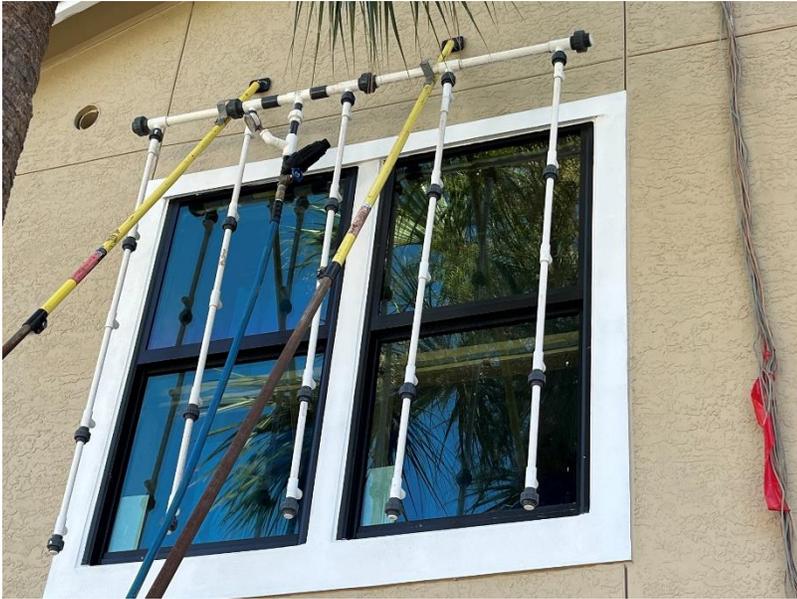
PHOTOGRAPH #9

**BUILDING 12
SECTION C- UNIT 1227**

Water testing performed by independent testing agency and passed in accordance with AAMA 502.

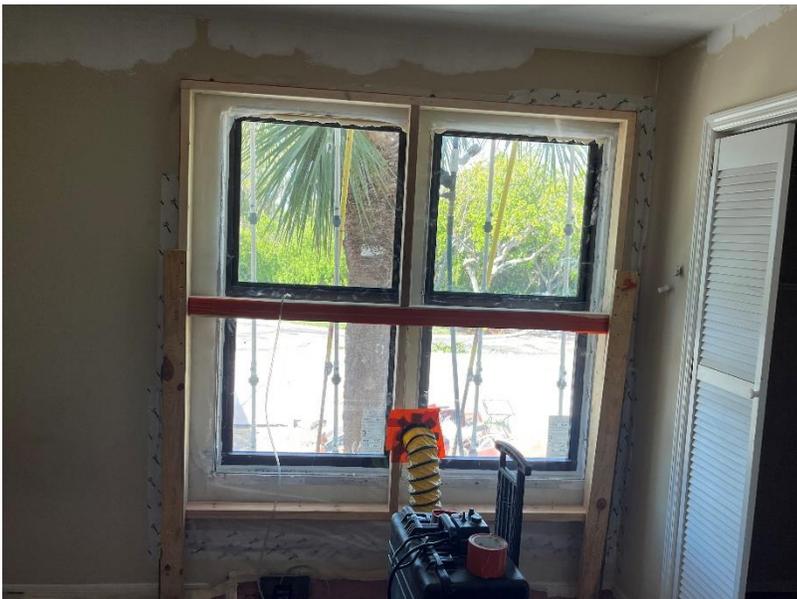
PHOTOGRAPH #10

**BUILDING 12
SECTION C- UNIT 1227**

Water testing performed by independent testing agency and passed in accordance with AAMA 502.

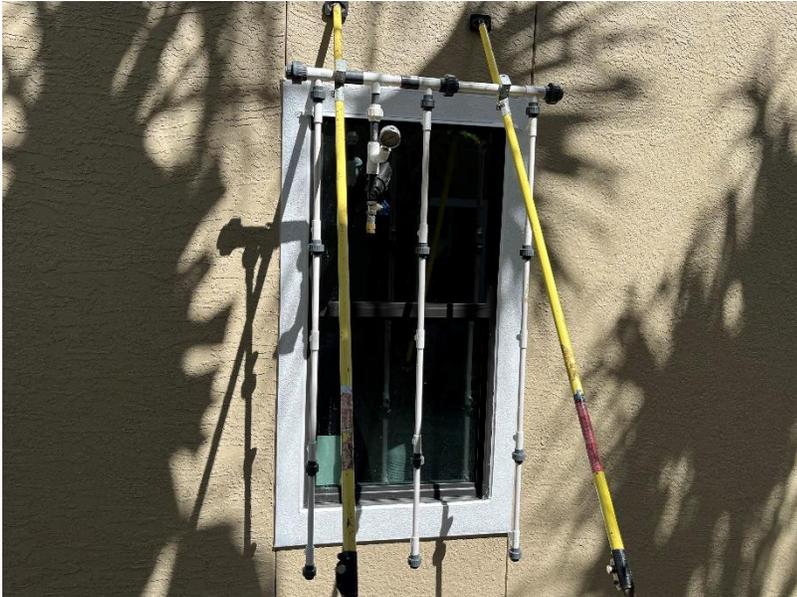
PHOTOGRAPH #11

**BUILDING 12
SECTION D-UNIT 1218**

Water testing performed by independent testing agency and passed in accordance with AAMA 502.

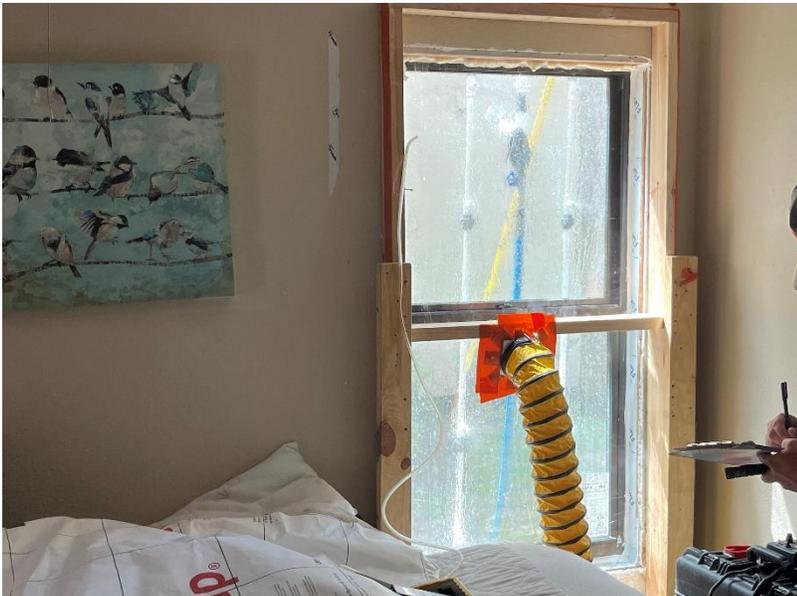
PHOTOGRAPH #12

**BUILDING 12
SECTION D-UNIT 1218**

Water testing performed by independent testing agency and passed in accordance with AAMA 502.

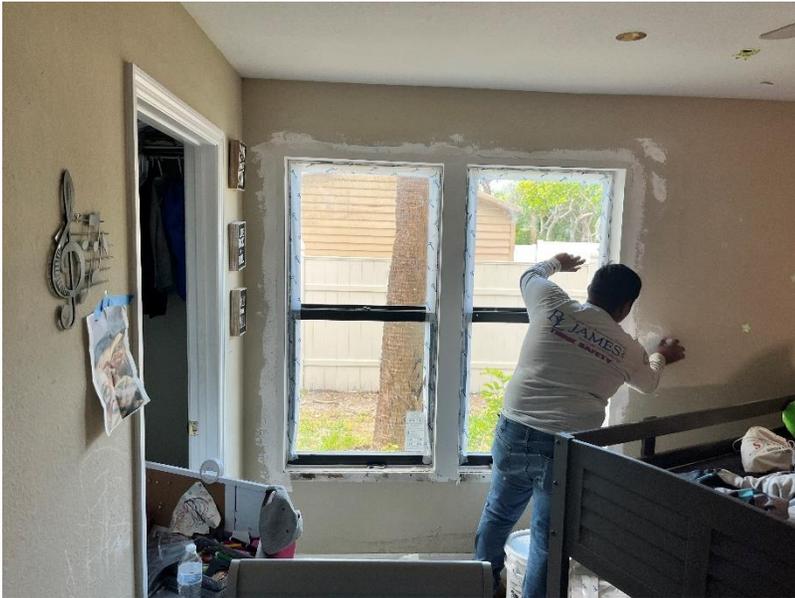
PHOTOGRAPH #13

**BUILDING 12
SECTION E-UNIT 1218**

Contractor performing drywall and windowsill repairs at new window openings.

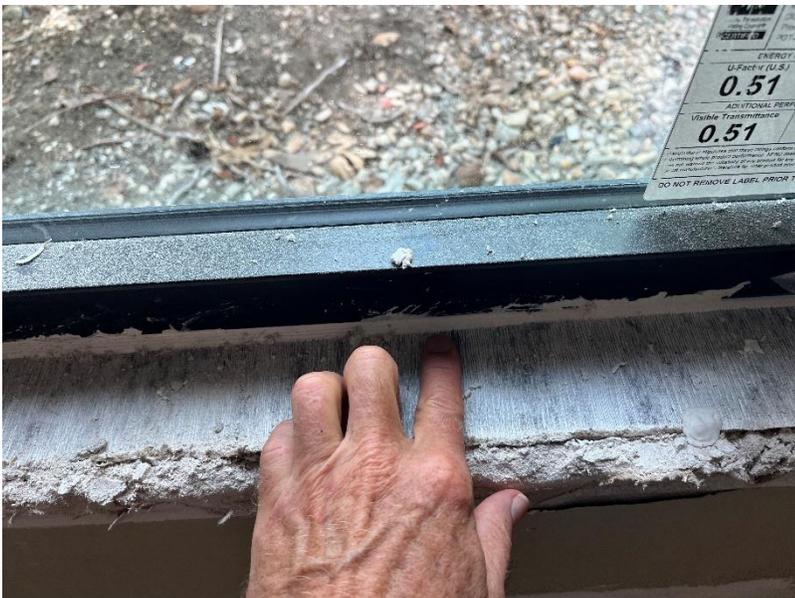
PHOTOGRAPH #14

**BUILDING 12
SECTION G-UNIT 1214**

New sealant applied at new Dupont sill flashing to new PGT window as per manufacturer's instruction and drawings.

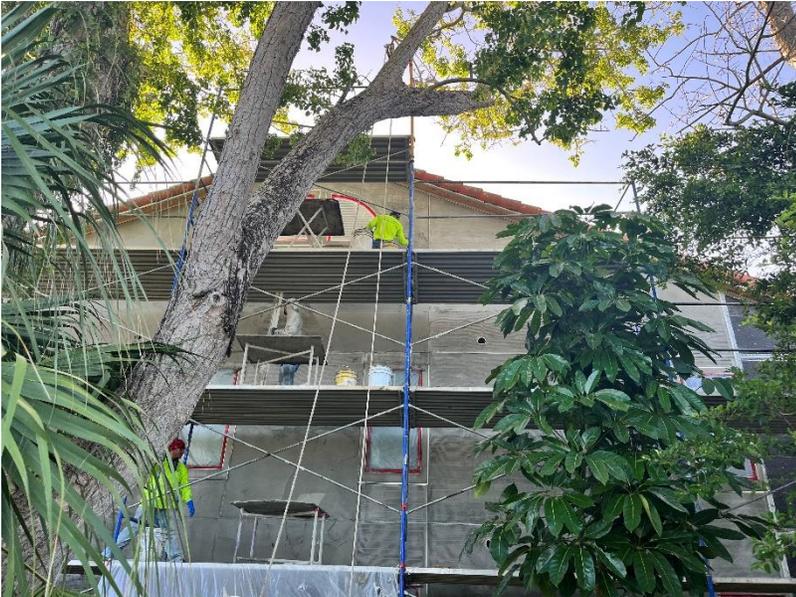
PHOTOGRAPH #15

**BUILDING 9
SECTION H**

Stucco Sub-contractor applying new three coat 5/8" stucco system as per ASTM C926.

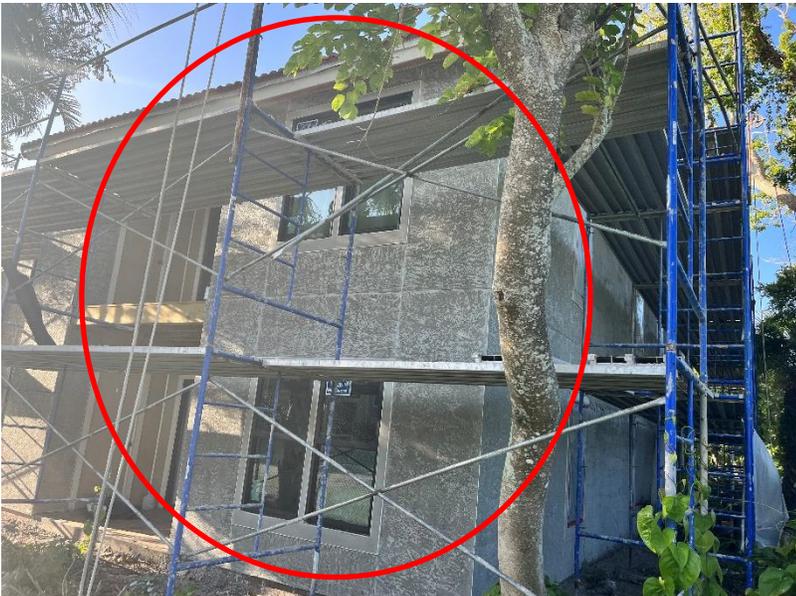
PHOTOGRAPH #16

**BUILDING 9
SECTION G**

Finish coat of stucco texture applied.

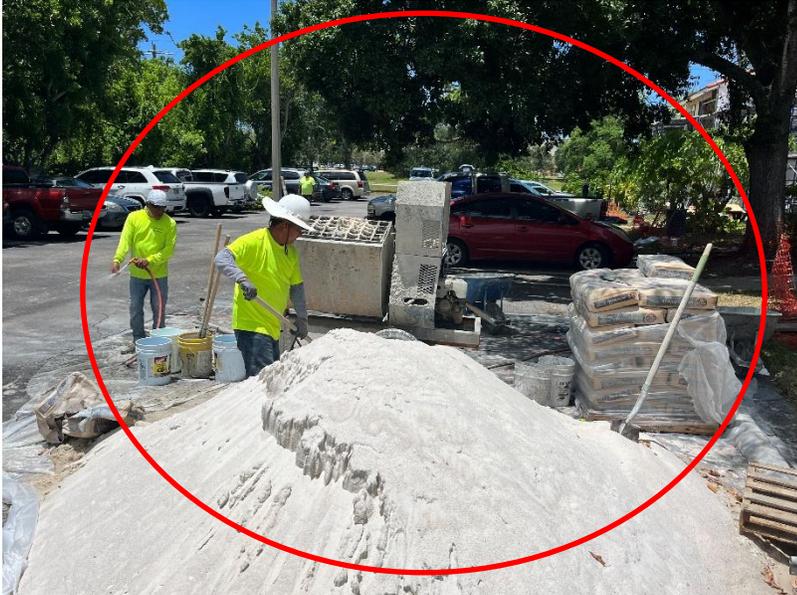
PHOTOGRAPH #17

**BUILDING 9
SECTION G**

Brocco stucco bag mix and sand being mixed on site.

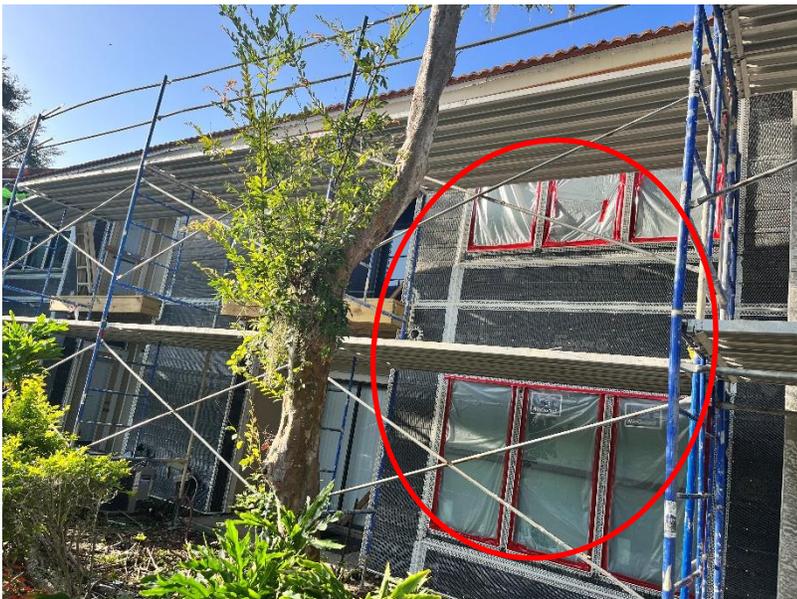
PHOTOGRAPH #18

**BUILDING 9
SECTION F**

New self-furring metal lath and vinyl stucco accessories completed, and new windows protected with plastic cover.

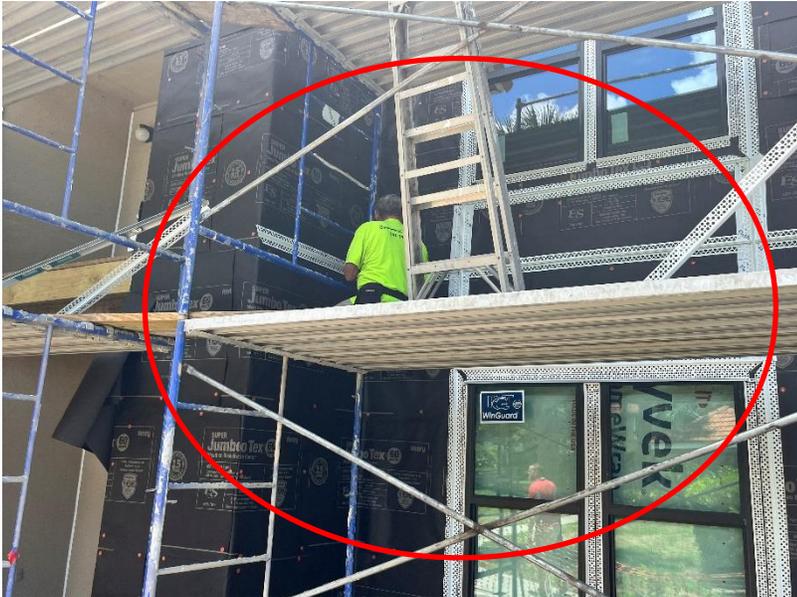
PHOTOGRAPH #19

**BUILDING 9
SECTION E**

Sub-contractor installing new control joint accessories over Jumbo Tex WRB.

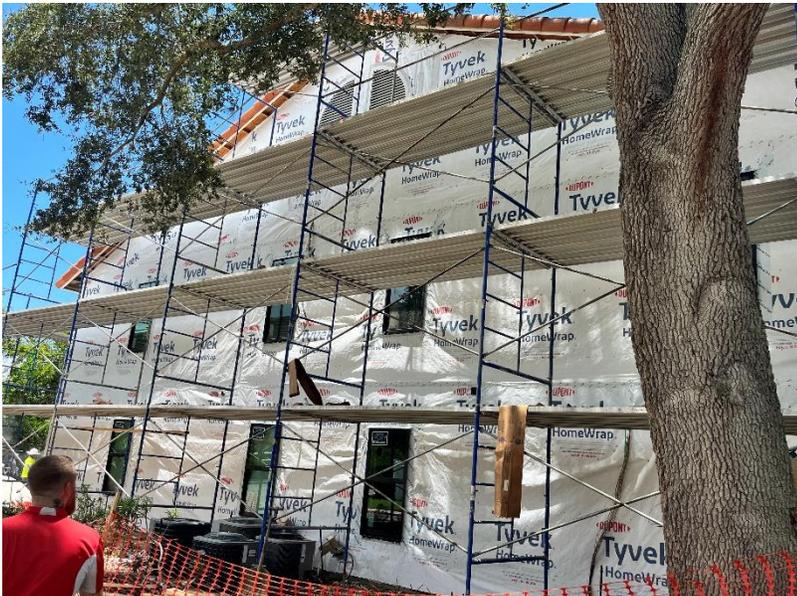
PHOTOGRAPH #20

**BUILDING 9
SECTION D**

Tyvek HomeWrap applied over new plywood sheathing and new PGT windows installed as per drawings.

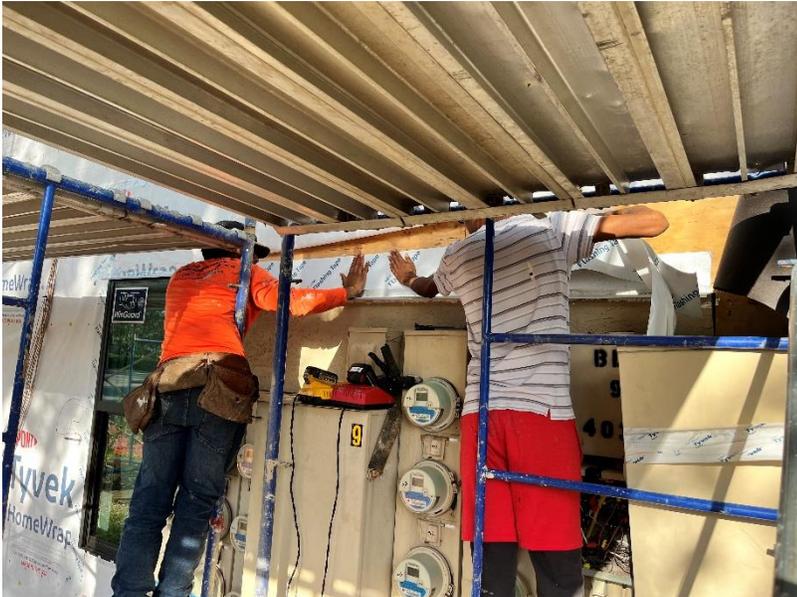
PHOTOGRAPH #21

**BUILDING 9
SECTION D**

Contractor installing head flashing detail over electrical panels as per drawings.

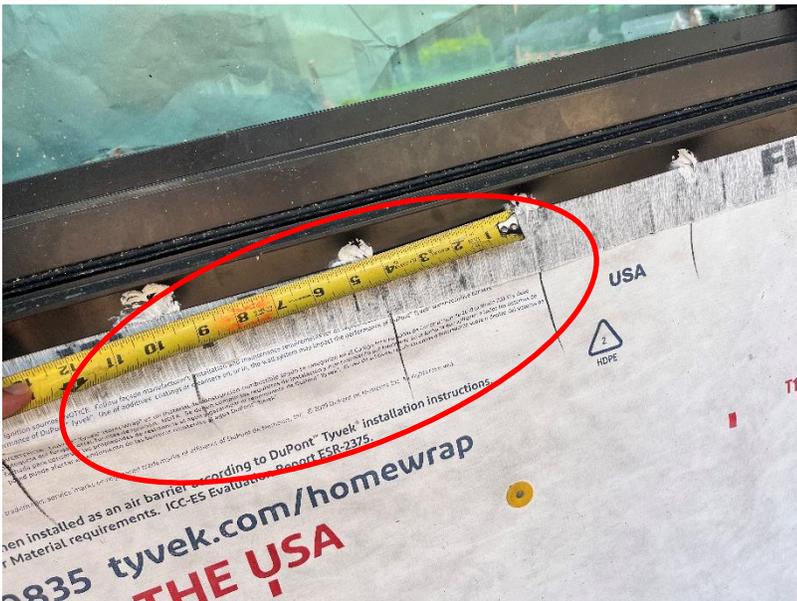
PHOTOGRAPH #22

**BUILDING 9
SECTION D**

New PGT window attached at fin at 5" O.C with 8d common nails as per drawings.

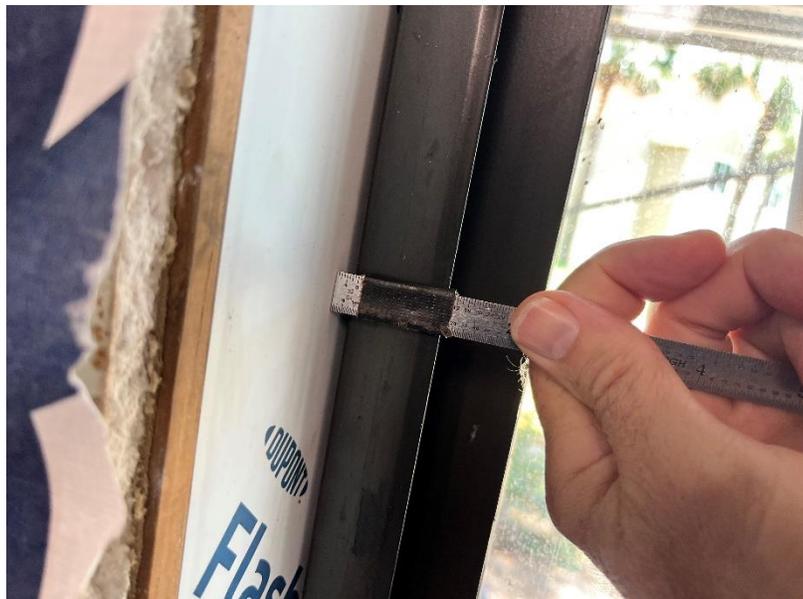
PHOTOGRAPH #23

**BUILDING 9
SECTION C- UNIT 917**

Gap between 2X wood studs and window frame does not exceed the allowed 5/16" max. gap as per drawings.

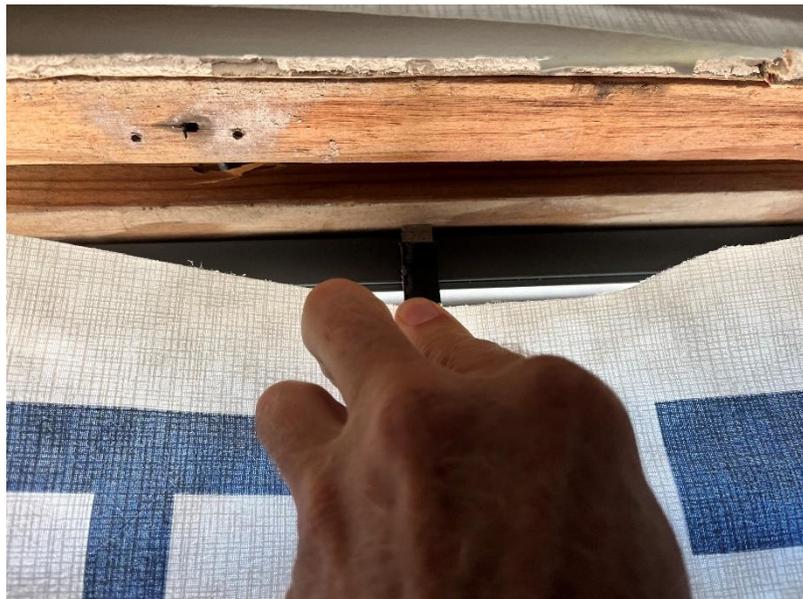
PHOTOGRAPH #24

**BUILDING 9
SECTION C-UNIT 917**

Gap between 2X wood studs and window frame does not exceed the allowed 5/16" max. gap as per drawings.

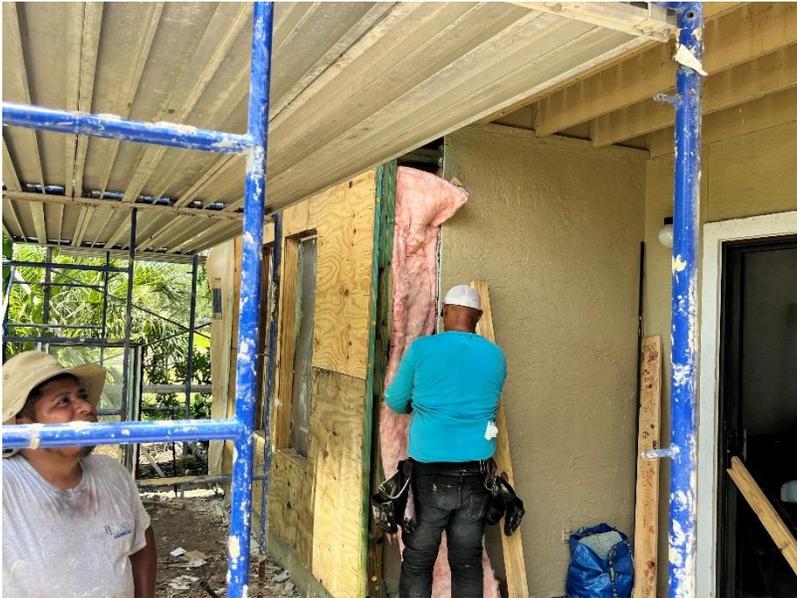
PHOTOGRAPH #25

**BUILDING 9
SECTION A**

Contractor installing R-16 insulation where missing or damaged.

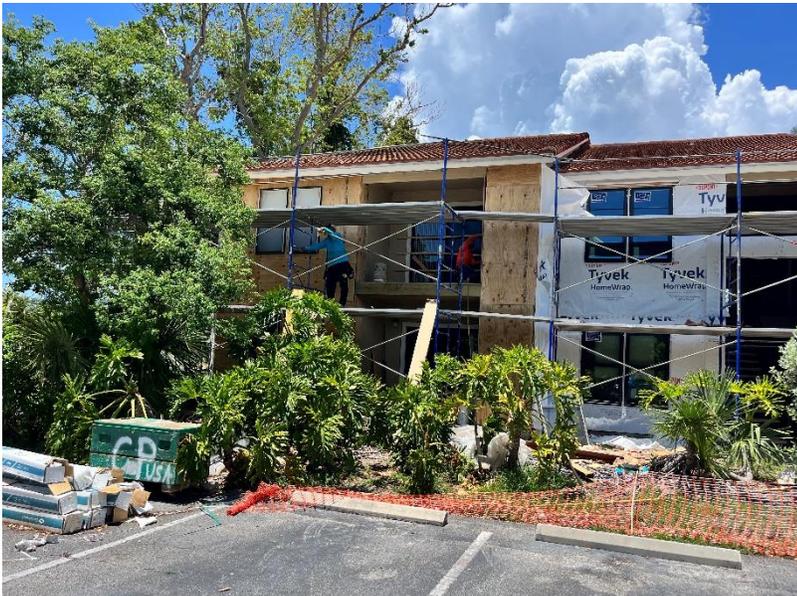
PHOTOGRAPH #26

**BUILDING 9
SECTION A**

Contractor installing 15/32 exterior rated plywood sheathing.

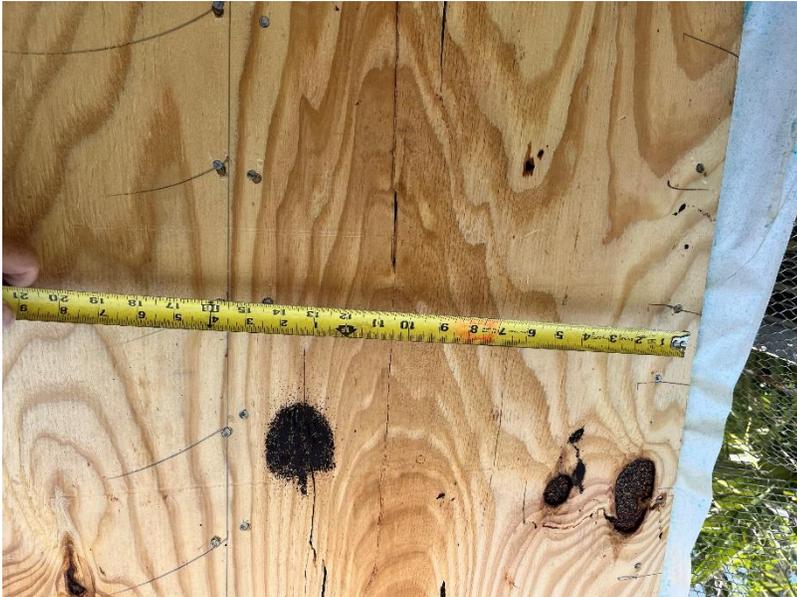
PHOTOGRAPH #27

**BUILDING 9
SECTION A**

Contractor installing 15/32 exterior rated plywood sheathing fastened with 0.113" x 2-3/8" electro galvanized ring shank nails at framing studs.

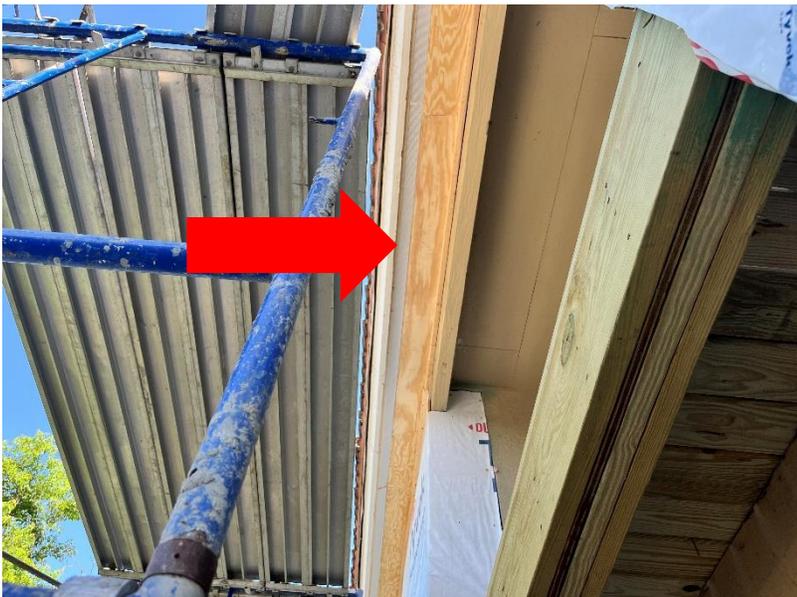
PHOTOGRAPH #28

**BUILDING 9
SECTION A**

New plywood soffit and vinyl soffit screen installed as per specifications.

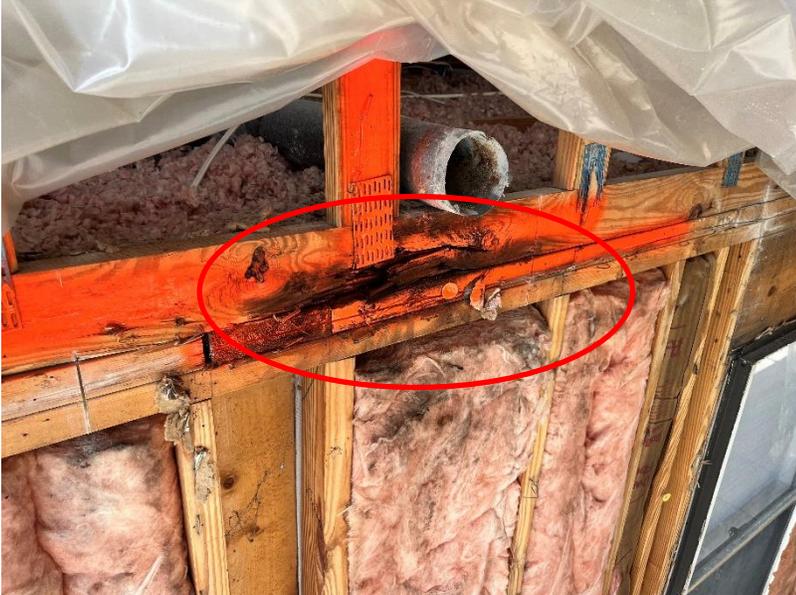
PHOTOGRAPH #29

**BUILDING 15
SECTION H**

Framing damaged marked for repairs at 2nd floor top plate and bottom cord of roof truss.

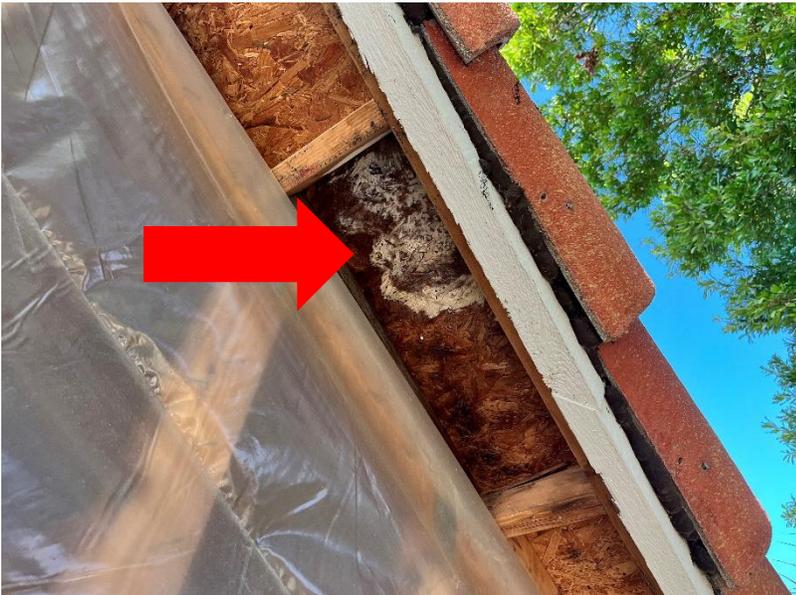
PHOTOGRAPH #30

**BUILDING 15
SECTION H**

Roof sheathing damage observed to be repaired by owners roofing contractor.

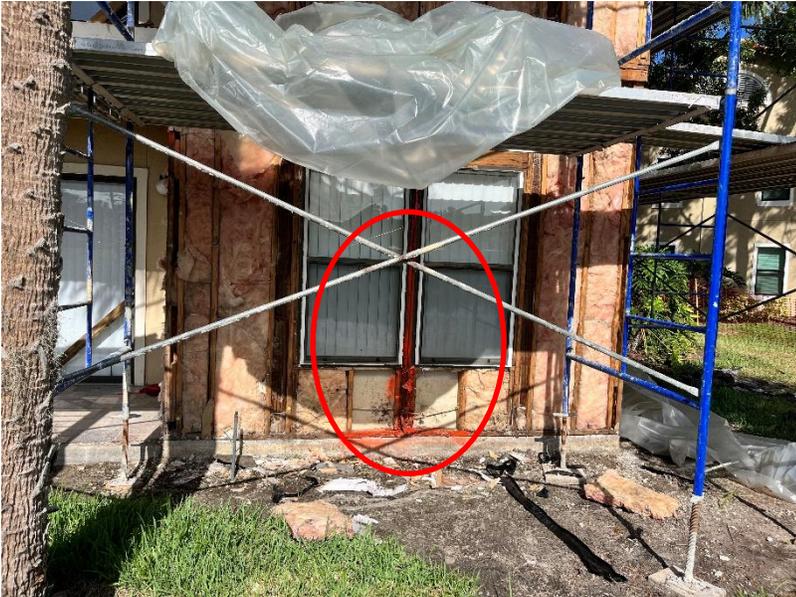
PHOTOGRAPH #31

**BUILDING 15
SECTION G**

Framing damage marked for repairs at bottom plate and window framing.

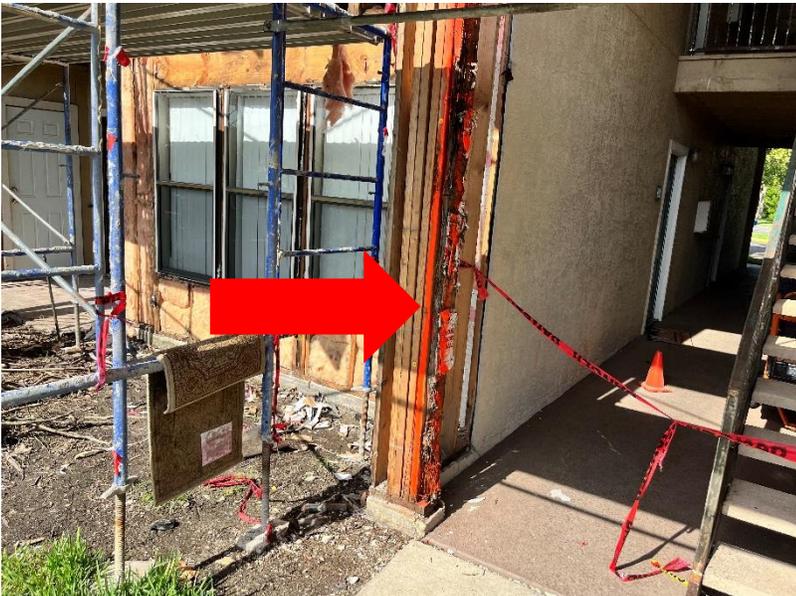
PHOTOGRAPH #32

**BUILDING 15
SECTION G**

Framing damage marked for repairs at breezeway post.

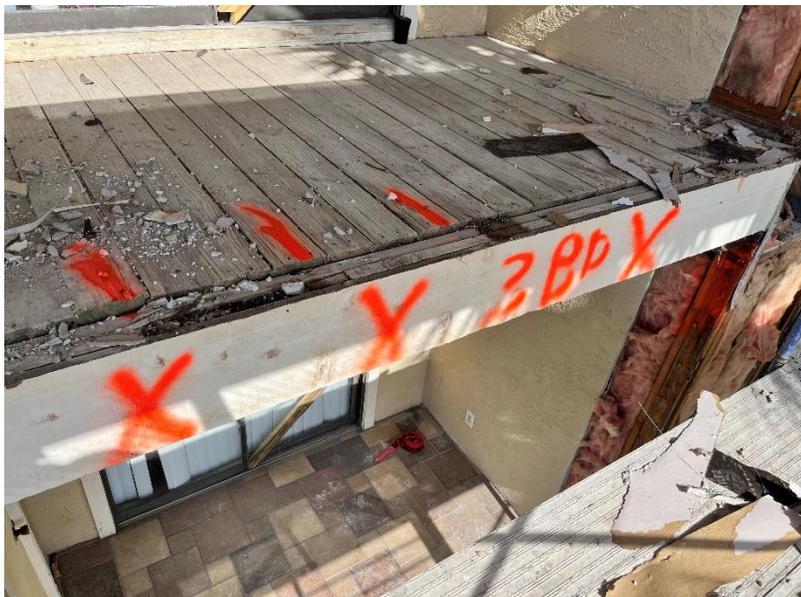
PHOTOGRAPH #33

**BUILDING 15
SECTION G- UNIT 1522**

Damaged built up beam and three deck boards marked for repairs.

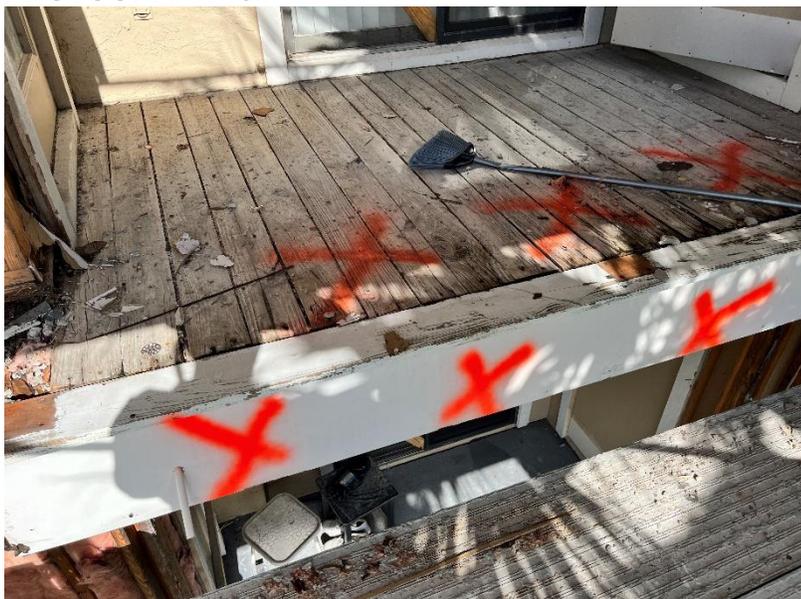
PHOTOGRAPH #34

**BUILDING 15
SECTION F- UNIT 1526**

Damaged built up beam and all deck boards marked for repairs.

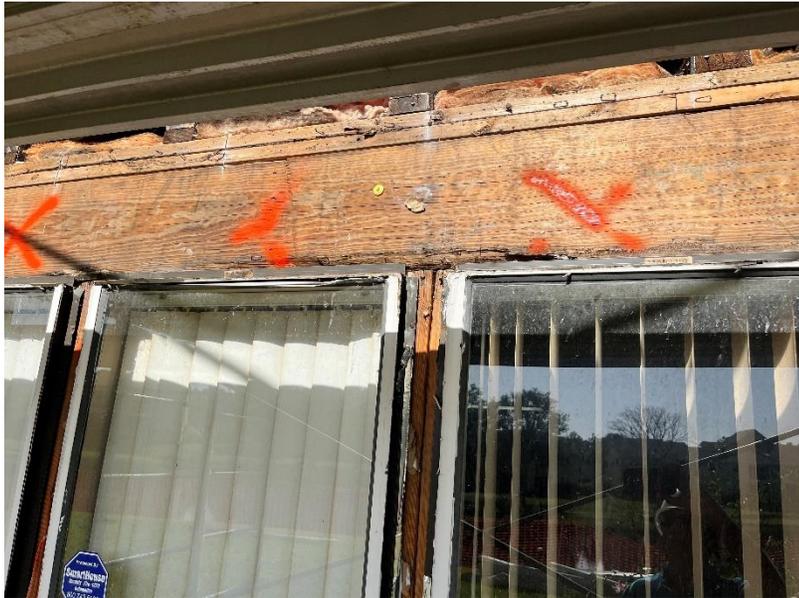
PHOTOGRAPH #35

**BUILDING 15
SECTION F**

Framing damage marked for repairs at windows triple header.

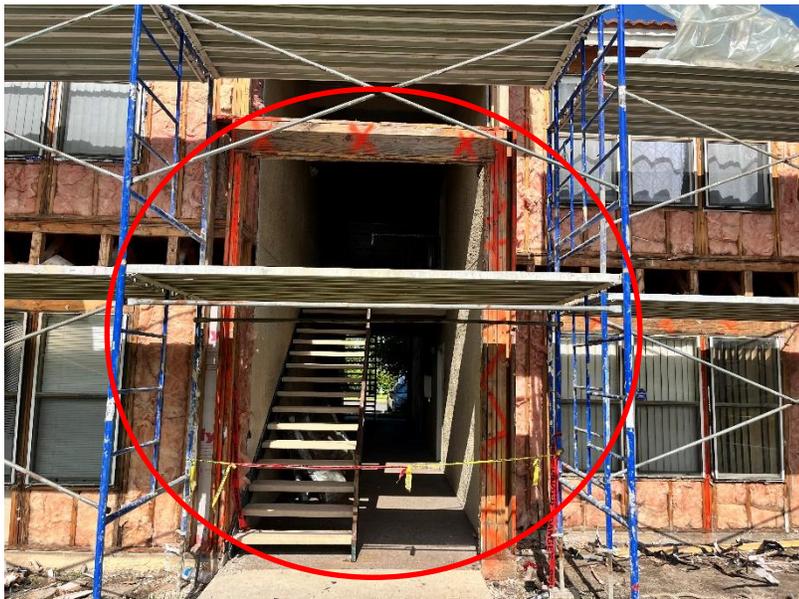
PHOTOGRAPH #36

**BUILDING 15
SECTION E**

Framing damage marked for full repairs at breezeway.

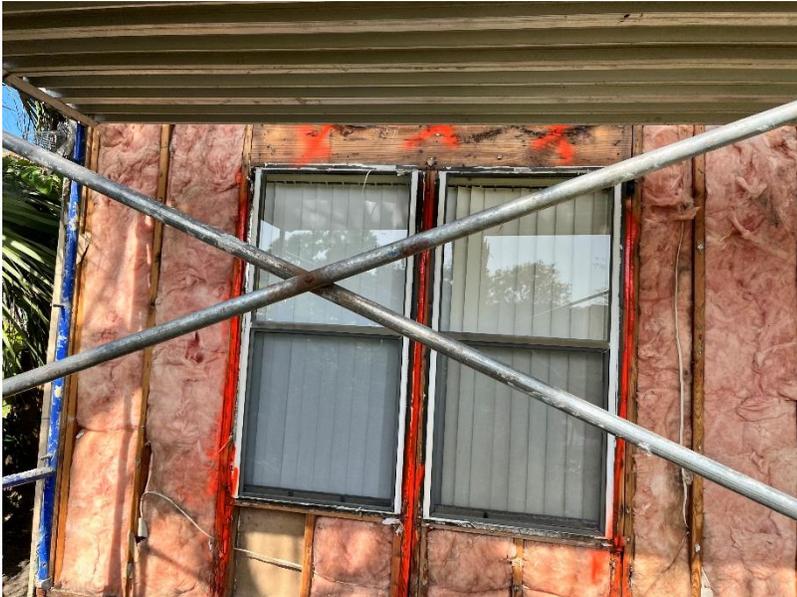
PHOTOGRAPH #37

**BUILDING 15
SECTION E**

Framing damage marked for repairs at windows double header and windows studs.
