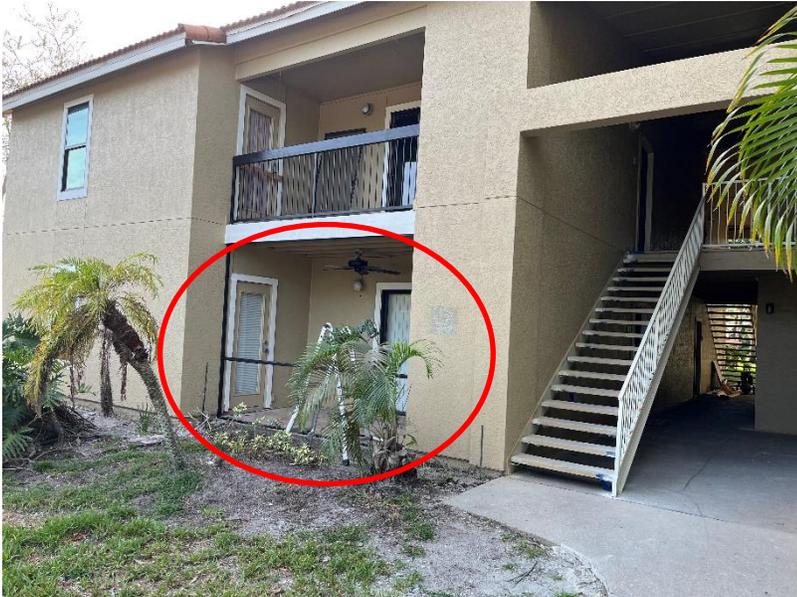
PHOTOGRAPH #1

**BUILDING 12
SECTION A**

Patio screen enclosures being installed.

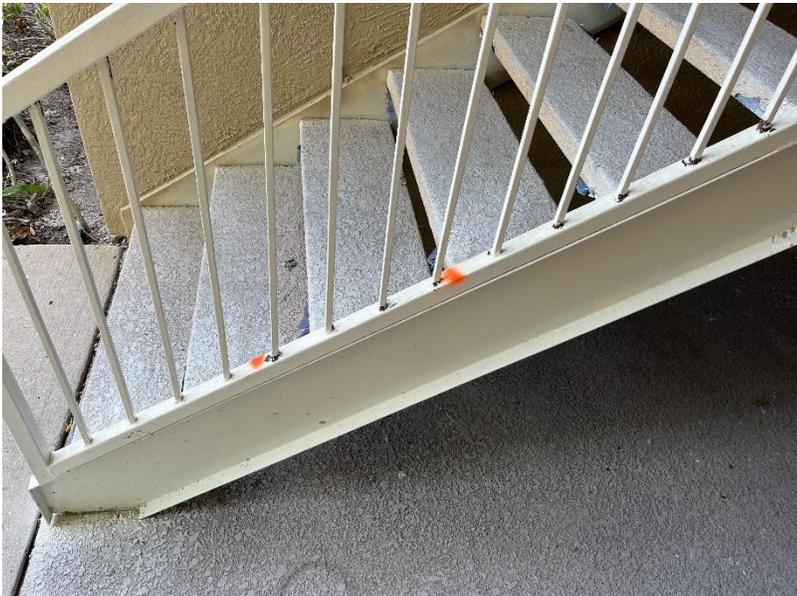
PHOTOGRAPH #2

**BUILDING 12
SECTION A**

Contractor performing additional rust removal as marked on breezeway railings.

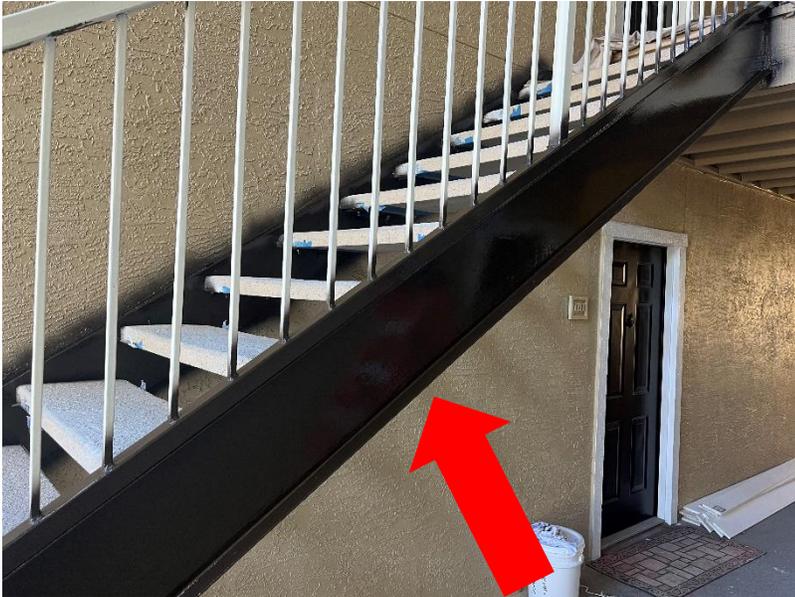
PHOTOGRAPH #3

**BUILDING 12
SECTION A**

Contractor applying Florida Paints HI-Performance urethane enamel at breezeway railings.

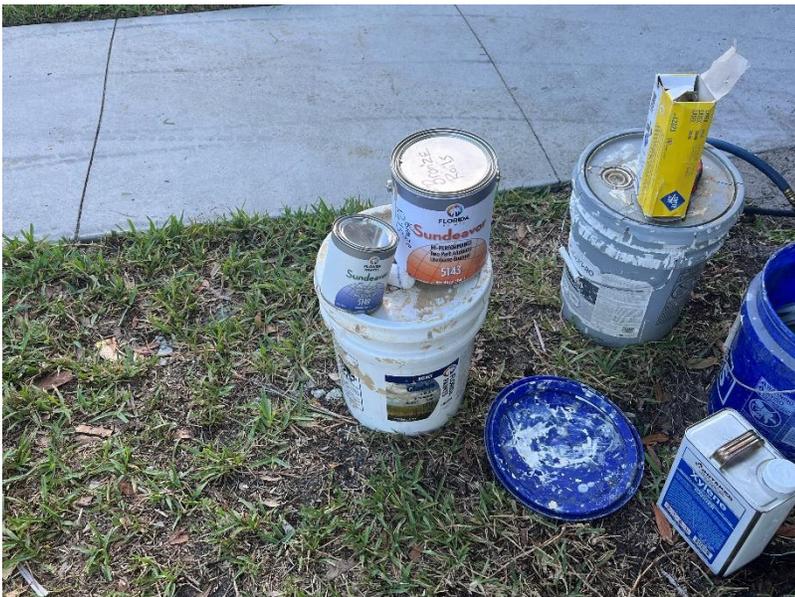
PHOTOGRAPH #4

**BUILDING 12
SECTION A**

Contractor applying Florida Paints HI-Performance urethane enamel at breezeway railings.

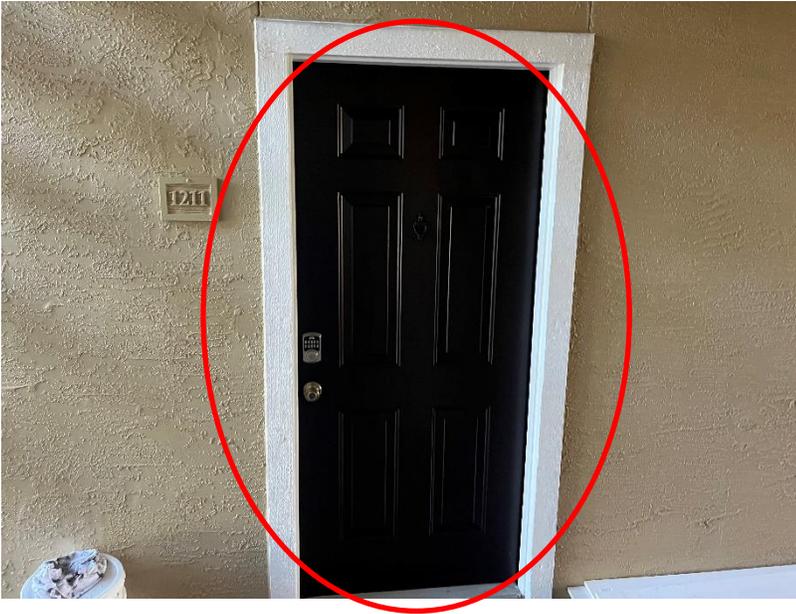
PHOTOGRAPH #5

**BUILDING 12
SECTION A**

Contractor has painted stucco wall and front doors at breezeway areas.

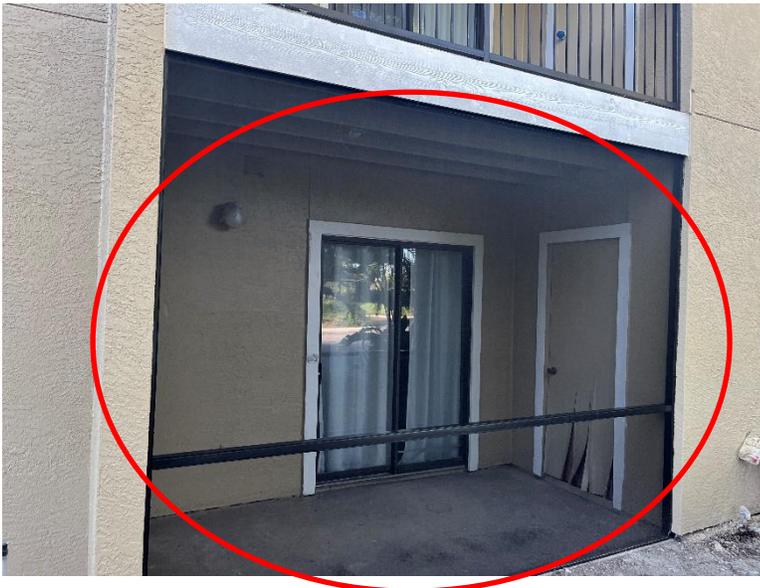
PHOTOGRAPH #6

**BUILDING 12
SECTION B**

Patio screen enclosures have been installed.

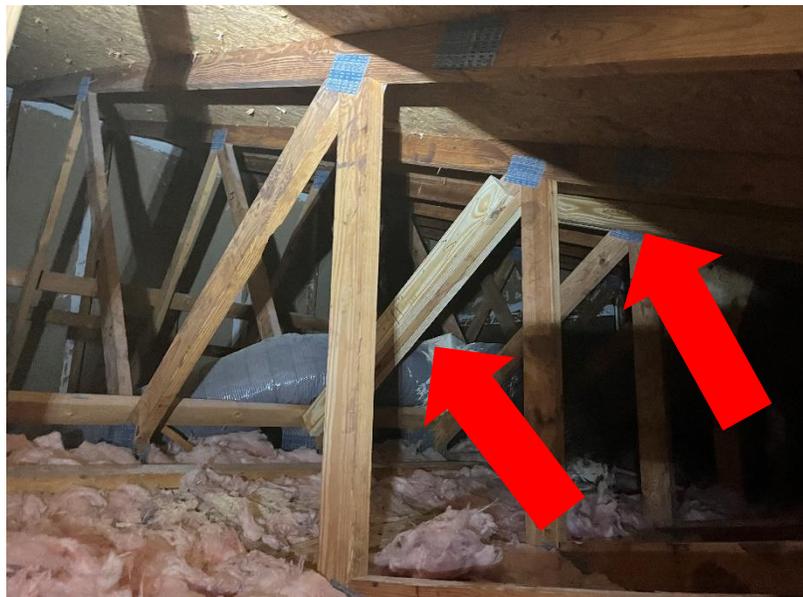
PHOTOGRAPH #7

**BUILDING 12
ATTIC REPAIRS - UNIT 1225**

Contractor has performed scab repairs at damaged trusses as per drawings.

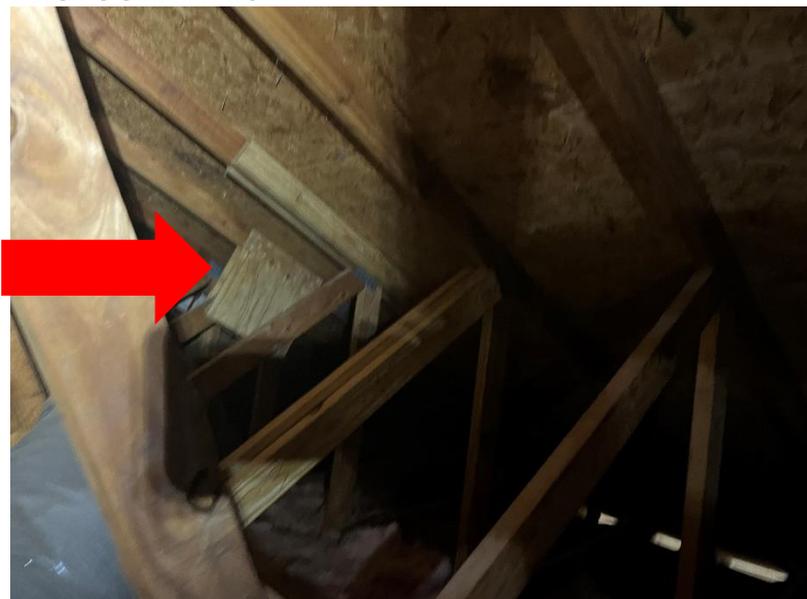
PHOTOGRAPH #8

**BUILDING 12
ATTIC REPAIRS - UNIT 1225**

Contractor has performed gusset repairs at truss intersections as per drawings.

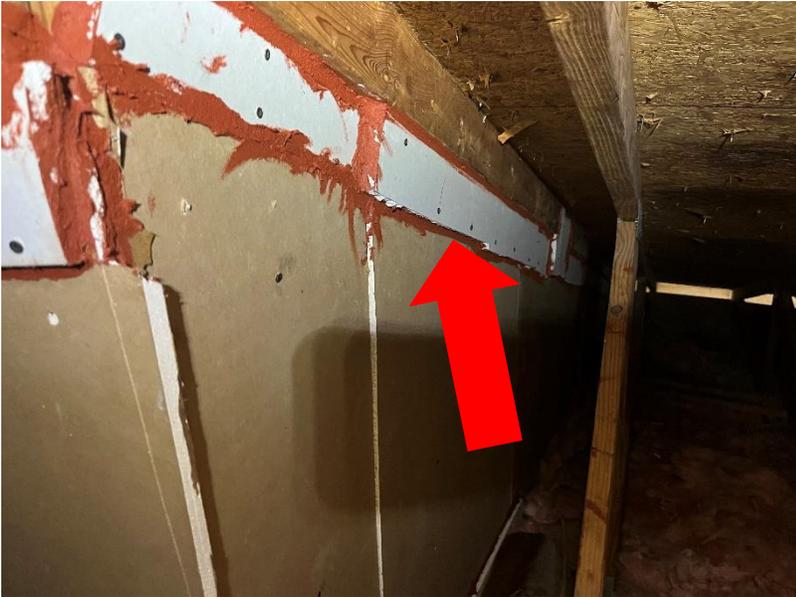
PHOTOGRAPH #9

**BUILDING 12
ATTIC REPAIRS - UNIT 1225**

Contractor has multiple fire wall repairs as per specifications.

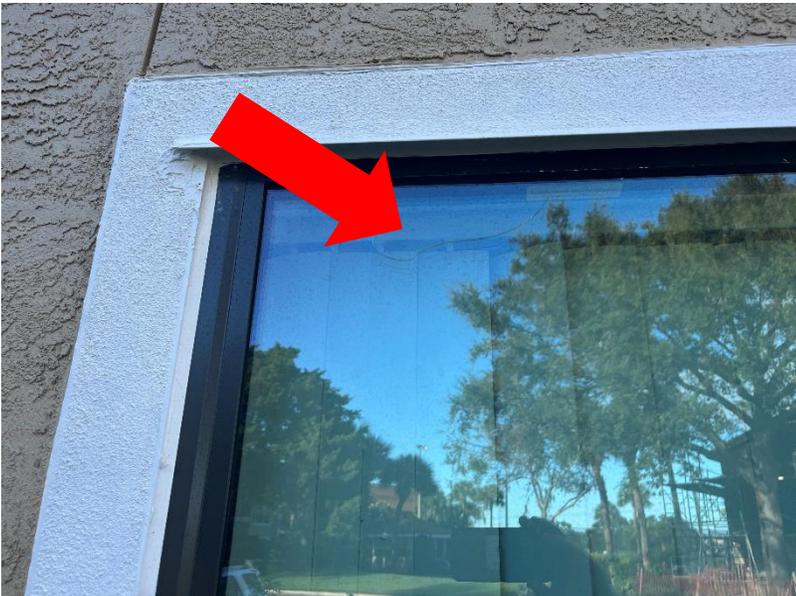
PHOTOGRAPH #10

**BUILDING 12
SECTION C- UNIT#1217**

New PGT window is cracked and will require replacement.

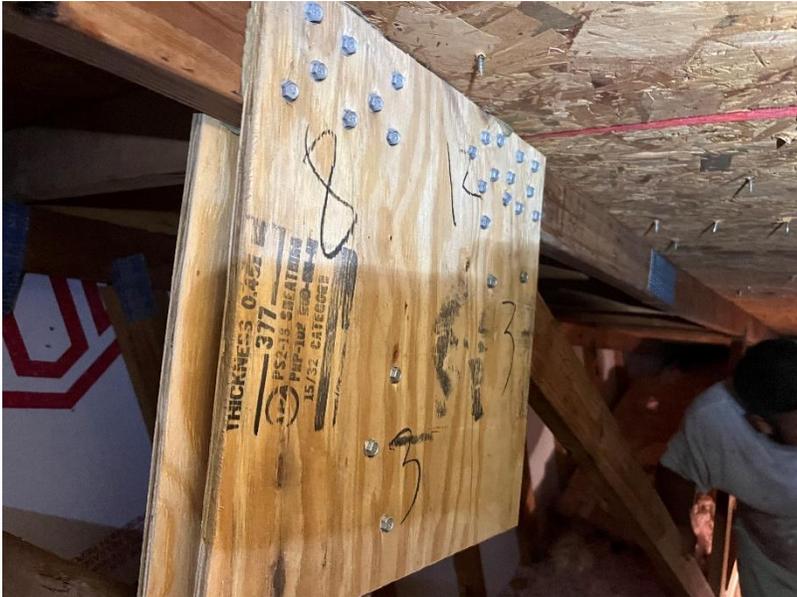
PHOTOGRAPH #11

**BUILDING 12
ATTIC REPAIRS - UNIT 1227**

Contractor has performed gusset repairs at truss intersections as per drawings.

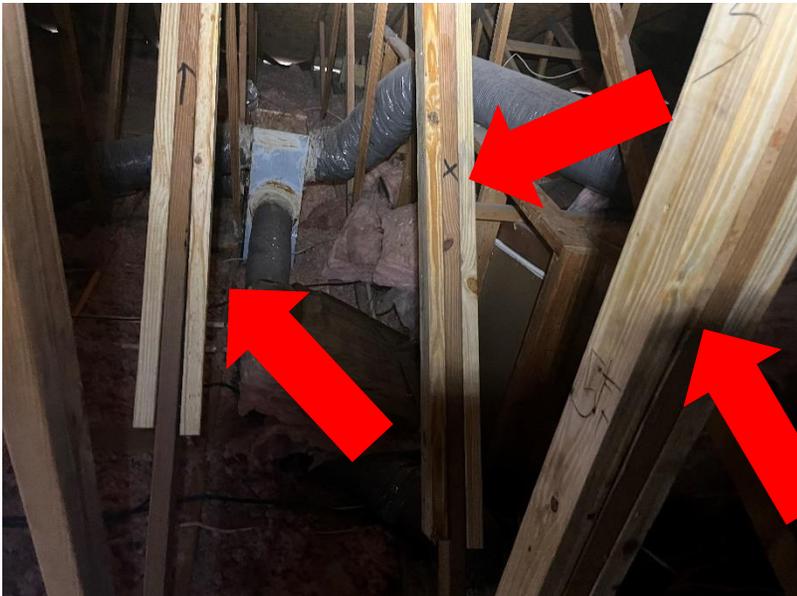
PHOTOGRAPH #12

**BUILDING 12
ATTIC REPAIRS - UNIT 1227**

Contractor has performed scab repairs at damaged trusses as per drawings.

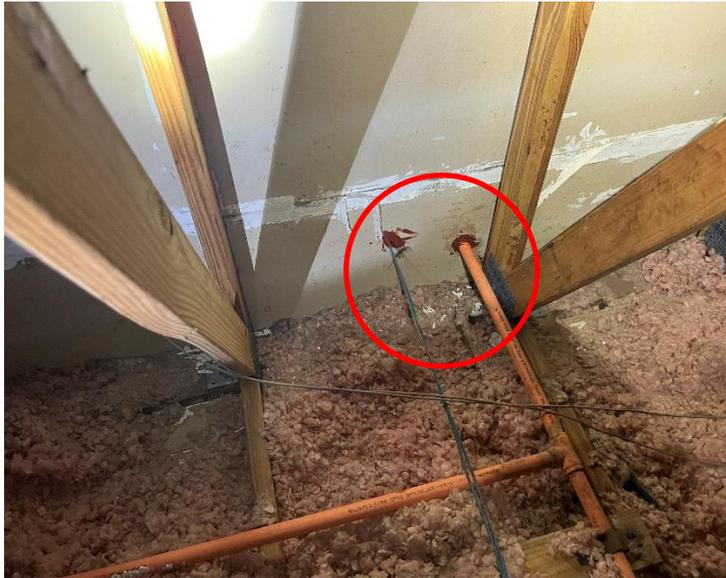
PHOTOGRAPH #13

**BUILDING 12
ATTIC REPAIRS - UNIT 1227**

Contractor has performed fire caulk repairs at fire wall penetrations.

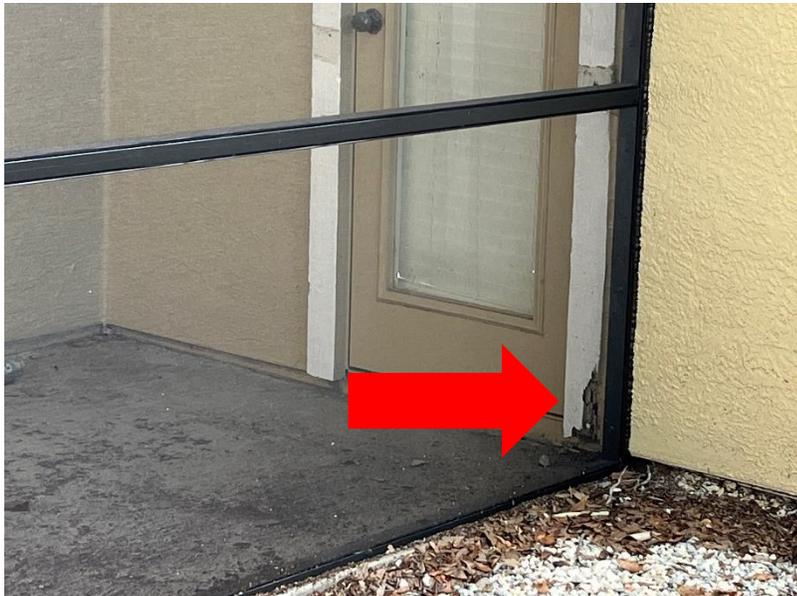
PHOTOGRAPH #14

**BUILDING 12
SECTION G-UNIT 1212**

Screen enclosure installed but door framing has not been repaired.

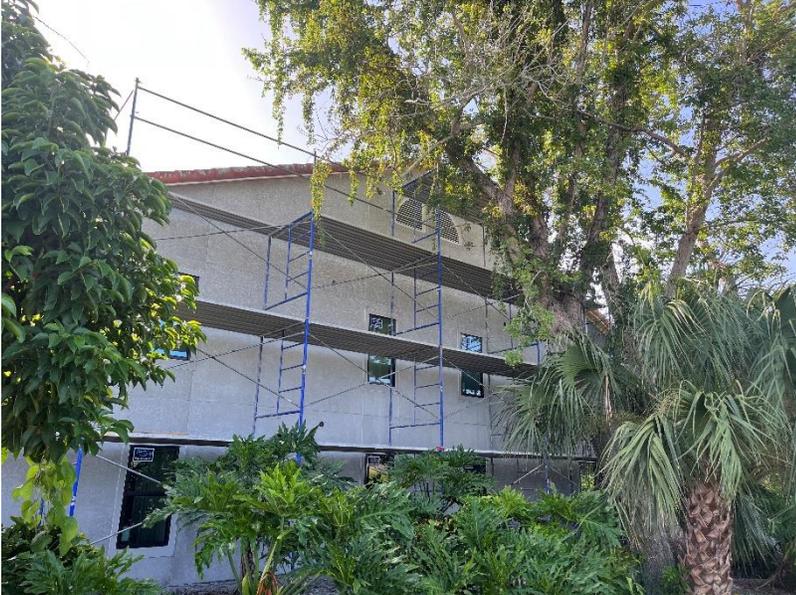
PHOTOGRAPH #15

**BUILDING 9
SECTION H**

Stucco Sub-contractor has completed new three coat 5/8" stucco system as per ASTM C926.

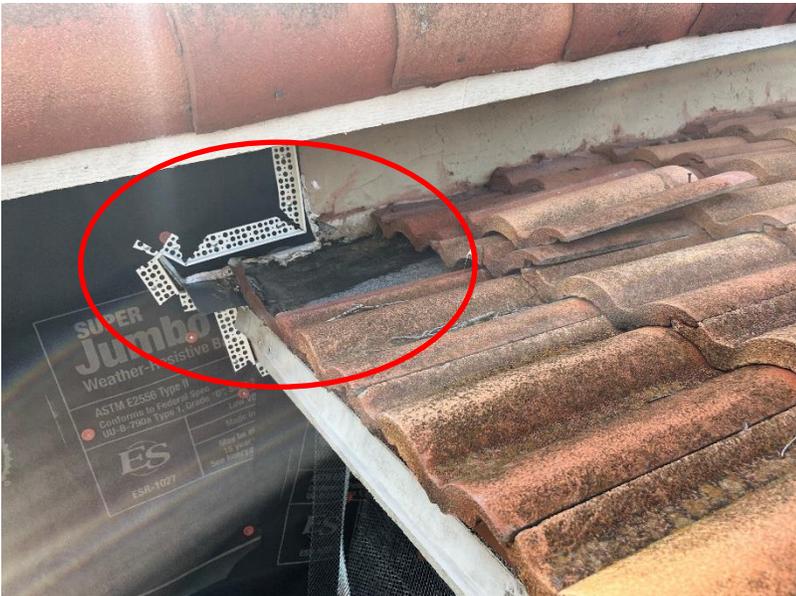
PHOTOGRAPH #16

**BUILDING 9
SECTION F**

Kick out flashing detail is incomplete at transition tie into existing roofing.

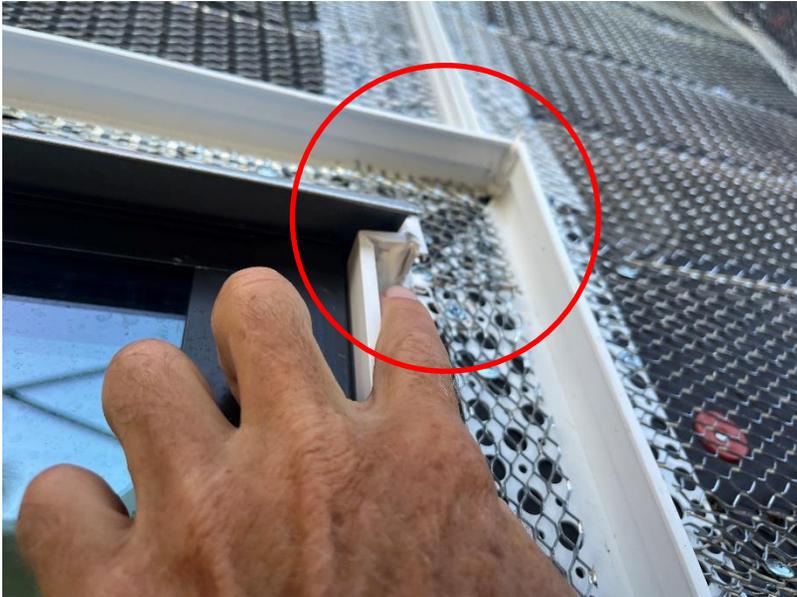
PHOTOGRAPH #17

**BUILDING 9
SECTION F**

Stucco sub-contractor has sealed vinyl stucco accessories with fast cure urethane sealant as per drawings.

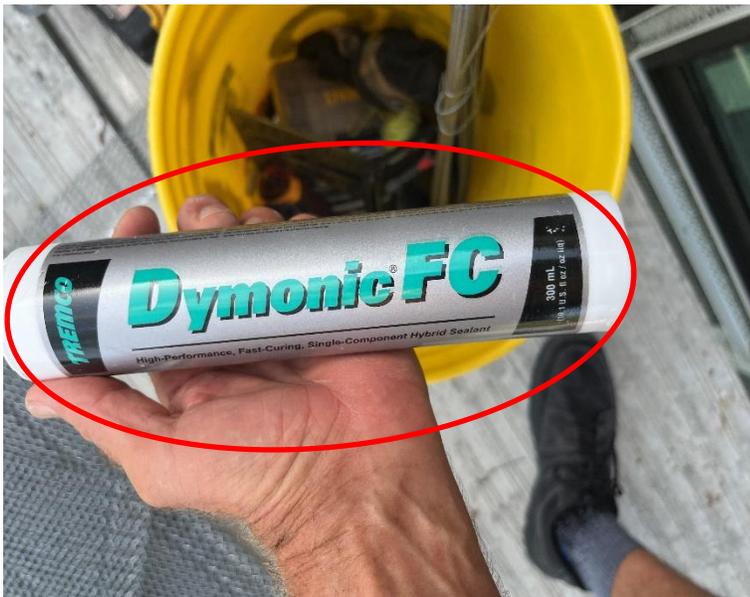
PHOTOGRAPH #18

**BUILDING 9
SECTION F**

Stucco sub-contractor has sealed vinyl stucco accessories with fast cure urethane sealant as per drawings.

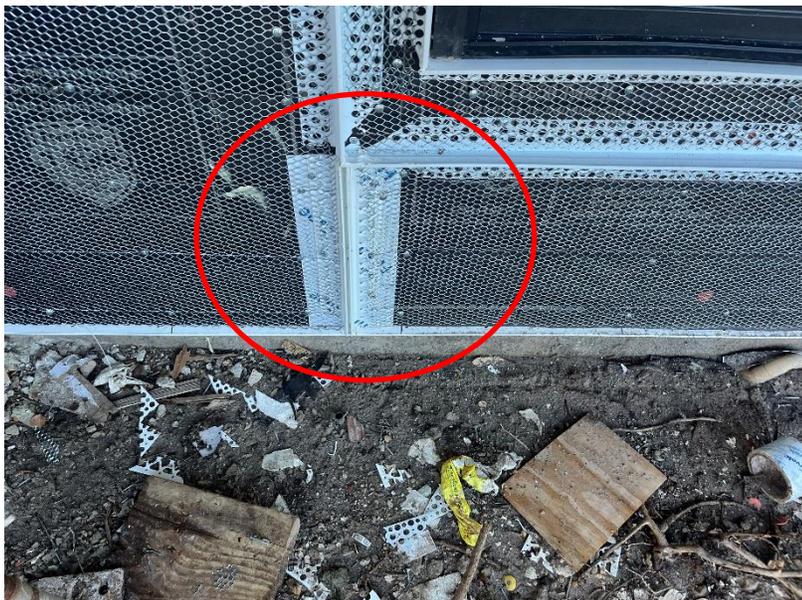
PHOTOGRAPH #19

**BUILDING 9
SECTION E**

Sub-contractor has installed Dupont Flashing behind vertical control joints as per drawings.

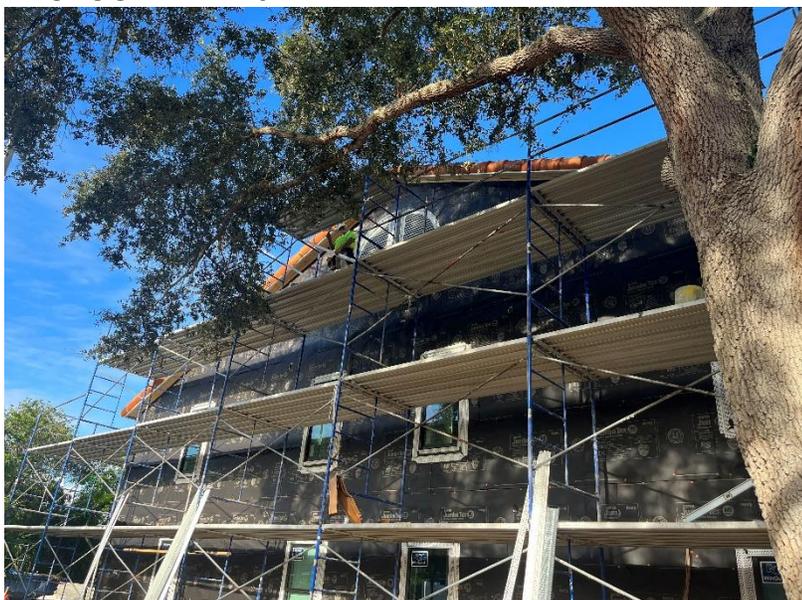
PHOTOGRAPH #20

**BUILDING 9
SECTION D**

Sub-contractor applying Henry Jumbo-Tex 60 water resistant barrier as per specifications.

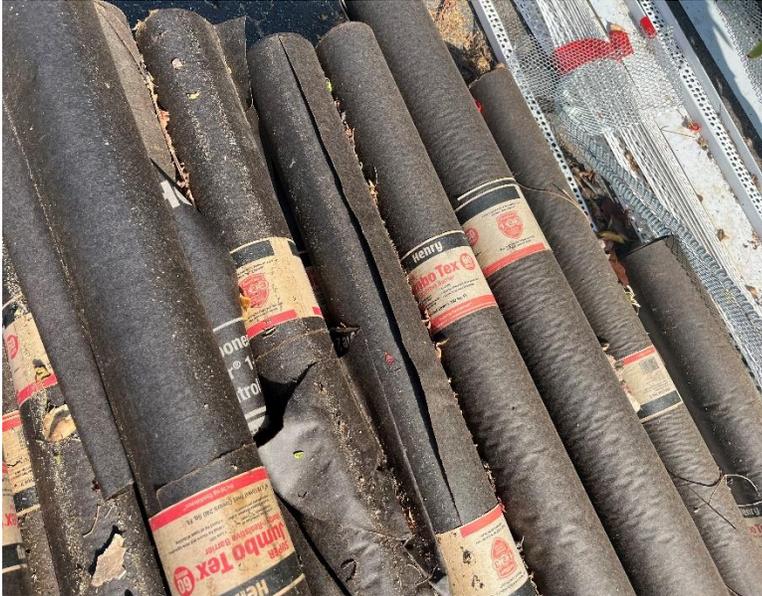
PHOTOGRAPH #21

**BUILDING 9
SECTION D**

Sub-contractor applying Henry Jumbo-Tex 60 water resistant barrier as per specifications.

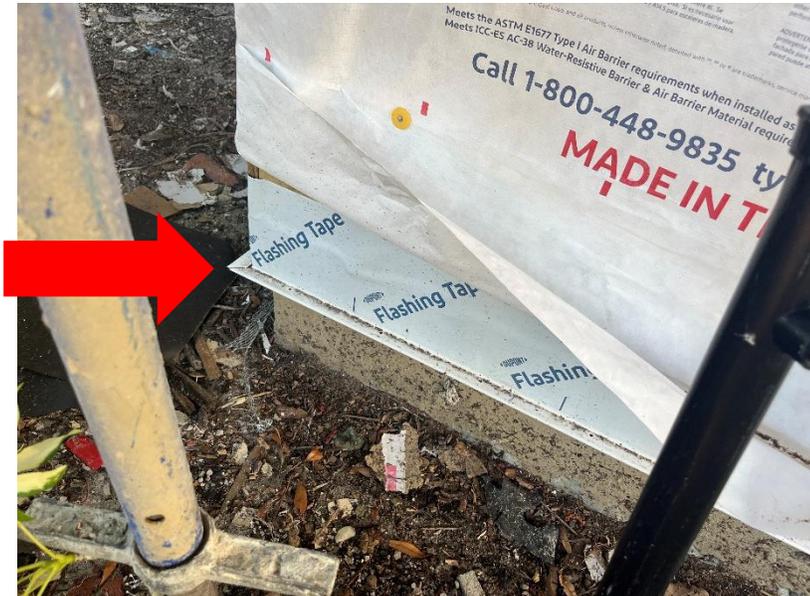
PHOTOGRAPH #22

**BUILDING 9
SECTION C**

Vinyl weep stucco accessory installed at base of wall and flashed with Dupont Flashing Tape as per drawings.

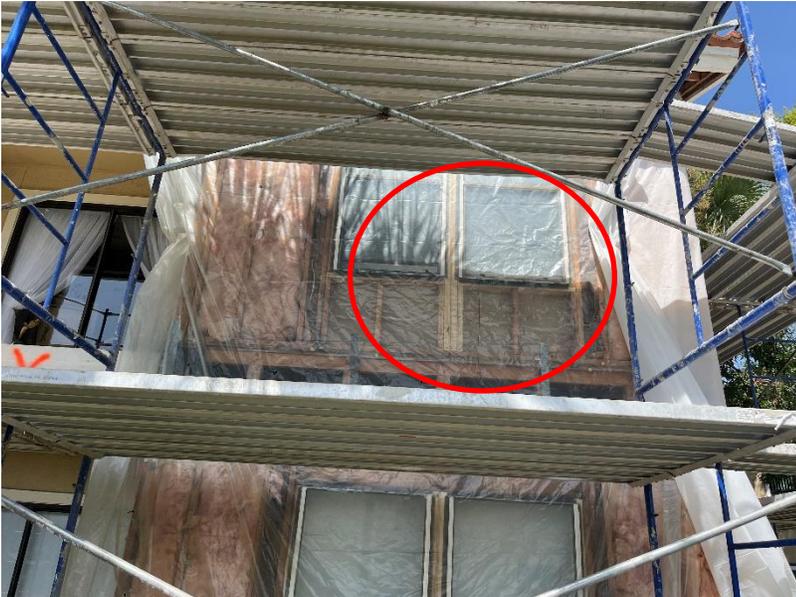
PHOTOGRAPH #23

**BUILDING 15
SECTION G**

Framing damaged repaired at 2nd floor window framing studs.

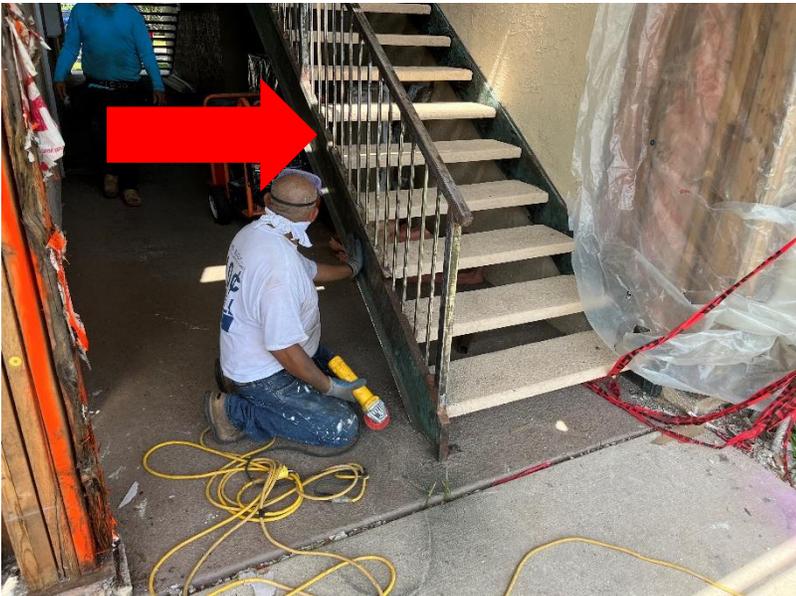
PHOTOGRAPH #24

**BUILDING 15
SECTION G**

Surface preparation with hand grinders in progress at breezeway stairways.

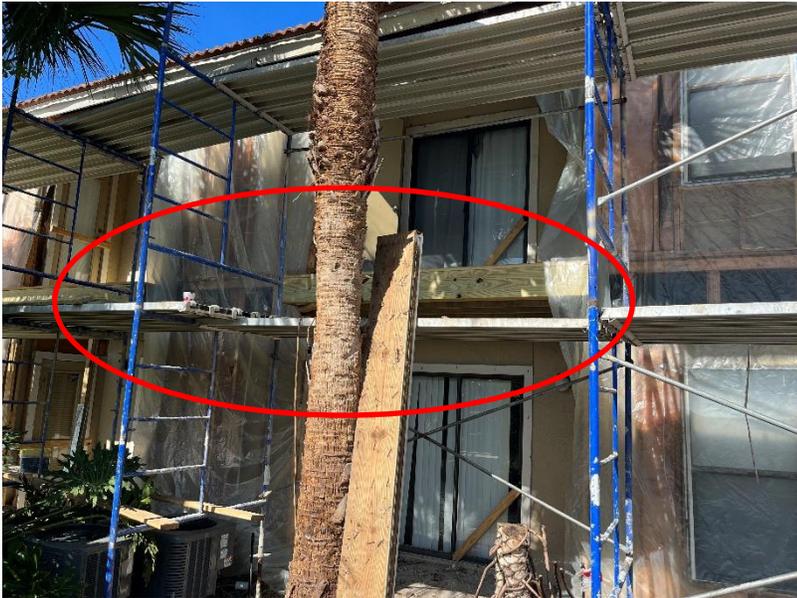
PHOTOGRAPH #25

**BUILDING 15
SECTION F**

Built up beam and deck repairs performed at 2nd floor balconies.

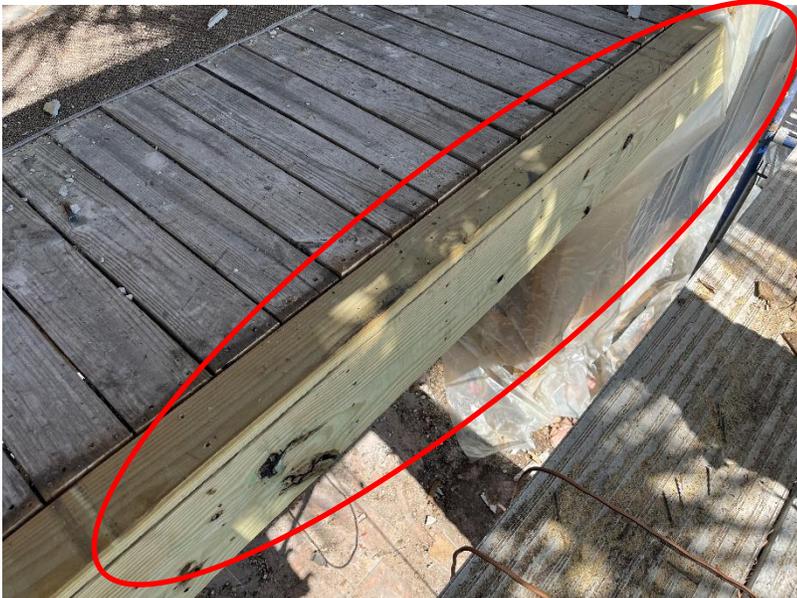
PHOTOGRAPH #26

**BUILDING 15
SECTION F – UNIT #1524**

Built up beam repair performed at balcony as per drawings and specifications.

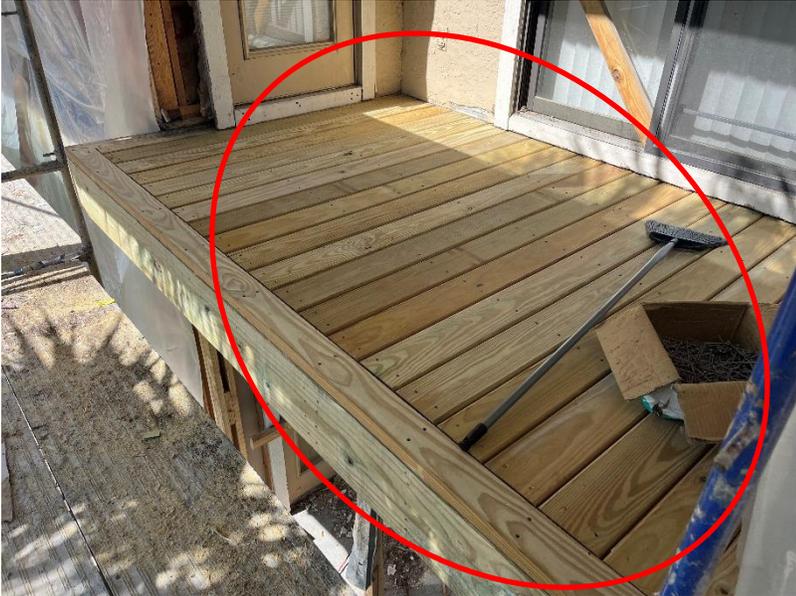
PHOTOGRAPH #27

**BUILDING 15
SECTION F – UNIT #1526**

Built up beam repair and full deck board replacement performed at balcony as per drawings and specifications.

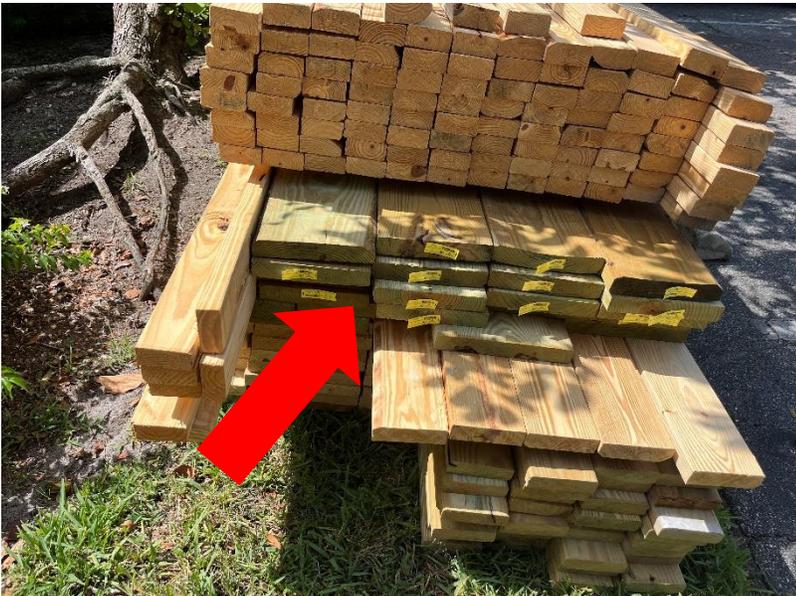
PHOTOGRAPH #28

**BUILDING 15
SECTION B**

New southern pine 2x4 studs and pressure treated 2X10 lumber delivered for repairs.
