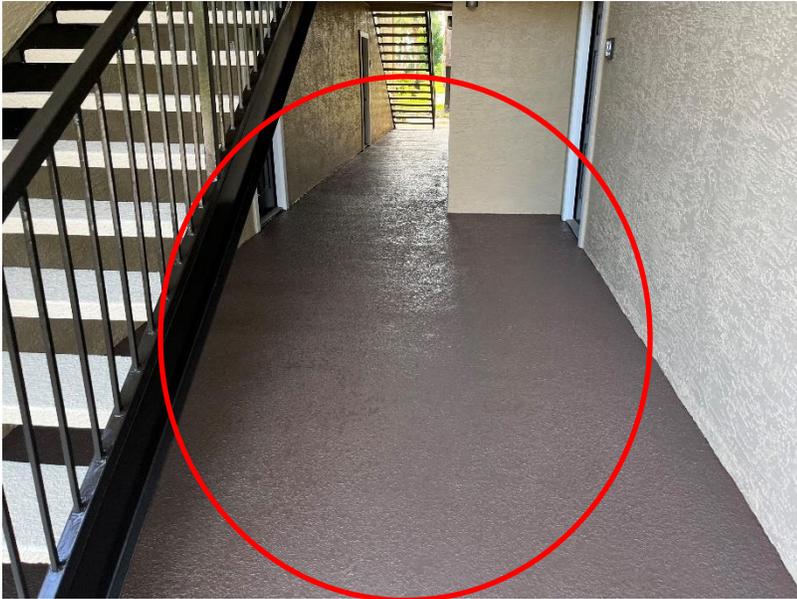
PHOTOGRAPH #1

**BUILDING 12
SECTION A-BREEZEWAY**

Flooring coated with Florida Paints TropiCrete Concrete Sealer.

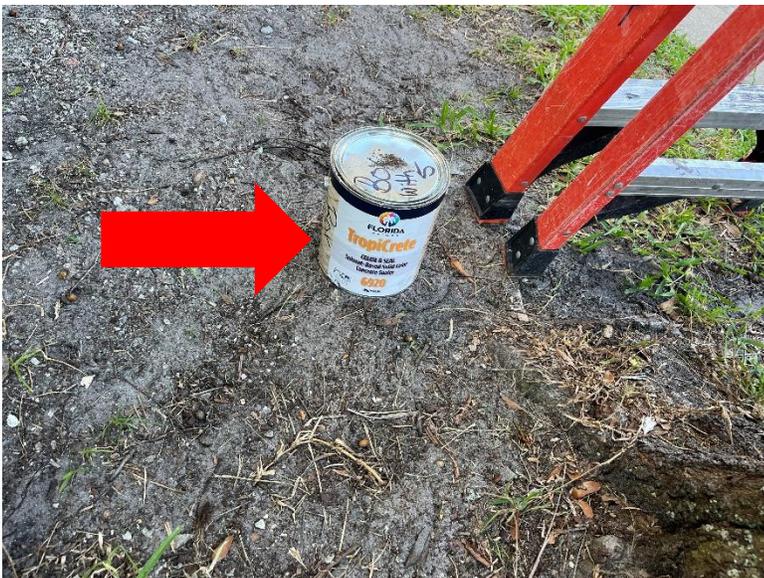
PHOTOGRAPH #2

**BUILDING 12
SECTION A-BREEZEWAY**

Flooring coated with Florida Paints TropiCrete Concrete Sealer.

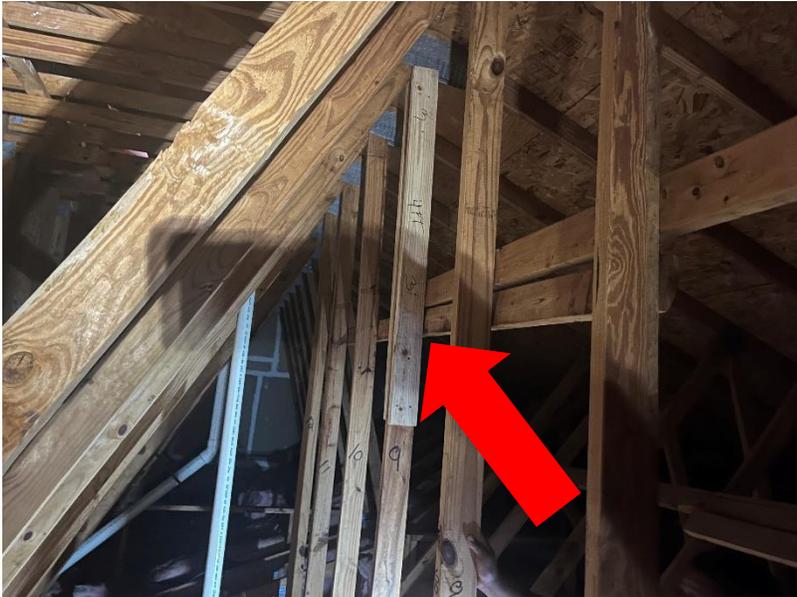
PHOTOGRAPH #3

**BUILDING 12
ATTIC REPAIRS - UNIT #1228**

Contractor has performed scab repairs at damaged trusses as per drawings.

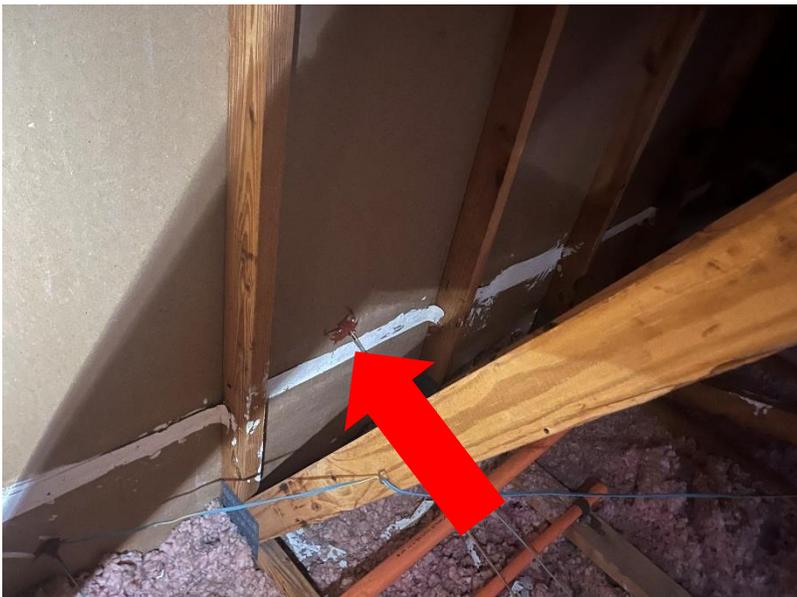
PHOTOGRAPH #4

**BUILDING 12
ATTIC REPAIRS - UNIT #1228**

Contractor has performed fire caulk repairs at penetration of fire wall.

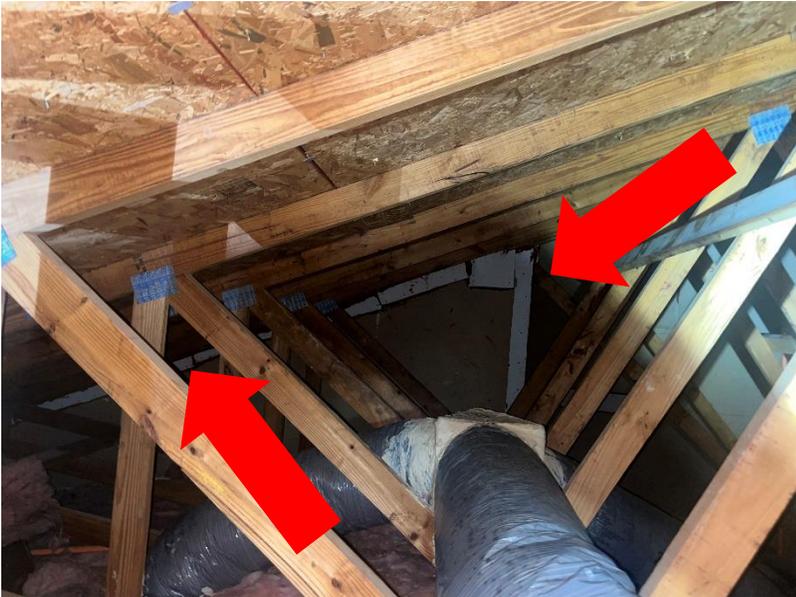
PHOTOGRAPH #5

**BUILDING 12
ATTIC REPAIRS - UNIT #1226**

Contractor has multiple fire wall repairs as per specifications.

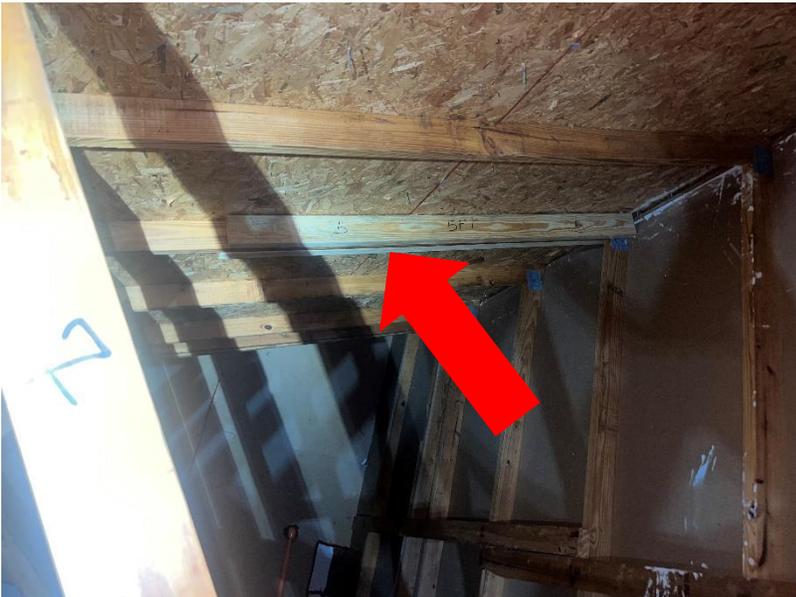
PHOTOGRAPH #6

**BUILDING 12
ATTIC REPAIRS - UNIT #1226**

Contractor has performed scab repairs at damaged trusses as per drawings.

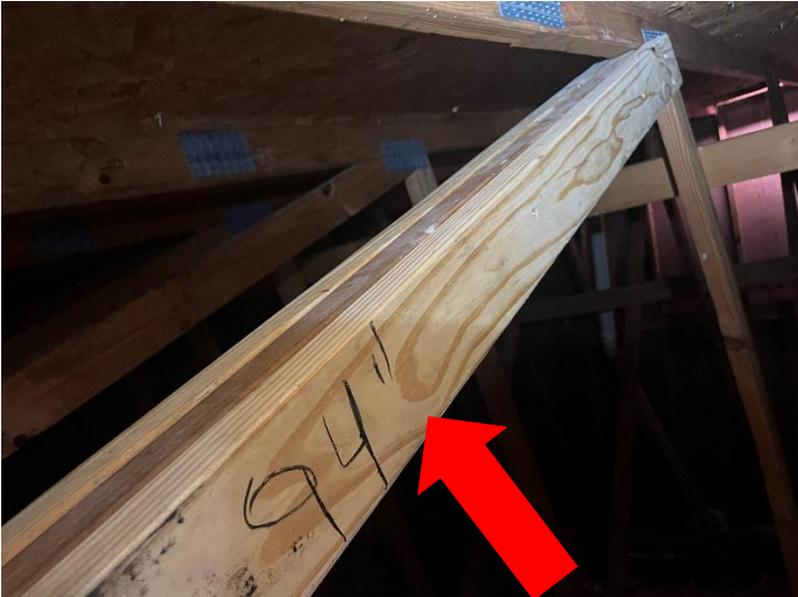
PHOTOGRAPH #7

**BUILDING 12
ATTIC REPAIRS - UNIT #1224**

Contractor has performed scab repairs at damaged trusses as per drawings.

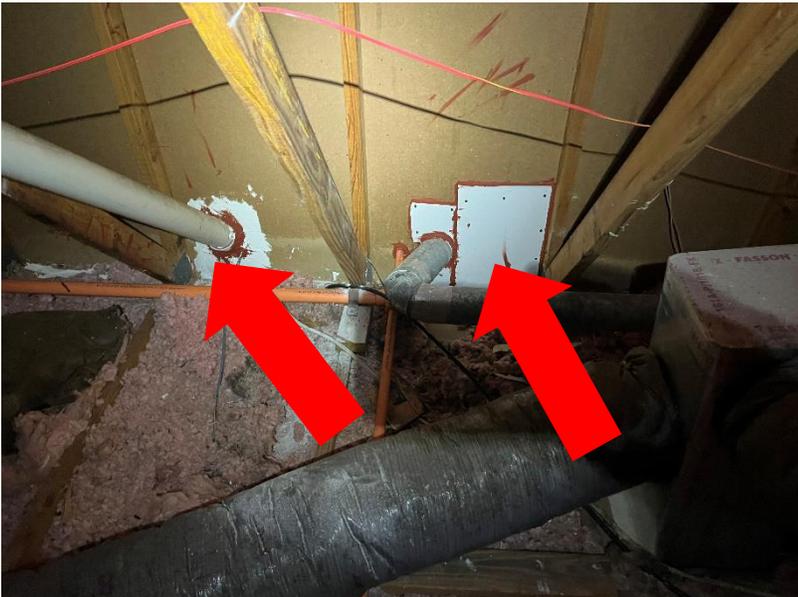
PHOTOGRAPH #8

**BUILDING 12
ATTIC REPAIRS - UNIT #1224**

Contractor has multiple fire wall repairs as per specifications.

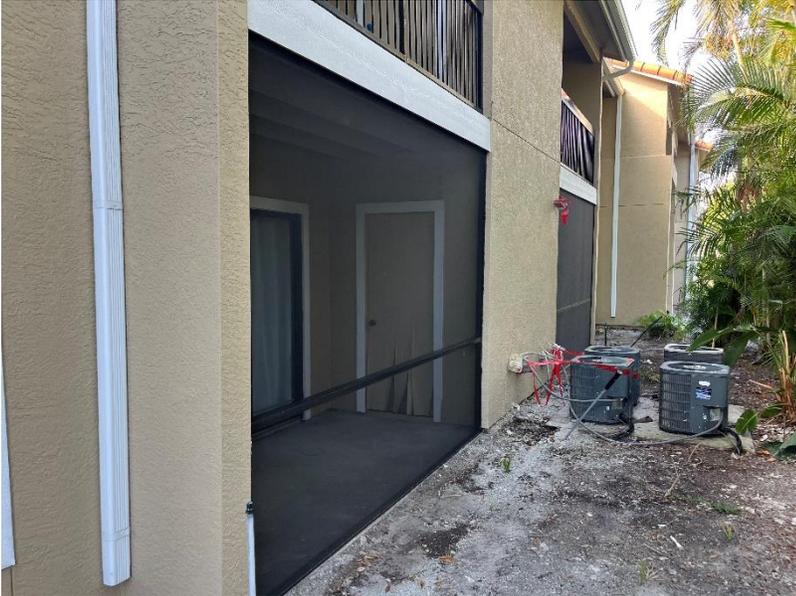
PHOTOGRAPH #9

**BUILDING 12
SECTION F**

Contractor has installed new screen enclosures at lower patios.

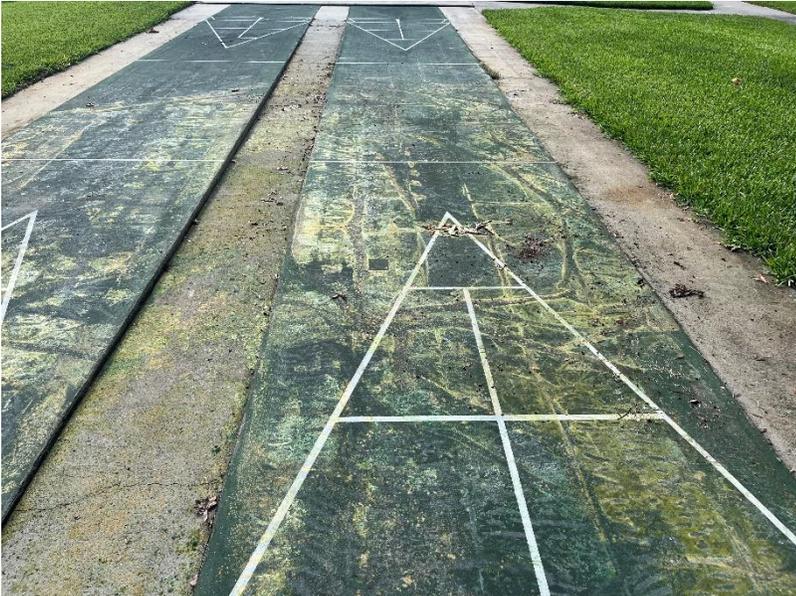
PHOTOGRAPH #10

**BUILDING 12
SECTION F**

Shuffleboard court stained by contractor covering and painting of railings.

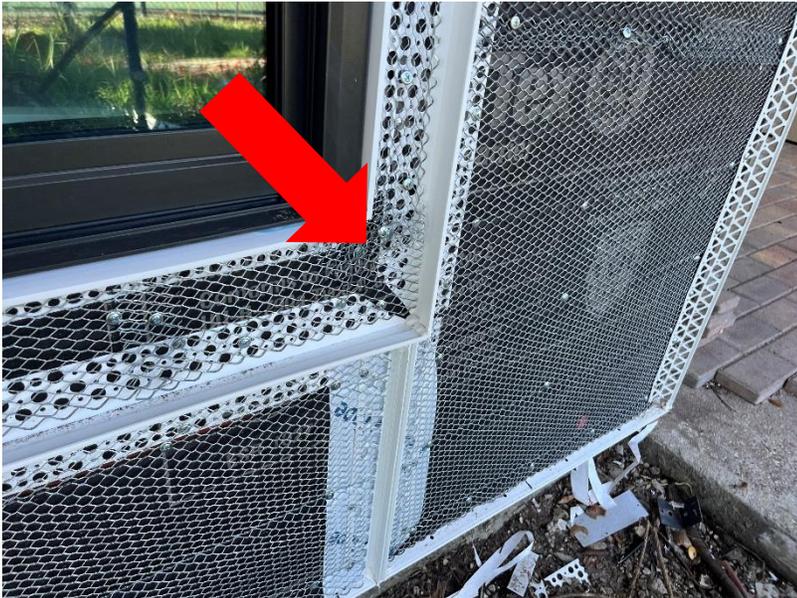
PHOTOGRAPH #11

**BUILDING 9
SECTION E**

Stucco Sub-contractor has installed metal lath butterfly fastened to self-furring metal lath at each corner of windows as per drawings.

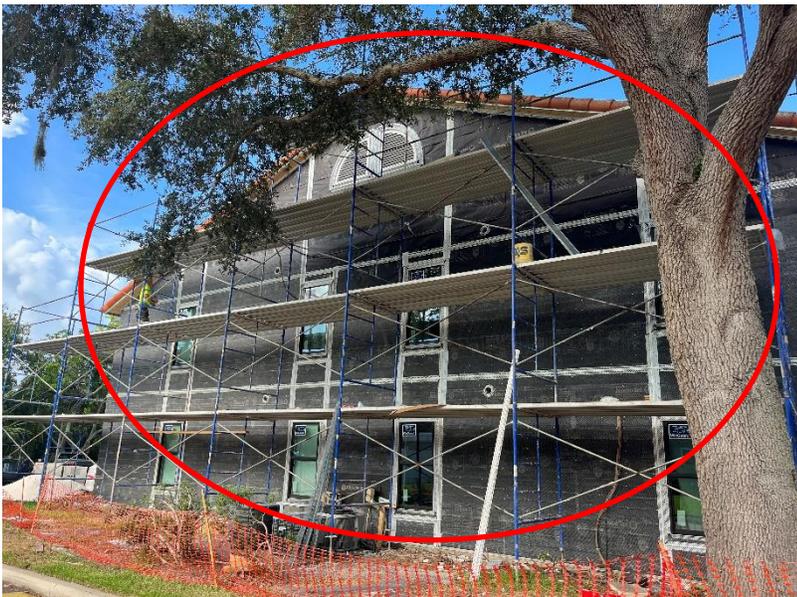
PHOTOGRAPH #12

**BUILDING 9
SECTION D**

Sub-contract has applied new vinyl stucco accessories and self-furring metal lath per ASTM C1063 for application of stucco.

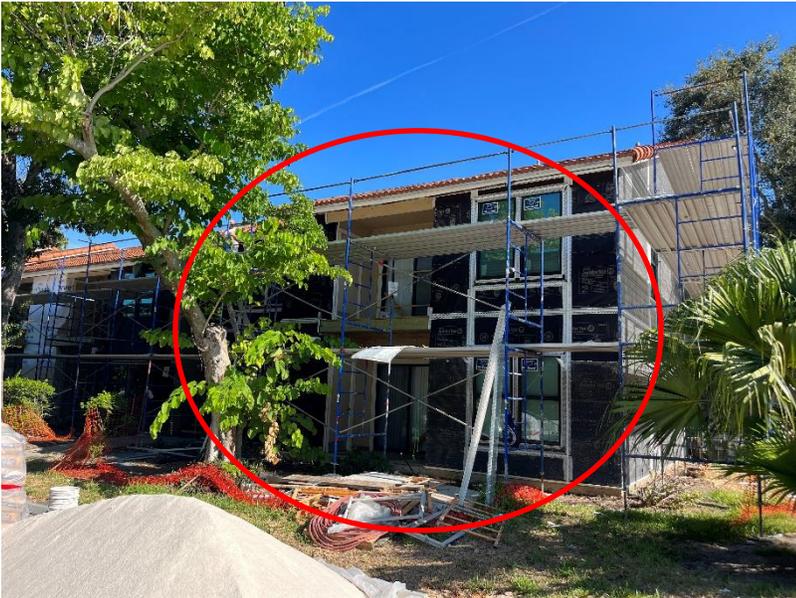
PHOTOGRAPH #13

**BUILDING 9
SECTION C**

Sub-contract has applied new Jumbo Tex WRB and vinyl stucco accessories over Tyvek water resistant barrier.

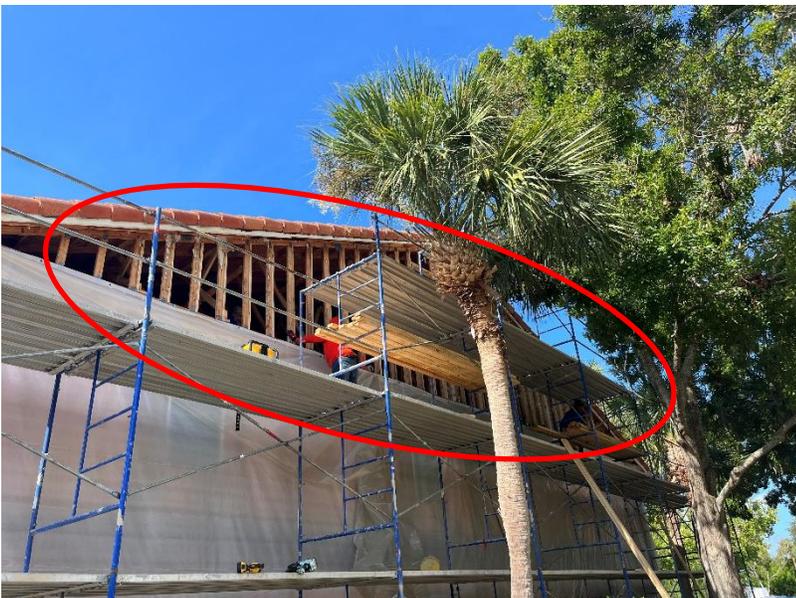
PHOTOGRAPH #14

**BUILDING 15
SECTION H**

Gable end wall bracing repairs in progress.

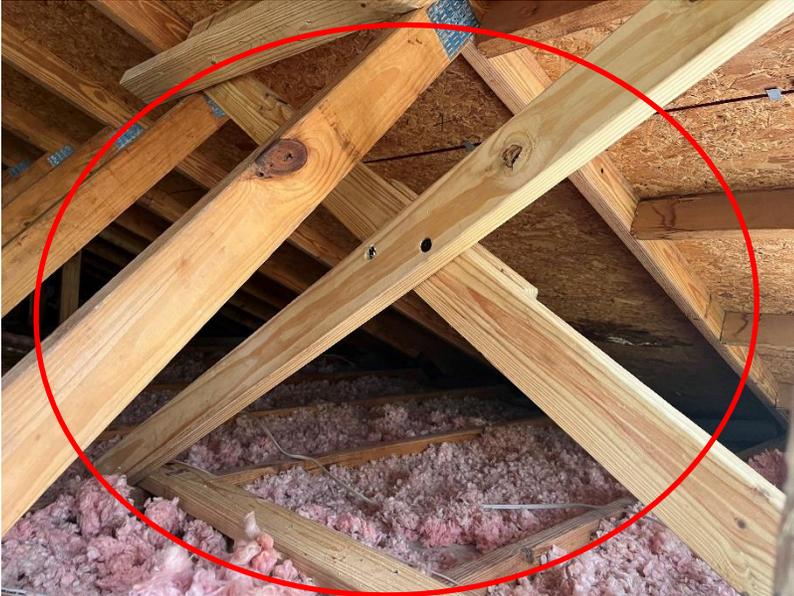
PHOTOGRAPH #15

**BUILDING 15
SECTION H**

2x4 bracing @48" O.C. as per drawings and details.

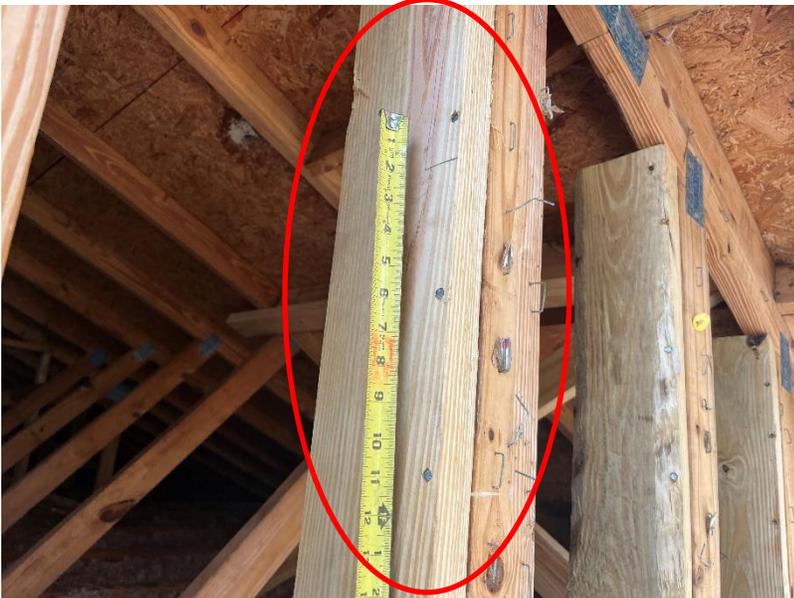
PHOTOGRAPH #16

**BUILDING 15
SECTION H**

2x6 L-Scab reinforcement fastened with 10d nails at 6" O.C. as per drawings.

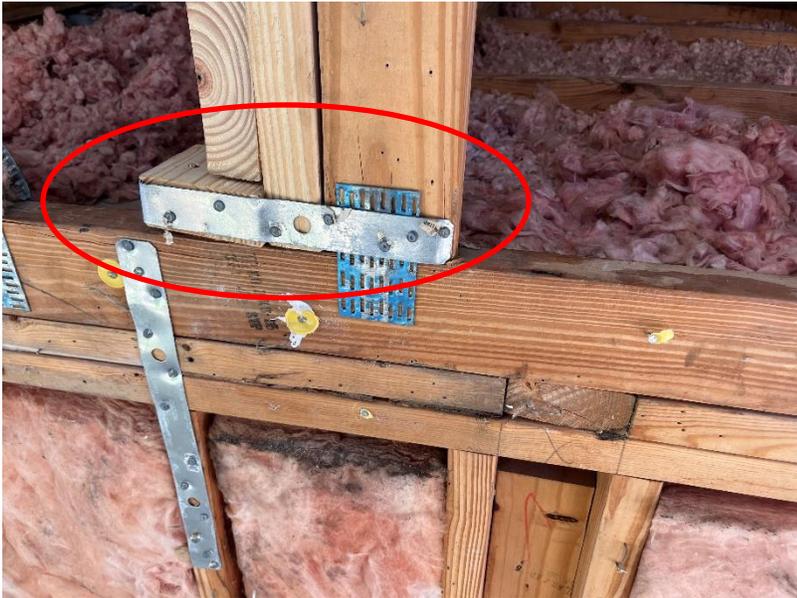
PHOTOGRAPH #17

**BUILDING 15
SECTION H**

Simpson #LSTA-21 strap at end of lateral braces as per drawings.

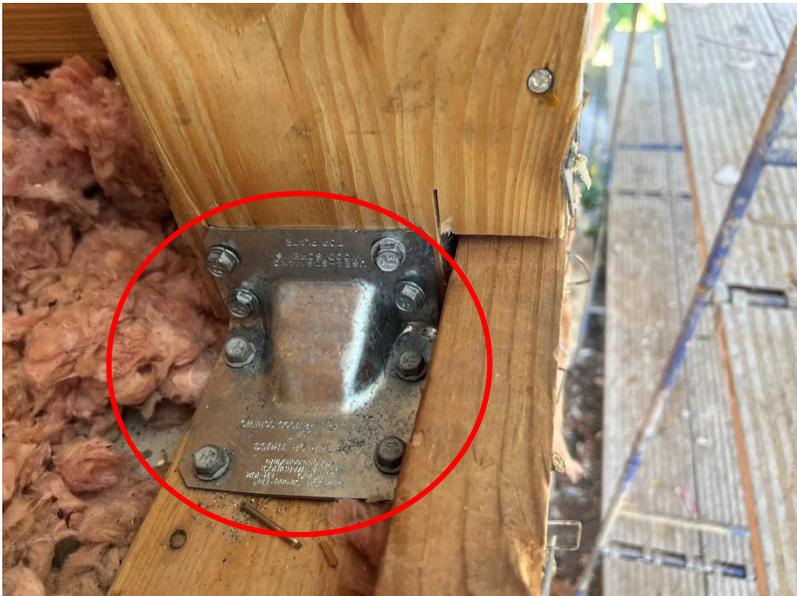
PHOTOGRAPH #18

**BUILDING 15
SECTION H**

Simpson #HGA10 attaching gable truss to plate as per drawings.

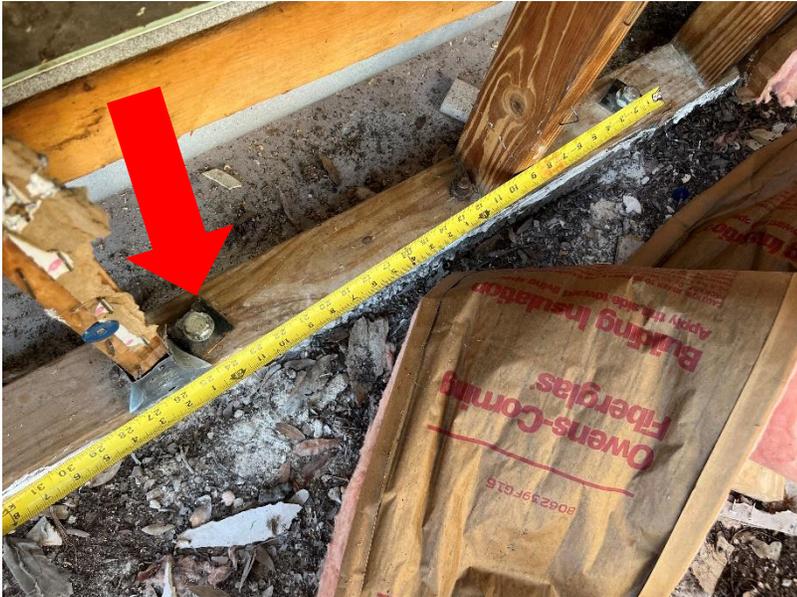
PHOTOGRAPH #19

**BUILDING 15
SECTION H**

Bottom plate fastened into existing footing with 5/8" Simpson Titen HD @ 24" O.C. as per drawings.

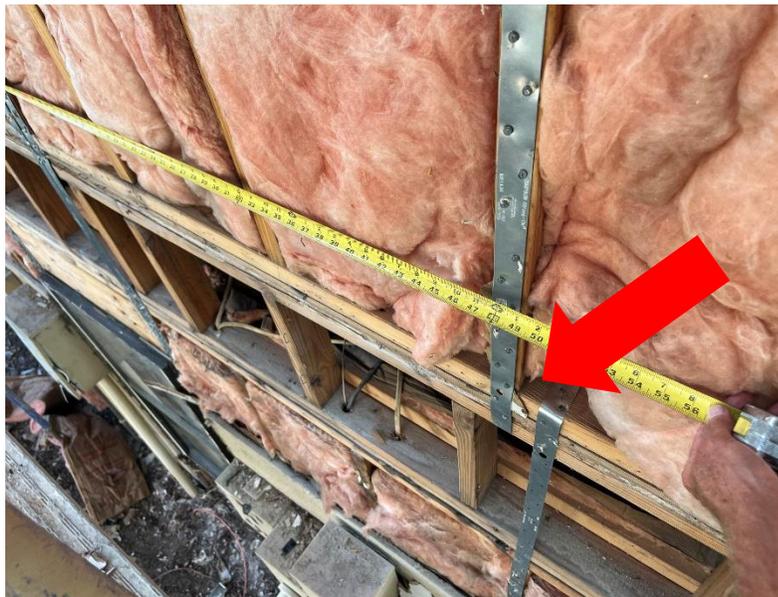
PHOTOGRAPH #20

**BUILDING 15
SECTION H**

Simpson MSTA 36 straps fastened from framing studs to second floor bottom plate and floor truss as per drawings.

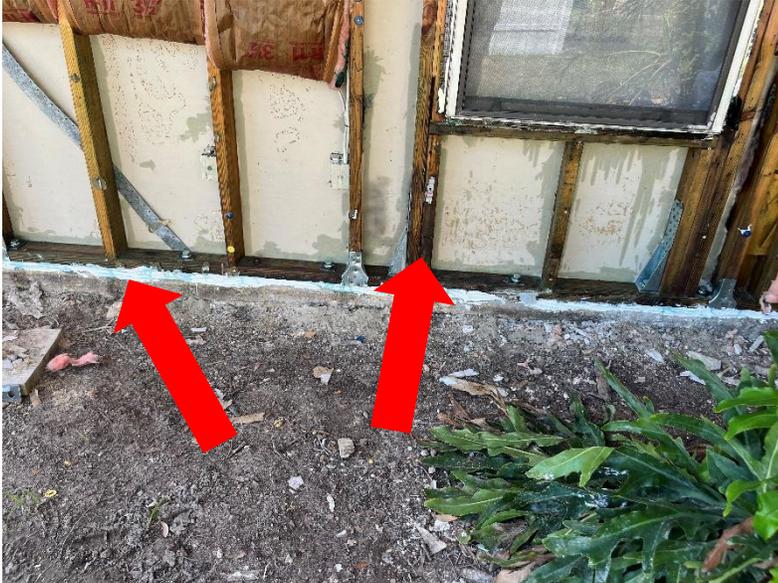
PHOTOGRAPH #21

**BUILDING 15
SECTION H**

New urethane sealant from bottom plate to existing footing and copper green wood preservative applied at bottom 2' of framing as per drawings and specifications.

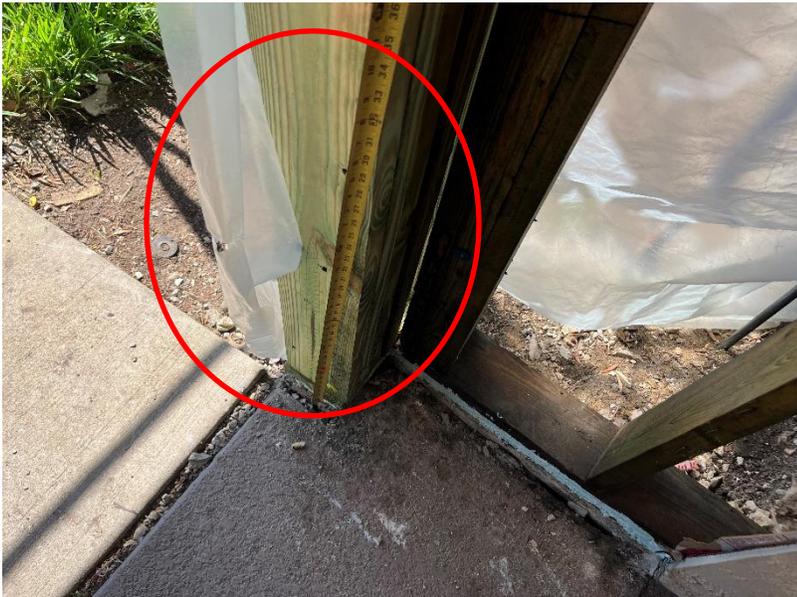
PHOTOGRAPH #22

**BUILDING 15
SECTION G**

Copper green wood preservative applied at bottom 2' of framing as per drawings and specifications.

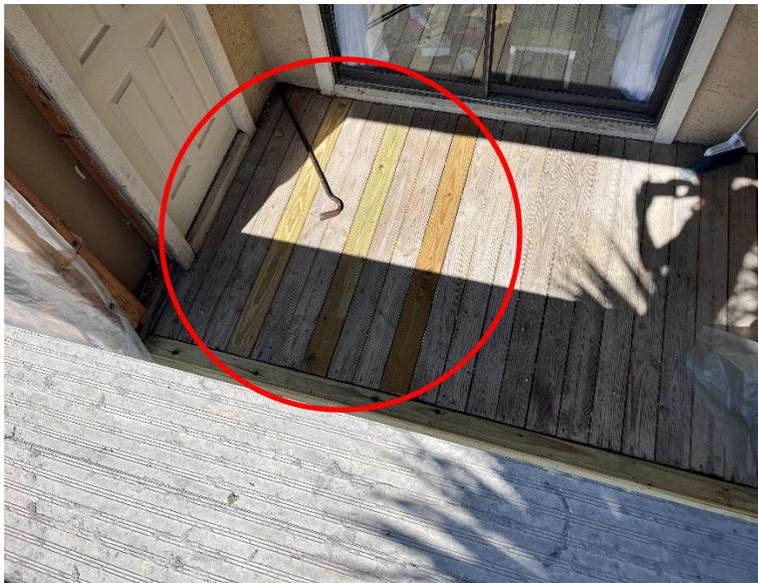
PHOTOGRAPH #23

**BUILDING 15
SECTION G-UNIT #1522**

New PT. 2x6 deck board replaced at balcony deck were marked for repairs.

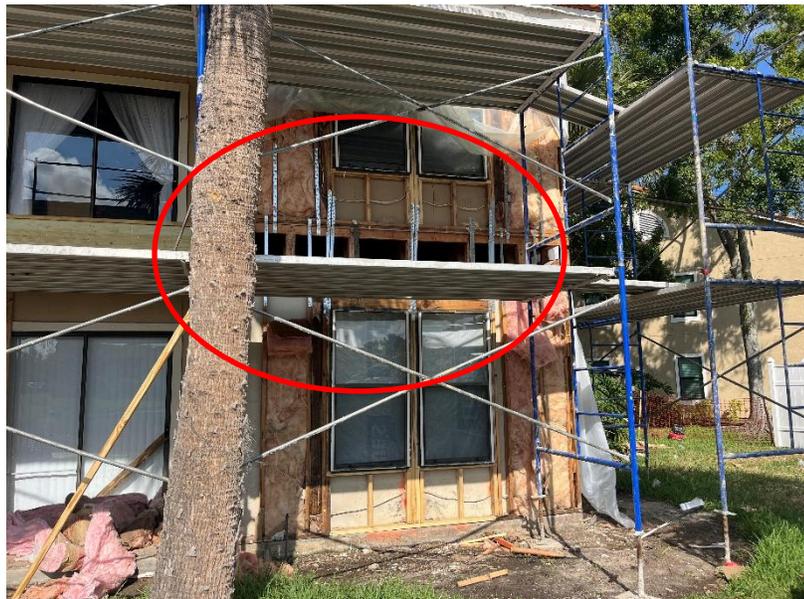
PHOTOGRAPH #24

**BUILDING 15
SECTION G**

Contractor has provided Simpson Strong-Tie MSTA straps at framing between floors as per drawings.
