**BUILDING 12
ATTIC REPAIRS -UNIT #1221**

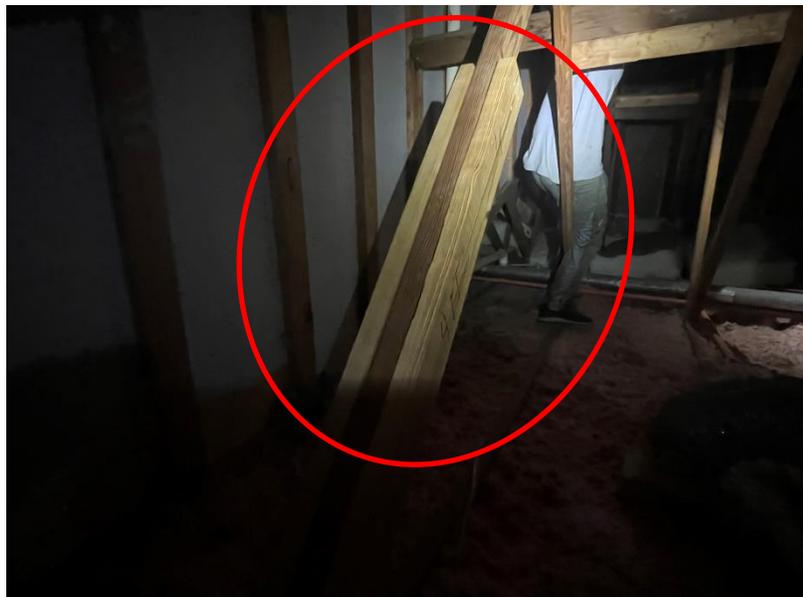
PHOTOGRAPH #1

Contractor has performed scab repairs at damaged trusses as per drawings.

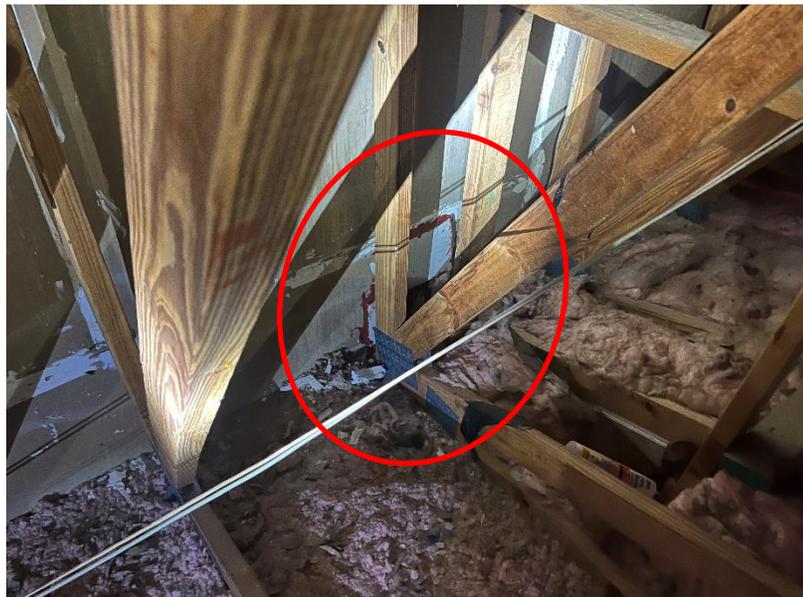
PHOTOGRAPH #2

**BUILDING 12
ATTIC REPAIRS -UNIT #1221**

Contractor has multiple fire wall repairs as per specifications.

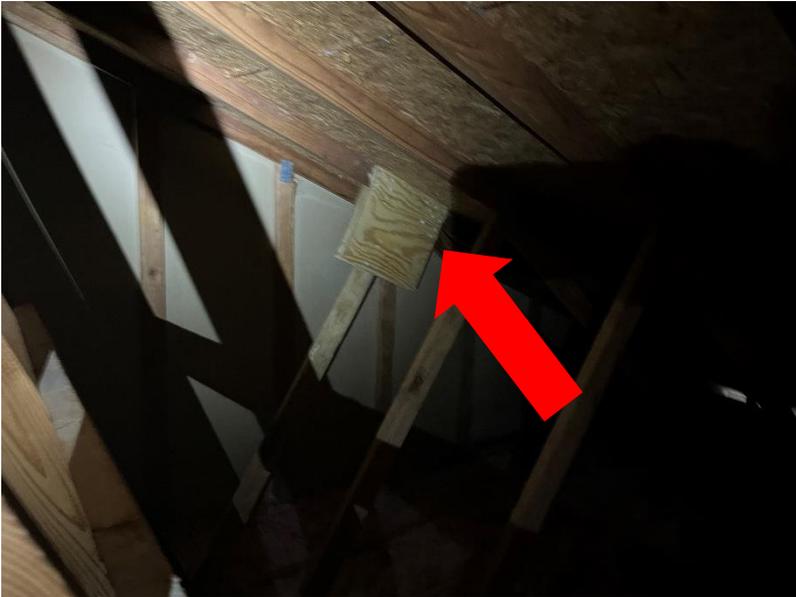
PHOTOGRAPH #3

**BUILDING 12
ATTIC REPAIRS - UNIT #1223**

Contractor has performed gusset repairs at damaged truss connectors as per drawings.

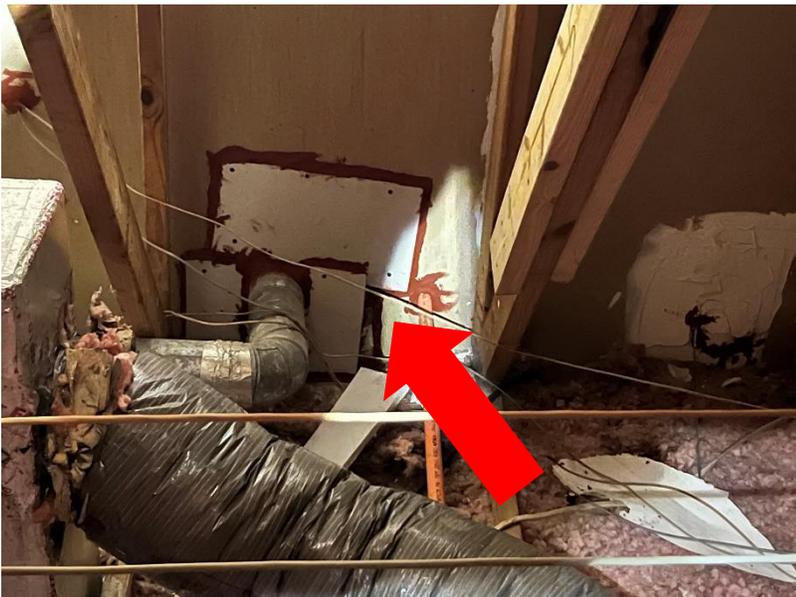
PHOTOGRAPH #4

**BUILDING 12
ATTIC REPAIRS - UNIT #1223**

Contractor has performed fire board and fire caulk repairs at penetrations of fire wall.

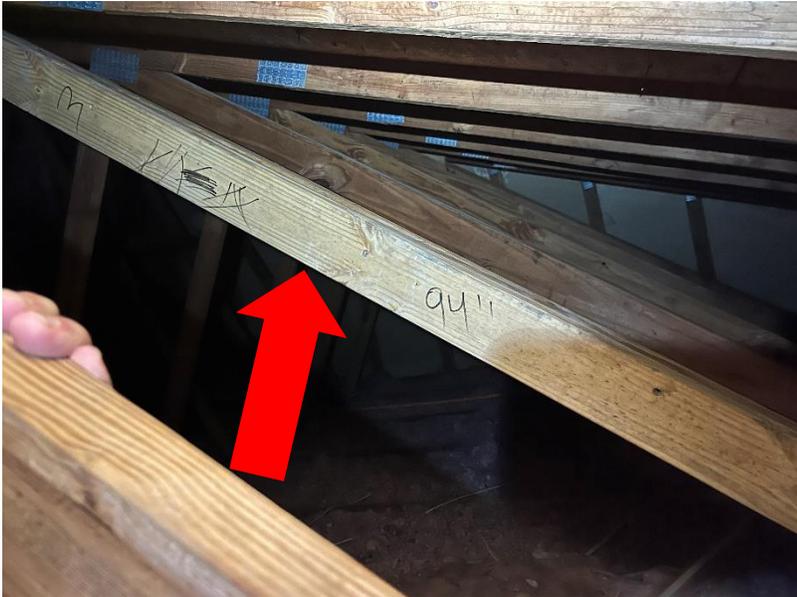
PHOTOGRAPH #5

**BUILDING 12
ATTIC REPAIRS - UNIT #1223**

Contractor has performed scab repairs at damaged trusses as per drawings.

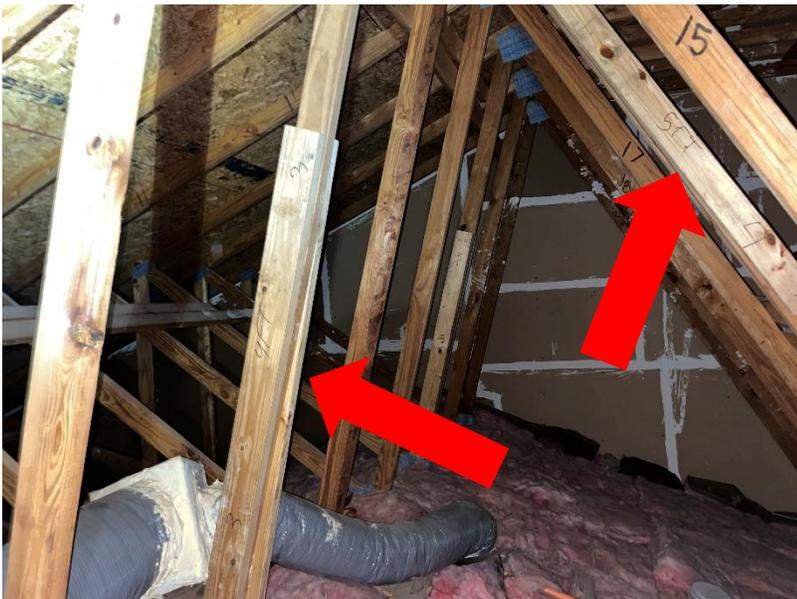
PHOTOGRAPH #6

**BUILDING 12
ATTIC REPAIRS - UNIT #1223**

Contractor has performed scab repairs at damaged trusses as per drawings.

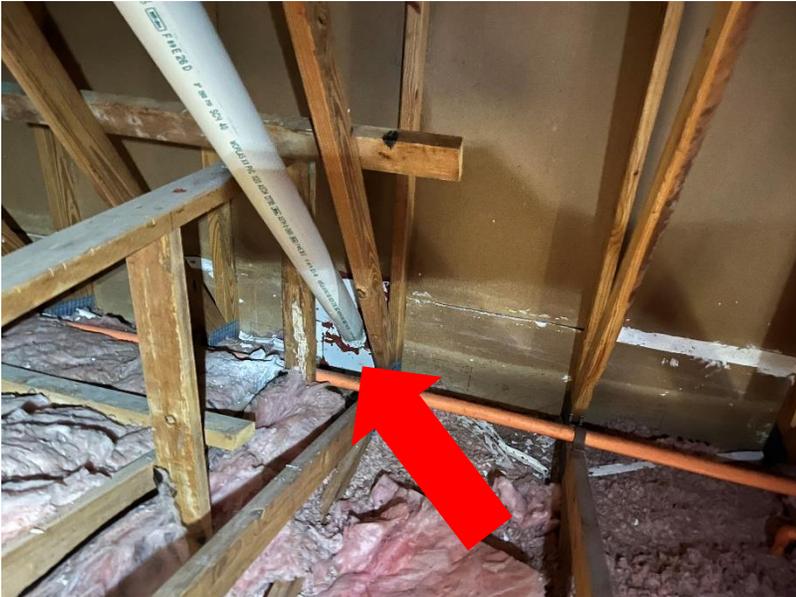
PHOTOGRAPH #7

**BUILDING 12
ATTIC REPAIRS - UNIT #1222**

Contractor has performed fire wall repairs as per specifications.

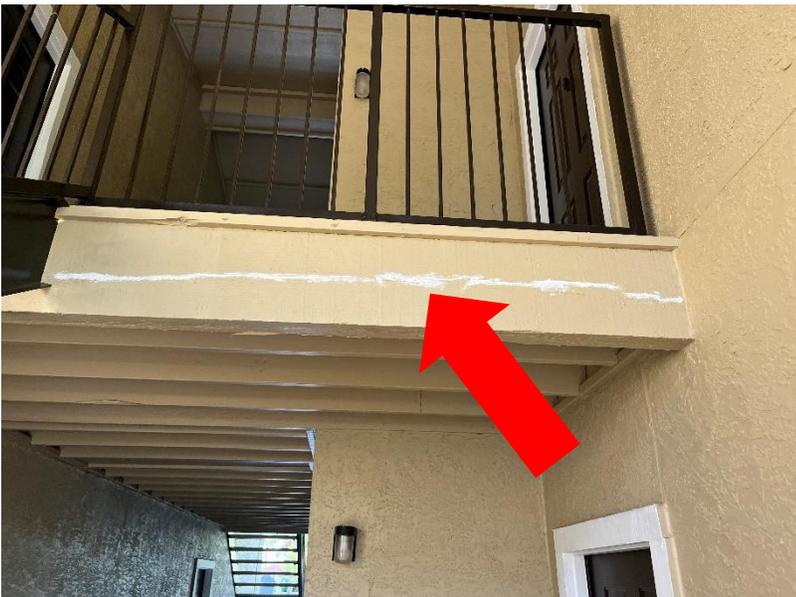
PHOTOGRAPH #8

**BUILDING 12
SECTION G-BREEZEWAYS**

Contractor has sealed cracks in cedar beams.

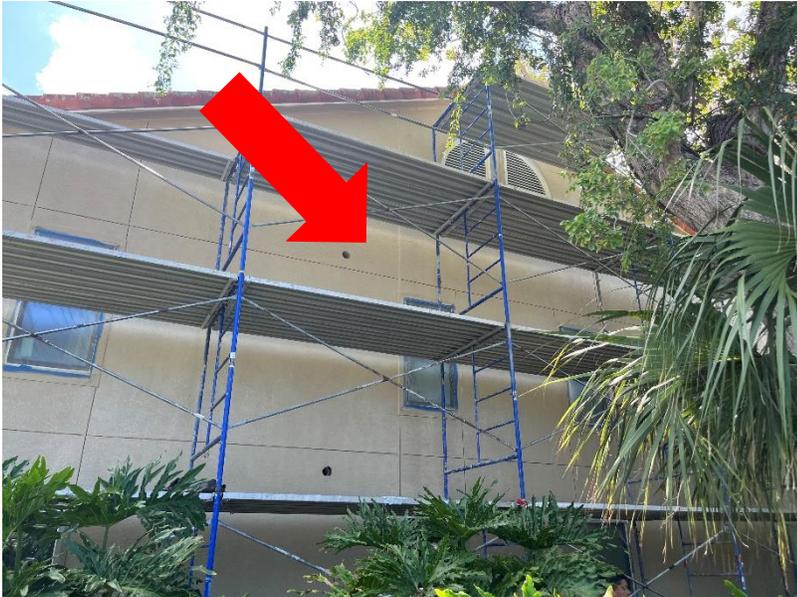
PHOTOGRAPH #9

**BUILDING 9
SECTION H**

Contractor has begun painting new stucco with Florida Paints Acrylic Paint.

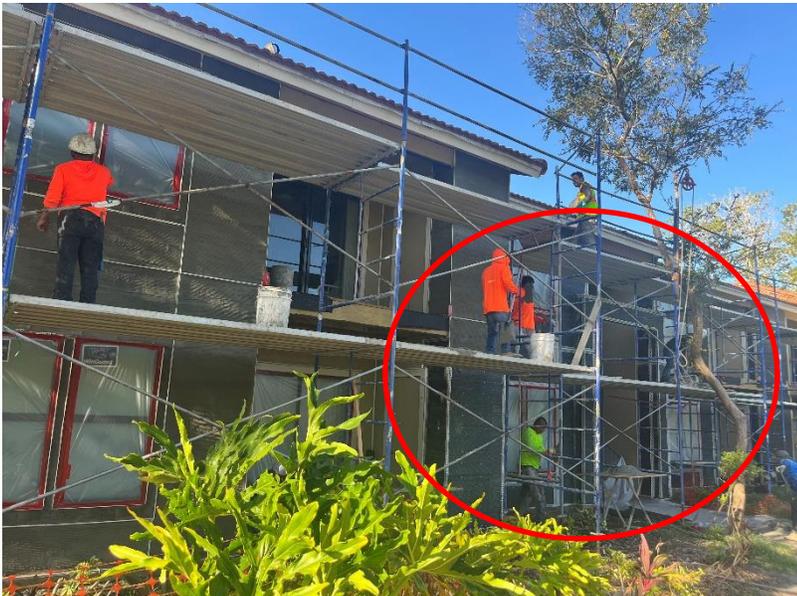
PHOTOGRAPH #10

**BUILDING 9
SECTION F**

Stucco sub-contract applying scratch coat of new stucco.

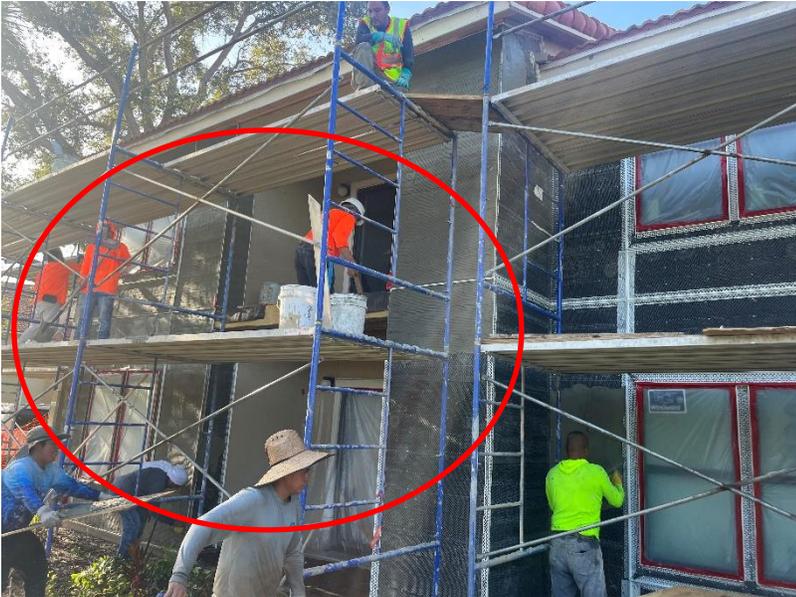
PHOTOGRAPH #11

**BUILDING 9
SECTION E**

Stucco sub-contract applying scratch coat of new stucco.

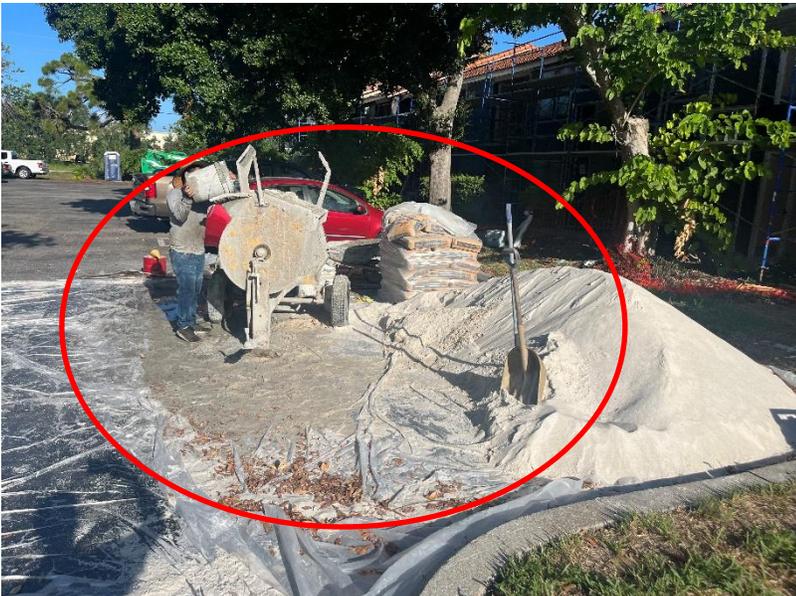
PHOTOGRAPH #12

**BUILDING 9
SECTION E**

Stucco sub-contractor mixing sand with CEMEX Broco stucco cement bag mix.

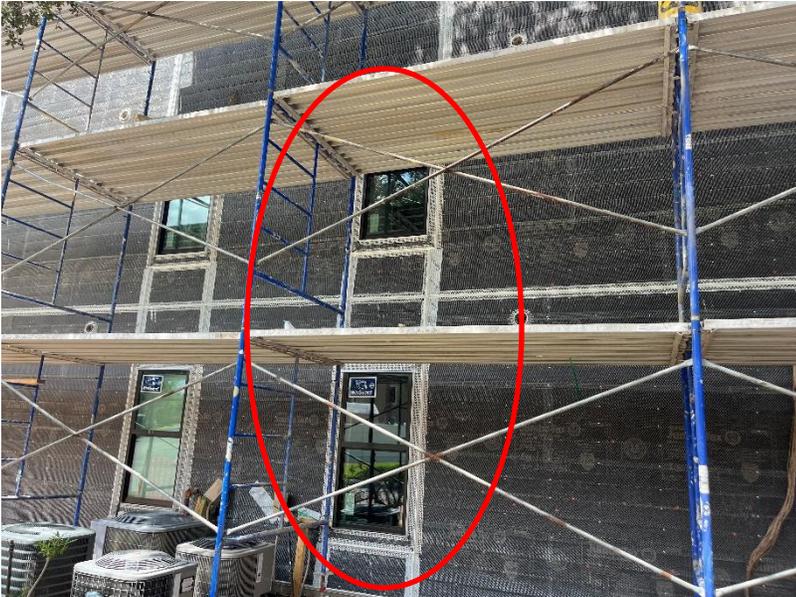
PHOTOGRAPH #13

**BUILDING 9
SECTION D**

Unit #918- New window framed and installed in wrong location not lining up with other windows.

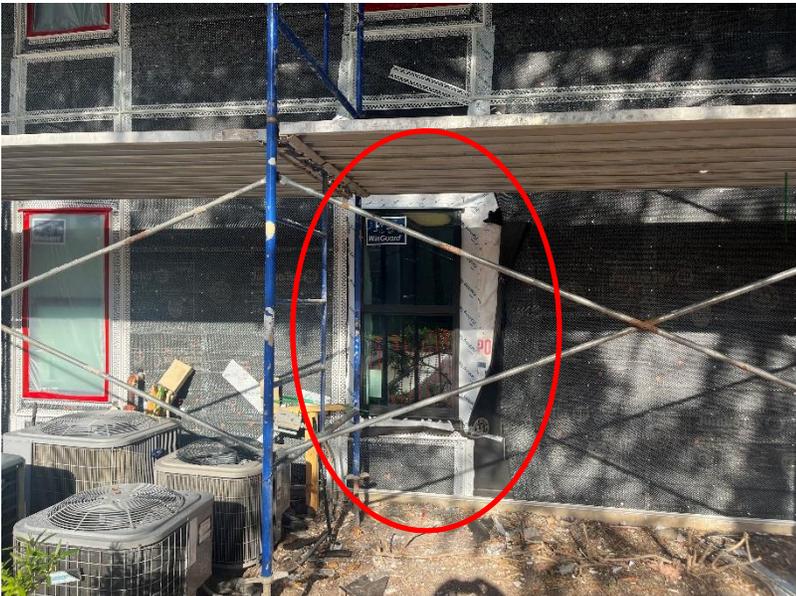
PHOTOGRAPH #14

**BUILDING 9
SECTION D**

Unit #918- Contractor removed, reframed, and reinstalled new PGT window in correct location.

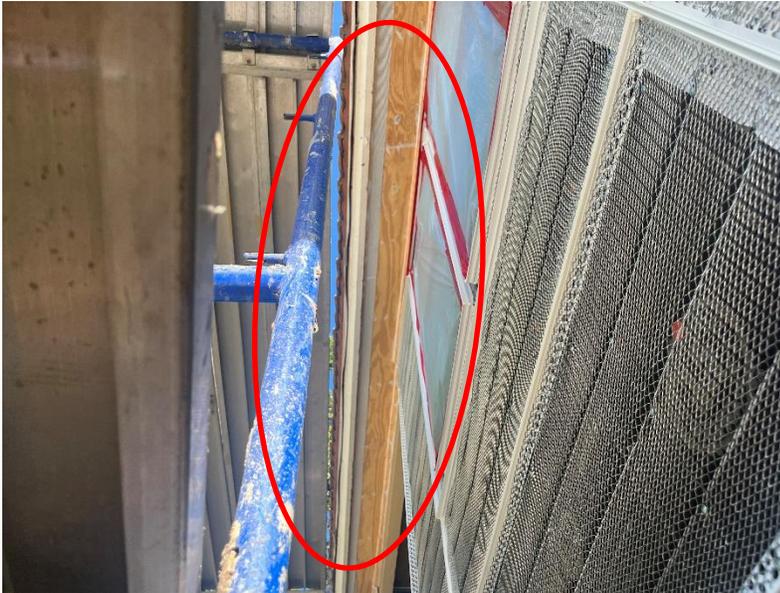
PHOTOGRAPH #15

**BUILDING 9
SECTION D**

Contractor has installed new plywood soffit with vinyl vent as per specifications.

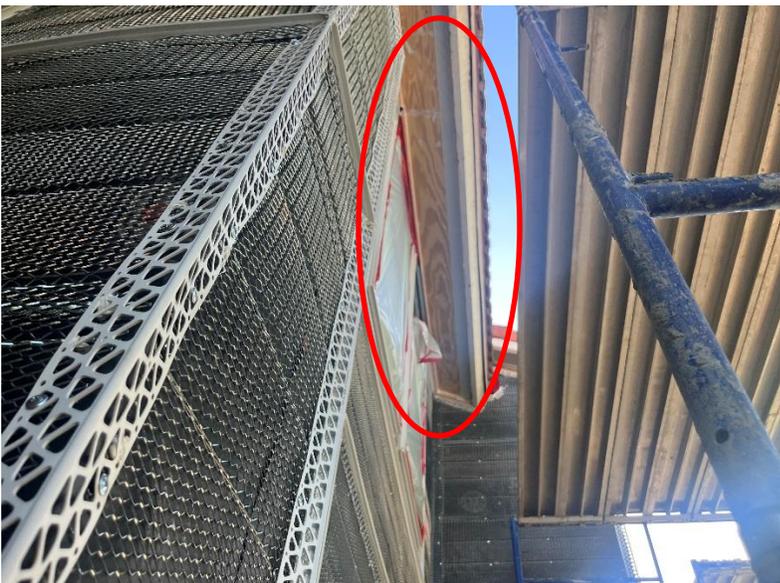
PHOTOGRAPH #16

**BUILDING 9
SECTION C**

Contractor has installed new plywood soffit with vinyl vent as per specifications.

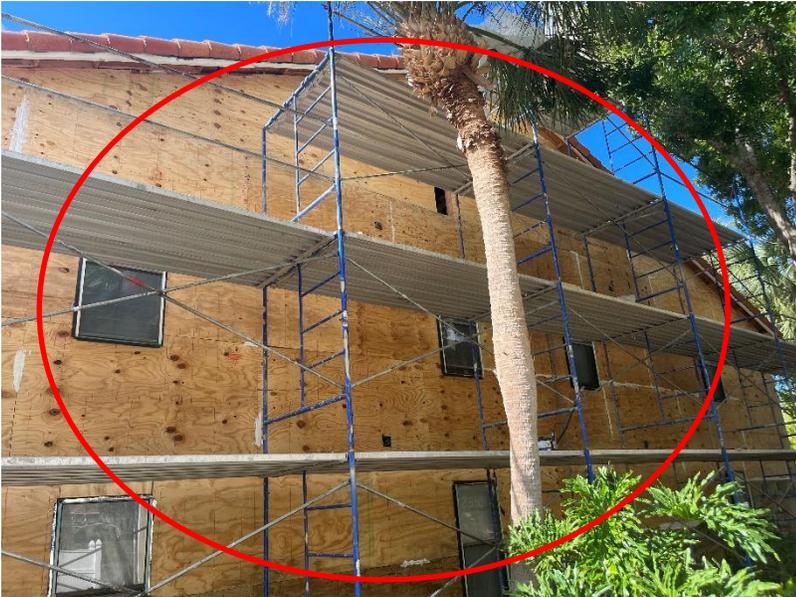
PHOTOGRAPH #17

**BUILDING 15
SECTION H**

New 15/32" plywood sheathing installed at gable end wall.

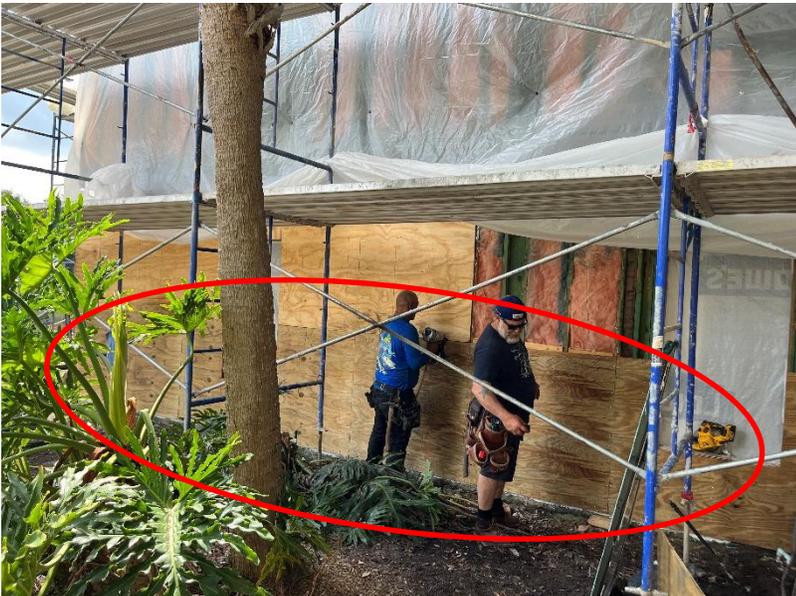
PHOTOGRAPH #18

**BUILDING 15
SECTION H**

Bottom 4x8 sheets of sheathing installed with pressure treated plywood as per specifications.

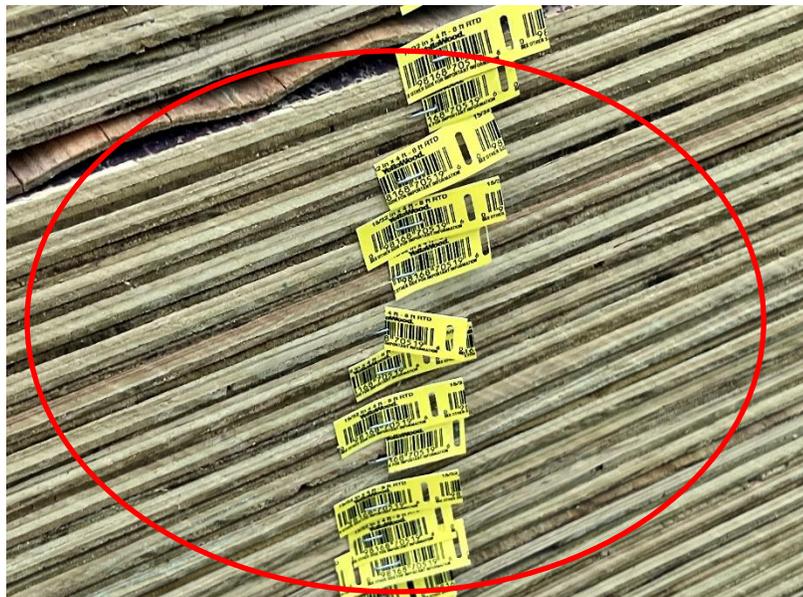
PHOTOGRAPH #19

**BUILDING 15
SECTION H**

Bottom 4x8 sheets of sheathing installed with pressure treated plywood as per specifications.

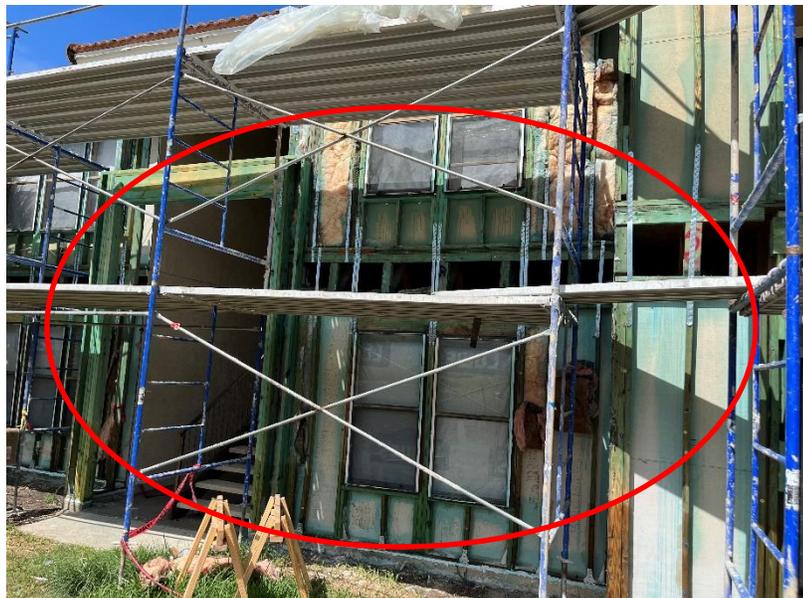
PHOTOGRAPH #20

**BUILDING 15
SECTION G**

Termite contractor has applied Bora Care termite treatment to wall framing as per specification.

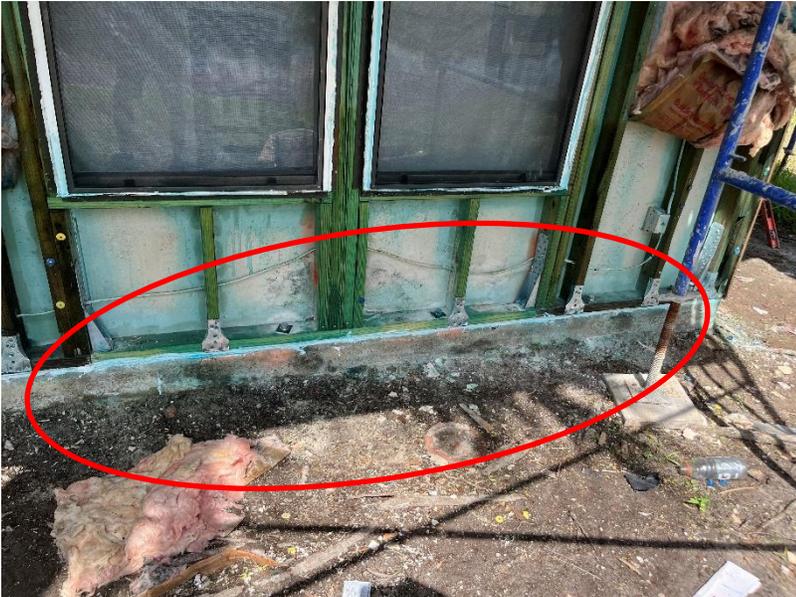
PHOTOGRAPH #21

**BUILDING 15
SECTION G**

Bottom plate fastened into existing footing with 5/8" Simpson Titen HD @ 24" O.C. as per drawings.

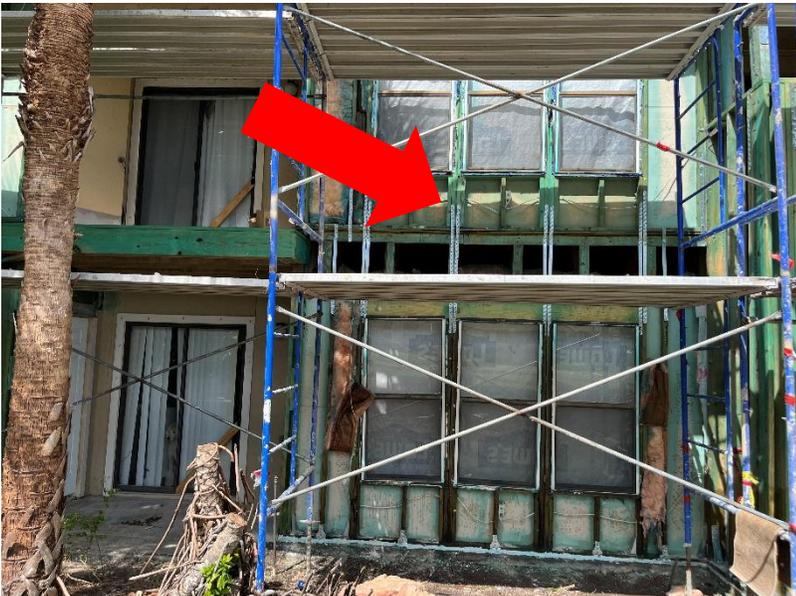
PHOTOGRAPH #22

**BUILDING 15
SECTION F**

Simpson MST A strap connectors installed from studs to studs at first to second floor transition as per drawings.

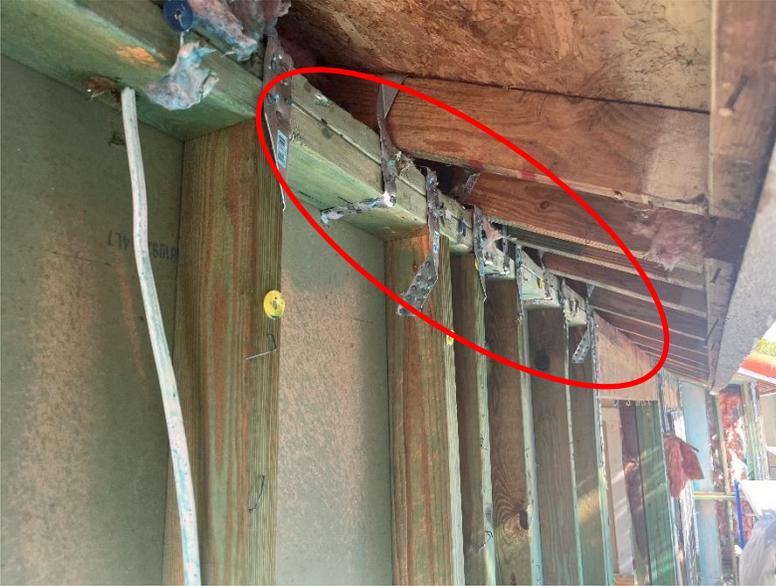
PHOTOGRAPH #23

**BUILDING 15
SECTION F**

Simpson Strong Tie connectors and screws attaching framing studs to top plate and top plate to roof trusses as per drawings.

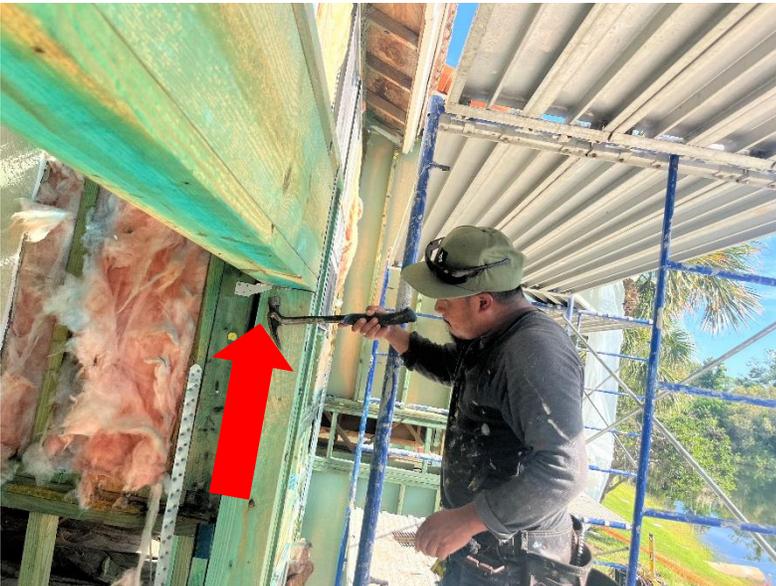
PHOTOGRAPH #24

**BUILDING 15
SECTION E**

Contractor installing Simpson H3 connector at box beam to stud as per drawings.

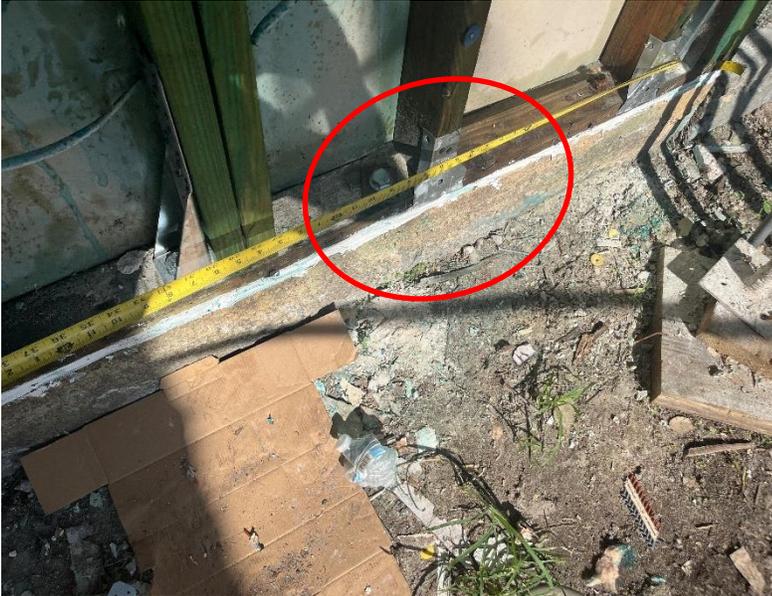
PHOTOGRAPH #25

**BUILDING 15
SECTION E**

Wall framing studs attached to bottom plate with Simpson SP1 connectors as per drawings.
