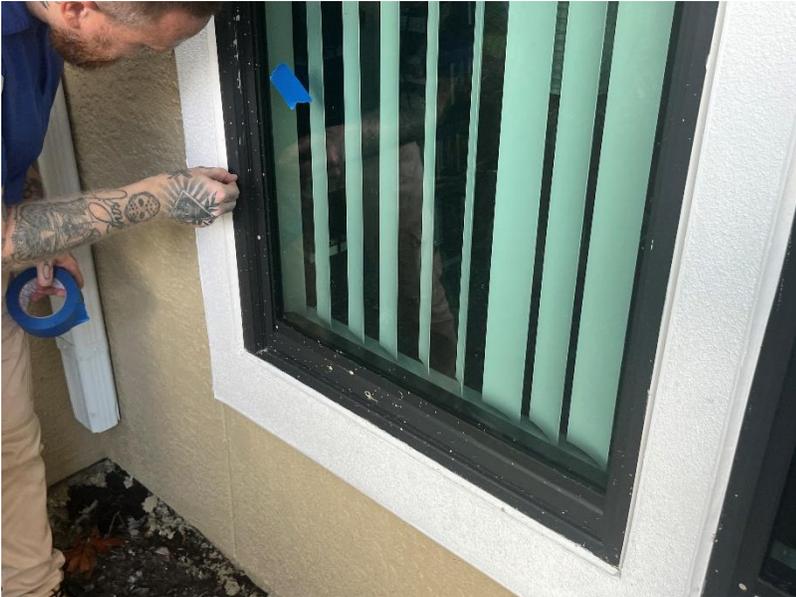
PHOTOGRAPH #1

**BUILDING 12
EXTERIOR PUNCH LIST**

Walked exterior of building with Contractor and developed an itemized punch list.

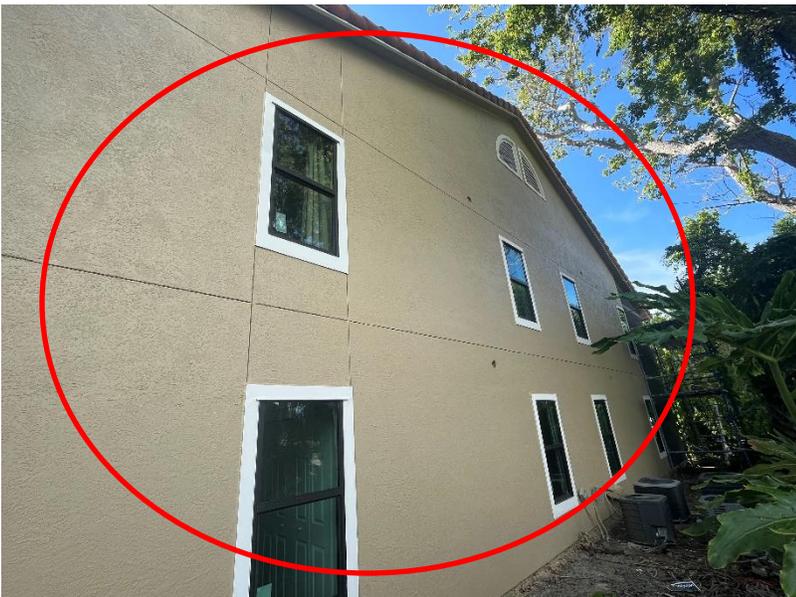
PHOTOGRAPH #2

**BUILDING 9
SECTION H**

Contractor has applied finish coat of Florida Paint Glades Exterior 100% acrylic paint and removed access scaffolding.

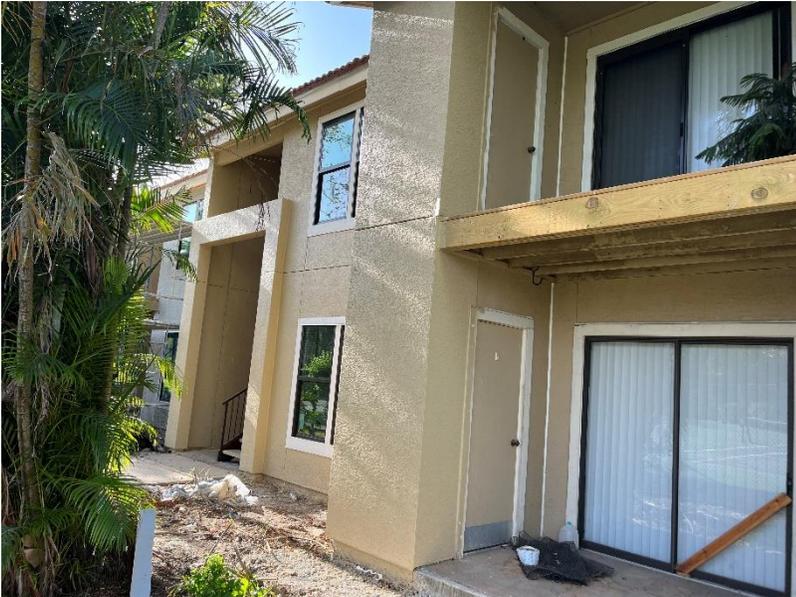
PHOTOGRAPH #3

**BUILDING 9
SECTION G**

Contractor has applied finish coat of Florida Paint Glades Exterior 100% acrylic paint and removed access scaffolding.

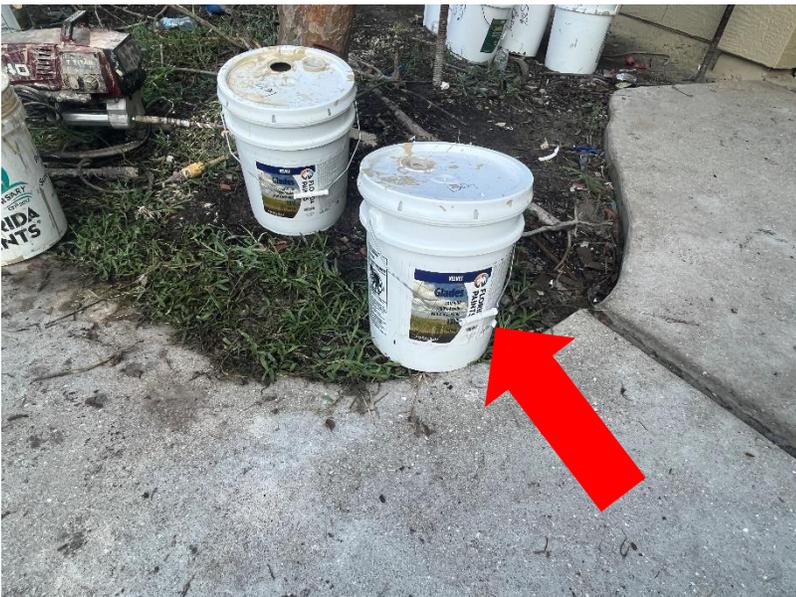
PHOTOGRAPH #4

**BUILDING 9
SECTION G**

Contractor has applied finish coat of Florida Paint Glades Exterior 100% acrylic paint and removed access scaffolding.

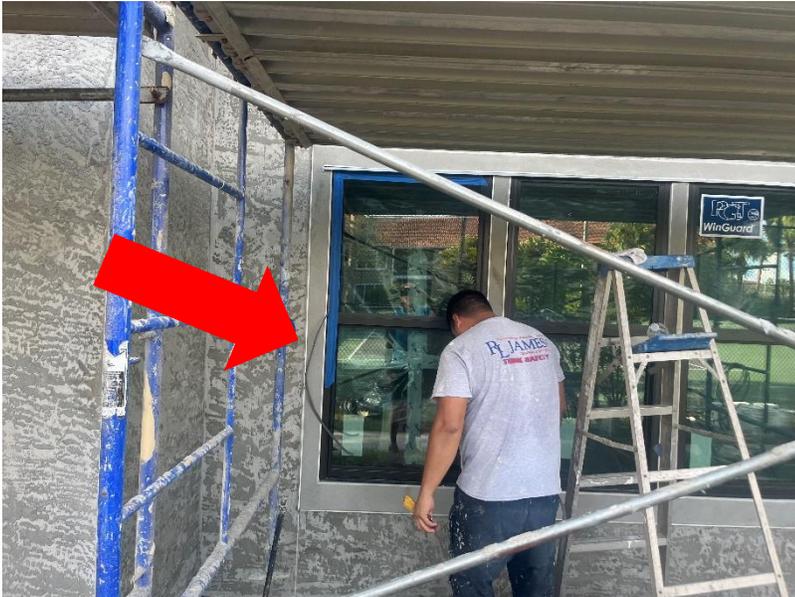
PHOTOGRAPH #5

**BUILDING 9
SECTION F**

Contractor installing masking window edge and installing soft cell backing rod in preparation for sealant installation at new PGT windows.

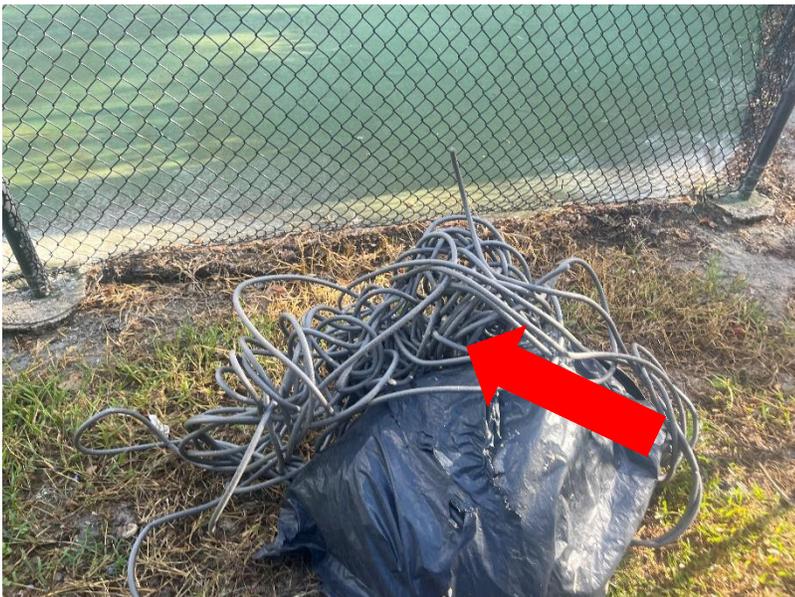
PHOTOGRAPH #6

**BUILDING 9
SECTION F**

Contractor installing masking window edge and installing soft cell backing rod in preparation for sealant installation at new PGT windows.

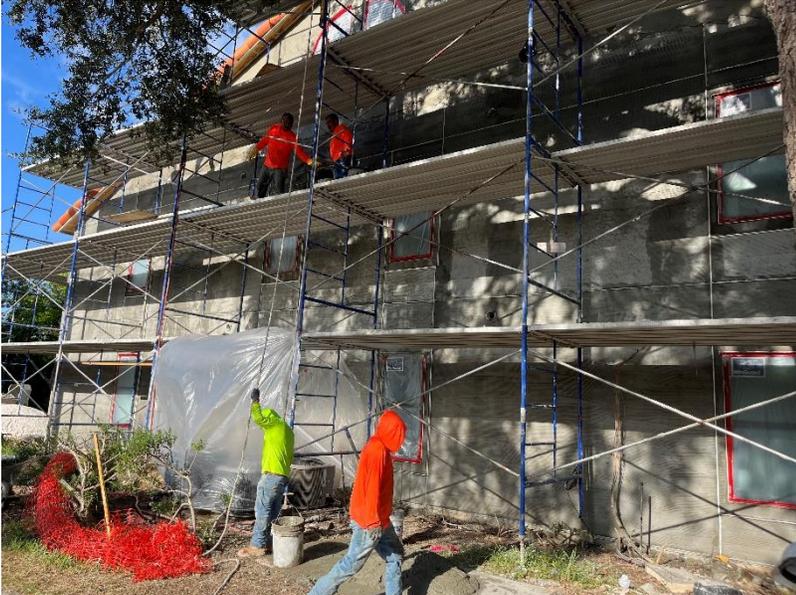
PHOTOGRAPH #7

**BUILDING 9
SECTION D**

Stucco sub-contractor applying scratch coat of three coat 7/8" stucco system.

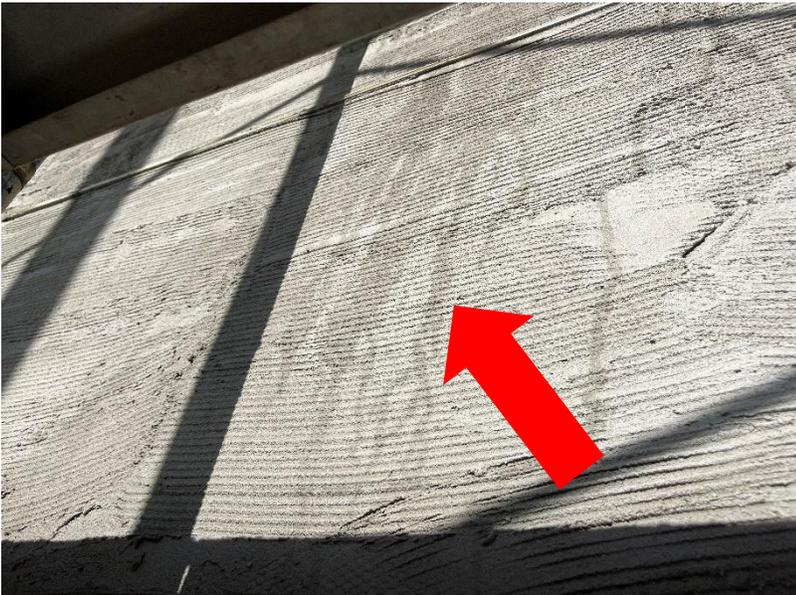
PHOTOGRAPH #8

**BUILDING 9
SECTION D**

Stucco sub-contractor applying scratch coat of three coat 7/8" stucco system.

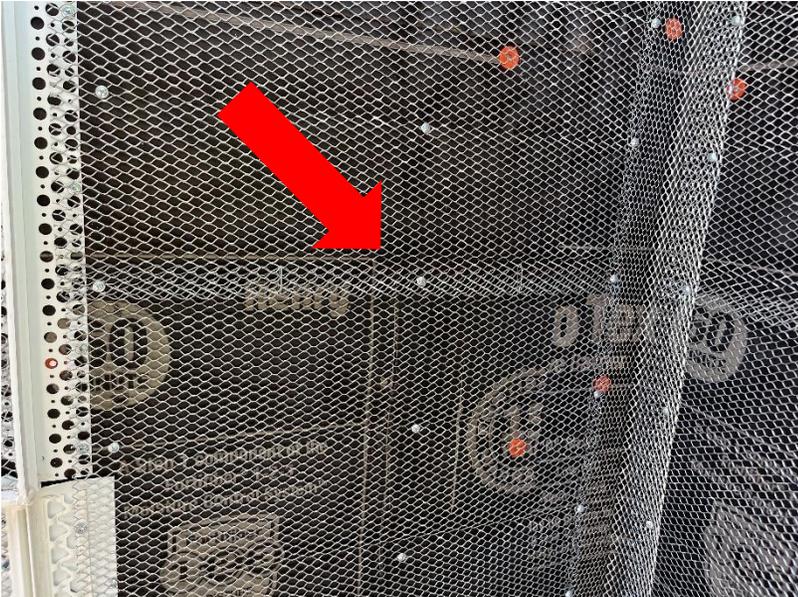
PHOTOGRAPH #9

**BUILDING 9
SECTION B**

Self-furring galvanized lath applied over Jumbo Tex WRB and attached at framing with approved self-tapping screws.

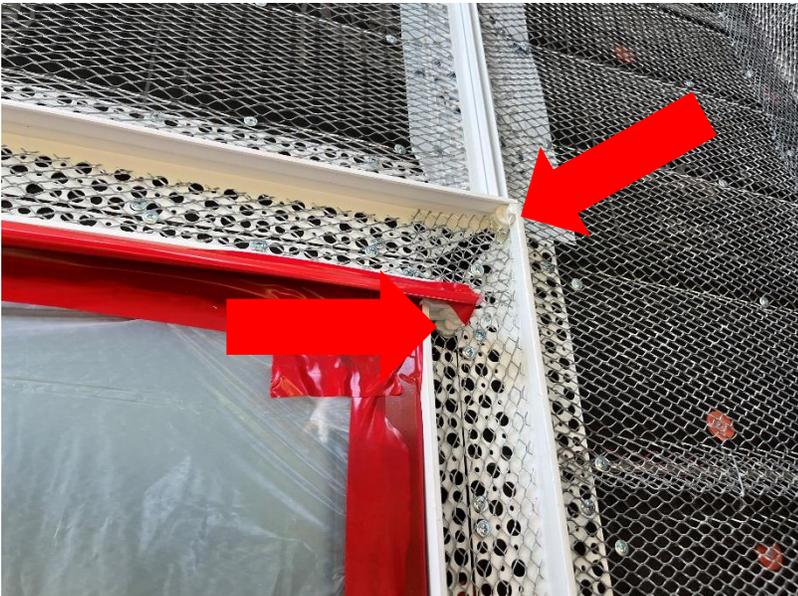
PHOTOGRAPH #10

**BUILDING 9
SECTION B**

Urethane sealant applied at intersections butts and junctures of vinyl stucco accessories as per drawings.

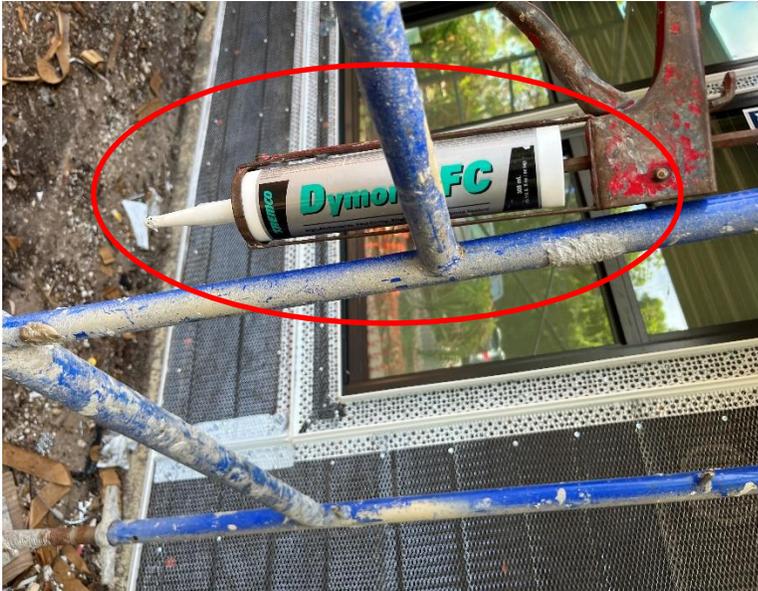
PHOTOGRAPH #11

**BUILDING 9
SECTION B**

Urethane sealant applied at intersections butts and junctures of vinyl stucco accessories as per drawings.

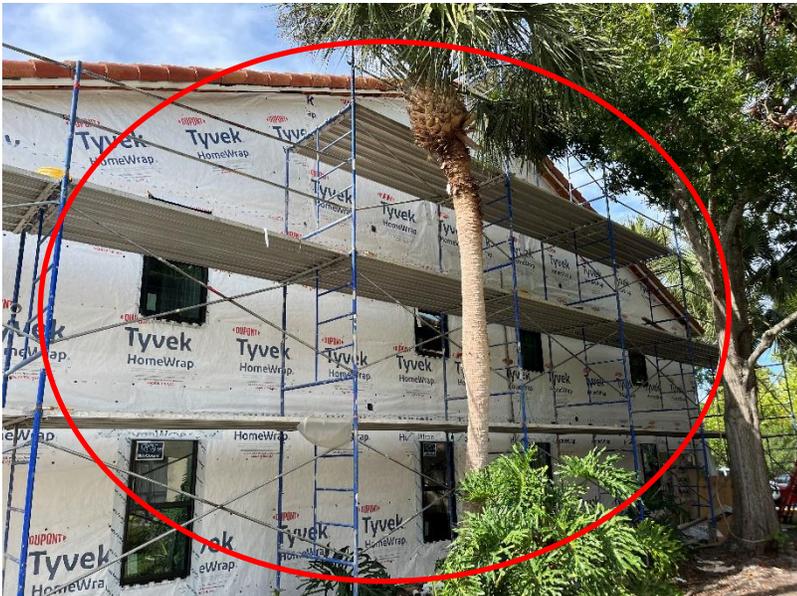
PHOTOGRAPH #12

**BUILDING 15
SECTION H**

New DuPont Tyvek HomeWrap applied and new PGT windows installed with DuPont Flashings as per manufacture's recommendations and drawings.

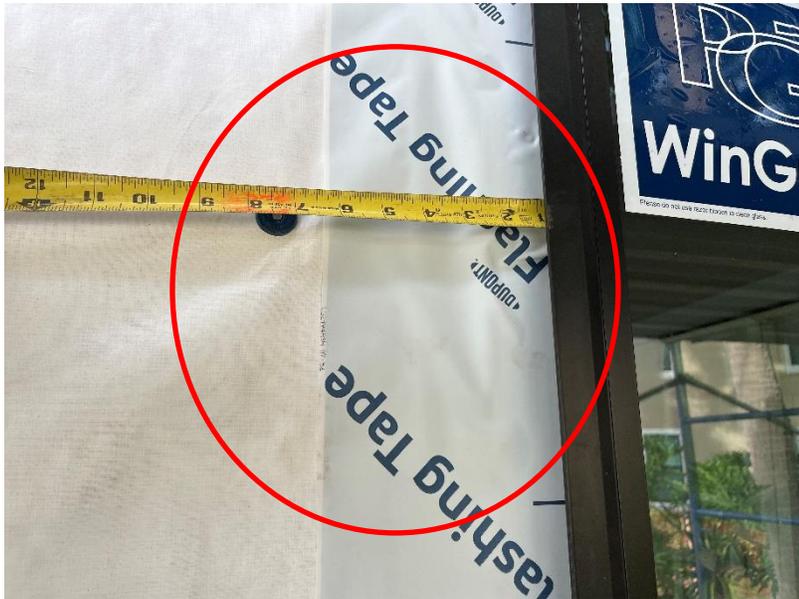
PHOTOGRAPH #13

**BUILDING 15
SECTION H**

DuPont Flashing tape applied over window frame as per manufacturer's recommendations and drawings. HomeWrap fastening tab is minimum 6" from window frame as per manufacturer's recommendations.

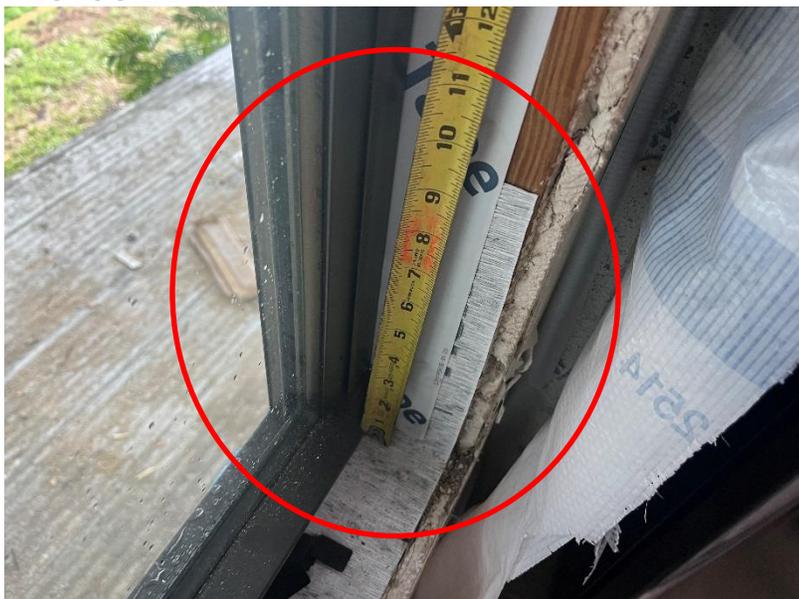
PHOTOGRAPH #14

**BUILDING 15
SECTION H- UNIT #1521**

Dupont flashing overlapping FlexWrap NF at jams as per manufacturer's recommendations and drawings.

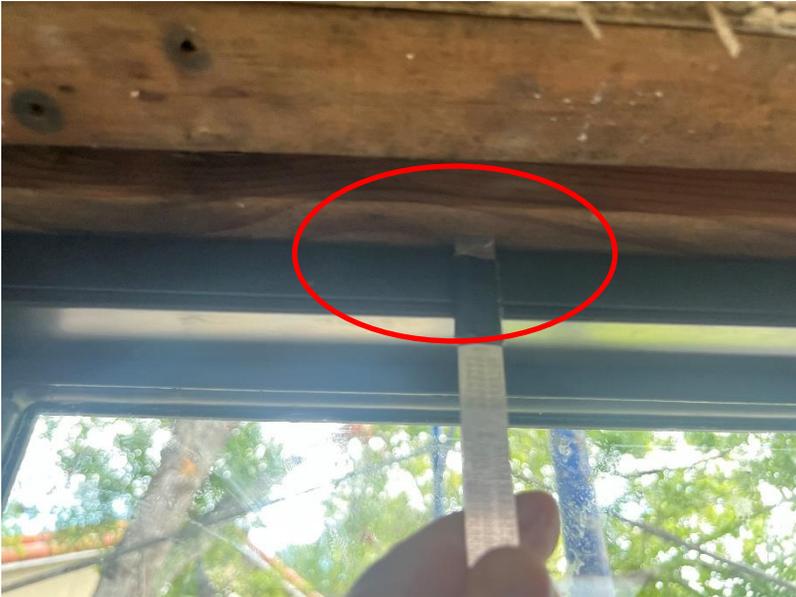
PHOTOGRAPH #15

**BUILDING 15
SECTION H- UNIT #1521**

Gap at window frame to header framing is within 5/16" max requirement for fin frame installation and manufacturers NOA.

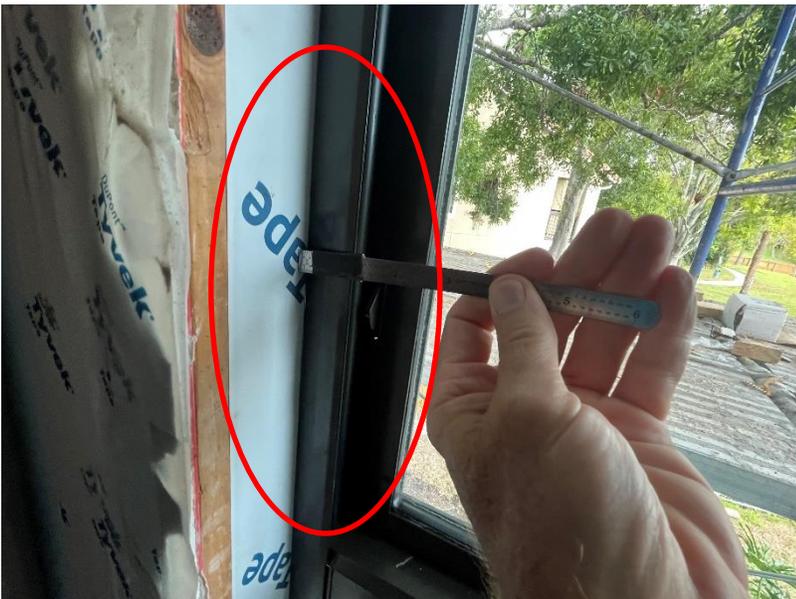
PHOTOGRAPH #16

**BUILDING 15
SECTION H- UNIT #1522**

Gap at window frame to jamb framing is within 5/16" max requirement for fin frame installation and manufacturers NOA.

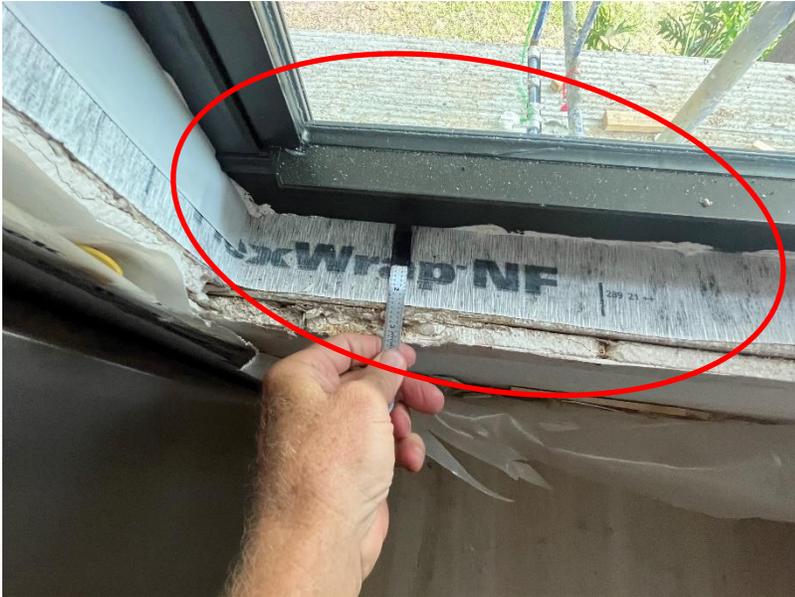
PHOTOGRAPH #17

**BUILDING 15
SECTION H- UNIT #1522**

Dupont FlexWrap NF at sill extends out to back edge of sill as per manufacture's recommendations and drawings.

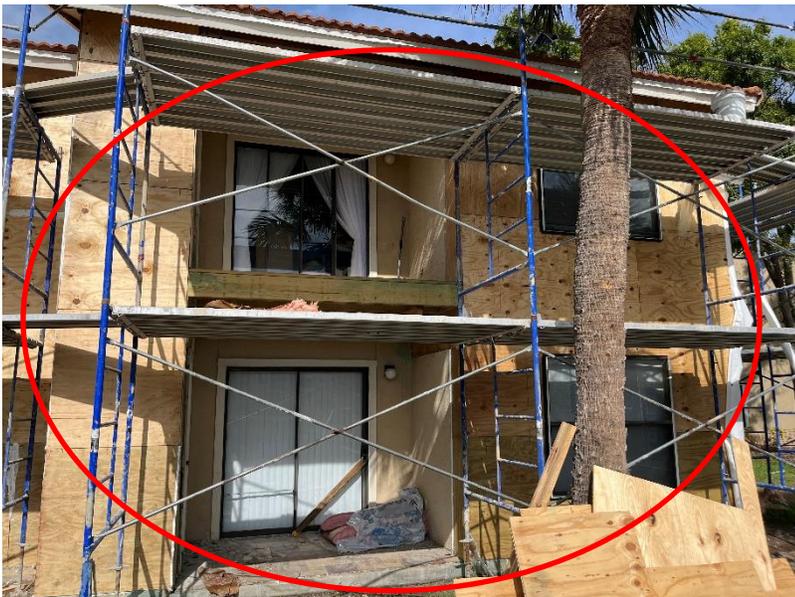
PHOTOGRAPH #18

**BUILDING 15
SECTION G**

New 15/32" sheathing attached at framing with 8d common nails as per drawings and specifications.

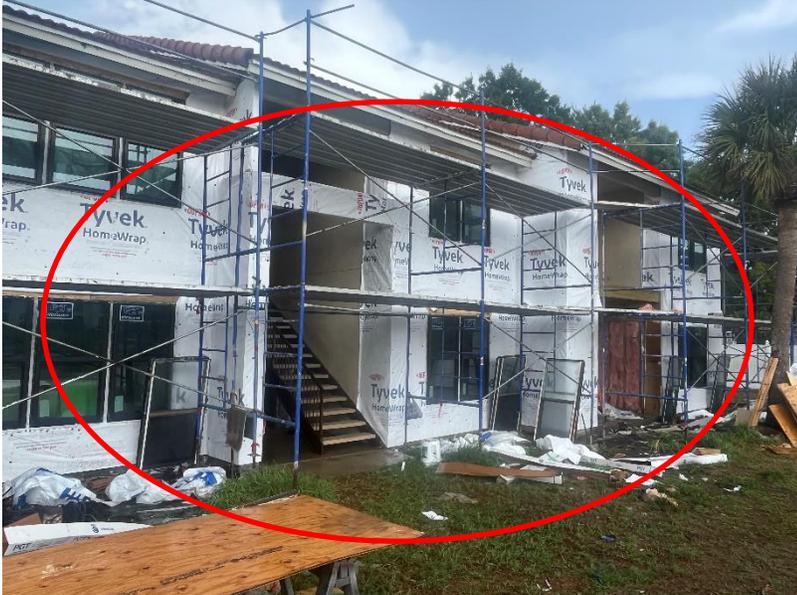
PHOTOGRAPH #19

**BUILDING 15
SECTION G**

Contractor applying Tyvek HomeWrap over new plywood sheathing.

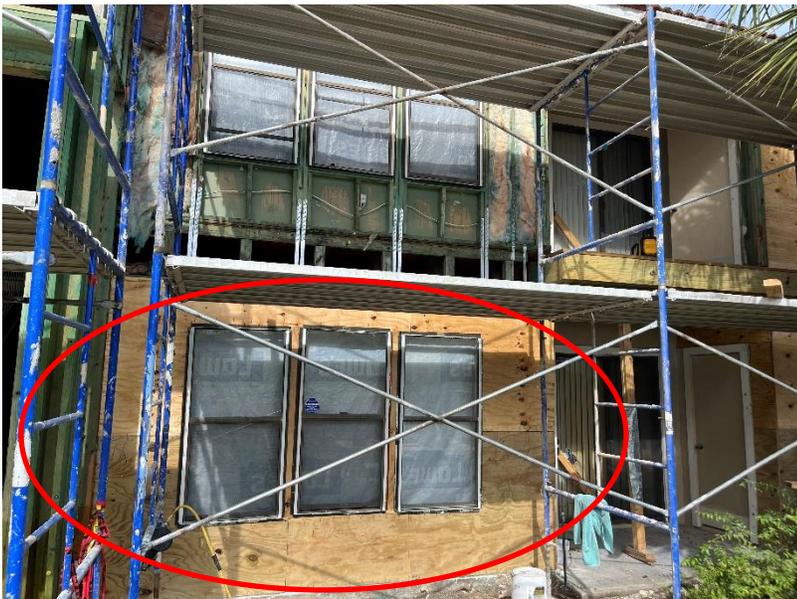
PHOTOGRAPH #20

**BUILDING 15
SECTION F**

Bottom 4x8 sheets of sheathing installed with pressure treated plywood as per specifications.

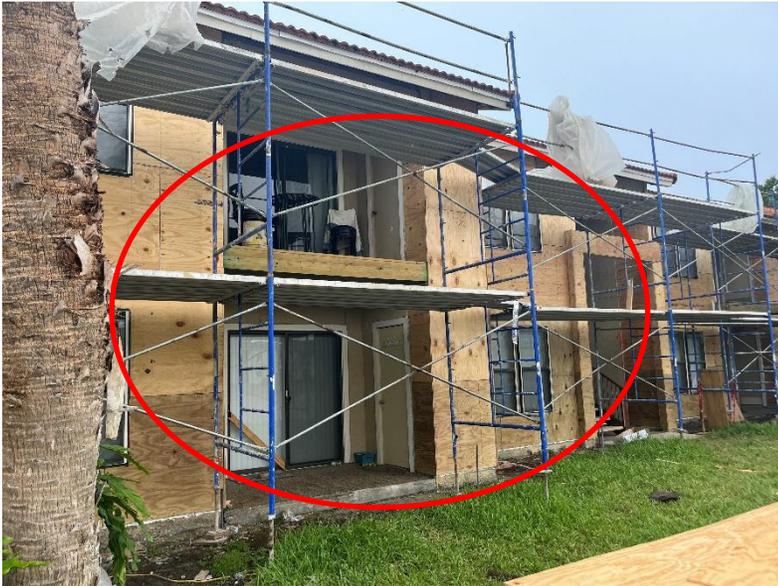
PHOTOGRAPH #21

**BUILDING 15
SECTION E**

New 15/32" sheathing attached at framing with 8d common nails as per drawings and specifications.

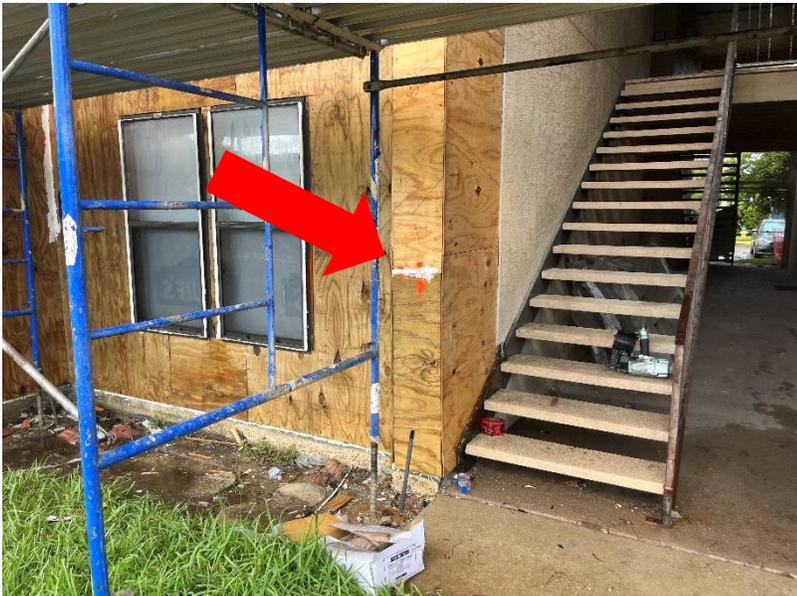
PHOTOGRAPH #22

**BUILDING 15
SECTION E**

Contractor made corrections were marked for missing fasteners and gaps.

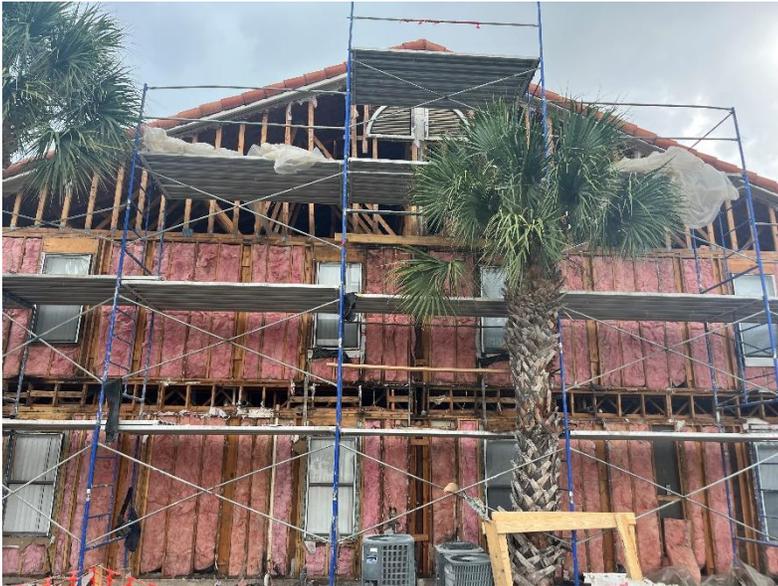
PHOTOGRAPH #23

**BUILDING 15
SECTION D**

Contractor has removed stucco and previous sheathing exposing framing for repairs.

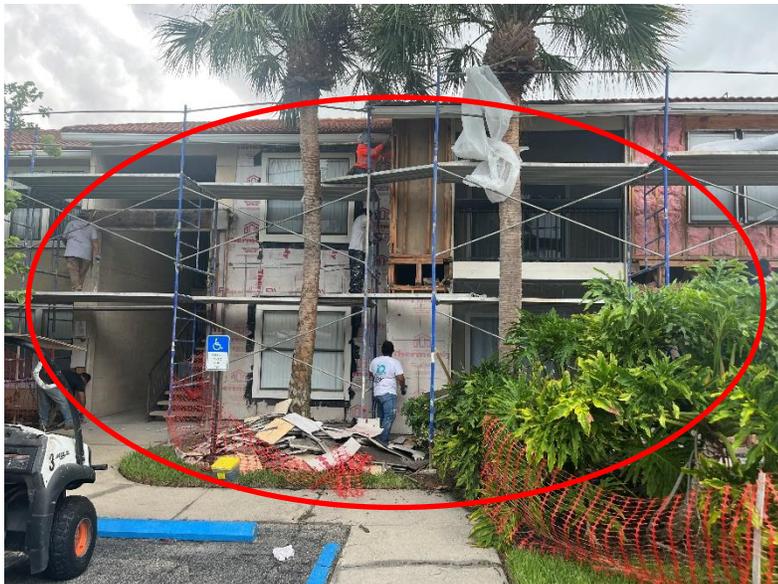
PHOTOGRAPH #24

**BUILDING 15
SECTION C**

Contractor in process of removed stucco and previous sheathing exposing framing for repairs.
