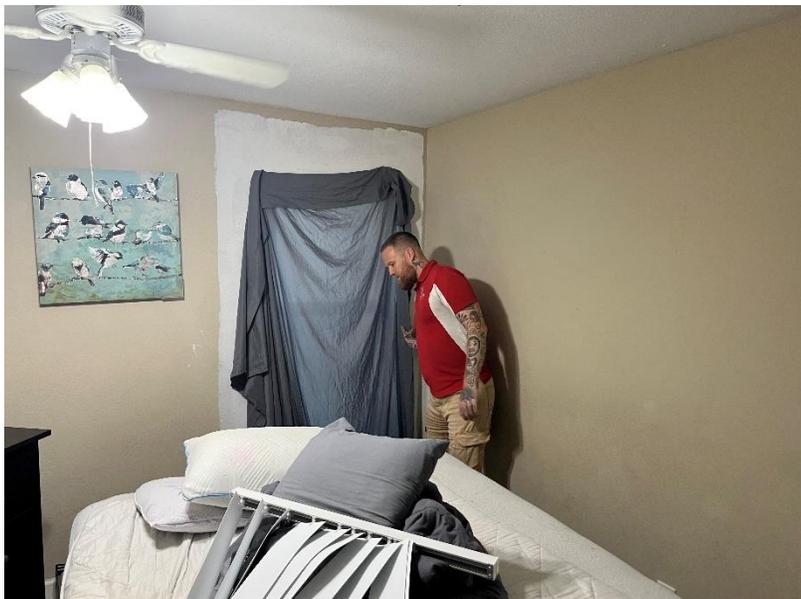
PHOTOGRAPH #1

**BUILDING 12
INTERIOR PUNCH LIST**

Walked interior of building with Contractor and developed an itemized punch list.

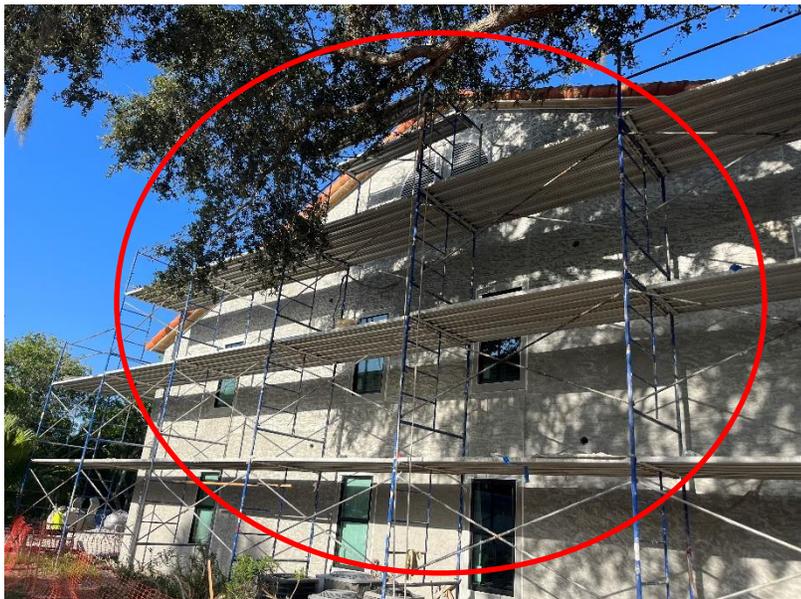
PHOTOGRAPH #2

**BUILDING 9
SECTION D**

Stucco sub-contractor has completed three coat 7/8" stucco system as per specifications.

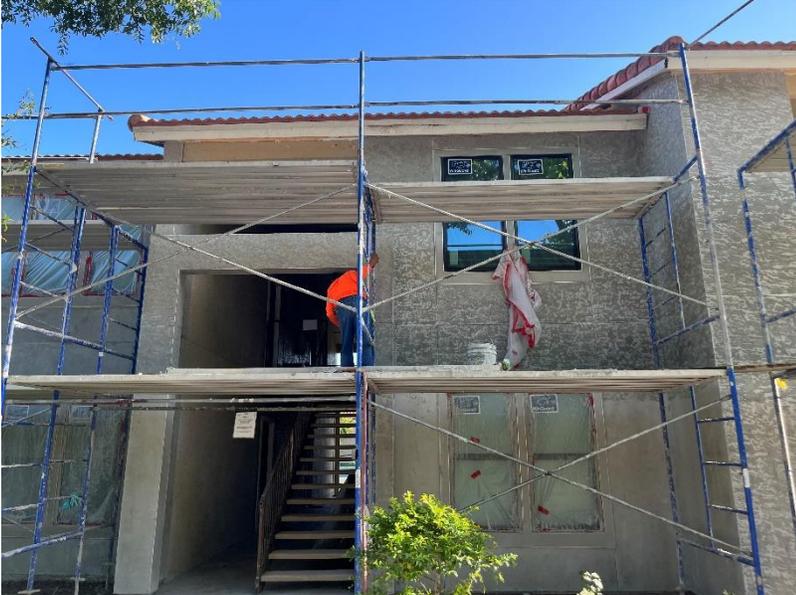
PHOTOGRAPH #3

**BUILDING 9
SECTION C**

Stucco sub-contractor applying finish texture coat of stucco.

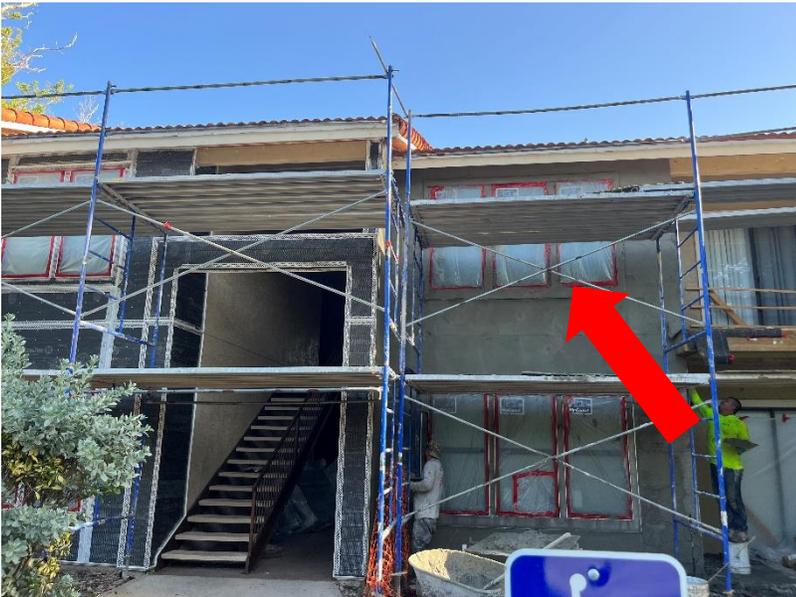
PHOTOGRAPH #4

**BUILDING 9
SECTION B**

Stucco sub-contractor has protected the new PGT windows and applied scratch and brown coats of stucco.

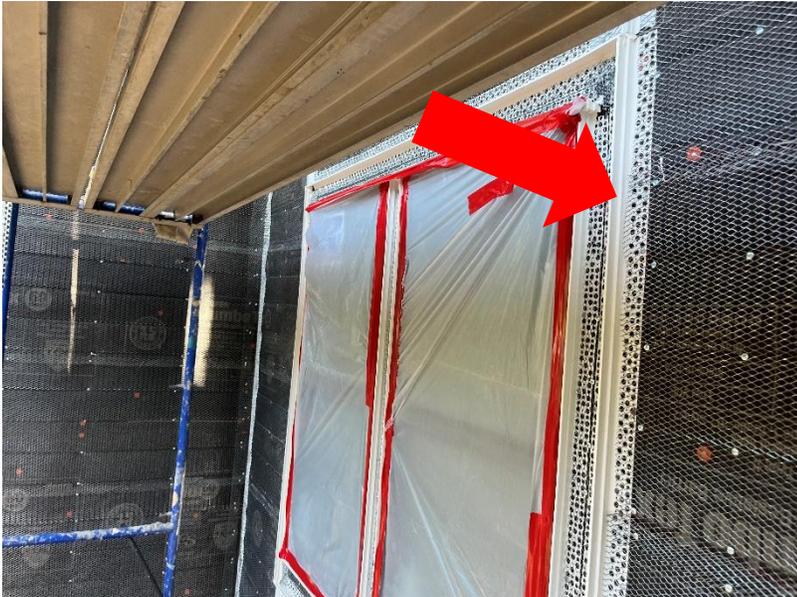
PHOTOGRAPH #5

**BUILDING 9
SECTION A**

Self-furring galvanized lath and new vinyl stucco accessories installed as per drawings and specifications.

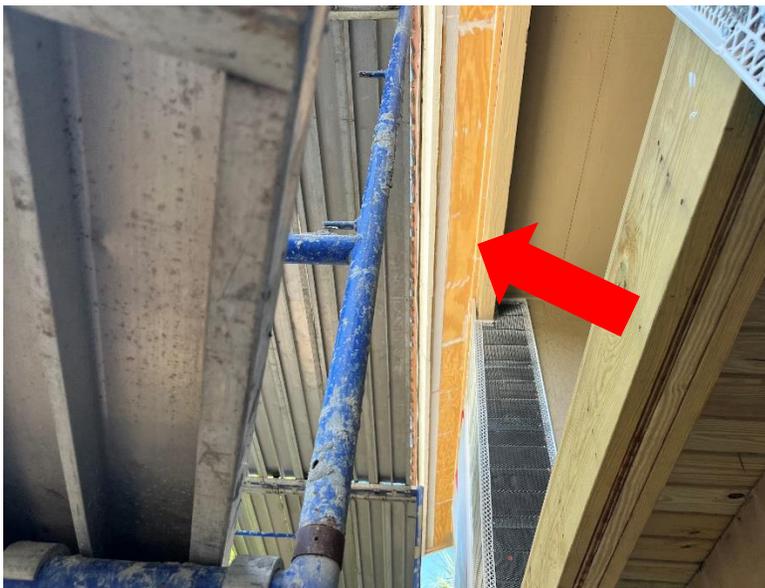
PHOTOGRAPH #6

**BUILDING 9
SECTION A**

New plywood soffit and vinyl soffit screen installed and prepared for prime and paint.

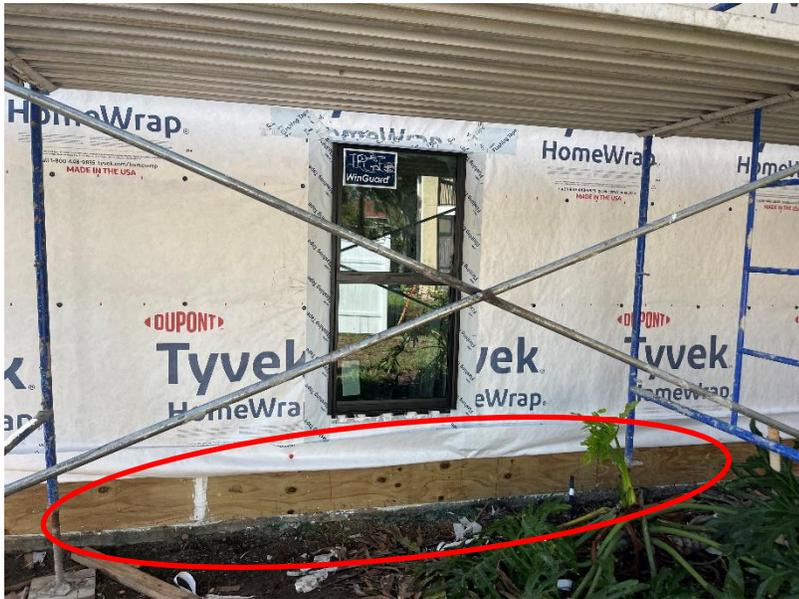
PHOTOGRAPH #7

**BUILDING 15
SECTION H**

Tyvek HomeWrap lifted for installation of vinyl weep stucco stop accessory.

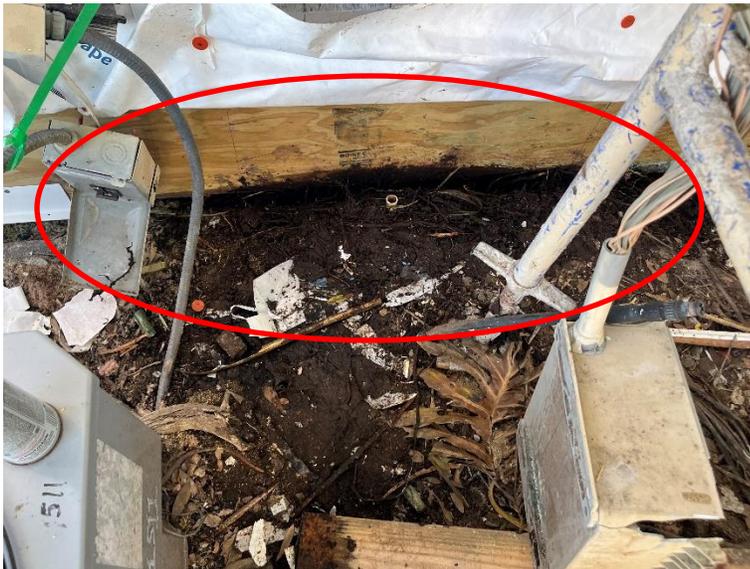
PHOTOGRAPH #8

**BUILDING 15
SECTION H**

Soil has not been regarded away from existing footing as per drawings, not allowing for proper installation of weep screed termination.

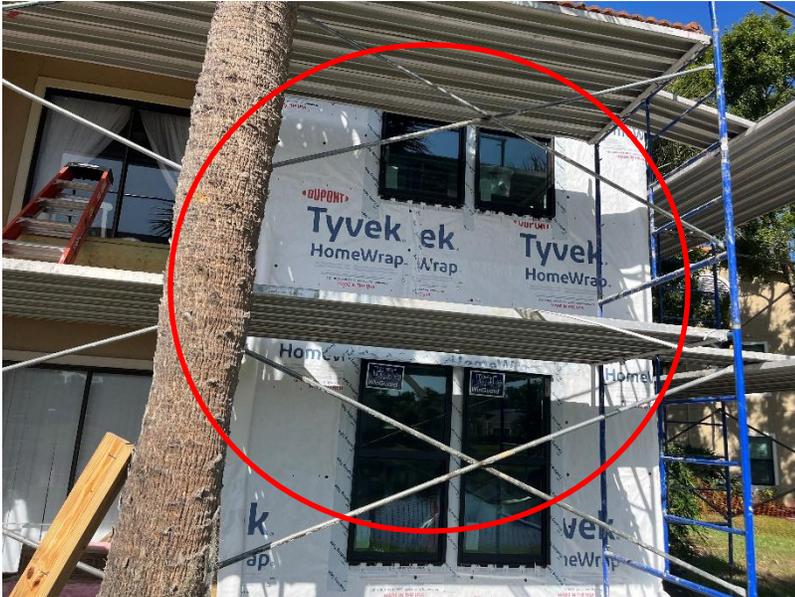
PHOTOGRAPH #9

**BUILDING 15
SECTION G**

New PGT windows installed as per drawings and DuPont flashing recommendations.

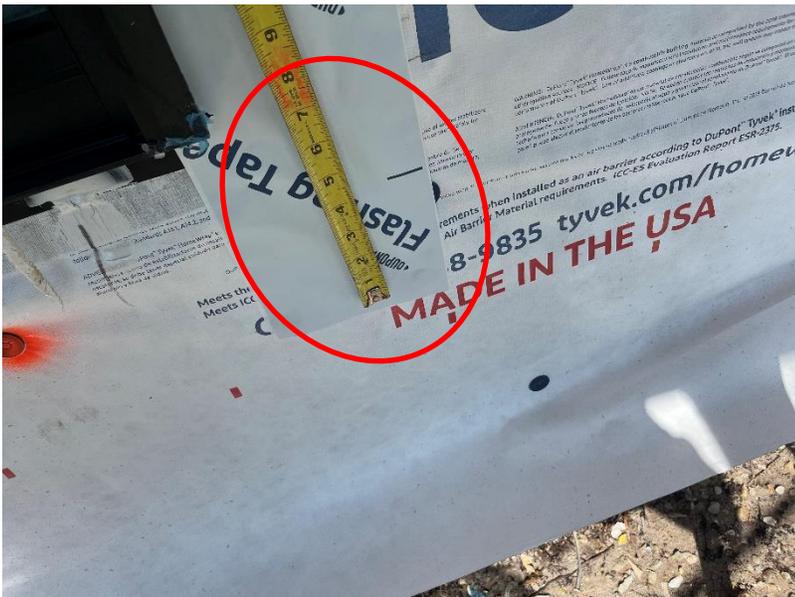
PHOTOGRAPH #10

**BUILDING 15
SECTION G- UNIT #1512**

DuPont Flashing tape extends the required 6" past window framing as per drawings.

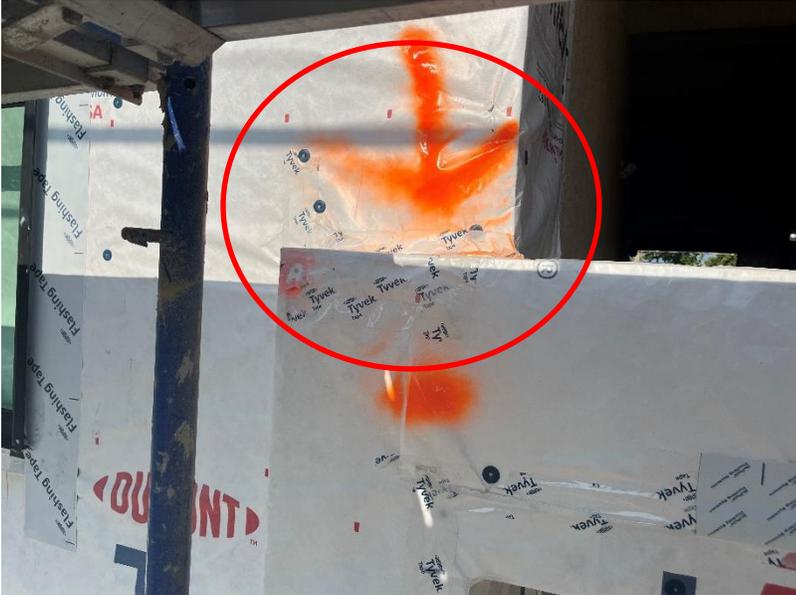
PHOTOGRAPH #11

**BUILDING 15
SECTION G-BREEZEWAY**

Gaps in Tyvek HomeWrap require repairs with new overlaps and / or Dupont FlexWarp flashing repairs as per Dupont details.

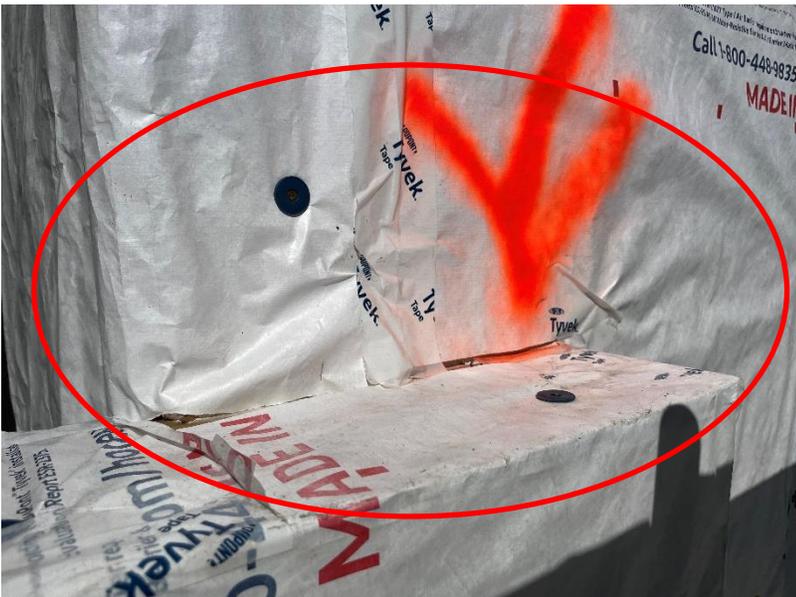
PHOTOGRAPH #12

**BUILDING 15
SECTION E- BREEZEWAY**

Gaps in Tyvek HomeWrap require repairs with new overlaps and / or Dupont FlexWarp flashing repairs as per Dupont details.

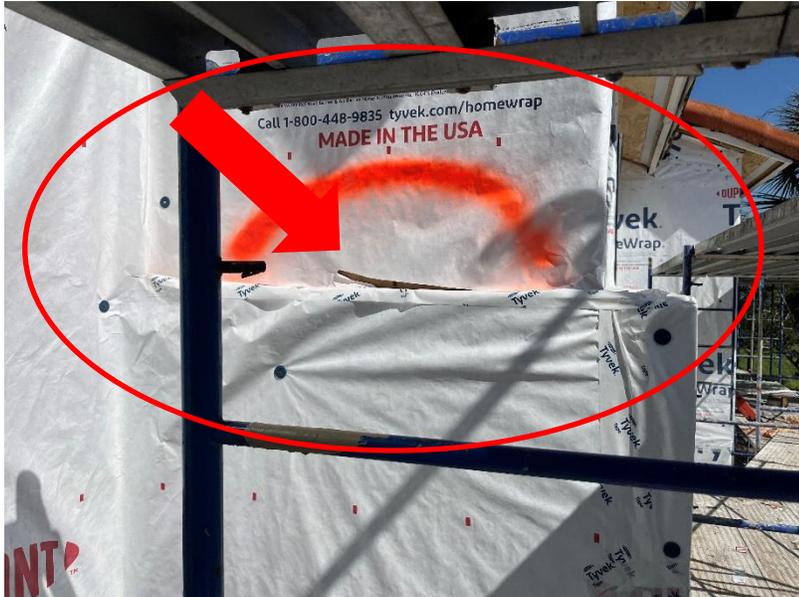
PHOTOGRAPH #13

**BUILDING 15
SECTION E- BREEZEWAY**

Gaps in Tyvek HomeWrap require repairs with new overlaps and / or Dupont FlexWarp flashing repairs as per Dupont details.

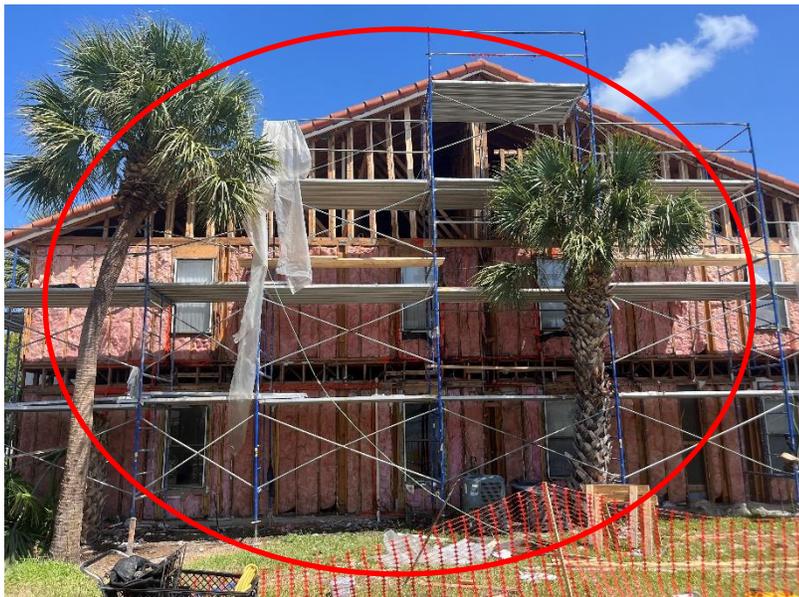
PHOTOGRAPH #14

**BUILDING 15
SECTION D**

Contractor has begun repairs at gable end reinforcement and Delta marked damaged framing for repairs.

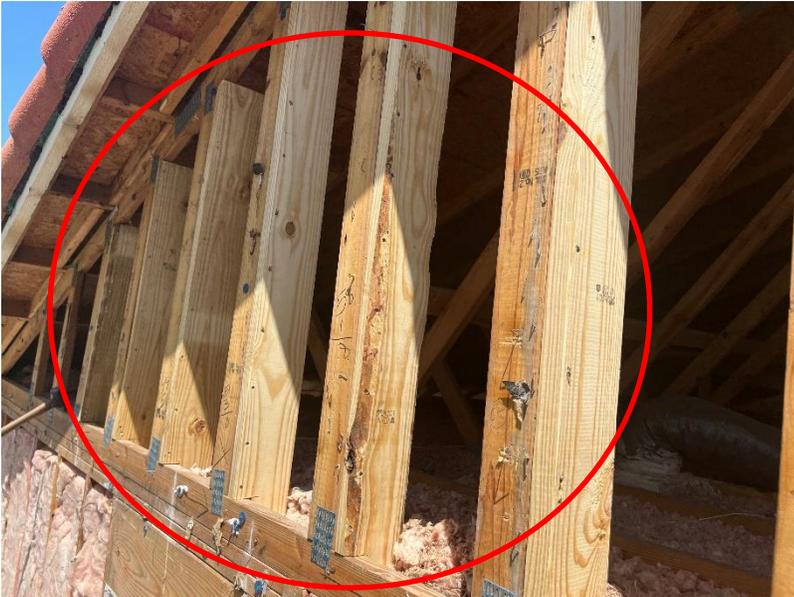
PHOTOGRAPH #15

**BUILDING 15
SECTION D**

New 2x6 L-Scab reinforcement attached with 10d nails at 6" O.C. as per drawings.

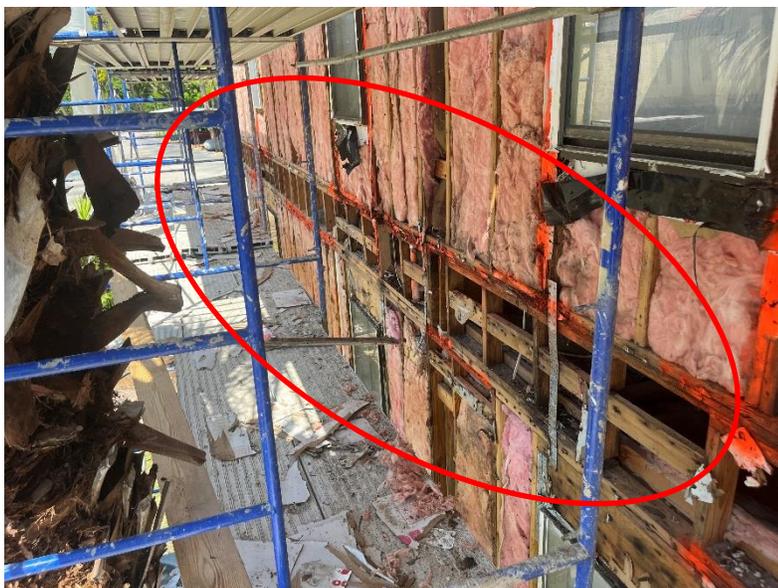
PHOTOGRAPH #16

**BUILDING 15
SECTION D**

Damage framing at studs, top plates and subflooring marked for repairs.

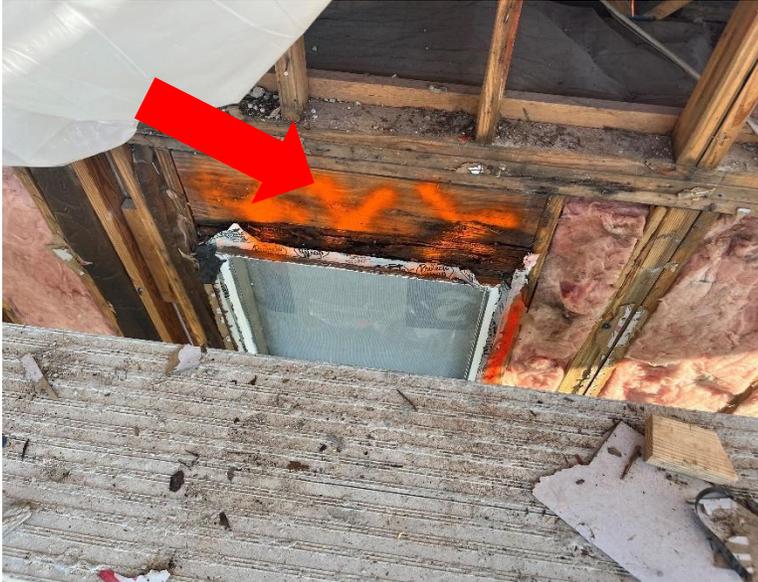
PHOTOGRAPH #17

**BUILDING 15
SECTION C**

Damaged window headers and window framing marked for repairs.

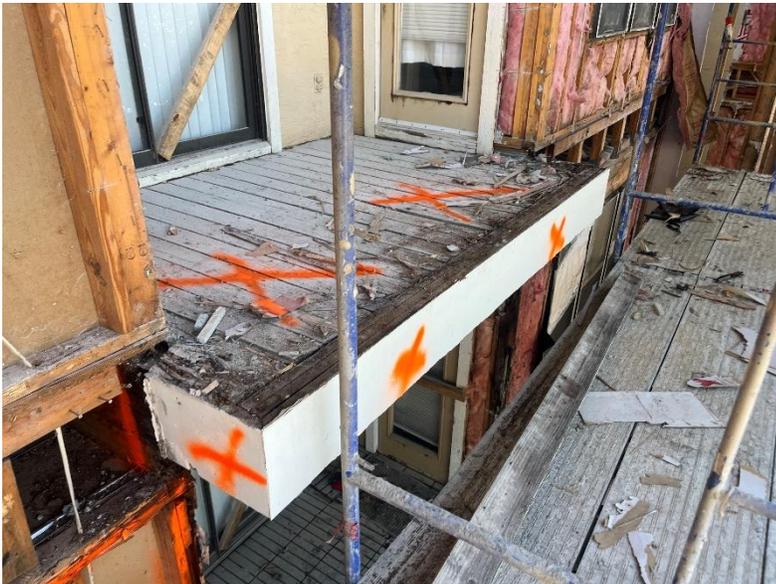
PHOTOGRAPH #18

**BUILDING 15
SECTION B- UNIT 1525**

Balcony framing built up repairs and deck boards marked for repairs.

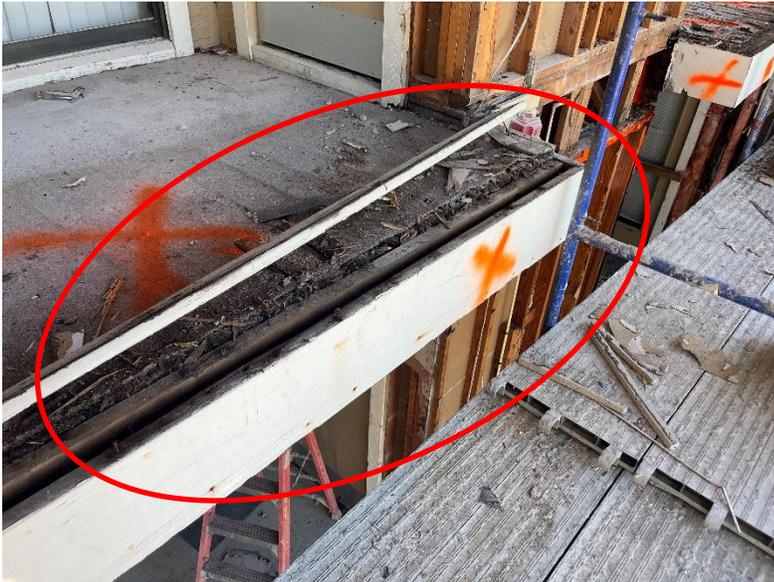
PHOTOGRAPH #19

**BUILDING 15
SECTION B- UNIT 1523**

Balcony framing built up repairs and deck boards marked for repairs.

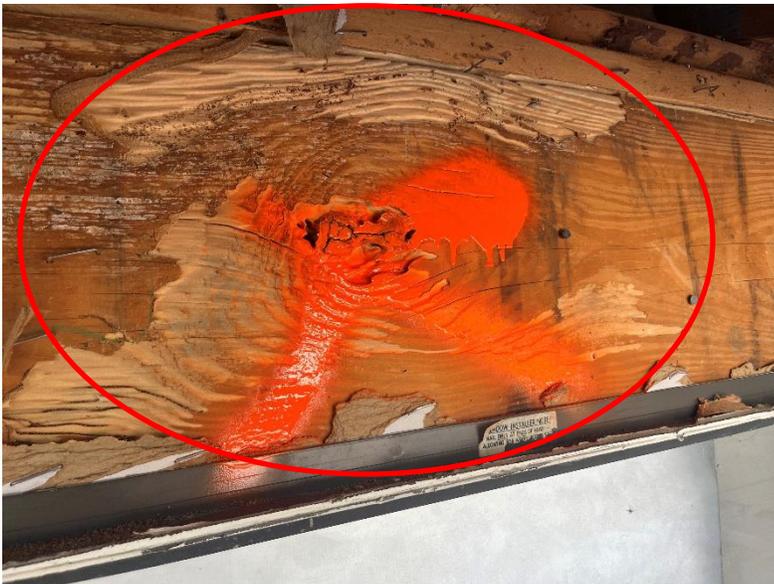
PHOTOGRAPH #20

**BUILDING 15
SECTION B**

Window header at 2nd level damaged by termites marked for removal and replacement.
