FIELD OBSERVATION REPORT - Bldg. #9

Permit No. 23 127178 00 BR
 Owner: Vintage Grand Condo Assn, Inc.
 Project Address: 4032 Crocker's Lake Blvd., Sarasota, FL
 Contractor: RL James Inc
 Inspector (s): Mark Boss
 Type of Assessment: Progress

FIELD OBSERVATION REPORT - Bldg. #15

FIELD OBSERVATION REPORT - Bldg. #16

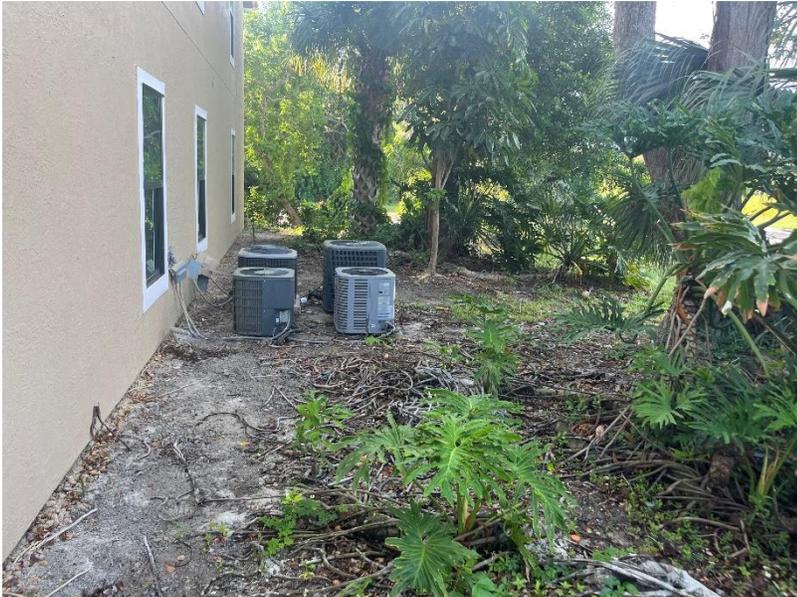
PHOTOGRAPH #1

**BUILDING 9
SECTION H**

Contractor has cleaned up debris at elevations where scaffolding and construction barriers have been removed.

G	X	NA	NA	X	X	X	X	X	X	X	X	NA	/		
H	X	X	X	X	X	X	X	X	X	X	X		X		Contractor has cleaned up debris at elevations where scaffolding and construction barriers have been removed (Photograph #1).

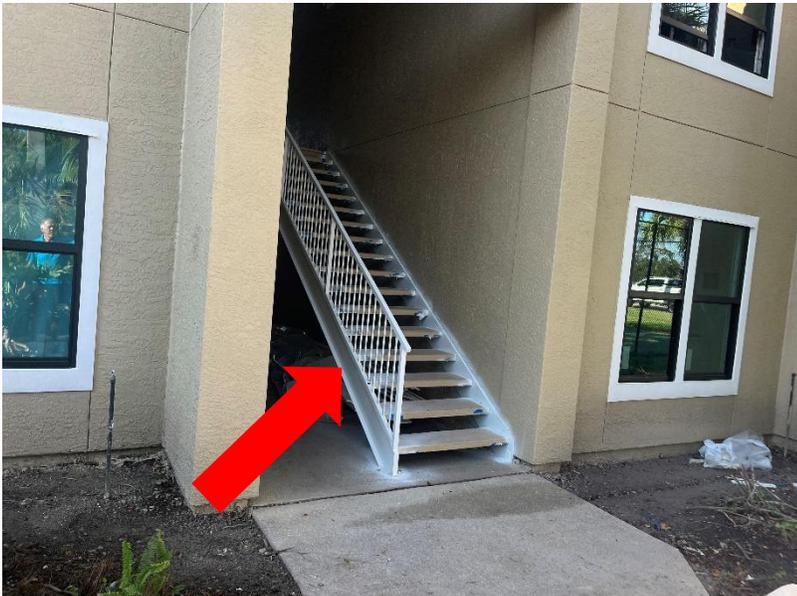
PHOTOGRAPH #2

**BUILDING 9
SECTION G**

Contractor has applied Florida Paints epoxy primer with conventional spray at stairway landings.

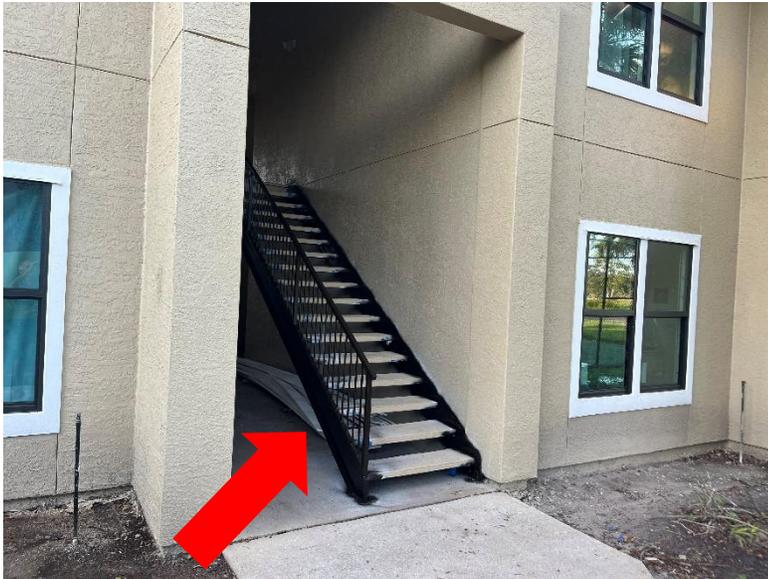
PHOTOGRAPH #3

**BUILDING 9
SECTION G**

Contractor applying Florida Paints Flo-Thane 2-part Urethane (formerly Sundeavor) with conventional spray at stairway landings.

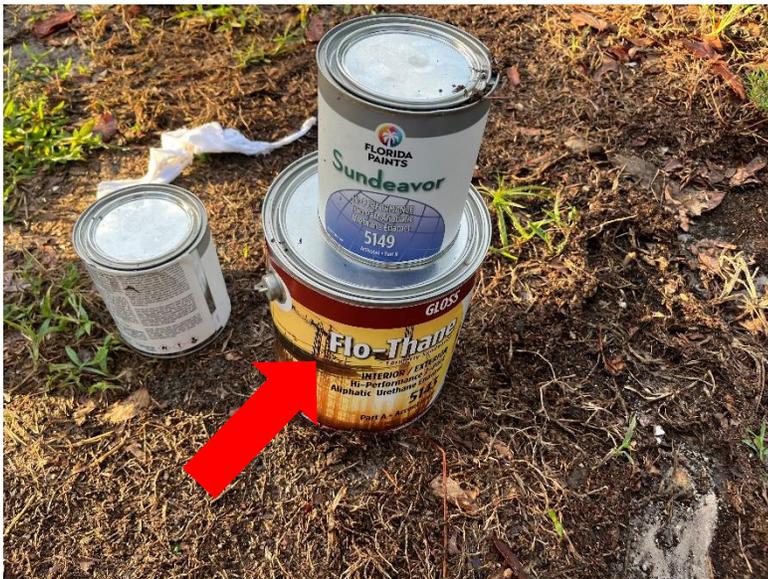
PHOTOGRAPH #4

**BUILDING 9
SECTION G**

Contractor applying Florida Paints Flo-Thane 2-part Urethane (formerly Sundeavor) with conventional spray at stairway landings.

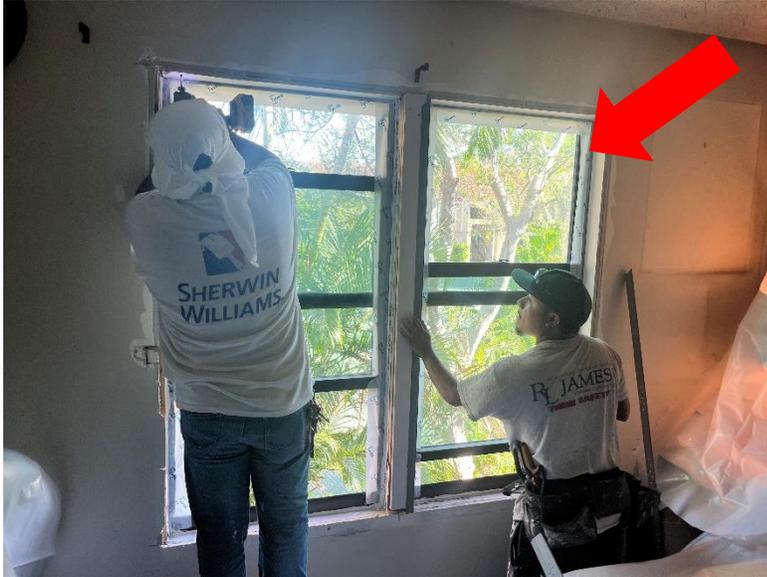
PHOTOGRAPH #5

**BUILDING 9
SECTION G- UNIT 922**

Contractor performing interior sealant and drywall repairs at areas of new PGT window installations.

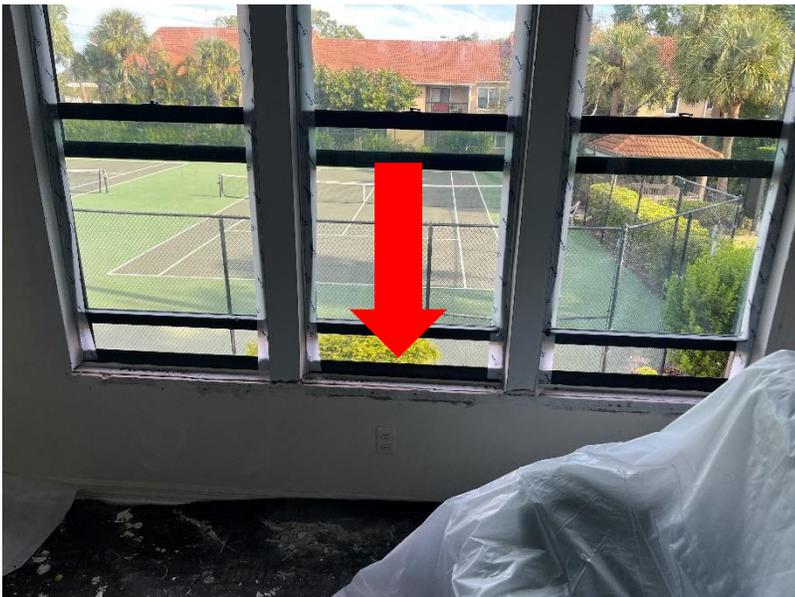
PHOTOGRAPH #6

**BUILDING 9
SECTION F- UNIT 926**

Contractor performing interior sealant and drywall repairs at areas of new PGT window installations.

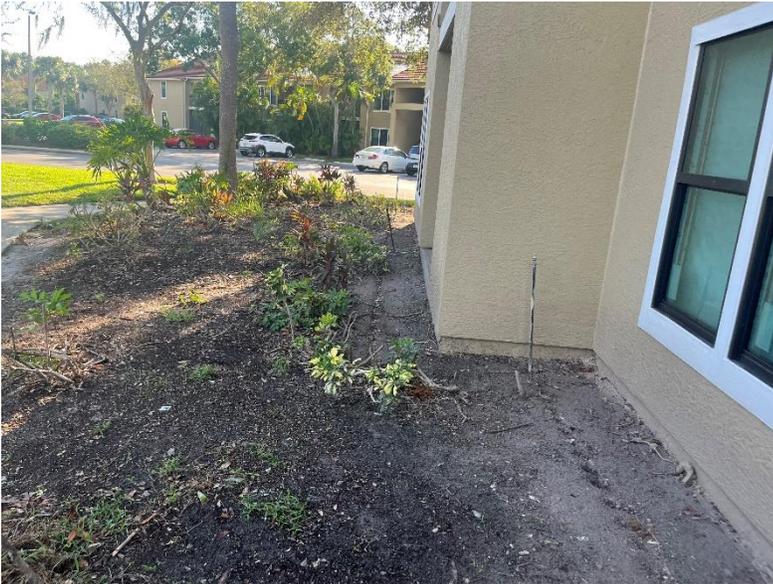
PHOTOGRAPH #7

**BUILDING 9
SECTION E**

Contractor has cleaned up debris at elevations where scaffolding and construction barriers have been removed.

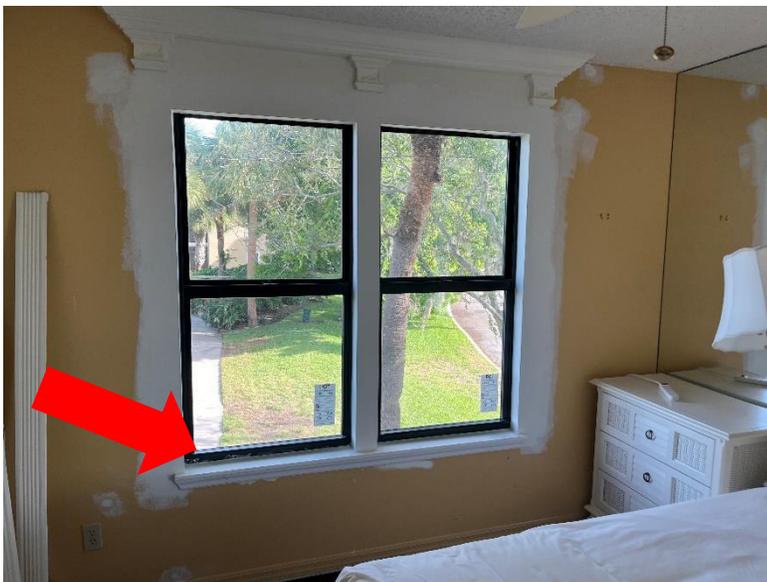
PHOTOGRAPH #8

**BUILDING 9
SECTION E- UNIT 928**

Contractor has completed interior drywall repairs and installed new windowsills at areas of new PGT window installations.

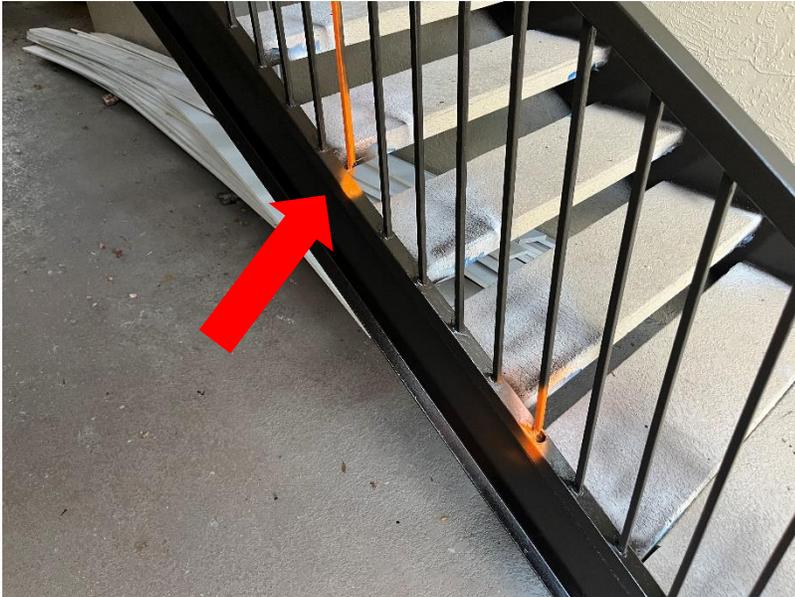
PHOTOGRAPH #9

**BUILDING 9
SECTION C**

Railing have been finish painted with Florida Paints Flo-Thane 2-part Urethane. Railing repairs have not been performed by owners welding contractor.

1. Repair stair picket railing at section G.

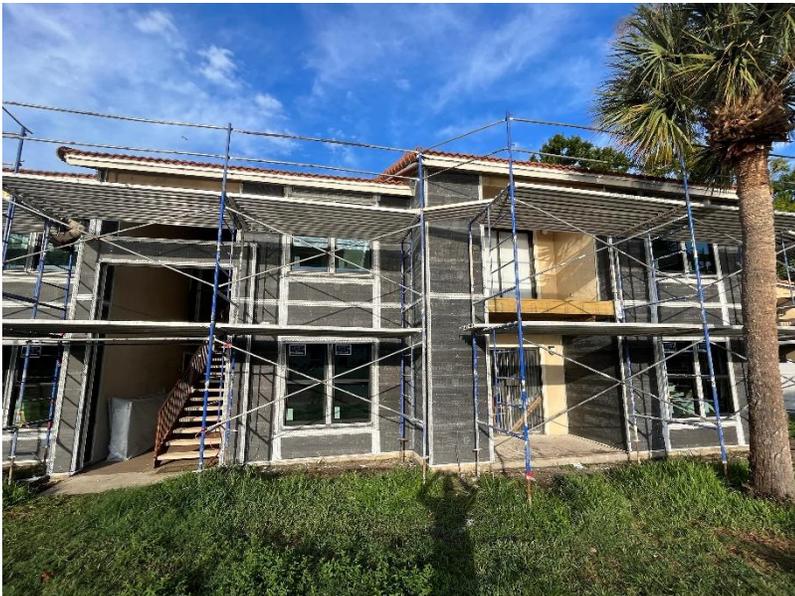
PHOTOGRAPH #10

**BUILDING 15
SECTION G**

Stucco sub-contractor has installed vinyl stucco accessories and galvanized self-furring metal lath over Jumbo Tex WRB in preparation for new stucco finish.

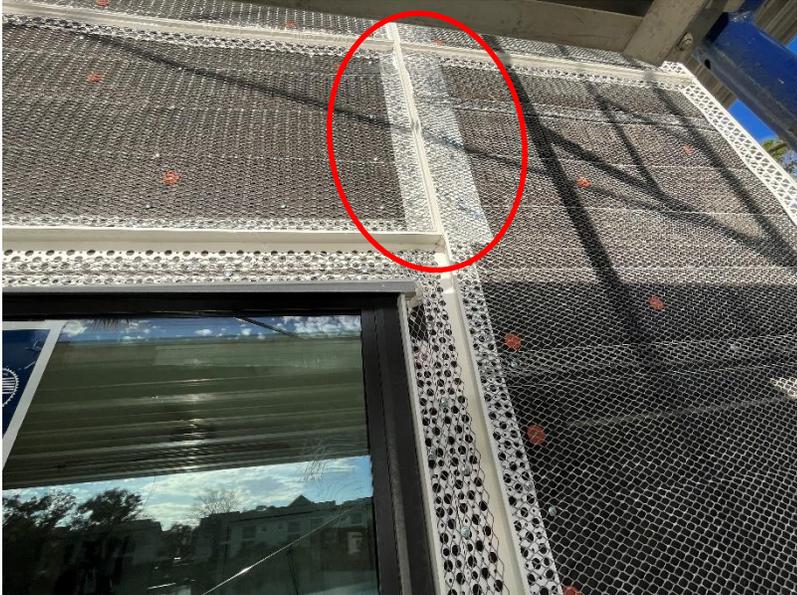
PHOTOGRAPH #11

**BUILDING 15
SECTION G**

Dupont Flashing tape installed behind vertical control joints as per drawings.

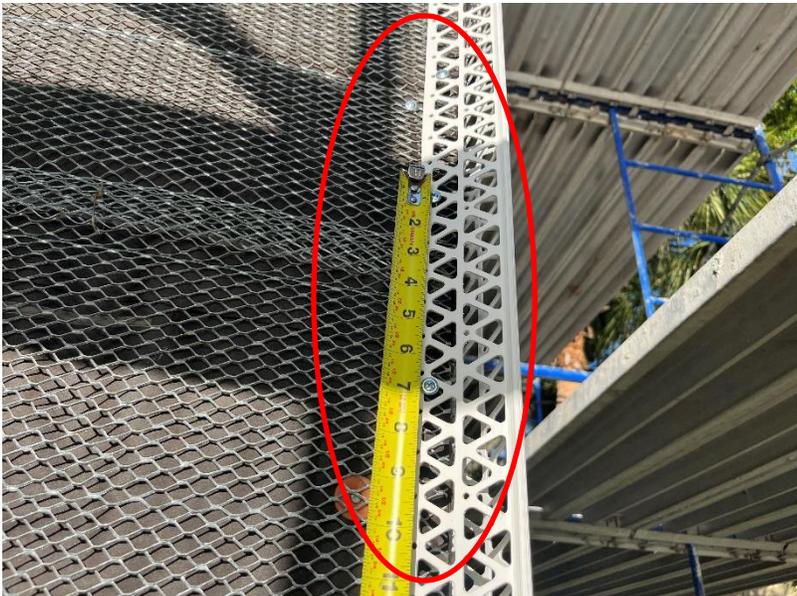
PHOTOGRAPH #12

**BUILDING 15
SECTION G**

Self-tapping waffle head fasteners installed at new vinyl corner bead accessories 7" O.C..

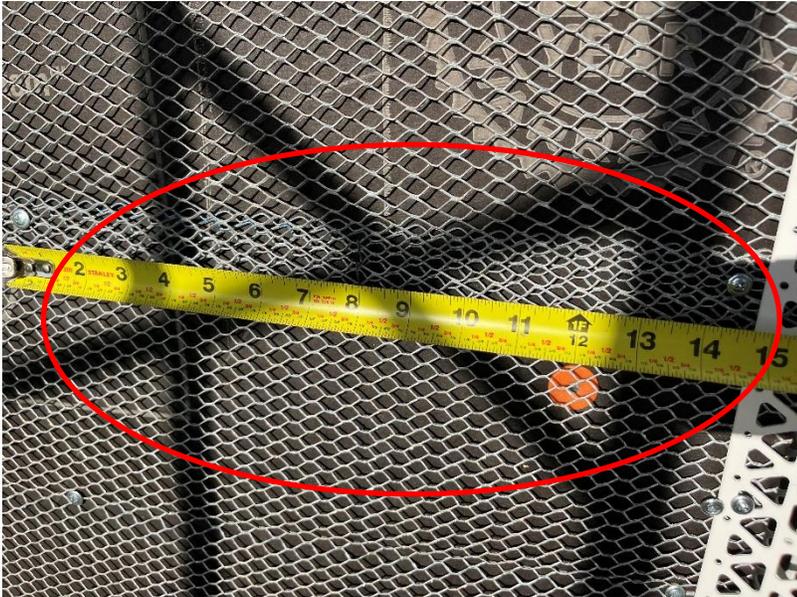
PHOTOGRAPH #13

**BUILDING 15
SECTION G**

Self-furring galvanized lath overlap and fastened at wood framing to meet ASTM 847.

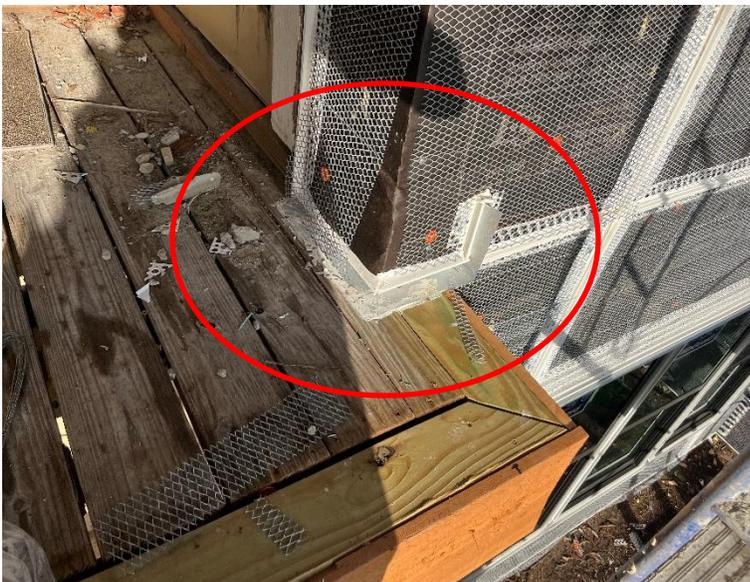
PHOTOGRAPH #14

**BUILDING 15
SECTION F**

New kick out flashing installed and sealed as per drawings.

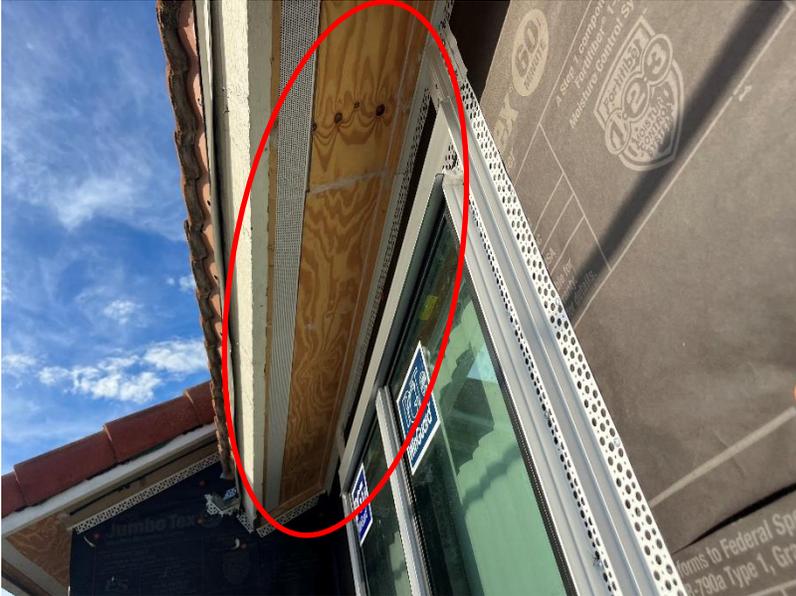
PHOTOGRAPH #15

**BUILDING 15
SECTION F**

Contractor has installed new plywood soffit with vinyl vented accessory per drawings.

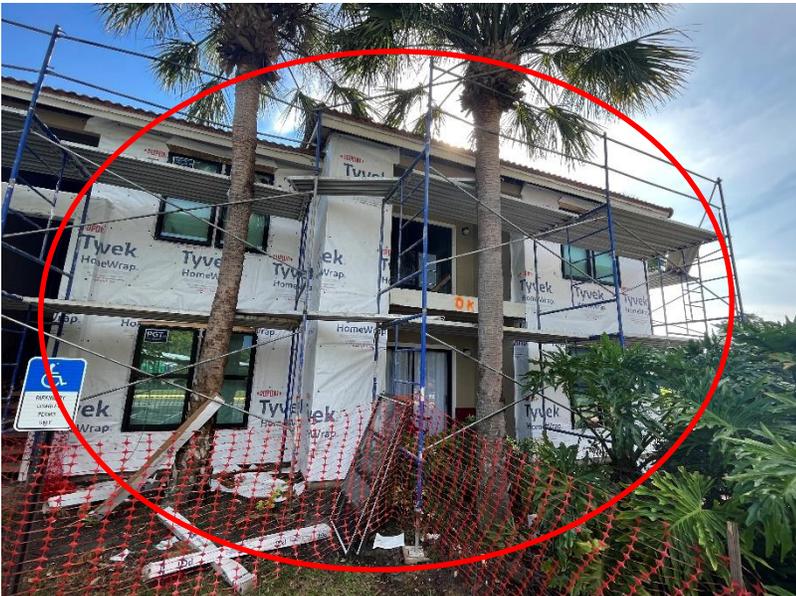
PHOTOGRAPH #16

**BUILDING 15
SECTION C**

Contractor has installed new PGT windows with Dupont flashing and Tyvek HomeWrap details as per specifications.

C	X	NA	NA	X	X		X	X							Contractor has installed new PGT windows with Dupont flashing and Tyvek HomeWrap details as per specifications (Photograph #16).
D	X	X	X	X	X	X	X	X							
E	X	NA	NA	X	X	X	X	X							
F	X	NA	NA	X	X	X	X	X	/						New kick out flashing installed and sealed as per drawings (Photograph #14). Contractor has installed new plywood soffit with vinyl vented accessory per drawings (Photograph #15).
G	X	NA	NA	X	X	X	X	X	X						Stucco sub-contractor has installed vinyl stucco accessories and galvanized self-furring metal lath over Jumbo Tex WRB in preparation for new stucco finish (Photograph #10). Dupont Flashing tape installed behind vertical control joints as per drawings (Photograph #11). Self-lapping waffle head fasteners installed at new vinyl corner bead accessories 7" O.C. (Photograph #12). Self-furring galvanized lath overlap and fastened at wood framing to meet ASTM 847 (Photograph #13).

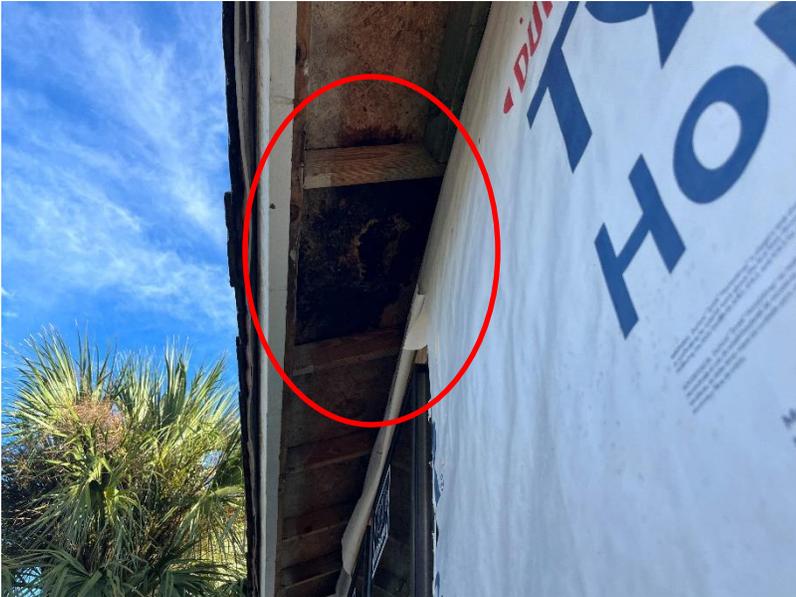
PHOTOGRAPH #17

**BUILDING 15
SECTION B**

Previous roof leaks have damaged roof sheathing.

- 1. Roof sheathing damage observed to be repaired by owners roofing contractor (Photograph #17).
- 2. Soil has not been re-graded by others to provide 6" minimum separation from grade to new stucco accessories as per drawings.

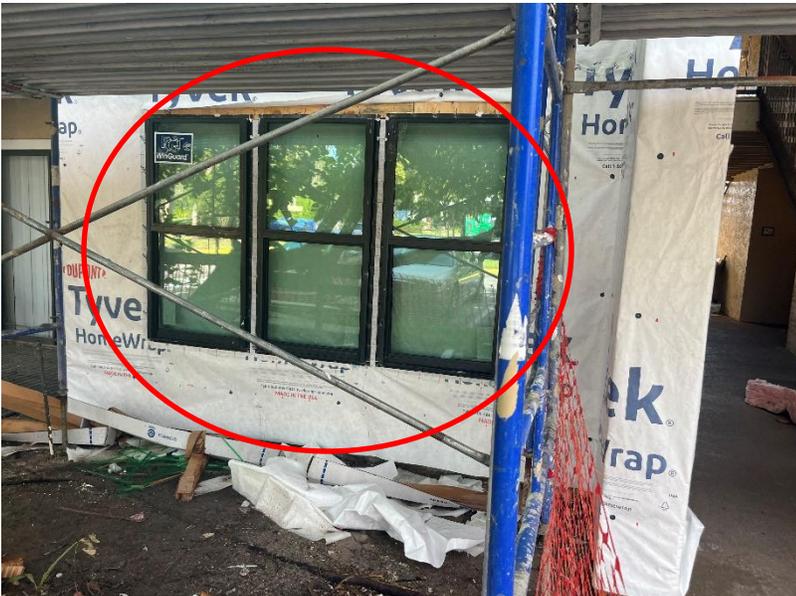
PHOTOGRAPH #18

**BUILDING 15
SECTION B- UNIT 1515**

Contractor has installed new PGT windows with Dupont flashing and Tyvek HomeWrap details as per specifications.

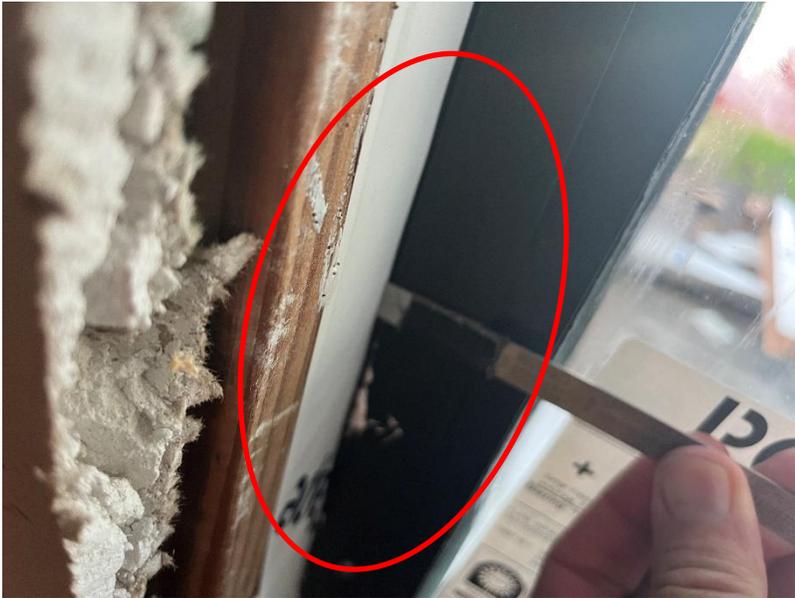
PHOTOGRAPH #19

**BUILDING 15
SECTION B- UNIT 1515**

Delta inspected interior gaps at window framing to jams and heads to verify installation follows manufactures NOA fastening requirements.

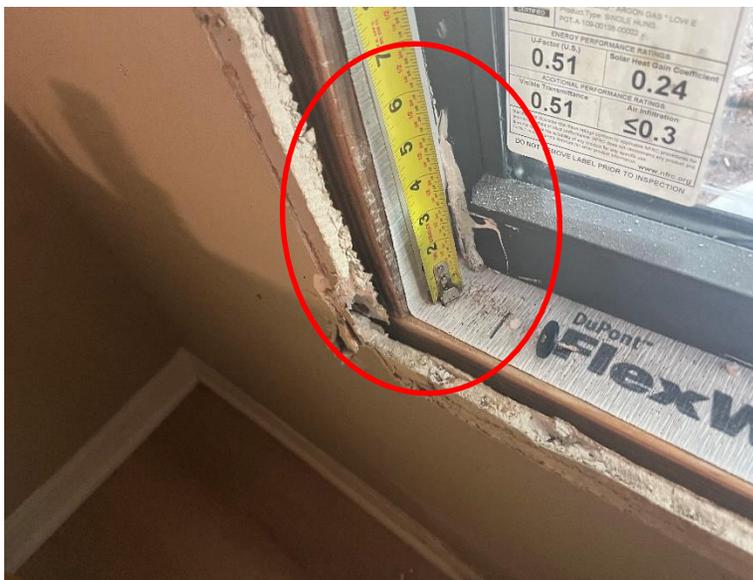
PHOTOGRAPH #20

**BUILDING 15
SECTION B- UNIT 1515**

Dupont flashing details overlapping at windowsill to jam as per drawings and specifications.

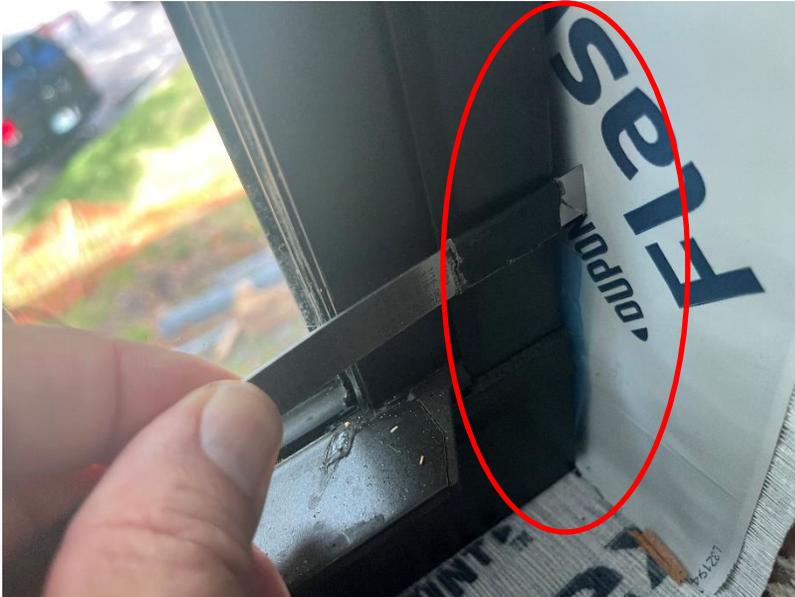
PHOTOGRAPH #21

**BUILDING 15
SECTION A – UNIT 1521**

Delta inspected interior gaps at window framing to jams and heads to verify installation follows manufactures NOA fastening requirements.

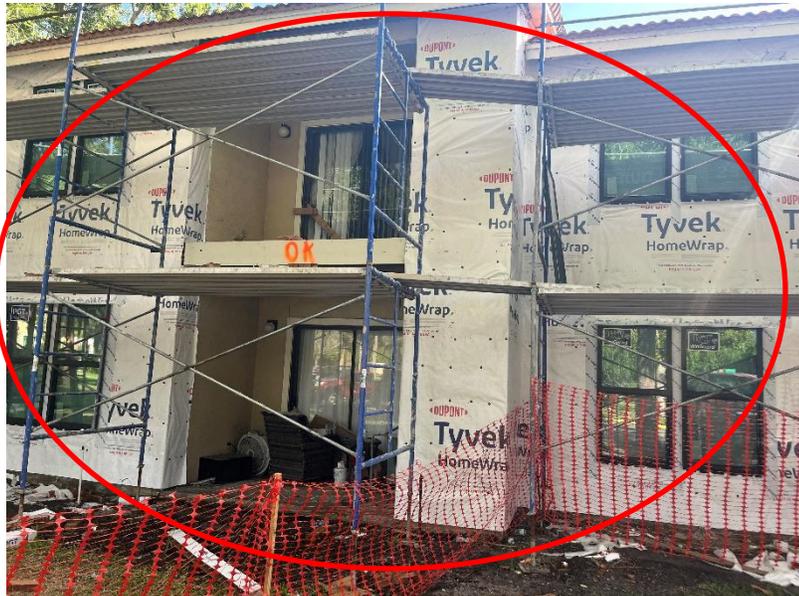
PHOTOGRAPH #22

**BUILDING 15
SECTION A**

Contractor has installed new PGT windows with Dupont flashing and Tyvek HomeWrap details as per specifications.

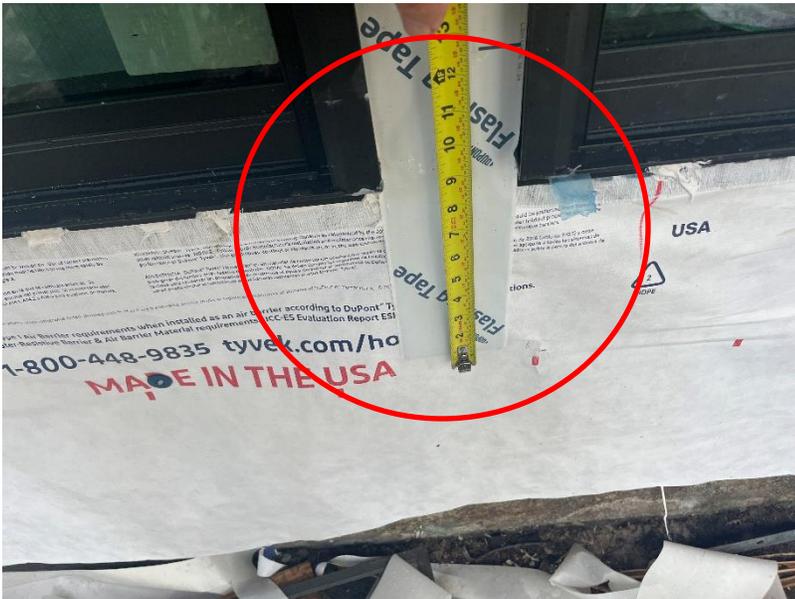
PHOTOGRAPH #23

**BUILDING 15
SECTION A – UNIT 1511**

New Dupont Flashing Tape covering window flange extends beyond window framing minimum of 6” as required by drawings and specifications.

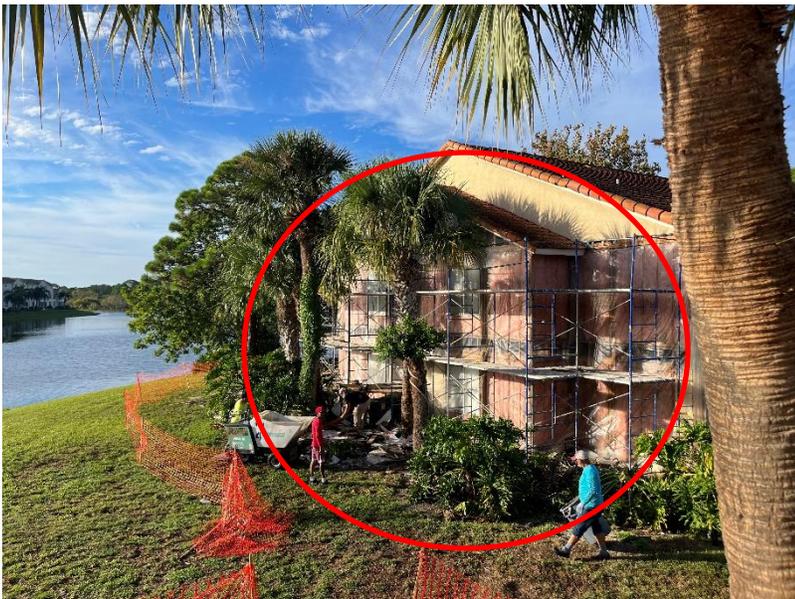
PHOTOGRAPH #24

**BUILDING 16
SECTION H**

Contractor has removed stucco and sheathing. Plastic tarps provided for temporary protection at open walls.

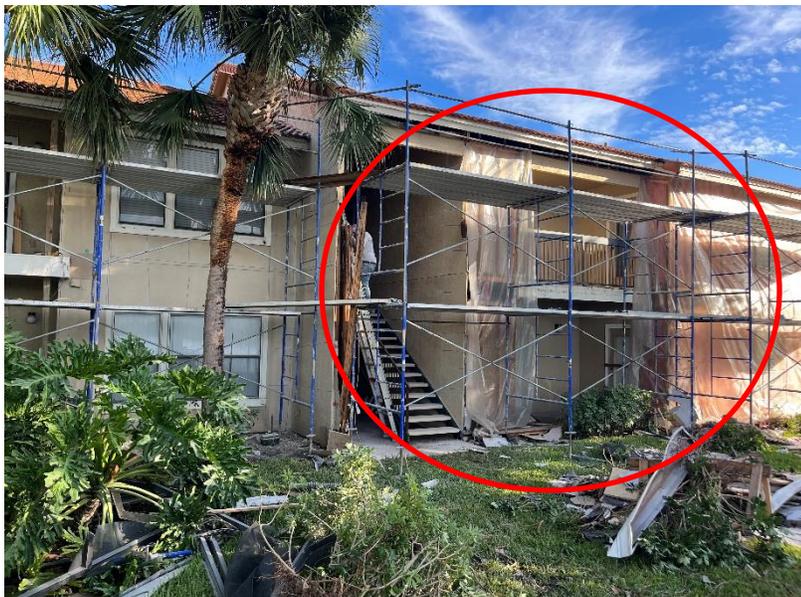
PHOTOGRAPH #25

**BUILDING 16
SECTION G**

Contractor has removed stucco and sheathing. Plastic tarps provided for temporary protection at open walls.

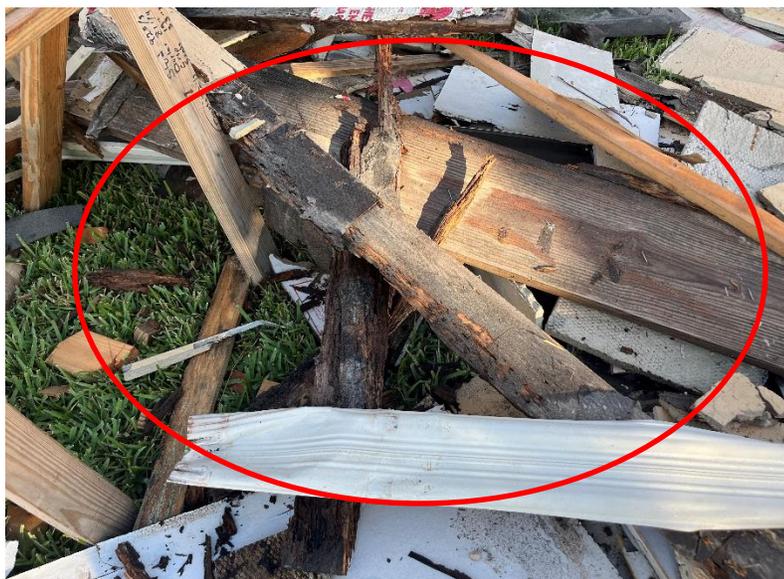
PHOTOGRAPH #26

**BUILDING 16
SECTION G**

Damaged framing removed during stucco removal at breezeway entrance.

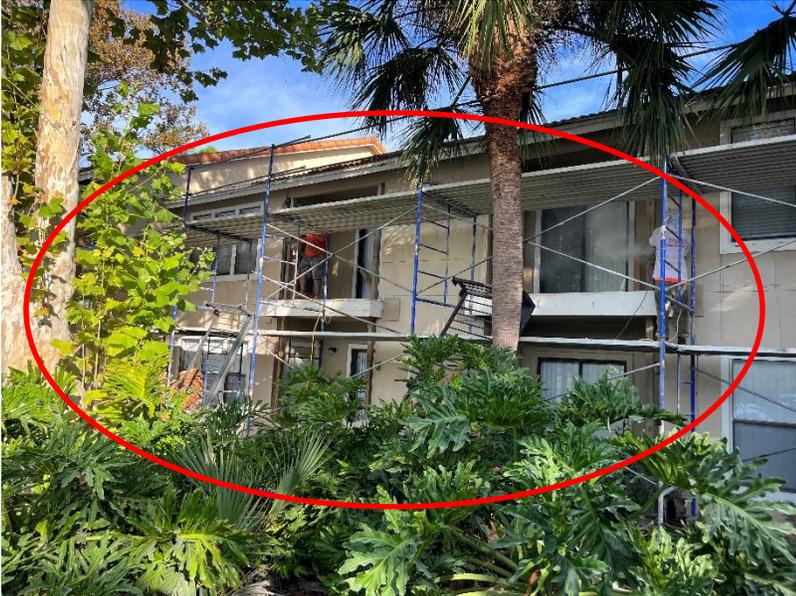
PHOTOGRAPH #27

**BUILDING 16
SECTION F**

Contractor has removed balcony railings
and begun to cut and remove stucco.

Elevation	Demo	Gable Bracing	Gable Vents	Framing & strapping	Sheathing	Soffit	Window flashing	Window Install	Stucco Lath Acc	Stucco	Sealant	Attics	Painting	Punch	Comments
A		NA													
B		NA													
C		NA													
D															
E		NA	NA												
F	/	NA	NA												Contractor has removed balcony railings and begun to cut and remove stucco (Photograph #27).
G	X	NA	NA												Contractor has removed stucco and sheathing. Plastic tarps provided contractor has removed stucco and sheathing. Plastic tarps provided for temporary protection at open walls (Photograph #25). Damaged framing removed during stucco removal at breezeway entrance (Photograph #26).
H	X														Contractor has removed stucco and sheathing. Plastic tarps provided for temporary protection at open walls (Photograph #24).
