FIELD OBSERVATION REPORT - Bldg. #12

FIELD OBSERVATION REPORT - Bldg. #9

FIELD OBSERVATION REPORT - Bldg. #16

FIELD OBSERVATION REPORT - Bldg. #15

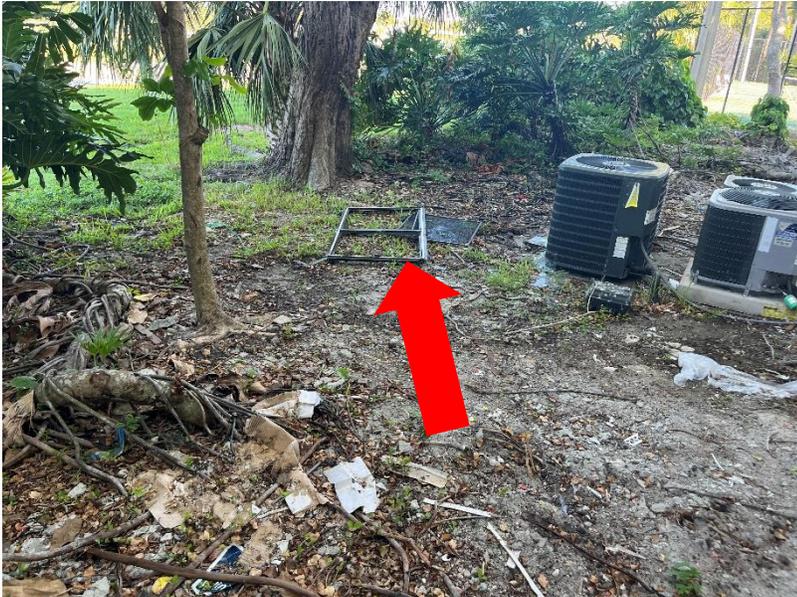
PHOTOGRAPH #1

**BUILDING 9
SECTION H**

Contractor has not cleaned up debris at elevations where scaffolding and construction barriers have been removed.

| Elevation | Demo | Gable Bracing | Gable Vents | Framing & Strapping | Sheathing | Soffit | Window flashing | Window Install | Stucco Lath Acc | Stucco | Sealant | Attics | Painting | Punch | Comments |
|---|---|---|---|---|---|---|---|---|---|---|---|---|---|---|--|
| H | X | X | X | X | X | X | X | X | X | X | X | | X | | Contractor has not cleaned up debris at elevations where scaffolding and construction barriers have been removed (Photograph #1). |

ACTION REQUIRED BY CONTRACTOR:
 1. Contractor has not cleaned up debris at elevations where scaffolding and construction barriers have been removed (Photograph #1 and #4).

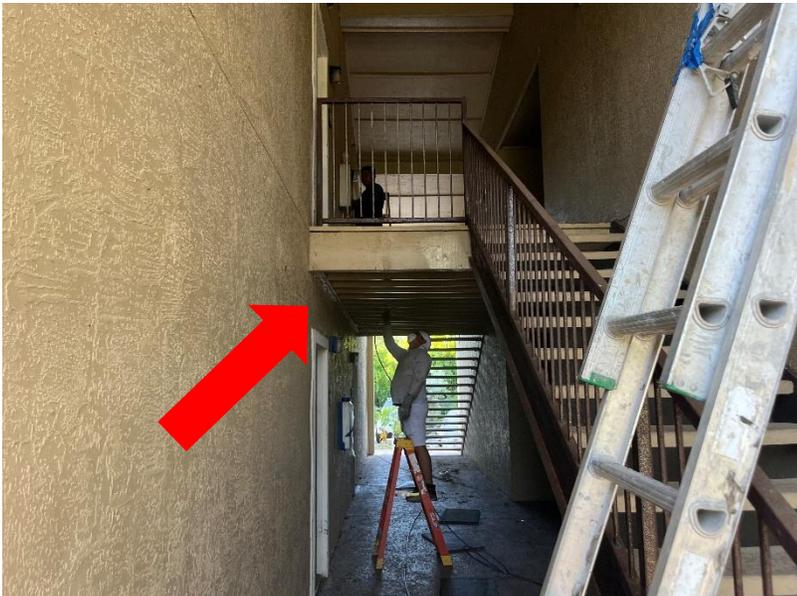
PHOTOGRAPH #2

**BUILDING 9
SECTION G**

Contractor applying Florida Paints Glades Exterior 100% Acrylic with airless spray at wood ceiling framing areas.

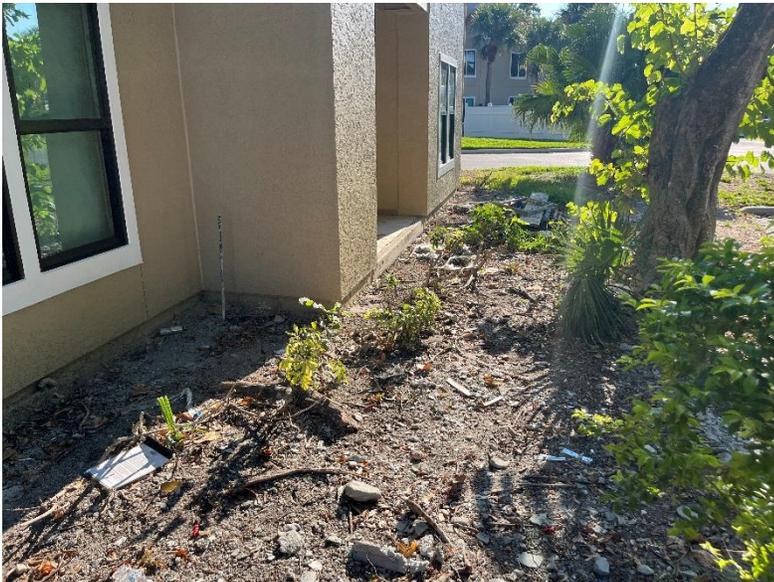
PHOTOGRAPH #4

**BUILDING 9
SECTION C**

Contractor has not cleaned up debris at elevations where scaffolding and construction barriers have been removed.

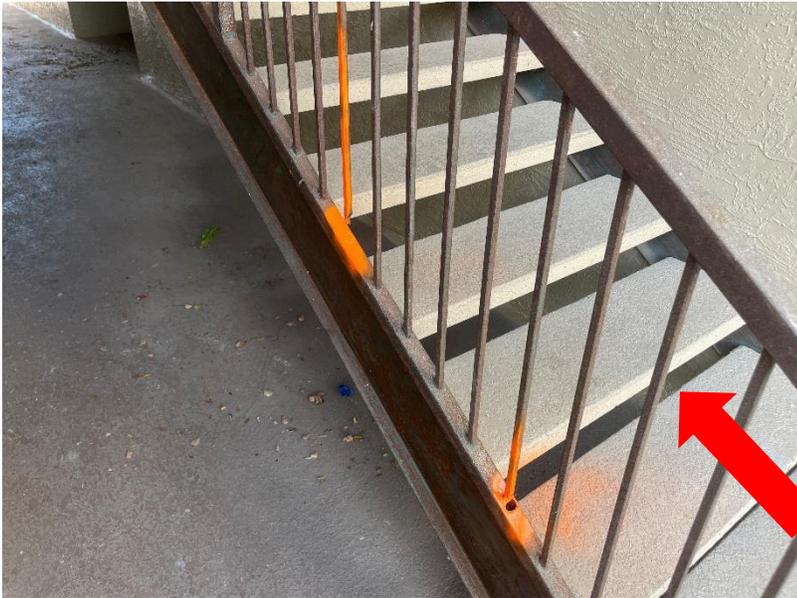
PHOTOGRAPH #5

**BUILDING 9
SECTION C**

Railing repairs have not been performed by owners welding contractor.

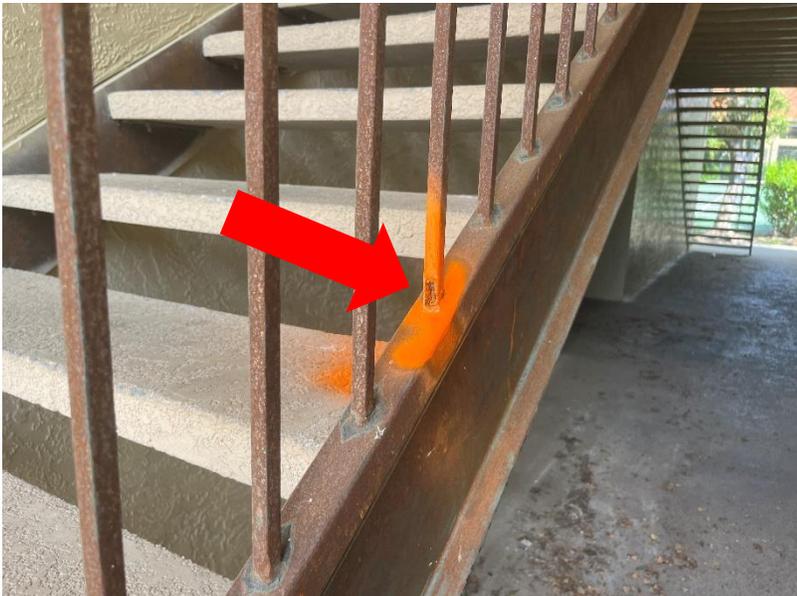
PHOTOGRAPH #6

**BUILDING 9
SECTION A**

Railing repairs have not been performed by owners welding contractor.

| Elevation | Demo | Gable Bracing | Gable Vents | Framing & Strapping | Sheathing | Soffit | Window flashing | Window Install | Stucco Lath Acc | Stucco | Sealant | Attics | Painting | Punch | Comments |
|---|---|---|---|---|---|---|---|---|---|---|---|---|---|---|--|
| A | X | NA | NA | X | X | X | X | X | X | X | X | NA | / | | Railing repairs have not been performed by owners welding contractor (Photograph #6). |

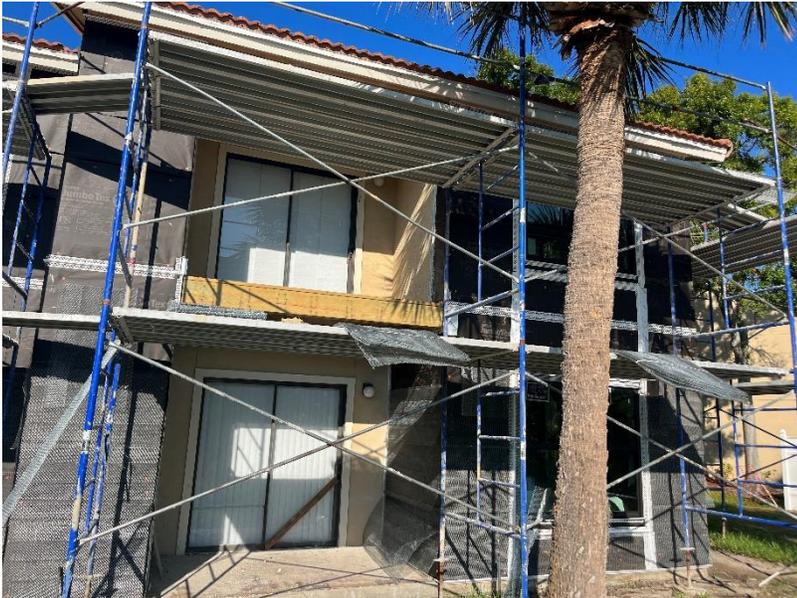
PHOTOGRAPH #7

**BUILDING 15
SECTION G**

Stucco sub-contractor in process of installing vinyl stucco accessories and metal lath over Jumbo Tex WRB.

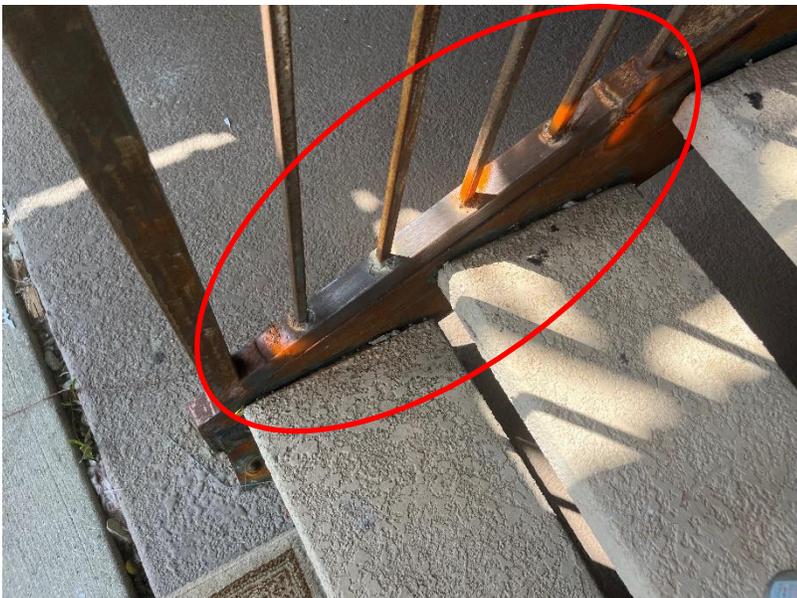
PHOTOGRAPH #8

**BUILDING 15
SECTION G**

Railing repairs have not been performed by owners welding contractor.

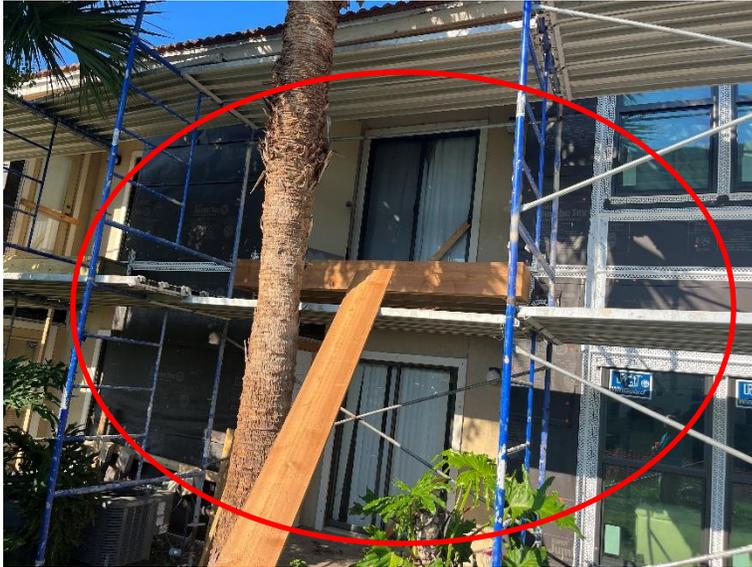
PHOTOGRAPH #9

**BUILDING 15
SECTION F**

Stucco sub-contractor in process of installing vinyl stucco accessories and metal lath over Jumbo Tex WRB.

| Elevation | Demo | Gable Bracing | Gable Vents | Framing & strapping | Sheathing | Soffit | Window flashing | Window Install | Stucco Lath Acc | Stucco | Sealant | Attics | Painting | Punch | Comments |
|---|---|---|---|---|---|---|---|---|---|---|---|---|---|---|---|
| E | X | NA | NA | X | X | X | X | X | | | | | | | Stucco sub-contractor in process of installing vinyl stucco accessories and metal lath over Jumbo Tex WRB (Photograph #9). |

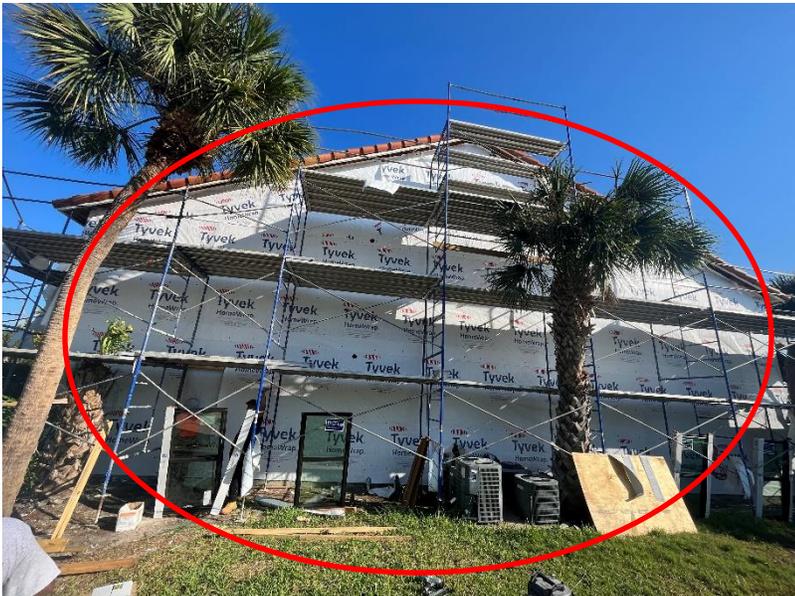
PHOTOGRAPH #10

**BUILDING 15
SECTION D**

Contractor has covered new plywood sheathing with Tyvek HomeWrap WRB.

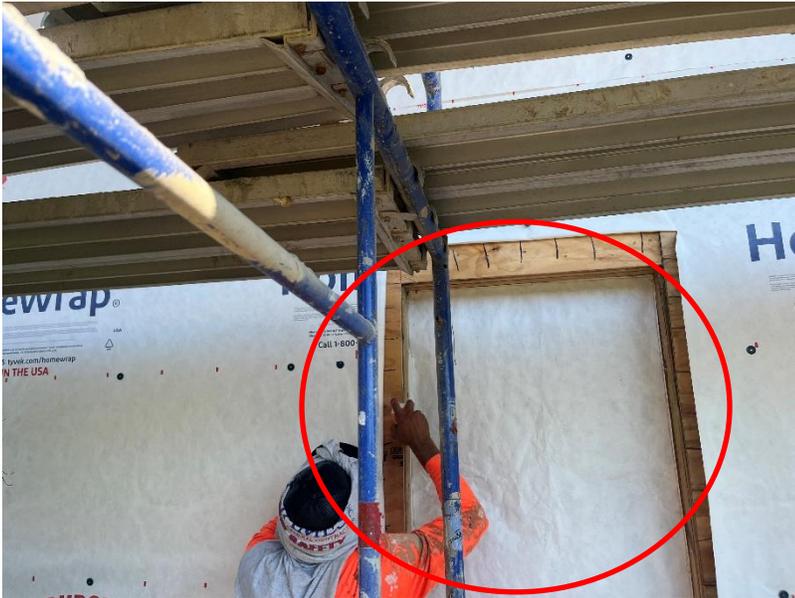
PHOTOGRAPH #11

**BUILDING 15
SECTION D- UNIT #1517**

Contractor preparing window opening for installation of new PGT Window.

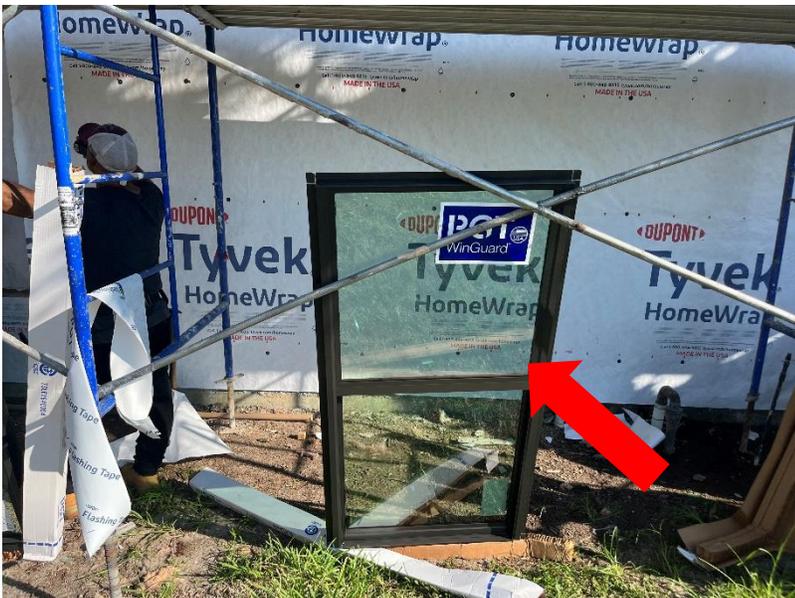
PHOTOGRAPH #12

**BUILDING 15
SECTION D**

New aluminum PGT single hung, single window ready for installation as per drawing window schedule.

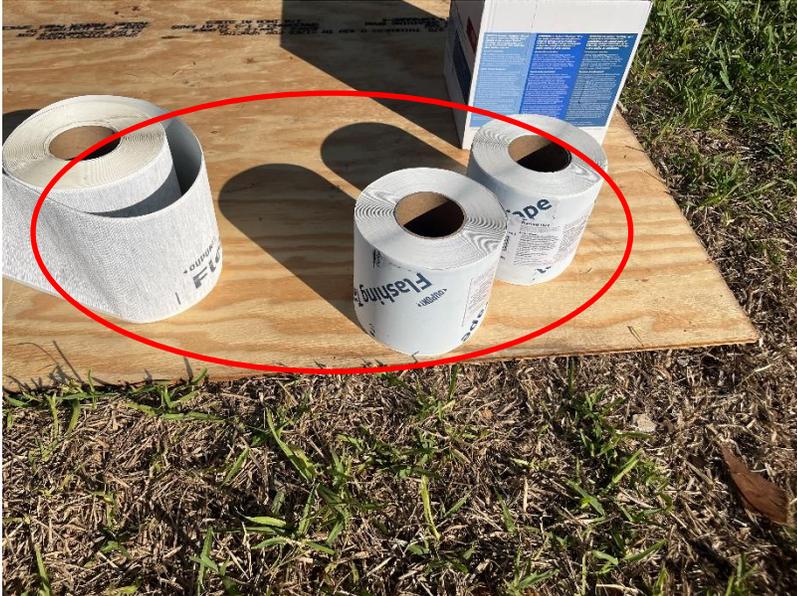
PHOTOGRAPH #13

**BUILDING 15
SECTION D**

Dupont flashing tape and FlexWrap NF ready for window installation.

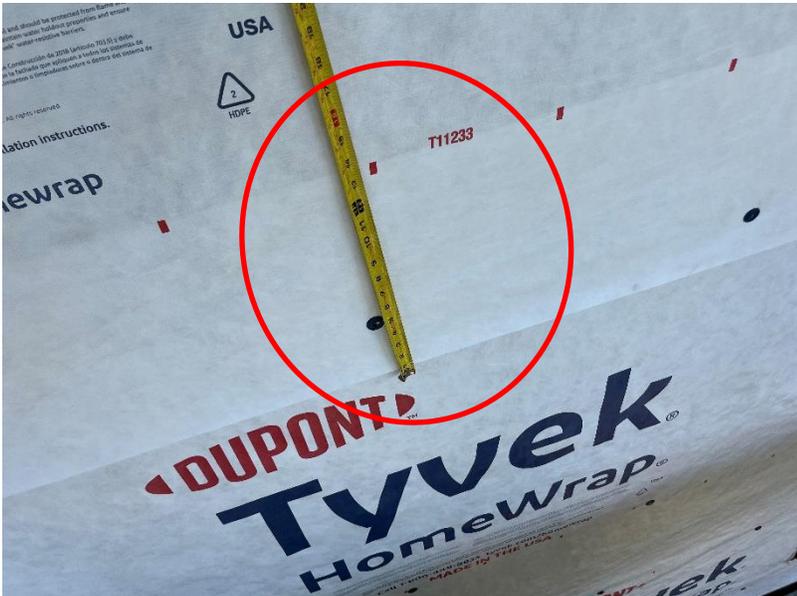
PHOTOGRAPH #14

**BUILDING 15
SECTION D**

Tyvek HomeWrap properly lapped at seams as per manufacturers specifications.

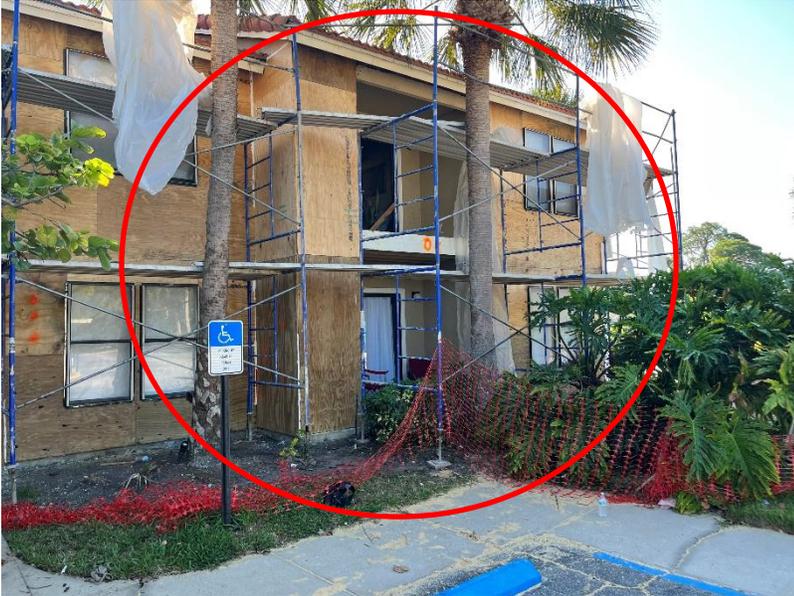
PHOTOGRAPH #15

**BUILDING 15
SECTION C**

Contractor has attached new 15/32" plywood sheathing to framing. Bottom 4' sheets are pressure treated as per specifications.

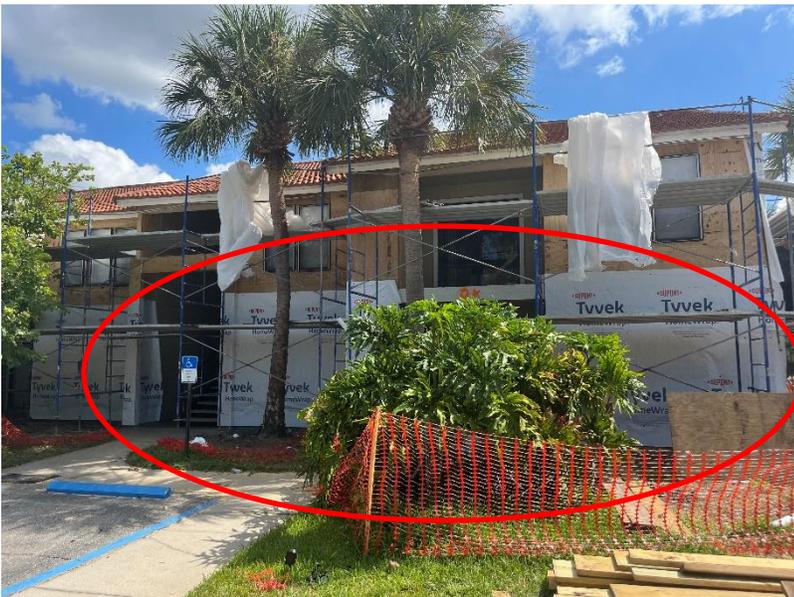
PHOTOGRAPH #16

**BUILDING 15
SECTION C**

Contractor has begun to apply new Tyvek HomeWrap WRB over new plywood sheathing.

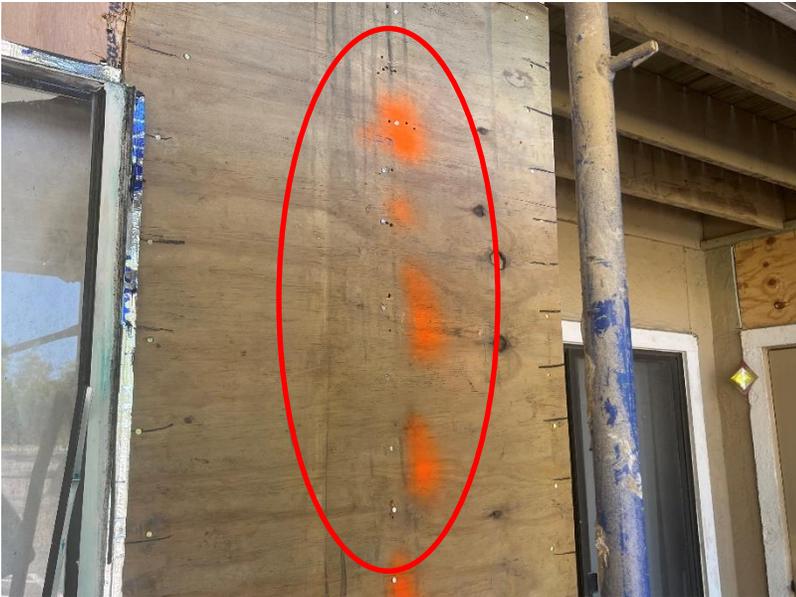
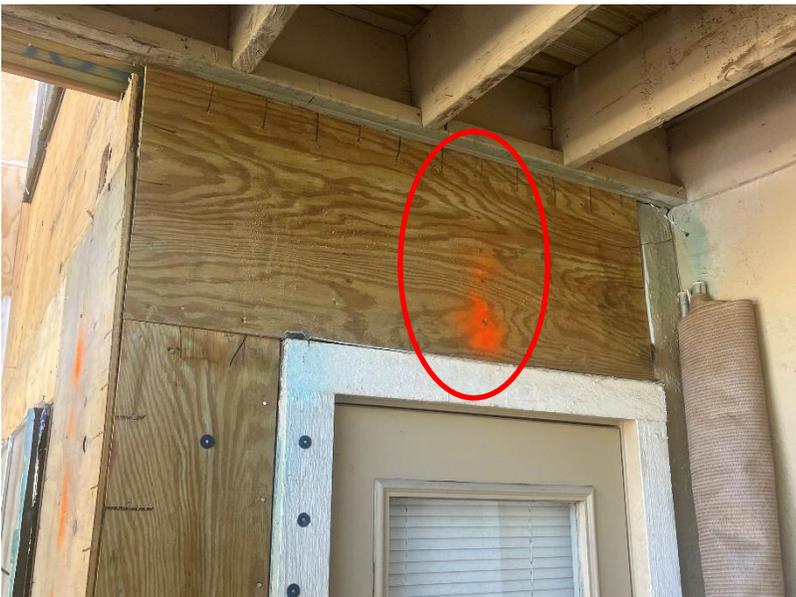
**BUILDING 15
SECTION B**

Contractor made fastening corrections where fasteners were missed and marked by Delta.

| Elevation | Demo | Gable Bracing | Gable Vents | Framing & strapping | Sheathing | Soffit | Window flashing | Window Install | Stucco Lath Acc | Stucco | Sealant | Attics | Painting | Punch | Comments |
|---|---|---|---|---|---|---|---|---|---|---|---|---|---|---|---|
| B | X | NA | NA | X | | | | | | | | | | | Contractor made fastening corrections where fasteners were missed and marked by Delta (Photographs #17 and #18). |

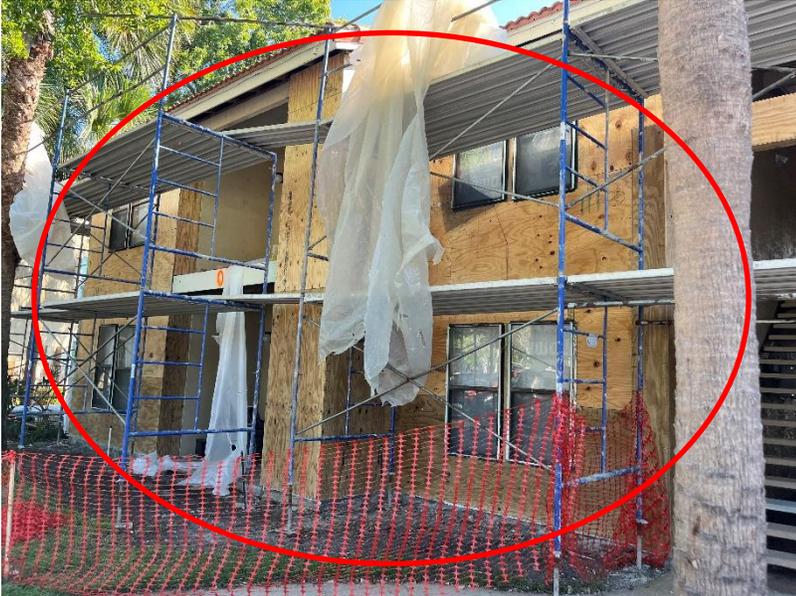
PHOTOGRAPH #19

**BUILDING 15
SECTION A**

Contractor has attached new 15/32" plywood sheathing to framing. Bottom 4' sheets are pressure treated as per specifications.

| Elevation | Demo | Gable Bracing | Gable Vents | Framing & strapping | Sheathing | Soffit | Window flashing | Window Install | Stucco Lath Acc | Stucco | Sealant | Attics | Painting | Punch | Comments |
|---|---|---|---|---|---|---|---|---|---|---|---|---|---|---|---|
| A | X | NA | NA | X | | | | | | | | | | | Contractor has attached new 15/32" plywood sheathing to framing. Bottom 4' sheets are pressure treated as per specifications (Photograph #19). |

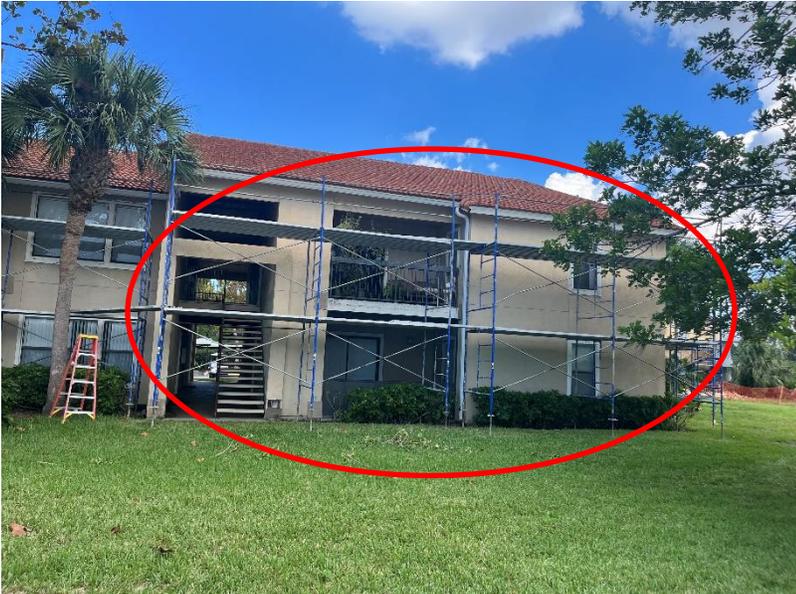
PHOTOGRAPH #20

**BUILDING 16
SECTION G**

Contractor has erected access scaffolding for repairs and inspections.

| Elevation | Demo | Gable Bracing | Gable Vents | Framing & strapping | Sheathing | Soffit | Window flashing | Window Install | Stucco Lath Acc | Stucco | Sealant | Attics | Painting | Punch | Comments |
|---|---|---|---|---|---|---|---|---|---|---|---|---|---|---|---|
| F | | NA | NA | | | | | | | | | | | | Contractor has erected access scaffolding for repairs and inspections(Photograph #20). |

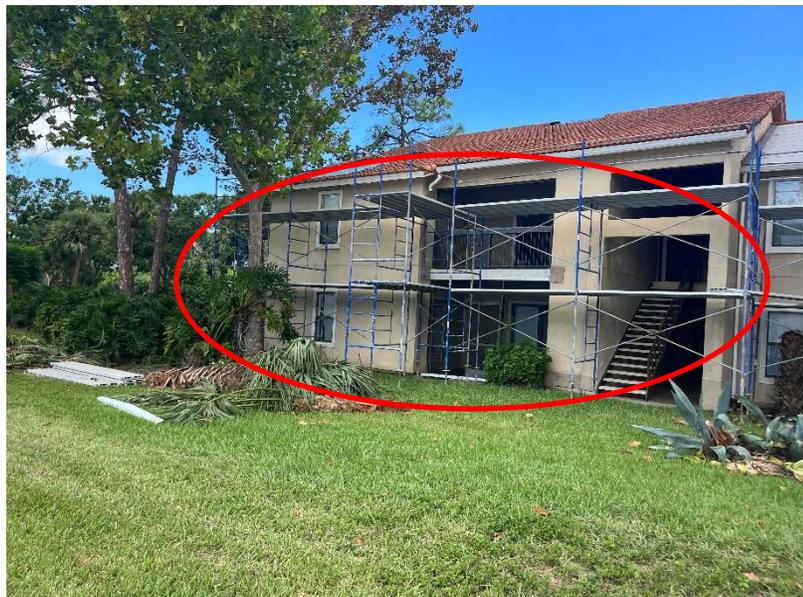
PHOTOGRAPH #21

**BUILDING 16
SECTION E**

Contractor has erected access scaffolding for repairs and inspections.

| Elevation | Demo | Gable Bracing | Gable Vents | Framing & strapping | Sheathing | Soffit | Window flashing | Window Install | Stucco Lath Acc | Stucco | Sealant | Attics | Painting | Punch | Comments |
|---|---|---|---|---|---|---|---|---|---|---|---|---|---|---|---|
| D | | | | | | | | | | | | | | | Contractor has erected access scaffolding for repairs and inspections (Photograph #21) |

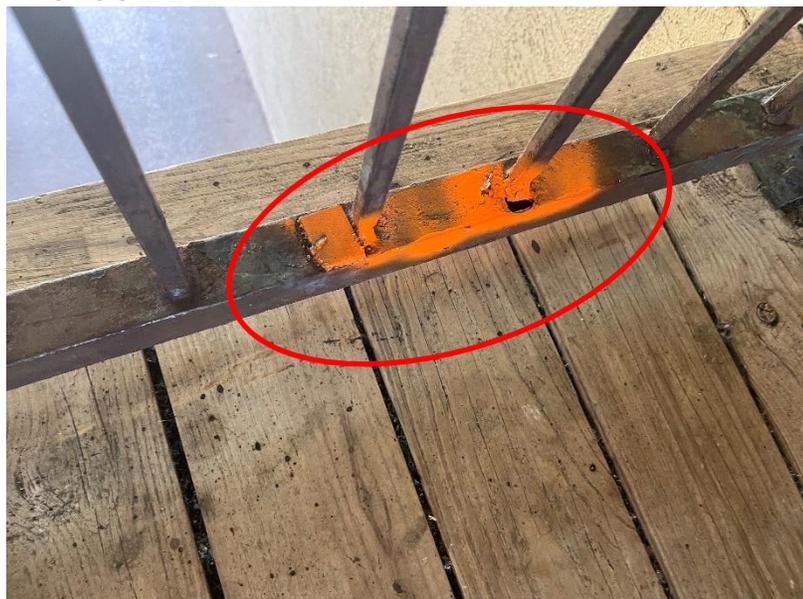
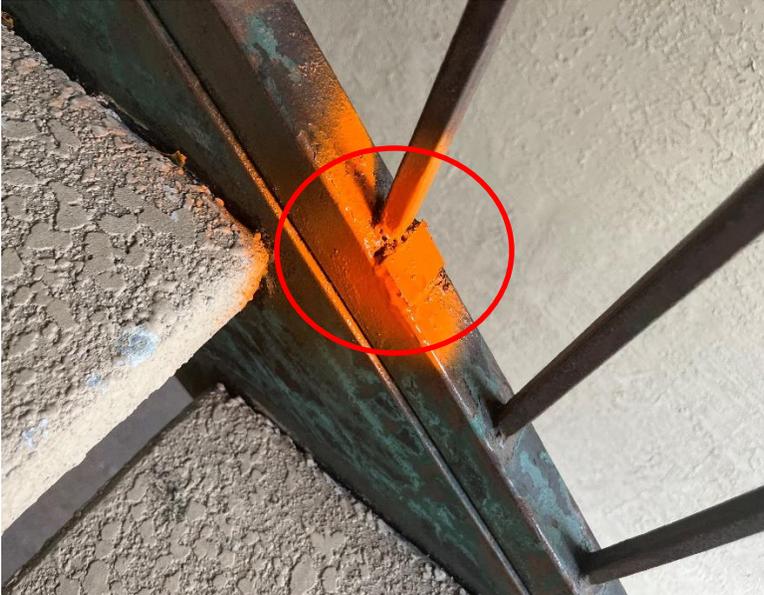
**BUILDING 16
BREEZEWAY RAILS**

Railing repairs have not been completed by owners welding contractor.

| Elevation | Demo | Gable Bracing | Gable Vents | Framing & strapping | Sheathing | Soffit | Window flashing | Window Install | Stucco Lath Acc | Stucco | Sealant | Attics | Painting | Punch | Comments |
|---|---|---|---|---|---|---|---|---|---|---|---|---|---|---|---|
| A | | NA | | | | | | | | | | | | | Railing repairs have not been completed by owners welding contractor (Photographs #22 & #23). |

1. Roof sheathing damage observed to be repaired by owners roofing contractor.
2. Soil has not been re-graded by others to provide 6" minimum separation from grade to new stucco accessories as per drawings.
3. Railing repairs have not been completed by owners welding contractor (Photographs 22 & 23).

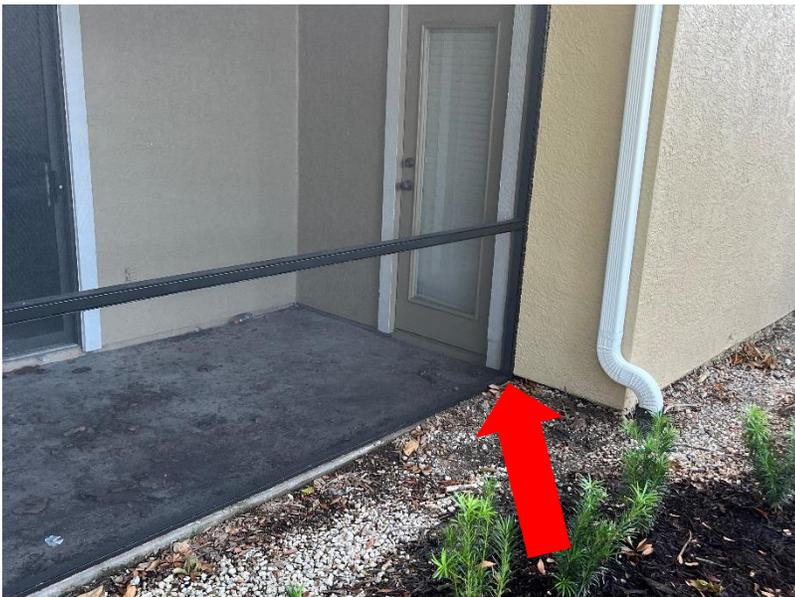
PHOTOGRAPH #24

**BUILDING 12
SECTION G – UNIT #1212**

Contractor has completed action and punch list item by replacing cedar trim at balcony doorway.

| Elevation | Demo | Gable Bracing | Gable Vents | Framing & strapping | Sheathing | Soffit | Window flashing | Window Install | Stucco Lath Acc | Stucco | Sealant | Attics | Painting | Punch | Comments |
|---|---|---|---|---|---|---|---|---|---|---|---|---|---|---|--|
| G | X | NA | NA | X | X | X | X | X | X | X | X | X | X | X | Contractor has completed action and punch list item by replacing cedar trim at balcony doorway (Photograph #24). |

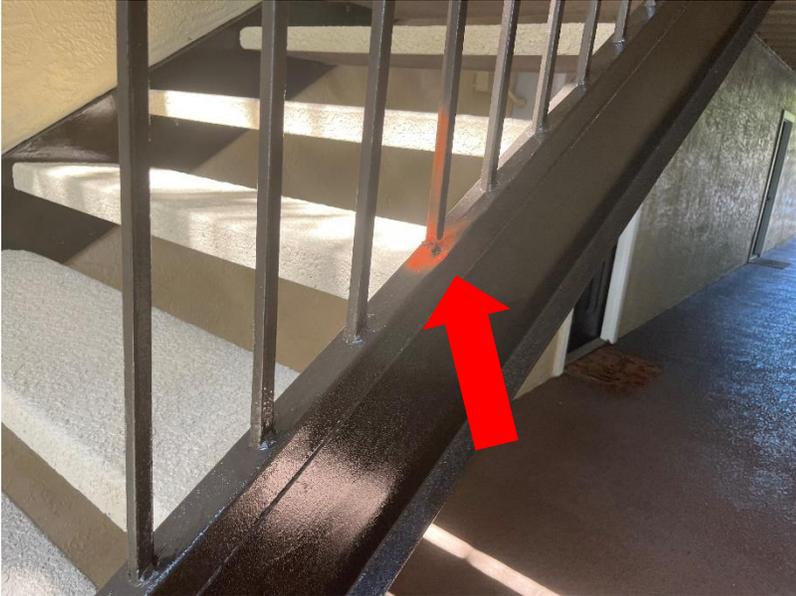
PHOTOGRAPH #25

**BUILDING 9
SECTION E**

Owners' contractor has not completed railing repairs at breezeway stairs.

| Elevation | Demo | Gable Bracing | Gable Vents | Framing & strapping | Sheathing | Soffit | Window flashing | Window Install | Stucco Lath Acc | Stucco | Sealant | Attics | Painting | Punch | Comments |
|---|---|---|---|---|---|---|---|---|---|---|---|---|---|---|--|
| D | X | X | X | X | X | X | X | X | X | X | X | X | X | X | Owners contractor has not completed railing repairs at breezeway stairs (Photograph #25). |

- Previous and current leaks have damaged roof sheathing. Owners to have repairs done by others.
- Soil has not been re-graded by others to provide 6" minimum separation from grade to new stucco accessories as per drawings .
- Landscaping is above bottom of wall requiring repairs.
- Owners' contractor has not completed railing repairs at breezeway stairs (Photograph #25).
