FIELD OBSERVATION REPORT - Bldg. #15

Permit No. 23100380 00 BR
 Owner: Vintage Grand Condo Assn, Inc.
 Project Address: 4013 Crockers Lake Blvd., Sarasota, FL
 Contractor: RL James Inc
 Inspector (s): Mark Boss
 Type of Assessment: Progress

FIELD OBSERVATION REPORT - Bldg. #16

FIELD OBSERVATION REPORT - Bldg. #9

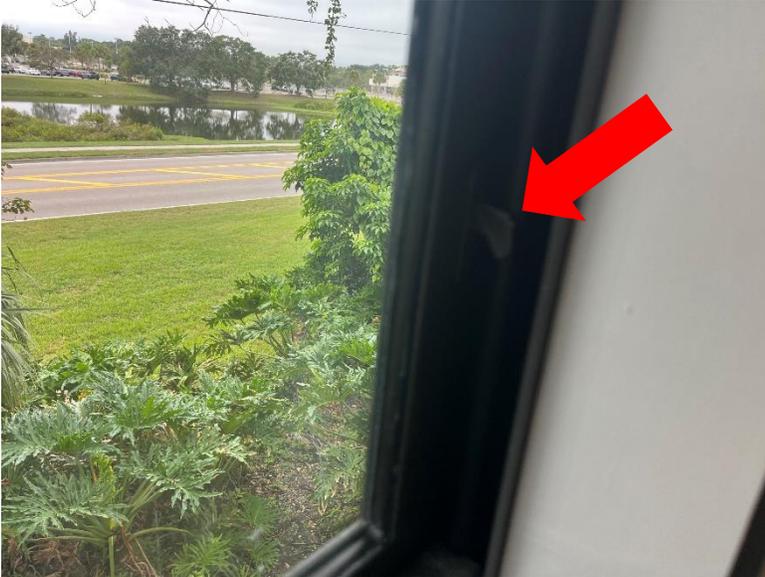
PHOTOGRAPH #1

New PGT window installed has broken safety device.

| Elevation | Demo | Gable Bracing | Gable Vents | Framing & strapping | Sheathing | Soffit | Window flashing | Window Install | Stucco Lath Acc | Stucco | Sealant | Attics | Painting | Punch | Comments |
|---|---|---|---|---|---|---|---|---|---|---|---|---|---|---|--|
| H | X | X | X | X | X | X | X | X | X | X | X | | X | | New PGT window installed has broken safety device (Photograph #1). |

ACTION REQUIRED BY CONTRACTOR:
 1. Repair broken safety device on new PGT window (Photographs #1 and #3)

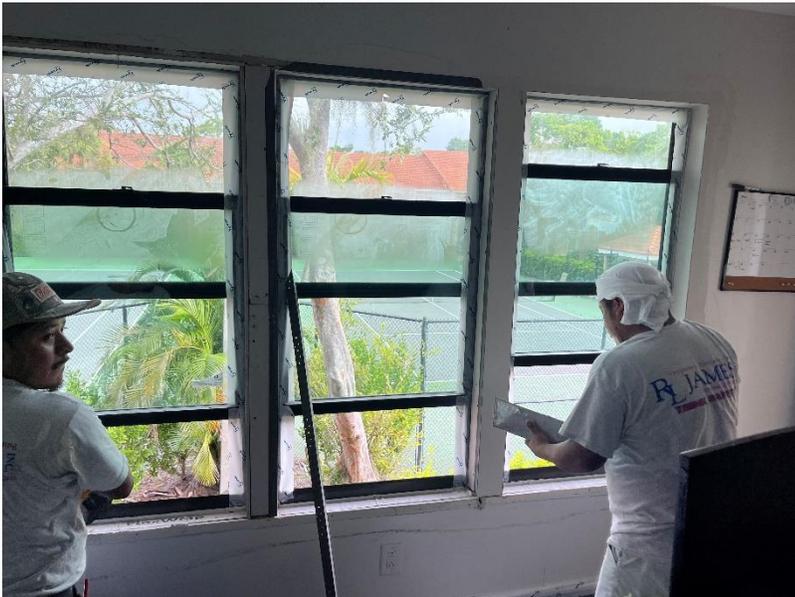
PHOTOGRAPH #2

Contractor performing interior sealant and drywall repairs at areas of new PGT window installations.

| Elevation | Demo | Gable Bracing | Gable Vents | Framing & strapping | Sheathing | Soffit | Window flashing | Window Install | Stucco Lath Acc | Stucco | Sealant | Attics | Painting | Punch | Comments |
|---|---|---|---|---|---|---|---|---|---|---|---|---|---|---|--|
| F | X | NA | NA | X | X | X | X | X | X | X | X | | / | | Contractor performing interior sealant and drywall repairs at areas of new PGT window installations (Photograph #2). |

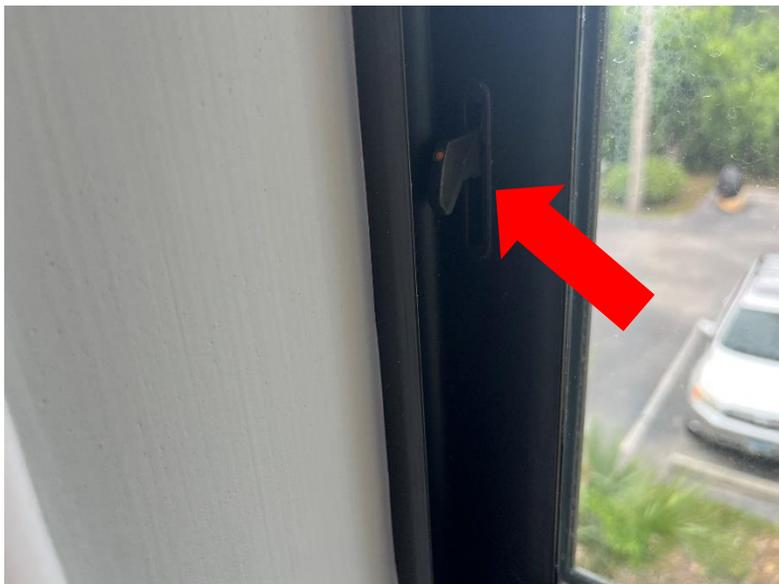
PHOTOGRAPH #3

New PGT window installed has broken safety devise.

| Elevation | Demo | Gable Bracing | Gable Vents | Framing & strapping | Sheathing | Soffit | Window flashing | Window Install | Stucco Lath Acc | Stucco | Sealant | Attics | Painting | Punch | Comments |
|---|---|---|---|---|---|---|---|---|---|---|---|---|---|---|--|
| A | X | NA | NA | X | X | X | X | X | X | X | X | NA | / | | New PGT window installed has broken safety device (Photograph #3). |

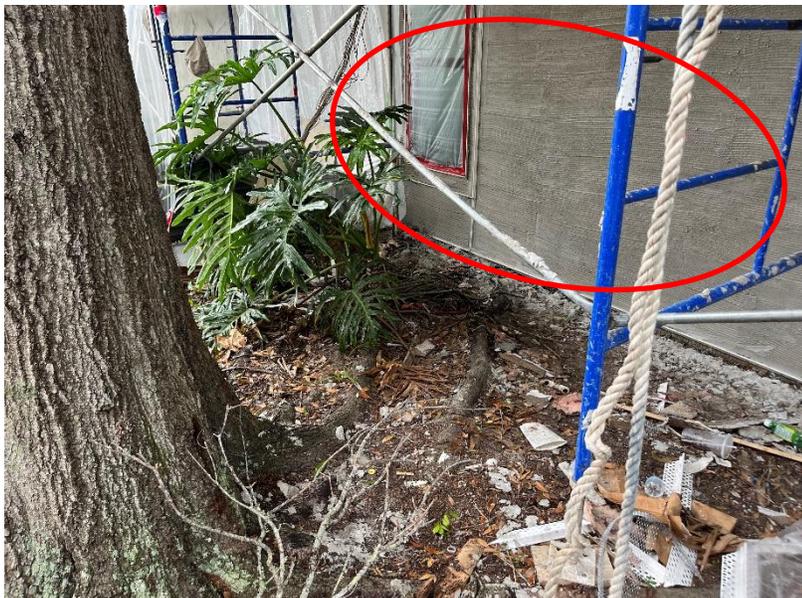
PHOTOGRAPH #4

Stucco sub-contractor has covered new windows and applied scratch coat of stucco at gable end wall.

| Elevation | Demo | Gable Bracing | Gable Vents | Framing & Strapping | Sheathing | Soffit | Window flashing | Window Install | Stucco Lath Acc | Stucco | Sealant | Attics | Painting | Punch | Comments |
|---|---|---|---|---|---|---|---|---|---|---|---|---|---|---|---|
| H | X | X | X | X | X | X | X | X | X | / | | | | | Stucco sub-contractor has covered new windows and applied scratch coat of stucco at gable end wall (Photograph #4). Stucco sub-contractor applying brown and finish coats of stucco at gable end wall (Photograph #5). |

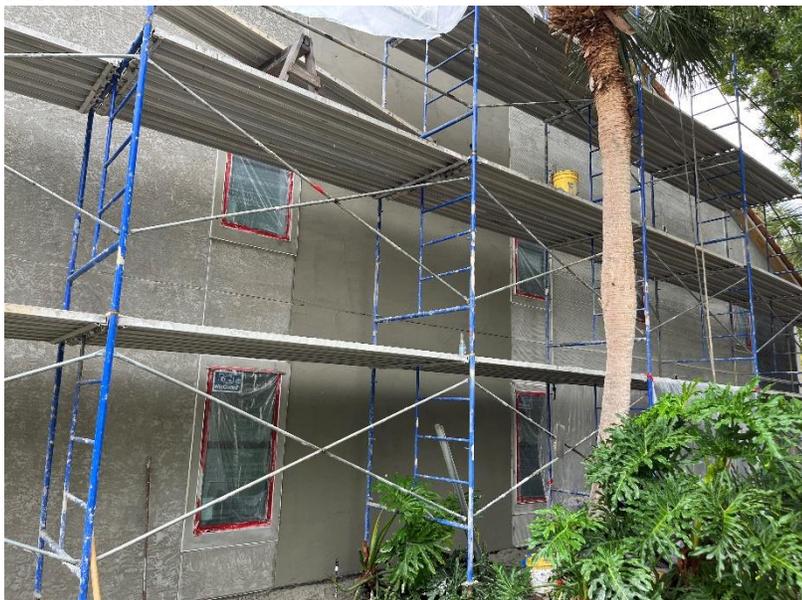
PHOTOGRAPH #5

Stucco sub-contractor applying, brown and finish coats of stucco at gable end wall.

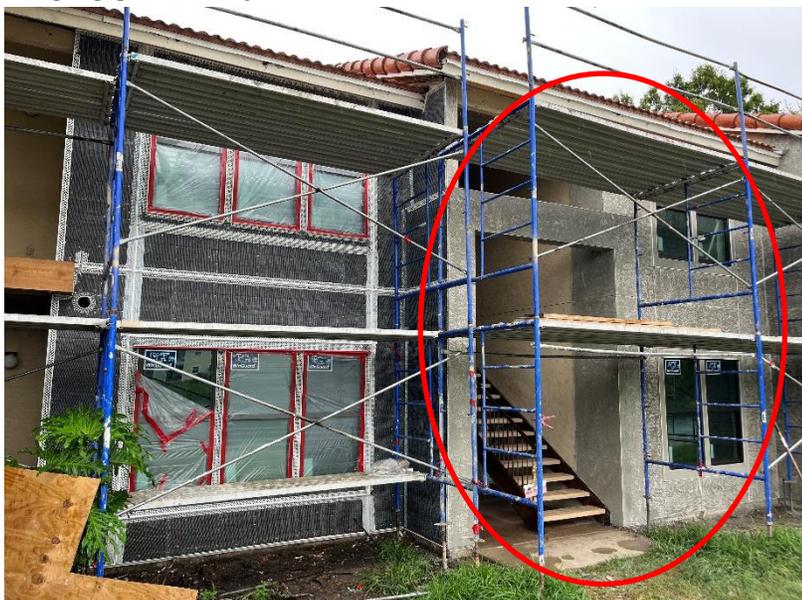
PHOTOGRAPH #6

Stucco sub-contractor has applied 3 coat 7/8" stucco system as per specifications.

| Elevation | Demo | Gable Bracing | Gable Vents | Framing & Strapping | Sheathing | Soffit | Window flashing | Window Install | Stucco Lath Acc | Stucco | Sealant | Attics | Painting | Punch | Comments |
|---|---|---|---|---|---|---|---|---|---|---|---|---|---|---|---|
| G | X | NA | NA | X | X | X | X | X | X | X | | | | | Stucco sub-contractor has applied 3 coat 7/8" stucco system as per specifications (Photograph #6). |

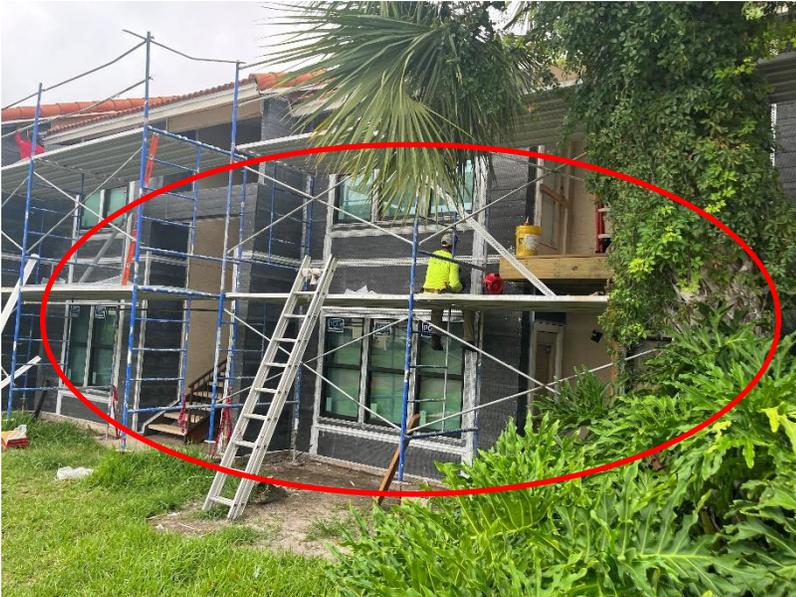
PHOTOGRAPH #7

Stucco sub-contractor applying new vinyl stucco over second water resistant barrier as per drawings and specifications.

| Elevation | Demo | Gable Bracing | Gable Vents | Framing & Strapping | Sheathing | Soffit | Window flashing | Window Install | Stucco Lath Acc | Stucco | Sealant | Attics | Painting | Punch | Comments |
|---|---|---|---|---|---|---|---|---|---|---|---|---|---|---|---|
| F | X | NA | NA | X | X | X | X | X | / | / | / | | | | Stucco sub-contractor applying new vinyl stucco over second water resistant barrier as per drawings and specifications (Photograph #7). Contractor masking window perimeters and installing soft cell backing rod in preparation for new sealant (Photograph #8). |

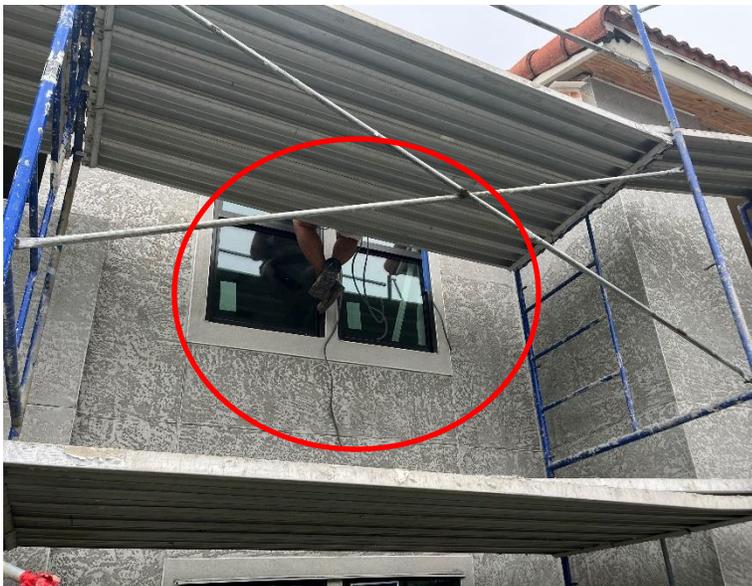
PHOTOGRAPH #8

Contractor masking window perimeters and installing soft cell backing rod in preparation for new sealant.

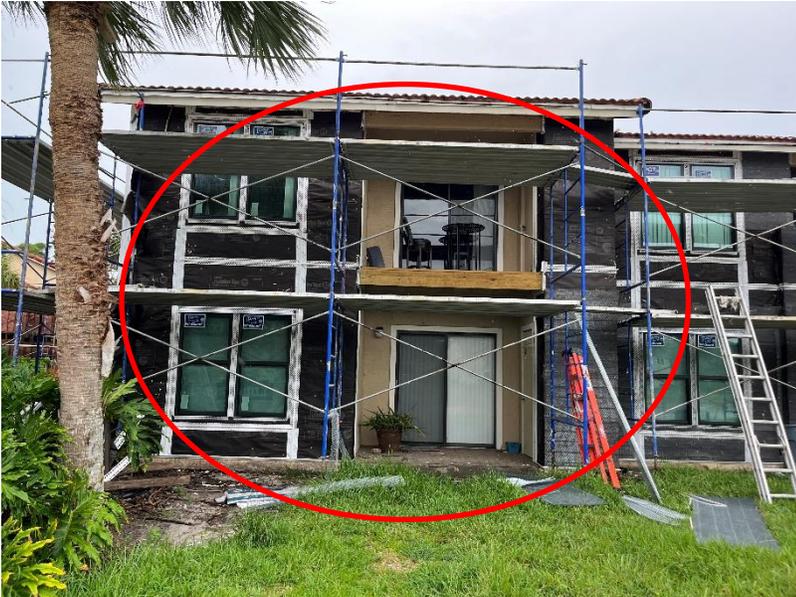
PHOTOGRAPH #9

Sub-contractor installing stucco accessories and galvanized lath in preparation for stucco.

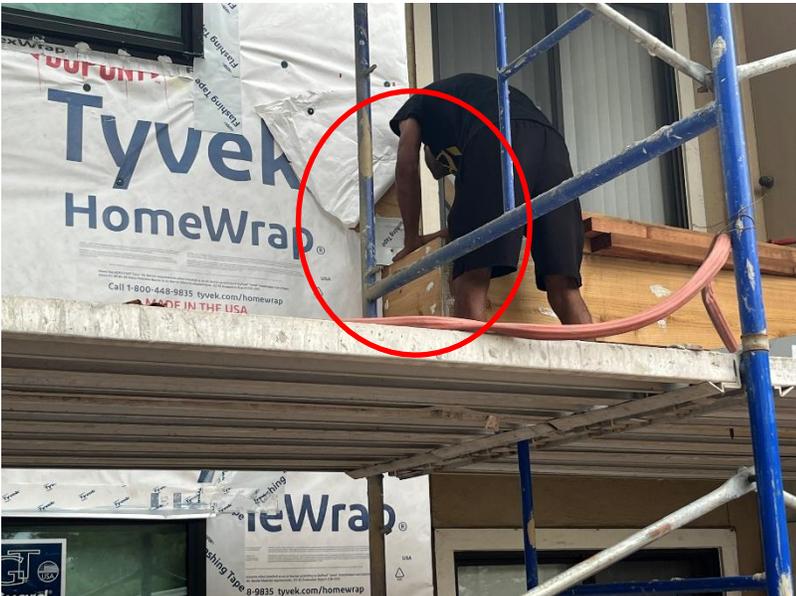
PHOTOGRAPH #10

Contractor installing new galvanized metal kick out flashing at balcony decks as per project manual and drawings.

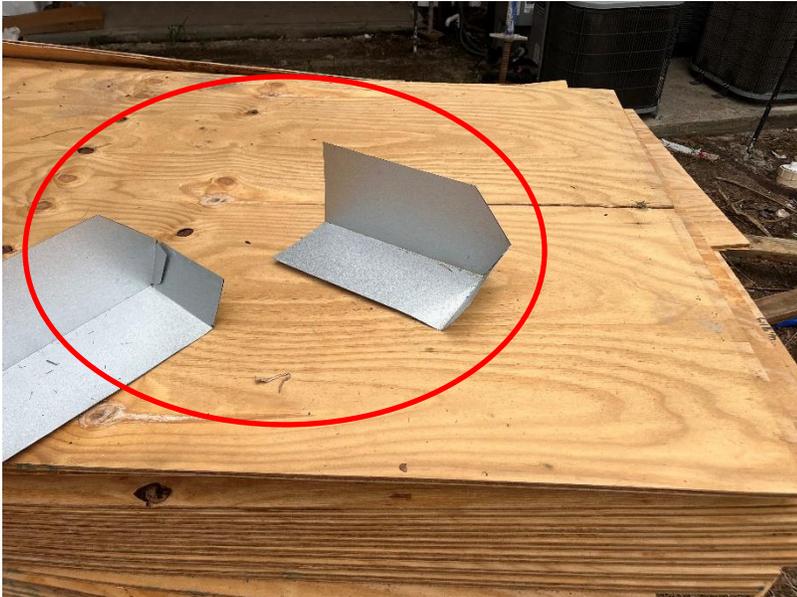
PHOTOGRAPH #11

Contractor installing new galvanized metal kick out flashing at balcony decks as per project manual and drawings.

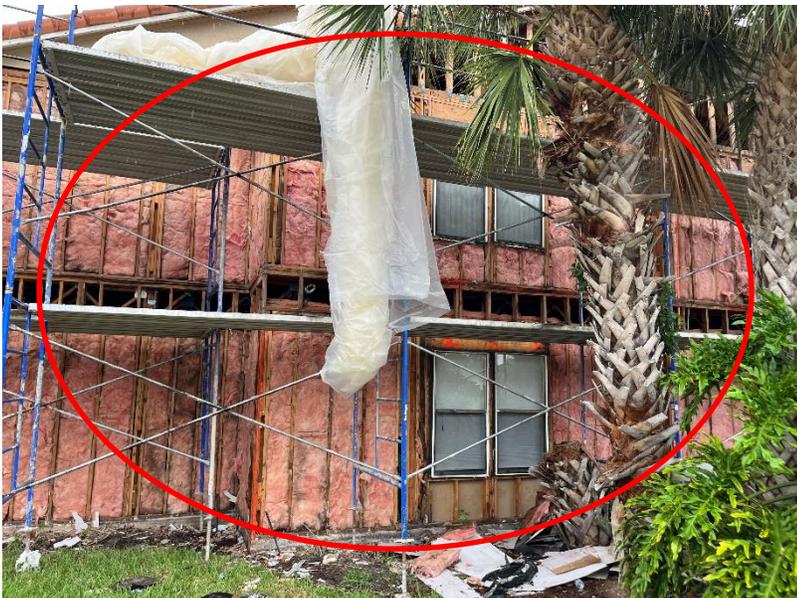
PHOTOGRAPH #12

Delta/Rimkus inspected damaged framing and marked for framing repairs.

| Elevation | Demo | Gable Bracing | Gable Vents | Framing & strapping | Sheathing | Soffit | Window flashing | Window Install | Stucco Lath Acc | Stucco | Sealant | Attics | Painting | Punch | Comments |
|---|---|---|---|---|---|---|---|---|---|---|---|---|---|---|---|
| G | X | NA | NA | | | | | | | | | | | | Delta/Rimkus inspected damaged framing and marked for framing repairs (Photograph #12). Damaged studs and top plate marked for repairs at gable end wall (Photograph #13). Damaged double window header marked for repairs at gable end wall (Photograph #14). Contractor has begun repairs of damaged framing at gable end wall (Photograph #15). |

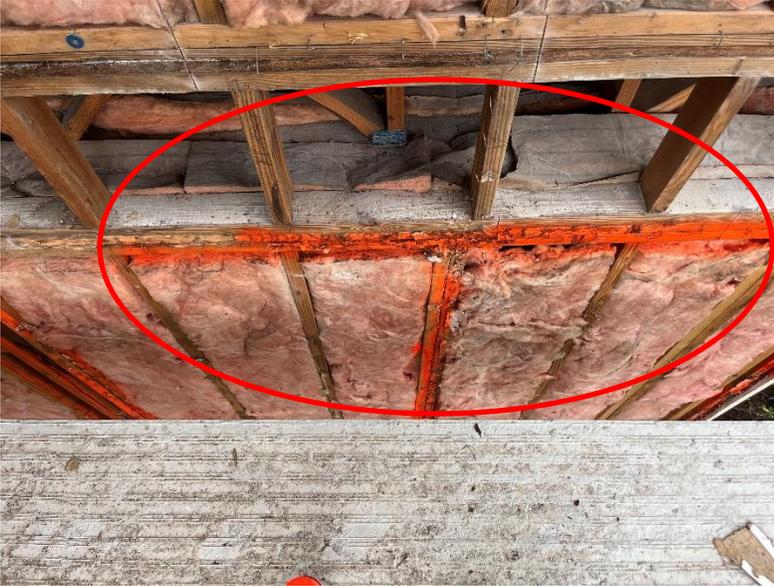
PHOTOGRAPH #13

Damaged studs and top plate marked for repairs at gable end wall.

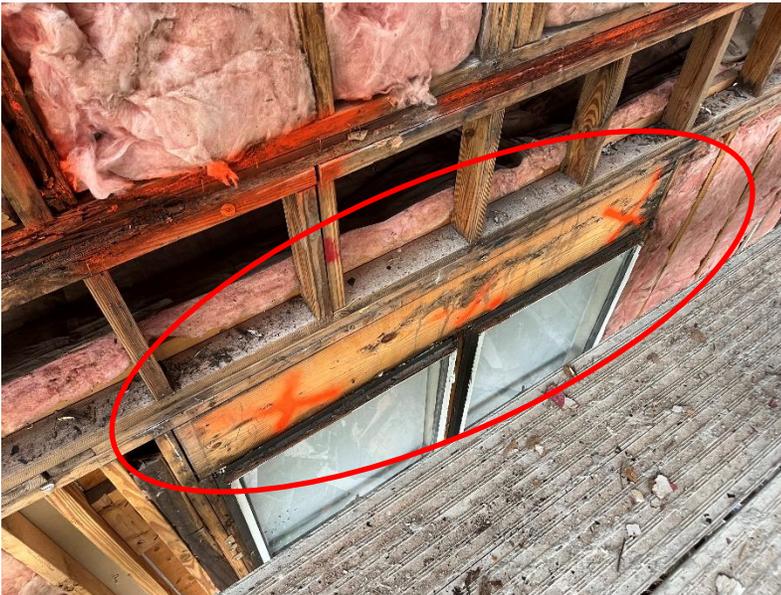
PHOTOGRAPH #14

Damaged double window header marked for repairs at gable end wall.

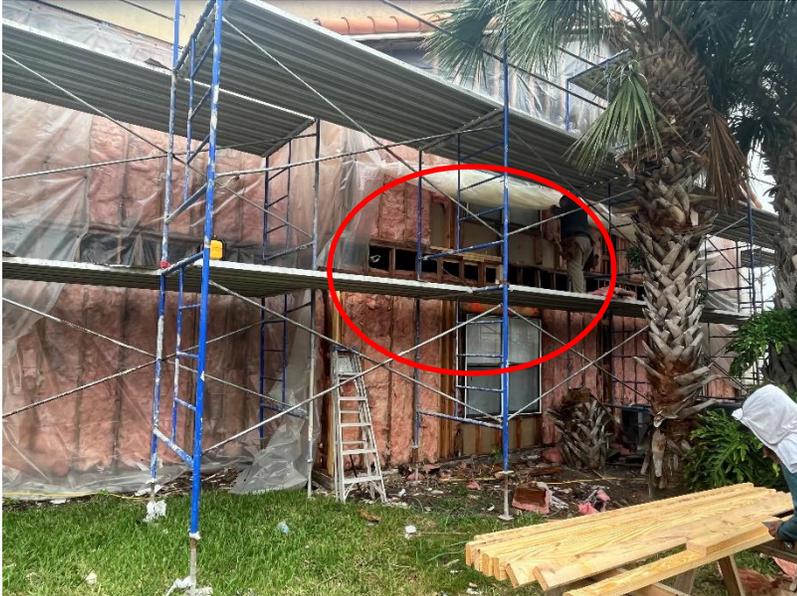
PHOTOGRAPH #15

Contractor has begun repairs of damaged framing at gable end wall.

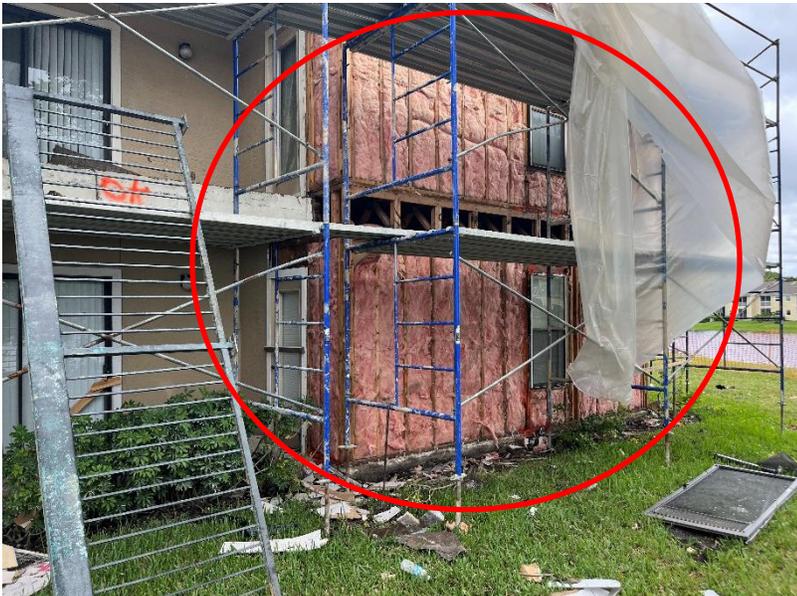
PHOTOGRAPH #16

Delta/Rimkus inspected damaged framing and marked for framing repairs.

| Elevation | Demo | Gable Bracing | Gable Vents | Framing & strapping | Sheathing | Soffit | Window flashing | Window Install | Stucco Lath Acc | Stucco | Sealant | Attics | Painting | Punch | Comments |
|---|---|---|---|---|---|---|---|---|---|---|---|---|---|---|---|
| F | X | NA | NA | | | | | | | | | | | | Delta/Rimkus inspected damaged framing and marked for framing repairs (Photograph #16). Damaged single window header marked for repairs (Photograph #17). Damaged breezeway framing post collapsed when stucco was removed (Photograph #18). Damaged framing at breezeway entrance that came down with stucco removal (Photograph #19). Contractor provided shoring support at breezeway entrance with 6" x 6" post (Photograph #20). Roofing sheathing deteriorated by previous roof leaks (Photograph #21). |

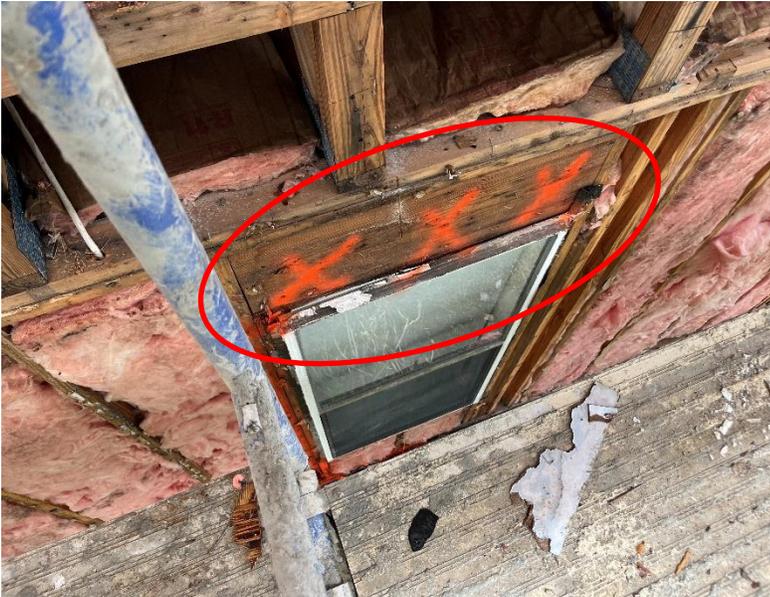
PHOTOGRAPH #17

Damaged single window header marked for repairs.

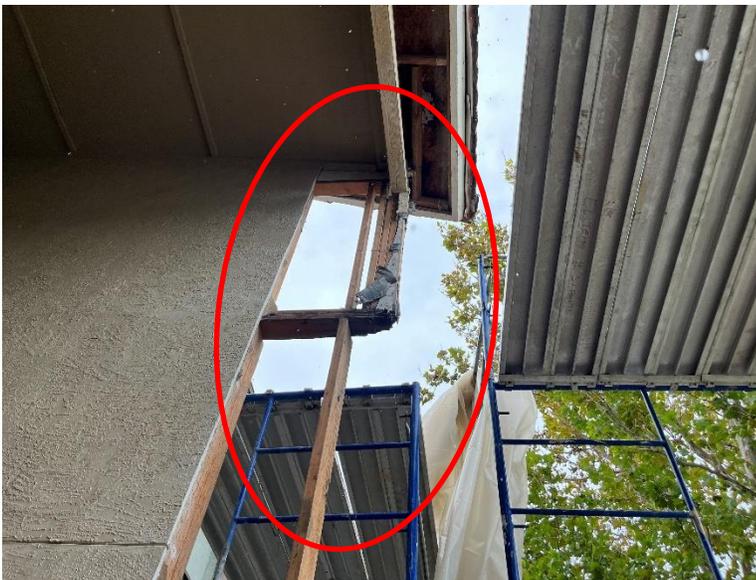
PHOTOGRAPH #18

Damaged breezeway framing post collapsed when stucco was removed.

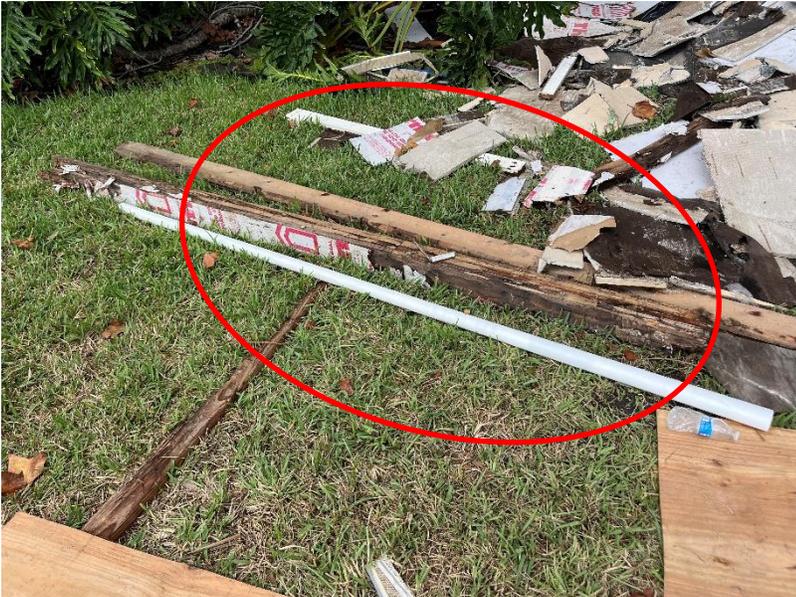
PHOTOGRAPH #19

Damaged framing at breezeway entrance that came down with stucco removal.

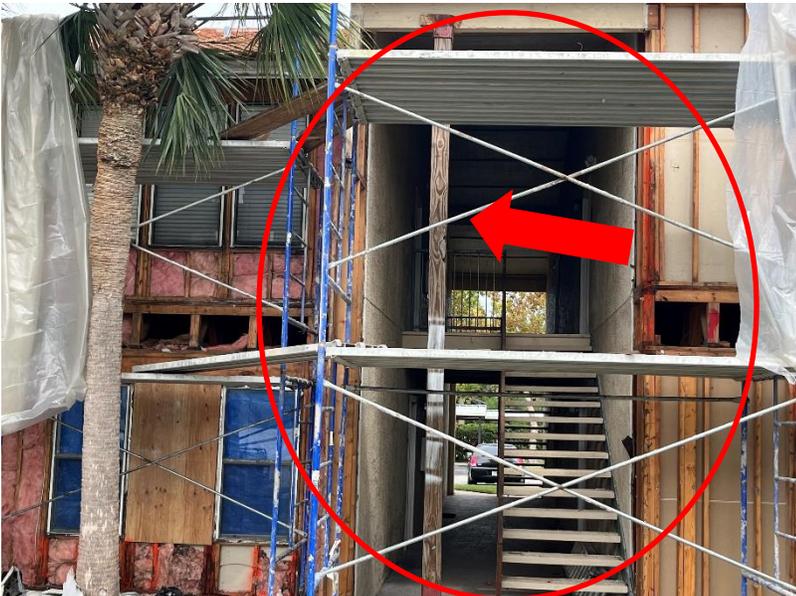
PHOTOGRAPH #20

Contractor provided shoring support at breezeway entrance with 6"x6" post.

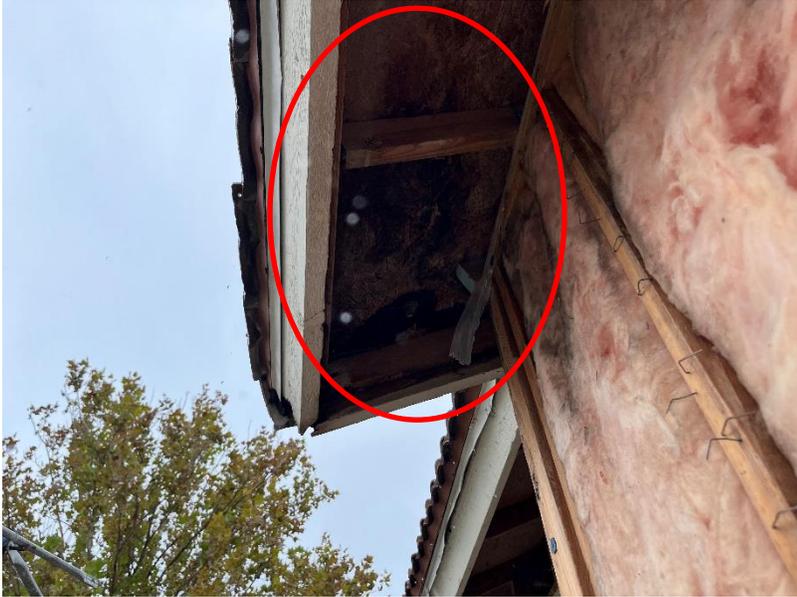
PHOTOGRAPH #21

Roofing sheathing deteriorated by previous roof leaks.

- 1. Roof sheathing damage observed to be repaired by owners roofing contractor (Photograph #21).
- 2. Soil has not been re-graded by others to provide 6" minimum separation from grade to new stucco accessories as per drawings.
- 3. Railing repairs have not been completed by owners welding contractor.

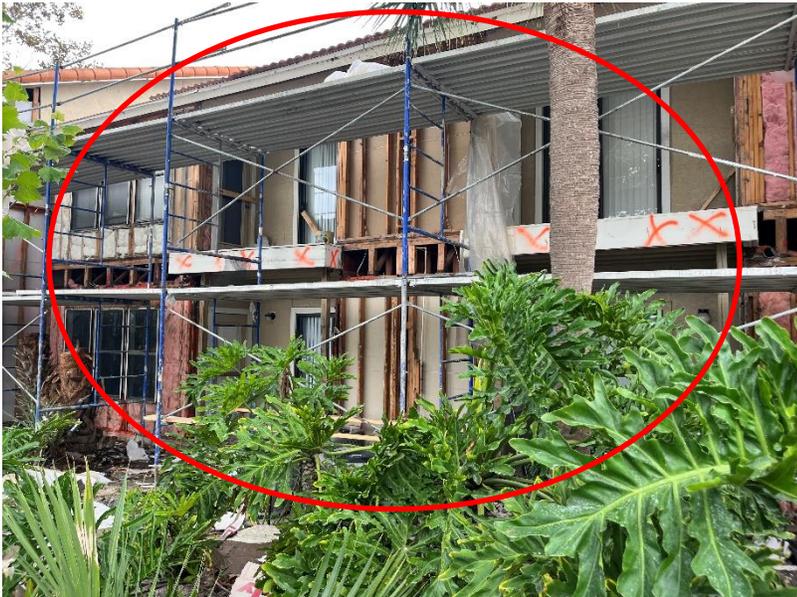
PHOTOGRAPH #22

Delta/Rimkus inspected damaged framing and marked for framing repairs.

| Elevation | Demo | Gable Bracing | Gable Vents | Framing & strapping | Sheathing | Soffit | Window flashing | Window Install | Stucco Lath Acc | Stucco | Sealant | Attics | Painting | Punch | Comments |
|---|---|---|---|---|---|---|---|---|---|---|---|---|---|---|---|
| E | X | NA | NA | | | | | | | | | | | | Delta/Rimkus inspected damaged framing and marked for framing repairs (Photograph #22). Damaged window jacks, jambs and sills marked for repairs (Photograph #23). Contractor removing paint and rust scale from steel railings with hand grinders (Photograph #24). |

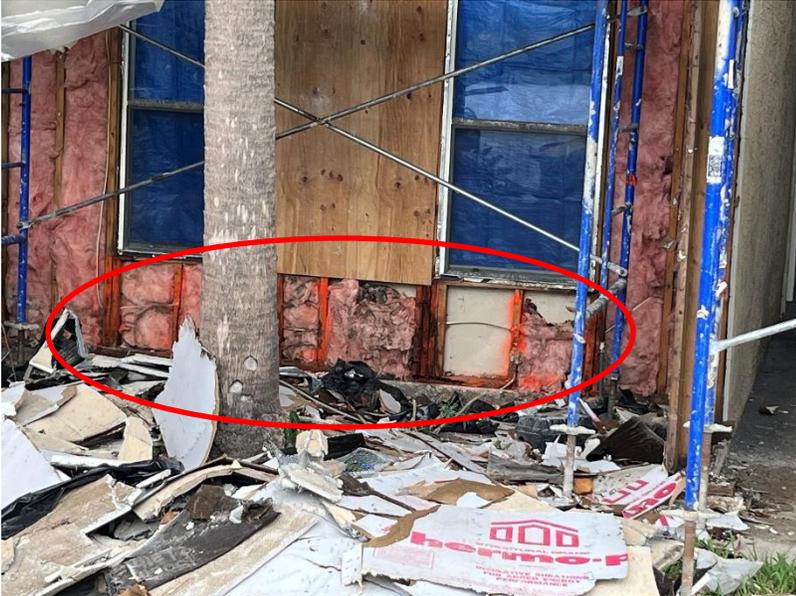
PHOTOGRAPH #23

Damaged window jacks, jambs and sills marked for repairs.

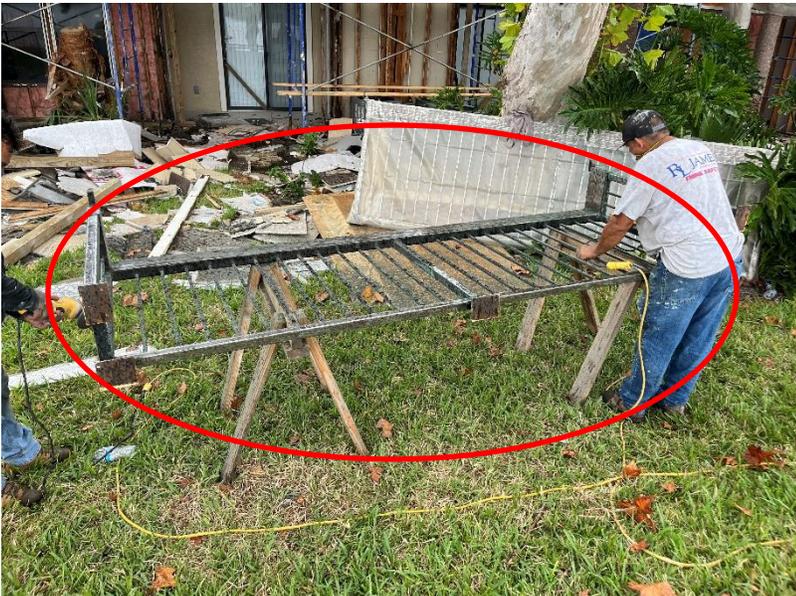
PHOTOGRAPH #24

Contractor removing paint and rust scale from steel railings with hand grinders.

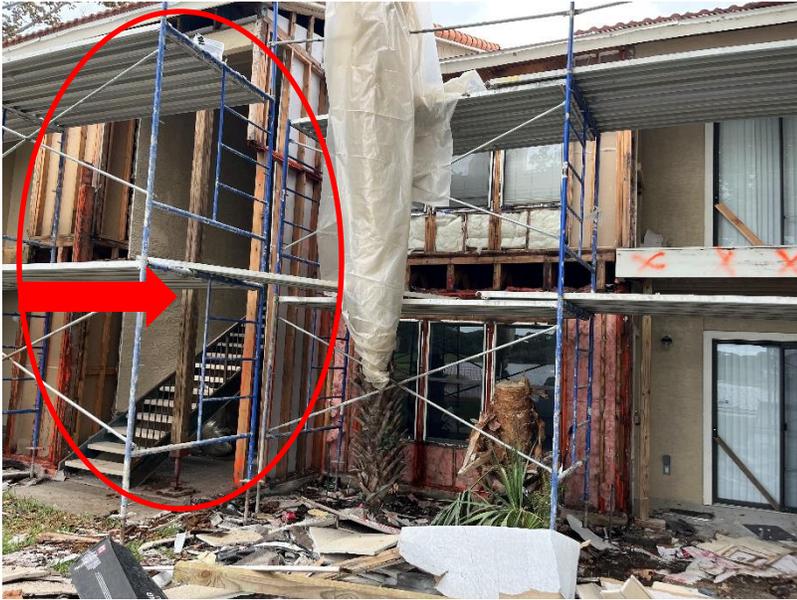
PHOTOGRAPH #25

Contractor provided shoring support at breezeway entrance with 6"x6" post.

| Elevation | Demo | Gable Bracing | Gable Vents | Framing & strapping | Sheathing | Soffit | Window flashing | Window Install | Stucco Lath Acc | Stucco | Sealant | Attics | Painting | Punch | Comments |
|---|---|---|---|---|---|---|---|---|---|---|---|---|---|---|---|
| D | | | | | | | | | | | | | | | Contractor provided shoring support at breezeway entrance with 6" x 6" post (Photograph #25). |
