FIELD OBSERVATION REPORT - Bldg #14

Permit No. 18-131555-00 BC
 Owner: Vintage Grand Condo Assn, Inc.
 Project Address: 4017 Crockers Lake Blvd., Sarasota, FL
 Contractor: RL James Inc
 Inspector (s): Mike Jones
 Type of Assessment: Progress

Project: R1503-302D
 Contact: Glenn Ateili
 Phone/Fax: (941) 923-7380
 Contact: Craig Nicholas / Robert Brancombe
 Phone: (941)232-6486 / (239) 379-1978

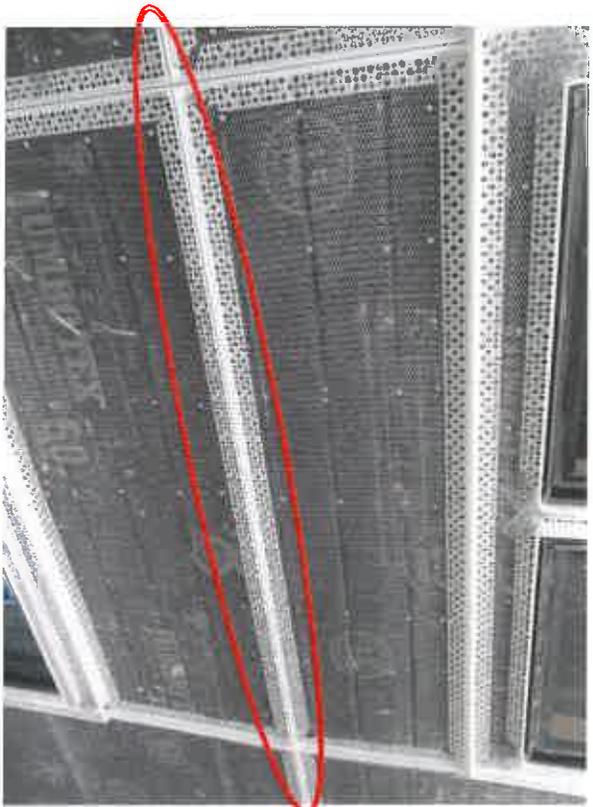
PHOTOGRAPH #1

**BUILDING 14
ELEVATION D & E**

Control joint flanges to be secured at no more than 7" intervals per ASTM C1063. Contractor to provide additional fasteners at elevations 'D & E'.

- Determine location each required mock-up (framing & strapping, sheathing, Tyvek, stucco, window & window flashing, sealant joints, and painting).
- Control joint flanges to be secured at no more than 7" intervals per ASTM C1063. Contractor to provide additional fasteners at elevations 'D & E'. (Photographs #1)

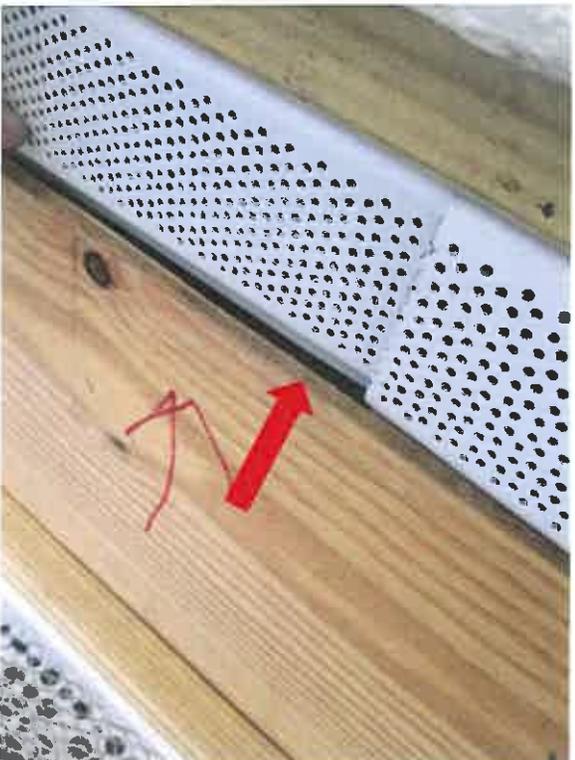
PHOTOGRAPH #2

**BUILDING 14
ELEVATION D & E**

Contractor to secure soffit vent to plywood. Contractor to provide additional fasteners at elevations 'D & E'.

- Contractor to secure soffit vent to plywood. Contractor to provide additional fasteners at elevations 'D & E'. (Photograph #2).
- Soffit trim not installed in a matching fashion. Contractor to reinstall soffit trim to match at butt joint. (Photograph #3).

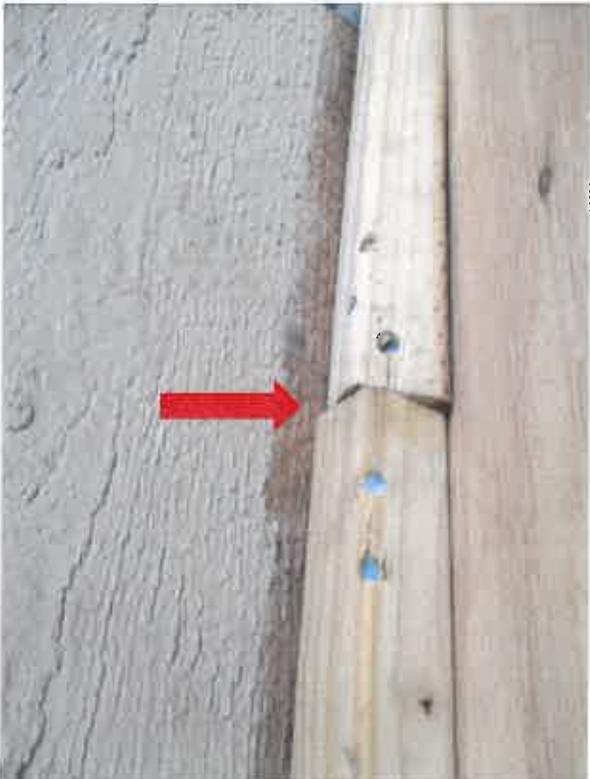
PHOTOGRAPH #3

**BUILDING 14
ELEVATION E**

Soffit trim not installed in a matching fashion. Contractor to reinstall soffit trim to match at butt joint.

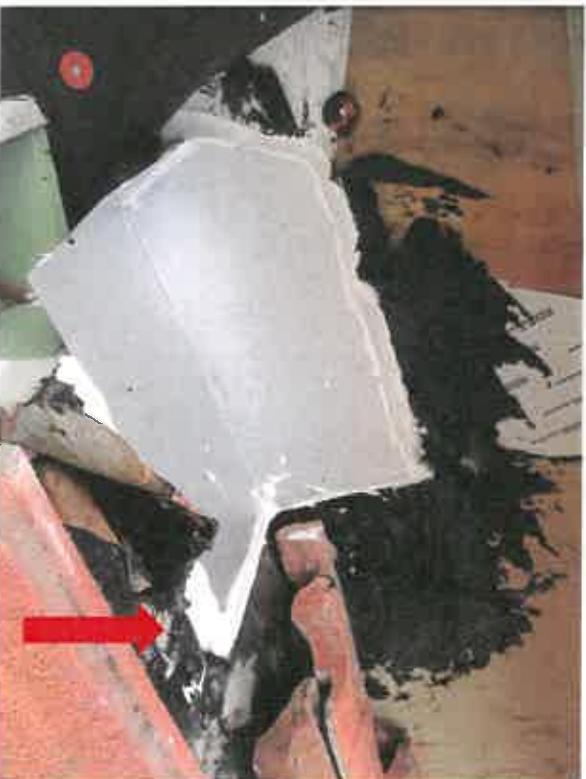
PHOTOGRAPH #4

**BUILDING 14
ELEVATION E**

Kick-out flashing above existing roof shingles. Contractor to remove and reinstall per contractor drawing.

- Kick-out flashing above existing roof shingles. Contractor to remove and reinstall per contractor drawing. (Photograph #4).
- Dryer vents in wall will require extension and flashing details per specifications prior to stucco system application. (Photograph #5)

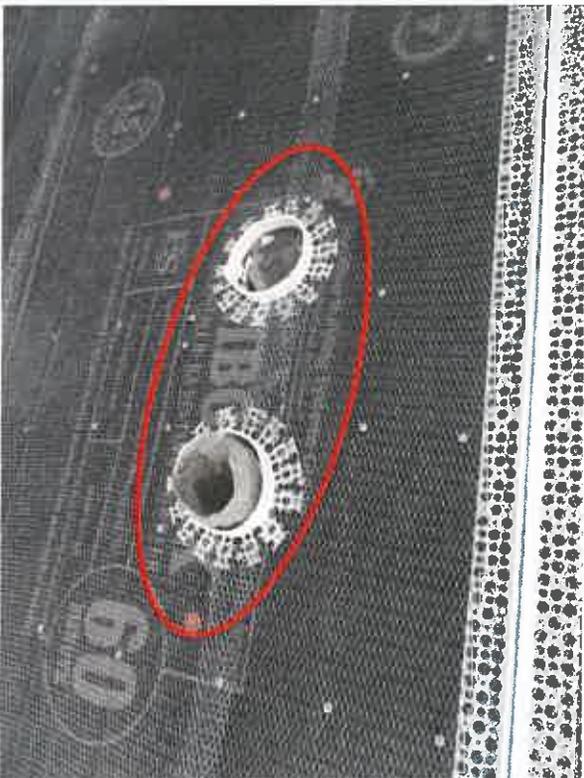
PHOTOGRAPH #5

**BUILDING 14
ELEVATION E**

Dryer vents in wall will require extension and flashing details per specifications prior to stucco system application.

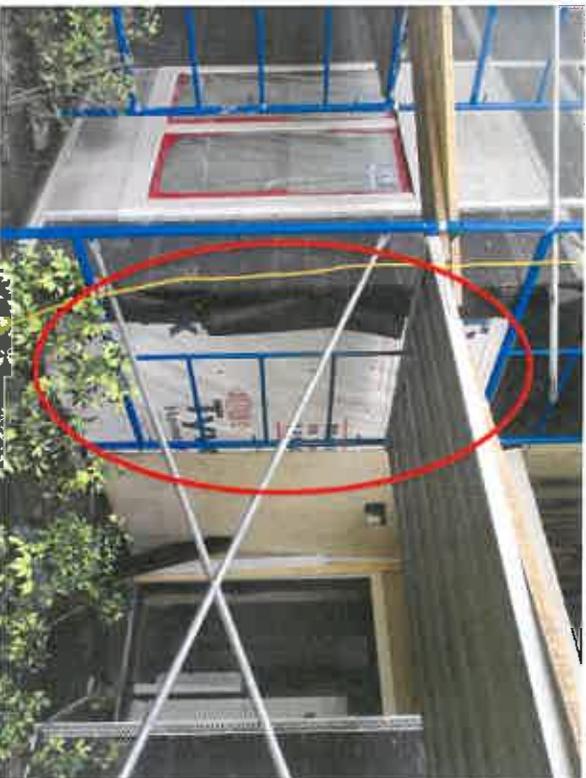
PHOTOGRAPH #6

**BUILDING 14
ELEVATION E**

Contractor to complete weather barrier & lath install per drawings and specifications.

- Contractor to complete weather barrier & lath install per drawings and specifications. (Photograph #6).
- Contractor to remove construction debris daily. Construction safety barriers to remain in place until completion of this project. (Photograph #7).

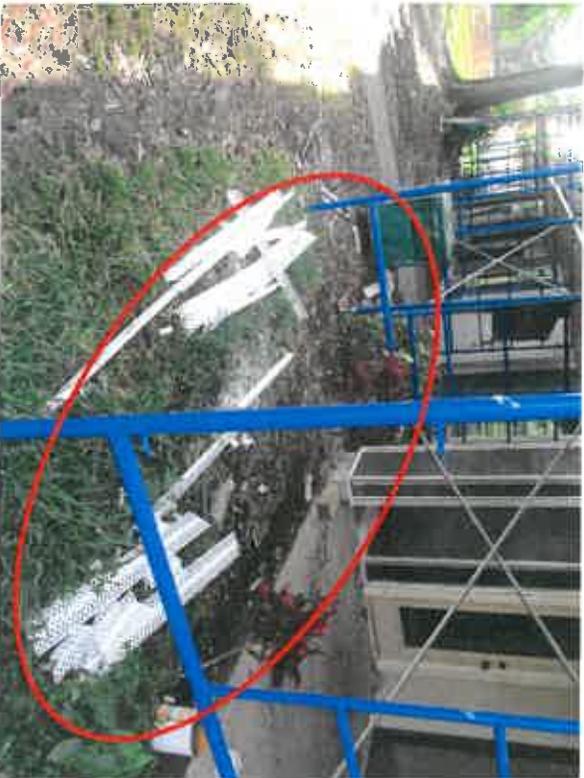
PHOTOGRAPH #7

**BUILDING 14
ELEVATION E**

Contractor to remove construction debris daily. Construction safety barriers to remain in place until completion of this project.

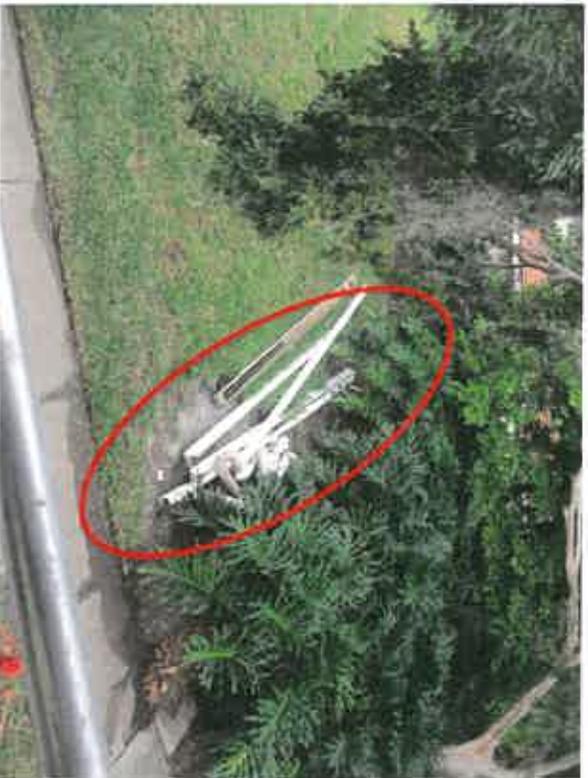
PHOTOGRAPH #8

**BUILDING 14
ELEVATION E**

Gutters and downspout to be stored inside designated construction area.

- Gutters and downspout to be stored inside designated construction area. (Photograph #8).
