**FIELD OBSERVATION REPORT - Bid #14**

Permit No. 18-131555-00 BC  
 Owner: Vinlege Grand Condo Assn, Inc.  
 Project Address: 4017 Crookers Lake Blvd., Sarasota, FL  
 Contractor: RL James Inc  
 Inspector (s): Mark Boas PM  
 Type of Assessment: Progress

Project: R1503-302D  
 Contact: Glenn Atelli  
 Phone/Fax: (941) 923-7390  
 Contact: Craig Nicholas / Robert Branscombe  
 Phone: (941) 232-6486 / (239) 378-1978

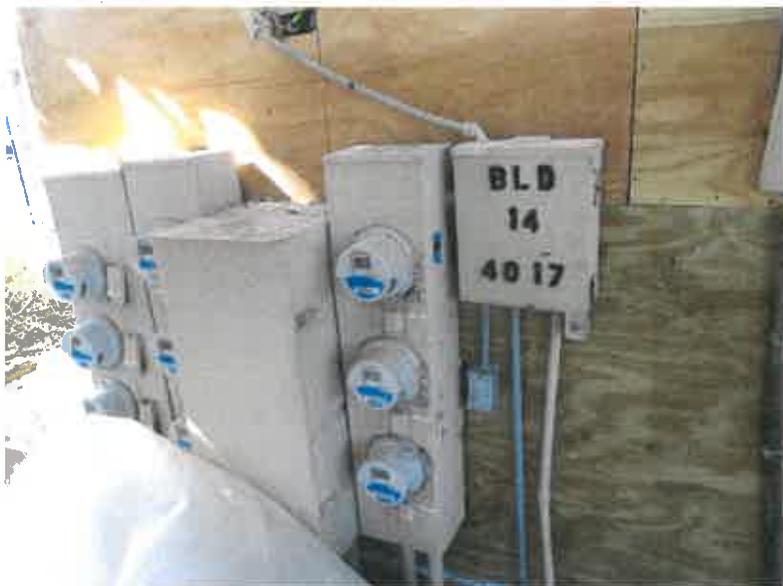
PHOTOGRAPH #1

### BUILDING 14 ELEVATION C

Contractor has removed partial stucco and sheathing behind FPL electrical panels. Delta directed contractor to not remove this area in order to avoid complications with high voltage electrical utilities.

- Determine location each required mock-up (framing & strapping, sheathing, Tyvek, stucco, window & window flashing, sealant joints, and painting).
- Contractor has removed partial stucco and sheathing behind FPL electrical panels. Delta directed contractor to not remove this area in order to avoid complications with high voltage electrical utilities. (Photographs #1)

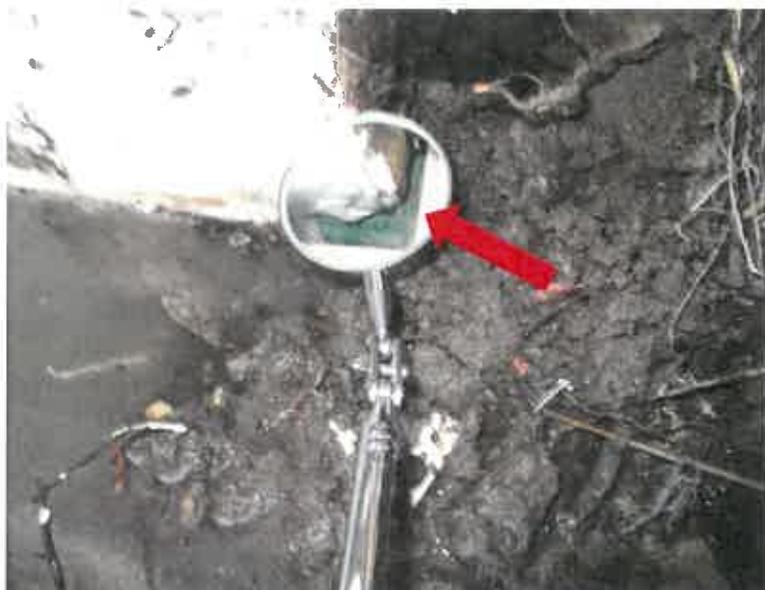
PHOTOGRAPH #2

### BUILDING 14 ELEVATION E

Contractor has not sealed bottom edge of wall termination as per C.O. #7. Stucco weep screed accessories and stucco has already been applied and will require removal for proper application.

- Contractor has not sealed bottom edge of wall termination as per C.O. #7. Stucco weep screed accessories and stucco has already been applied and will require removal for proper application (Photograph #2).

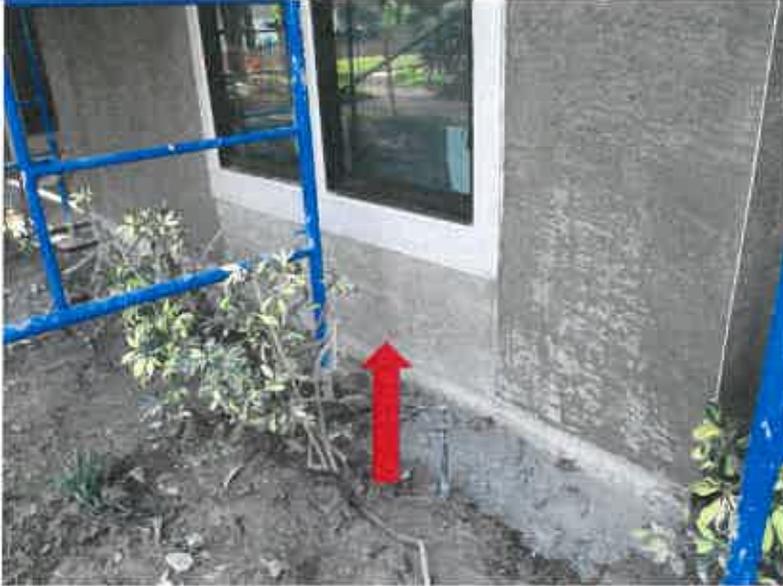
**PHOTOGRAPH #3**

**BUILDING 14  
ELEVATION E**

Stucco finish mock up has been completed and accepted.

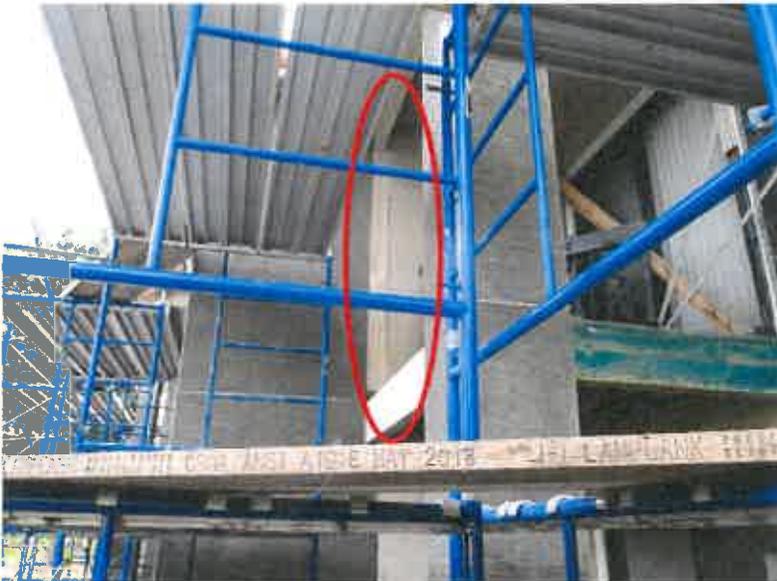
**PHOTOGRAPH #4**

**BUILDING 14  
ELEVATION E**

New Stucco to existing stucco termination is to far outboud of balcony. Termination is to occur within the balcony area that will not be seen from the exterior when screen framing is installed.

- Stucco finish mock up has been completed and accepted (Photograph #3).
- New Stucco to existing stucco termination is to far outboard of balcony. Termination is to occur within the balcony area that will not be seen from the exterior when screen framing is installed. (Photograph #4).

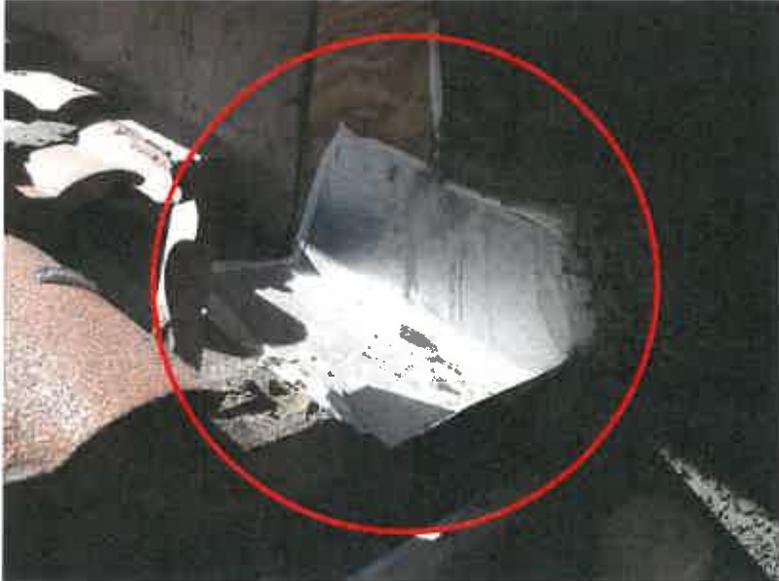
**PHOTOGRAPH #5**

**BUILDING 14  
ELEVATION D**

Kick out flashing is above existing roof shingles. Contractor to remove and reinstall per contract drawings.

- Kick out flashing is above existing roof shingles. Contractor to remove and reinstall per contract drawings (Photograph #5).
- Dryer vents in wall have not been extended or flashed as per specifications prior to stucco application (Photograph #6).

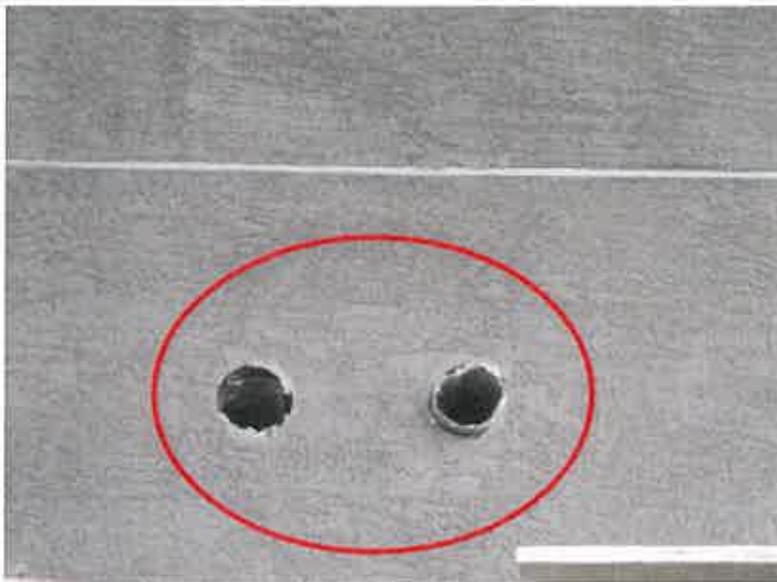
**PHOTOGRAPH #6**

**BUILDING 14  
ELEVATION D**

Dryer vents in wall have not been extended or flashed as per specifications prior to stucco application.

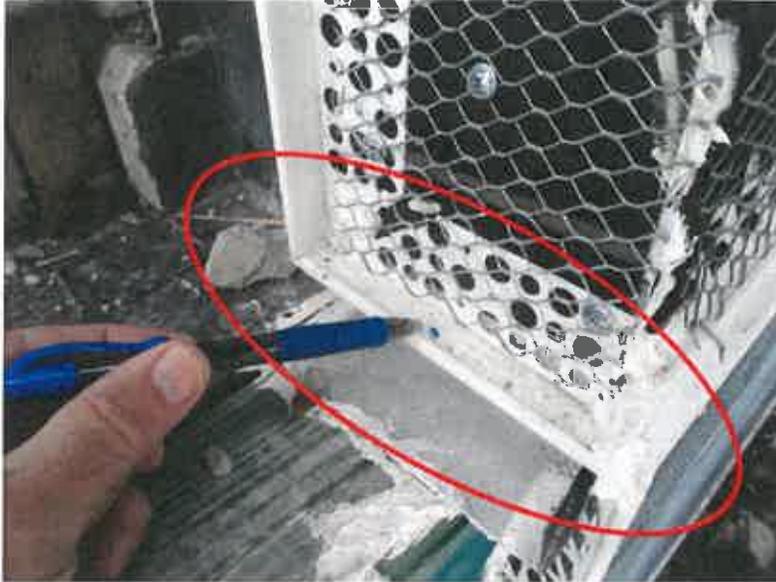
**PHOTOGRAPH #7**

**BUILDING 14  
ELEVATION F**

Contractor to use weep screed with holes or provide holes when using stucco stop accessories above flashing at balcony as per drawings.

- Contractor to use weep screed with holes or provide tubes when using stucco stop accessories above flashing at balcony as per drawings (Photograph #7).

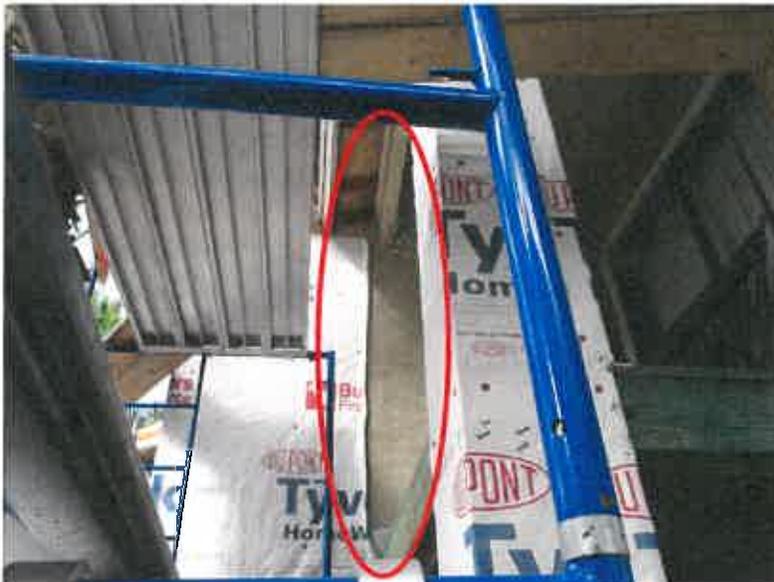
**PHOTOGRAPH #8**

**BUILDING 14  
ELEVATION B**

New Stucco to existing stucco termination is too far outbound of balcony. Termination is to occur within the balcony area that will not be seen from the exterior when screen framing is installed.

- New Stucco to existing stucco termination is too far outboard of balcony. Termination is to occur within the balcony area that will not be seen from the exterior when screen framing is installed (Photograph #8).
