**FIELD OBSERVATION REPORT - Bldgs. #24**

Permit No. 18-177559-00 BC  
 Owner: Vintage Grand Condo Assn, Inc.  
 Project Address: 4017 Crockers Lake Blvd., Sarasota, FL  
 Contractor: RL James Inc  
 Inspector (s): Mark Boss PM  
 Type of Assessment: Progress

PROJECT NAME:  
 WOOD FRAME REPAIRS & RELATED WORK (PHASE II)  
 VINTAGE GRANDE CONDOMINIUM ASSOCIATION, INC.  
 4012 CROCKERS LAKE BLVD., SARASOTA, FL 34238

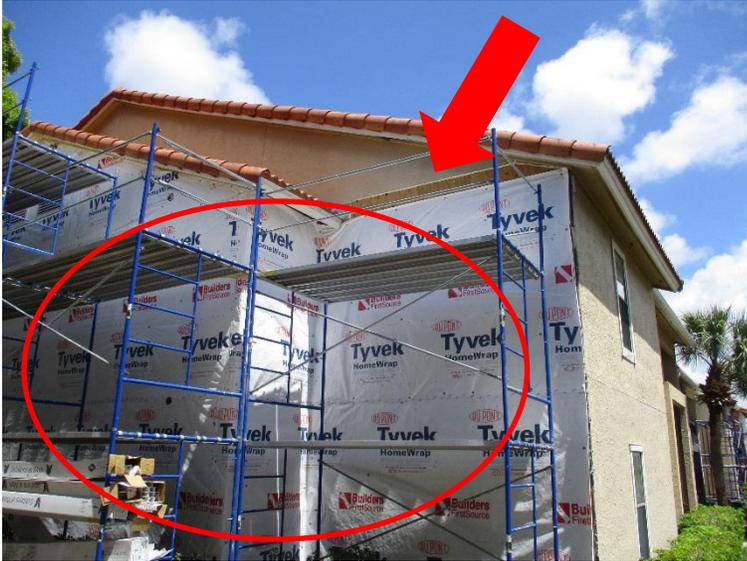
**PHOTOGRAPH #1**

**BUILDING 24  
SECTION D**

Contractor has covered new sheathing with Tyvek HomeWrap. Top transition will be tied in, properly lapped and taped prior to stucco accessories and lath applications.

- 1. HomeWrap at Top transition will be tied in, properly lapped and taped prior to stucco accessories and lath applications (Photograph #1).

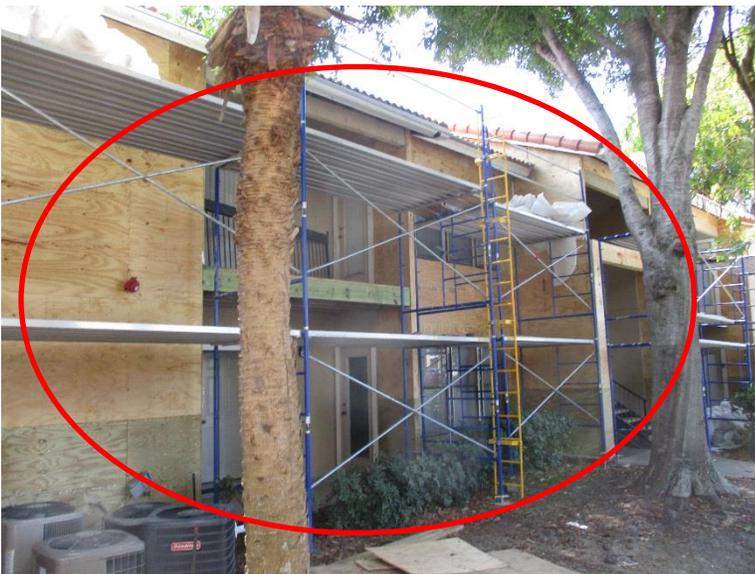
**PHOTOGRAPH #2**

**BUILDING 24  
SECTION B**

Contractor has provided new sheathing at frame walls.

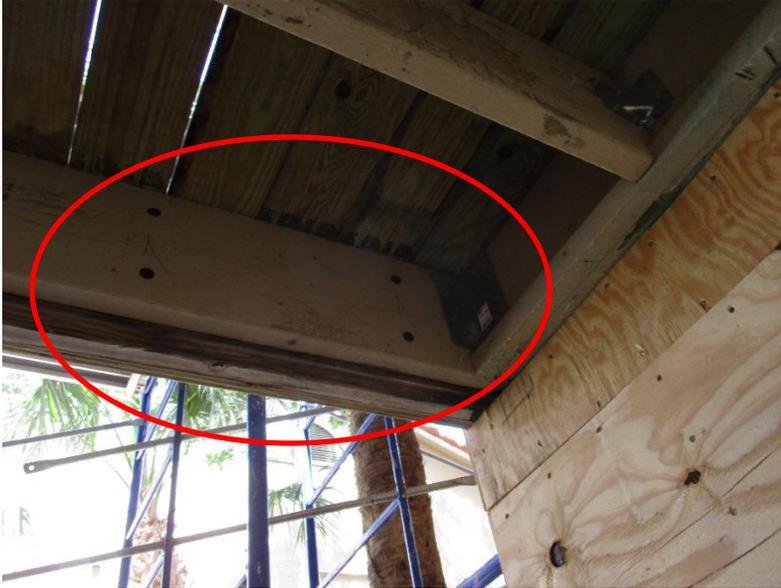
**PHOTOGRAPH #3**

**BUILDING 24  
SECTION B**

Contractor has provided Simpson Strong-Tie hardware and screw at existing balcony built-up beam.

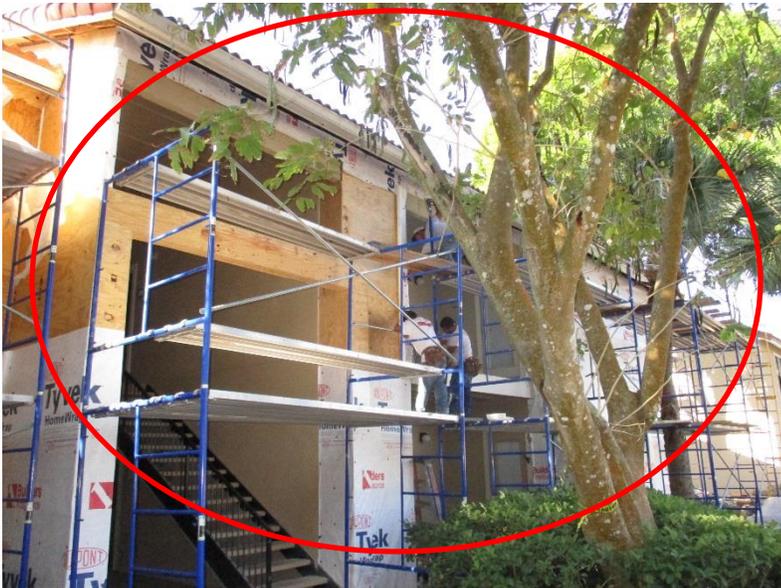
**PHOTOGRAPH #4**

**BUILDING 24  
SECTION B**

Contractor is providing Tyvek HomeWrap over new sheathing.

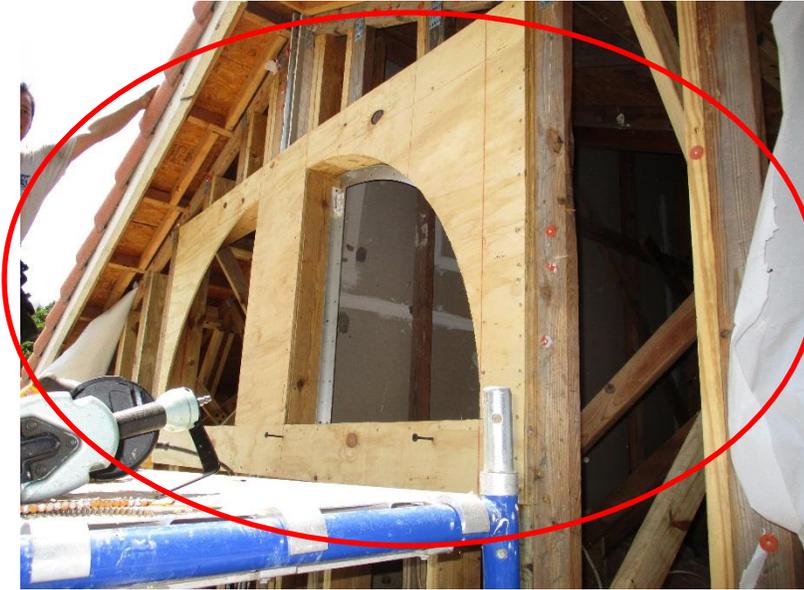
**PHOTOGRAPH #5**

H	X	X	/	/								X			Contractor has provided gable end wall bracing and is framing out new vent locations (Photograph #5). Contractor is repairing damaged framing at window locations as identified and marked (Photograph #6).

**BUILDING 24  
SECTION H**

Contractor has provided gable end wall bracing and is framing out new vent locations.

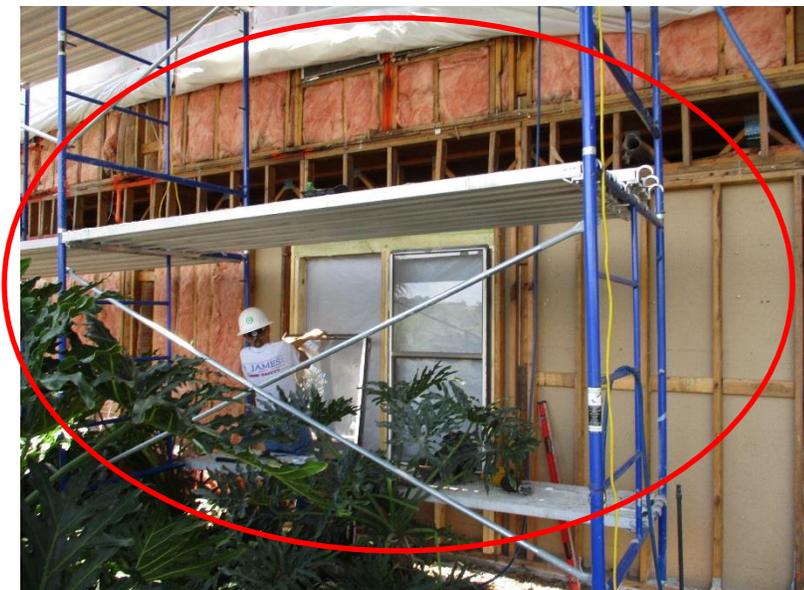
**PHOTOGRAPH #6**

**BUILDING 24  
SECTION H**

Contractor is repairing damaged framing at window locations as identified and marked.

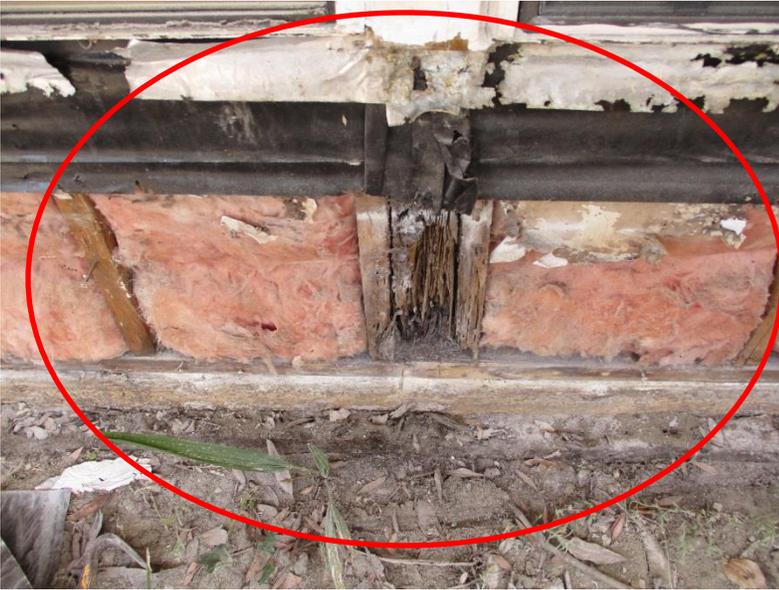
**PHOTOGRAPH #7**

**BUILDING 24  
SECTION G**

Contractor has removed stucco and Thermo-Ply sheathing exposing damaged framing.

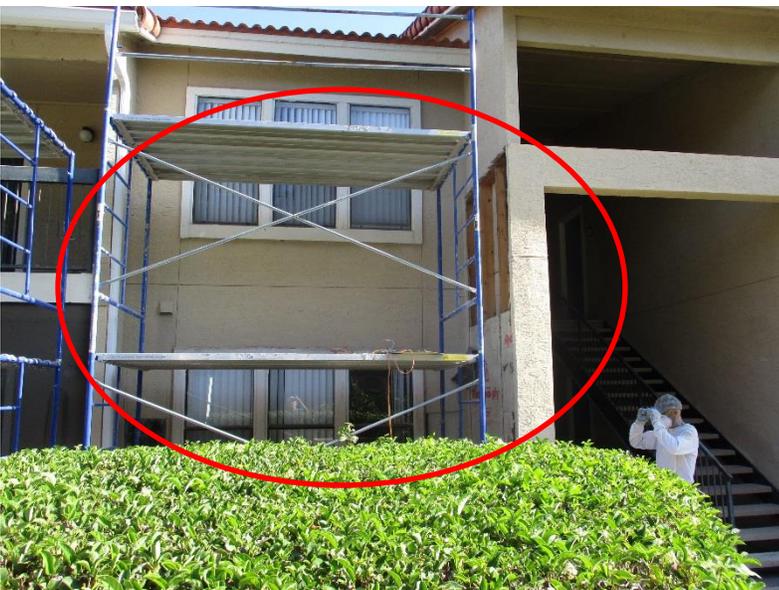
**PHOTOGRAPH #8**

**BUILDING 24  
SECTION F**

Contractor has begun to remove stucco and Thermo-Ply at wall sections.

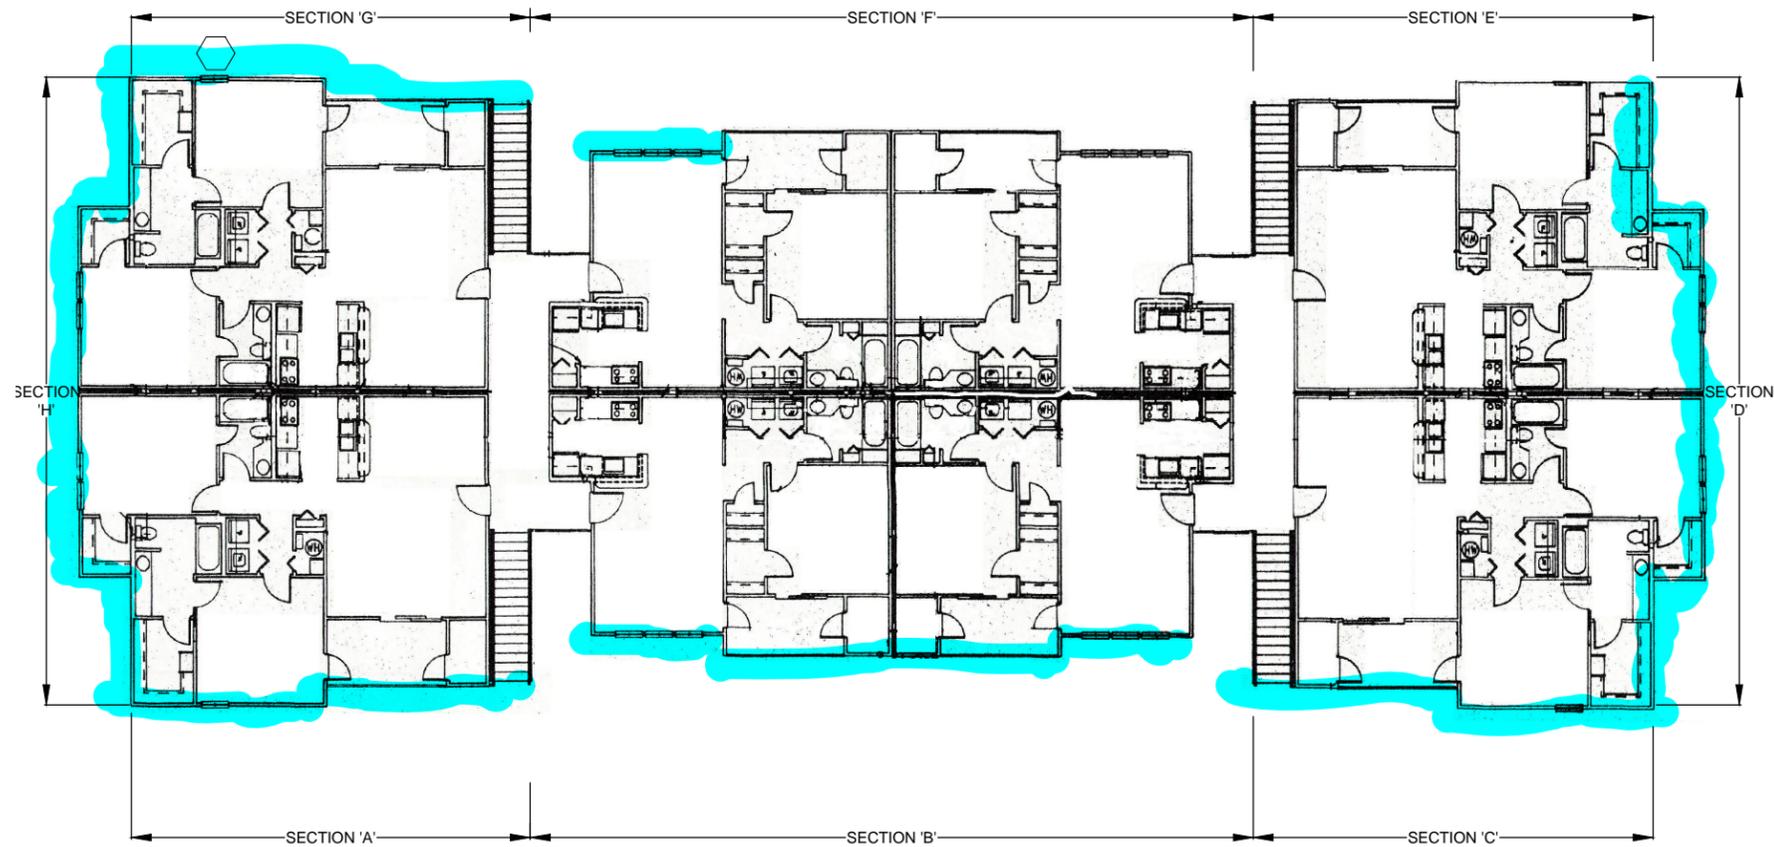
1 TYPICAL PLAN - TYPE 2  
 S-1.0A SCALE: N.T.S. BUILDING: 24

DENOTES AREA OF WORK
