**FIELD OBSERVATION REPORT - Bldg. #25**

Permit No. 18-146012-00 BC  
 Owner: Vintage Grand Condo Assn, Inc.  
 Project Address: 4017 Crockers Lake Blvd., Sarasota, FL  
 Contractor: RL James Inc  
 Inspector (s): Mark Boss  
 Type of Assessment: Progress

Project: R1503-302D  
 Contact: Glenn Ateili  
 Phone/Fax: (941) 923-7380  
 Contact: Craig Nicholas / Robert Branscombe  
 Phone: (941)232-6486 / (239) 379-1978

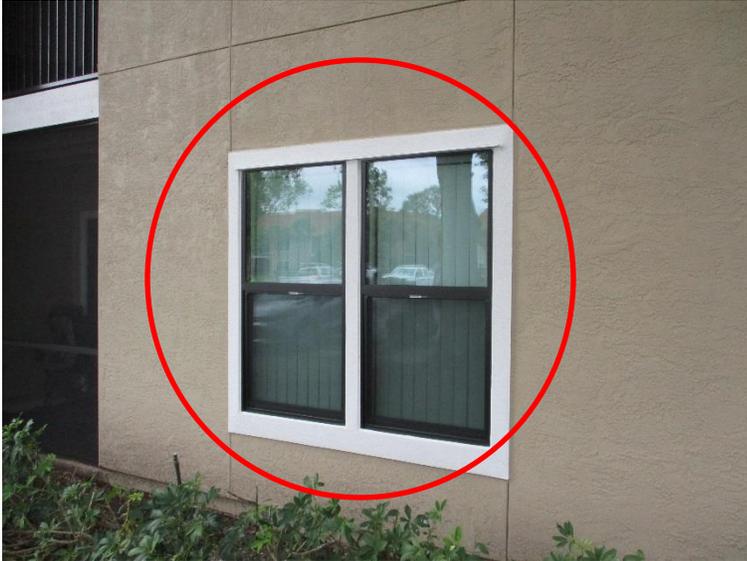
**PHOTOGRAPH #1**

Elevation	Demo	Gable Bracing	Gable Vents	Framing & strapping	Sheathing	Soffit	Window flashing	Window Install	Stucco Lath Acc	Stucco	Sealant	Painting	Punch	Comments
A	X	NA	NA	X	X	X	X	X	X	X	X	X	/	
B	X	NA	NA	X	X	X	X	X	X	X	X	X	/	
C	X	NA	NA	X	X	X	X	X	X	X	X	X	/	
D	X	X	X	X	X	X	X	X	X	X	X	X	/	
E	X	NA	NA	X	X	X	X	X	X	X	X	X	/	
F	X	NA	NA	X	X	X	X	X	X	X	X	X	/	Contractor has completed installation of window screens noted on last report (Photograph #1).
G	X	NA	NA	X	X	X	X	X	X	X	X	X	/	
H	X	X	X	X	X	X	X	X	X	X	X	X	/

**BUILDING 25  
SCREEN ENCLOSURES**

Contractor has completed installation of window screens noted on last report.

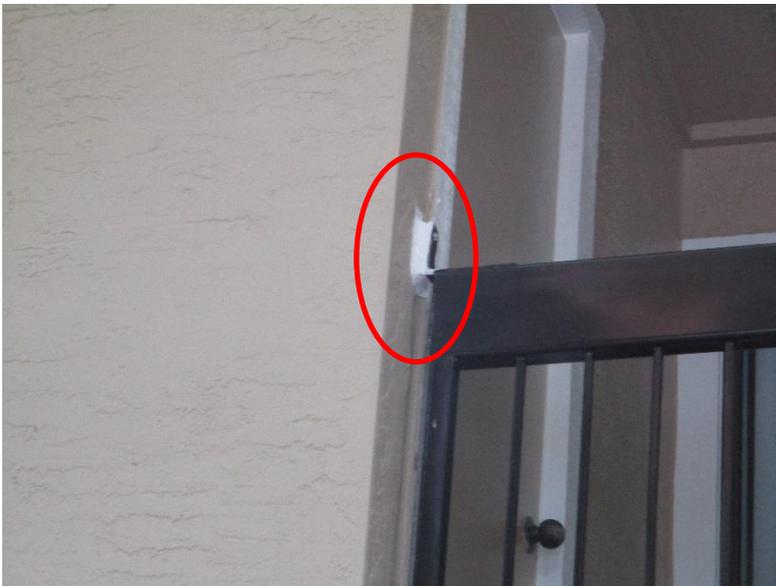
**PHOTOGRAPH #2**

Unit	Demo	Framing & strapping	Sheathing	Stucco	Sealant	Painting	Punch	Comments
727	X	X	X	X	X	X		Contractor has installed railing with fastening angle at top of rail not fitting properly to stucco (Photograph #2).

**BUILDING 7  
UNIT #727 BALCONY**

Contractor has installed railing with fastening angle at top of rail not fitting properly to stucco.

- Contractor will move fastening angle at top of railing in order to properly fit up to stucco and re-fasten (Photograph #2)

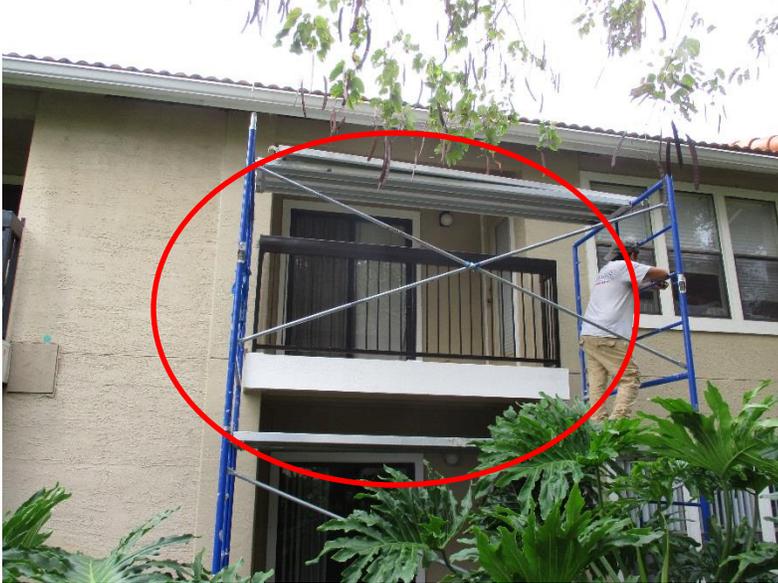
**PHOTOGRAPH #3**

Unit	Demo	Framing & strapping	Sheathing	Stucco	Sealant	Painting	Punch	Comments
1324	X	X	X	X	X	/		Contractor has finish painted railing and re-installed at balcony (Photograph #3) . Contractor has not replaced soffit or screen enclosure (Photograph #4).

**BUILDING 13  
UNIT #1324 BALCONY**

Contractor has finish painted railing and re-installed at balcony.

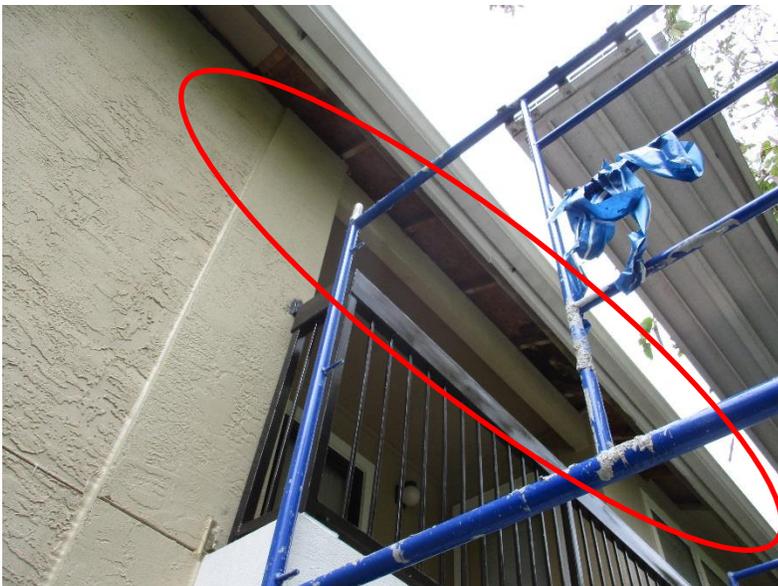
**PHOTOGRAPH #4**

**BUILDING 13  
UNIT #1324 BALCONY**

Contractor has not replaced soffit or screen enclosure.

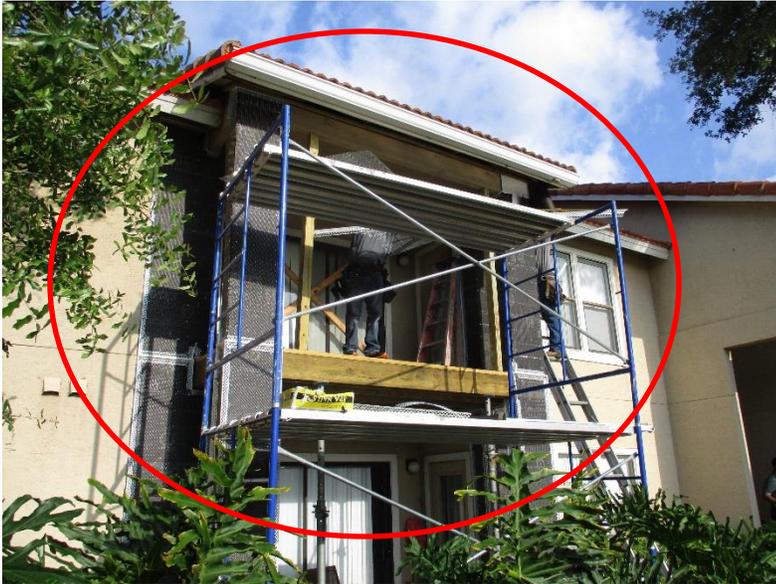
**PHOTOGRAPH #5**

Unit	Demo	Framing & strapping	Sheathing	Stucco	Sealant	Painting	Punch	Comments
1824A	X	X	X	/				Stucco Subcontractor installing new stucco accessories and lath in preparation for new stucco ( <b>Photograph #5</b> ). Contractor has not replaced soffit removed in order to complete framing repairs( <b>Photograph #6</b> ).

**BUILDING 18  
UNIT #1824 BALCONY**

Stucco subcontractor installing new stucco accessories and lath in preparation for new stucco.

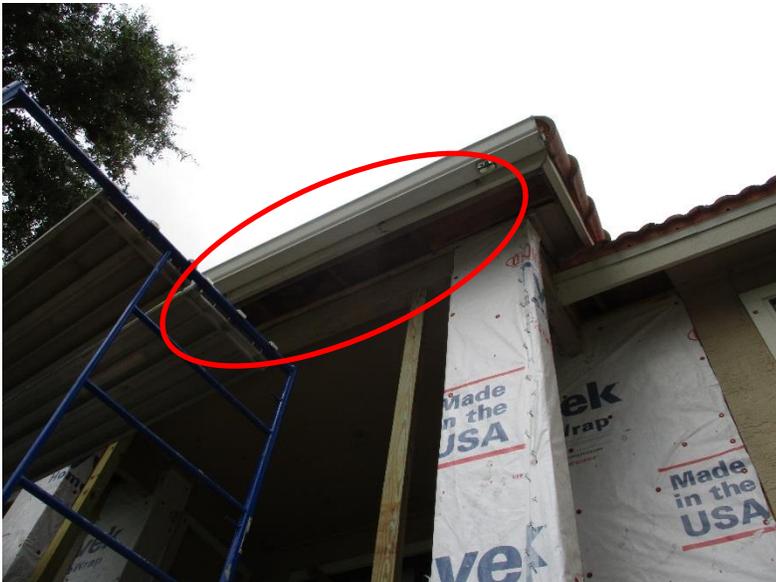
**PHOTOGRAPH #6**

**BUILDING 18  
UNIT #1824 BALCONY**

Contractor has not replaced soffit removed in order to complete framing repairs.

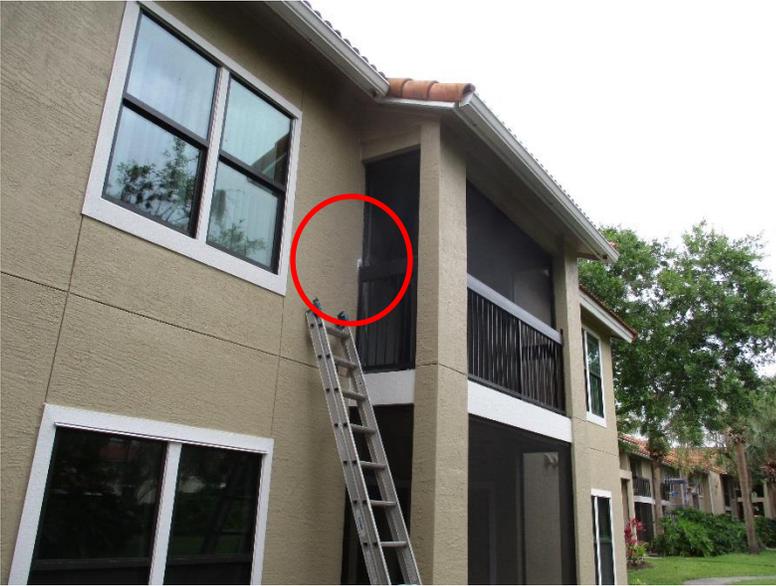
**PHOTOGRAPH #7**

Elevation	Demo	Gable Bracing	Gable Vents	Framing & strapping	Sheathing	Soffit	Window flashing	Window Install	Stucco Lath Acc	Stucco	Sealant	Painting	Punch	Comments
A	X	NA	NA	X	X	X	X	X	X	X	X	X	X	
B	X	NA	NA	X	X	X	X	X	X	X	X	X	X	
C	X	X	X	X	X	X	X	X	X	X	X	X	X	
D	X	NA	NA	X	X	X	X	X	X	X	X	X	/	Units - 1422 and 1412- Screen completion and final touch ups remain (Photograph #7).
E	X	NA	NA	X	X	X	X	X	X	X	X	X	X	
F	X	X	X	X	X	X	X	X	X	X	X	X	X

**BUILDING 14  
UNIT #1422 BALCONY**

Screen completion and final touch ups remain.
