**PHOTOGRAPHS**

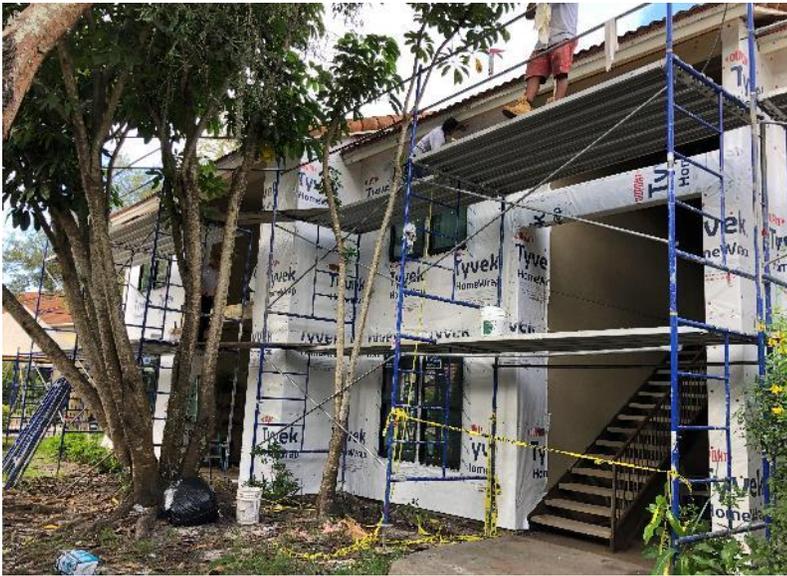
**PHOTOGRAPH #1**

**BUILDING 6  
SECTION E**

Contractor installed PGT windows and verified WOCDs are installed on windows for second floor.

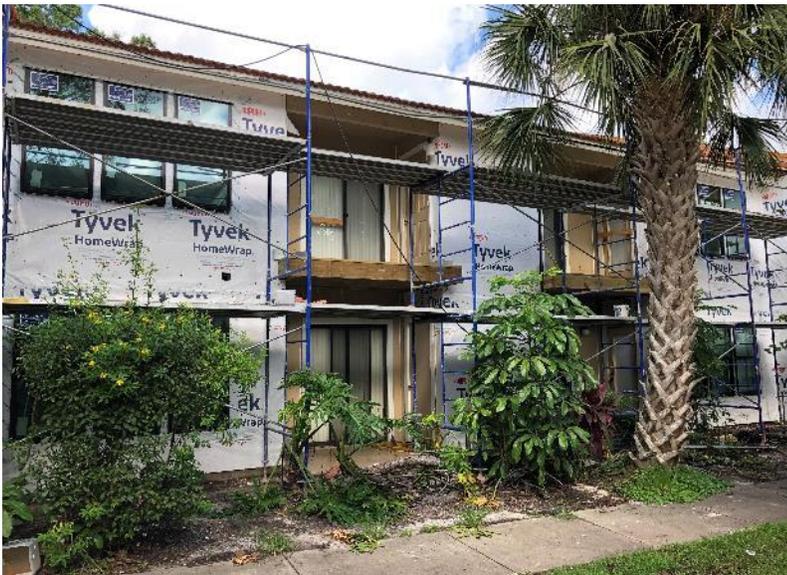
**PHOTOGRAPH #2**

**BUILDING 6  
SECTION F**

Contractor installed PGT windows and verified WOCDs are installed on windows for second floor.

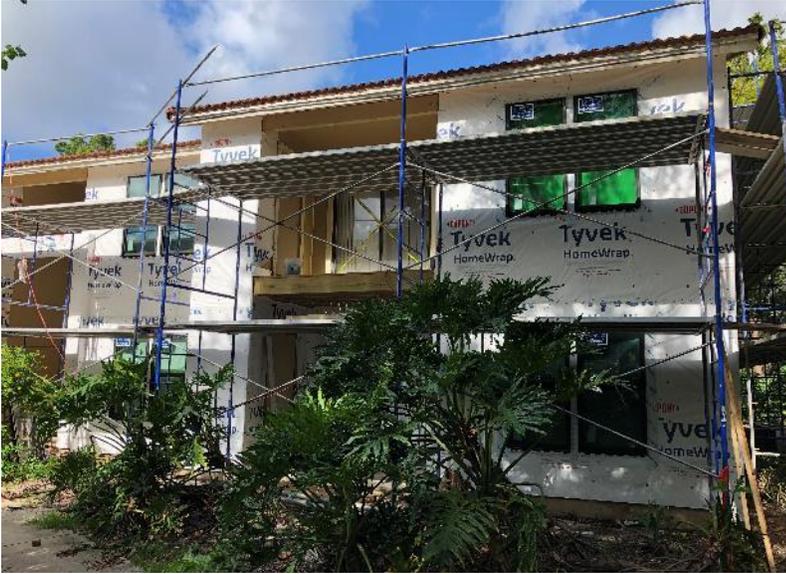
**PHOTOGRAPH #3**

**BUILDING 6  
SECTION G**

Contractor installed PGT windows and verified WOCDs are installed on windows for second floor.

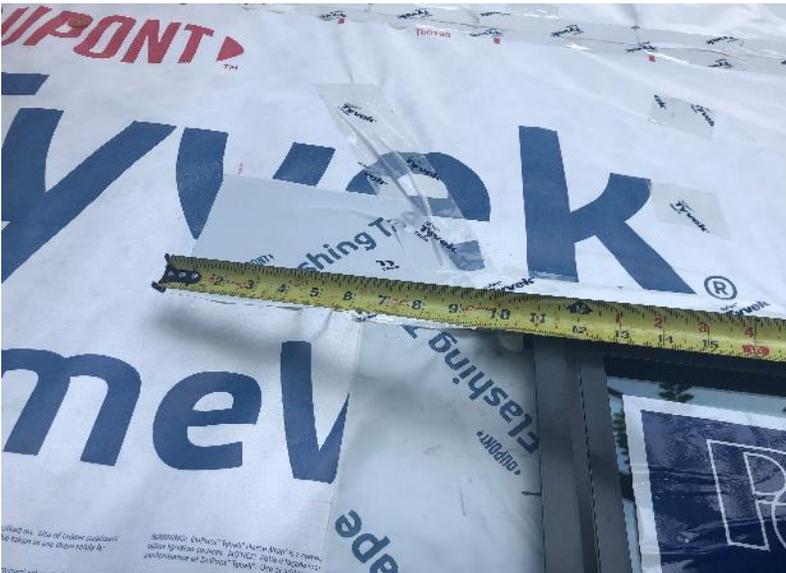
**PHOTOGRAPH #4**

**BUILDING 6  
SECTION G**

Contractor installed Dupont Flashing Tape at window head and extended 12".

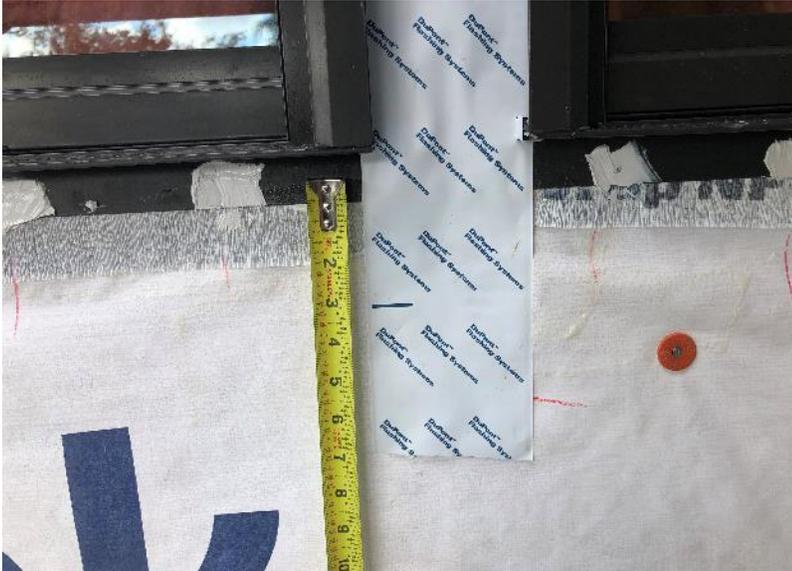
**PHOTOGRAPH #5**

**BUILDING 6  
SECTION G**

Contractor installed Dupont Flashing Tape at window and extended 6" below.

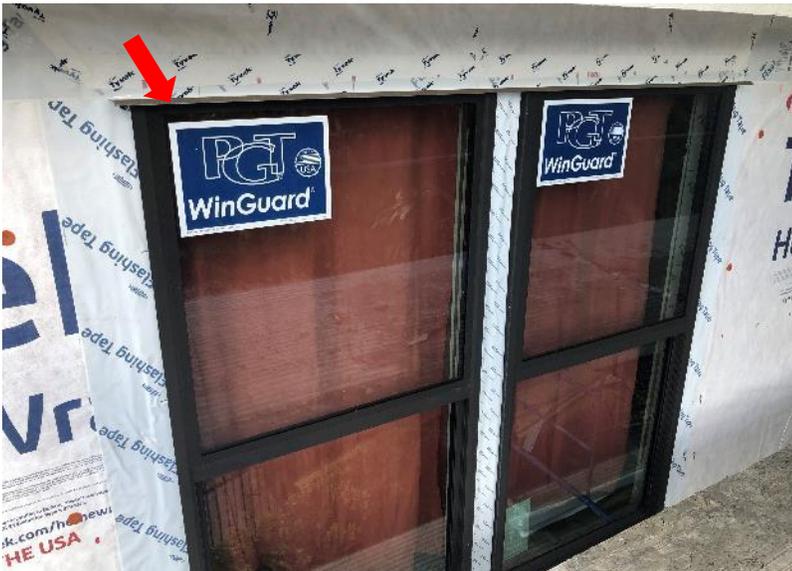
**PHOTOGRAPH #6**

**BUILDING 6  
SECTION G**

Contractor installed L-flashing behind Tyvek with sealant per the construction drawings.

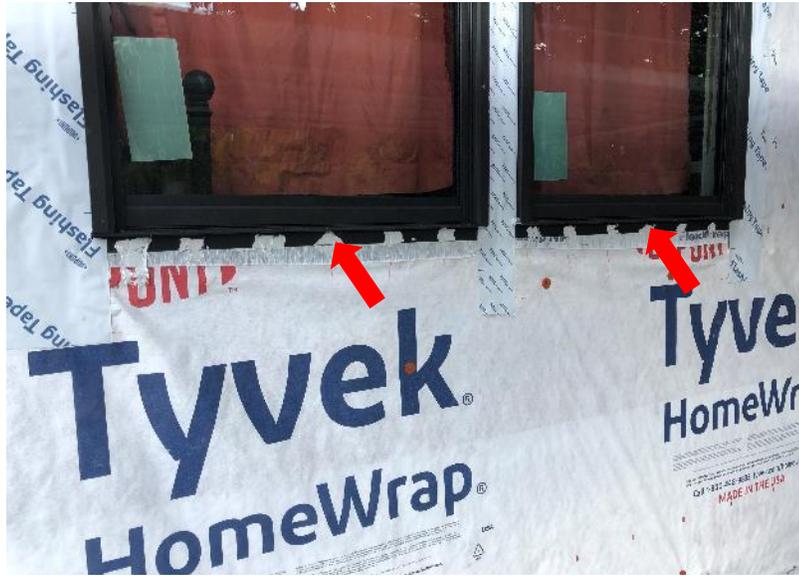
**HOTOGRAPH #7**

**BUILDING 6  
SECTION G**

Contractor installed windows and covered fasteners with MasterSeal NP 150.

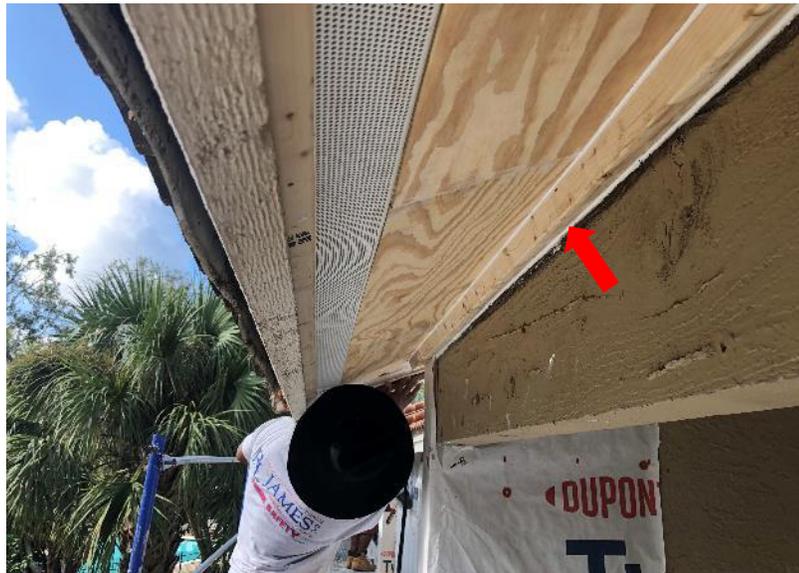
**PHOTOGRAPH #8**

**BUILDING 6  
SECTION G**

Contractor installed new soffit and applied caulk to fill seams and nail holes.

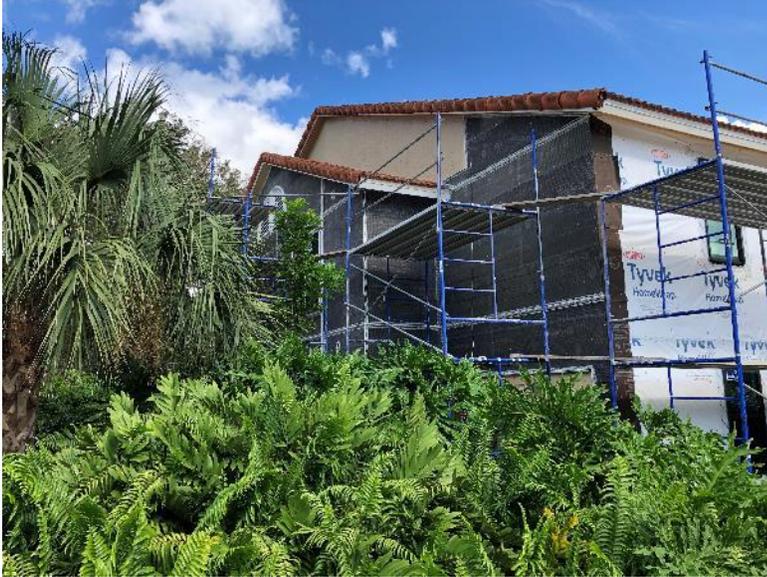
**PHOTOGRAPH #9**

**BUILDING 3  
SECTION H**

Stucco Sub-contractor installed stucco accessories and is ready for stucco application.

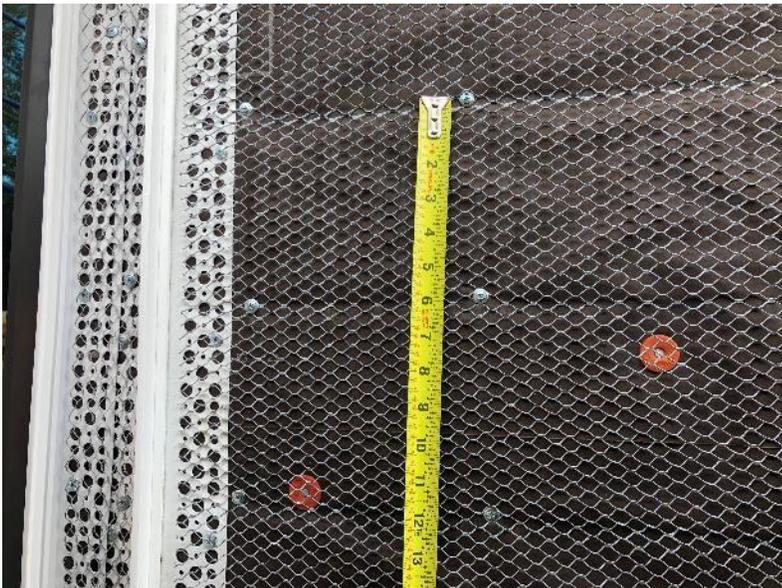
**PHOTOGRAPH #10**

**BUILDING 3  
SECTION H**

Lath fasteners are spaced 6" on-center.

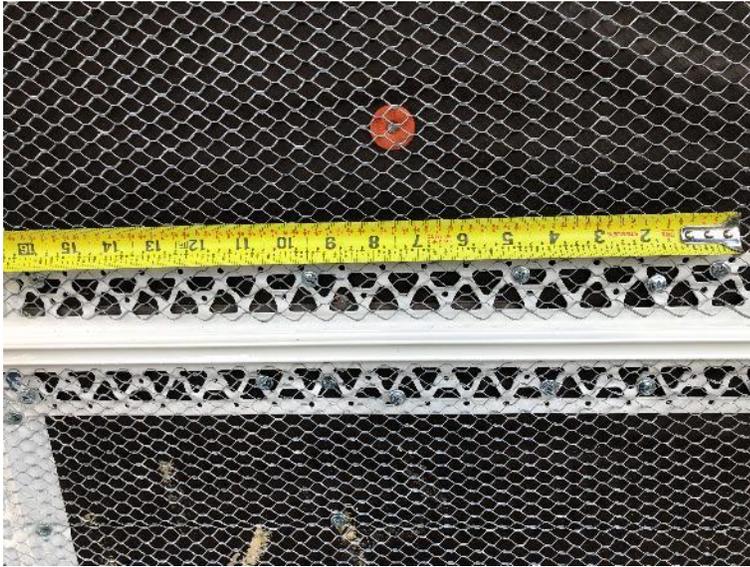
**PHOTOGRAPH #11**

**BUILDING 3  
SECTION H**

Stucco accessories are fastened within 7" on-center.

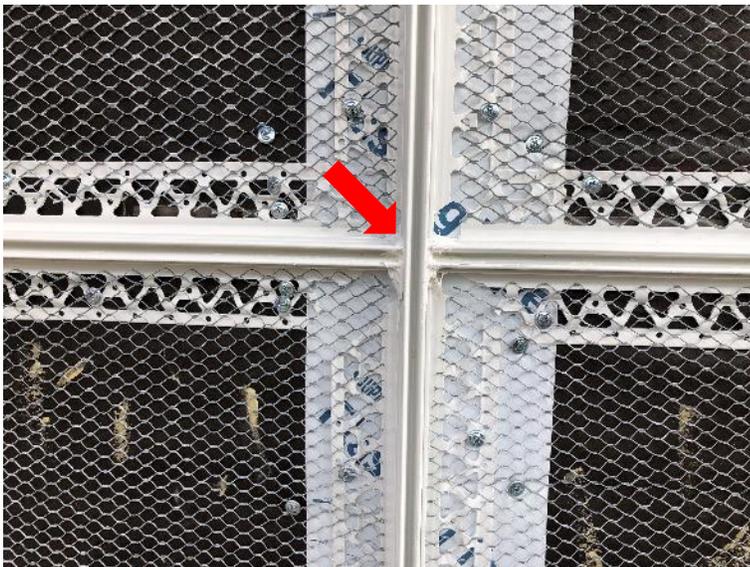
**PHOTOGRAPH #12**

**BUILDING 3  
SECTION H**

MasterSeal NP 150 sealant was applied to accessory ends, corners, and intersections.

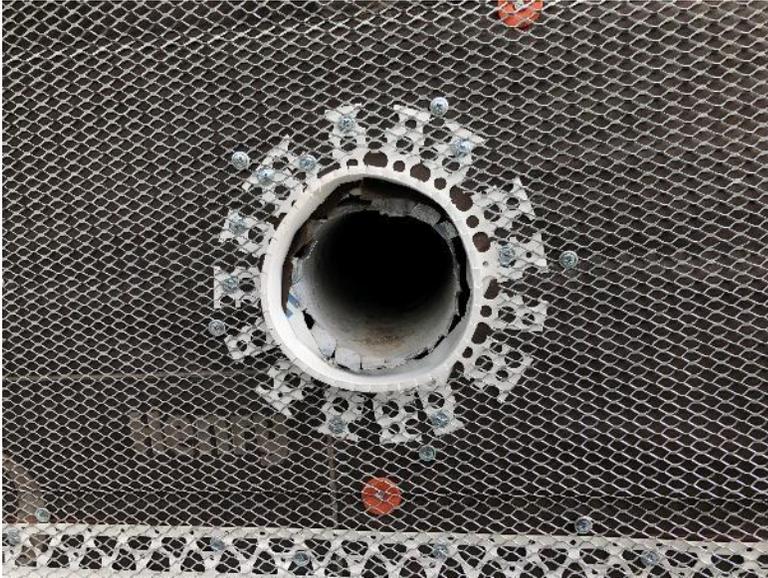
**PHOTOGRAPH #13**

**BUILDING 3  
SECTION H**

Protrusions have been flashed and sealed per the contract drawings.

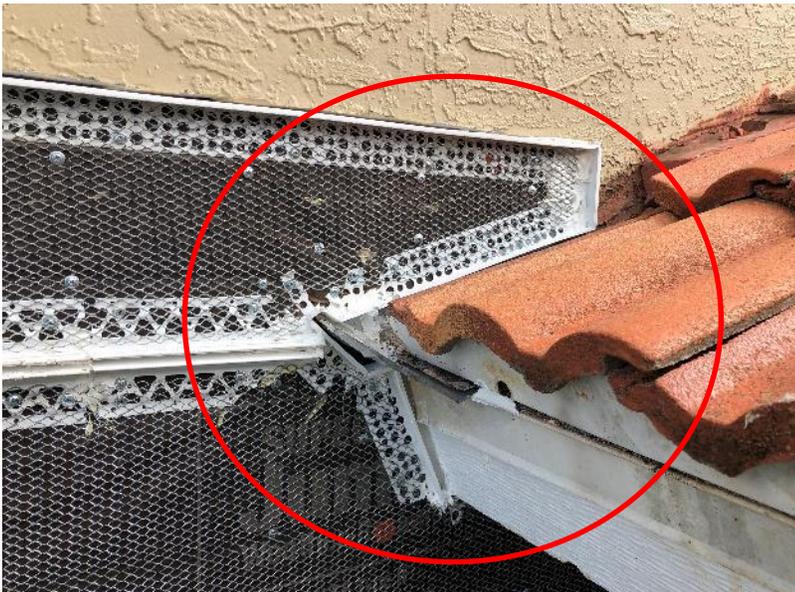
**PHOTOGRAPH #14**

**BUILDING 3  
SECTION H**

Kickout flashing and accessories have been installed per the contract drawings.

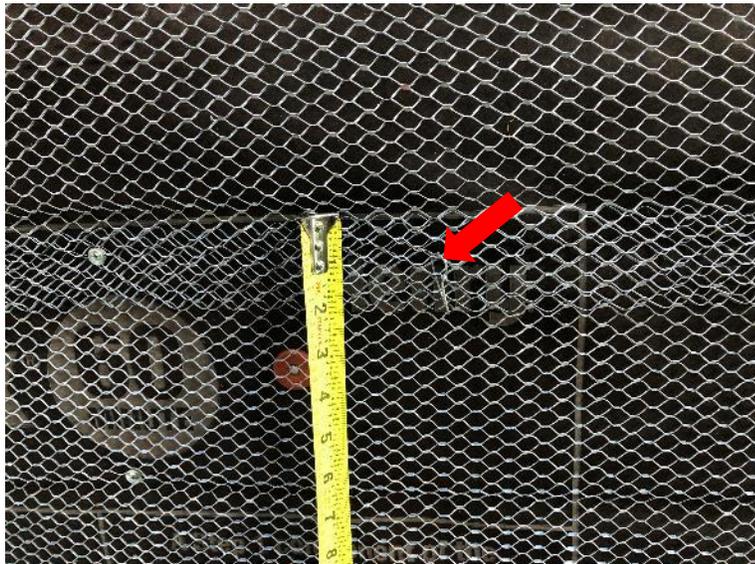
**PHOTOGRAPH #15**

**BUILDING 3  
SECTION G**

Stucco Sub-contractor overlapped lath 2" minimum per the construction drawings and installed tie wire between fasteners.

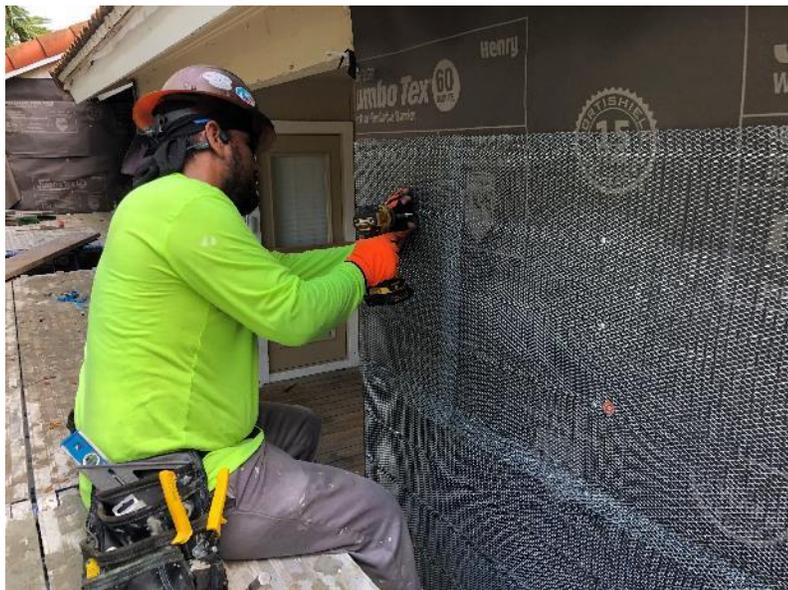
**PHOTOGRAPH #16**

**BUILDING 3  
SECTION F**

Stucco Sub-contractor installing lath with fasteners 6" on-center.

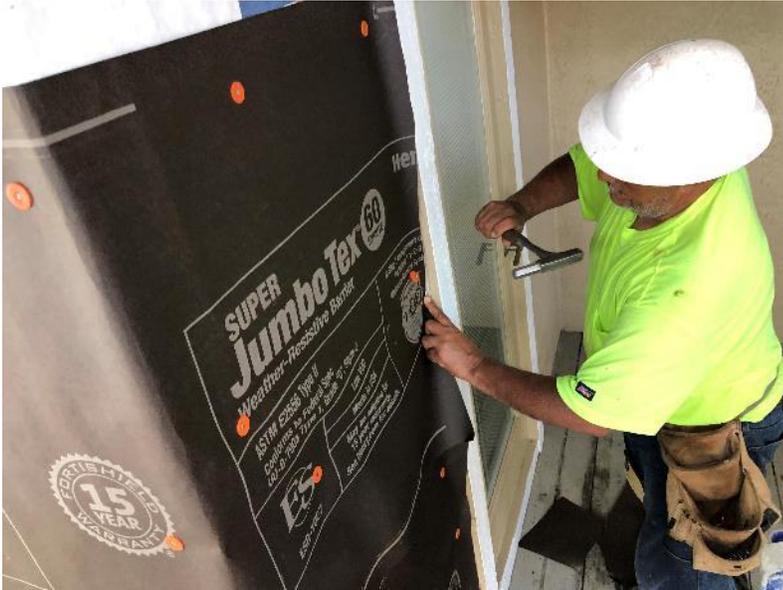
**PHOTOGRAPH #17**

**BUILDING 3  
SECTION E**

Stucco Sub-contractor installing Super JumboTex 60 Minute Weather-Resistive Barrier.

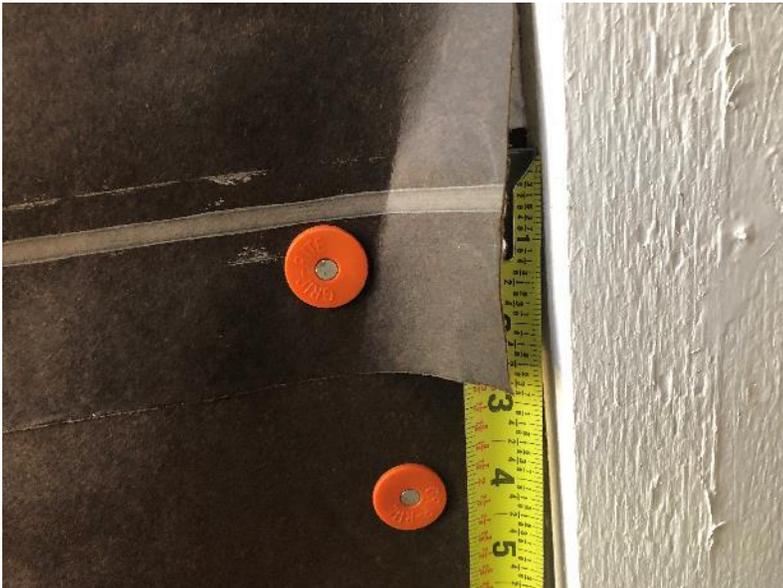
**PHOTOGRAPH #18**

**BUILDING 3  
SECTION E**

Stucco Sub-contractor provided over 2" horizontal overlap and 6" minimum vertical overlap.

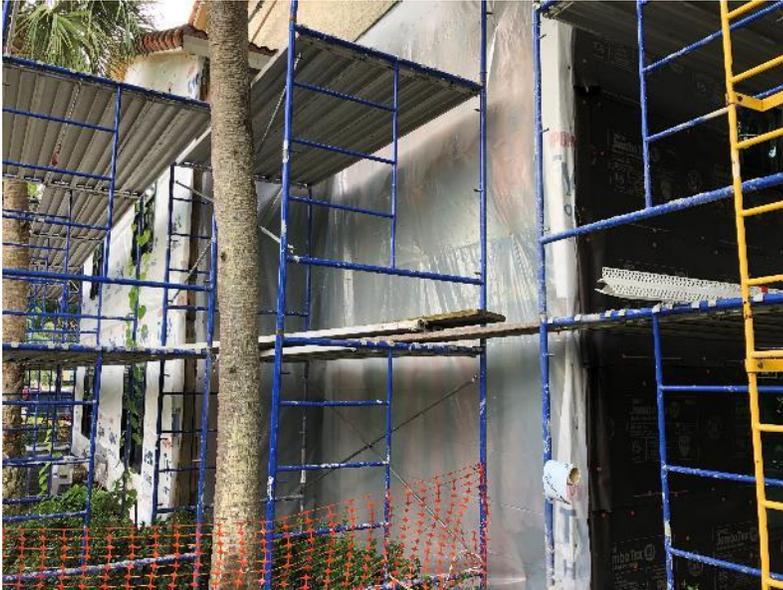
**PHOTOGRAPH #19**

**BUILDING 3  
SECTION D**

Contractor to install sheathing and Tyvek weather barrier.

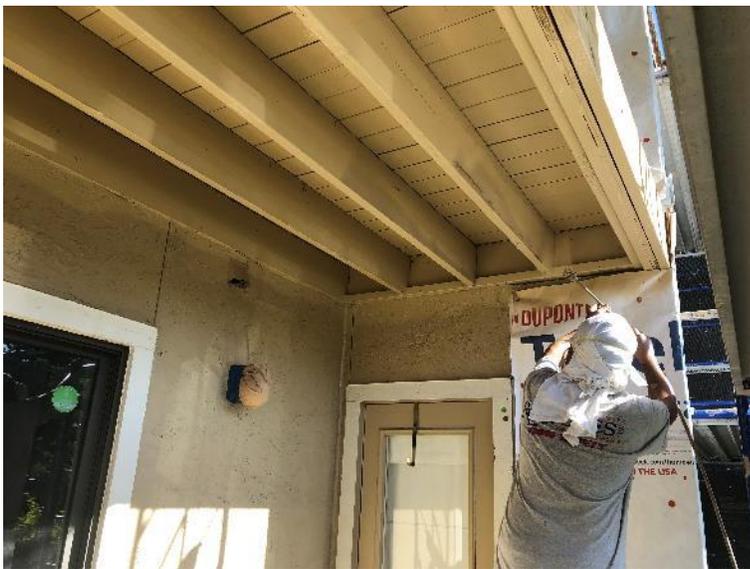
**PHOTOGRAPH #20**

**BUILDING 3  
SECTION B**

Contractor painted underside of balconies with Florida Paints Ultra Exterior Supercoat.

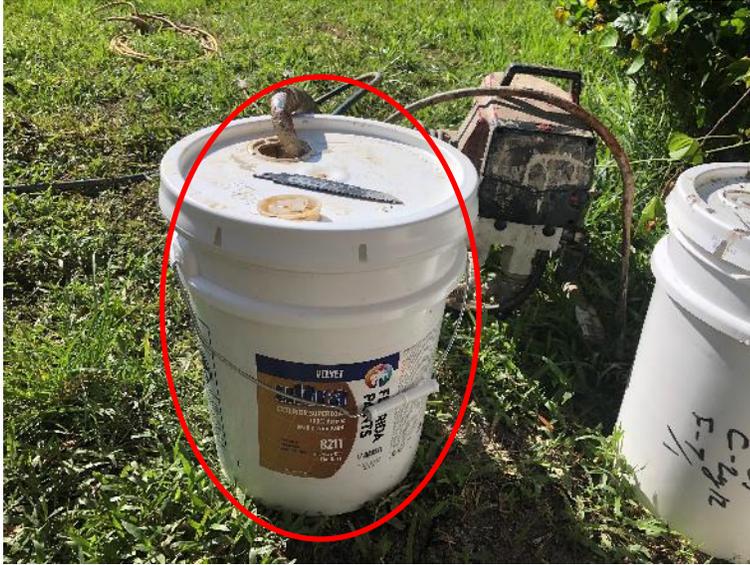
**PHOTOGRAPH #21**

**BUILDING 3  
SECTION B**

Contractor painted underside of balconies with Florida Paints Ultra Exterior Supercoat.
