## PHOTOGRAPHS

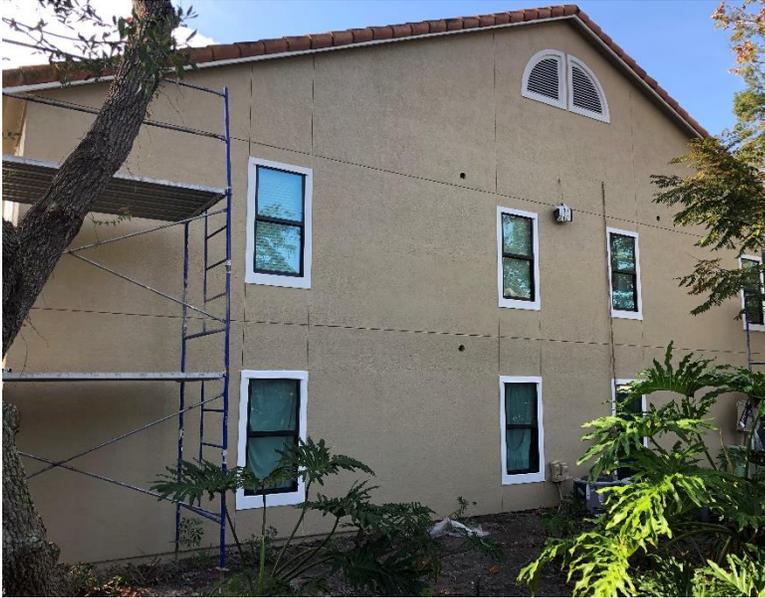
**PHOTOGRAPH #1**

### **BUILDING 6 SECTION H**

Florida Paints SunFlex acrylic primer and Ultra Exterior Supercoat applied to new stucco surfaces per manufacturer's specifications.

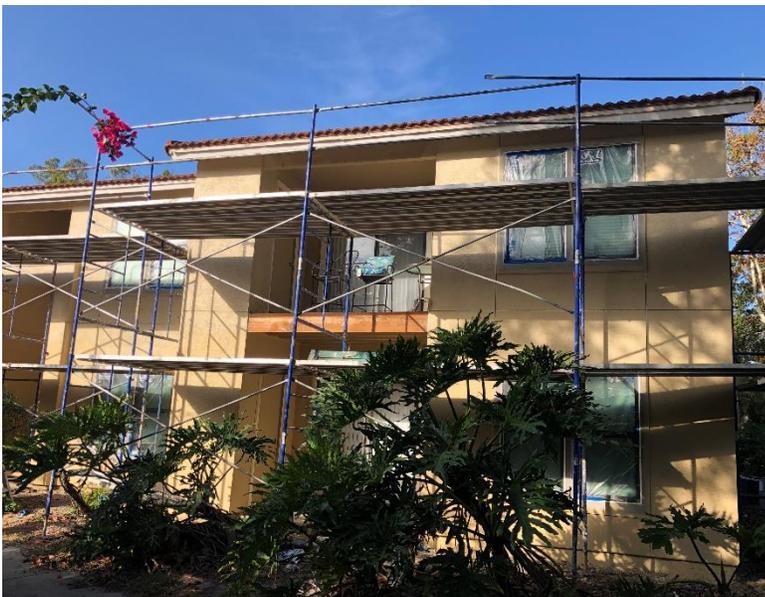
**PHOTOGRAPH #2**

### **BUILDING 6 SECTION G**

Florida Paints SunFlex acrylic primer and Ultra Exterior Supercoat applied to new stucco surfaces per manufacturer's specifications.

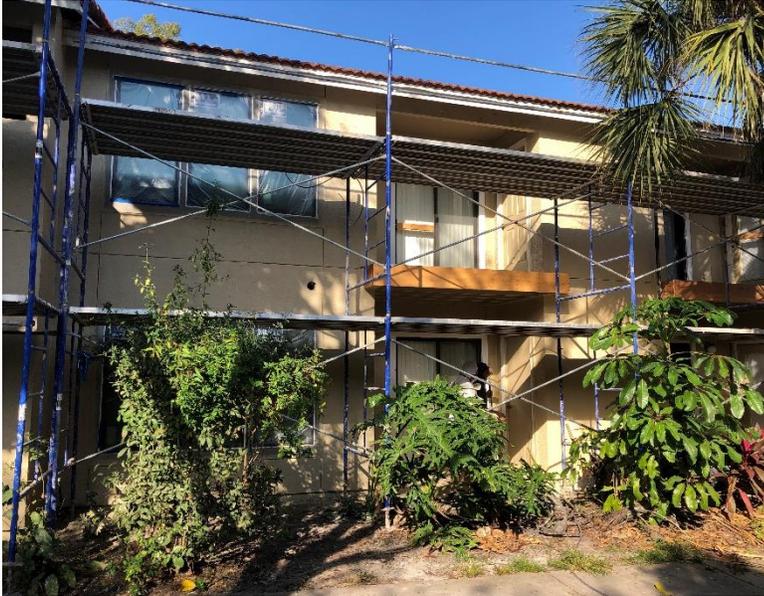
**PHOTOGRAPH #3**

**BUILDING 6  
SECTION F**

Florida Paints SunFlex acrylic primer and Ultra Exterior Supercoat applied to new stucco surfaces per manufacturer's specifications.

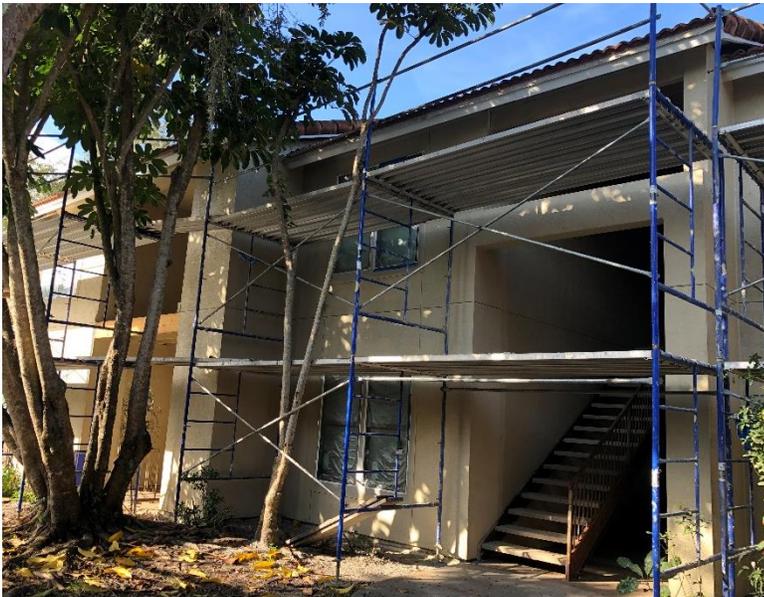
**PHOTOGRAPH #4**

**BUILDING 6  
SECTION E**

Florida Paints SunFlex acrylic primer and Ultra Exterior Supercoat applied to new stucco surfaces per manufacturer's specifications.

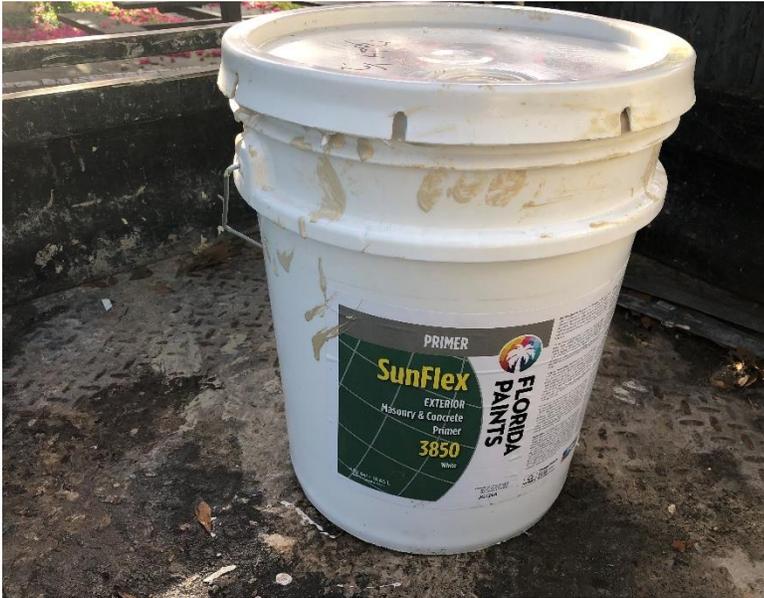
**PHOTOGRAPH #5**

**BUILDING 6  
SECTION E**

Florida Paints SunFlex acrylic primer and Ultra Exterior Supercoat applied to new stucco surfaces per manufacturer's specifications.

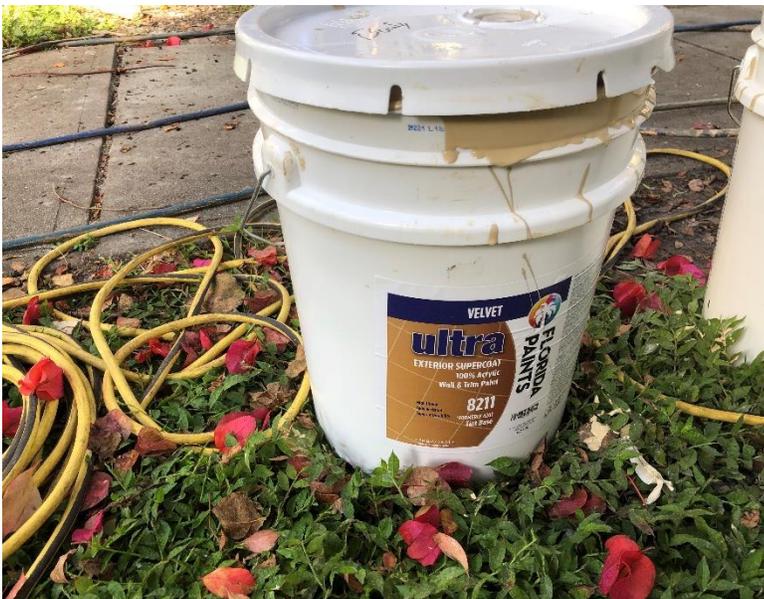
**PHOTOGRAPH #6**

**BUILDING 6  
SECTION E**

Florida Paints SunFlex acrylic primer and Ultra Exterior Supercoat applied to new stucco surfaces per manufacturer's specifications.

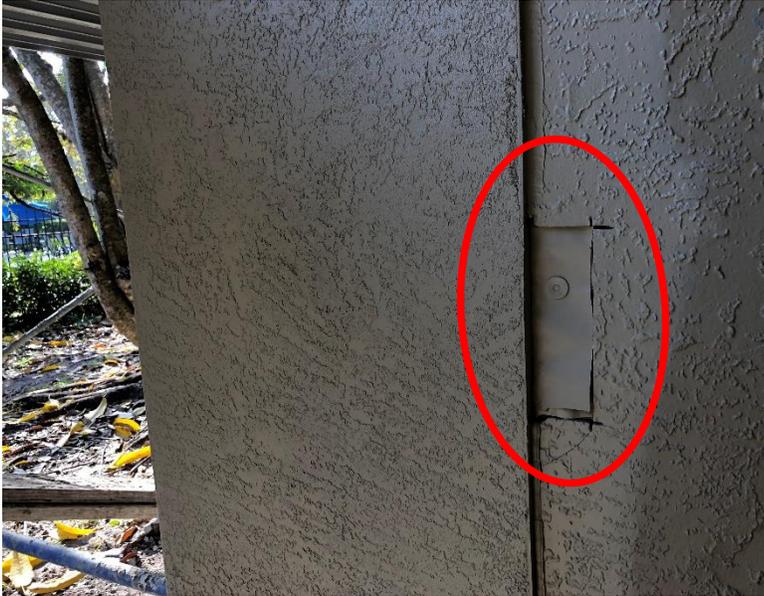
**PHOTOGRAPH #7**

**BUILDING 6  
SECTION E**

A section of stucco was removed at the breezeway and should be repaired prior to painting.

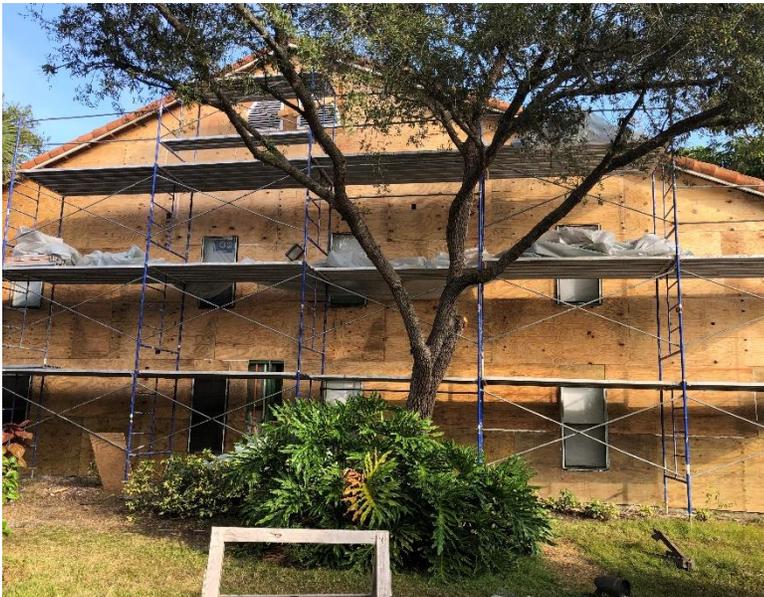
**PHOTOGRAPH #8**

**BUILDING 6  
SECTION D**

15/32" exterior rated plywood sheathing installed with 8d common nails spaced at 4" on-center.

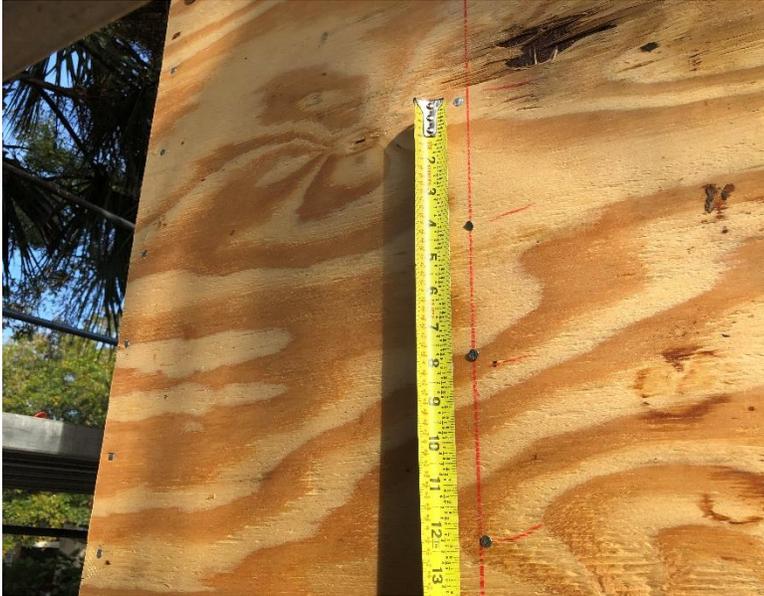
**PHOTOGRAPH #9**

**BUILDING 6  
SECTION D**

15/32" exterior rated plywood sheathing installed with 8d common nails spaced at 4" on-center.

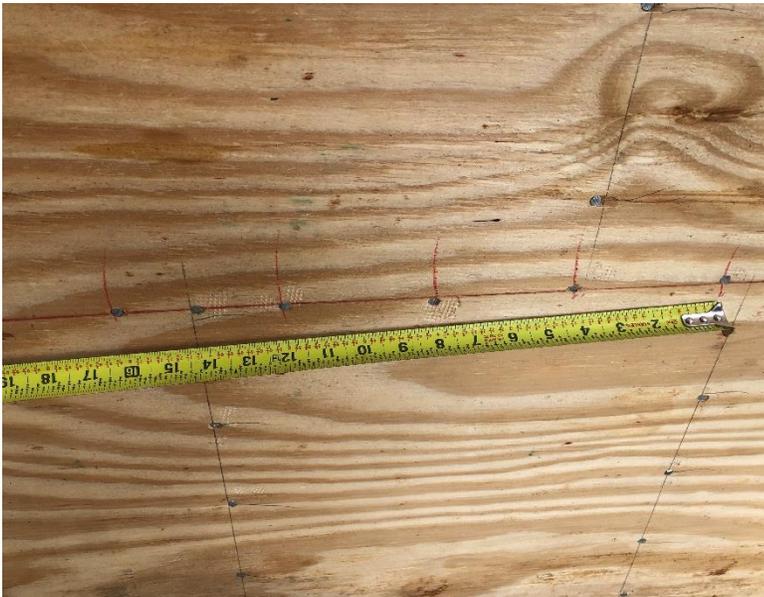
**PHOTOGRAPH #10**

**BUILDING 6  
SECTION D**

15/32" exterior rated plywood sheathing installed with 8d common nails spaced at 4" on-center.

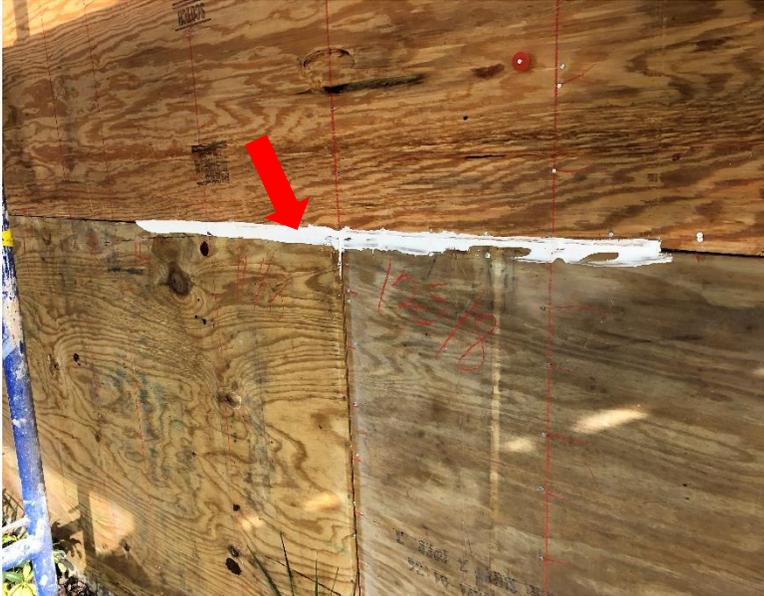
**PHOTOGRAPH #11**

**BUILDING 6  
SECTION D**

BASF Urethane Sealant applied at gaps larger than 1/8".

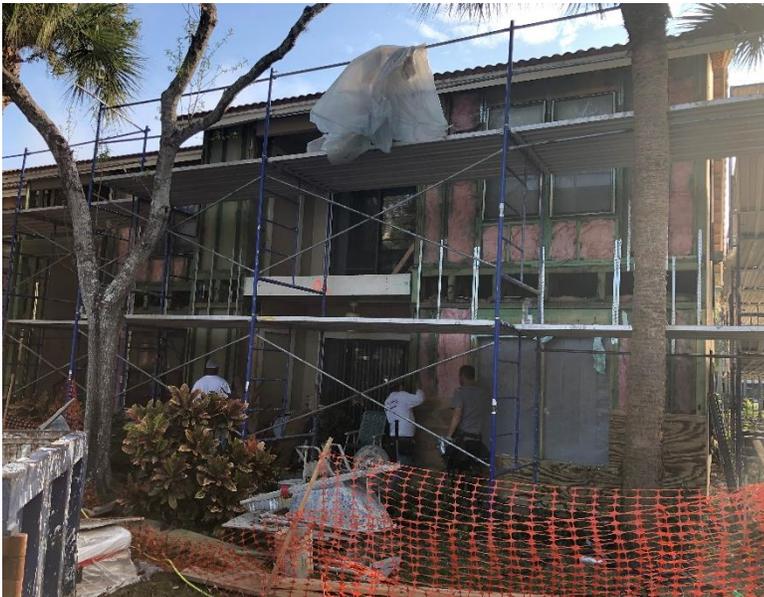
**PHOTOGRAPH #12**

**BUILDING 6  
SECTION C**

Simpson Strong Tie connectors, straps, and anchors were installed per drawings and specifications.

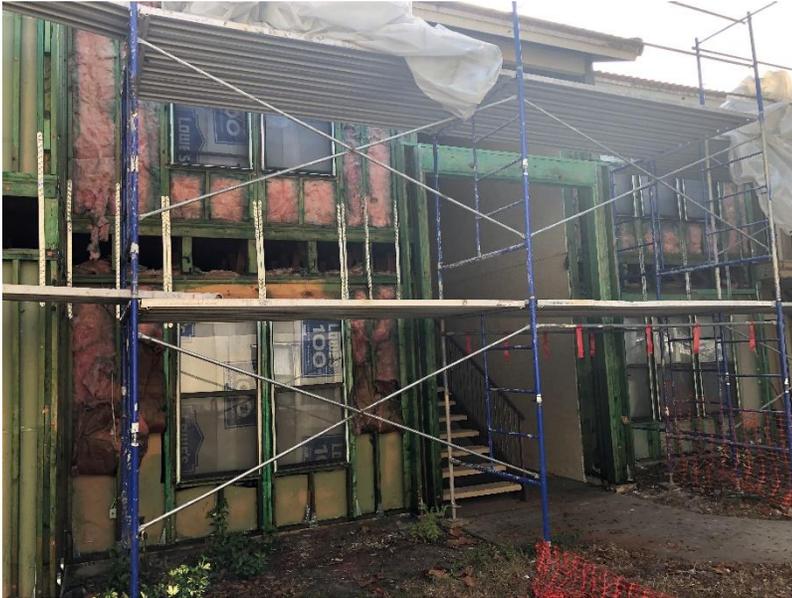
**PHOTOGRAPH #13**

**BUILDING 6  
SECTION B**

Simpson Strong Tie connectors, straps, and anchors were installed per drawings and specifications.

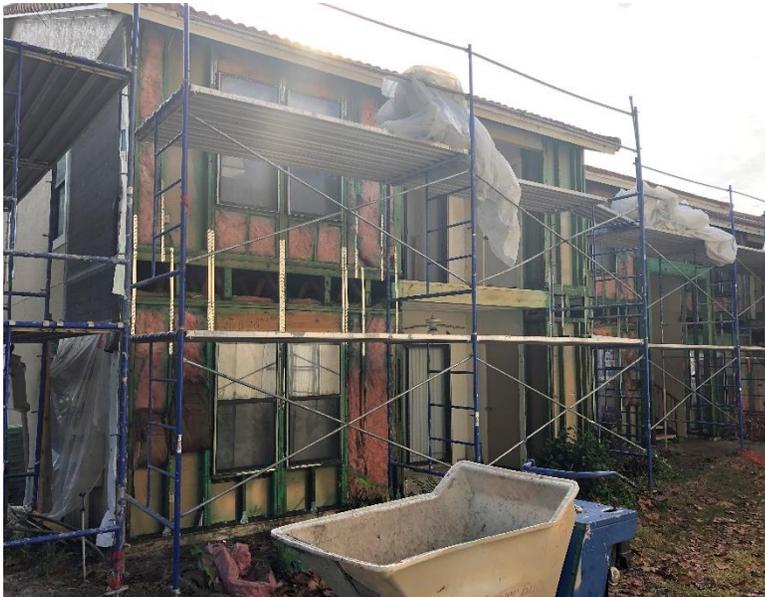
**PHOTOGRAPH #14**

**BUILDING 6  
SECTION A**

Simpson Strong Tie connectors, straps, and anchors were installed per drawings and specifications.

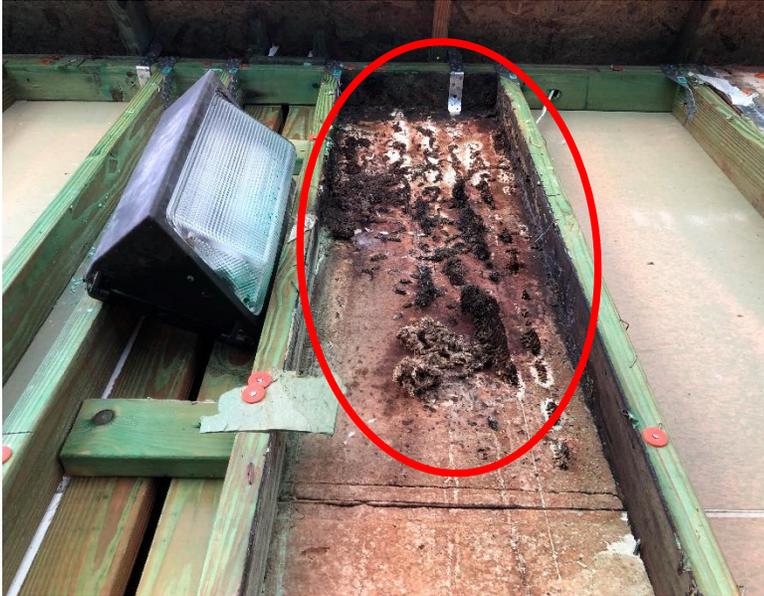
**PHOTOGRAPH #15**

**BUILDING 6  
SECTION B**

Beehive and debris to be completely removed.

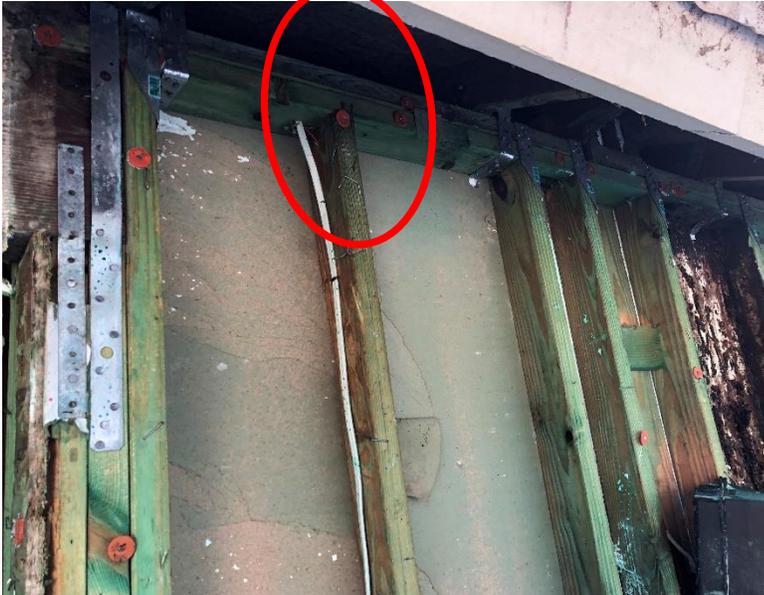
**PHOTOGRAPH #16**

**BUILDING 6  
SECTION B**

Missing TSP strap from stud to top plate.

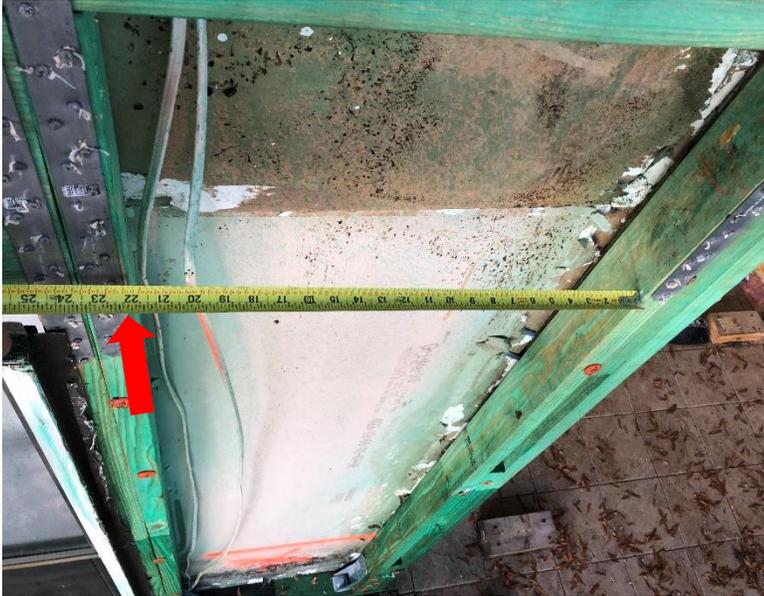
**PHOTOGRAPH #17**

**BUILDING 6  
SECTION B**

Studs are spaced greater than 16" on-center. Contractor to add intermediate stud.

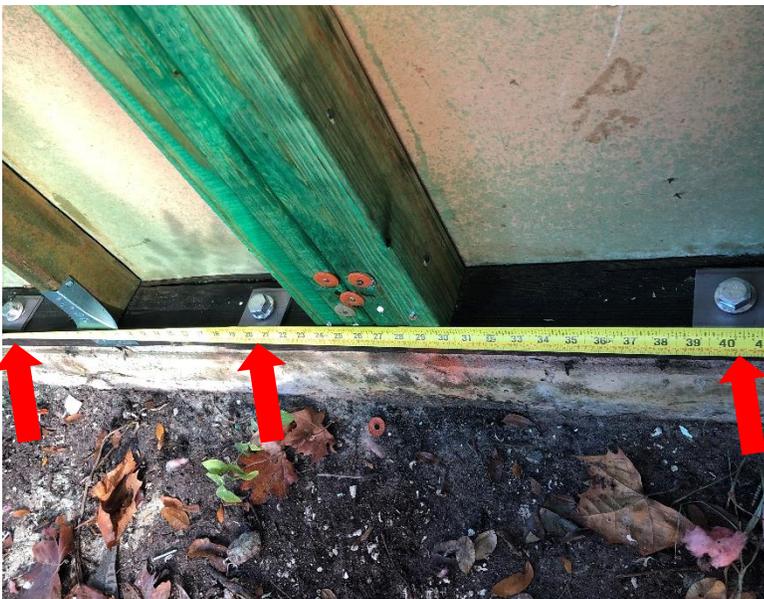
**PHOTOGRAPH #18**

**BUILDING 6  
SECTION A**

5/8" diameter Simpson Strong Titen HD Anchors with base plate installed at 24" on-center per contract drawings and specifications.

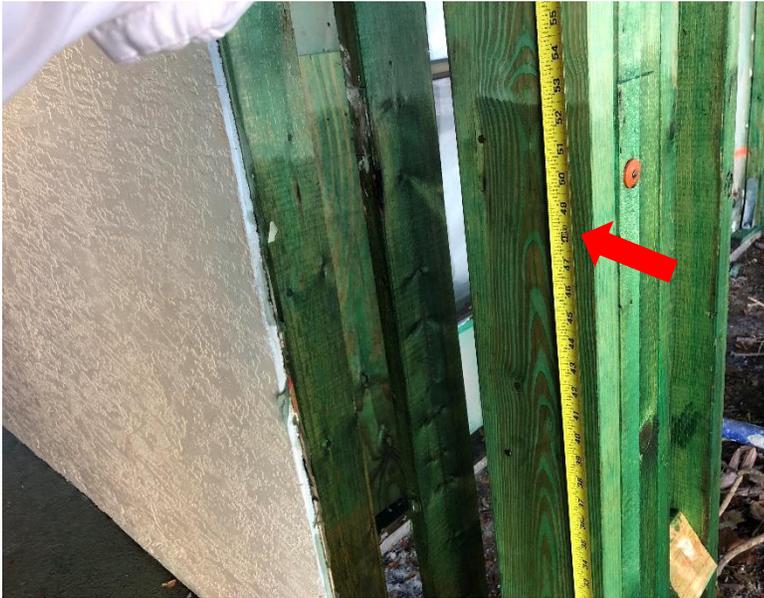
**PHOTOGRAPH #19**

**BUILDING 6  
SECTION A-D**

Copper-Green Wood Preservative was applied to the bottom 48" of framing.

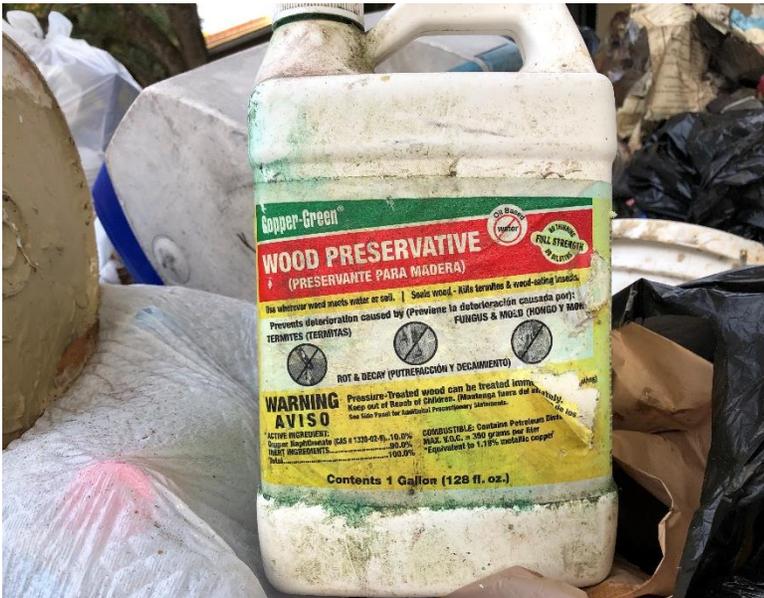
**PHOTOGRAPH #20**

**BUILDING 6  
SECTION A-D**

Copper-Green Wood Preservative was applied to the bottom 48" of framing.

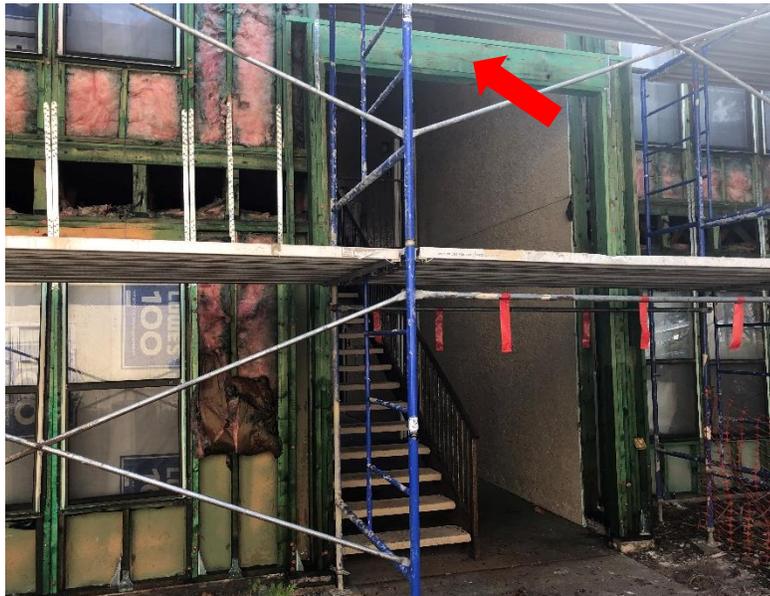
**PHOTOGRAPH #21**

**BUILDING 6  
SECTION A**

Contractor applied termite wood treatment over all framing.

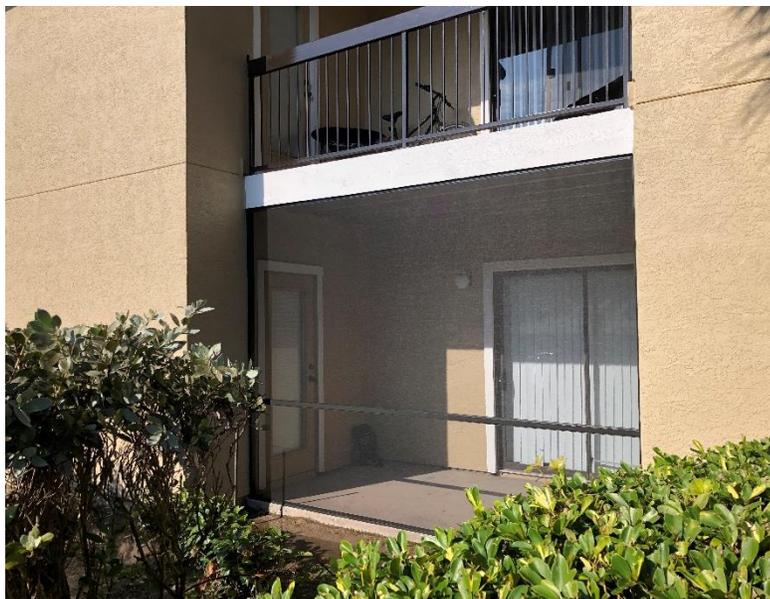
**PHOTOGRAPH #22**

**BUILDING 3  
SECTION A**

Screen enclosures were installed at balconies.

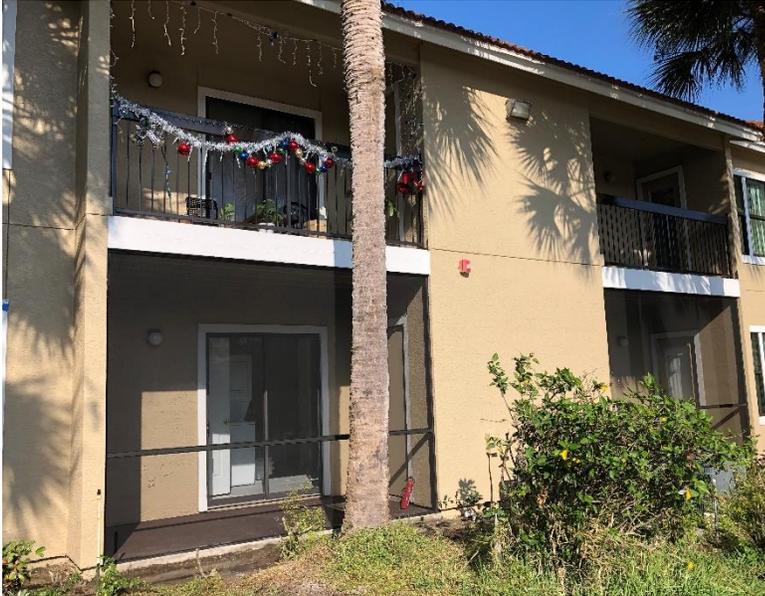
**PHOTOGRAPH #23**

**BUILDING 3  
SECTION B**

Screen enclosures were installed at balconies.

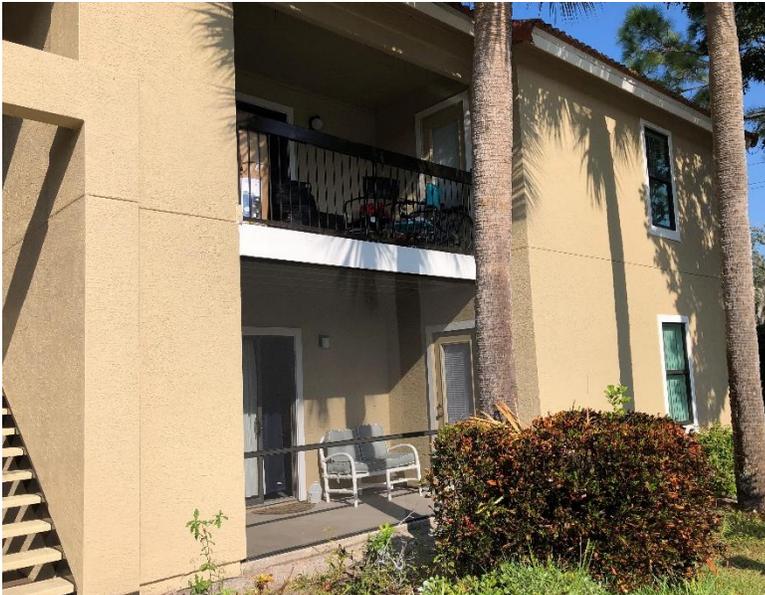
**PHOTOGRAPH #24**

**BUILDING 3  
SECTION C**

Screen enclosures were installed at balconies.

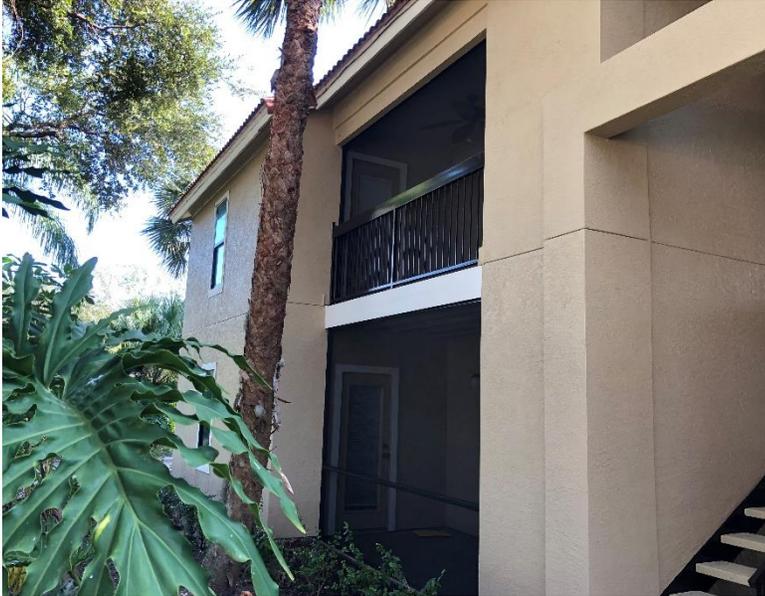
**PHOTOGRAPH #25**

**BUILDING 3  
SECTION E**

Screen enclosures were installed at balconies.

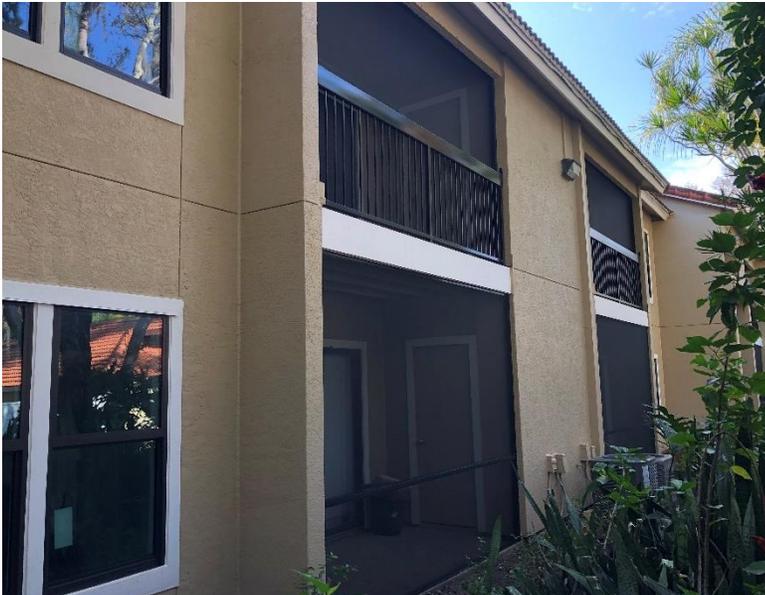
**PHOTOGRAPH #26**

**BUILDING 3  
SECTION F**

Screen enclosures were installed at balconies.

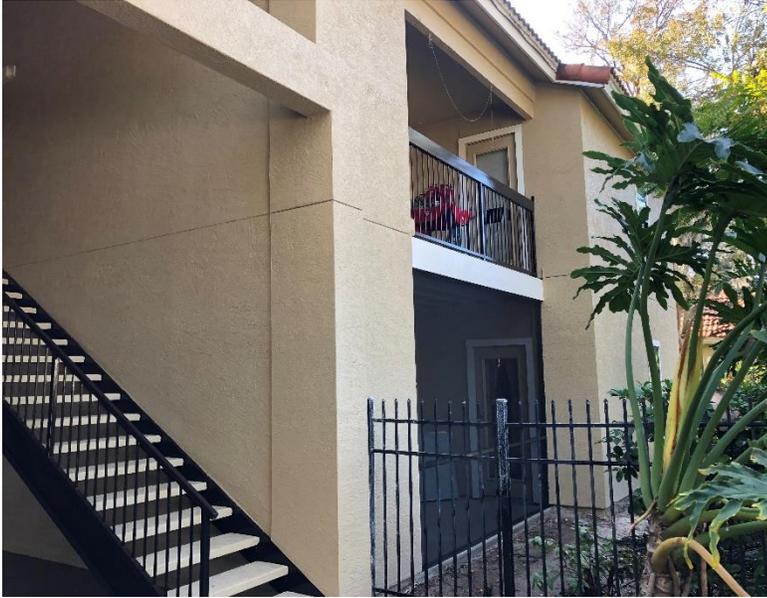
**PHOTOGRAPH #27**

**BUILDING 3  
SECTION G**

Screen enclosures were installed at balconies.
