**BUILDING 18
SECTION A**

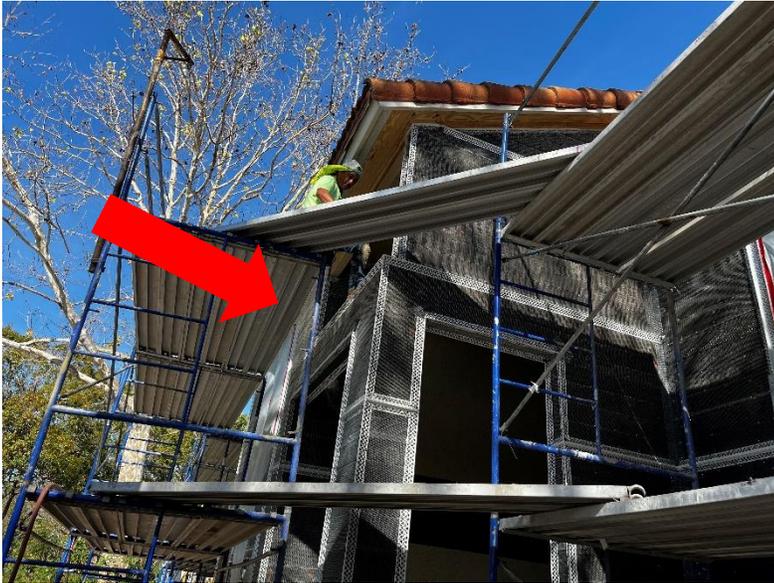
PHOTOGRAPH #1

Stucco sub-contractor installing vinyl stucco accessories as per drawings and specifications.

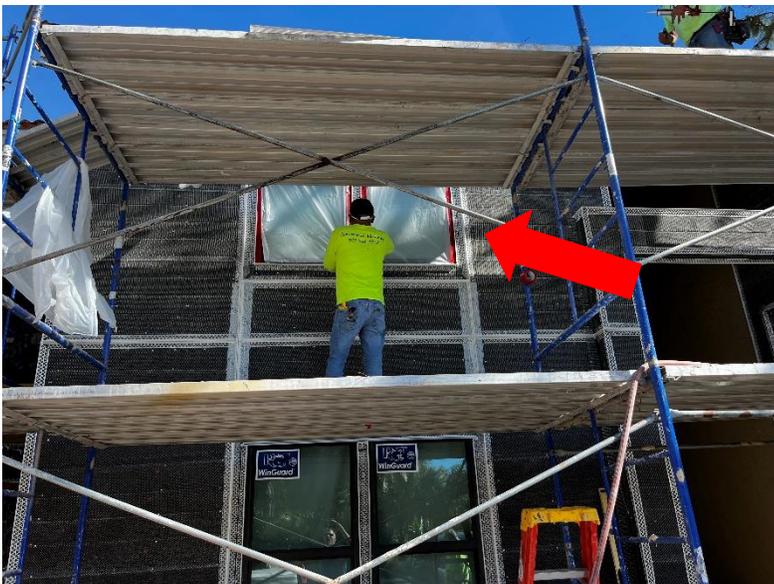
PHOTOGRAPH #2

**BUILDING 18
SECTION A**

Stucco sub-contractor protecting new windows with plastic covering prior to stucco applications.

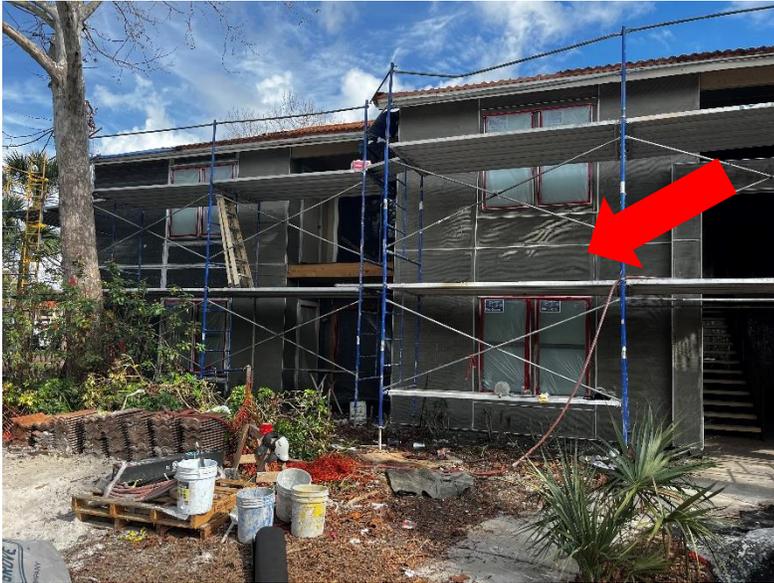
PHOTOGRAPH #3

**BUILDING 18
SECTION A**

Stucco sub-contractor has applied scratch coat of stucco system as per ASTM C 926.

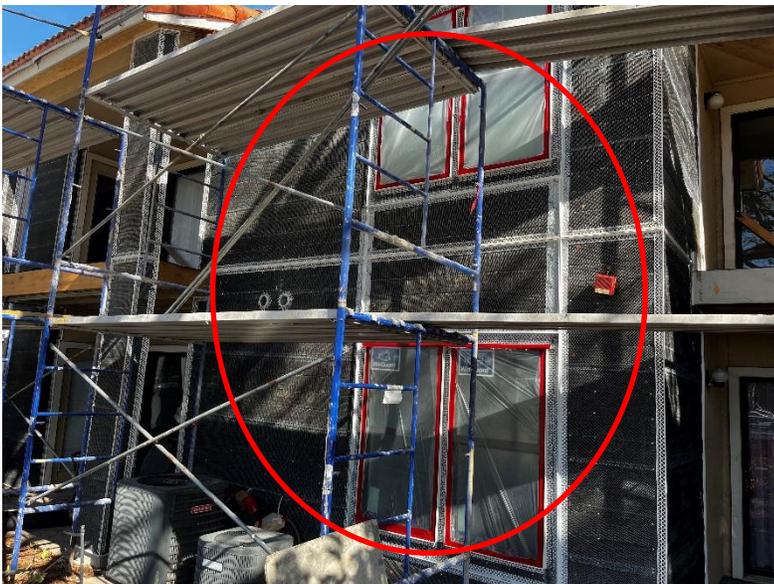
PHOTOGRAPH #4

**BUILDING 18
SECTION B**

Stucco sub-contractor protecting new windows with plastic covering prior to stucco applications.

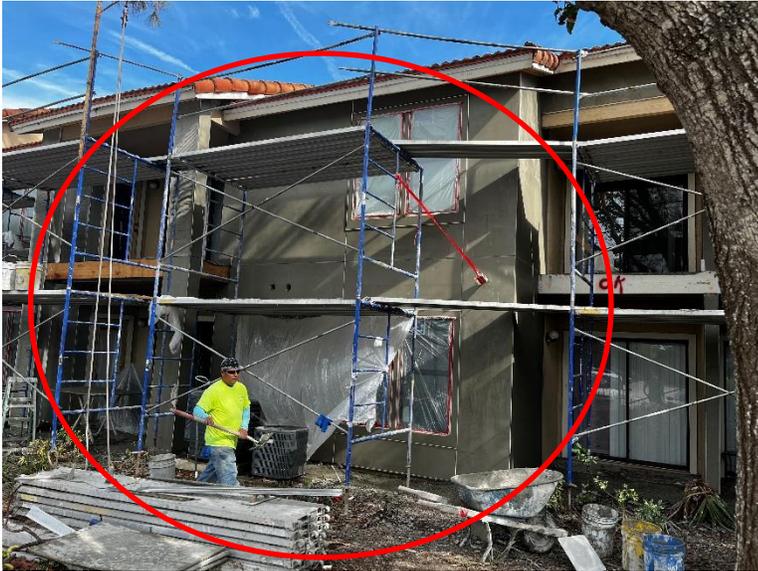
PHOTOGRAPH #5

**BUILDING 18
SECTION B**

Stucco sub-contractor has applied brown coat of stucco system as per ASTM C 926.

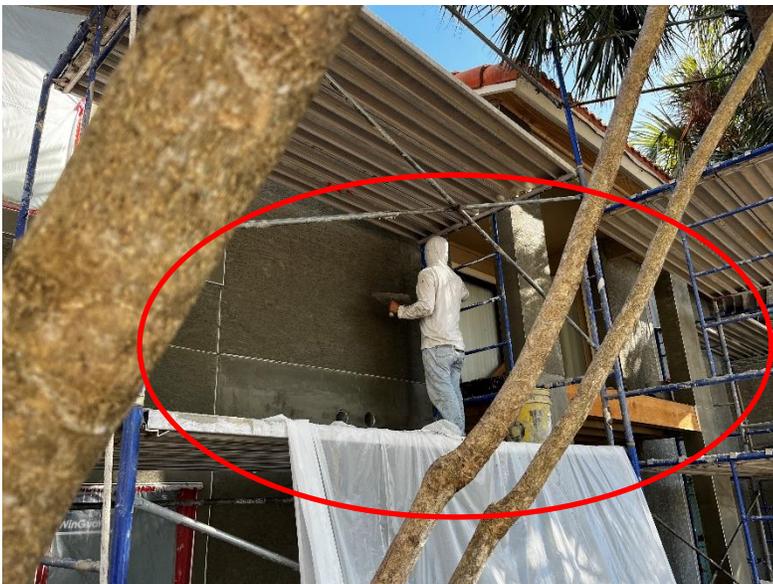
PHOTOGRAPH #6

**BUILDING 18
SECTION B**

Stucco sub-contractor has applying finish coat of stucco system as per ASTM C 926.

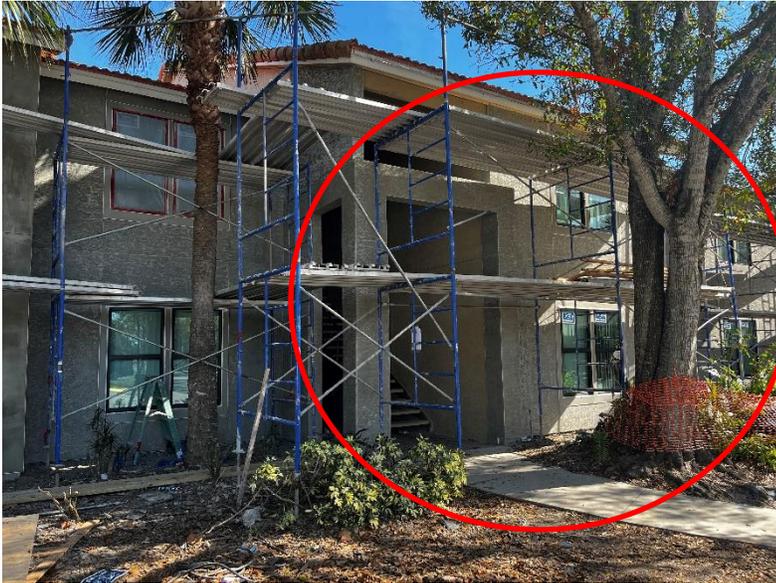
PHOTOGRAPH #7

**BUILDING 18
SECTION C**

Stucco sub-contractor has applied full three coat 7/8" stucco system as per ASTM C 926.

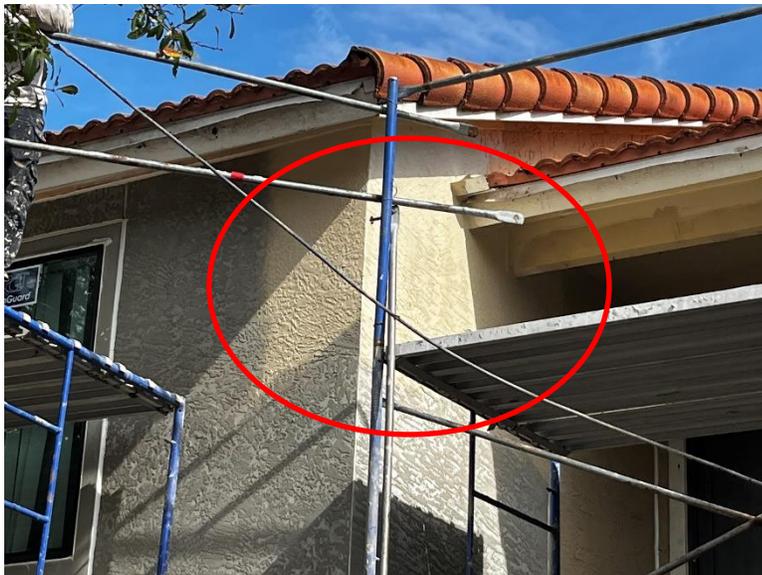
PHOTOGRAPH #8

**BUILDING 18
SECTION C**

Contractor has begun priming new stucco.
