# Uniform Mitigation Verification Inspection Form

| Inspection Date: 08/09/2024 | | |
| Owner Name: Vintage Grand Condominium Association, Inc. | | Contact Person: |
| Address: 4021 Crockers Lake Blvd | | Home Phone: |

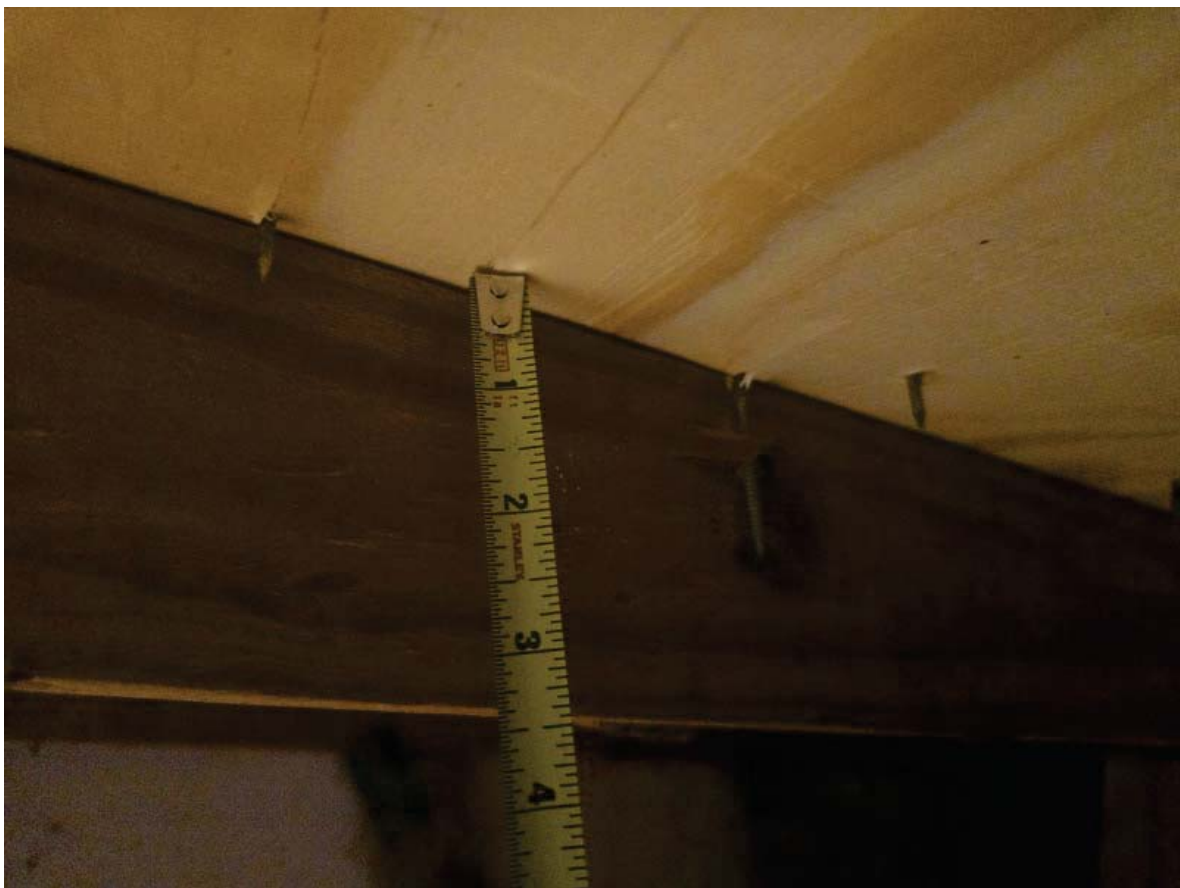
8D NAILS

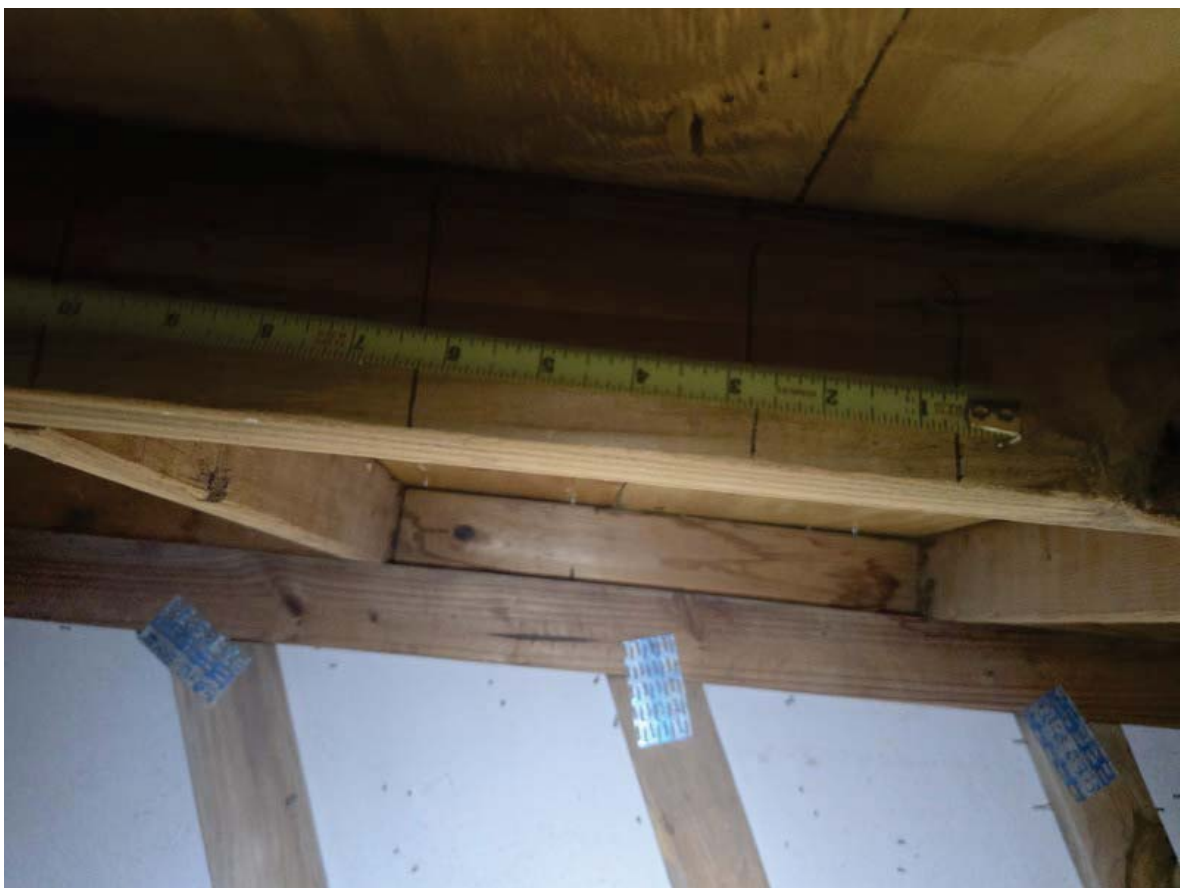
- ☒ C. Plywood/OSB roof sheathing with a minimum thickness of 7/16" inch attached to the roof truss/rafter (spaced a maximum of 24" inches o.c.) by 8d common nails spaced a maximum of 6" inches in the field. -OR- Dimensional lumber/Tongue & Groove decking with a minimum of 2 nails per board (or 1 nail per board if each board is equal to or less than 6 inches in width). -OR- Any system of screws, nails, adhesives, other deck fastening system or truss/rafter spacing that is shown to have an equivalent

ROOF DECK NAILED EVERY 6" IN FIELD OR BETTER OK

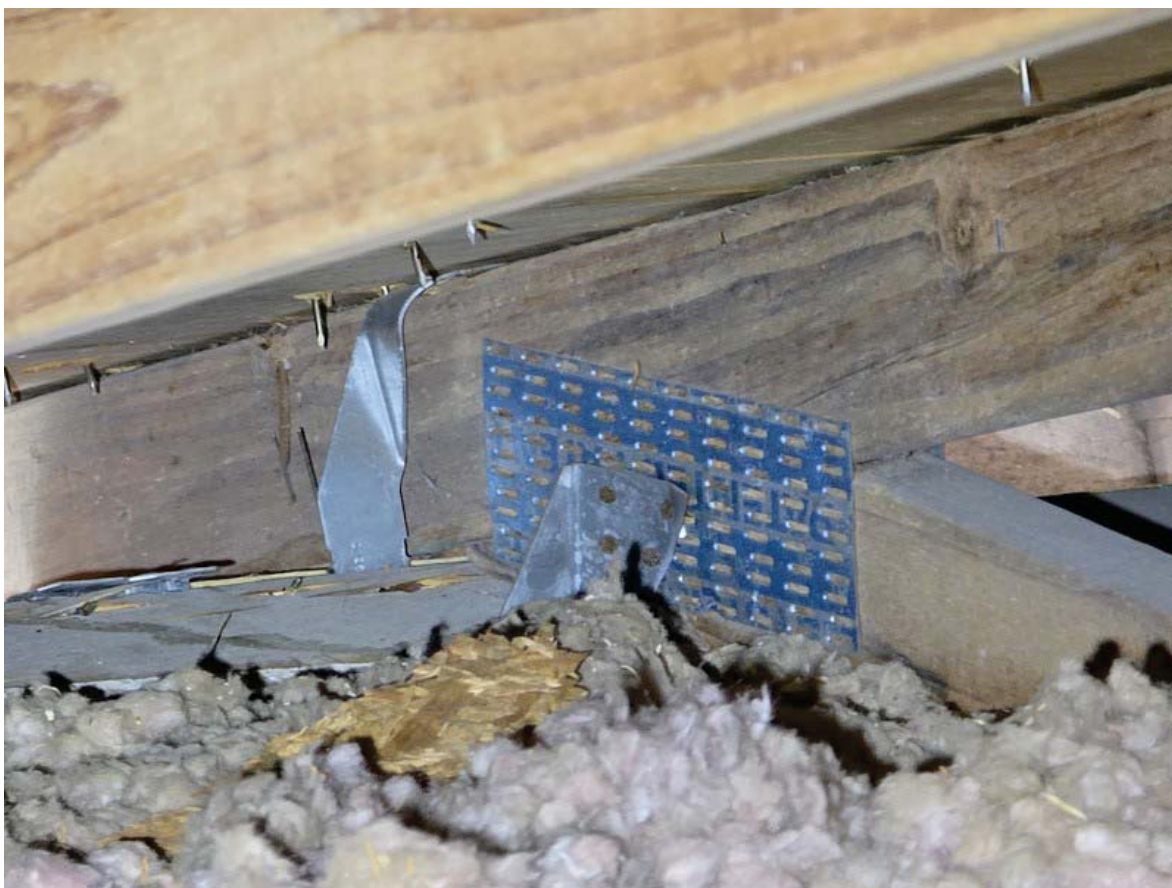
☒ B. Clips

- ☒ Metal connectors that do not wrap over the top of the truss/rafter, **or**
- ☐ Metal connectors with a minimum of 1 strap that wraps over the top of the truss/rafter and does not meet the nail position requirements of C or D, but is secured with a minimum of 3 nails.

ROOF TO WALL - HURRICANE CLIPS - OK
