# Uniform Mitigation Verification Inspection Form

| Inspection Date: 08/09/2024 | | |
| Owner Name: Vintage Grand Condominium Association, Inc. | | Contact Person: |
| Address: 4025 Crockers Lake Blvd | | Home Phone: |

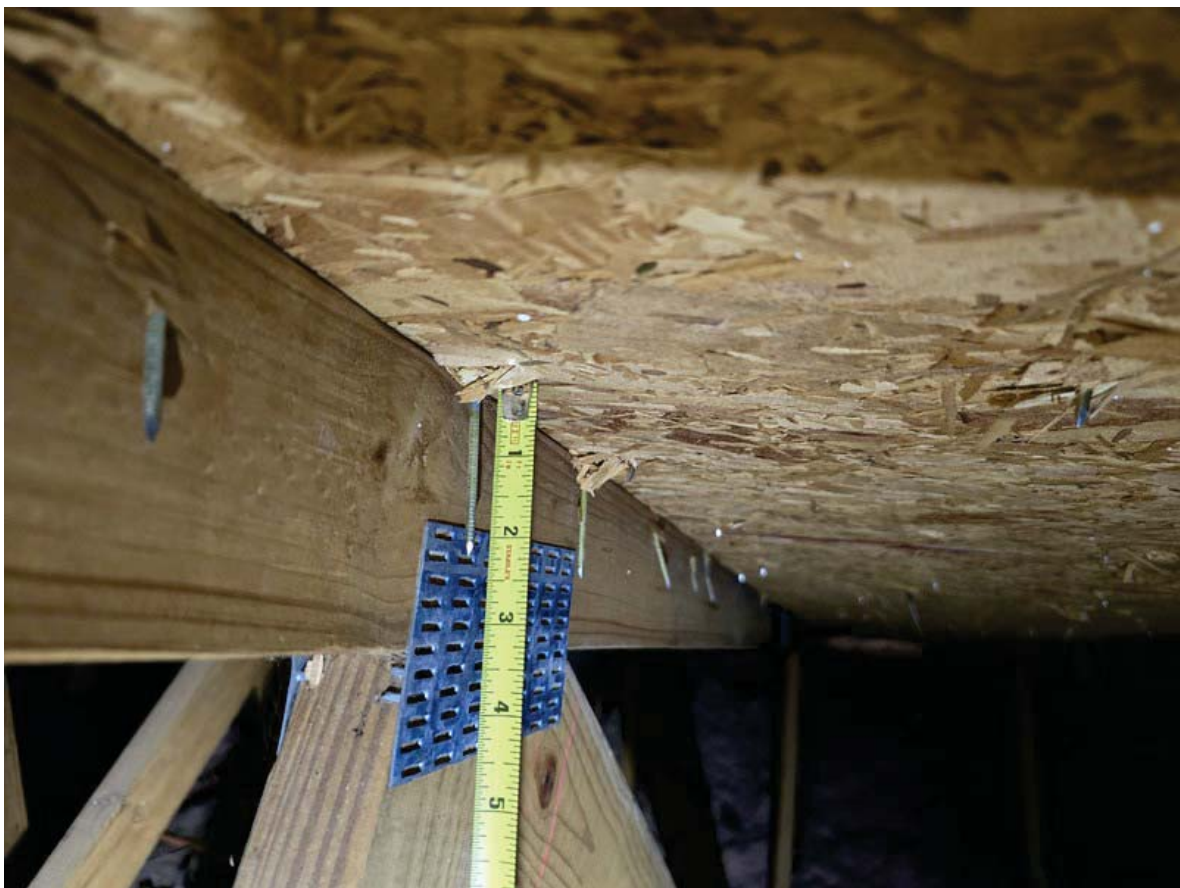
- ☒ C. Plywood/OSB roof sheathing with a minimum thickness of 7/16" inch attached to the roof truss/rafter (spaced a maximum of 24" inches o.c.) by 8d common nails spaced a maximum of 6" inches in the field. -OR- Dimensional lumber/Tongue & Groove decking with a minimum of 2 nails per board (or 1 nail per board if each board is equal to or less than 6 inches in width). -OR- Any system of screws, nails, adhesives, other deck fastening system or truss/rafter spacing that is shown to have an equivalent

8D NAILS

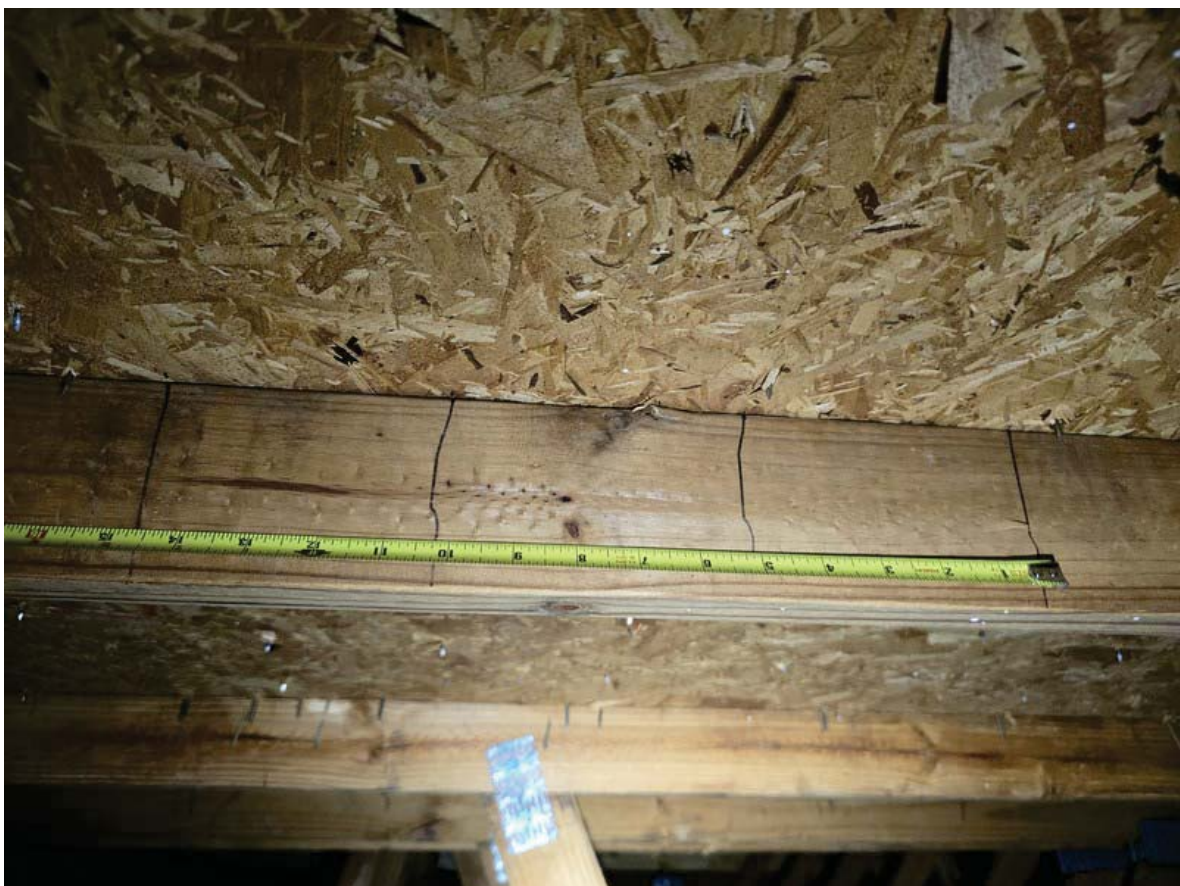
ROOF DECK NAILED EVERY 6" IN FIELD OR BETTER OK

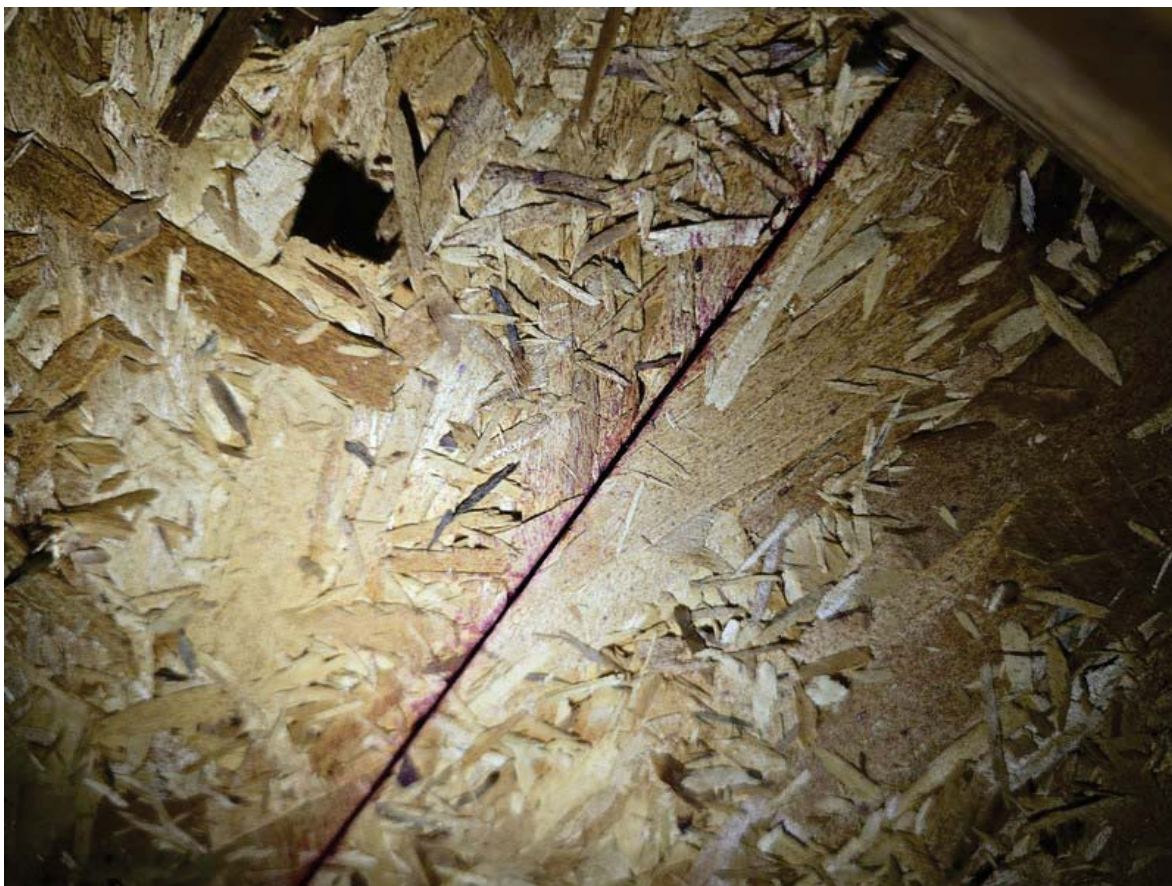
- ☒ A. SWR (also called Sealed Roof Deck) Self-adhering polymer modified-bitumen roofing underlayment applied directly to the sheathing or foam adhesive SWR barrier (not foamed-on insulation) applied as a supplemental means to protect the dwelling from water intrusion in the event of roof covering loss.
- ☐ B. No SWR.
- ☐ C. Unknown or undetermined.

SWR

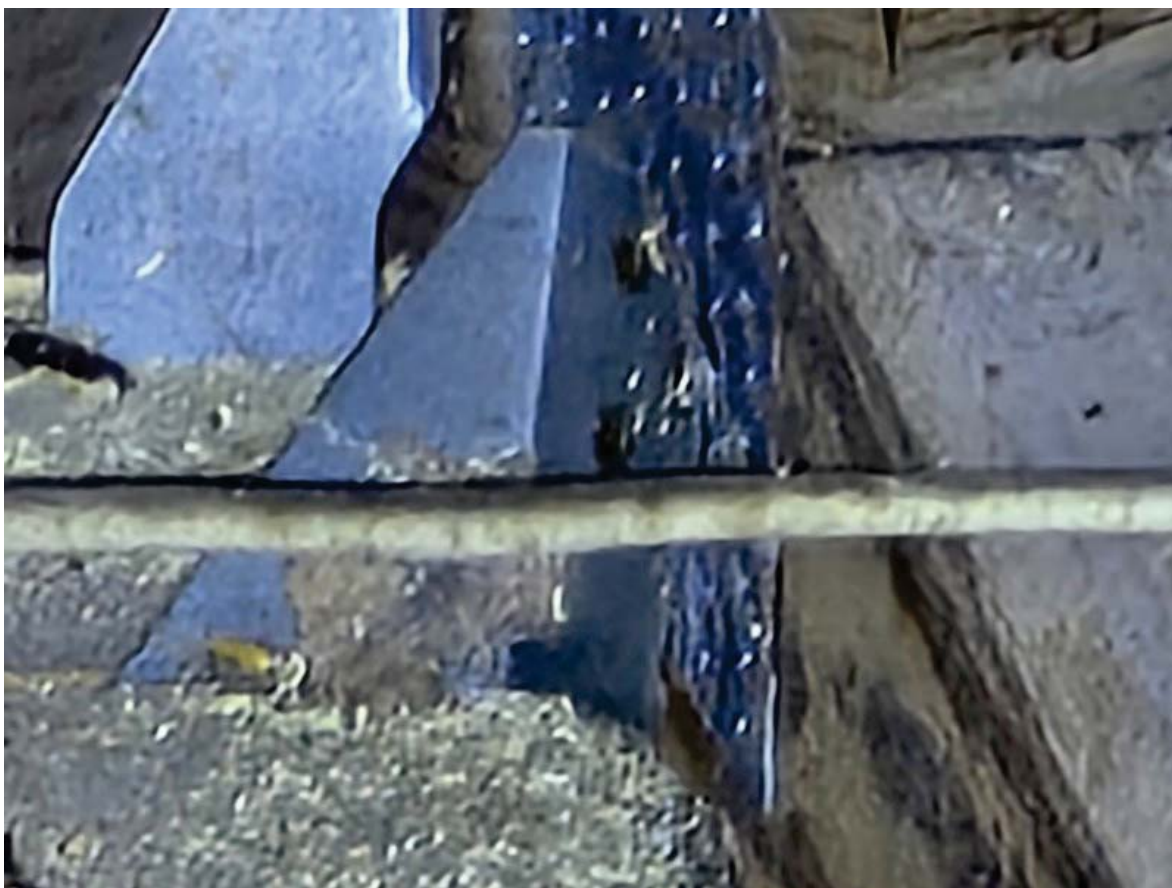
☒ B. Clips

- ☒ Metal connectors that do not wrap over the top of the truss/rafter, **or**
- ☐ Metal connectors with a minimum of 1 strap that wraps over the top of the truss/rafter and does not meet the nail position requirements of C or D, but is secured with a minimum of 3 nails.

ROOF TO WALL - HURRICANE CLIPS - OK

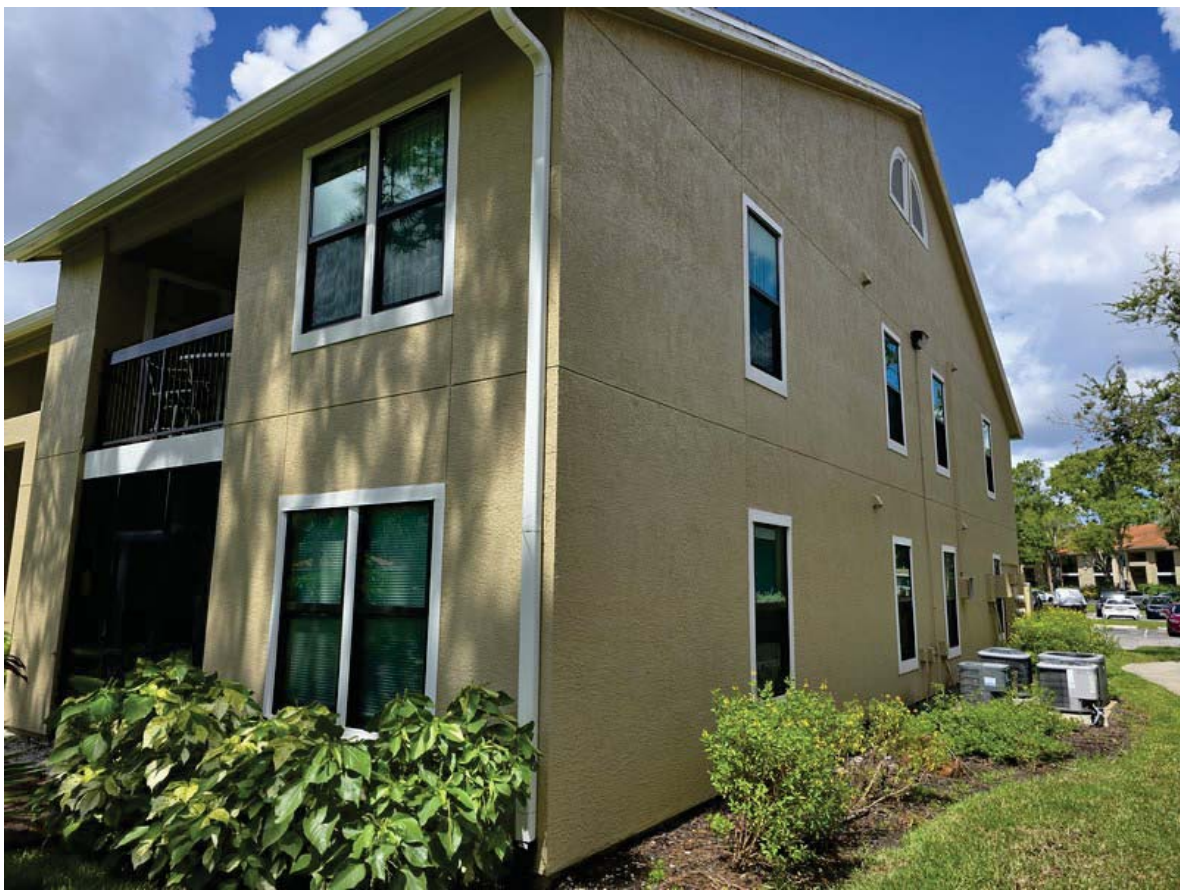
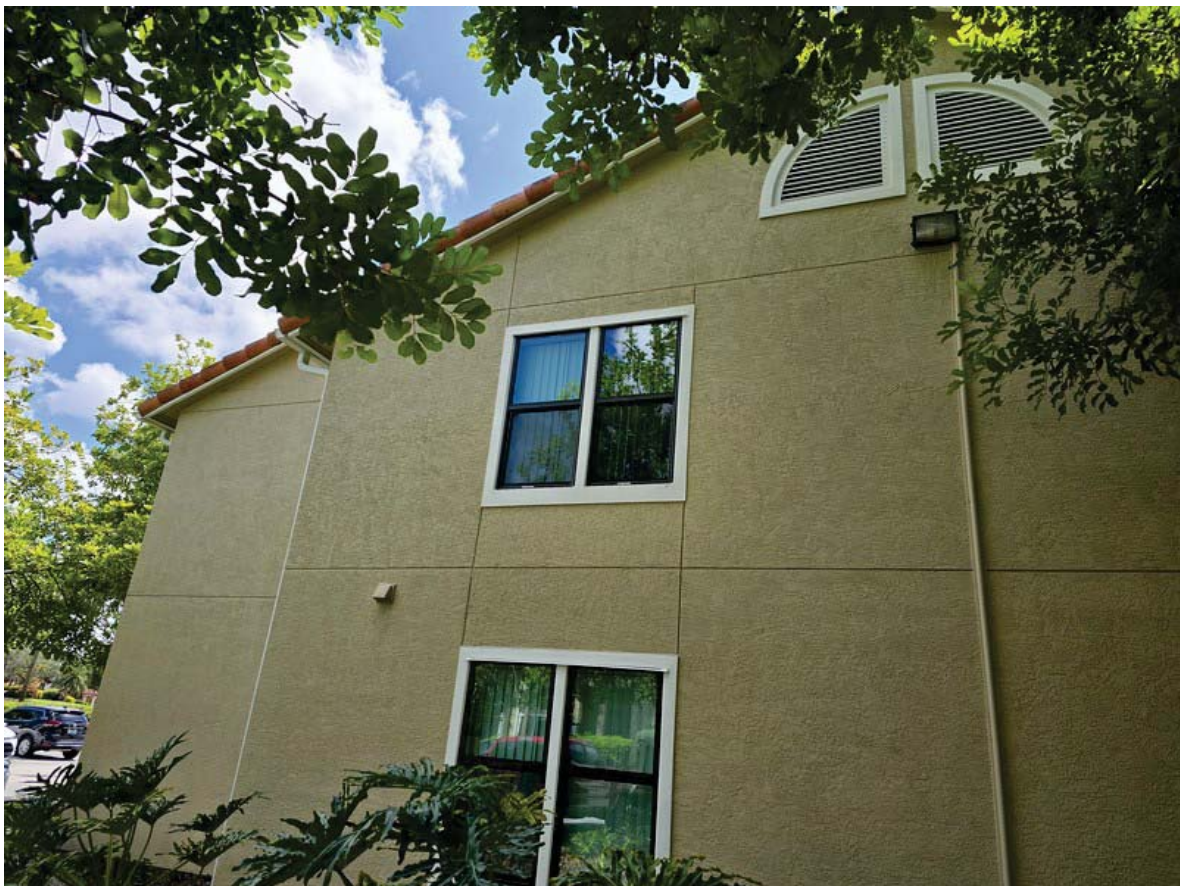
THE ENTIRE BUILDING'S WINDOWS WERE REPLACED WITH IMPACT RATED WINDOWS

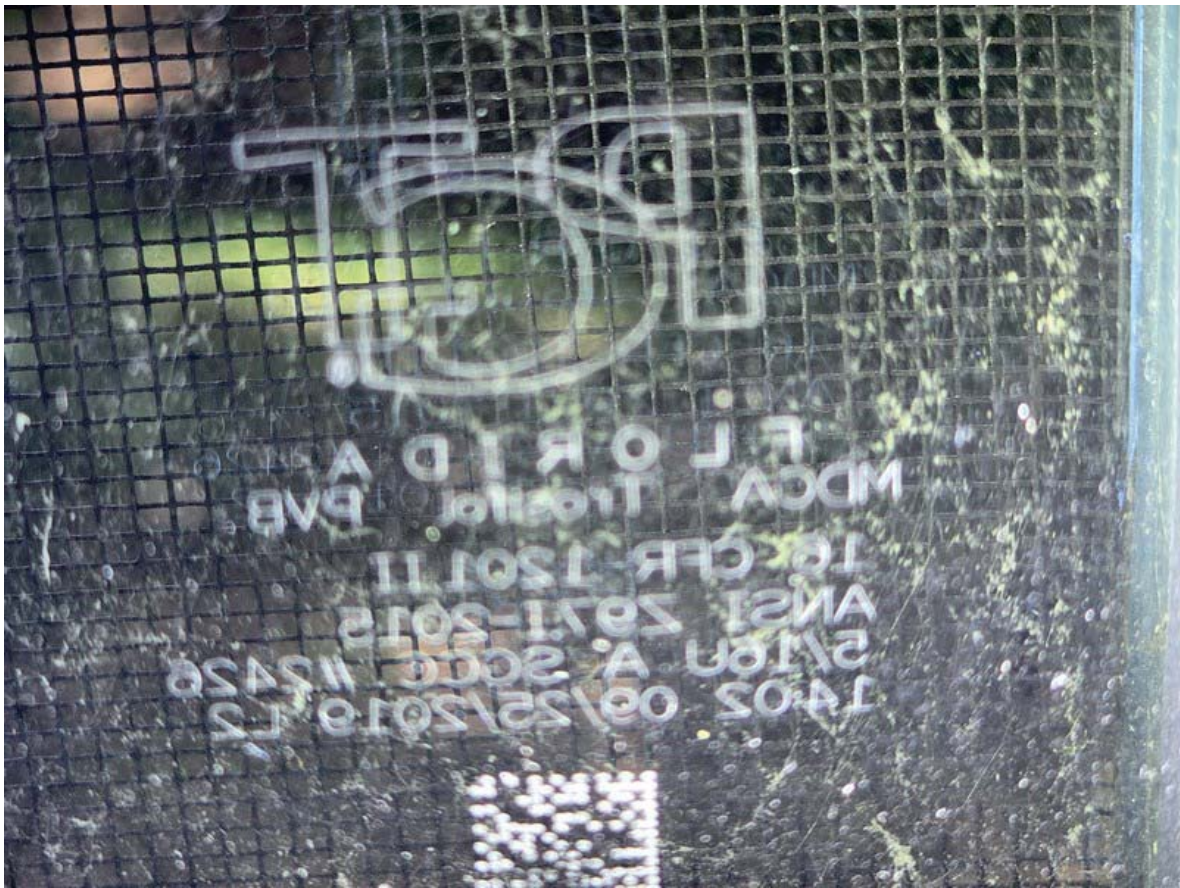
ALL WINDOWS WERE MCDA IMPACT RATED LAMINATED SAFETY GLASS

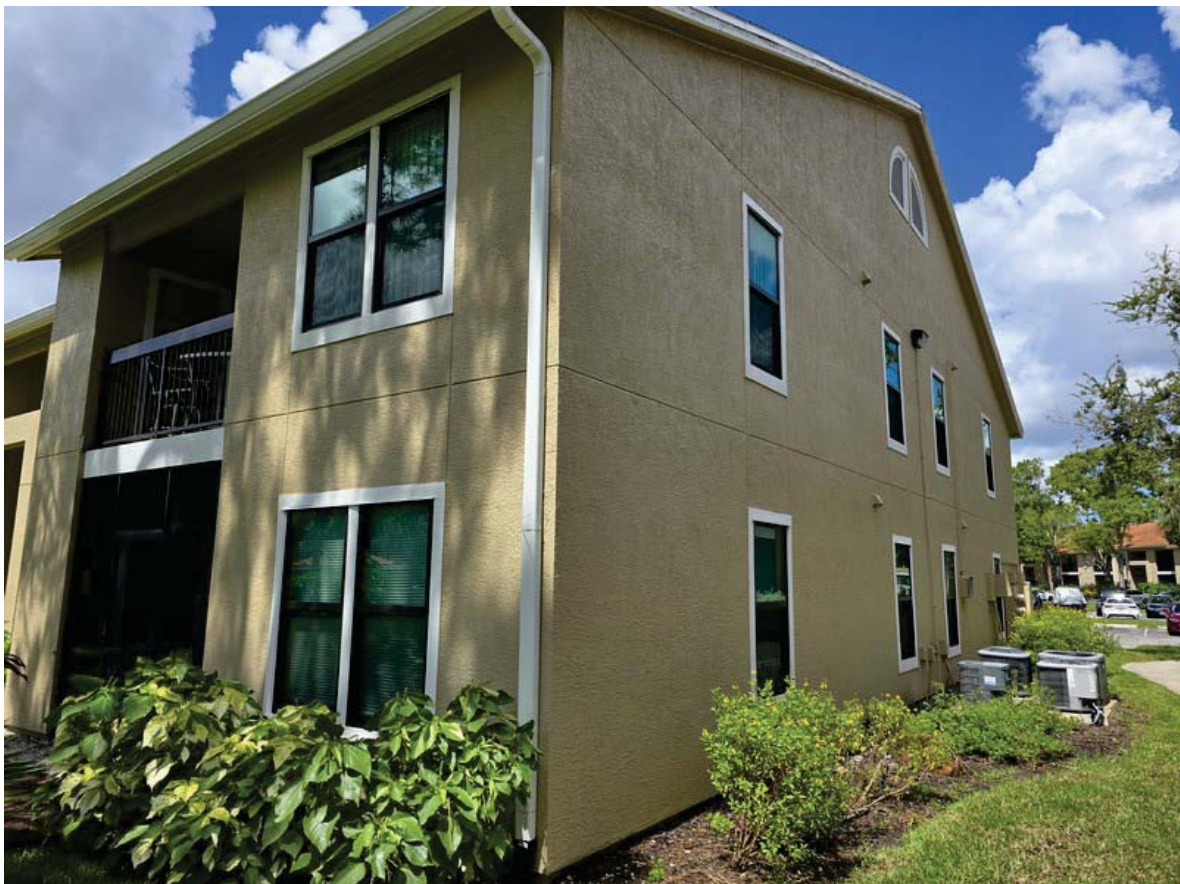
| Opening Protection Level Chart<br>Place an "X" in each row to identify all forms of protection in use for each opening type. Check only one answer below (A thru X), based on the weakest form of protection (lowest row) for any of the Glazed openings and indicate the weakest form of protection (lowest row) for Non-Glazed openings. | | Glazed Openings | | | | Non-Glazed Openings | |
|---|---|---|---|---|---|---|---|
| X | No Windborne Debris Protection | X | | | | | |

☒ **X. None or Some Glazed Openings** One or more Glazed openings classified and Level X in the table above.

BUILDING'S OLDER SLIDING GLASS DOORS WERE NOT IMPACT RATED
