# Uniform Mitigation Verification Inspection Form

| Inspection Date: 08/09/2024 | | |
| Owner Name: Vintage Grand Condominium Association, Inc. | | Contact Person: |
| Address: 4029 Crockers Lake Blvd | | Home Phone: |

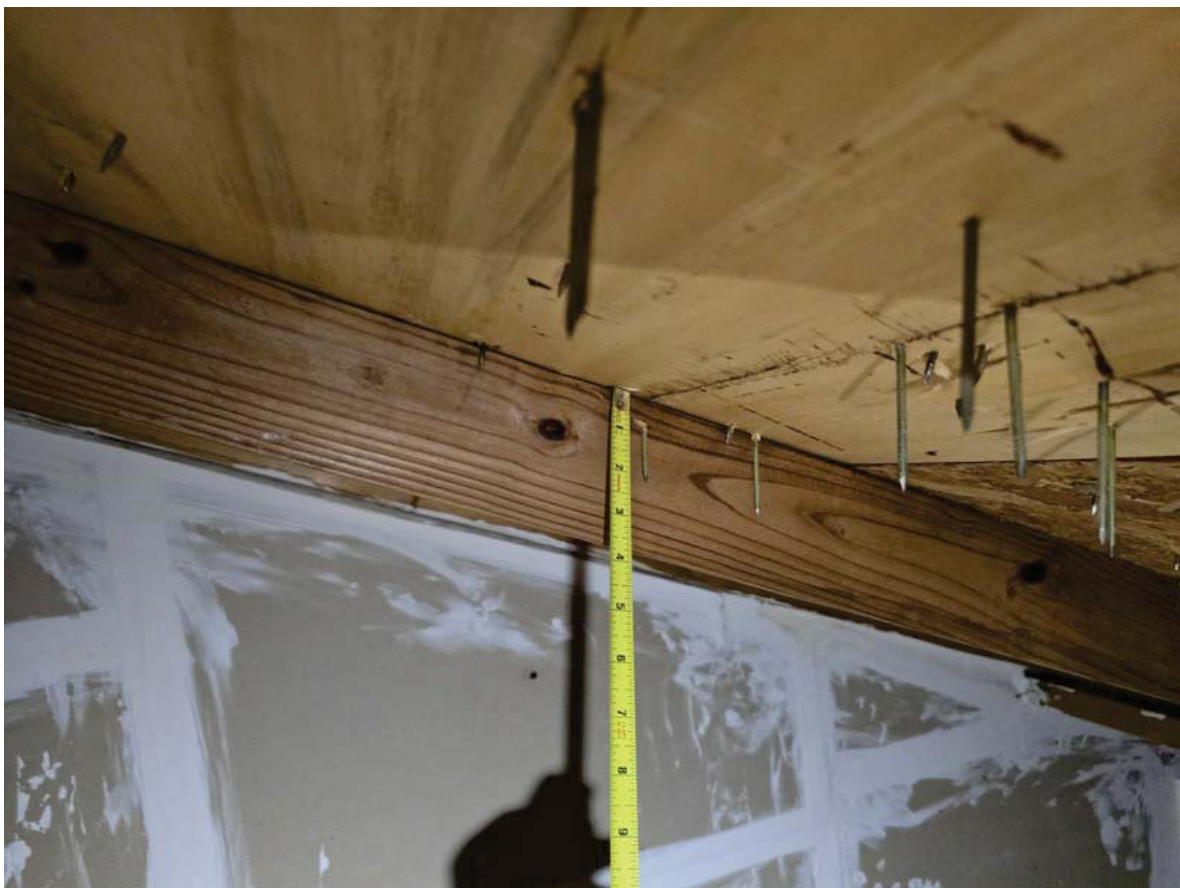
8D NAILS

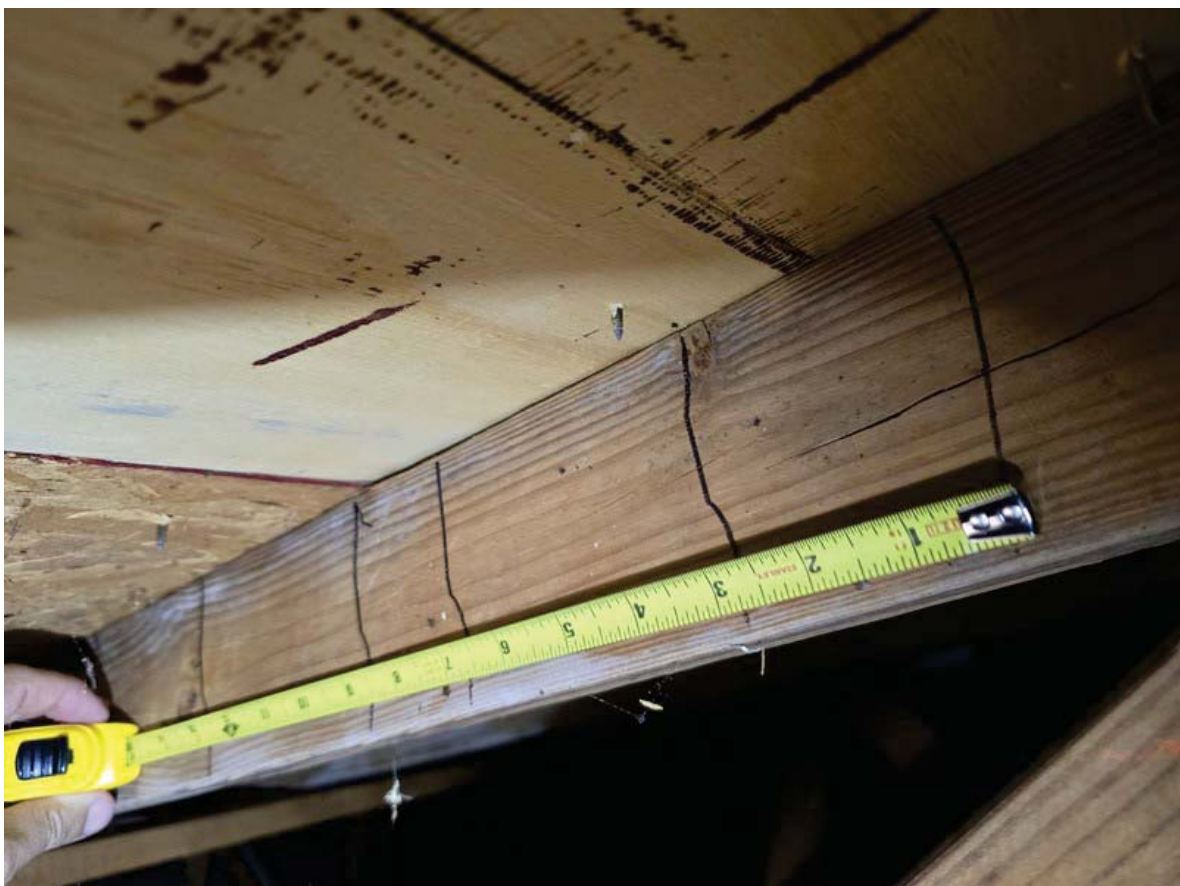
- ☒ C. Plywood/OSB roof sheathing with a minimum thickness of 7/16" inch attached to the roof truss/rafter (spaced a maximum of 24" inches o.c.) by 8d common nails spaced a maximum of 6" inches in the field. -OR- Dimensional lumber/Tongue & Groove decking with a minimum of 2 nails per board (or 1 nail per board if each board is equal to or less than 6 inches in width). -OR- Any system of screws, nails, adhesives, other deck fastening system or truss/rafter spacing that is shown to have an equivalent

ROOF DECK NAILED EVERY 6" IN FIELD OR BETTER OK

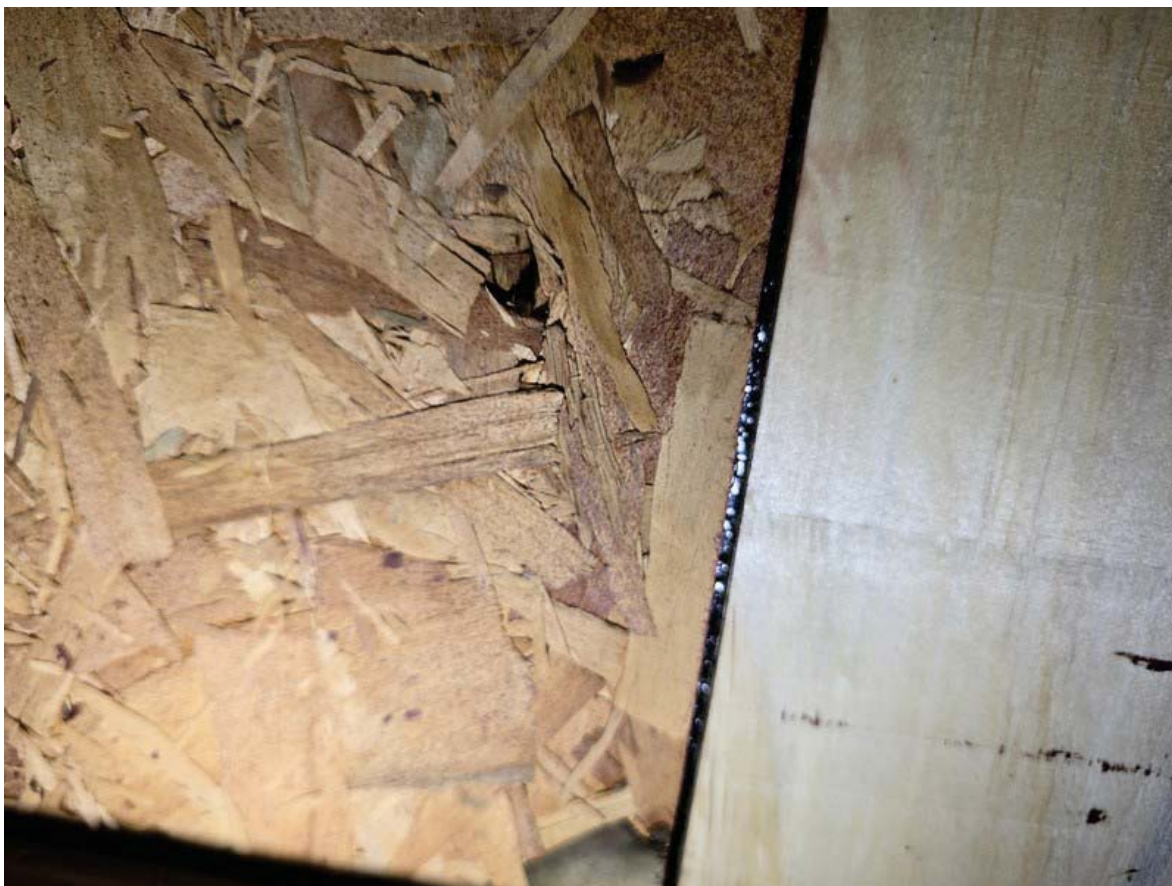
- ☒ A. SWR (also called Sealed Roof Deck) Self-adhering polymer modified-bitumen roofing underlayment applied directly to the sheathing or foam adhesive SWR barrier (not foamed-on insulation) applied as a supplemental means to protect the dwelling from water intrusion in the event of roof covering loss.
- ☐ B. No SWR.
- ☐ C. Unknown or undetermined.

SWR

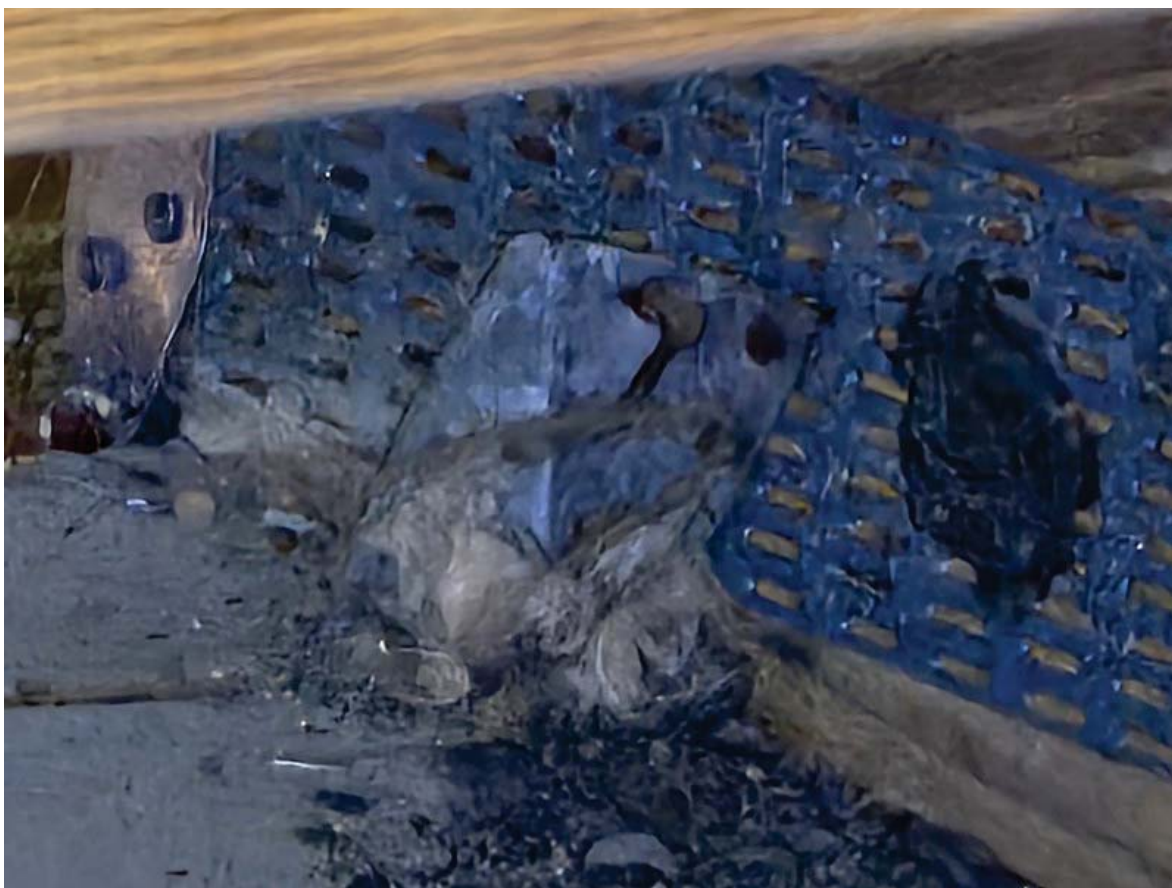
☒ B. Clips

- ☒ Metal connectors that do not wrap over the top of the truss/rafter, **or**
- ☐ Metal connectors with a minimum of 1 strap that wraps over the top of the truss/rafter and does not meet the nail position requirements of C or D, but is secured with a minimum of 3 nails.

ROOF TO WALL - HURRICANE CLIPS - OK
