# Uniform Mitigation Verification Inspection Form

| Inspection Date: 08/09/2024 | | |
| Owner Name: Vintage Grand Condominium Association, Inc. | | Contact Person: |
| Address: 4033 Crockers Lake Blvd | | Home Phone: |

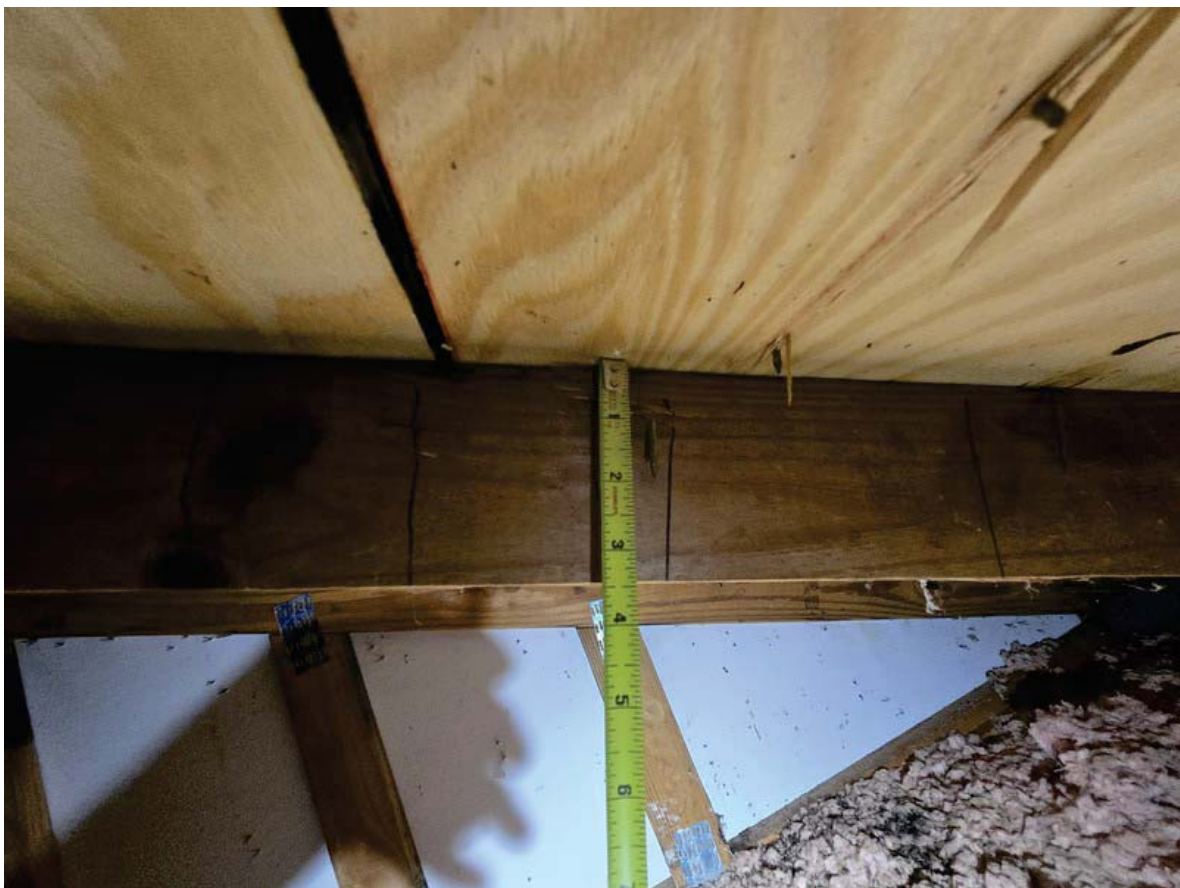
- ☒ C. Plywood/OSB roof sheathing with a minimum thickness of 7/16" inch attached to the roof truss/rafter (spaced a maximum of 24" inches o.c.) by 8d common nails spaced a maximum of 6" inches in the field. -OR- Dimensional lumber/Tongue & Groove decking with a minimum of 2 nails per board (or 1 nail per board if each board is equal to or less than 6 inches in width). -OR- Any system of screws, nails, adhesives, other deck fastening system or truss/rafter spacing that is shown to have an equivalent

8D NAILS

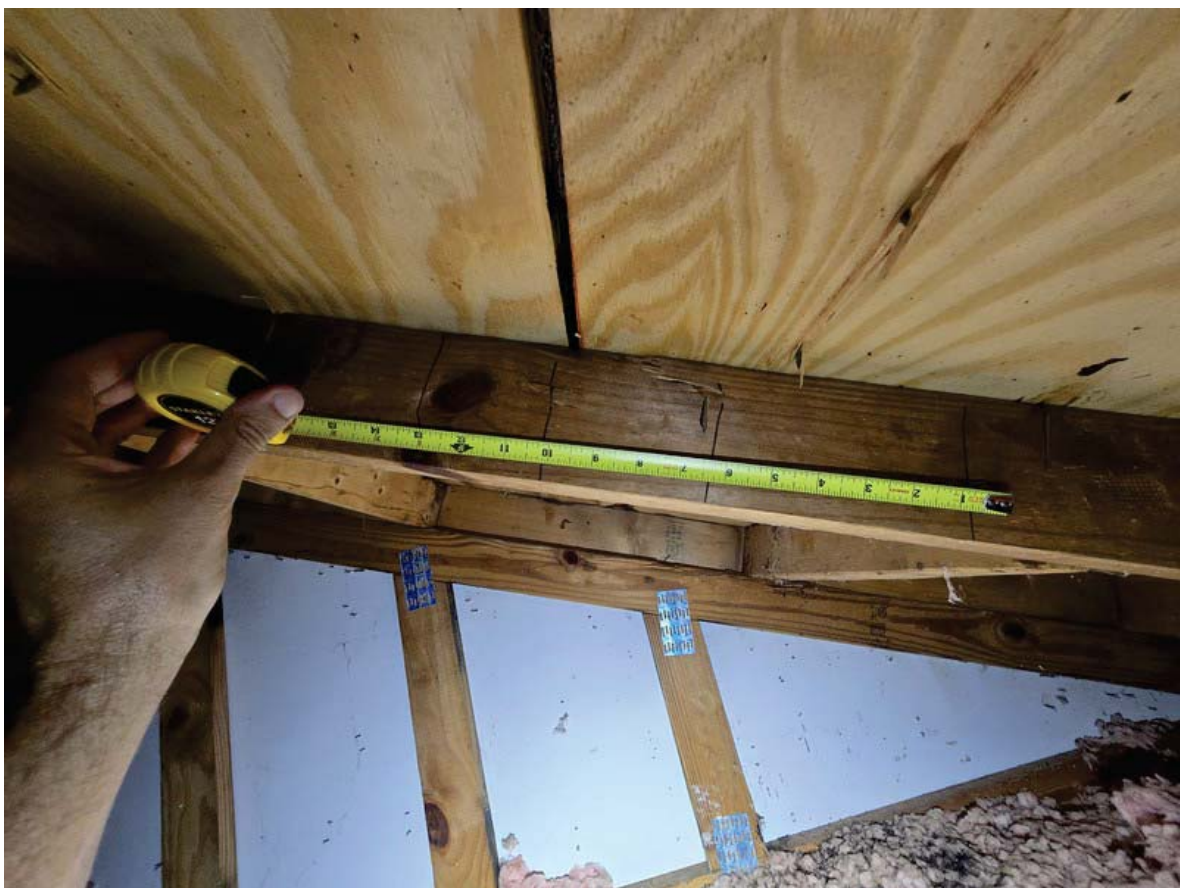
ROOF DECK NAILED EVERY 6" IN FIELD OR BETTER OK

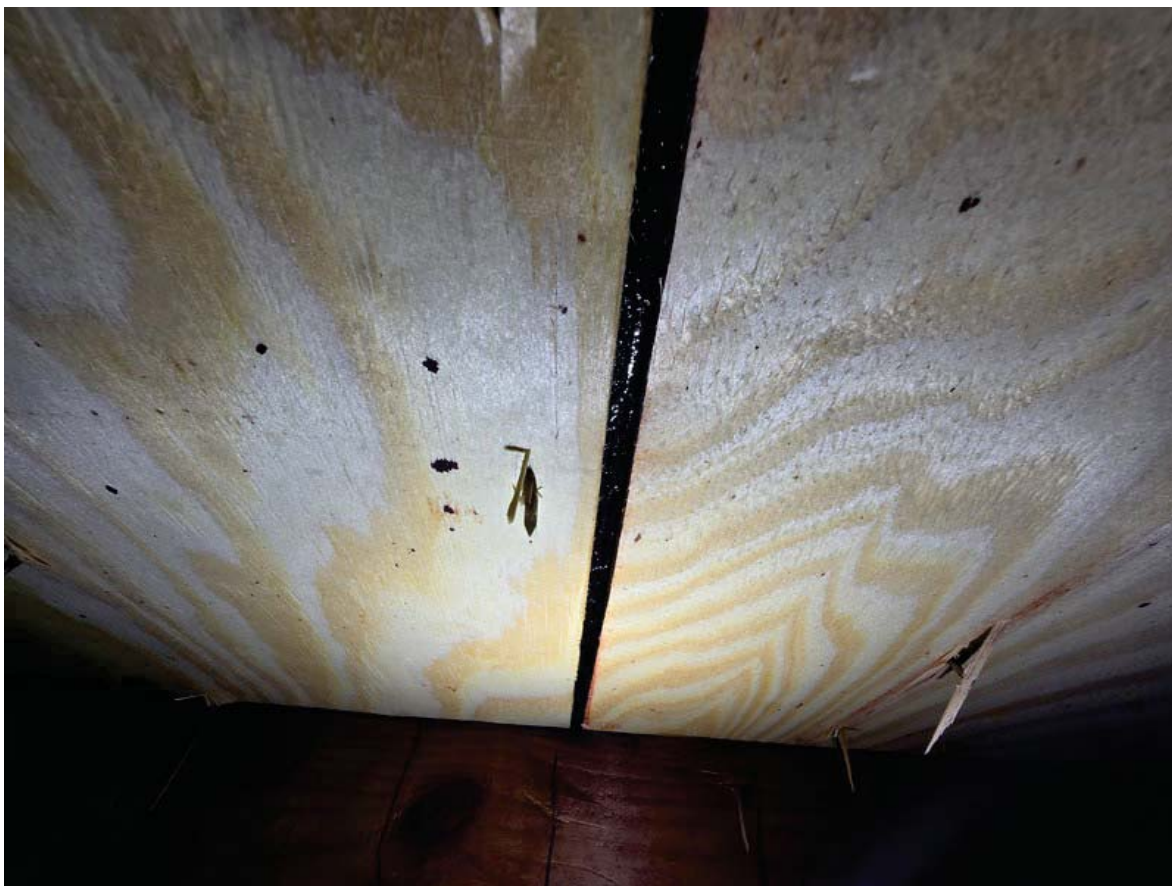
- ☒ A. SWR (also called Sealed Roof Deck) Self-adhering polymer modified-bitumen roofing underlayment applied directly to the sheathing or foam adhesive SWR barrier (not foamed-on insulation) applied as a supplemental means to protect the dwelling from water intrusion in the event of roof covering loss.
- ☐ B. No SWR.
- ☐ C. Unknown or undetermined.

SWR
