# Uniform Mitigation Verification Inspection Form

| Inspection Date: 11/06/2024 | | |
| Owner Name: Vintage Grand Condominium Association, Inc. | | Contact Person: |
| Address: 4006 Crockers Lake Blvd | | Home Phone: |

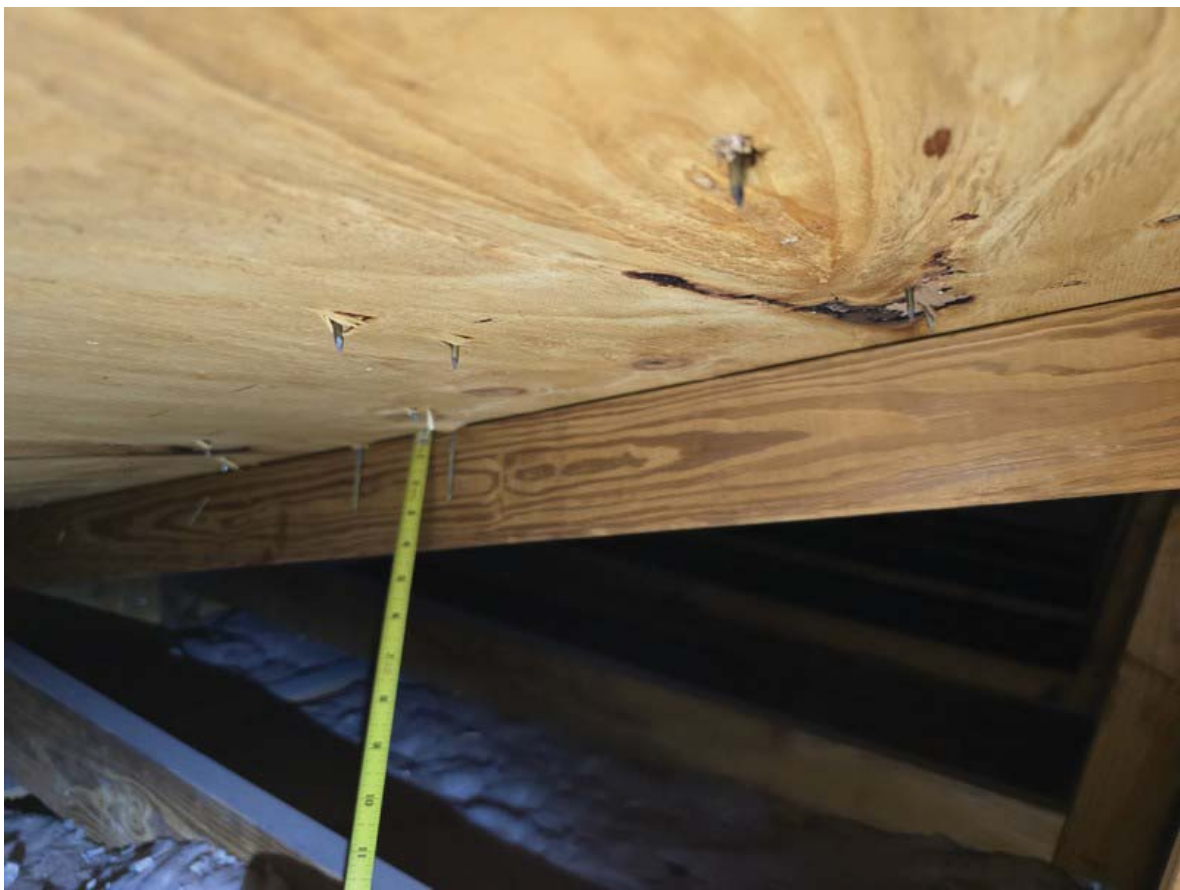
- ☒ C. Plywood/OSB roof sheathing with a minimum thickness of 7/16" inch attached to the roof truss/rafter (spaced a maximum of 24" inches o.c.) by 8d common nails spaced a maximum of 6" inches in the field. -OR- Dimensional lumber/Tongue & Groove decking with a minimum of 2 nails per board (or 1 nail per board if each board is equal to or less than 6 inches in width). -OR- Any system of screws, nails, adhesives, other deck fastening system or truss/rafter spacing that is shown to have an equivalent

8D NAILS

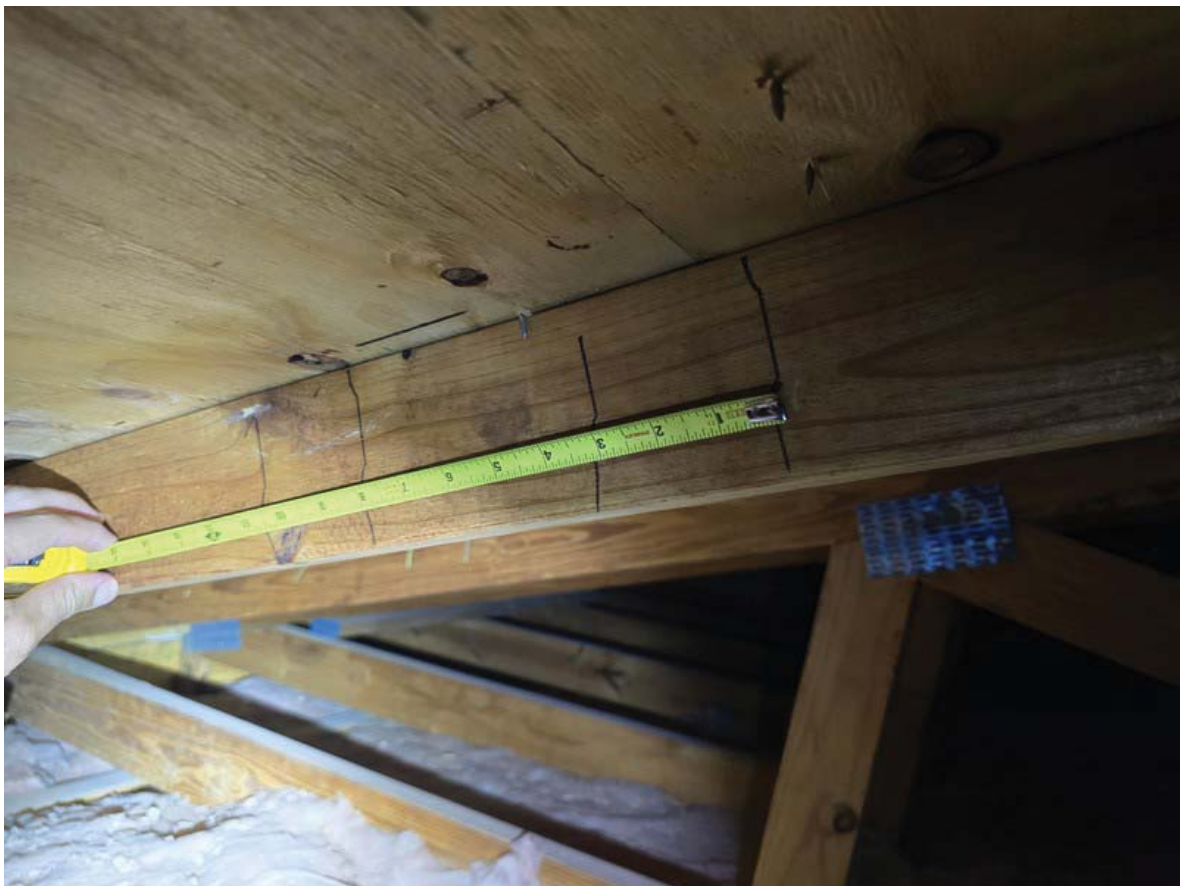
ROOF DECK NAILED EVERY 6" IN FIELD OR BETTER OK

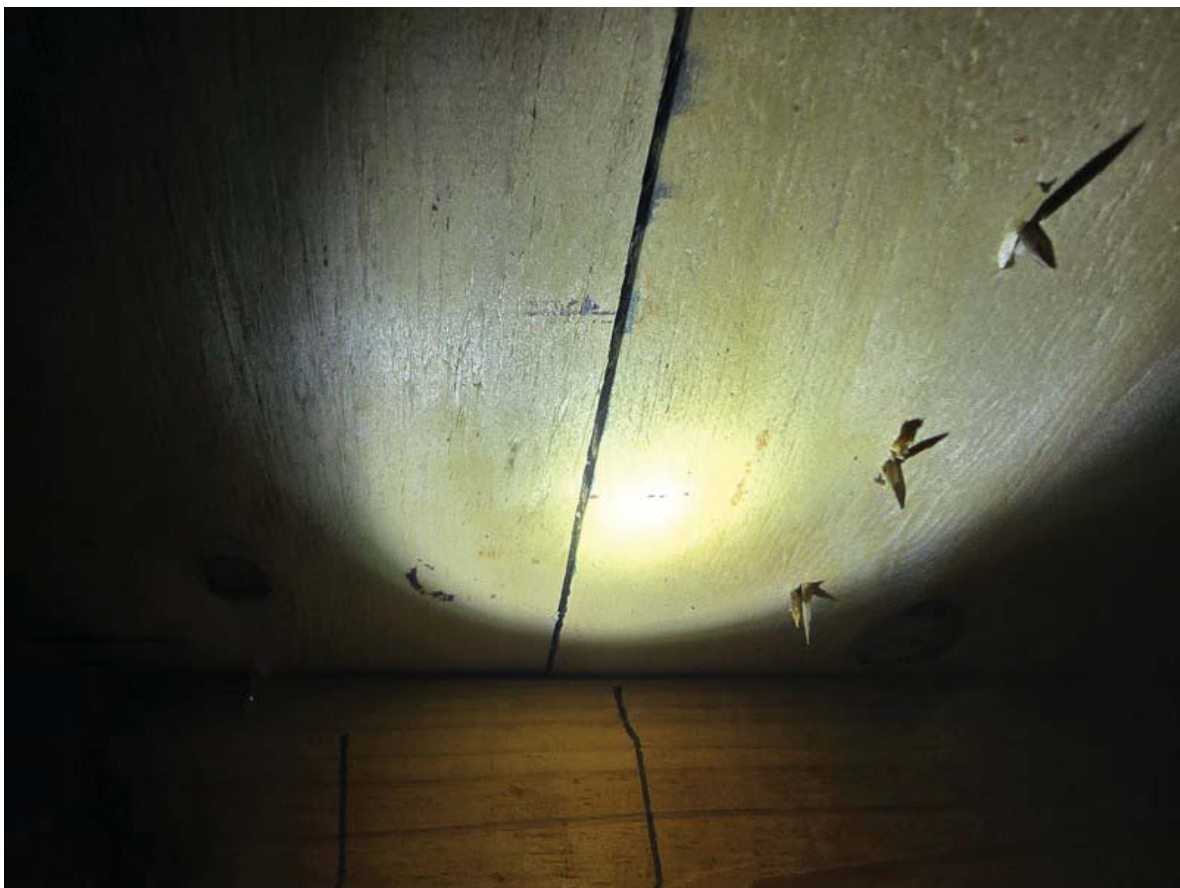
- ☒ A. SWR (also called Sealed Roof Deck) Self-adhering polymer modified-bitumen roofing underlayment applied directly to the sheathing or foam adhesive SWR barrier (not foamed-on insulation) applied as a supplemental means to protect the dwelling from water intrusion in the event of roof covering loss.
- ☐ B. No SWR.
- ☐ C. Unknown or undetermined.

SWR

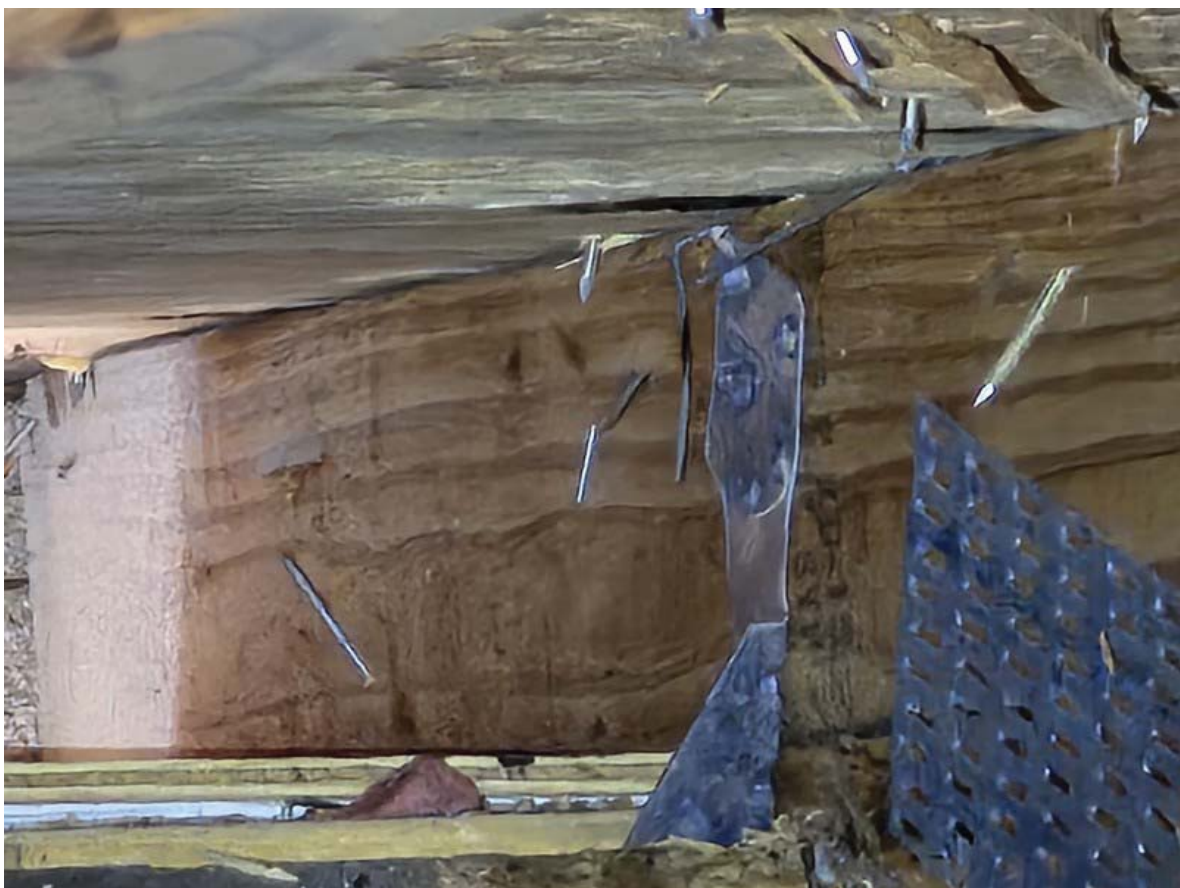
☒ B. Clips

- ☒ Metal connectors that do not wrap over the top of the truss/rafter, **or**
- ☐ Metal connectors with a minimum of 1 strap that wraps over the top of the truss/rafter and does not meet the nail position requirements of C or D, but is secured with a minimum of 3 nails.

ROOF TO WALL - HURRICANE CLIPS - OK
