# Uniform Mitigation Verification Inspection Form

| Inspection Date: 08/09/2024 | | |
| Owner Name: Vintage Grand Condominium Association, Inc. | | Contact Person: |
| Address: 4037 Crockers Lake Blvd | | Home Phone: |

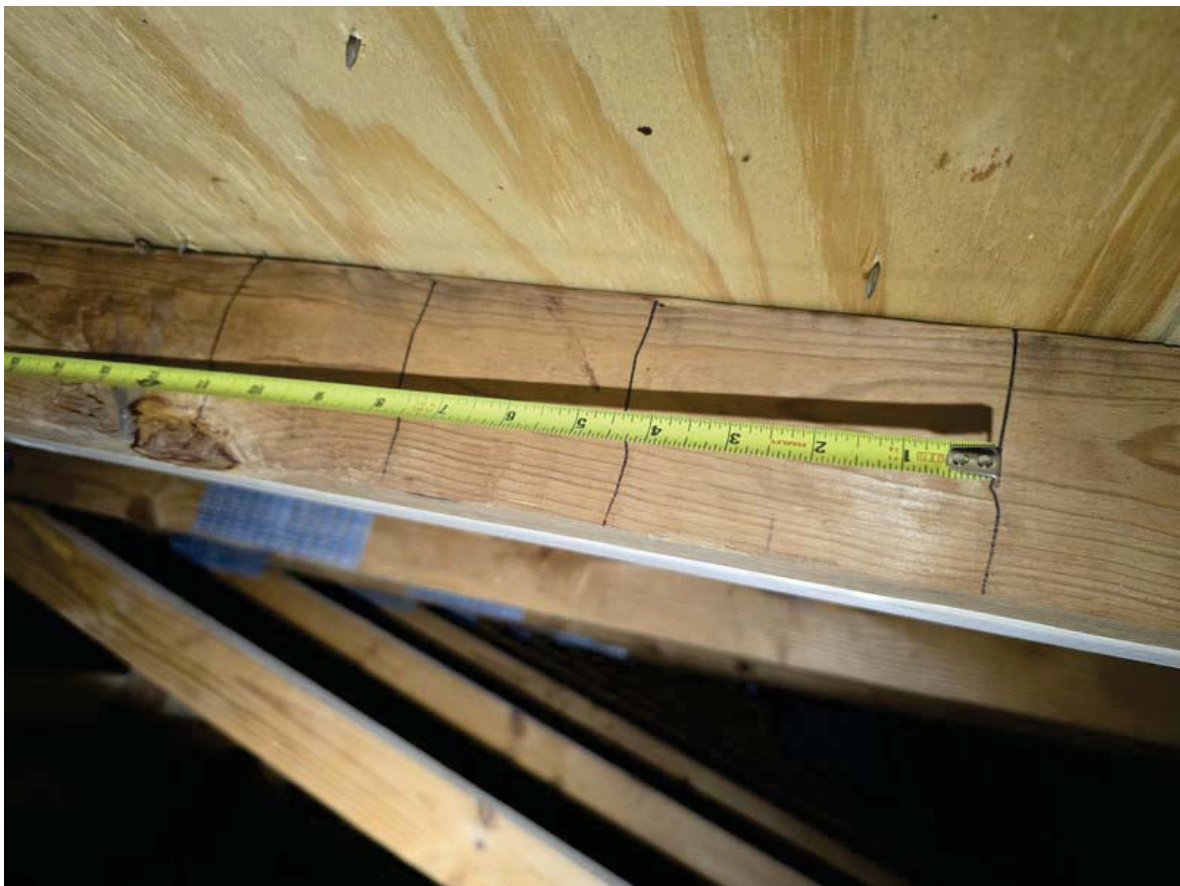
- ☒ C. Plywood/OSB roof sheathing with a minimum thickness of 7/16" inch attached to the roof truss/rafter (spaced a maximum of 24" inches o.c.) by 8d common nails spaced a maximum of 6" inches in the field. -OR- Dimensional lumber/Tongue & Groove decking with a minimum of 2 nails per board (or 1 nail per board if each board is equal to or less than 6 inches in width). -OR- Any system of screws, nails, adhesives, other deck fastening system or truss/rafter spacing that is shown to have an equivalent

ROOF DECK NAILED EVERY 6" IN FIELD OR BETTER OK
