# Uniform Mitigation Verification Inspection Form

| Inspection Date: 08/09/2024 | | |
| Owner Name: Vintage Grand Condominium Association, Inc. | | Contact Person: |
| Address: 4041 Crockers Lake Blvd | | Home Phone: |

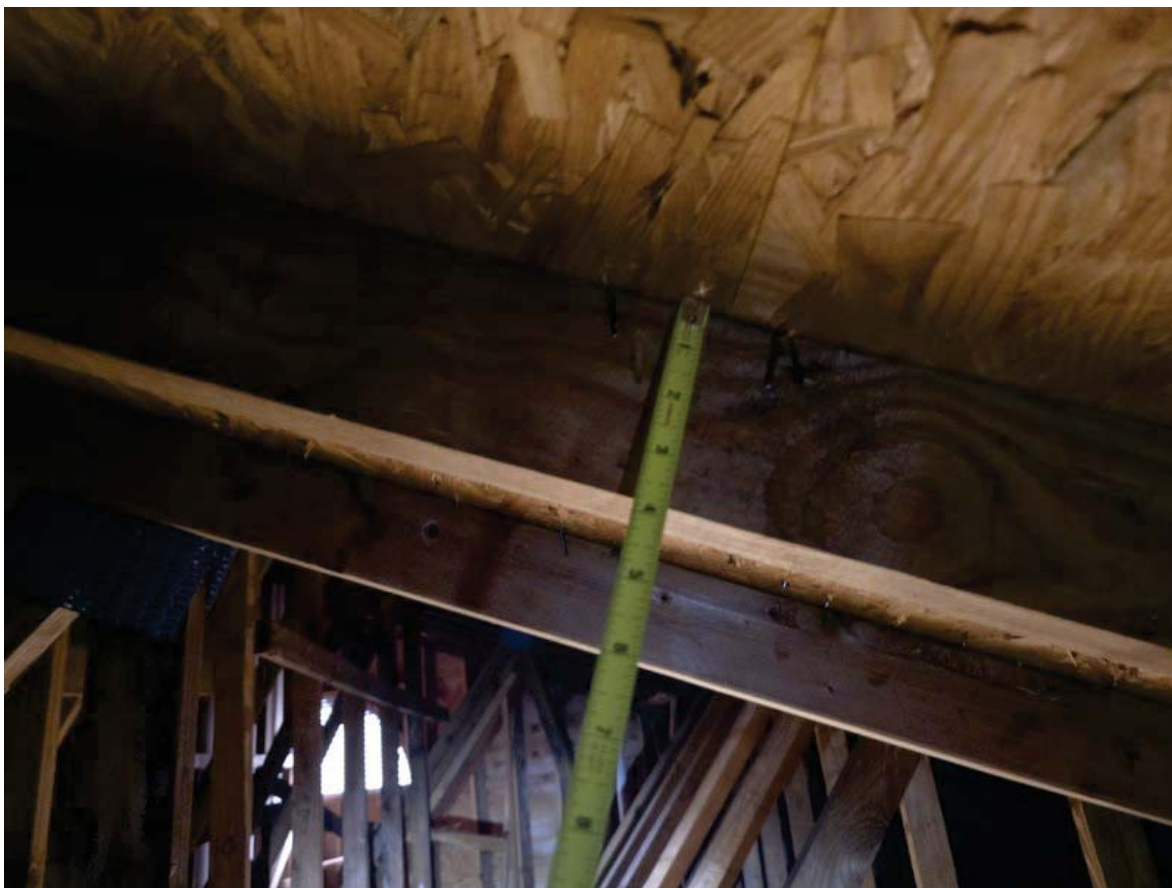
8D NAILS

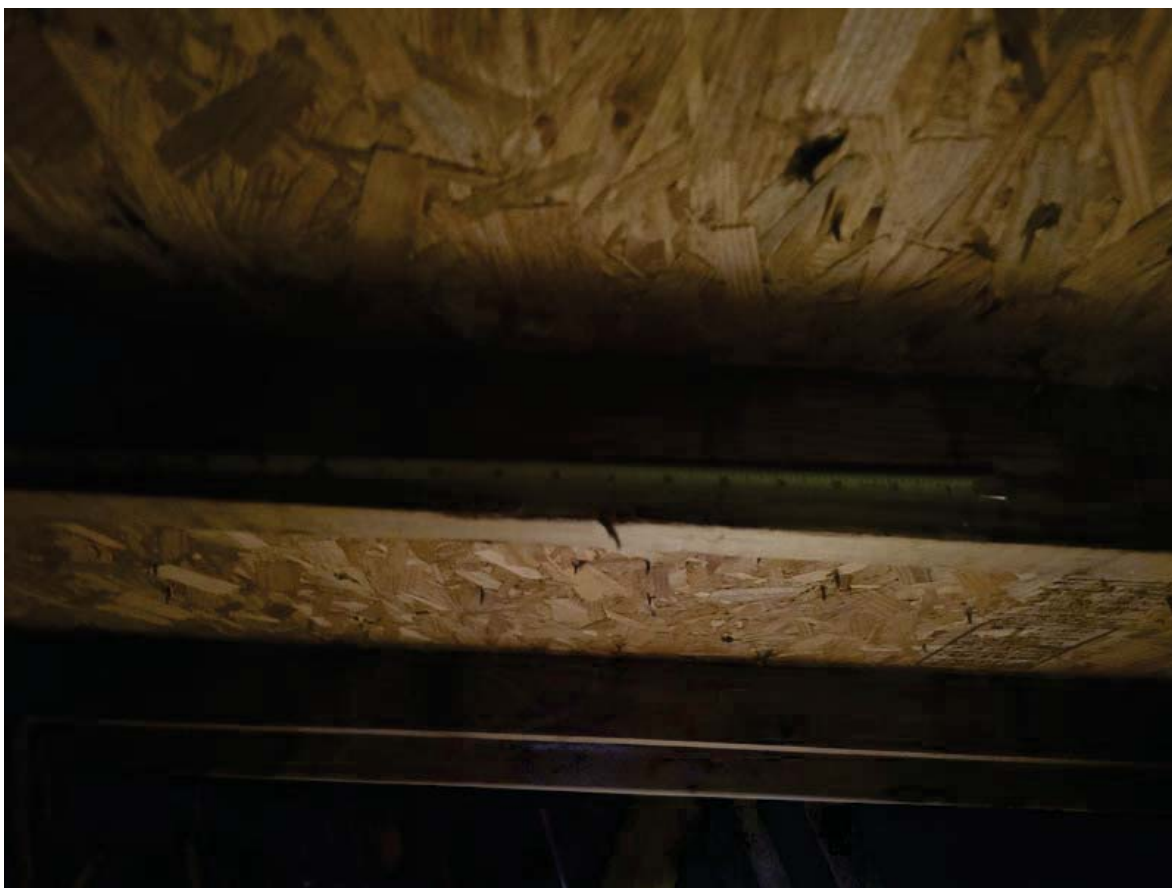
- ☒ C. Plywood/OSB roof sheathing with a minimum thickness of 7/16" inch attached to the roof truss/rafter (spaced a maximum of 24" inches o.c.) by 8d common nails spaced a maximum of 6" inches in the field. -OR- Dimensional lumber/Tongue & Groove decking with a minimum of 2 nails per board (or 1 nail per board if each board is equal to or less than 6 inches in width). -OR- Any system of screws, nails, adhesives, other deck fastening system or truss/rafter spacing that is shown to have an equivalent

ROOF DECK NAILED EVERY 6" IN FIELD OR BETTER OK

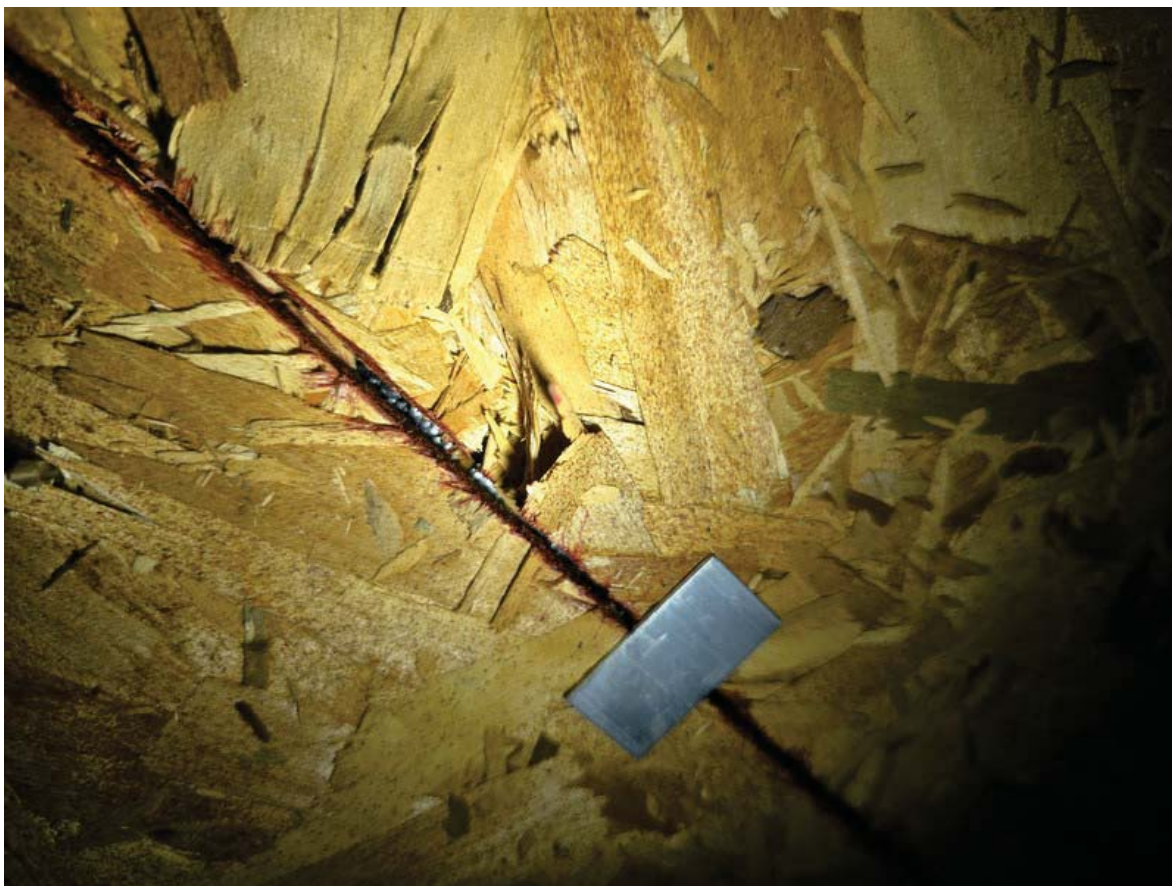
- ☒ A. SWR (also called Sealed Roof Deck) Self-adhering polymer modified-bitumen roofing underlayment applied directly to the sheathing or foam adhesive SWR barrier (not foamed-on insulation) applied as a supplemental means to protect the dwelling from water intrusion in the event of roof covering loss.
- ☐ B. No SWR.
- ☐ C. Unknown or undetermined.

SWR

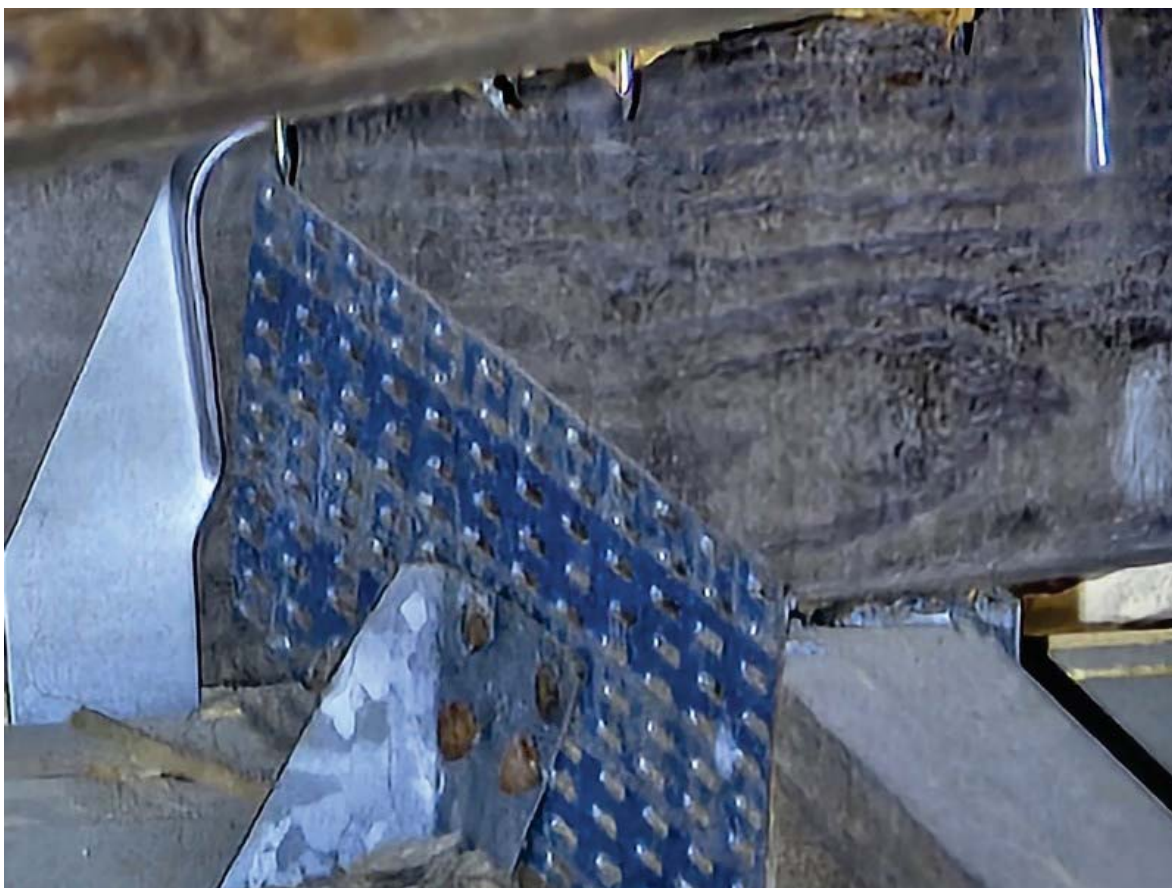
☒ B. Clips

- ☒ Metal connectors that do not wrap over the top of the truss/rafter, **or**
- ☐ Metal connectors with a minimum of 1 strap that wraps over the top of the truss/rafter and does not meet the nail position requirements of C or D, but is secured with a minimum of 3 nails.

ROOF TO WALL - HURRICANE CLIPS - OK
