# Uniform Mitigation Verification Inspection Form

| Inspection Date: 08/09/2024 | | |
| Owner Name: Vintage Grand Condominium Association, Inc. | | Contact Person: |
| Address: 4045 Crockers Lake Blvd | | Home Phone: |

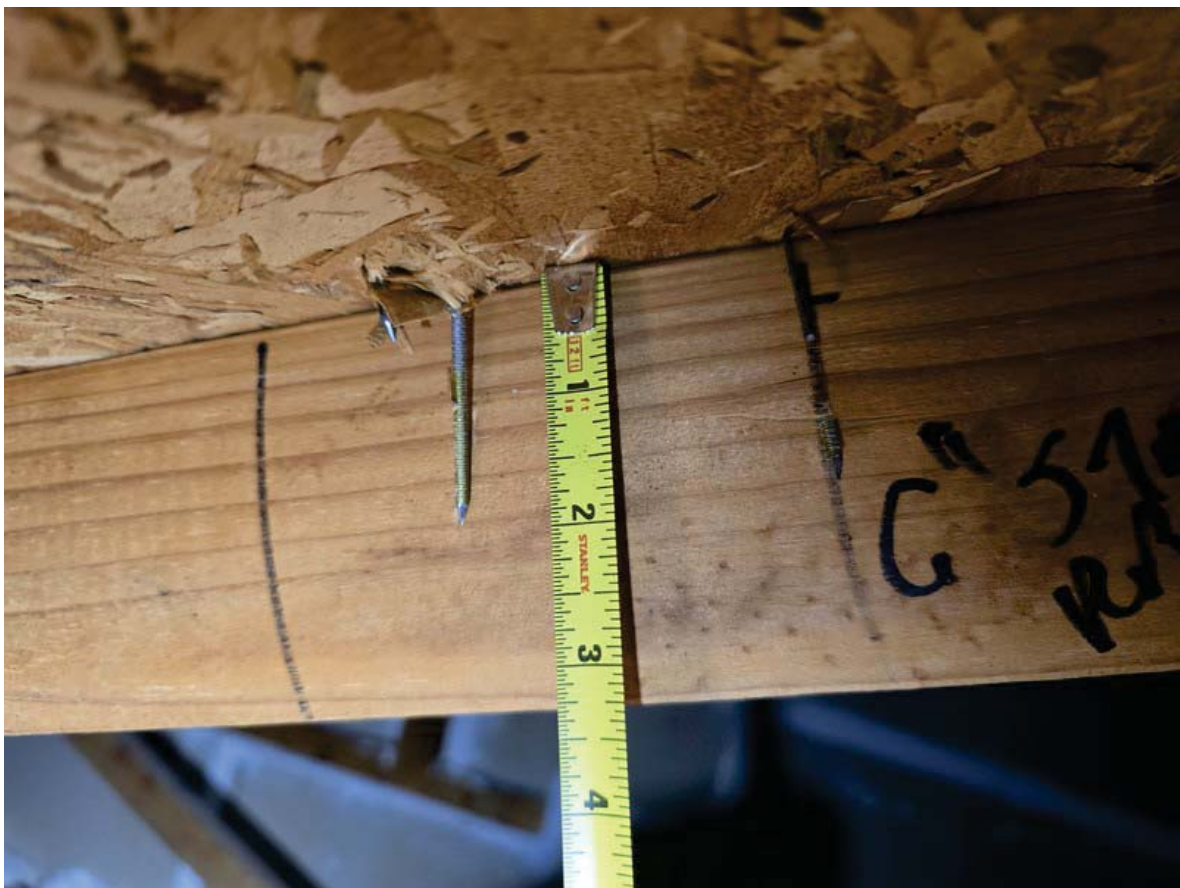
- ☒ C. Plywood/OSB roof sheathing with a minimum thickness of 7/16" inch attached to the roof truss/rafter (spaced a maximum of 24" inches o.c.) by 8d common nails spaced a maximum of 6" inches in the field. -OR- Dimensional lumber/Tongue & Groove decking with a minimum of 2 nails per board (or 1 nail per board if each board is equal to or less than 6 inches in width). -OR- Any system of screws, nails, adhesives, other deck fastening system or truss/rafter spacing that is shown to have an equivalent

8D NAILS

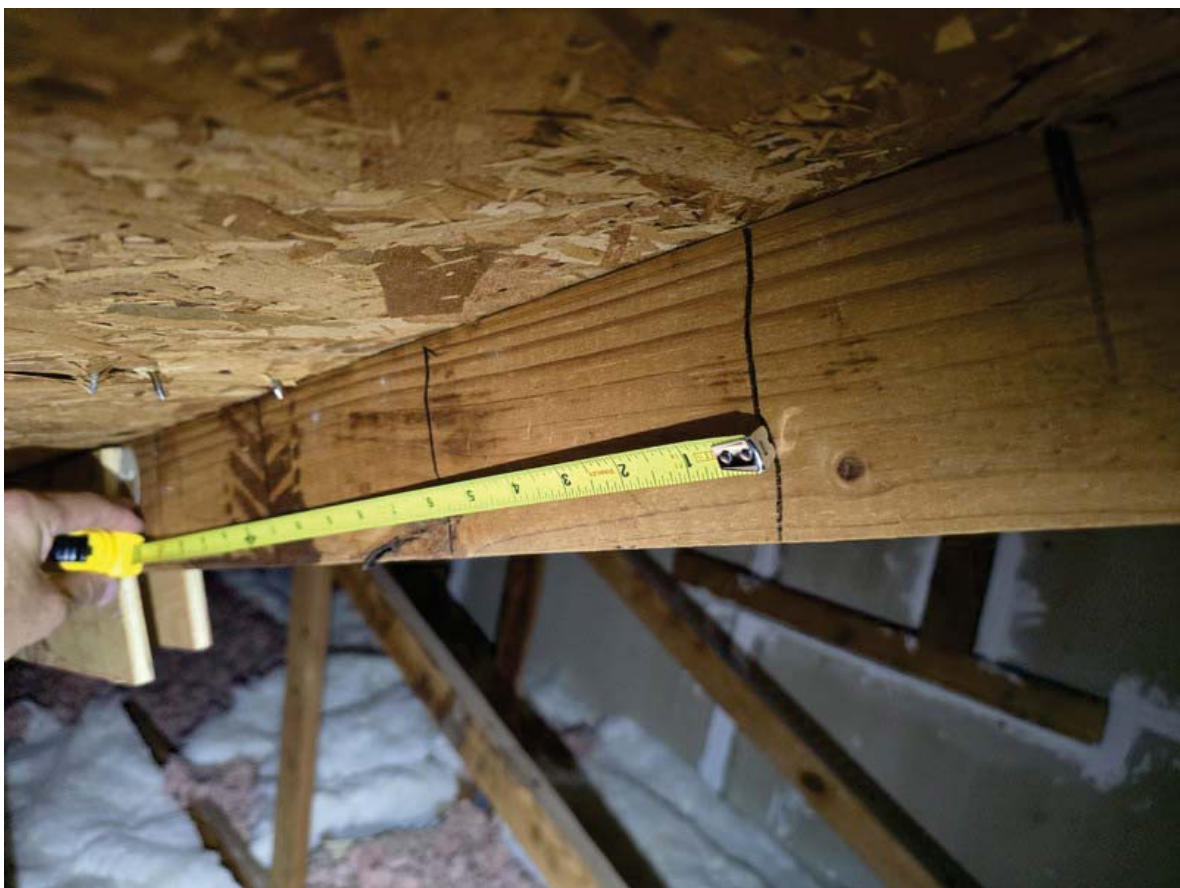
ROOF DECK NAILED EVERY 6" IN FIELD OR BETTER OK

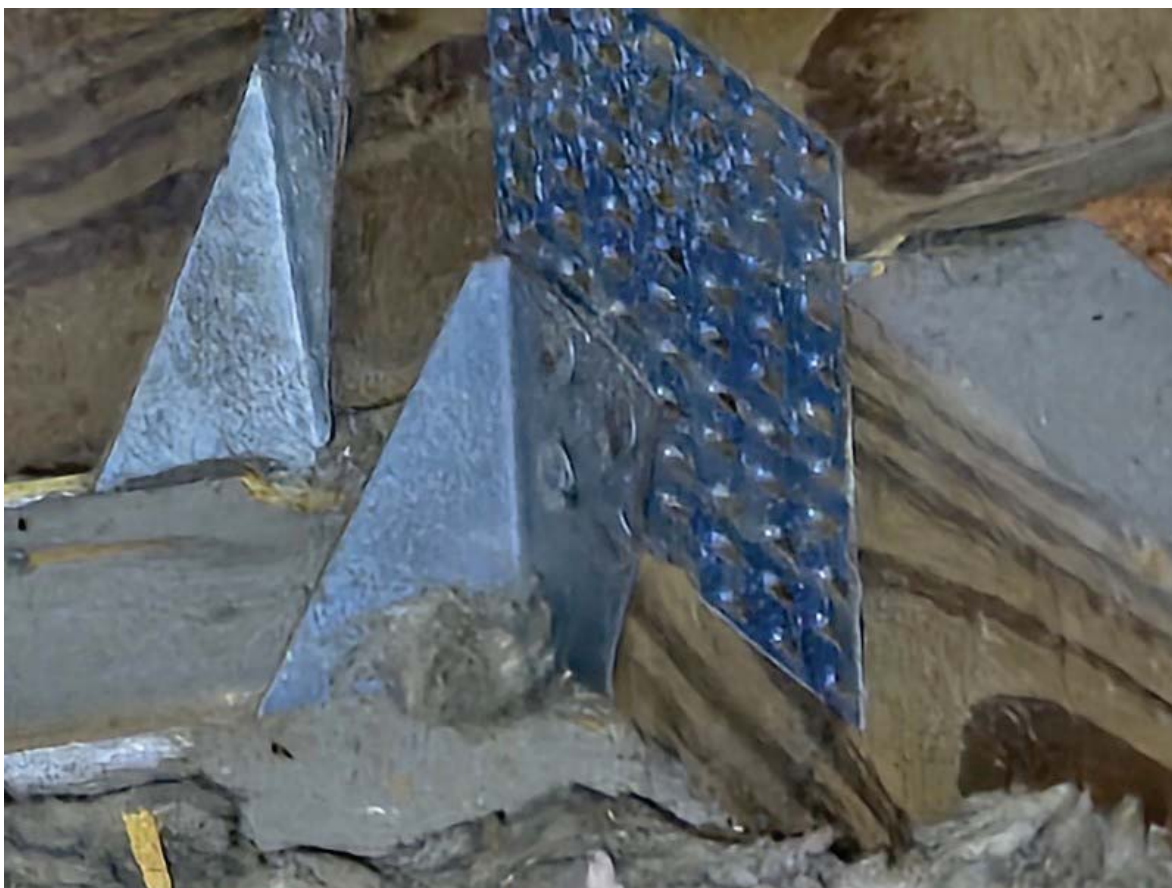
☒ B. Clips

- ☒ Metal connectors that do not wrap over the top of the truss/rafter, **or**
- ☐ Metal connectors with a minimum of 1 strap that wraps over the top of the truss/rafter and does not meet the nail position requirements of C or D, but is secured with a minimum of 3 nails.

ROOF TO WALL - HURRICANE CLIPS - OK
