# Uniform Mitigation Verification Inspection Form

| Inspection Date: 07/05/2024 | | |
| Owner Name: Vintage Grand Condominium Association, Inc. | | Contact Person: |
| Address: 4049 Crockers Lake Blvd | | Home Phone: |

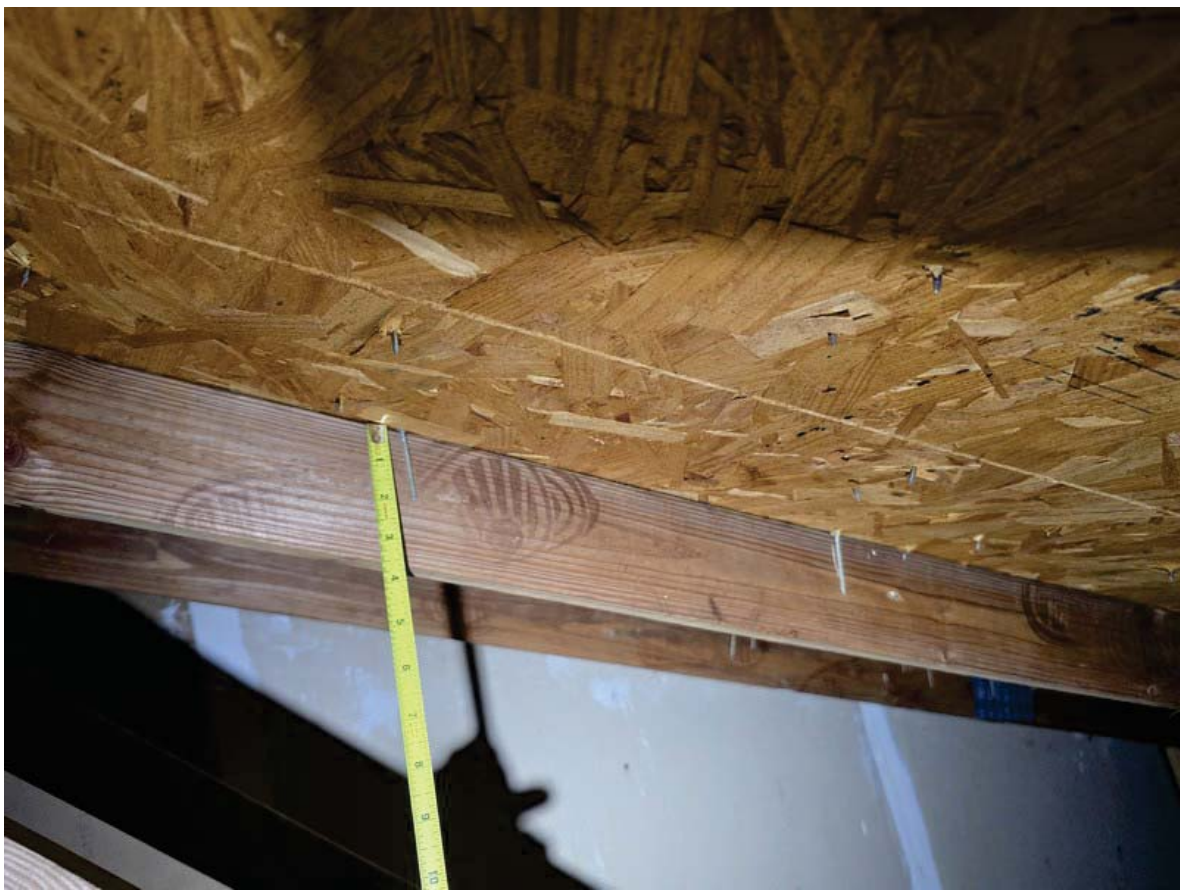
- ☒ C. Plywood/OSB roof sheathing with a minimum thickness of 7/16" inch attached to the roof truss/rafter (spaced a maximum of 24" inches o.c.) by 8d common nails spaced a maximum of 6" inches in the field. -OR- Dimensional lumber/Tongue & Groove decking with a minimum of 2 nails per board (or 1 nail per board if each board is equal to or less than 6 inches in width). -OR- Any system of screws, nails, adhesives, other deck fastening system or truss/rafter spacing that is shown to have an equivalent

8D NAILS

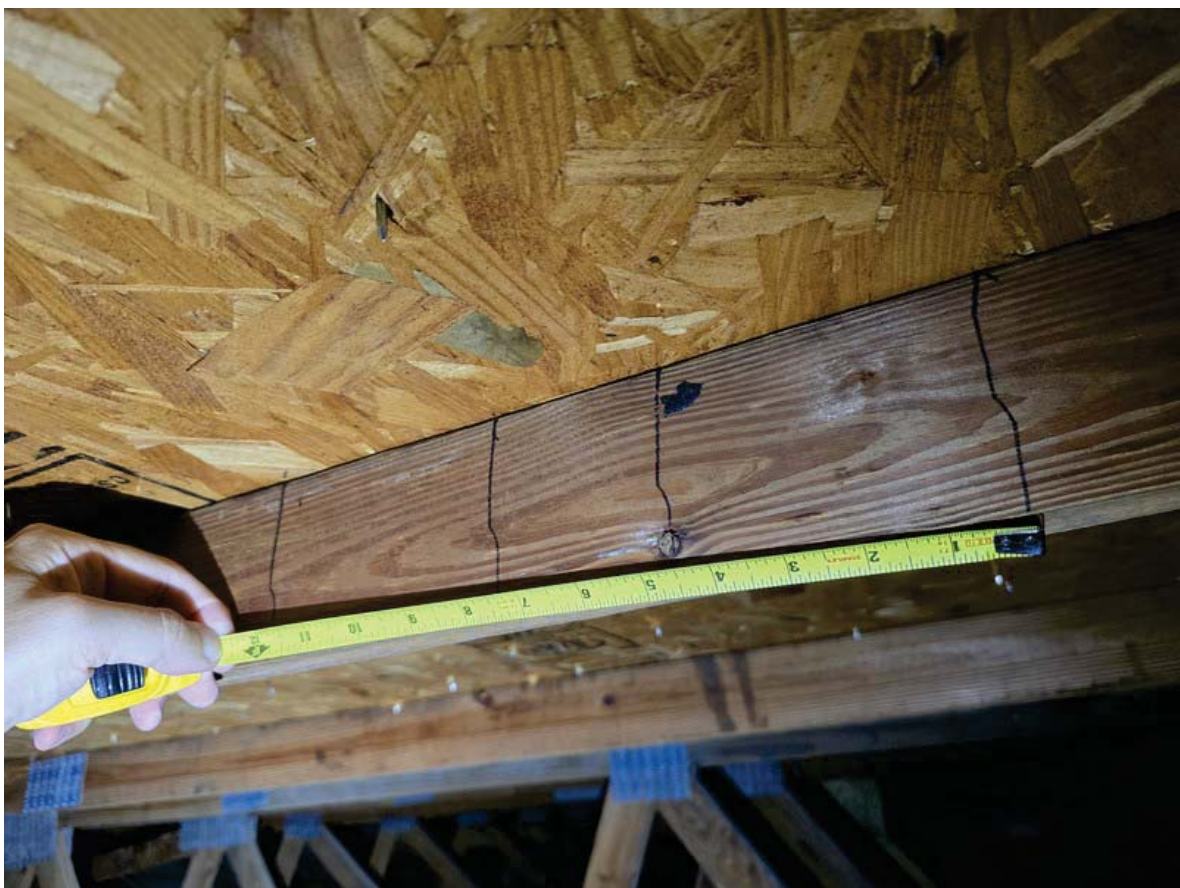
ROOF DECK NAILED EVERY 6" IN FIELD OR BETTER OK

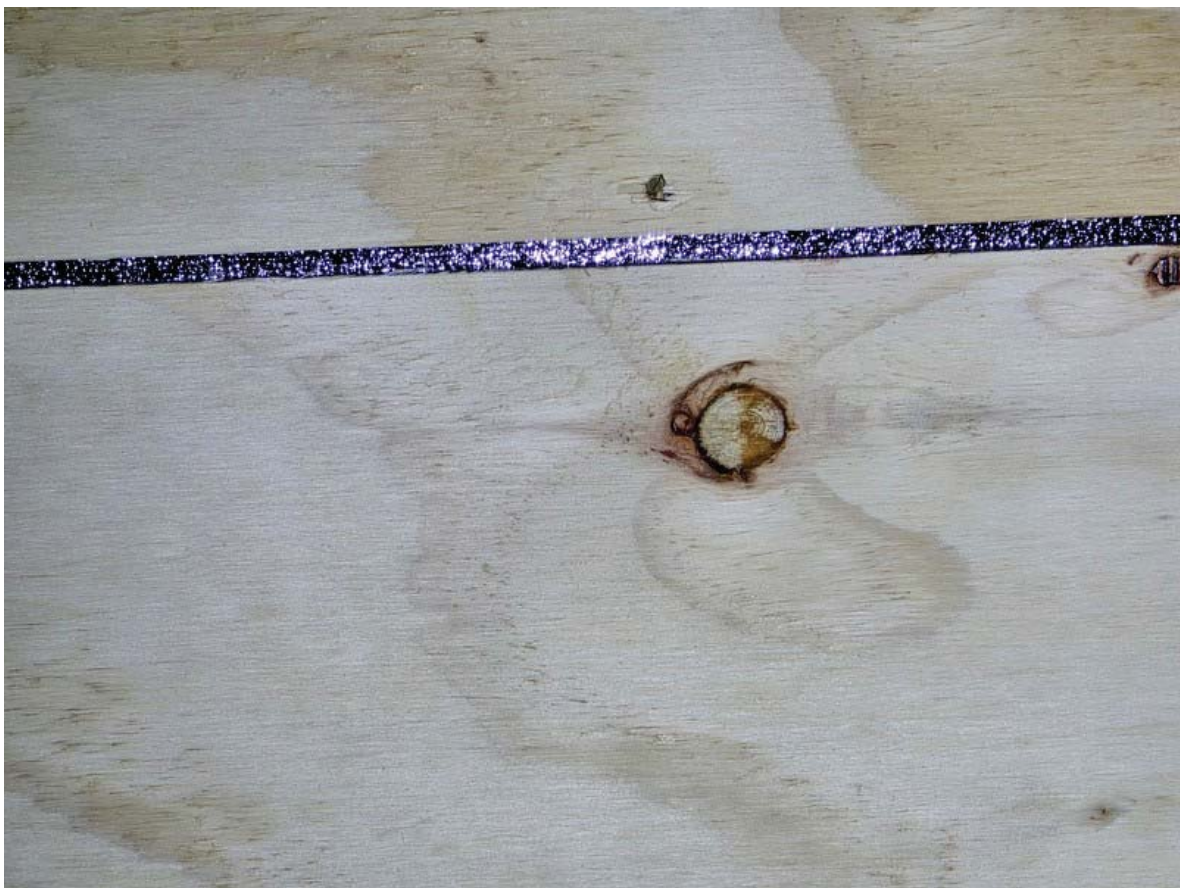
- ☒ A. SWR (also called Sealed Roof Deck) Self-adhering polymer modified-bitumen roofing underlayment applied directly to the sheathing or foam adhesive SWR barrier (not foamed-on insulation) applied as a supplemental means to protect the dwelling from water intrusion in the event of roof covering loss.
- ☐ B. No SWR.
- ☐ C. Unknown or undetermined.

SWR

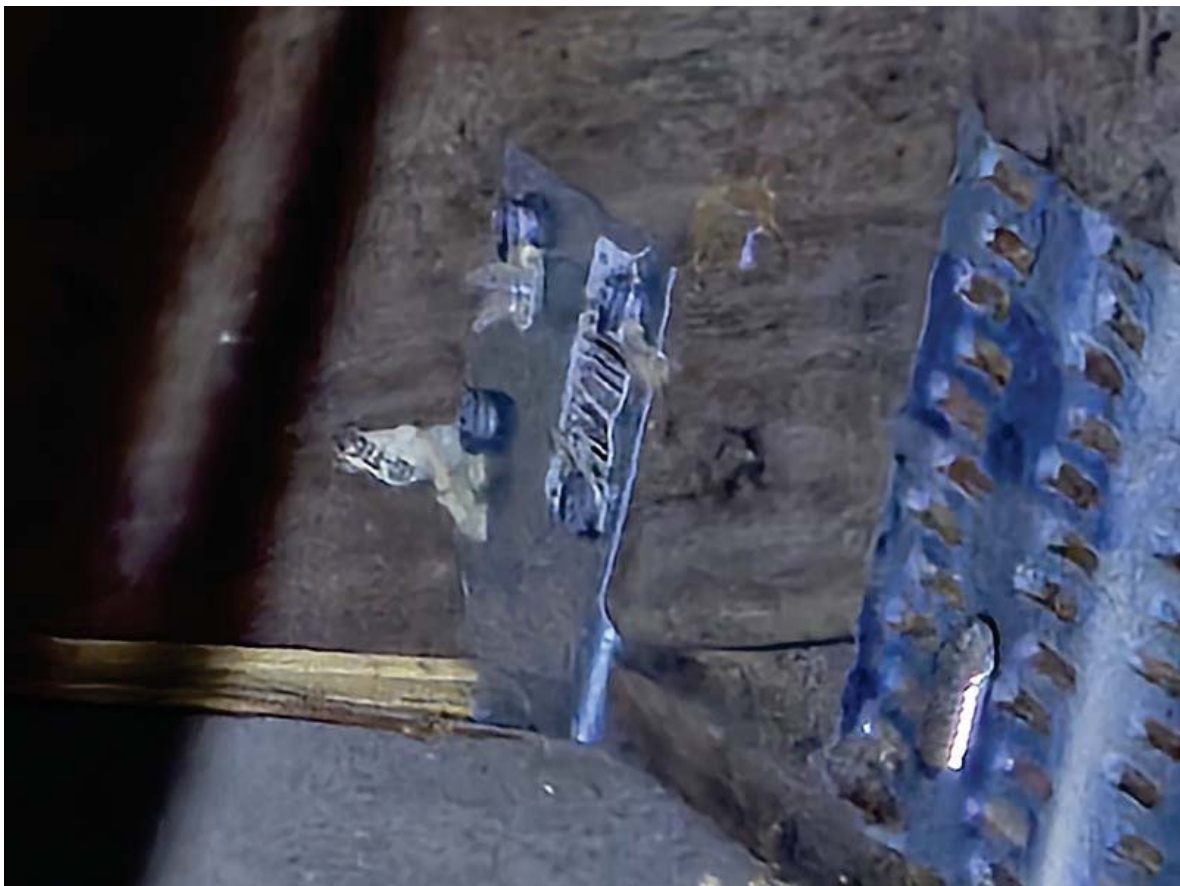
☒ B. Clips

- ☒ Metal connectors that do not wrap over the top of the truss/rafter, **or**
- ☐ Metal connectors with a minimum of 1 strap that wraps over the top of the truss/rafter and does not meet the nail position requirements of C or D, but is secured with a minimum of 3 nails.

ROOF TO WALL - HURRICANE CLIPS - OK
