# Uniform Mitigation Verification Inspection Form

| Inspection Date: 07/05/2024 | | |
| Owner Name: Vintage Grand Condominium Association, Inc. | | Contact Person: |
| Address: 4053 Crockers Lake Blvd | | Home Phone: |

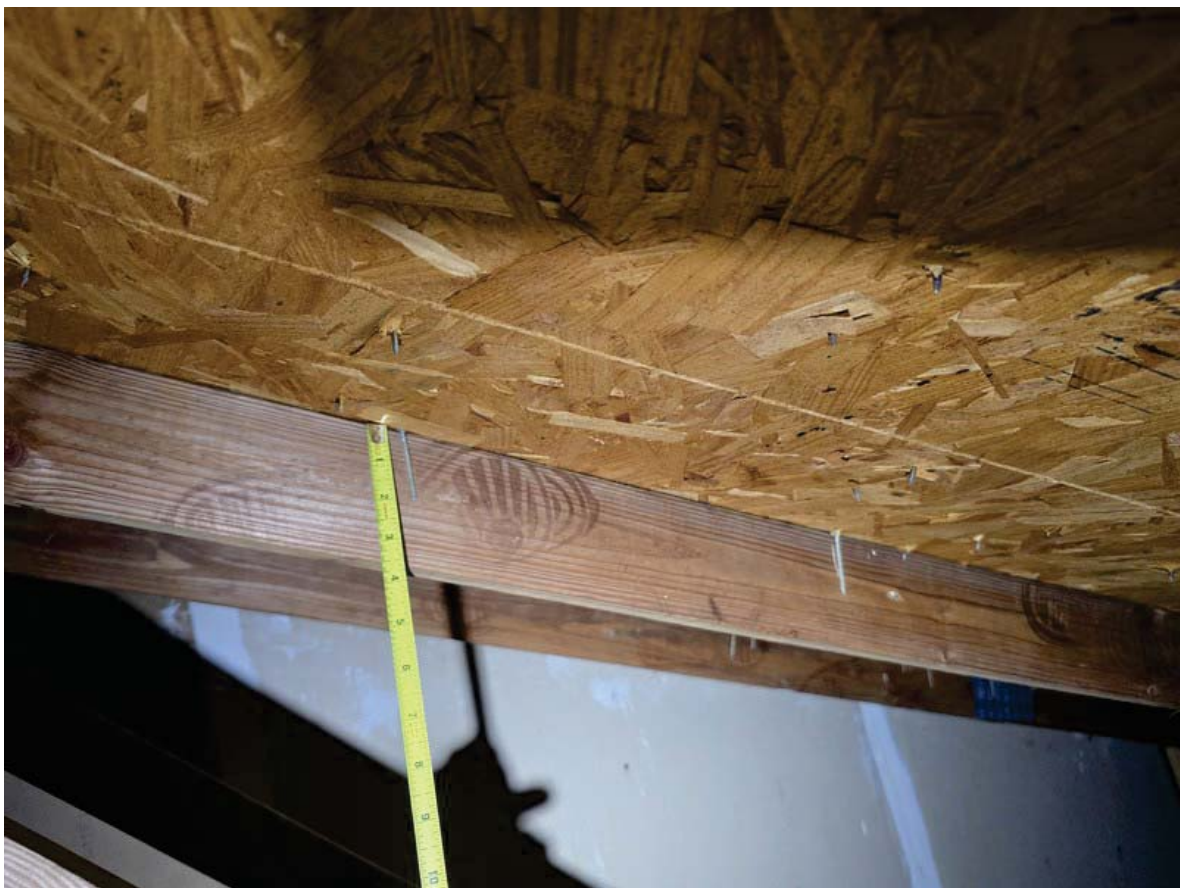
- ☒ C. Plywood/OSB roof sheathing with a minimum thickness of 7/16" inch attached to the roof truss/rafter (spaced a maximum of 24" inches o.c.) by 8d common nails spaced a maximum of 6" inches in the field. -OR- Dimensional lumber/Tongue & Groove decking with a minimum of 2 nails per board (or 1 nail per board if each board is equal to or less than 6 inches in width). -OR- Any system of screws, nails, adhesives, other deck fastening system or truss/rafter spacing that is shown to have an equivalent

8D NAILS

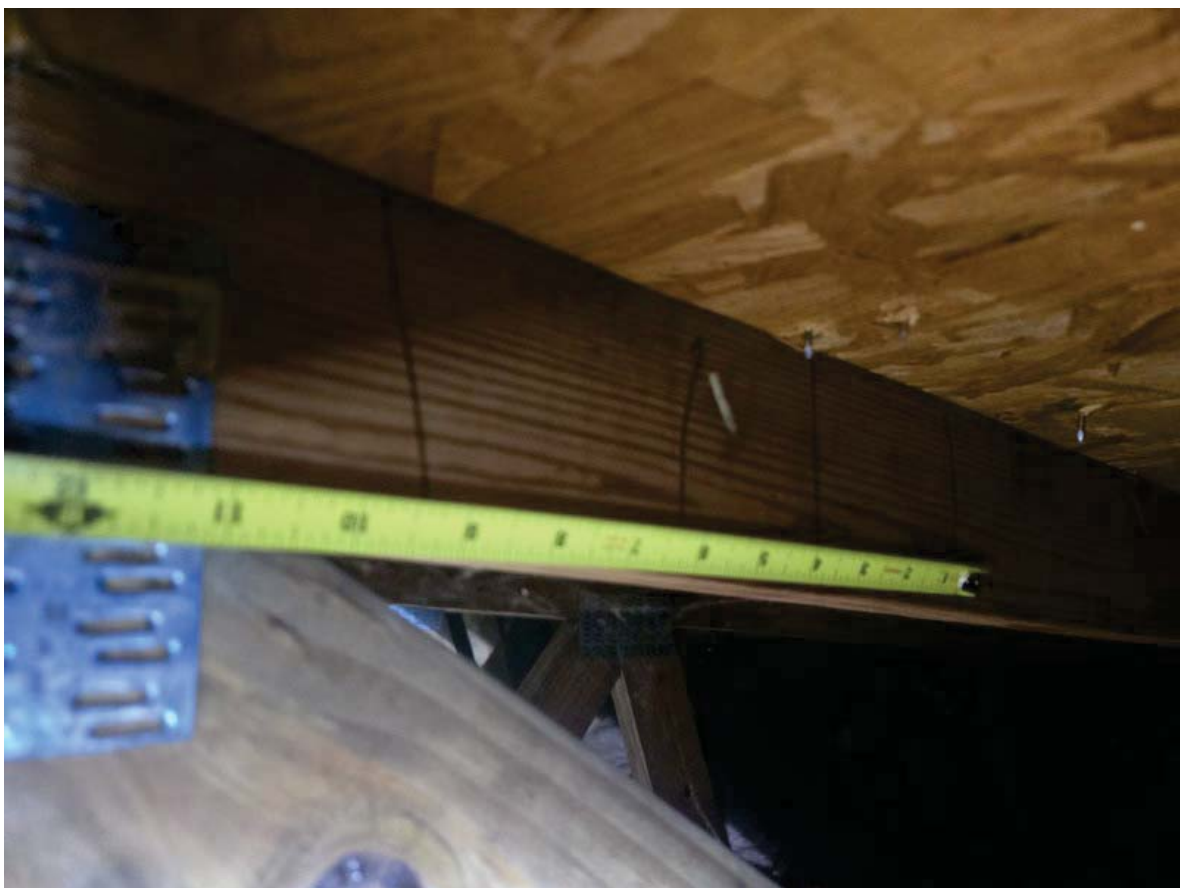
ROOF DECK NAILED EVERY 6" IN FIELD OR BETTER OK

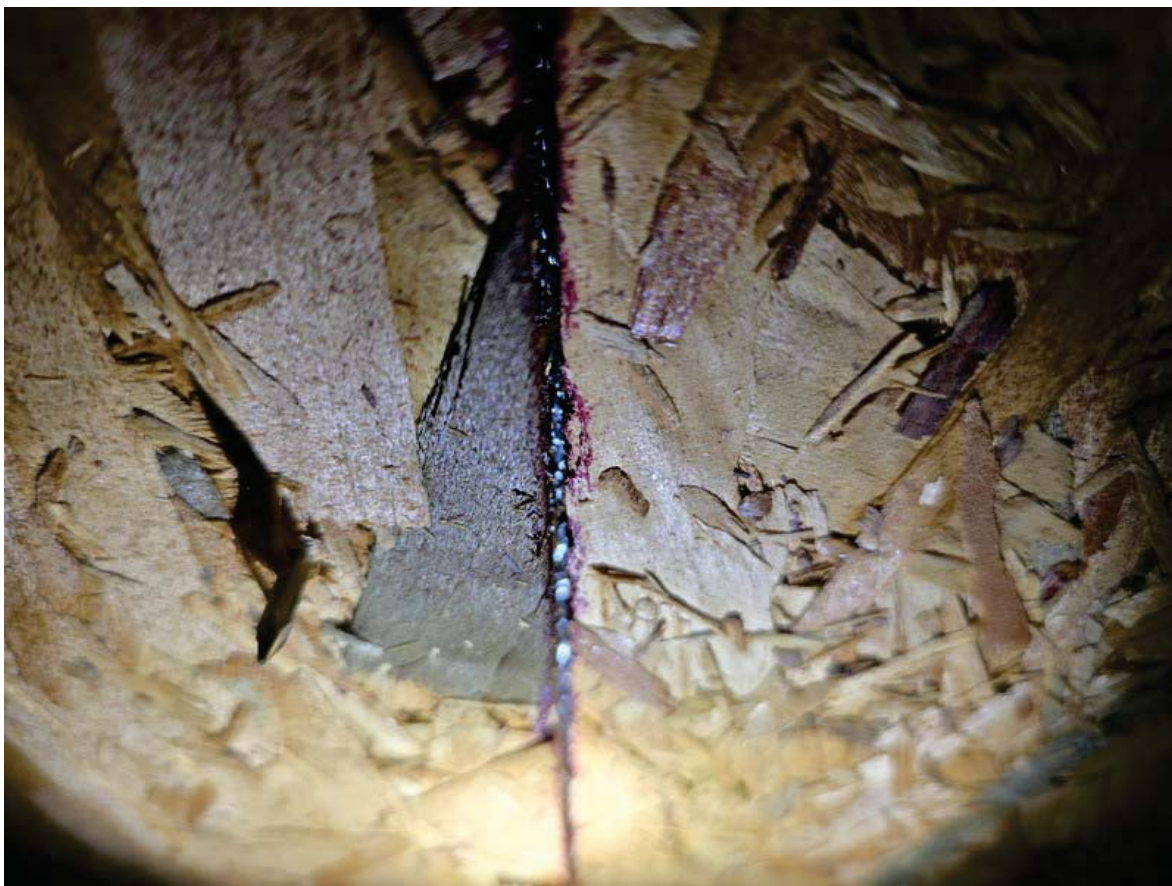
- ☒ A. SWR (also called Sealed Roof Deck) Self-adhering polymer modified-bitumen roofing underlayment applied directly to the sheathing or foam adhesive SWR barrier (not foamed-on insulation) applied as a supplemental means to protect the dwelling from water intrusion in the event of roof covering loss.
- ☐ B. No SWR.
- ☐ C. Unknown or undetermined.

SWR

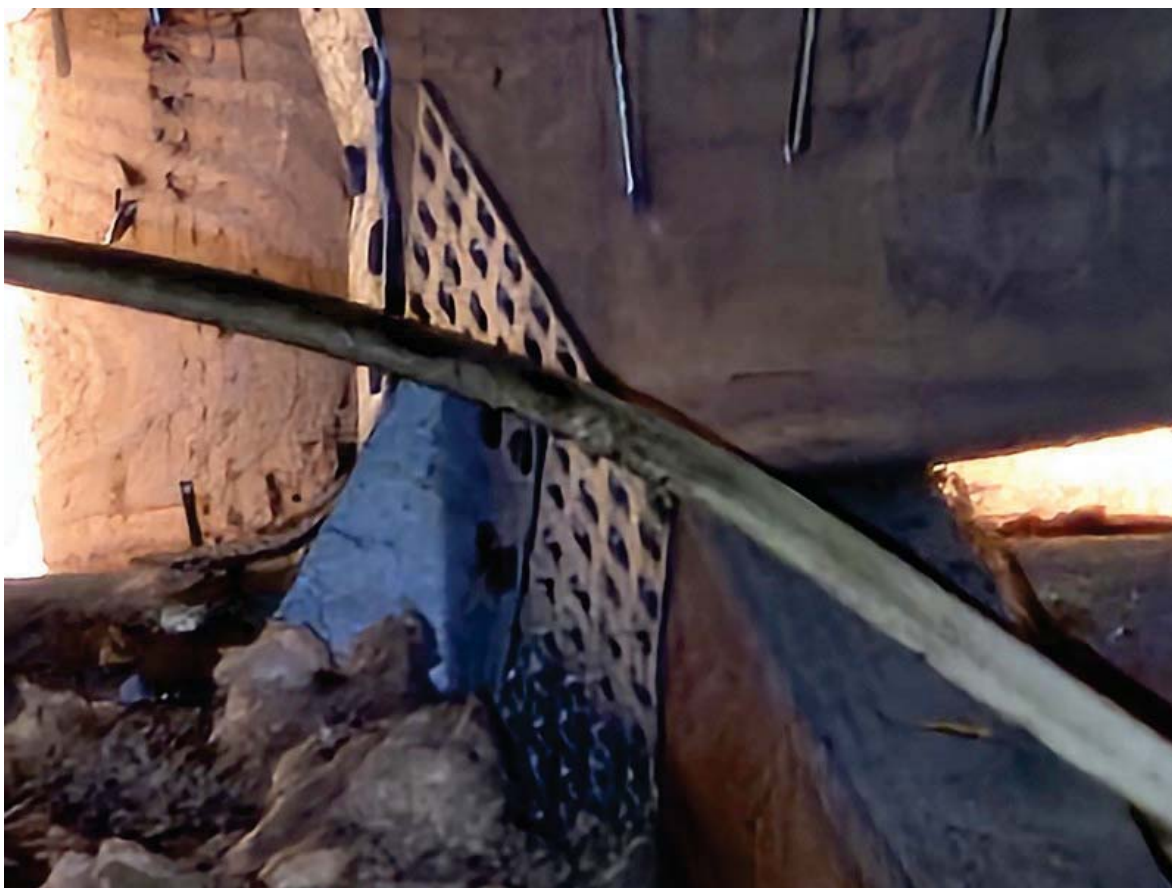
☒ B. Clips

- ☒ Metal connectors that do not wrap over the top of the truss/rafter, **or**
- ☐ Metal connectors with a minimum of 1 strap that wraps over the top of the truss/rafter and does not meet the nail position requirements of C or D, but is secured with a minimum of 3 nails.

ROOF TO WALL - HURRICANE CLIPS - OK
