# Uniform Mitigation Verification Inspection Form

| Inspection Date: 07/05/2024 | | |
| Owner Name: Vintage Grand Condominium Association, Inc. | | Contact Person: |
| Address: 4057 Crockers Lake Blvd | | Home Phone: |

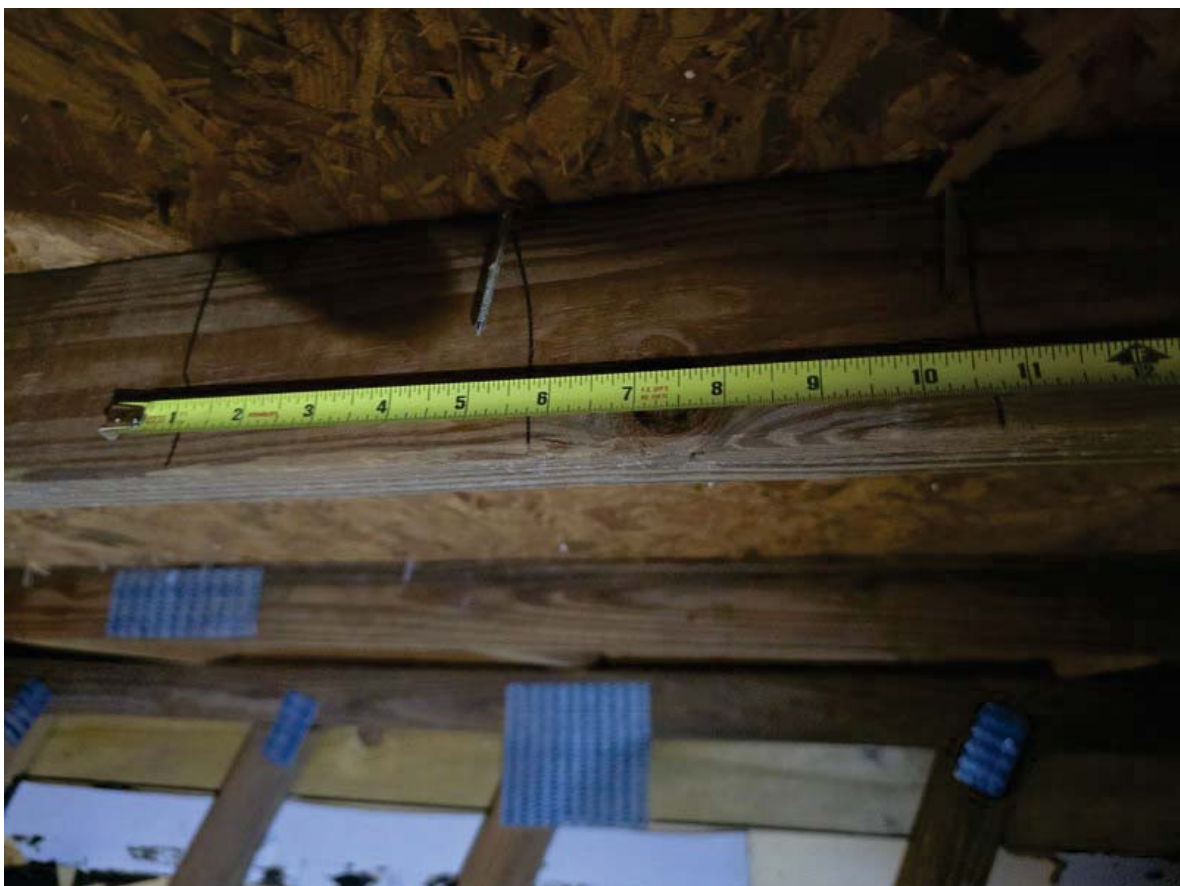
- ☒ C. Plywood/OSB roof sheathing with a minimum thickness of 7/16" inch attached to the roof truss/rafter (spaced a maximum of 24" inches o.c.) by 8d common nails spaced a maximum of 6" inches in the field. -OR- Dimensional lumber/Tongue & Groove decking with a minimum of 2 nails per board (or 1 nail per board if each board is equal to or less than 6 inches in width). -OR- Any system of screws, nails, adhesives, other deck fastening system or truss/rafter spacing that is shown to have an equivalent

ROOF DECK NAILED EVERY 6" IN FIELD OR BETTER OK

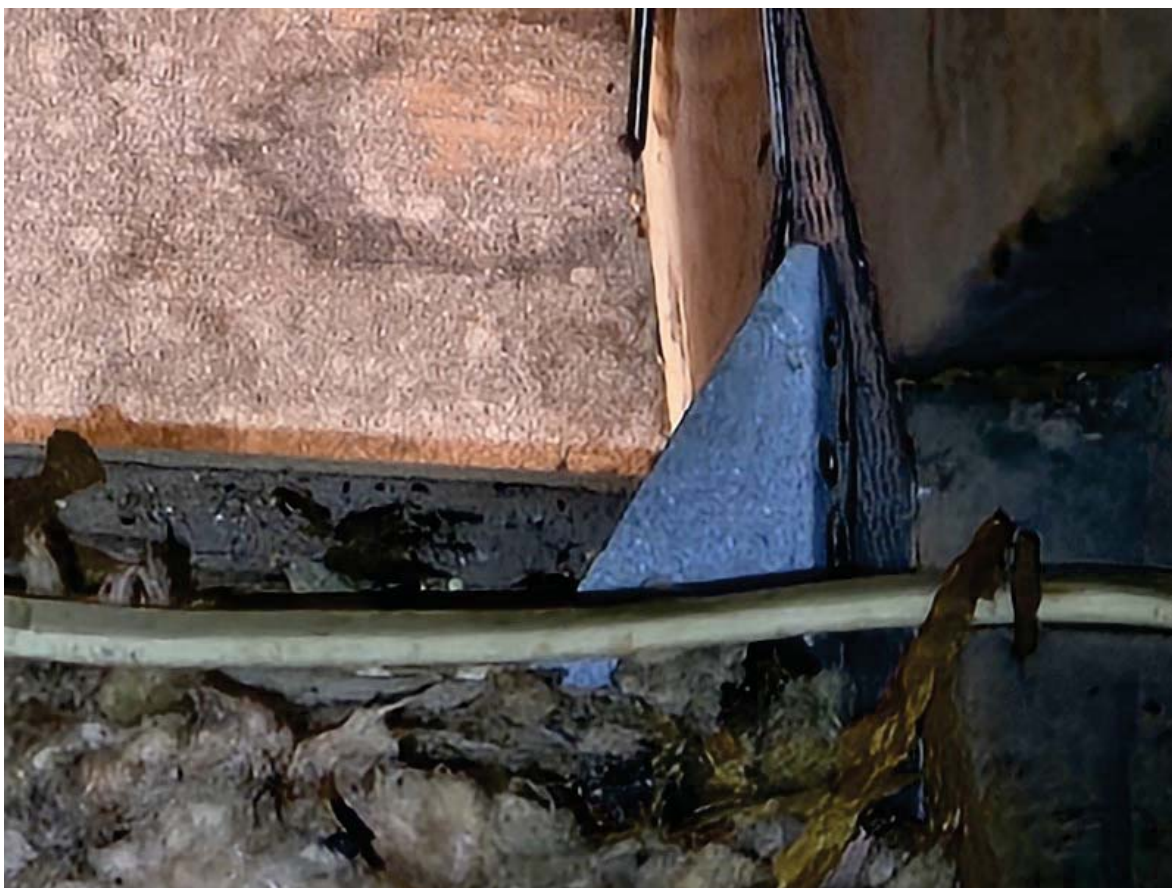
☒ B. Clips

- ☒ Metal connectors that do not wrap over the top of the truss/rafter, **or**
- ☐ Metal connectors with a minimum of 1 strap that wraps over the top of the truss/rafter and does not meet the nail position requirements of C or D, but is secured with a minimum of 3 nails.

ROOF TO WALL - HURRICANE CLIPS - OK
