# Uniform Mitigation Verification Inspection Form

| Inspection Date: 07/05/2024 | | |
| Owner Name: Vintage Grand Condominium Association, Inc. | | Contact Person: |
| Address: 4065 Crockers Lake Blvd | | Home Phone: |

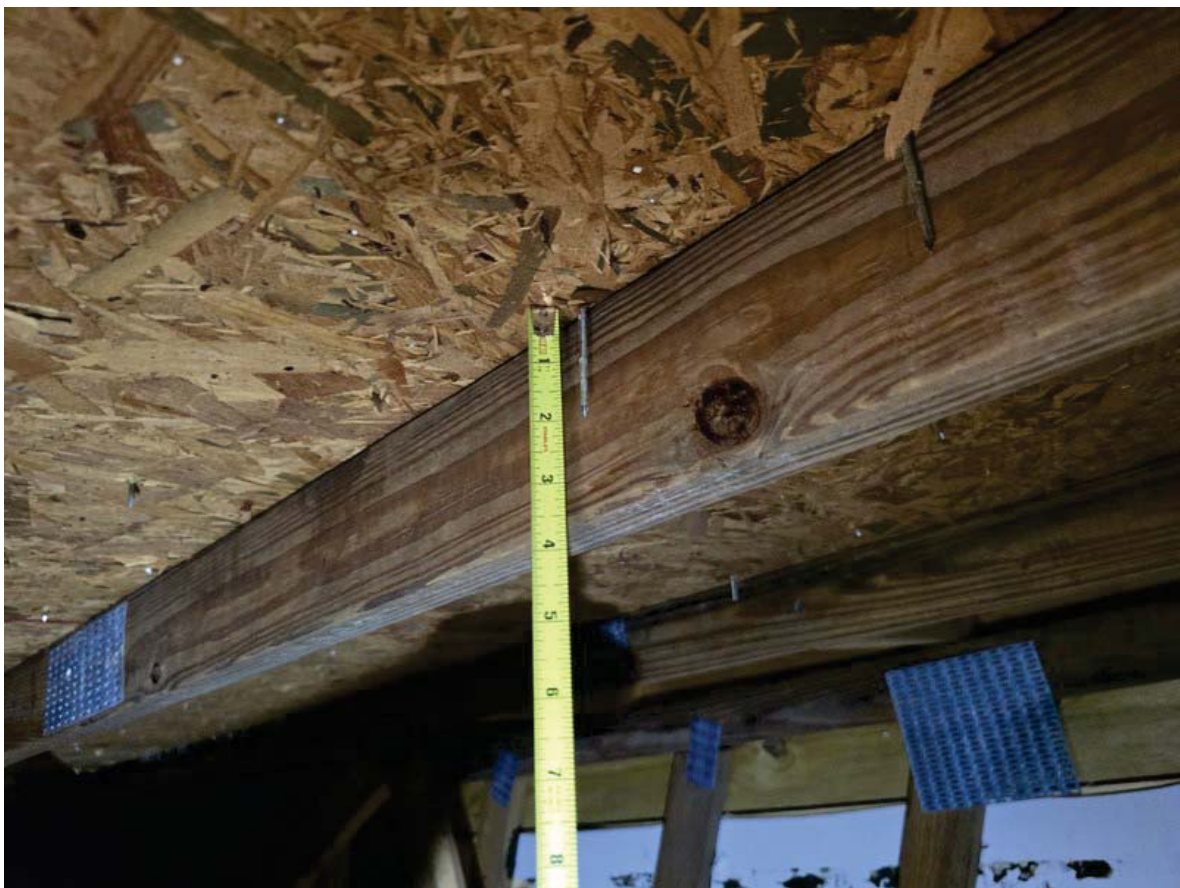
8D NAILS

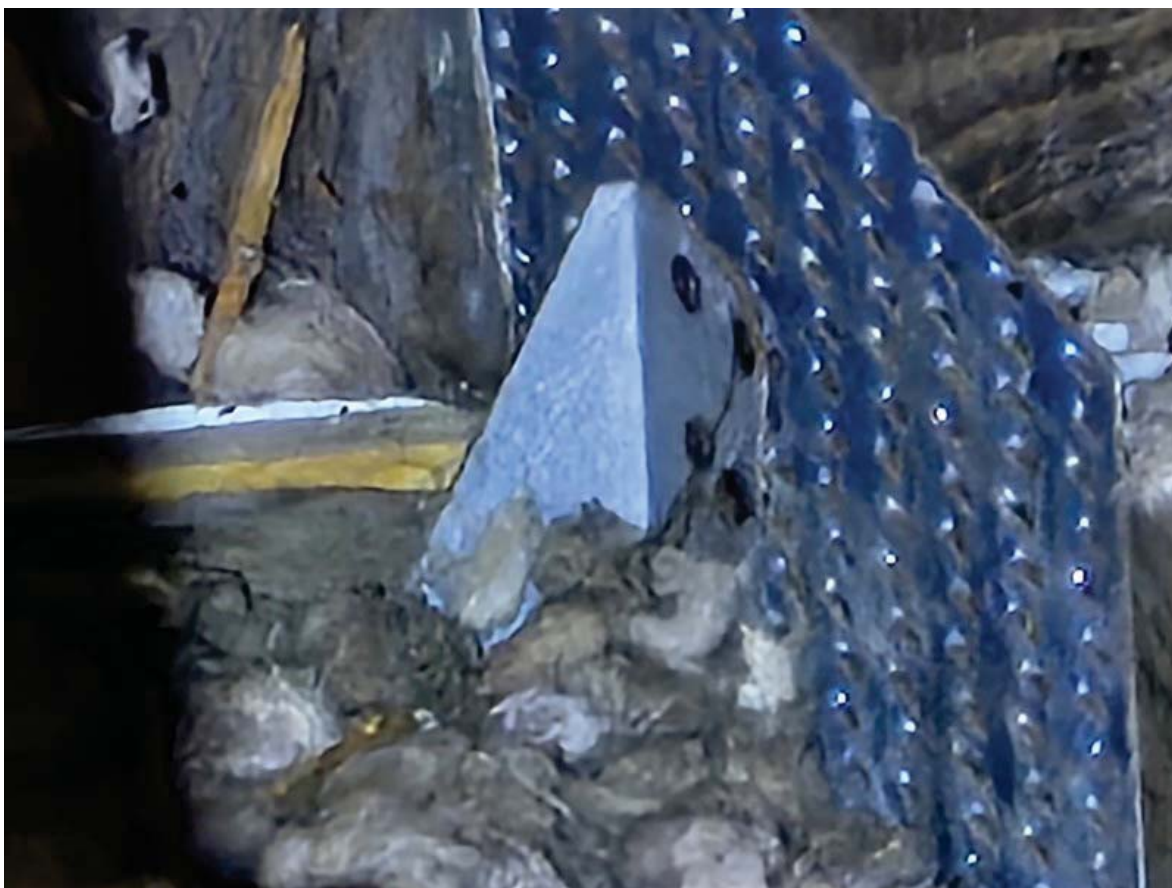
☒ B. Clips

- ☒ Metal connectors that do not wrap over the top of the truss/rafter, **or**
- ☐ Metal connectors with a minimum of 1 strap that wraps over the top of the truss/rafter and does not meet the nail position requirements of C or D, but is secured with a minimum of 3 nails.

ROOF TO WALL - HURRICANE CLIPS - OK
