# Uniform Mitigation Verification Inspection Form

| Inspection Date: 11/06/2024 | | |
| Owner Name: Vintage Grand Condominium Association, Inc. | | Contact Person: |
| Address: 4008 Crockers Lake Blvd | | Home Phone: |

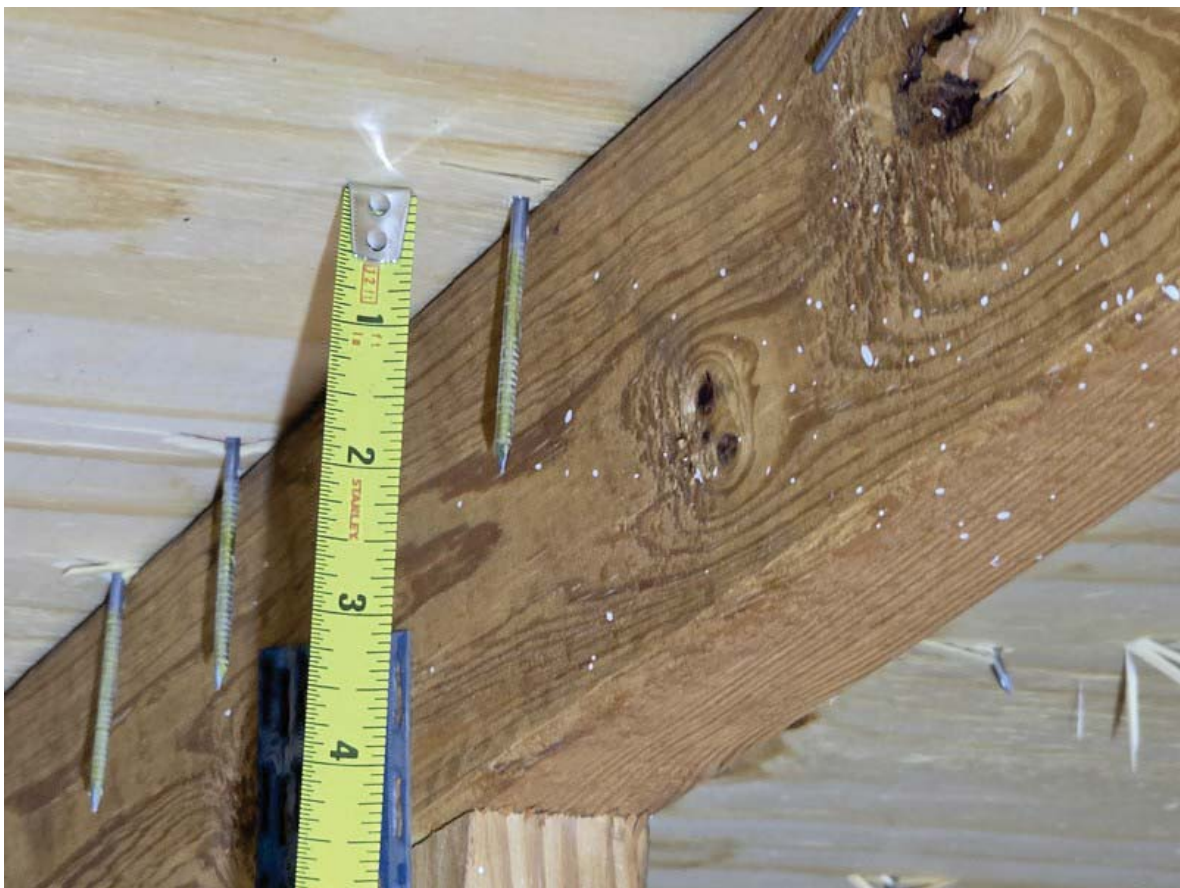
- ☒ C. Plywood/OSB roof sheathing with a minimum thickness of 7/16" inch attached to the roof truss/rafter (spaced a maximum of 24" inches o.c.) by 8d common nails spaced a maximum of 6" inches in the field. -OR- Dimensional lumber/Tongue & Groove decking with a minimum of 2 nails per board (or 1 nail per board if each board is equal to or less than 6 inches in width). -OR- Any system of screws, nails, adhesives, other deck fastening system or truss/rafter spacing that is shown to have an equivalent

8D NAILS

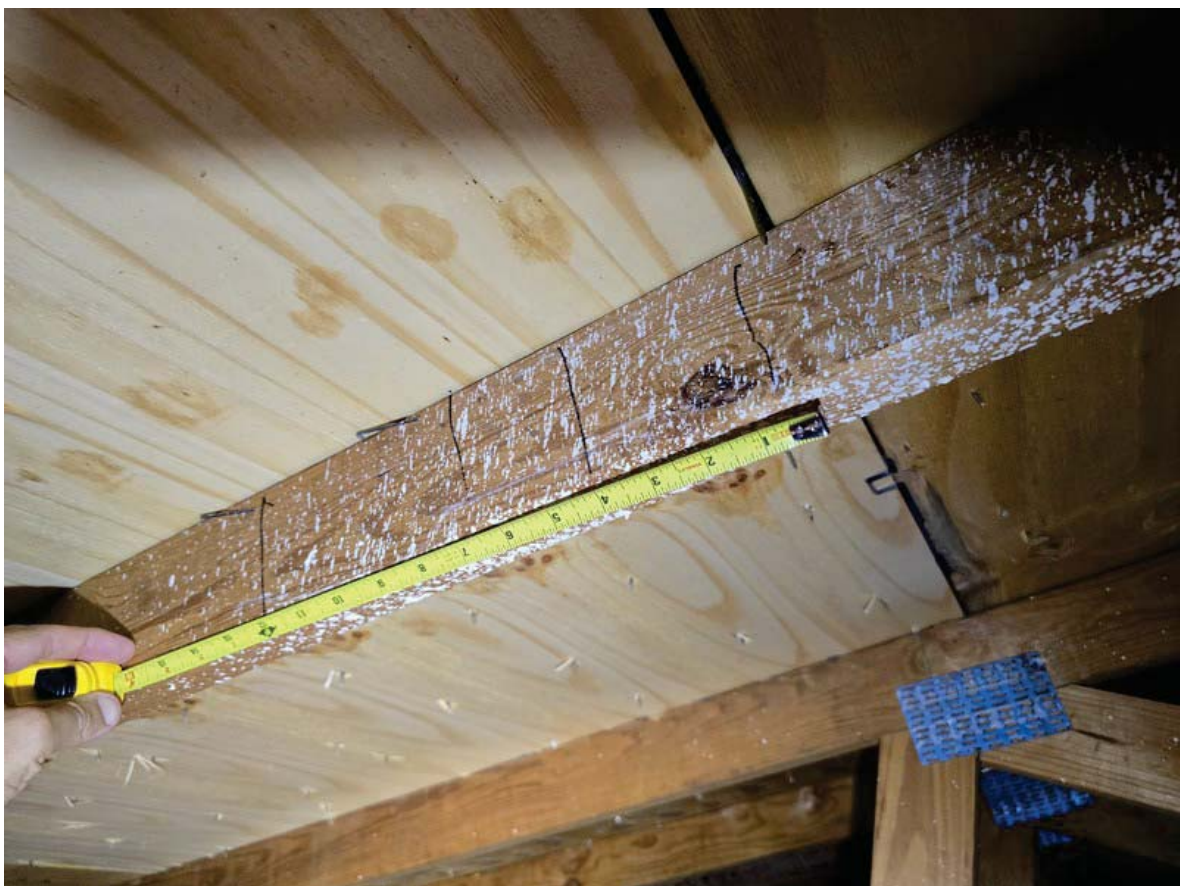
ROOF DECK NAILED EVERY 6" IN FIELD OR BETTER OK

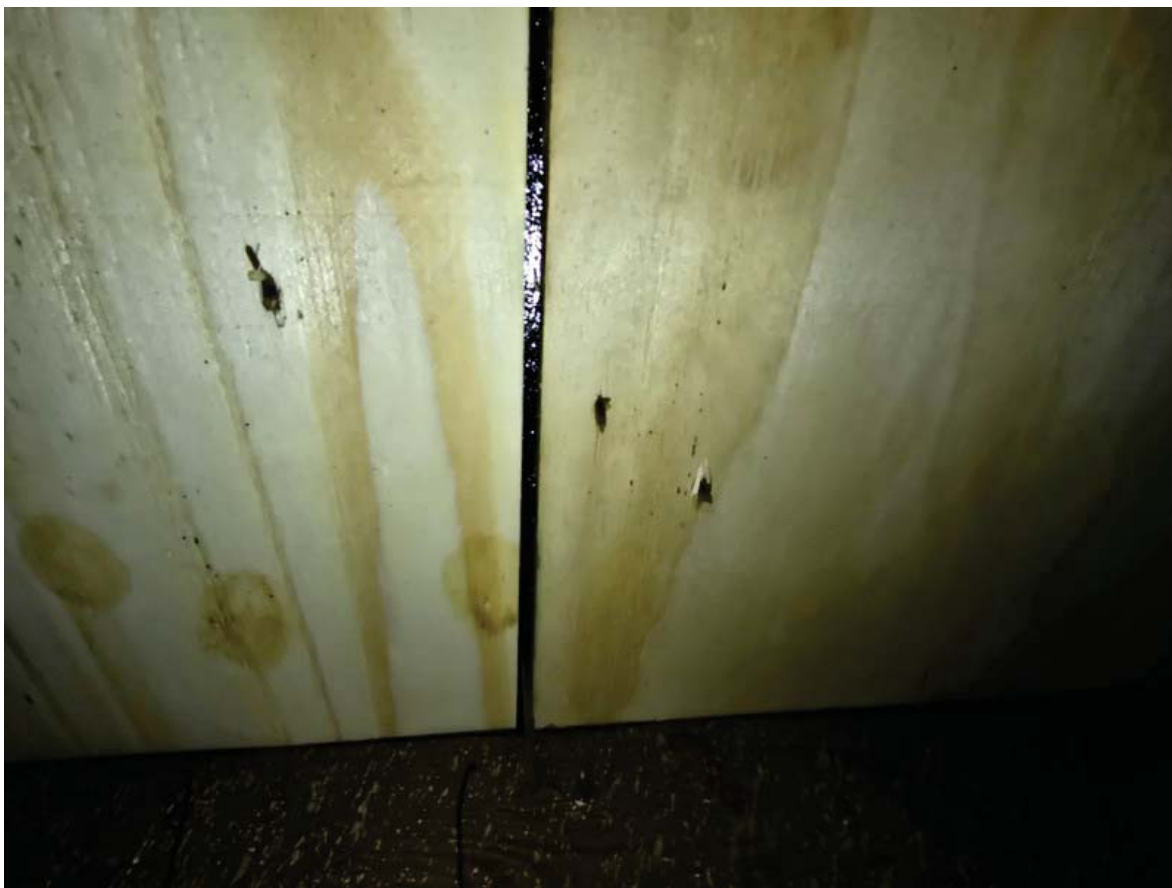
- ☒ A. SWR (also called Sealed Roof Deck) Self-adhering polymer modified-bitumen roofing underlayment applied directly to the sheathing or foam adhesive SWR barrier (not foamed-on insulation) applied as a supplemental means to protect the dwelling from water intrusion in the event of roof covering loss.
- ☐ B. No SWR.
- ☐ C. Unknown or undetermined.

SWR
