# Uniform Mitigation Verification Inspection Form

| Owner Name: Vintage Grand Condominium Association, Inc. | | Contact Person: |
| Address: 4024 Crockers Lake Blvd | | Home Phone: |

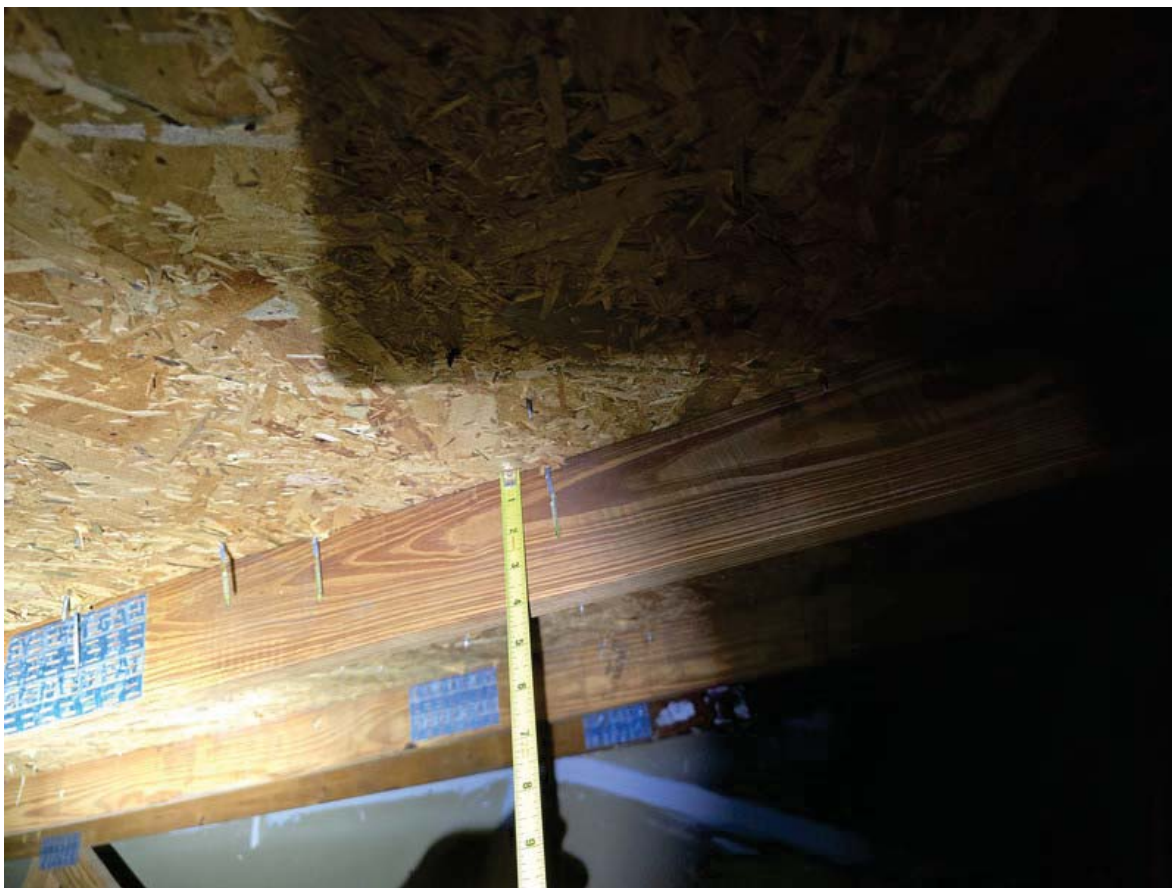
- ☒ C. Plywood/OSB roof sheathing with a minimum thickness of 7/16" inch attached to the roof truss/rafter (spaced a maximum of 24" inches o.c.) by 8d common nails spaced a maximum of 6" inches in the field. -OR- Dimensional lumber/Tongue & Groove decking with a minimum of 2 nails per board (or 1 nail per board if each board is equal to or less than 6 inches in width). -OR- Any system of screws, nails, adhesives, other deck fastening system or truss/rafter spacing that is shown to have an equivalent

8D NAILS

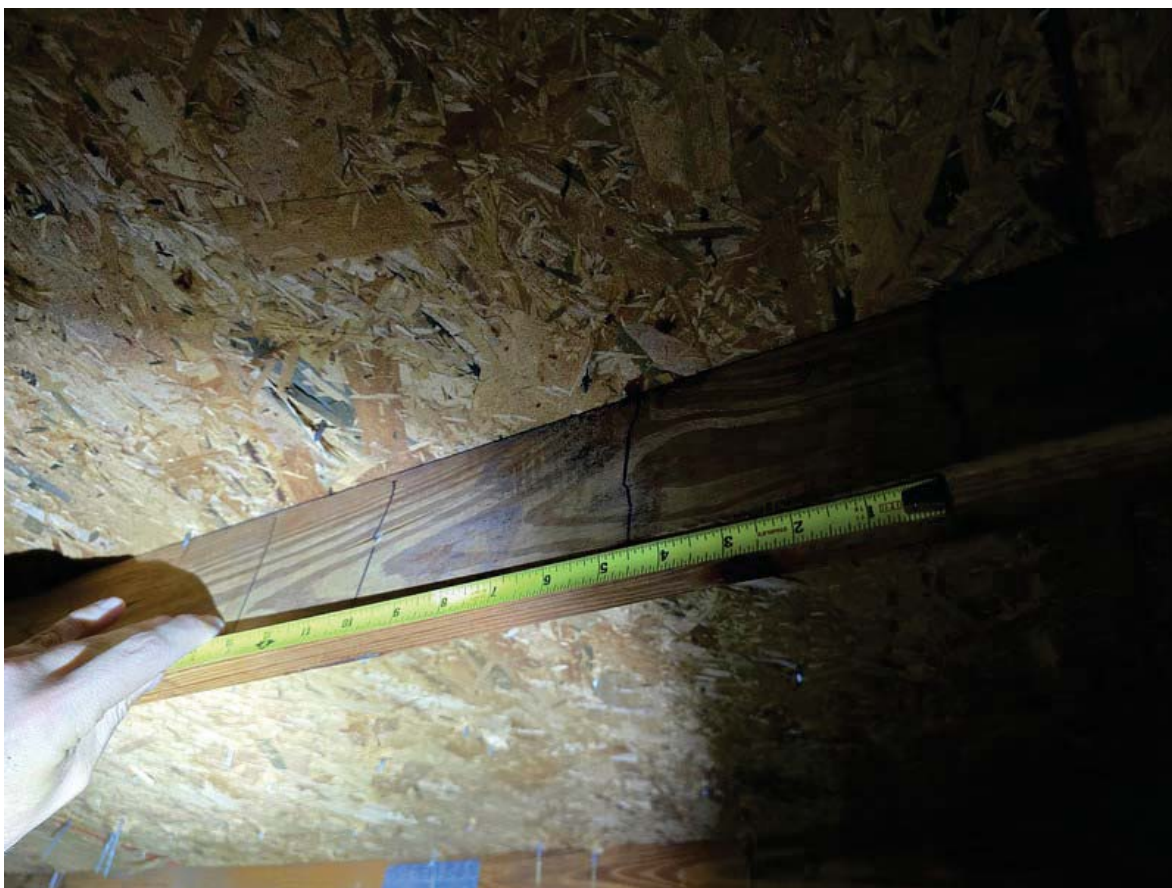
ROOF DECK NAILED EVERY 6" IN FIELD OR BETTER OK

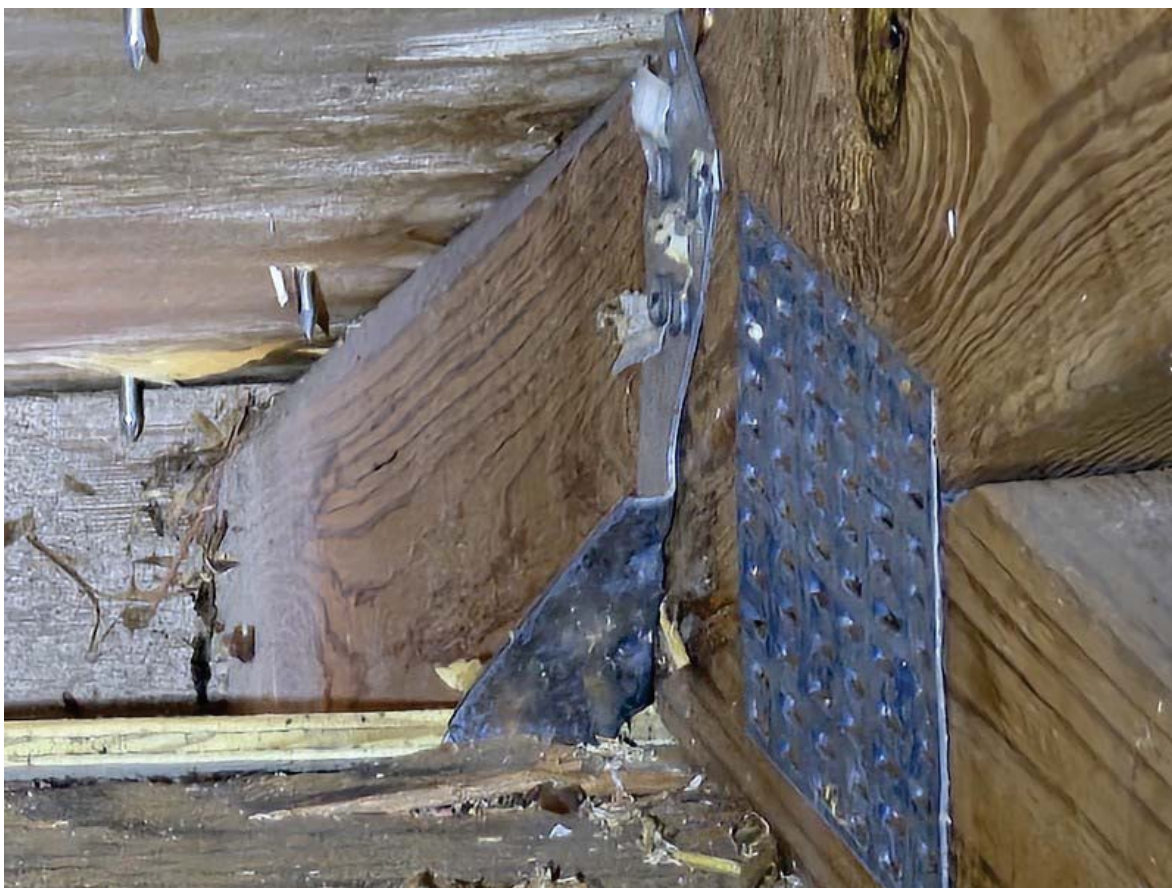
☒ B. Clips

- ☒ Metal connectors that do not wrap over the top of the truss/rafter, **or**
- ☐ Metal connectors with a minimum of 1 strap that wraps over the top of the truss/rafter and does not meet the nail position requirements of C or D, but is secured with a minimum of 3 nails.

ROOF TO WALL - HURRICANE CLIPS - OK
