# Uniform Mitigation Verification Inspection Form

| Inspection Date: 09/11/2024 | | |
| Owner Name: Vintage Grand Condominium Association, Inc. | | Contact Person: |
| Address: 4028 Crockers Lake Blvd | | Home Phone: |

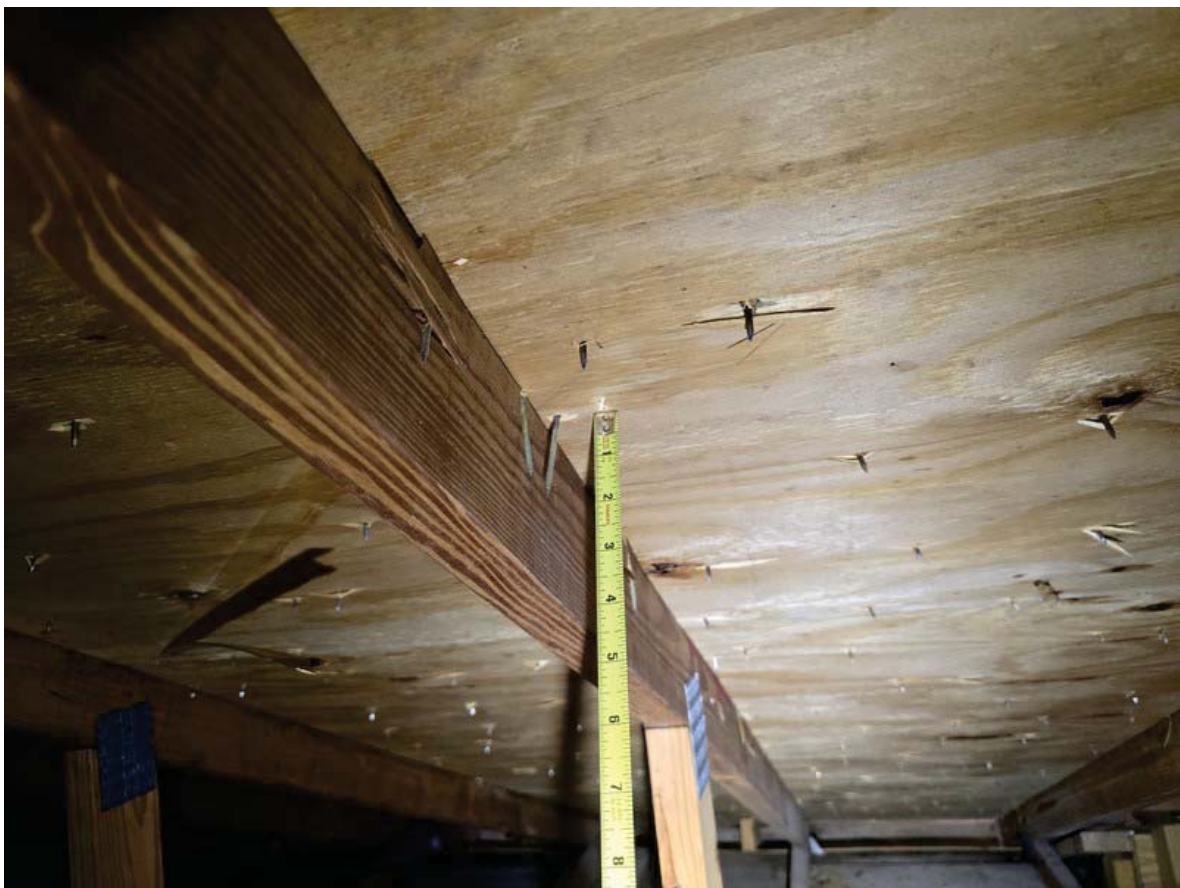
8D NAILS

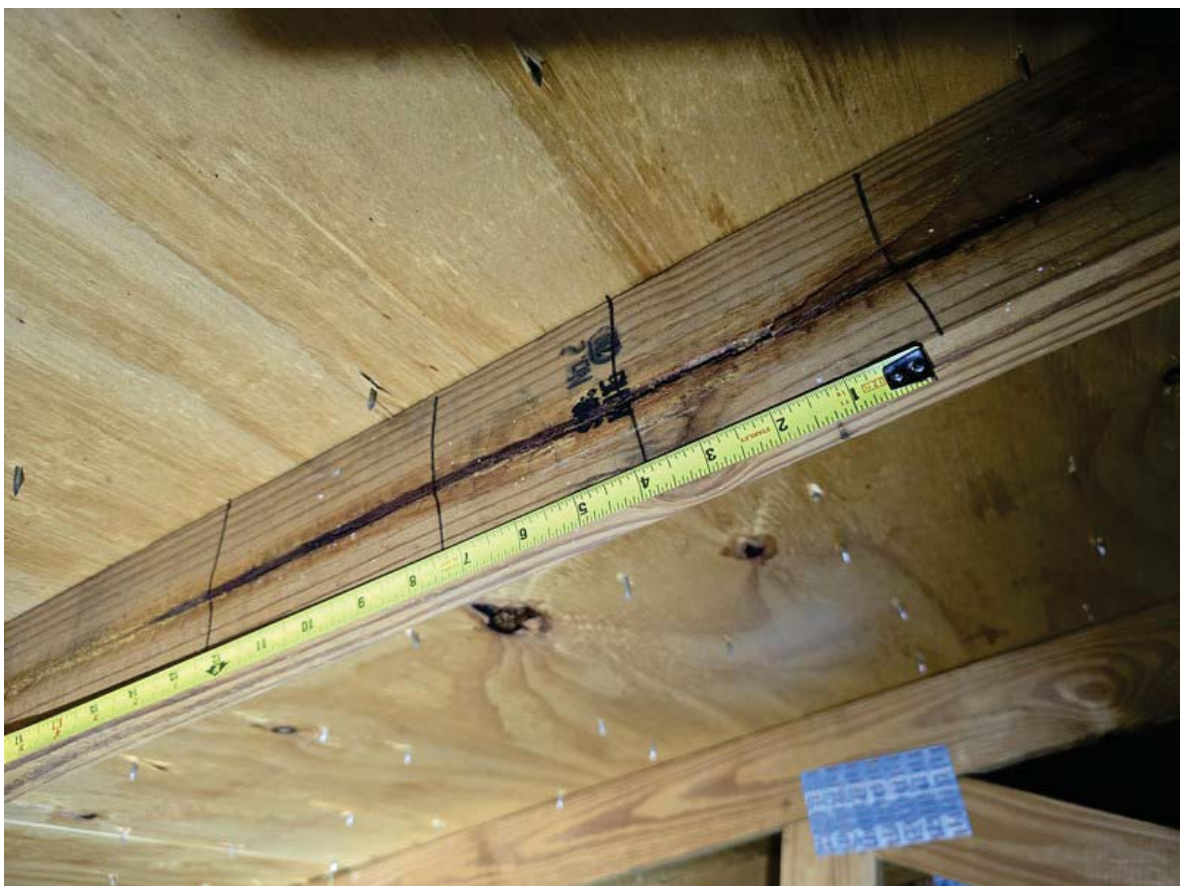
- ☒ C. Plywood/OSB roof sheathing with a minimum thickness of 7/16" inch attached to the roof truss/rafter (spaced a maximum of 24" inches o.c.) by 8d common nails spaced a maximum of 6" inches in the field. -OR- Dimensional lumber/Tongue & Groove decking with a minimum of 2 nails per board (or 1 nail per board if each board is equal to or less than 6 inches in width). -OR- Any system of screws, nails, adhesives, other deck fastening system or truss/rafter spacing that is shown to have an equivalent

ROOF DECK NAILED EVERY 6" IN FIELD OR BETTER OK

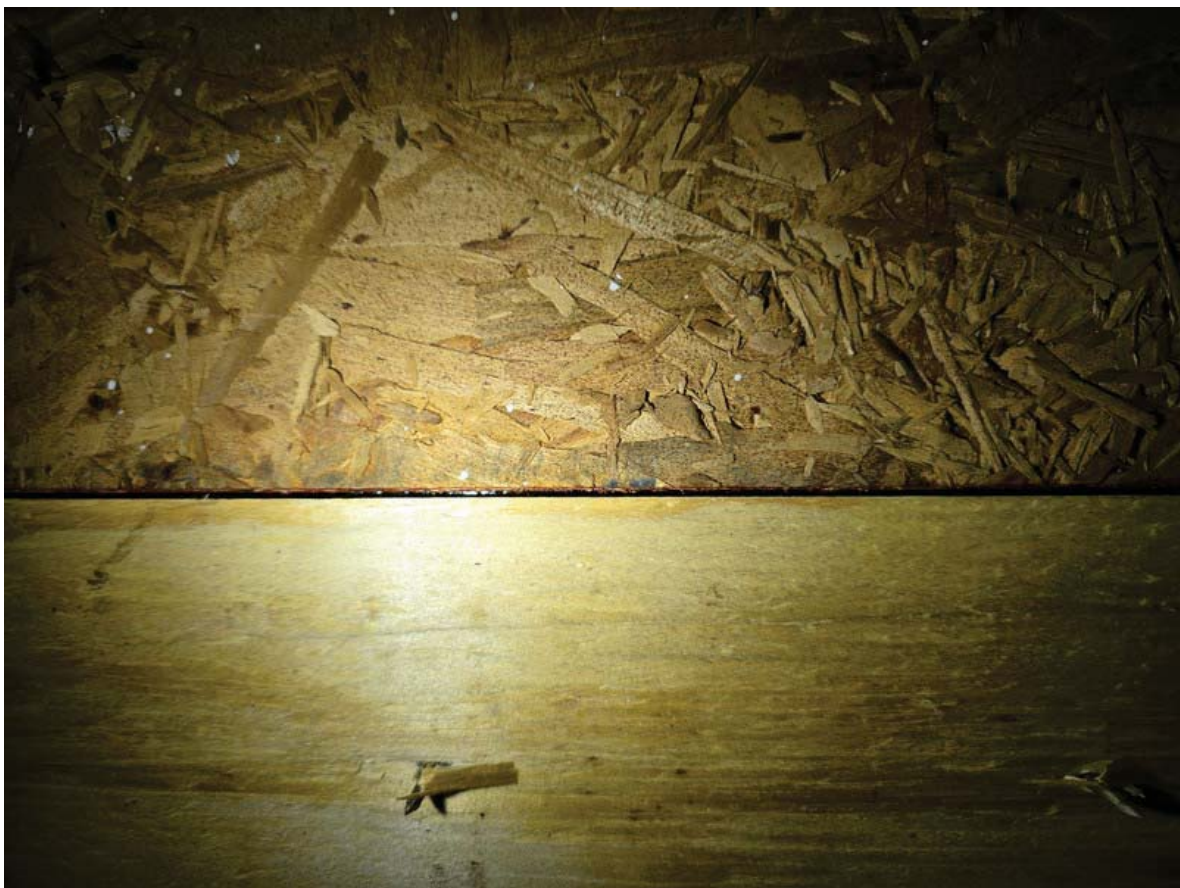
- ☒ A. SWR (also called Sealed Roof Deck) Self-adhering polymer modified-bitumen roofing underlayment applied directly to the sheathing or foam adhesive SWR barrier (not foamed-on insulation) applied as a supplemental means to protect the dwelling from water intrusion in the event of roof covering loss.
- ☐ B. No SWR.
- ☐ C. Unknown or undetermined.

SWR

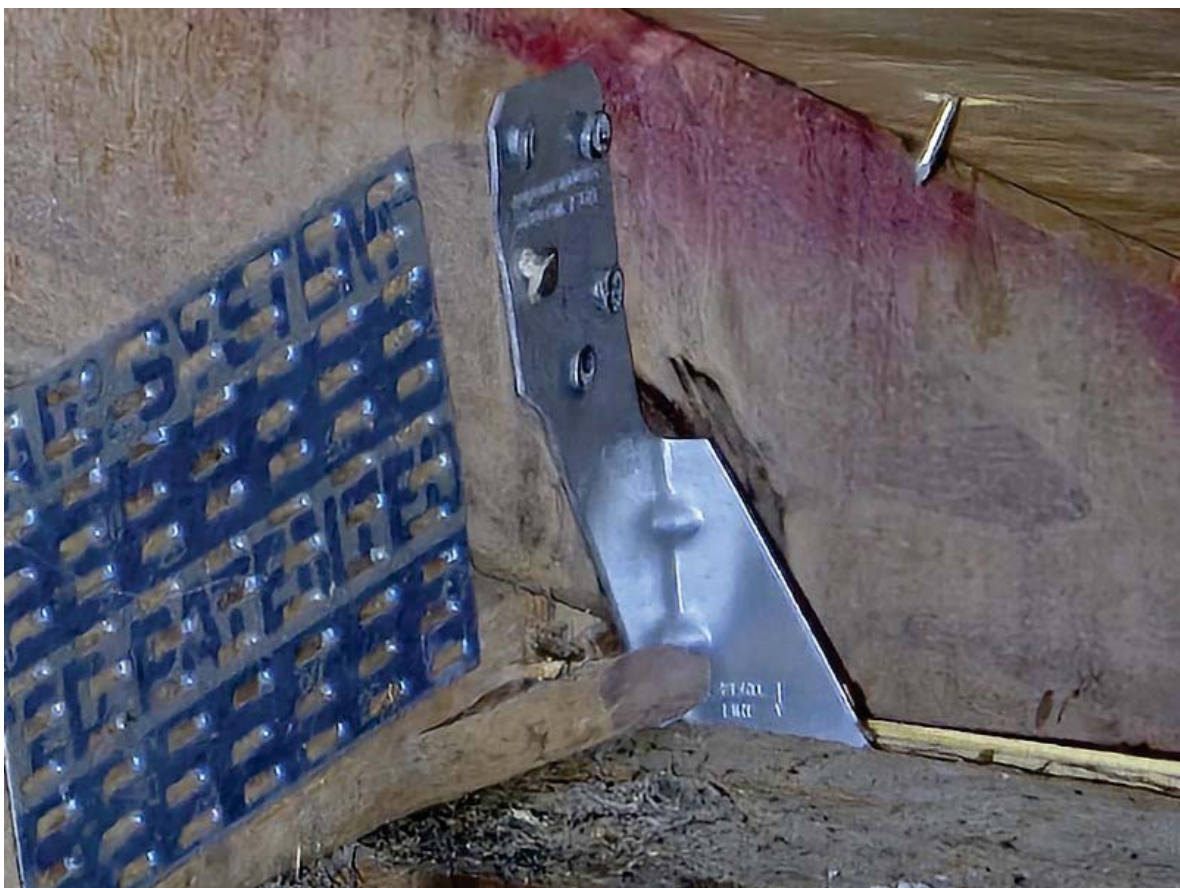
☒ B. Clips

- ☒ Metal connectors that do not wrap over the top of the truss/rafter, **or**
- ☐ Metal connectors with a minimum of 1 strap that wraps over the top of the truss/rafter and does not meet the nail position requirements of C or D, but is secured with a minimum of 3 nails.

ROOF TO WALL - HURRICANE CLIPS - OK
