# Uniform Mitigation Verification Inspection Form

| Inspection Date: 09/11/2024 | | |
| Owner Name: Vintage Grand Condominium Association, Inc. | | Contact Person: |
| Address: 4036 Crockers Lake Blvd | | Home Phone: |

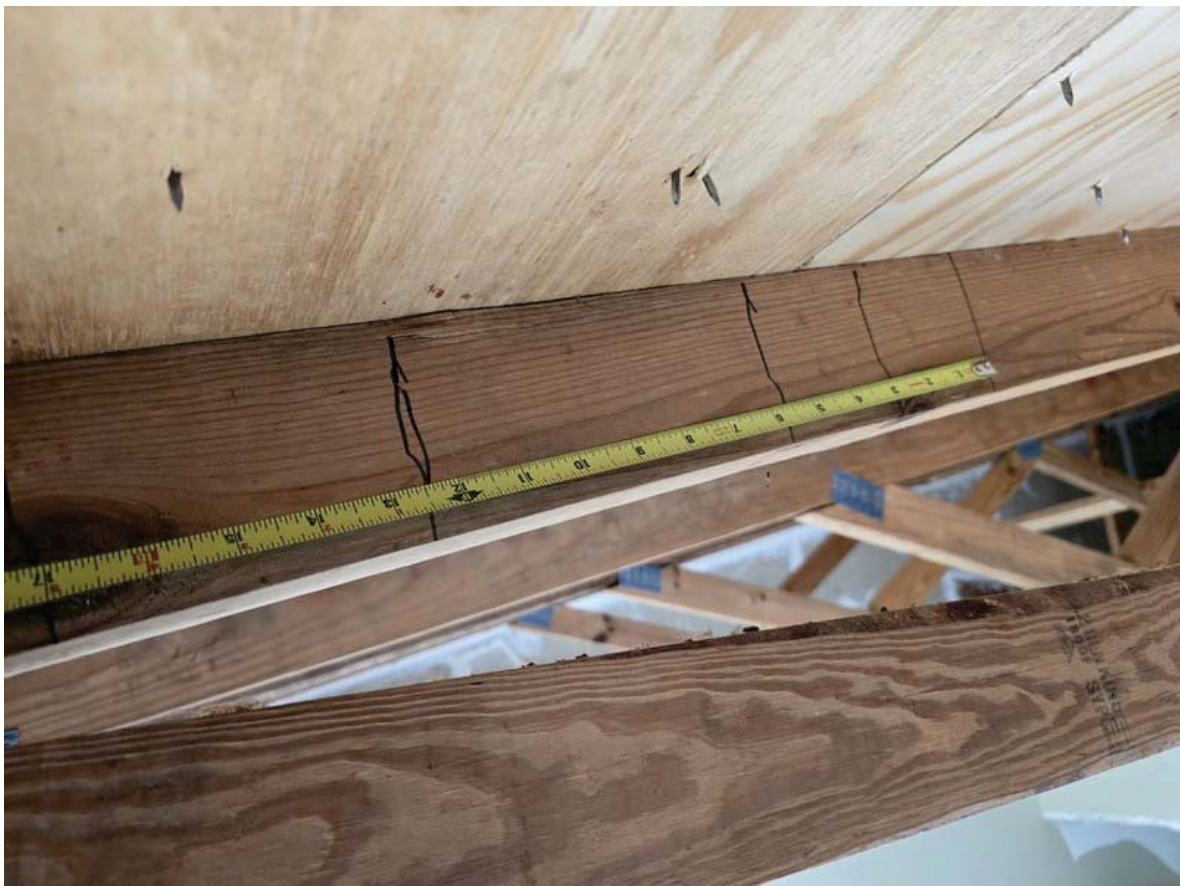
- ☒ C. Plywood/OSB roof sheathing with a minimum thickness of 7/16" inch attached to the roof truss/rafter (spaced a maximum of 24" inches o.c.) by 8d common nails spaced a maximum of 6" inches in the field. -OR- Dimensional lumber/Tongue & Groove decking with a minimum of 2 nails per board (or 1 nail per board if each board is equal to or less than 6 inches in width). -OR- Any system of screws, nails, adhesives, other deck fastening system or truss/rafter spacing that is shown to have an equivalent

ROOF DECK NAILED EVERY 6" IN FIELD OR BETTER OK

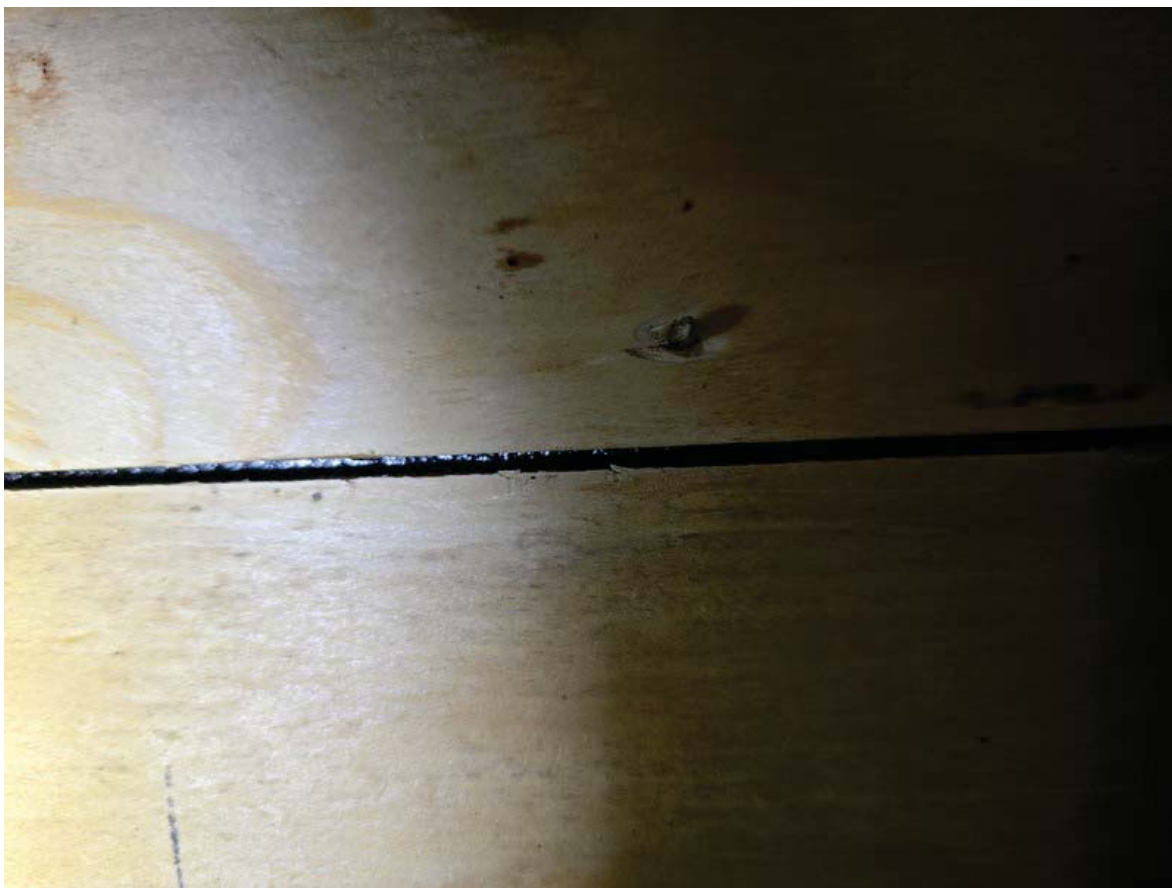
- ☒ A. SWR (also called Sealed Roof Deck) Self-adhering polymer modified-bitumen roofing underlayment applied directly to the sheathing or foam adhesive SWR barrier (not foamed-on insulation) applied as a supplemental means to protect the dwelling from water intrusion in the event of roof covering loss.
- ☐ B. No SWR.
- ☐ C. Unknown or undetermined.

SWR

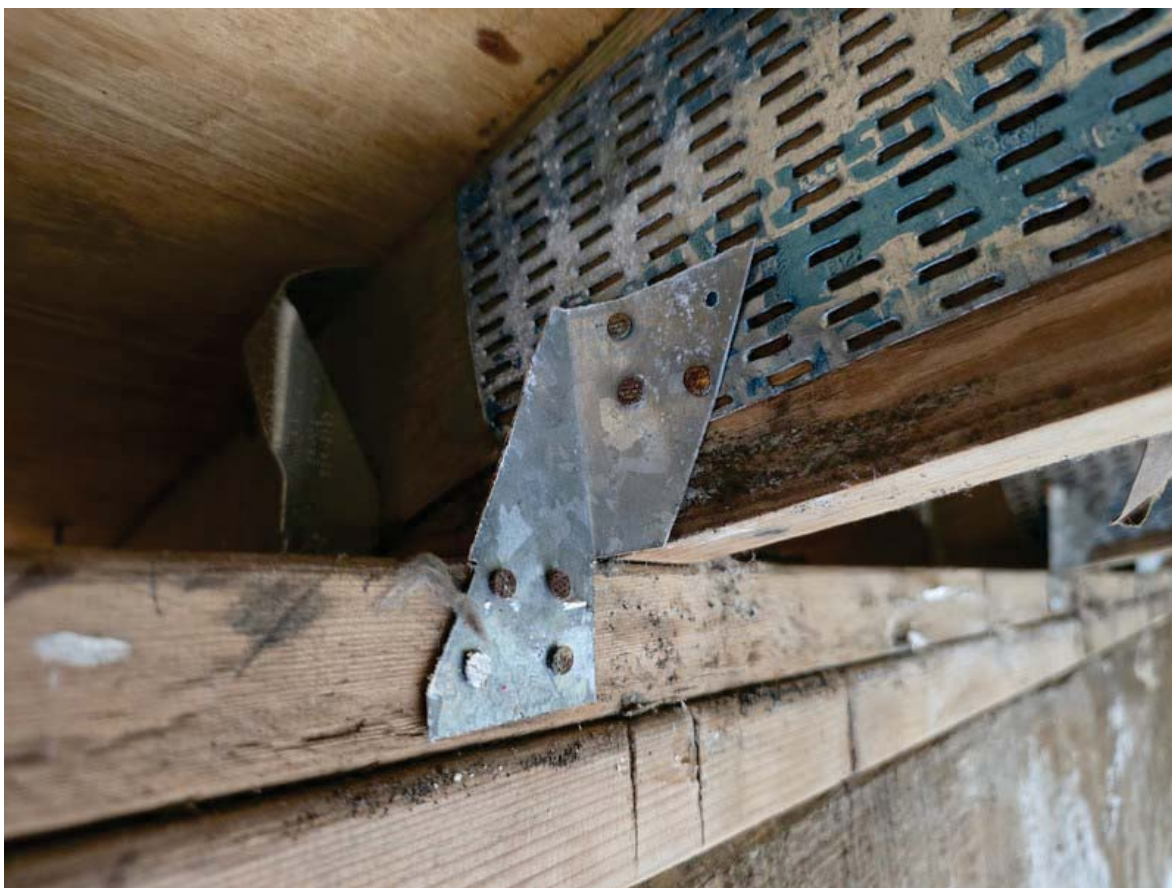
- ☒ Secured to truss/rafter with a minimum of three (3) nails **and**
- ☒ Attached to the wall top plate of the wall framing, or embedded in the bond beam, with less than a 1/2" gap from the blocking or truss/rafter **and** blocked no more than 1.5" of the truss/rafter **and** free of visible severe corrosion.

☒ B. Clips

- ☒ Metal connectors that do not wrap over the top of the truss/rafter, **or**
- ☐ Metal connectors with a minimum of 1 strap that wraps over the top of the truss/rafter and does not meet the nail position requirements of C or D, but is secured with a minimum of 3 nails.

ROOF TO WALL - HURRICANE CLIPS - OK
