HEADQUARTERS
6497 PARKLAND DR., STE. C
SARASOTA, FLORIDA 34243
PH: 941-727-2600 FX: 941-758-5012
www.delta-engineers.com

Project No. R1610-042

Mr. Bob Kresnik
Vintage Grand Condominium Association, Inc.
4012 Crockers Lake Blvd.
Sarasota, Florida 34238

RE: DRAFT Attic Survey – Vintage Grand

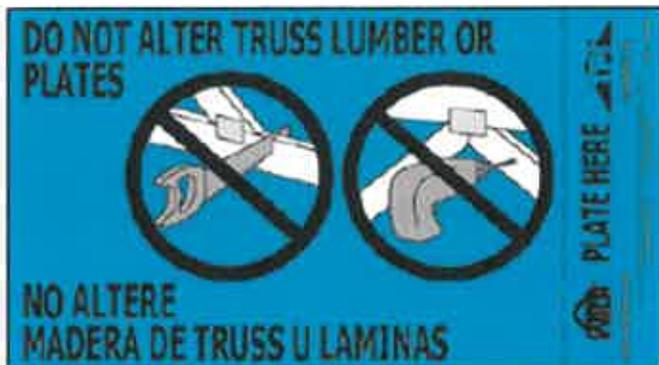
FIGURE B5-1

✔ Some Truss Manufacturers will mark the Trusses with warnings against jobsite modifications. An example of one such supplemental marking is the Truss tag shown in Figure B5-1.

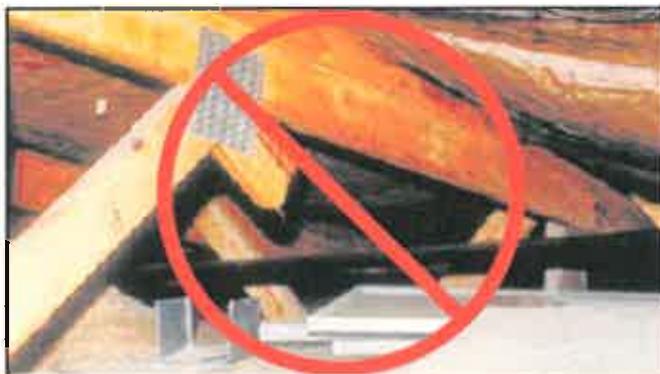
PHOTO B5-1

❌ **DON'T** cut Truss Webs. The modification shown in Photo B5-1 requires a repair.
