FIELD OBSERVATION REPORT - Bldg #14

Permit No. 18-131555-00 DC
 Owner: Vinager Grand Centro Assn, Inc.
 Project Address: 4017 Crookers Lake Blvd., Sarasota, FL
 Contractor: RL James Inc.
 Inspector (s): Mark Boss / Mike James
 Type of Assessment: Progress

Project: R1603-302D
 Contact: Glenn Asbill
 Phone/Fax: (941) 923-7390
 Contact: Craig Nicholas / Robert Barncombe
 Phone: (941) 232-6486 / (239) 379-1978

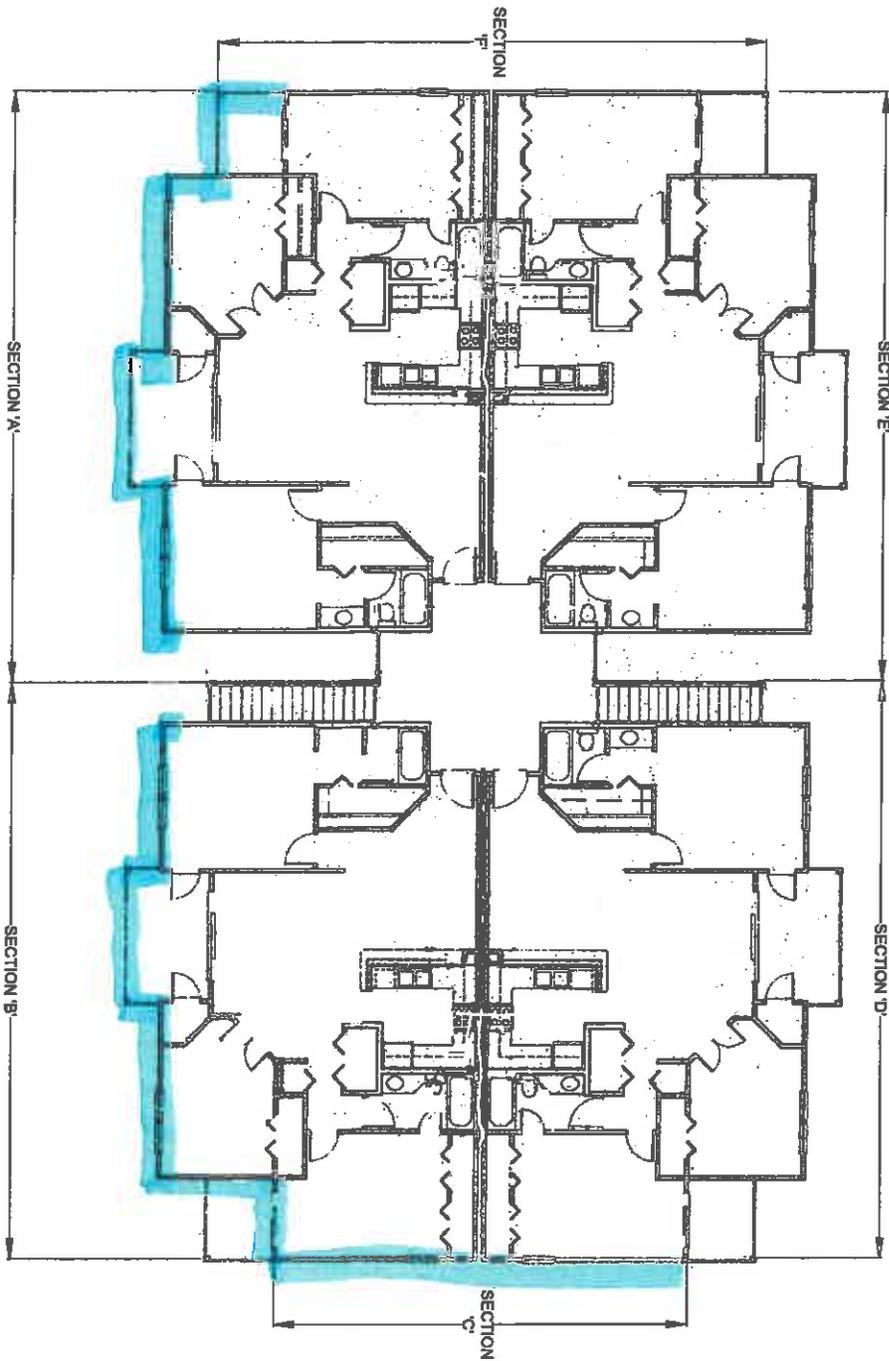
**BUILDING 14
ELEVATION E**

As defined by OSHA, scaffolding must be designed by qualified person. Erection, dismantling, moving or altering must be supervised by competent person. The access ladder is not correct or the rail in place at wallboards between platforms. Contractor will make corrections as per OSHA regulations.
