**FIELD OBSERVATION REPORT - Bldg #14**

Permit No. 18-131555-00 BC  
Owner: Village Grand Condo Assn, Inc.  
Project Address: 4017 Crookers Lake Blvd., Sarasota, FL  
Contractor: RL James Inc  
Inspector (s): Mark Boss PM / Mike Jones  
Type of Assessment: Progress

Project: R1503-302D  
Contact: Glenn Atelli  
Phone/Fax: (941) 923-7380  
Contact: Craig Nicholas / Robert Branscombe  
Phone: (941)232-6486 / (239) 379-1978

**FIELD OBSERVATION REPORT - Bldg #25**

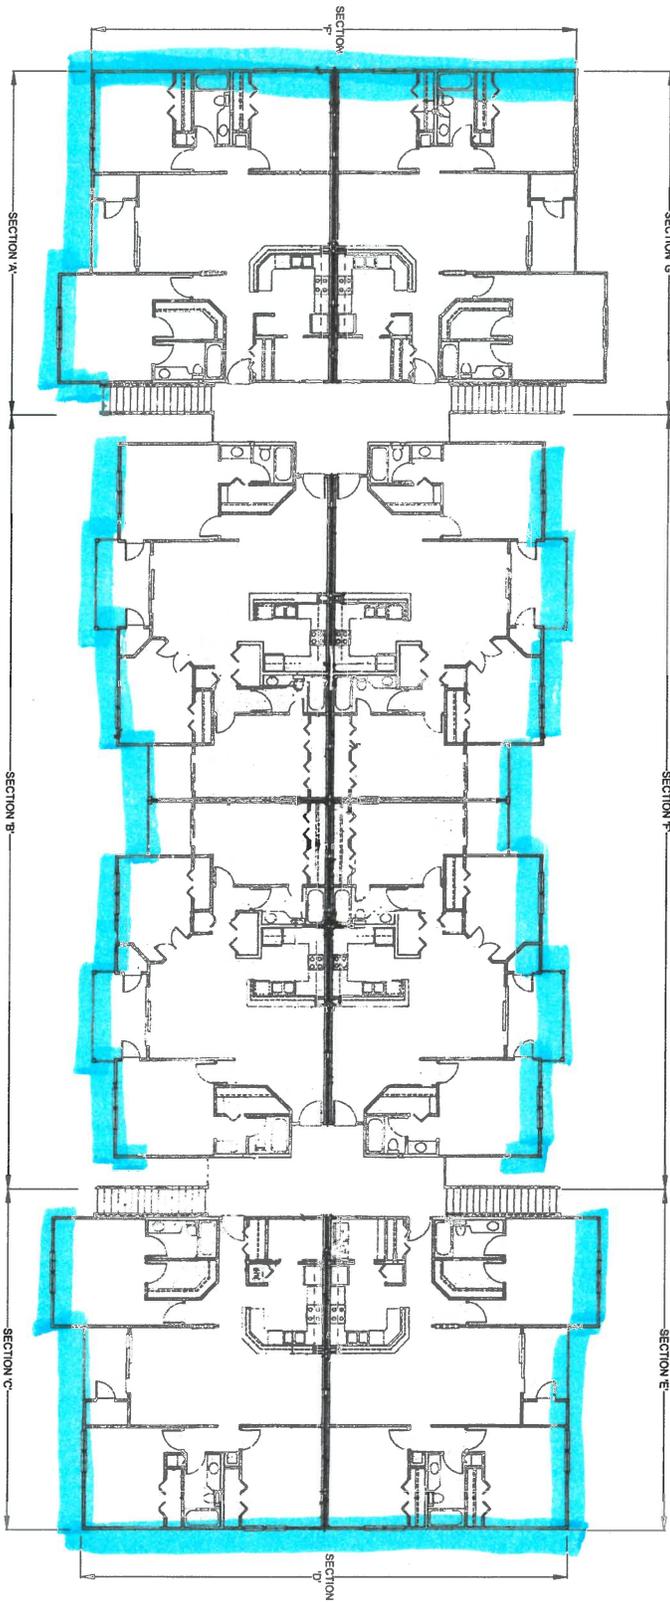
1 BUILDING #25 FLOOR PLAN - TYPE 1  
 S-1.0 SCALE: N.T.S.

Drywall has been installed prior to finish bead of sealant being installed at window perimeter. Contractor will remove drywall and complete window installation as per drawing and specifications.
